Inspection Report (Skip Loader)

Year	2004
Make	Case
Model	570MXT
Serial Number	JJG0301527
Hour Meter Reading	800.00 + 5,090 = both hour meters
Previous Application (e.g., earth moving, mining, demolition, etc)	General Construction

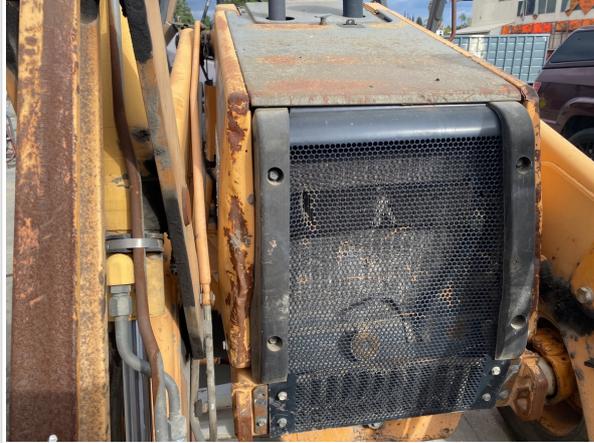
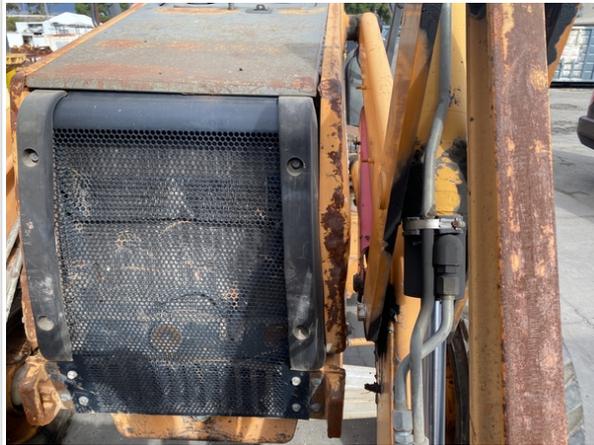
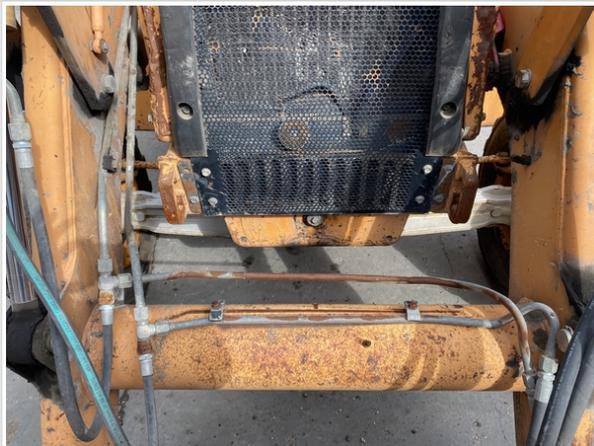
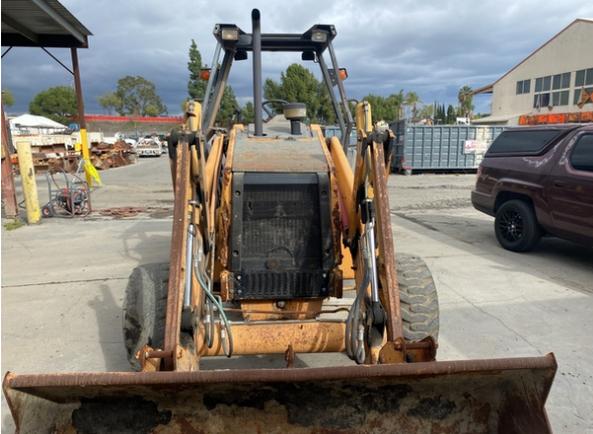
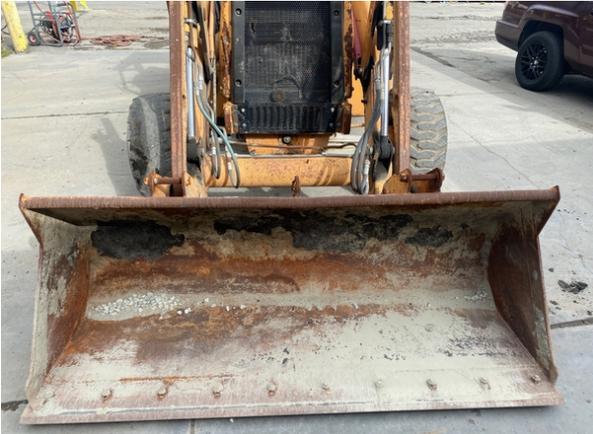
Front Photos

Front	3 - Normal Wear & Tear
Front Condition	Other (see comments), Large dents or cracks
Comments	Front outside of hood damaged on both sides

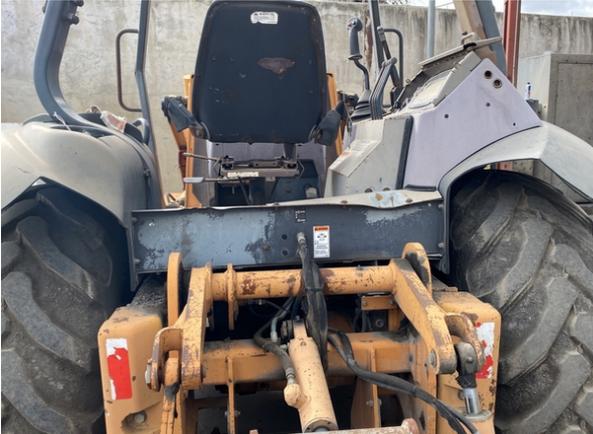
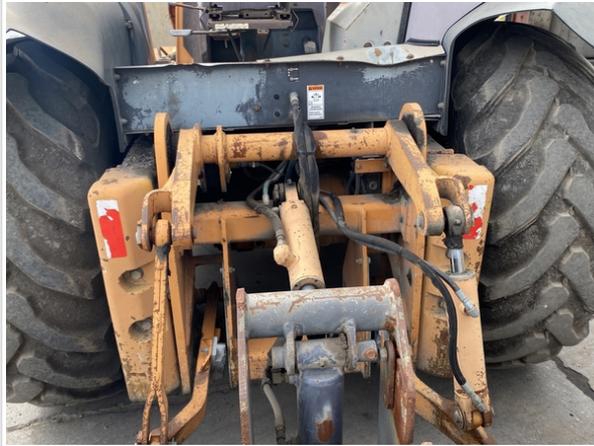
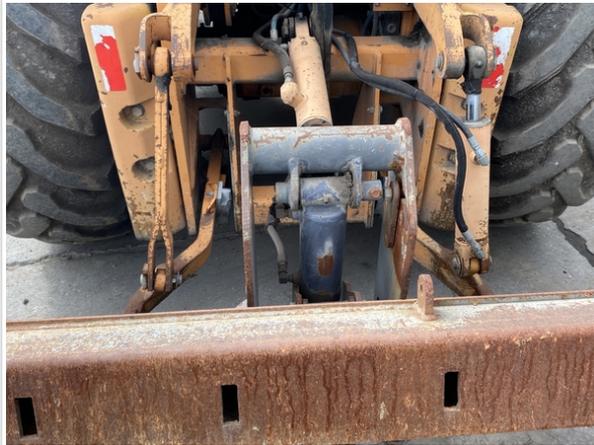
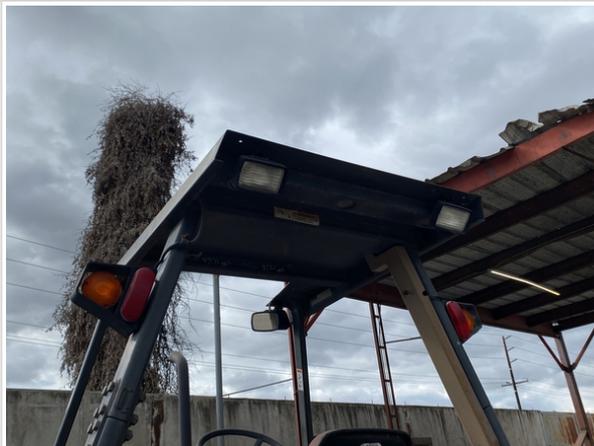
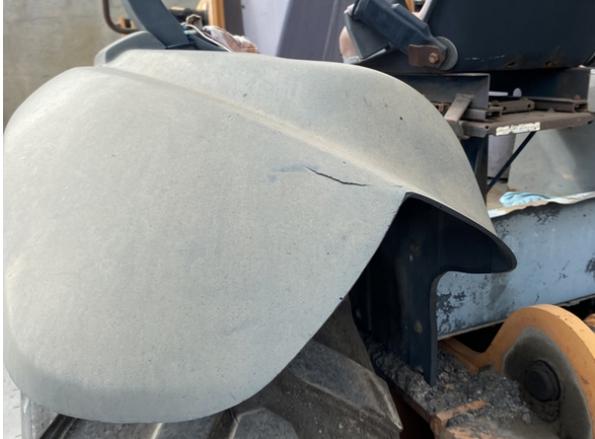
Rear	3 - Normal Wear & Tear
Rear Condition	Other (see comments)
Comments	Normal scuff marks, small crack at left fender, rear panel bent
Rear Photos

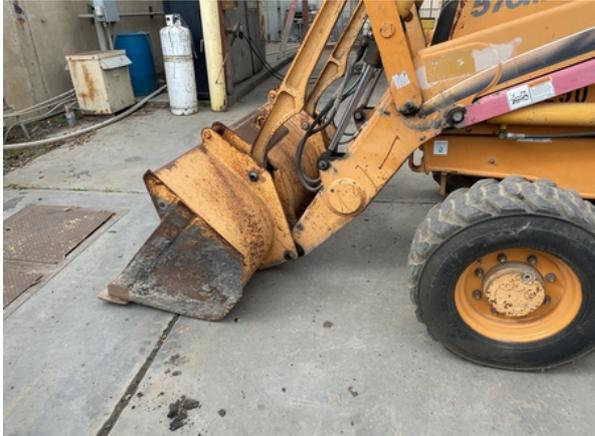
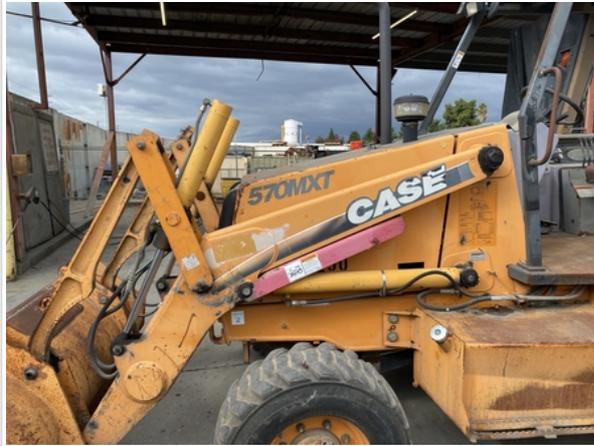
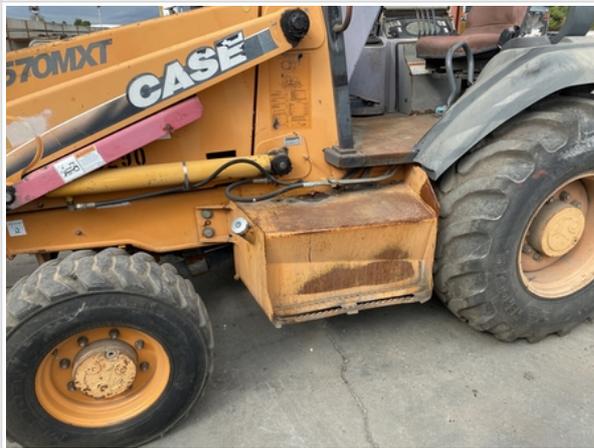
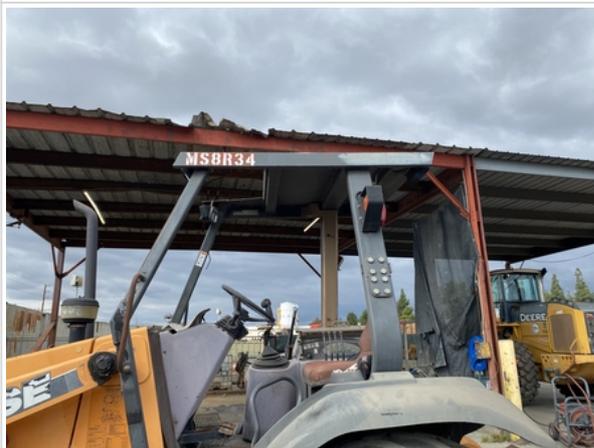
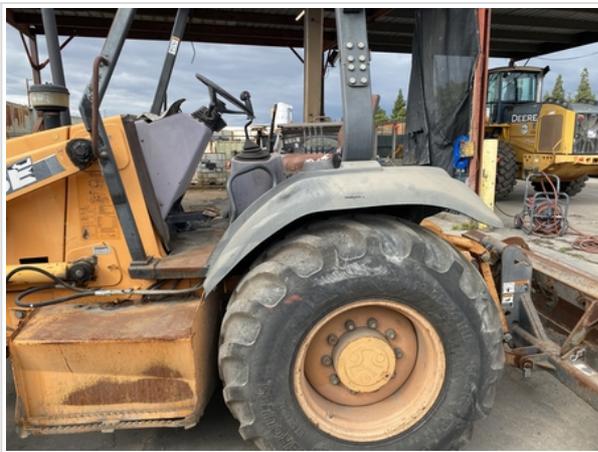
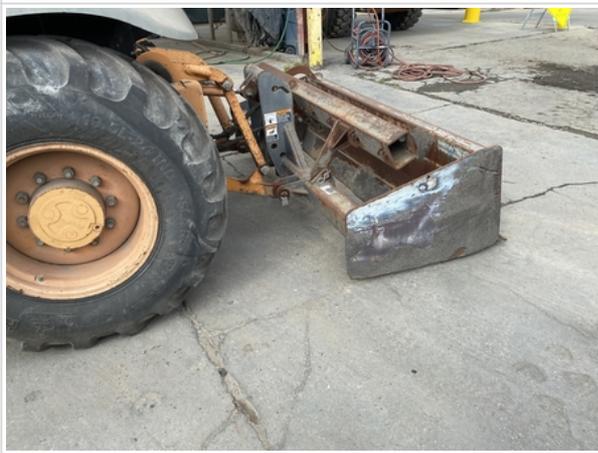
Left	3 - Normal Wear & Tear
Left Condition	No visible damage, Other (see comments)
Comments	Normal wear and tear
Left Photos

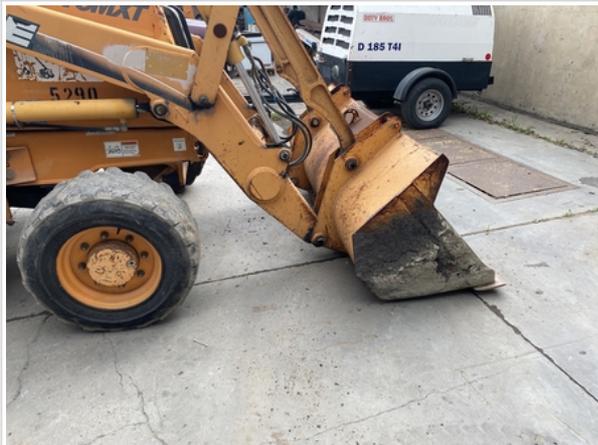
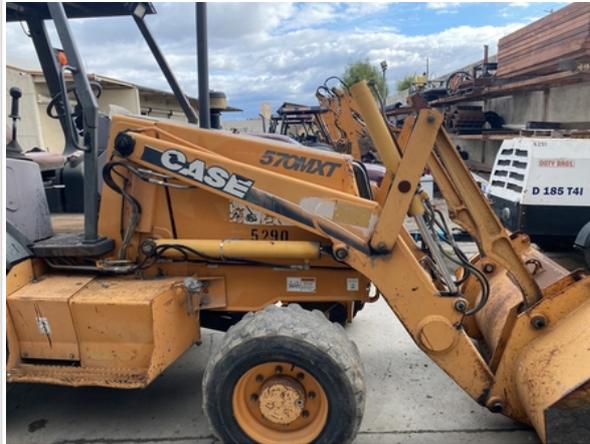
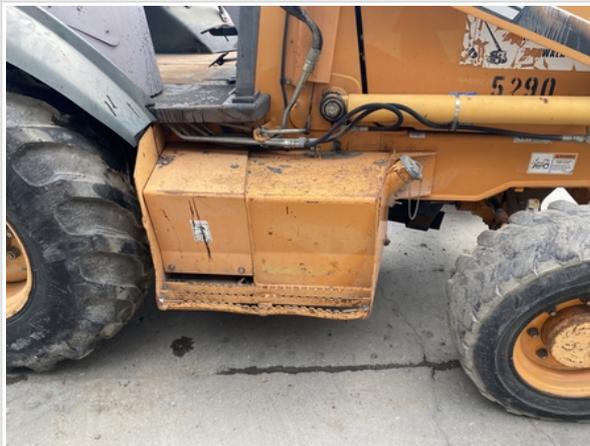
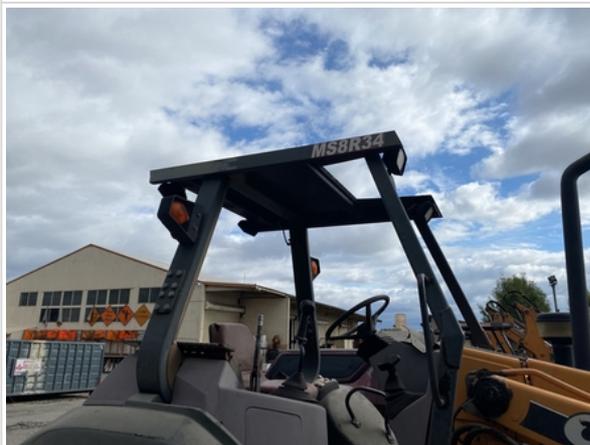
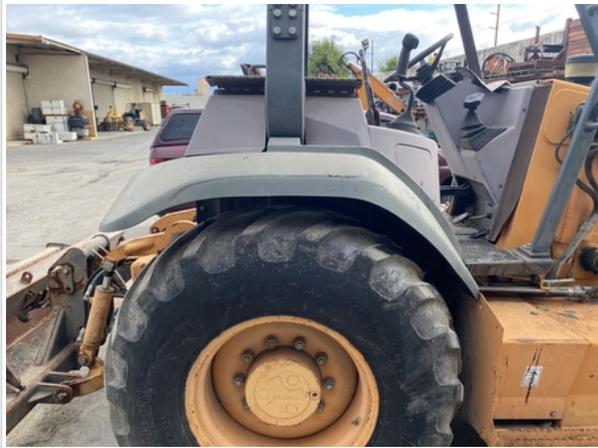
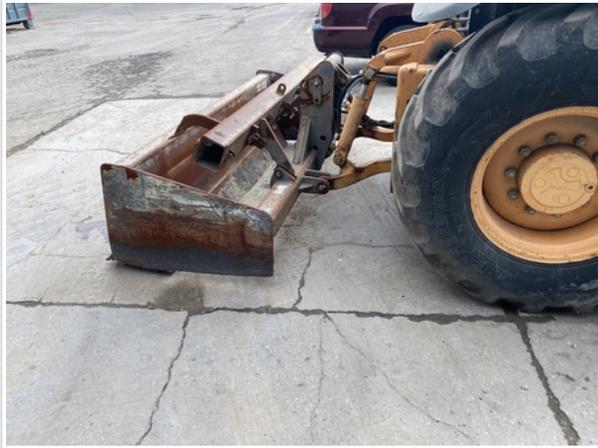
Right	3 - Normal Wear & Tear	
Right Condition	No visible damage	
Right Photos

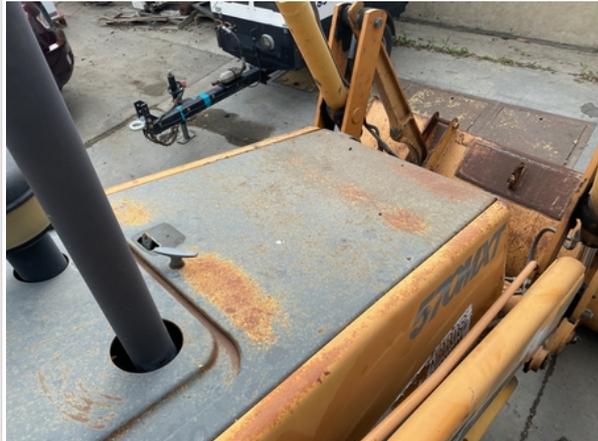
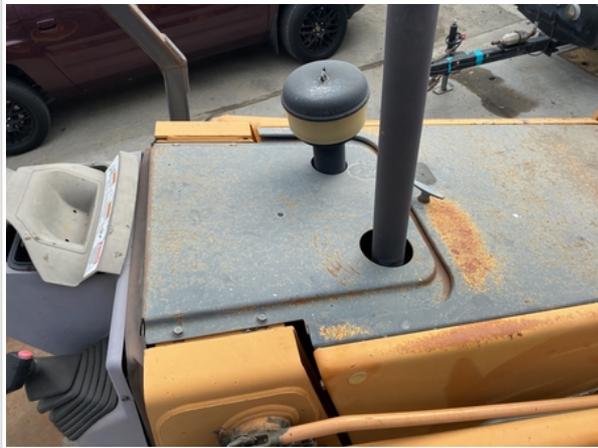
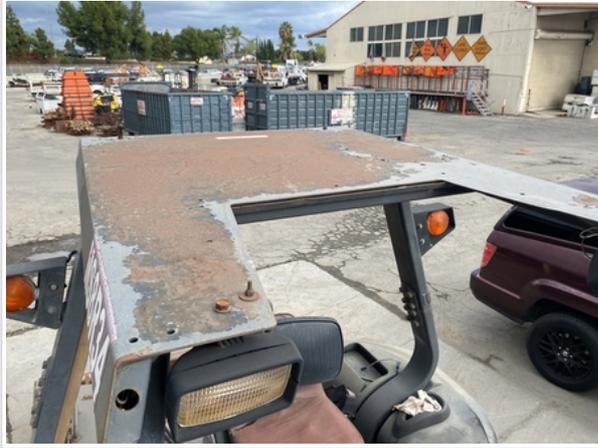
Upper	3 - Normal Wear & Tear
Upper Condition	No visible damage, Other (see comments)
Upper Photos

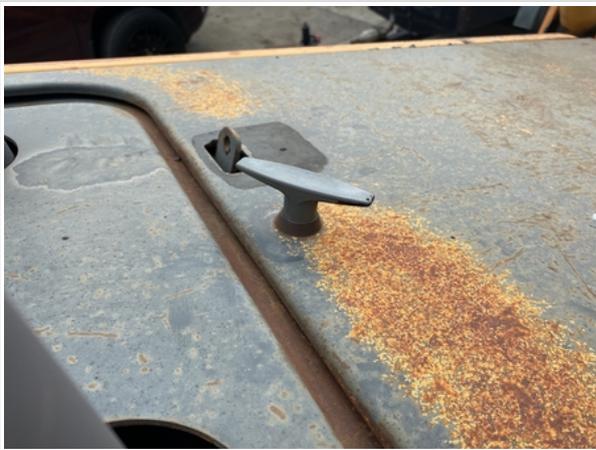
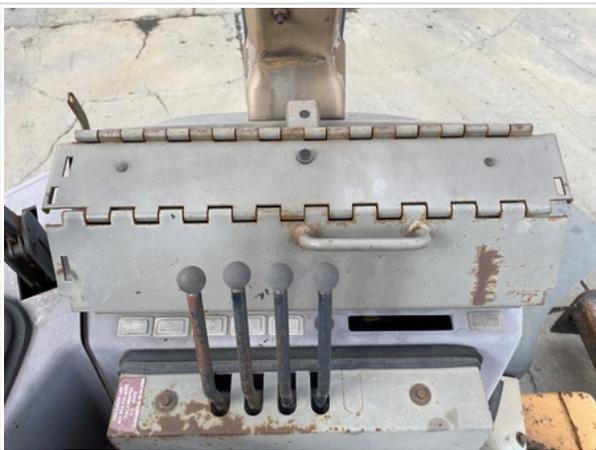
Doors / Canopy Latches Photos

Doors / Canopy Latches	3 - Normal Wear & Tear
Doors / Canopy Latches Condition	No visible damage

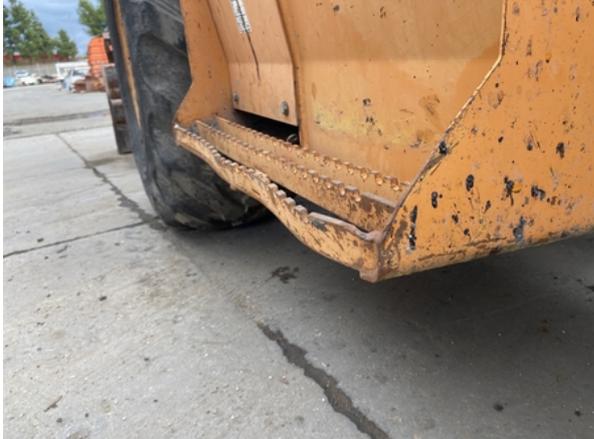
Steps / Ladders	3 - Normal Wear & Tear
Steps / Ladders Condition	Steps/ladders are fully intact and appear structurally sound, Bent or broken steps or rungs, Other (see comments)
Comments	Steps bent slightly
Steps / Ladders Photos

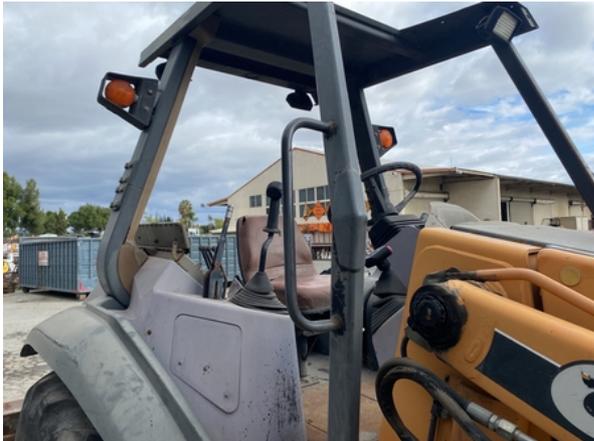
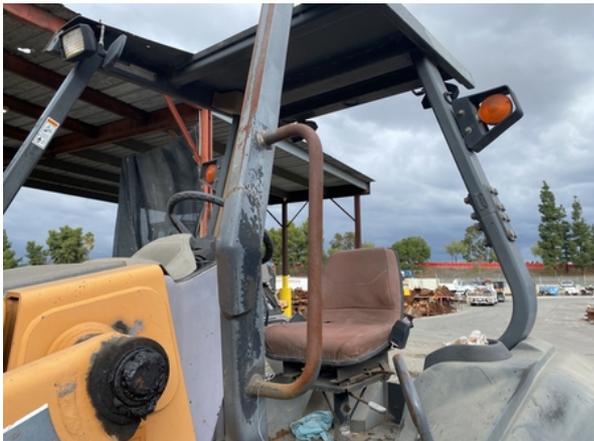
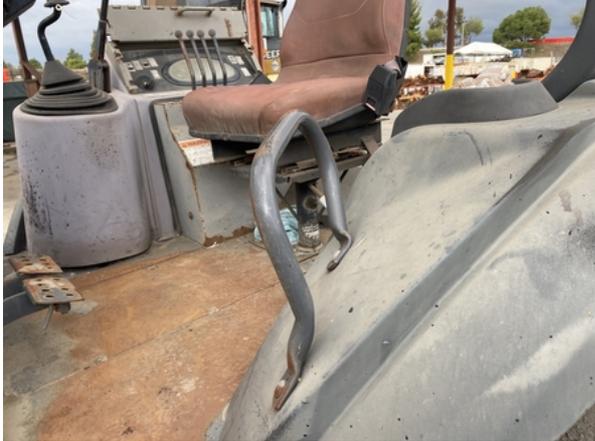
Handrails	3 - Normal Wear & Tear	
Handrails Condition	Handrails are fully intact and appear structurally sound	
Handrail Photos

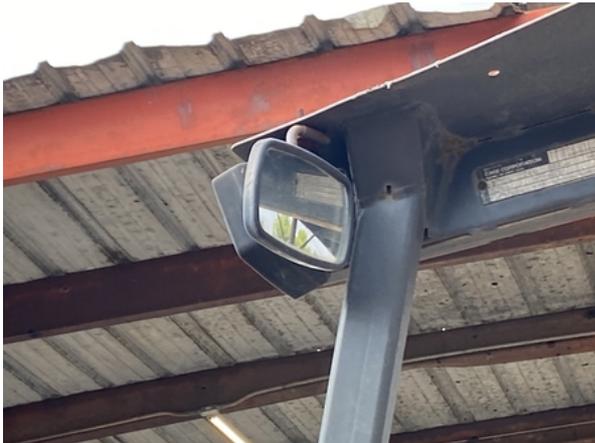
Glass Condition	0	
Mirrors	3 - Normal Wear & Tear	
Mirror Condition Notes	Mirrors present and intact, no visible damage	
Mirrors Photos

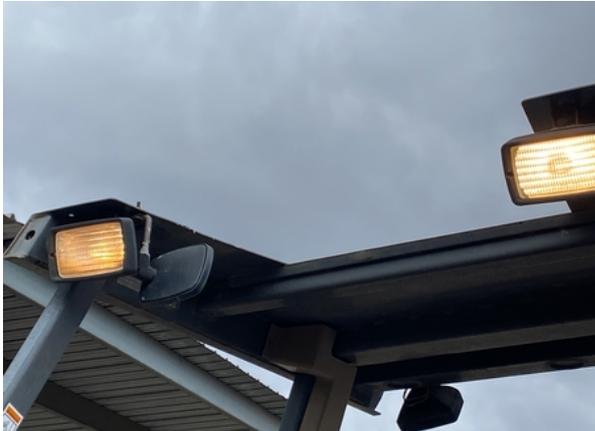
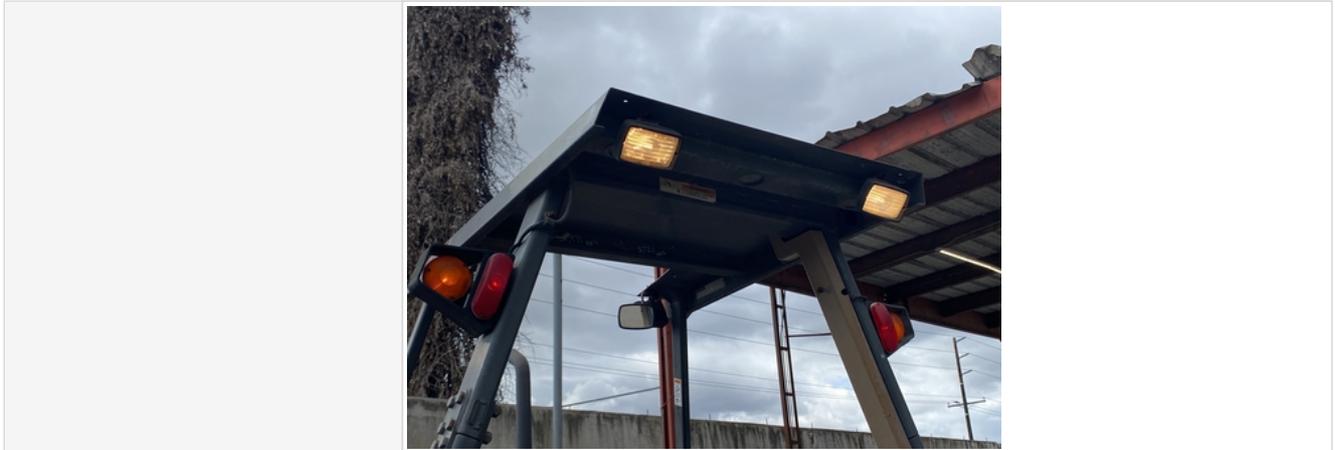
Lighting System	3 - Normal Wear & Tear	
Lighting System Condition	No visible damage, lighting system is operational	
Lighting System Photos

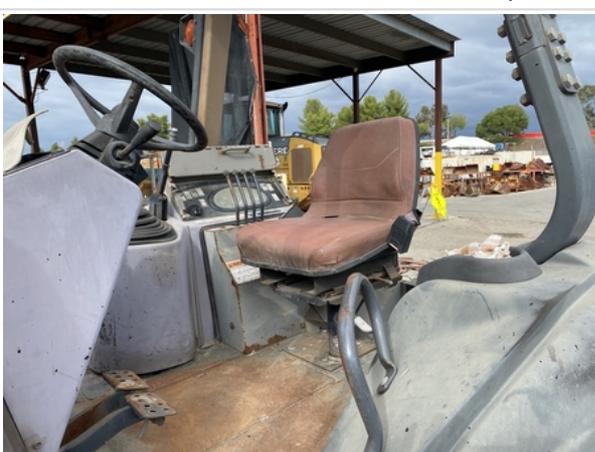
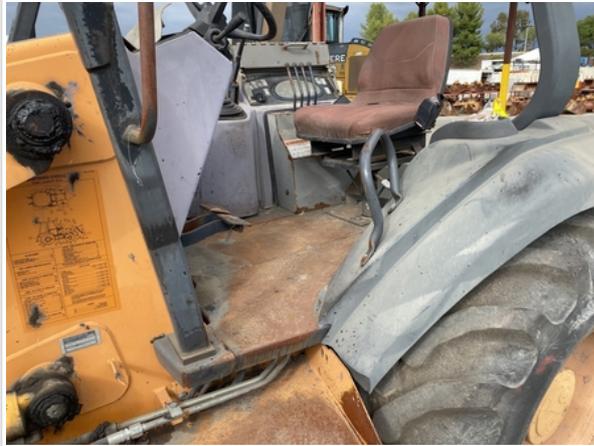
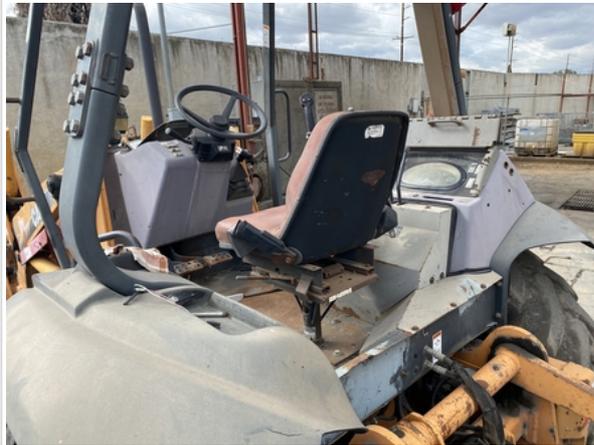
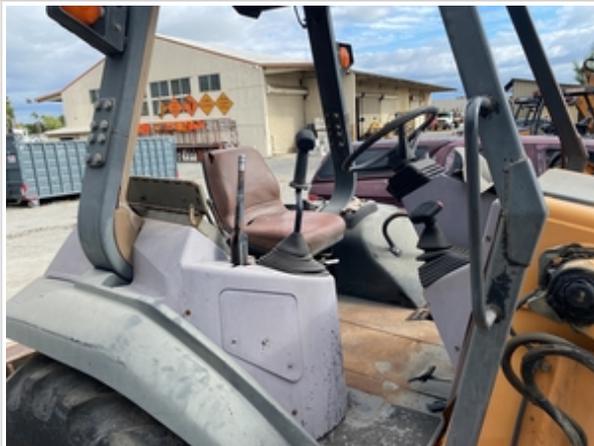
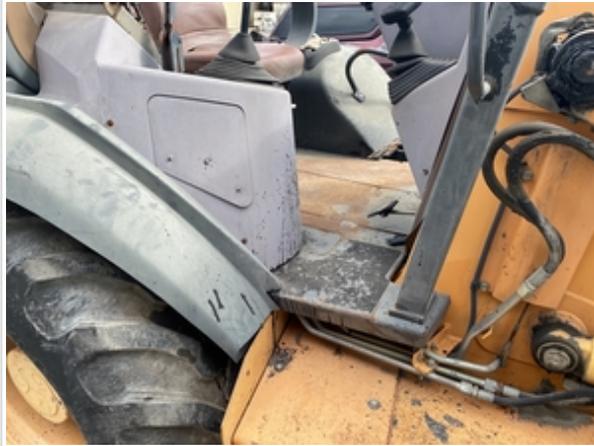
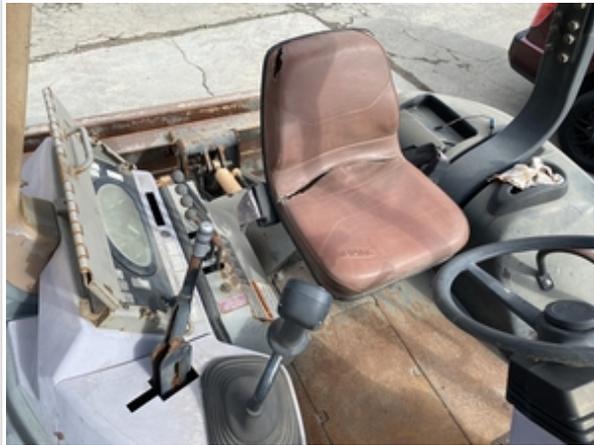
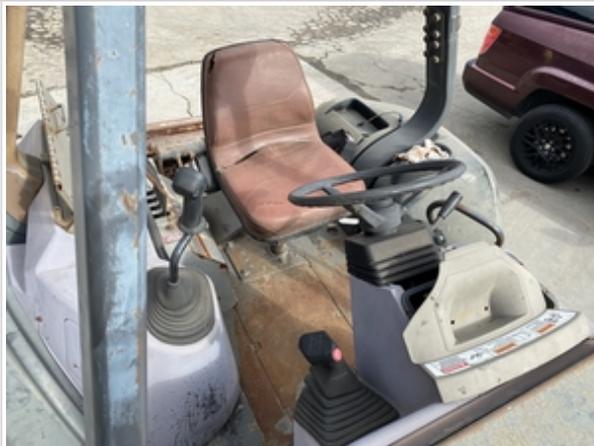
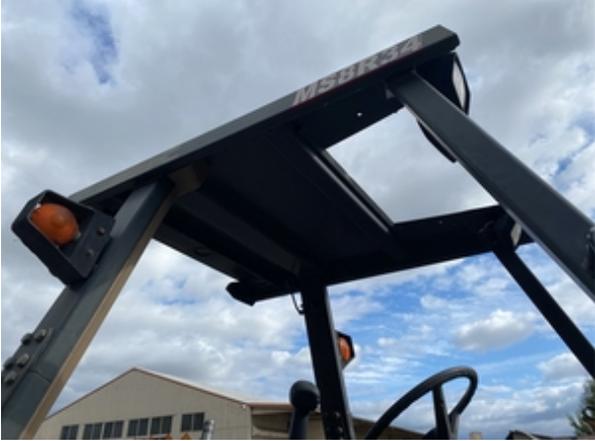
Operator Cabin Overall	3 - Normal Wear & Tear
Operator Cabin Overall Condition	Minor cosmetic wear to cabin surfaces, floors, panels, and ceiling
Operator Cabin Photos

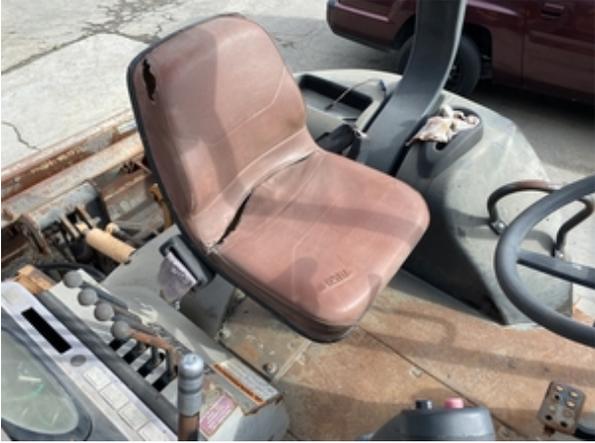
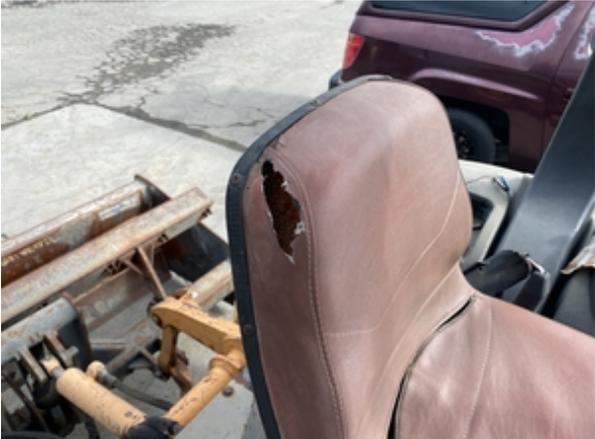
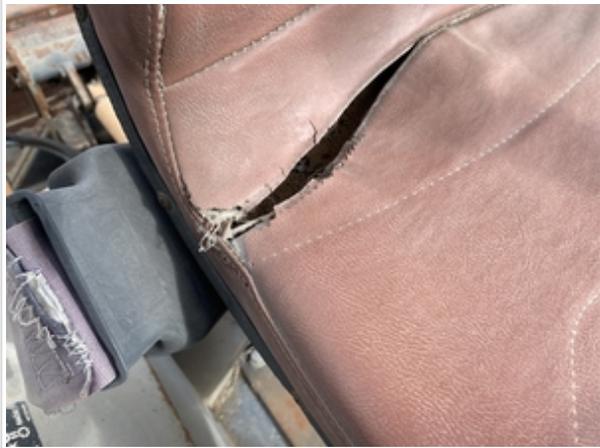
Operator's Seat & Arm Rests	3 - Normal Wear & Tear	
Operator's Seat & Arm Rests Condition	Seat(s) have minor surface staining or small tears	
Operator's Seat & Arm Rests Photos

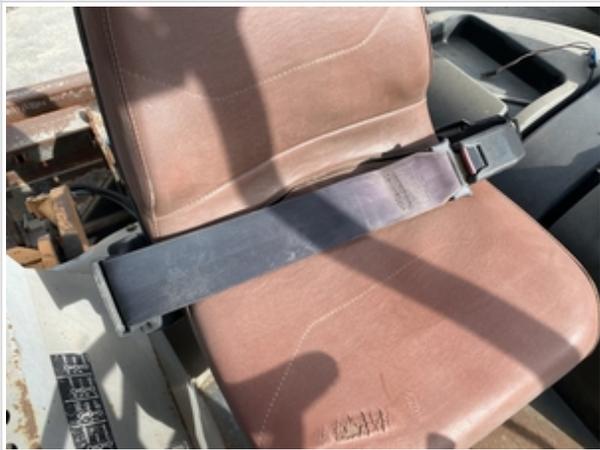
Seat Belt	3 - Normal Wear & Tear	
Seat Belt Condition	Seat belt secures properly. Belt is intact and in good condition	
Seat Belt Photos

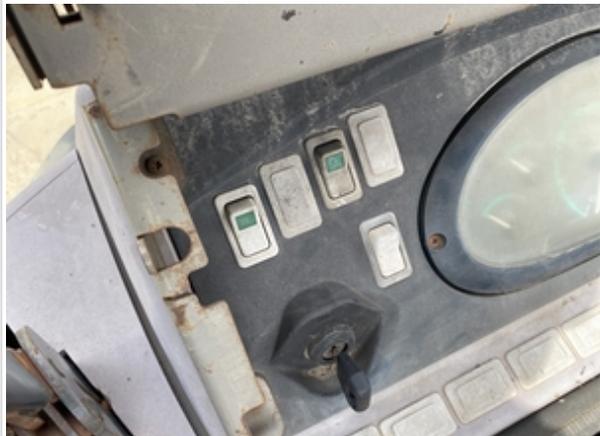
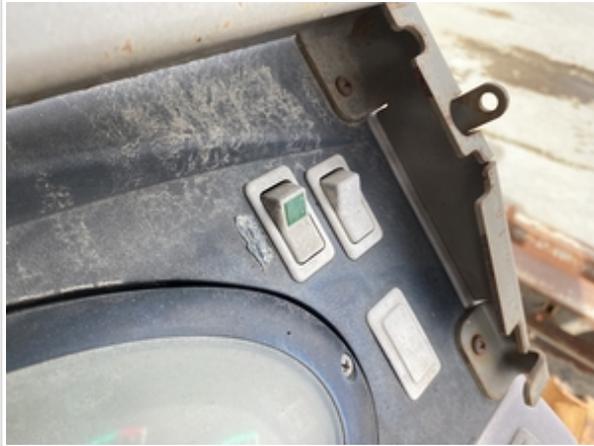
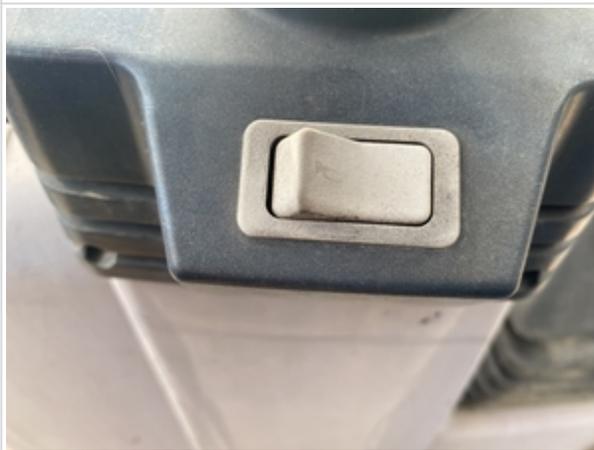
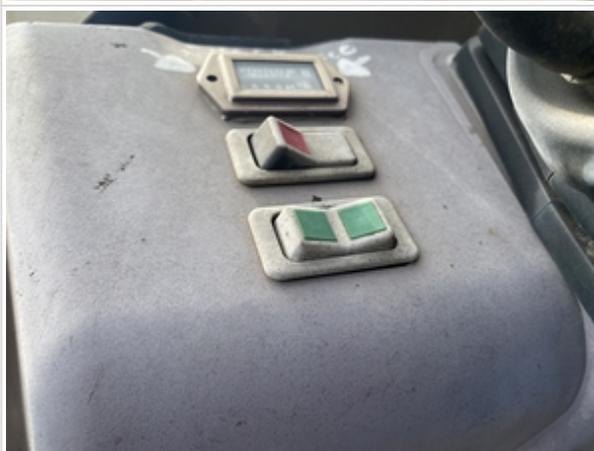
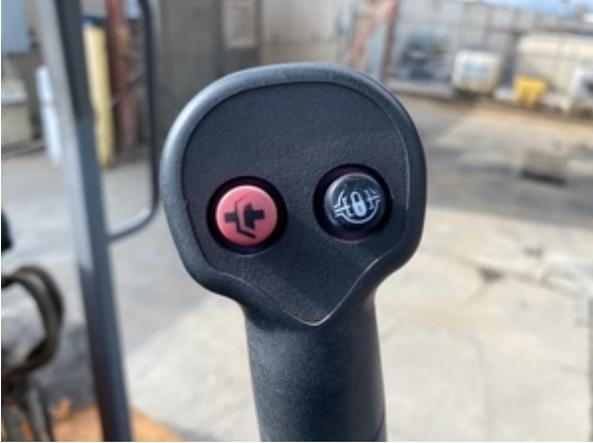
Cabin Lights	0	
Safety Lock Out / Stop	0	
Controls & Switches	3 - Normal Wear & Tear	
Controls & Switches Condition	All switches are installed and functional	
Controls & Switches Photos

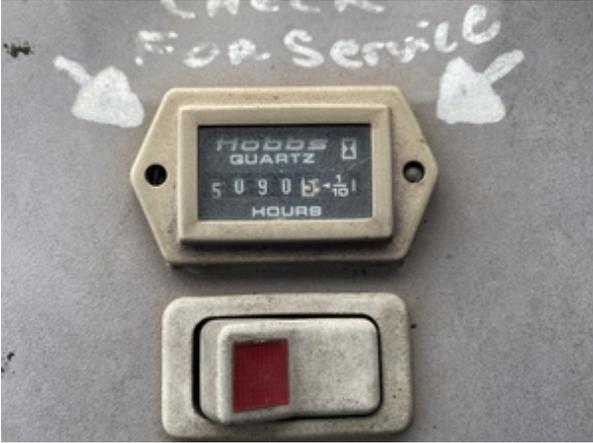
Hour Meter Activity	3 - Normal Wear & Tear
Hour Meter Condition	Hour meter is functional and in good condition
Hour Meter Activity Photos

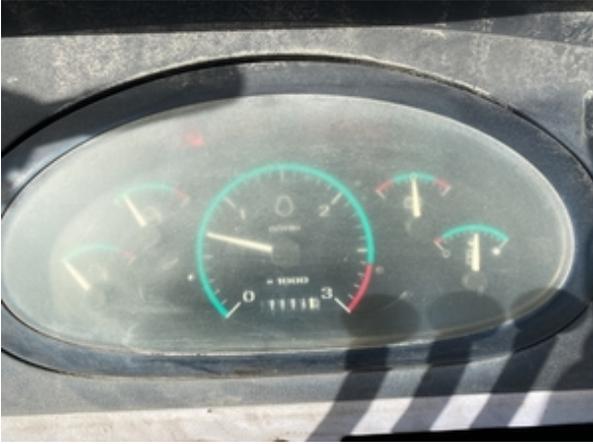
Other Gauge Activity	3 - Normal Wear & Tear
Other Gauge Condition	Gauges are functional, with some wear and/or cosmetic damage
Other Gauge Activity Photos

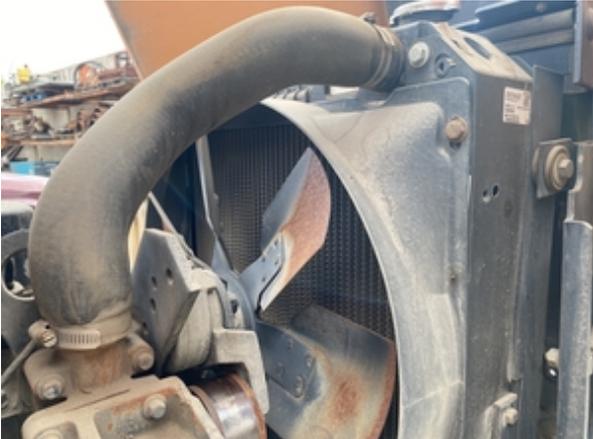
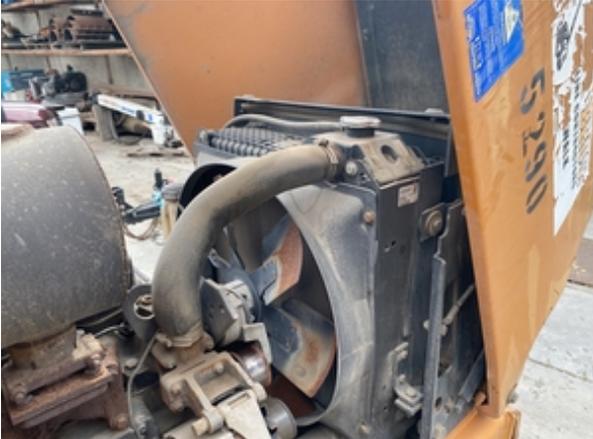
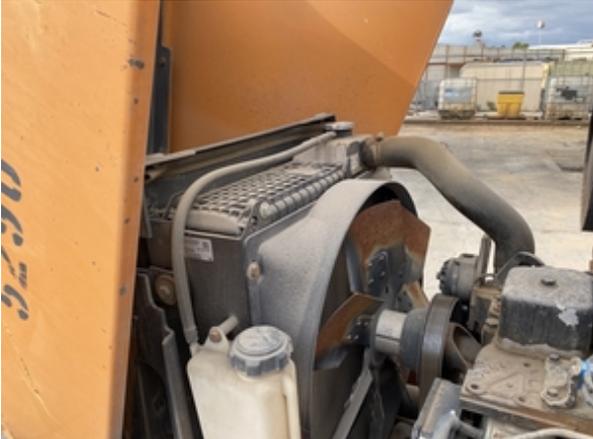
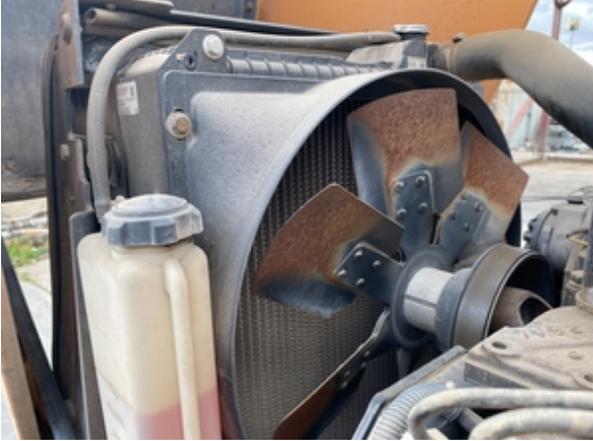
Battery	3 - Normal Wear & Tear
Battery Condition	Inaccessible, unable to determine condition, Other (see comments)
Comments	Innaccessible for photo
Radiator	3 - Normal Wear & Tear
Radiator Condition	Radiator fins & components appear to be in good working order, no signs of damage or leaks
Radiator Photos

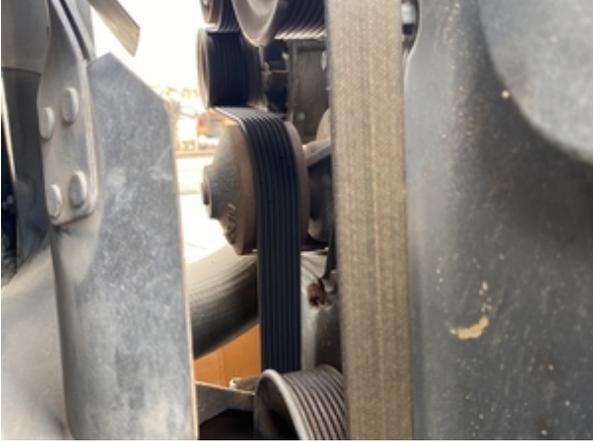
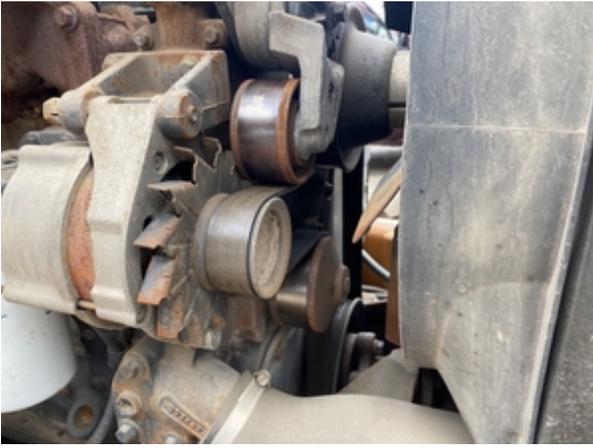
Belts	3 - Normal Wear & Tear
Belt Condition	Belts appear in good condition & alignment with proper tension
Belt Photos

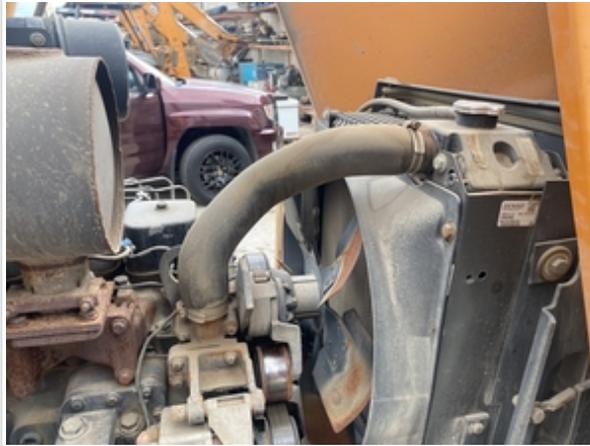
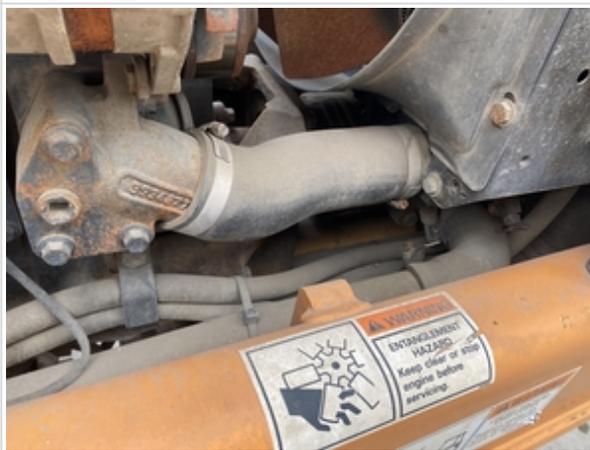
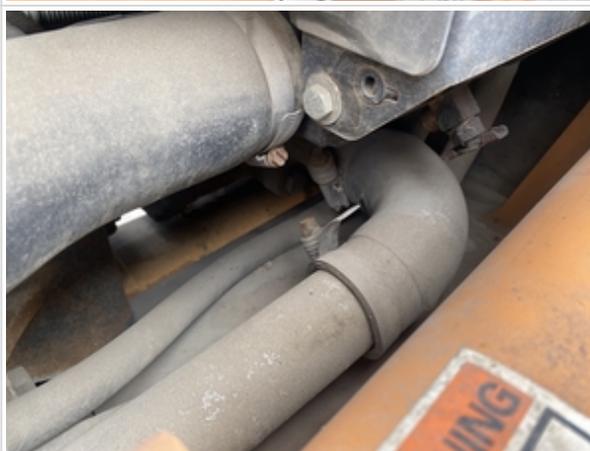
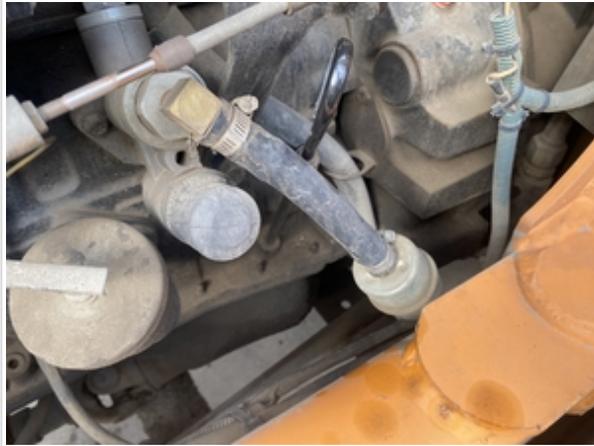
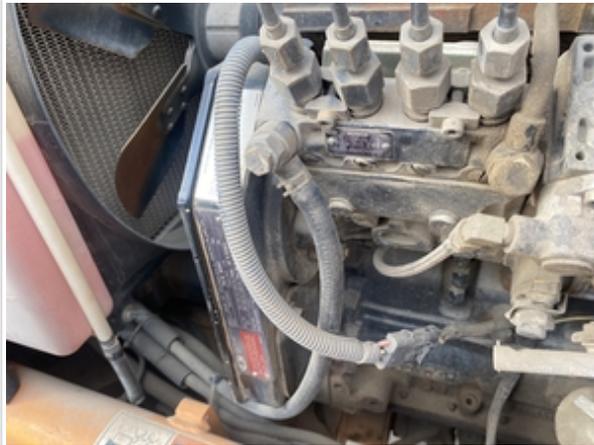
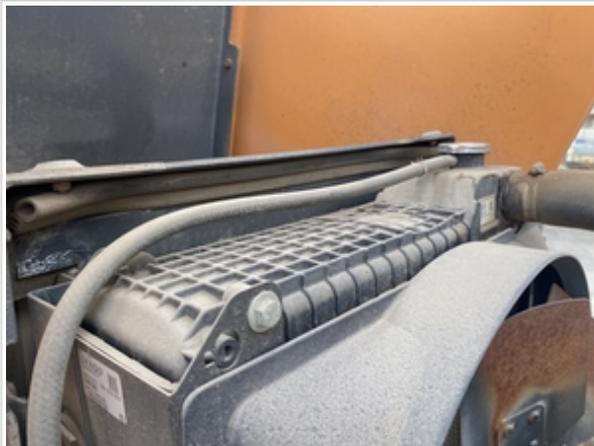
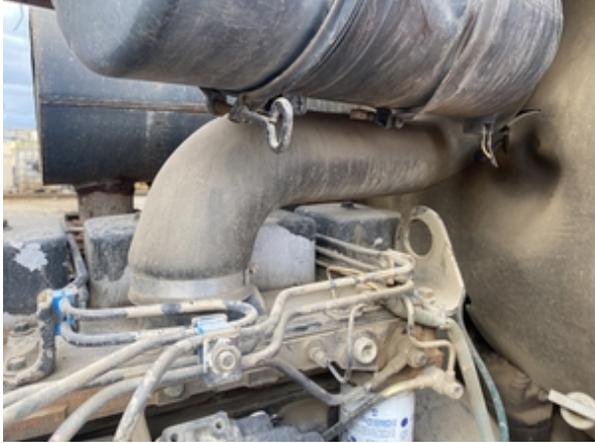
Hose Photos

Hoses	3 - Normal Wear & Tear
Hose Condition	Firm, pliant hoses with no signs of wear or leaks

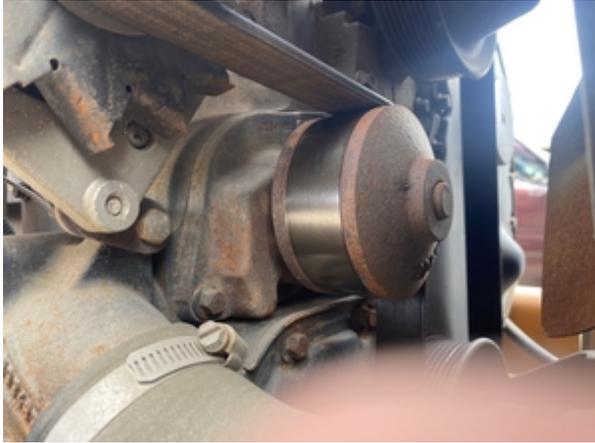
Water Pump	3 - Normal Wear & Tear
Water Pump Condition	No unusual pump noises heard
Water Pump Photos

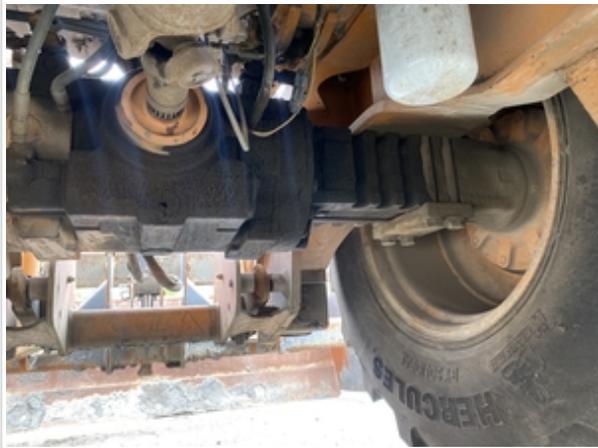
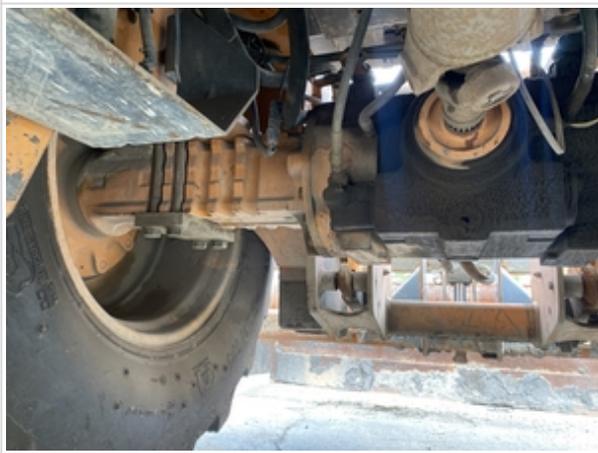
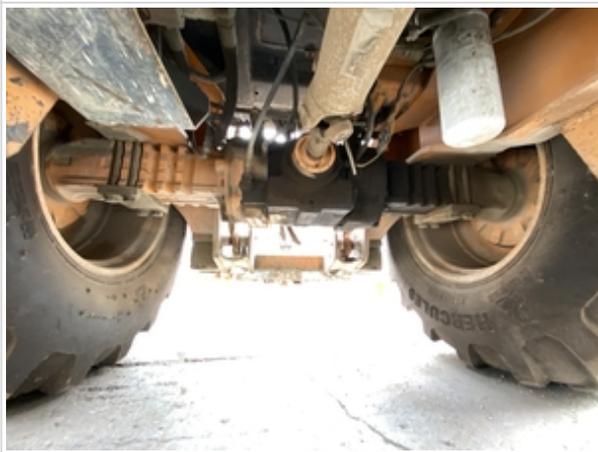
Rear Axle Appearance	3 - Normal Wear & Tear	
Comments	Signs of oil leaks/seepage buildup may have started from top of axle	
Rear Axle Appearance Photos

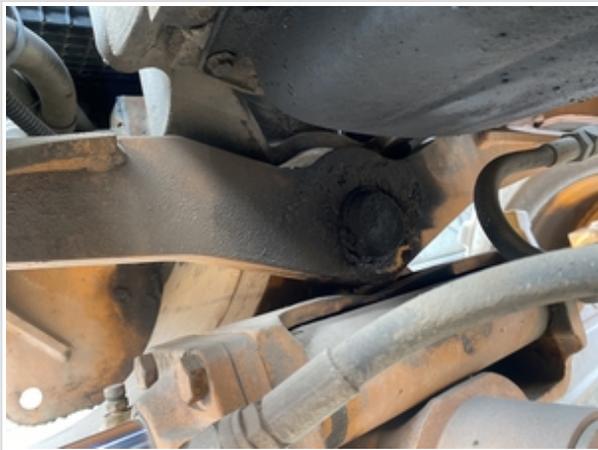
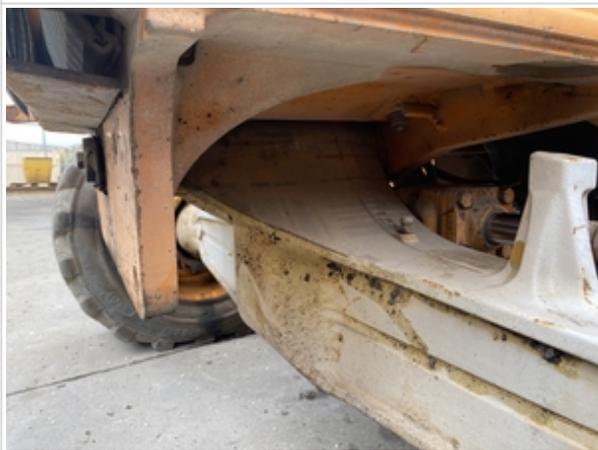
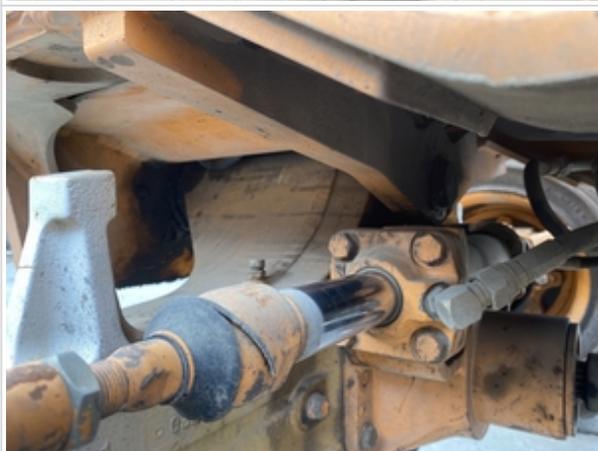
<p>Oscillating Pin Appearance Photos</p>

<p>Oscillating Pin Appearance</p>	<p>3 - Normal Wear & Tear</p>

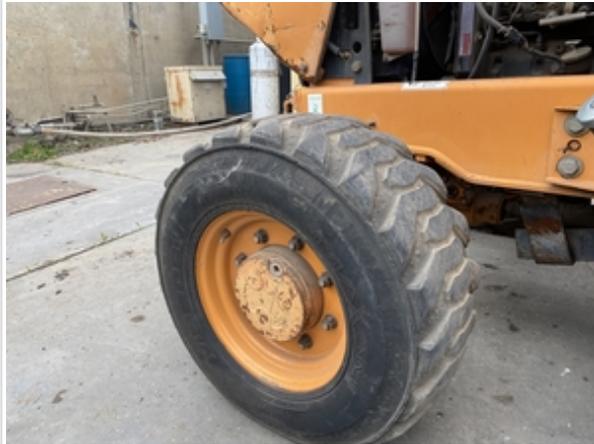
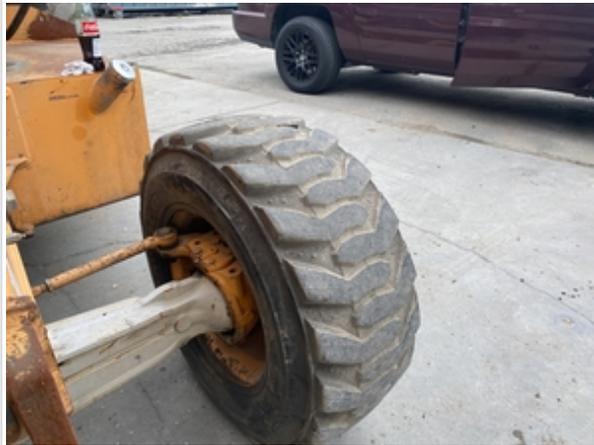
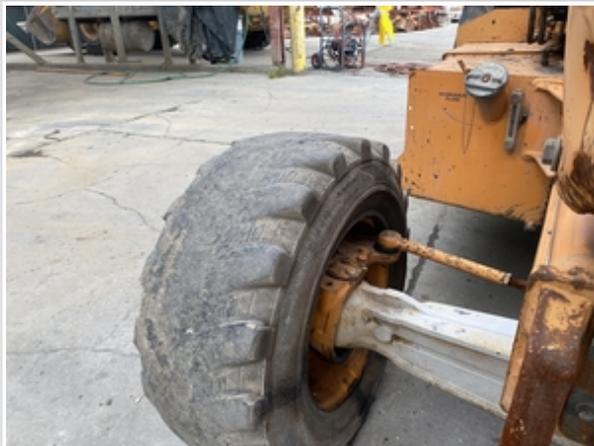
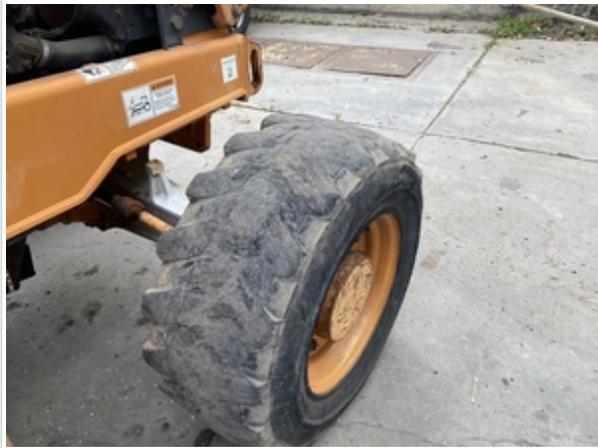
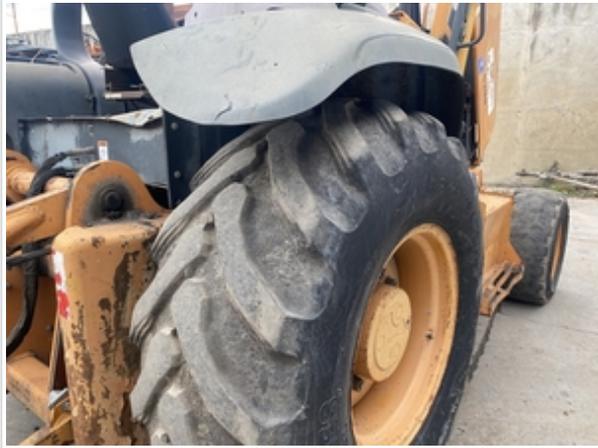
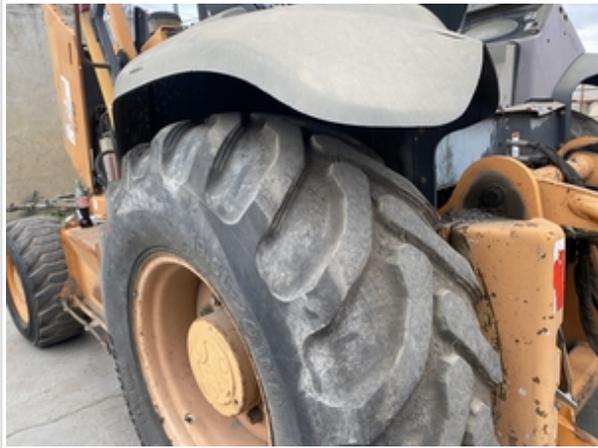
Wheels & Tires Photos

<p>Wheels & Tires</p>	<p>3 - Normal Wear & Tear</p>

Tire Brand	Front - Maxim. Rear - Hercules
Tire Size	Front - 12-16.5. Rear - 19.5L - 24
Front Left Tire - Ratio Remaining	30%
Rear Left Tire - Ratio Remaining	70%
Front Right Tire - Ratio Remaining	10%
Rear Right Tire - Ratio Remaining	70%
Lift Arm	3 - Normal Wear & Tear

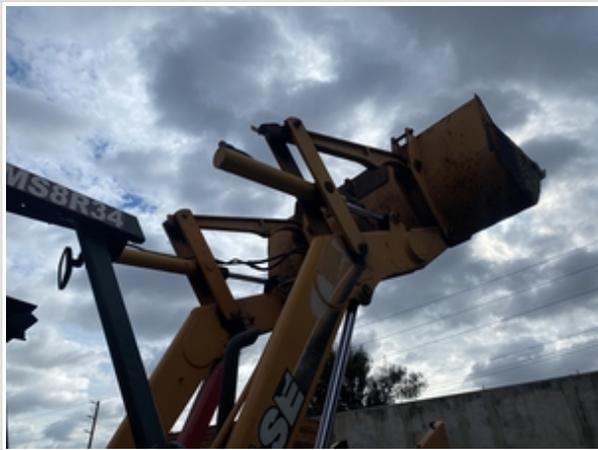
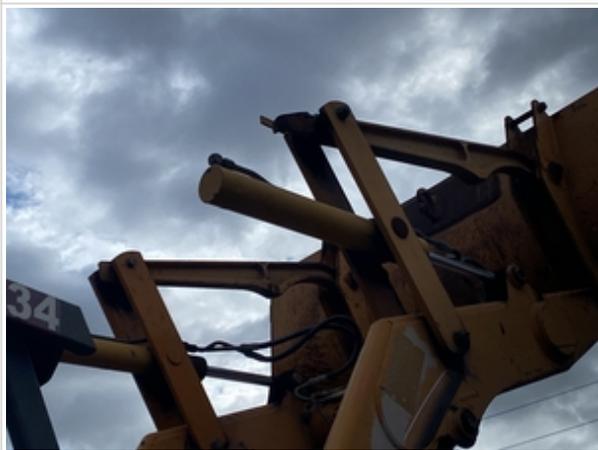
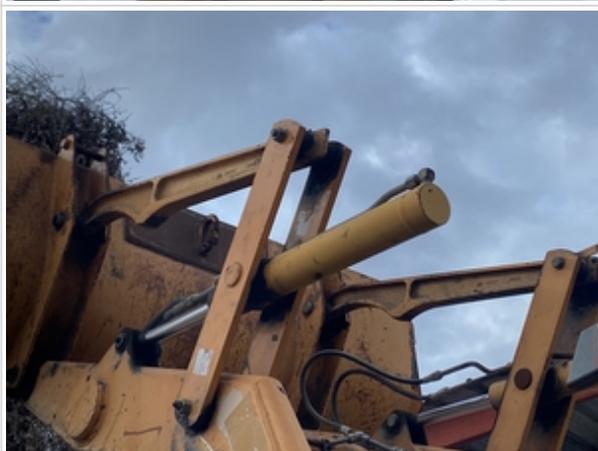
Tilt Linkage Photos

Chassis to Arm Pins	3 - Normal Wear & Tear
Tilt Linkage	3 - Normal Wear & Tear
