Inspection Report (Skip Loader)

Year	2004
Make	Case
Model	570MXT
Serial Number	JJG0301527
Hour Meter Reading	800.00 + 5,090 = both hour meters
Previous Application (e.g., earth moving, mining, demolition, etc)	General Construction

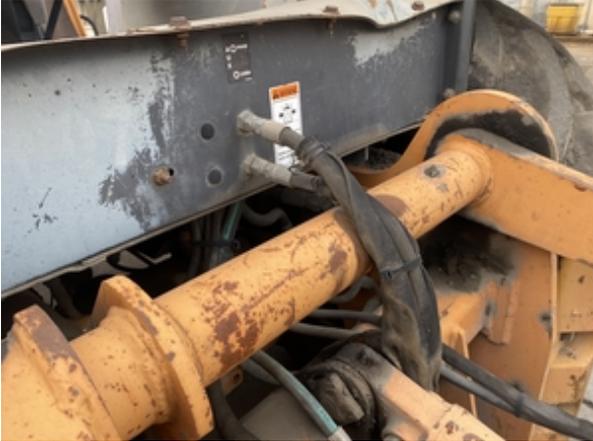
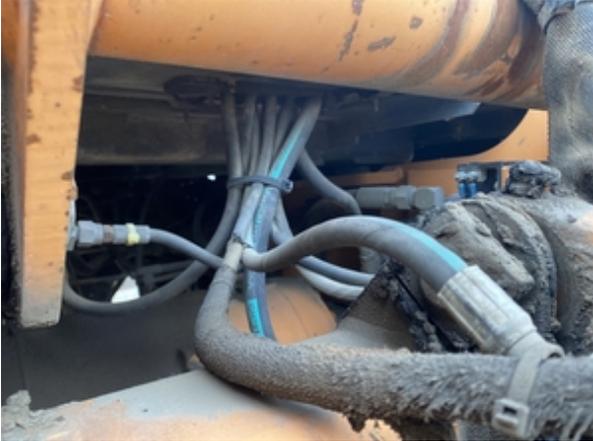
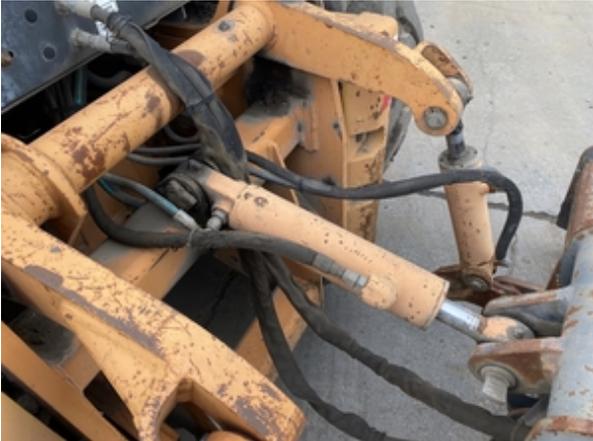
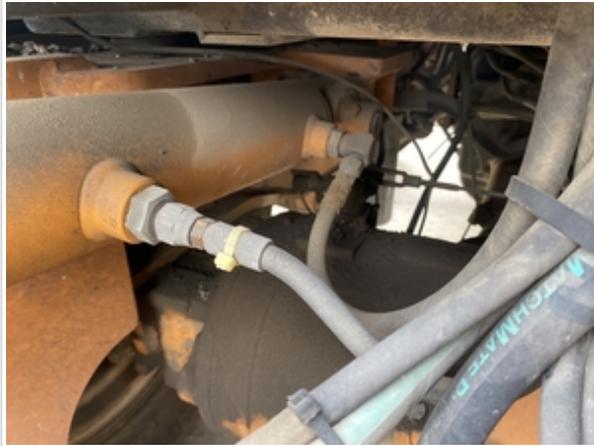
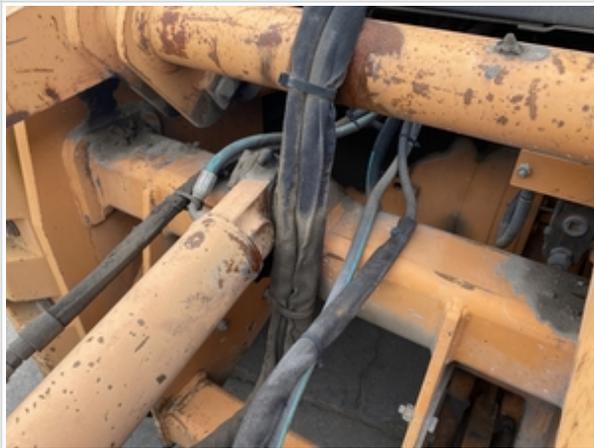
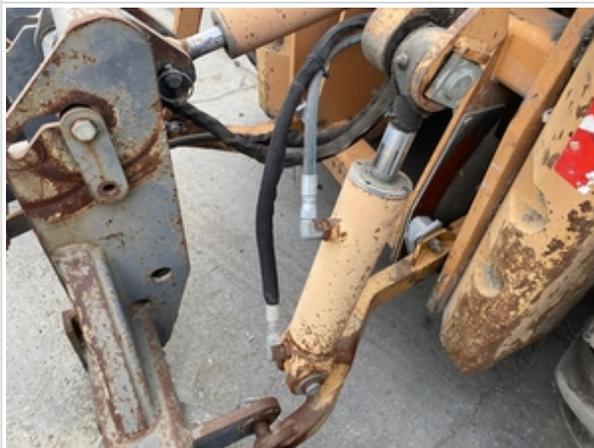
Appearance of Hydraulic Lines / Fittings	3
Hydraulic Lines / Fittings Condition	Hydraulic lines & fittings are clean and in good condition
Appearance of Hydraulic Lines / Fittings Photos

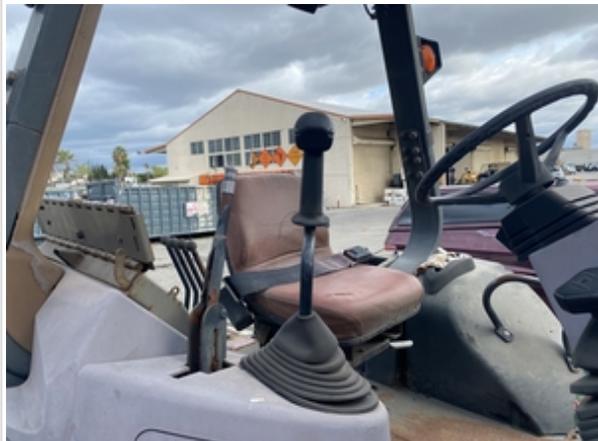
External Controls / Levers Photos

Unusual Noises (Hydraulic Pump)	No
Hydraulic Pump Notes	No unusual noises heard during operation
External Controls / Levers	3
External Controls / Levers Condition	Good function & condition of hydraulic controls

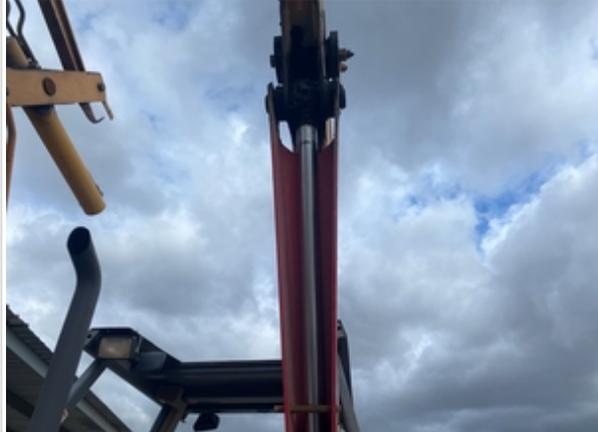
Bucket Lift / Tilt Cylinders	Check the bucket lift and tilt cylinders. Note any wear, pitting, discoloration, etc. Take photos.
Bucket Lift / Tilt Cylinders: Mounting Pin	3
Bucket Lift / Tilt Cylinders: Oil Leaks	Yes
Comments	Minor seepage out of L/S lift cylinder, Left side tilt cylinder has dried seepage buildup but no active leak seen
Bucket Lift / Tilt Cylinders Photos

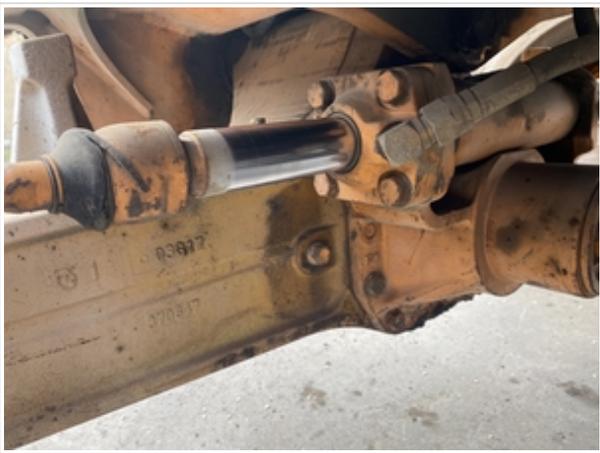
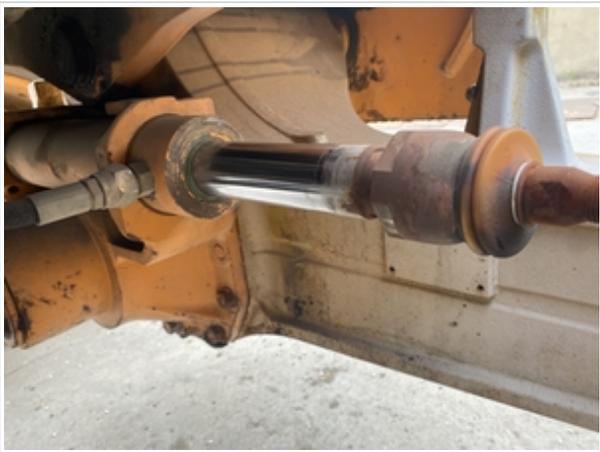
Steering Cylinder	Check the steering cylinder. Note any wear, pitting, discoloration, etc. Take photos.	
Steering Cylinder: Mounting Pin	3	
Steering Cylinder: Oil Leaks	No	
Steering Cylinder Photos

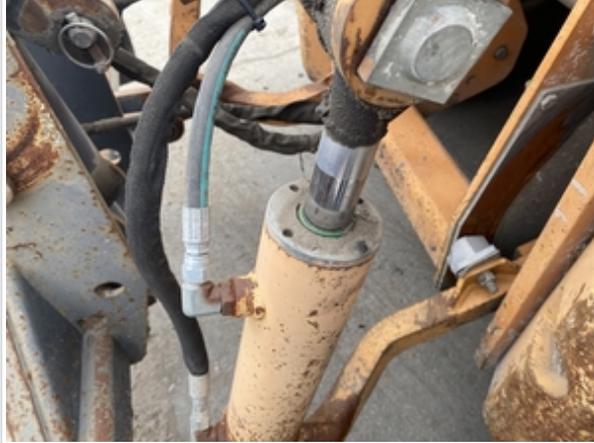
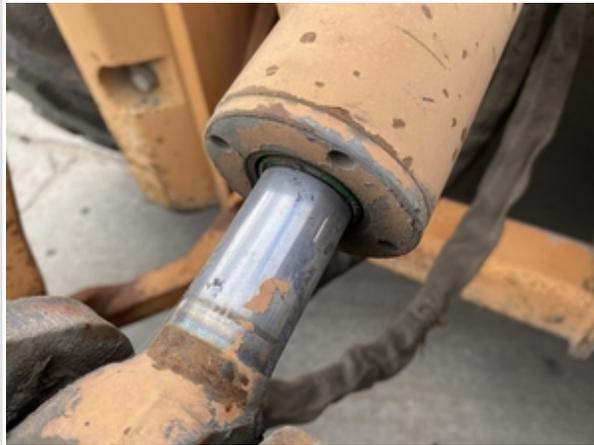
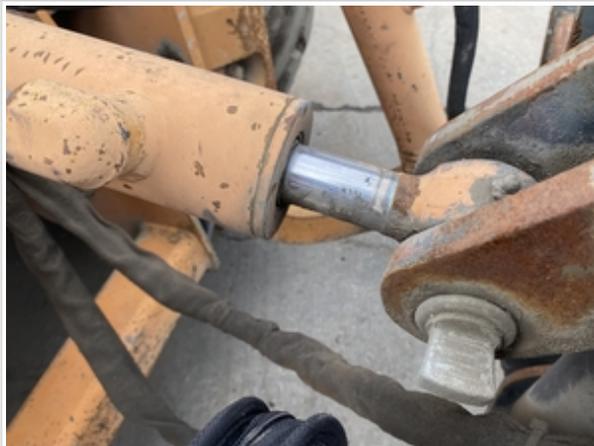
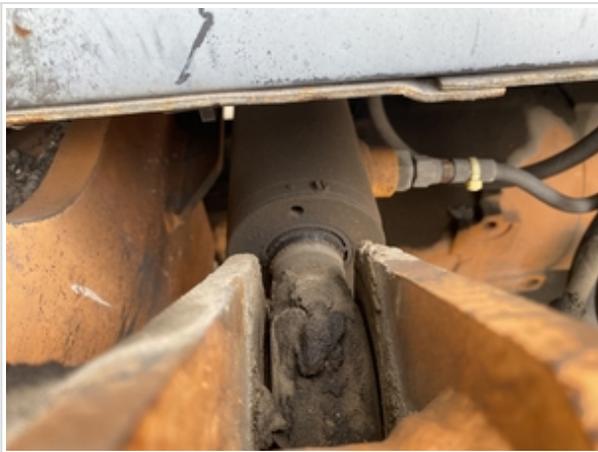
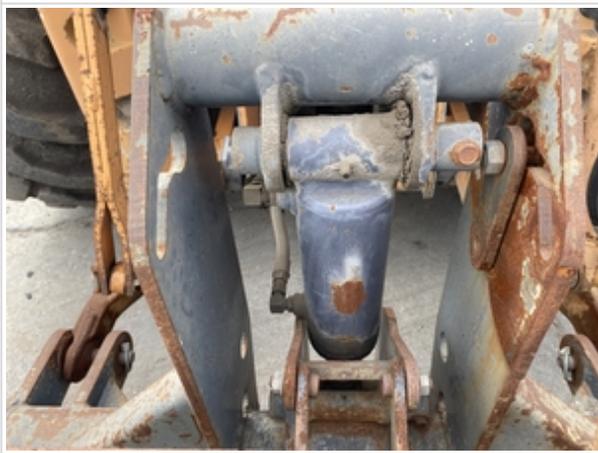
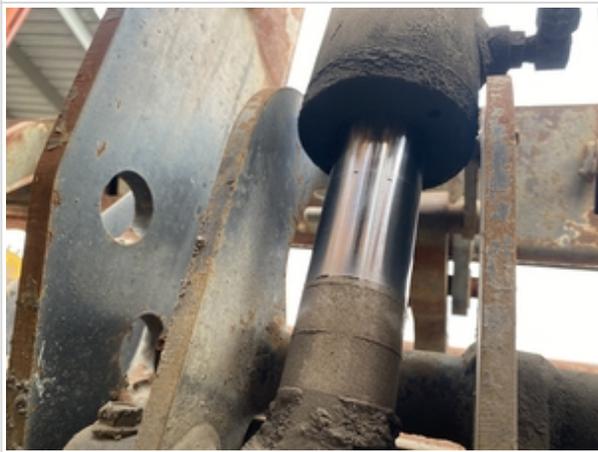
Box Cylinders Photos

Box Cylinders	Check the box blade cylinders. Note any wear, pitting, discoloration, etc. Take photos.	
Box Cylinders: Mounting Pin	3	
Box Cylinders: Oil Leaks	No

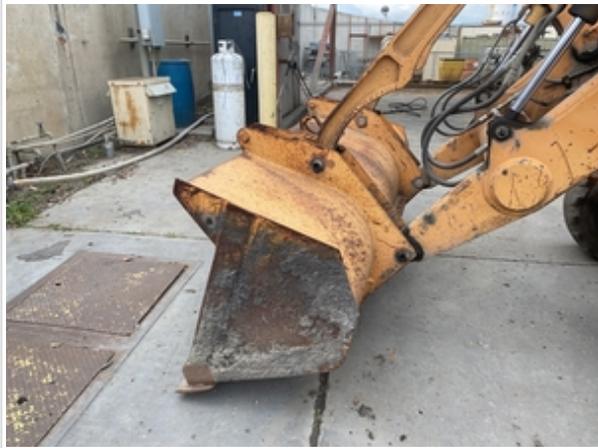
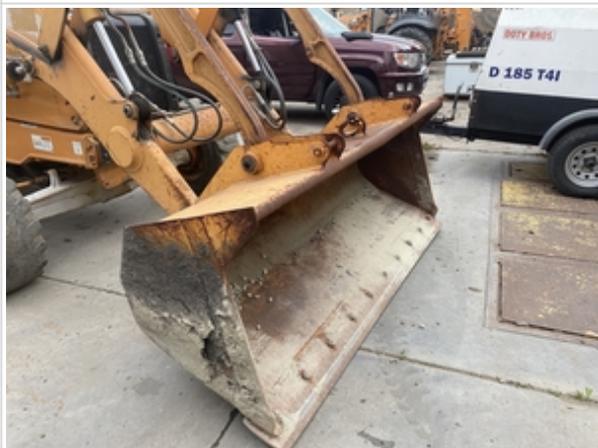
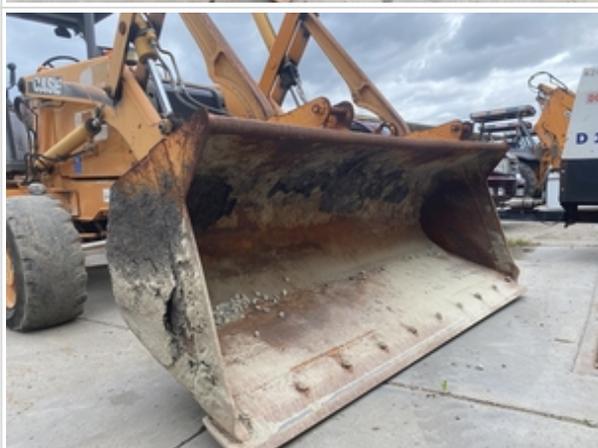
<p>Bucket Photos</p>

Bucket	3 - Normal Wear & Tear
---------------	------------------------

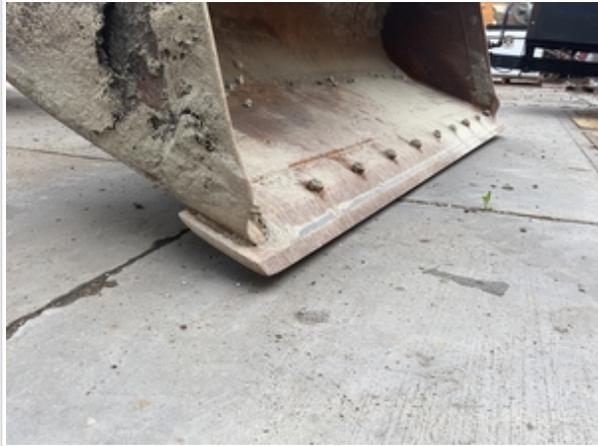
<p>Bucket Edge / Deflectors Photos</p>

<p>Bucket Edge / Deflectors</p>	<p>3 - Normal Wear & Tear</p>

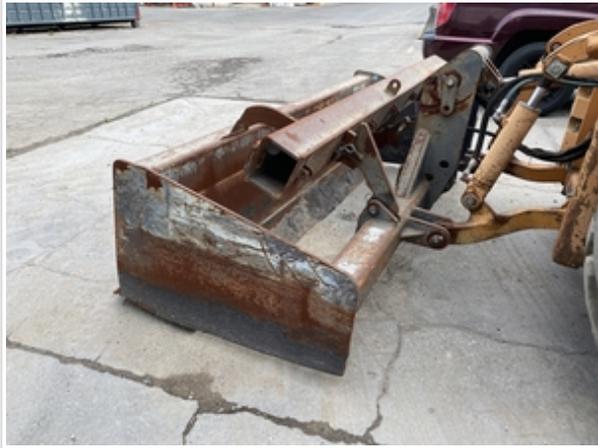
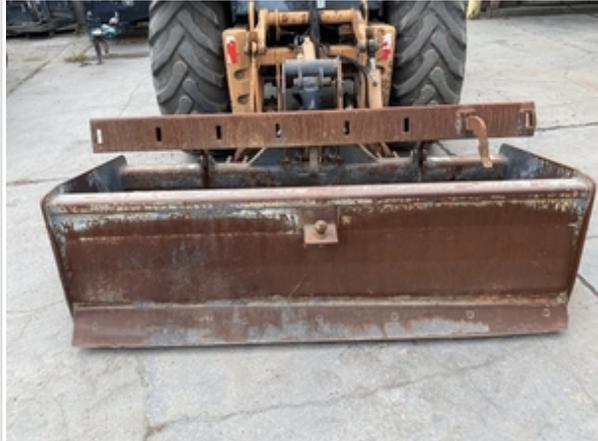
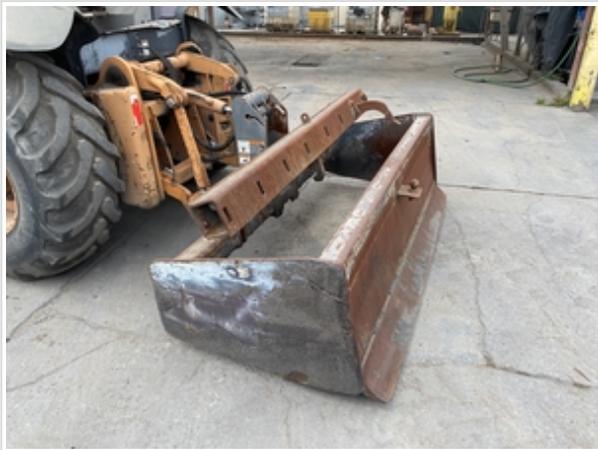
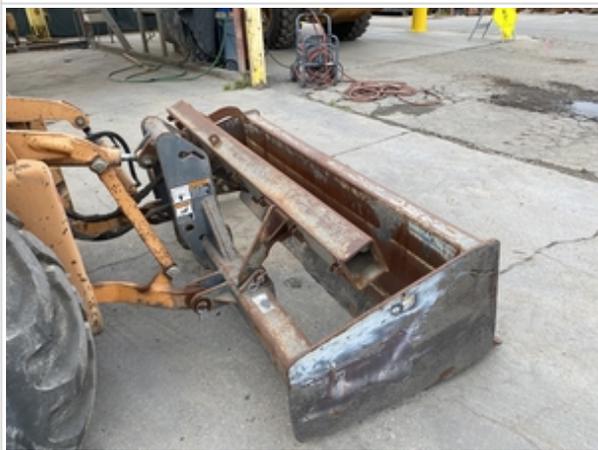
<p>Box</p>	<p>3 - Normal Wear & Tear</p>
<p>Box Photos</p>

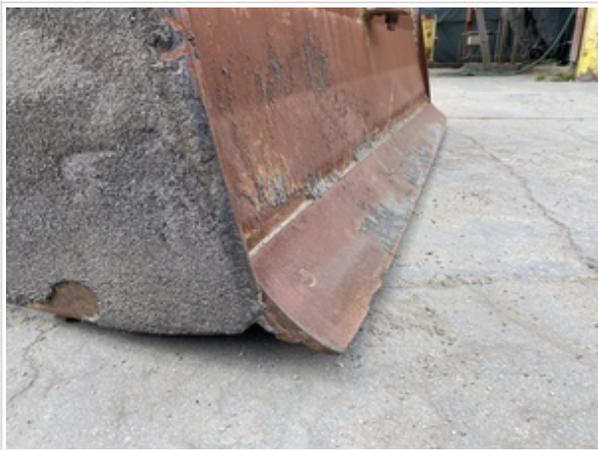
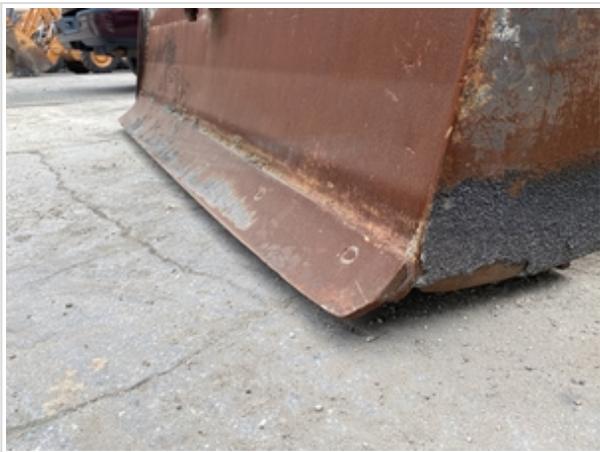
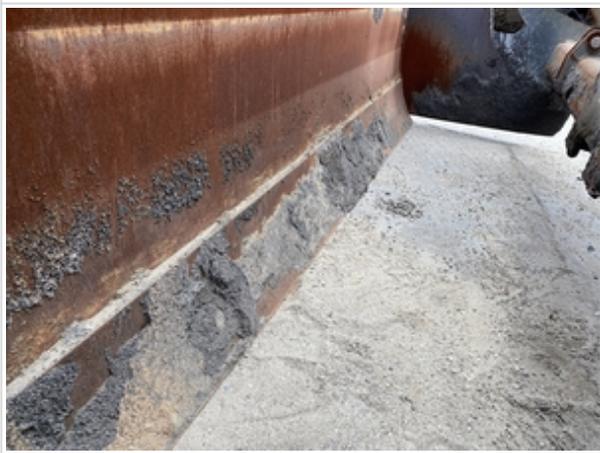
<p>Blade</p>	<p>3 - Normal Wear & Tear</p>
<p>Blade Photos</p>
