Inspection Report (Bulldozer)

Year	2015
Make	CAT
Model	D6T XL
Serial Number	KMR00412
Hour Meter Reading	5,264 Hours
Previous Application (e.g., earth moving, mining, demolition, etc)	General Construction

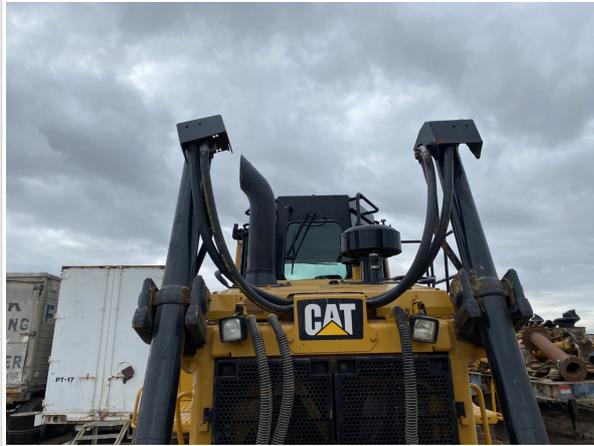
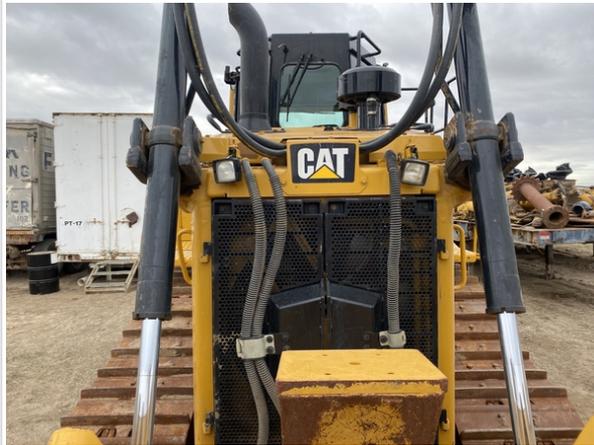
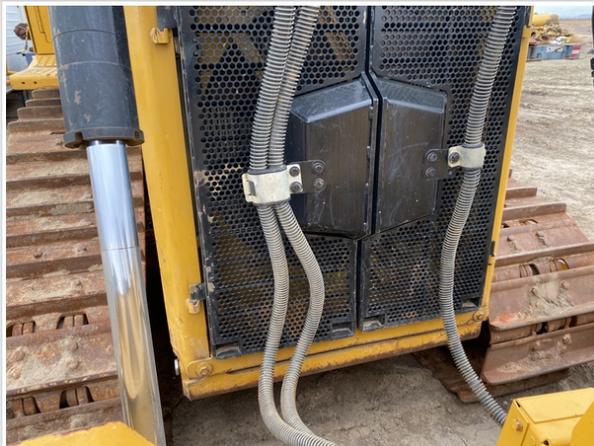
Front Photos

Front	3 - Normal Wear & Tear
Front Condition	No visible damage

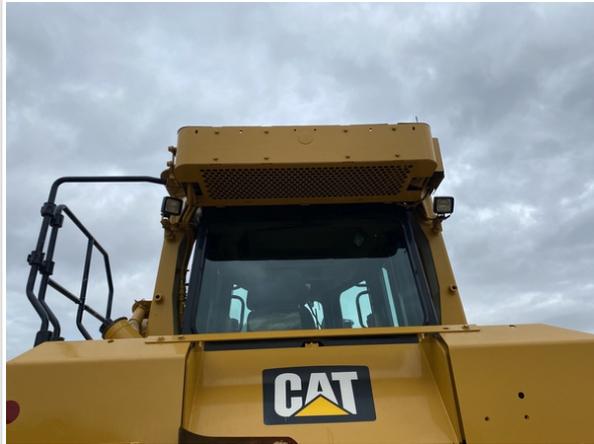
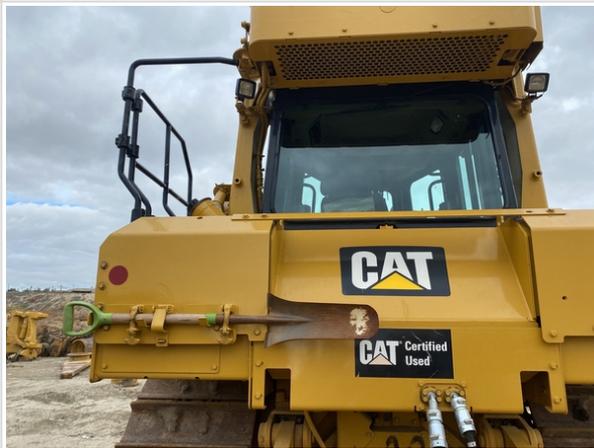
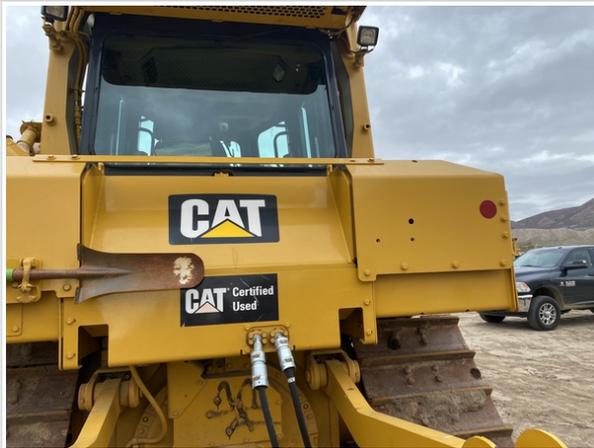
Rear Photos

Rear	3 - Normal Wear & Tear
Rear Condition	No visible damage

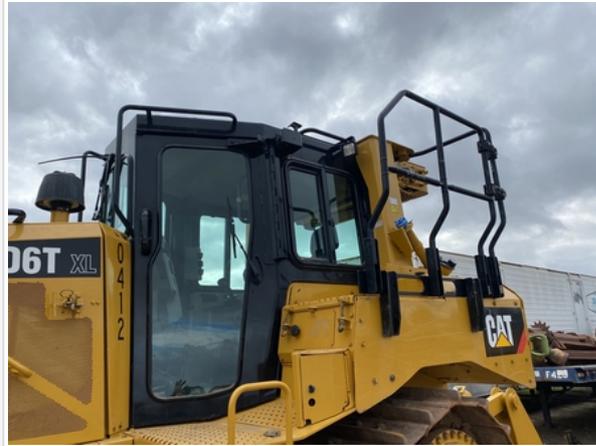
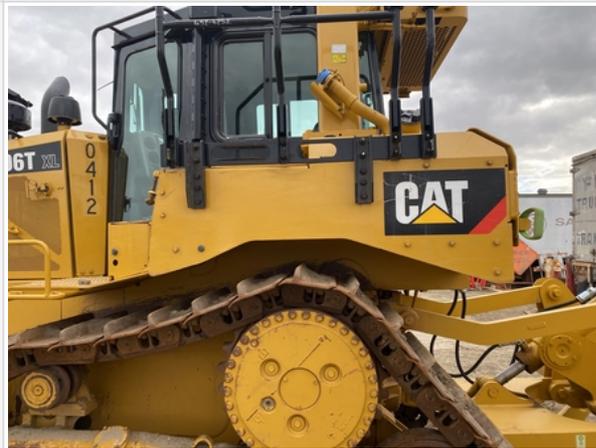
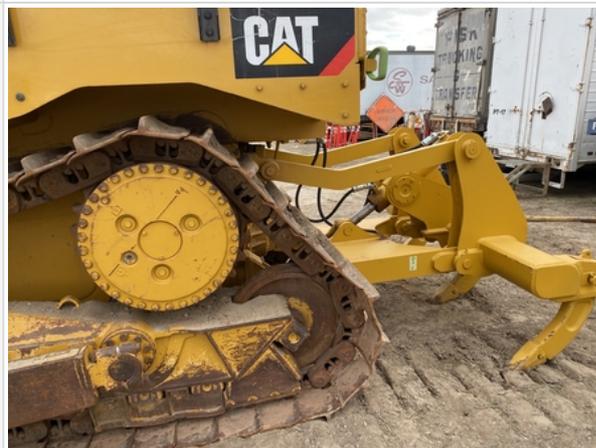
Left	3 - Normal Wear & Tear
Left Condition	No visible damage
Left Photos

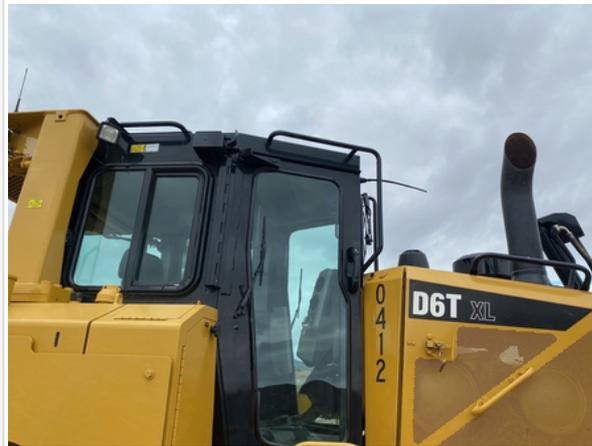
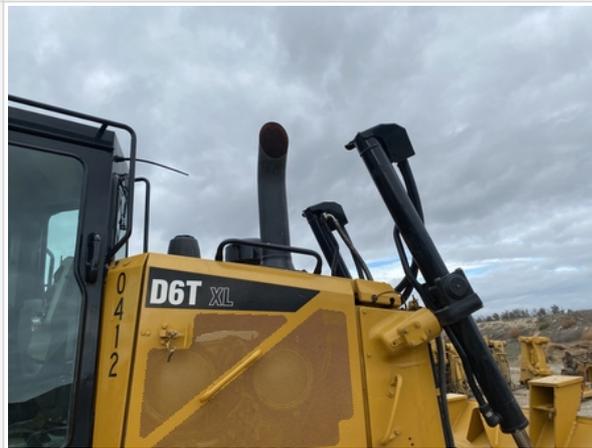
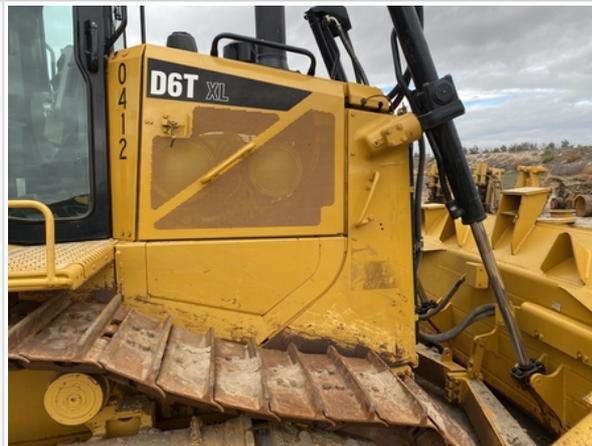
<p>Right</p>	<p>3 - Normal Wear & Tear</p>	
<p>Right Condition</p>	<p>No visible damage</p>	
<p>Right Photos</p>

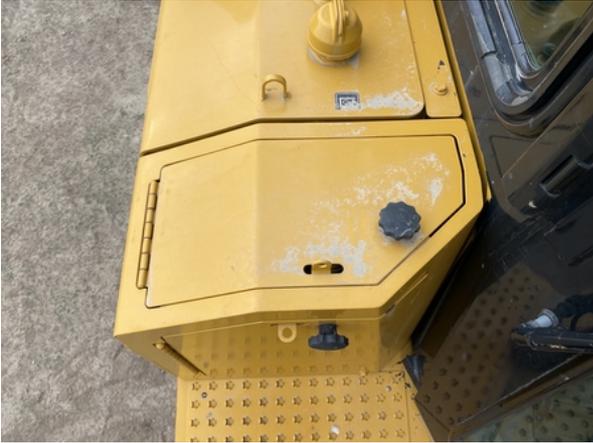
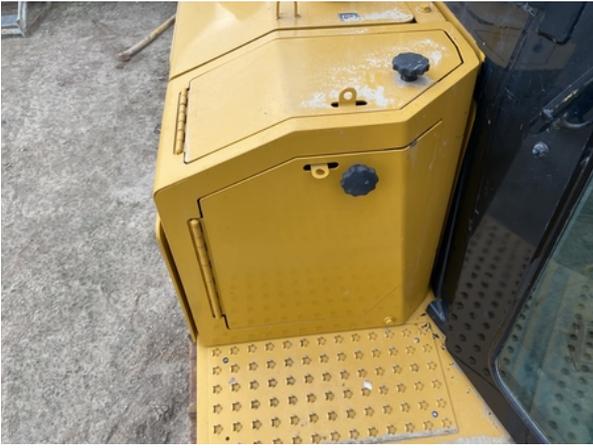
Body Panels (Any Rust Damage?)	3 - Normal Wear & Tear
Body Panel Condition	No visible damage, good paint condition and panel fitment
Body Panels Photos

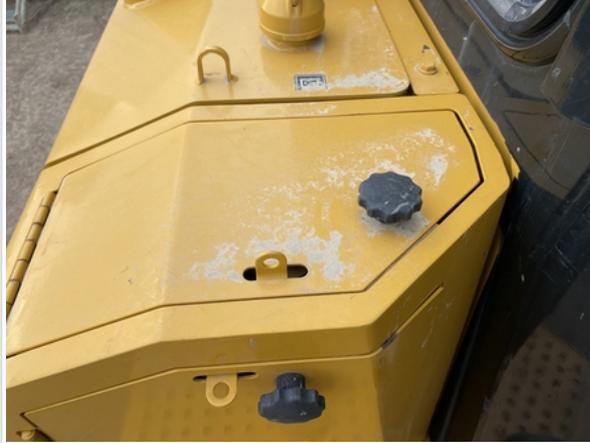
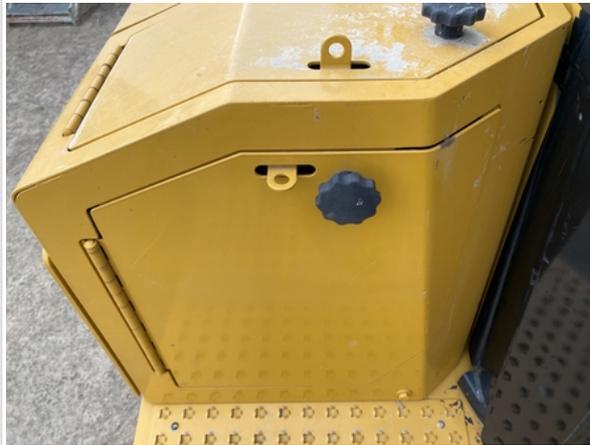
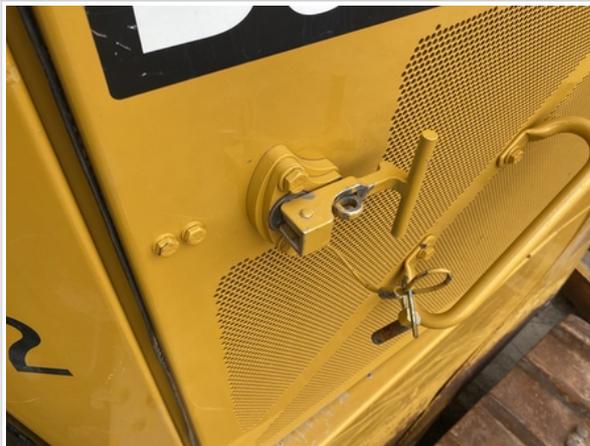
Doors / Canopy Latches Photos

Doors / Canopy Latches	3 - Normal Wear & Tear
Doors / Canopy Latches Condition	No visible damage

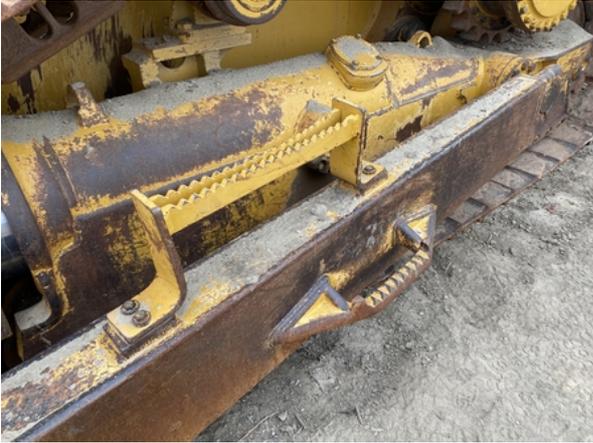
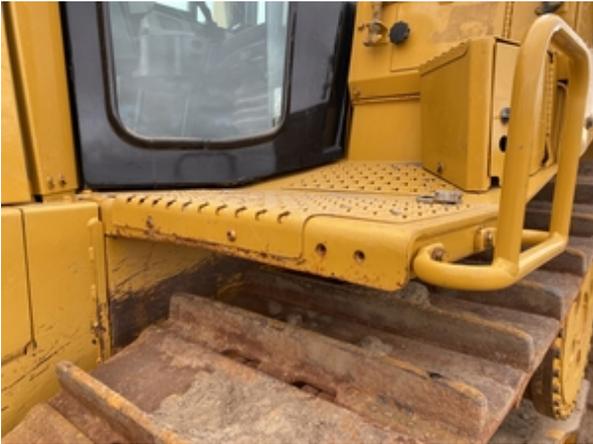
Steps / Ladders	3 - Normal Wear & Tear	
Steps / Ladders Condition	Steps/ladders are fully intact and appear structurally sound	
Steps / Ladders Photos

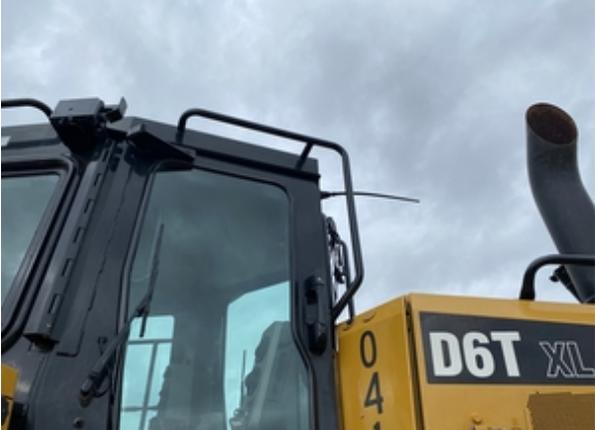
Handrails	3 - Normal Wear & Tear	
Handrails Condition	Handrails are fully intact and appear structurally sound	
Handrail Photos

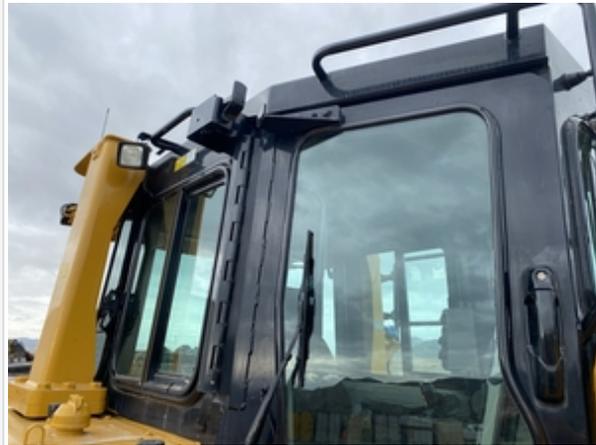
Glass Condition Photos

Glass Condition	3 - Normal Wear & Tear
Glass Condition Notes	Glass intact, no visible damage

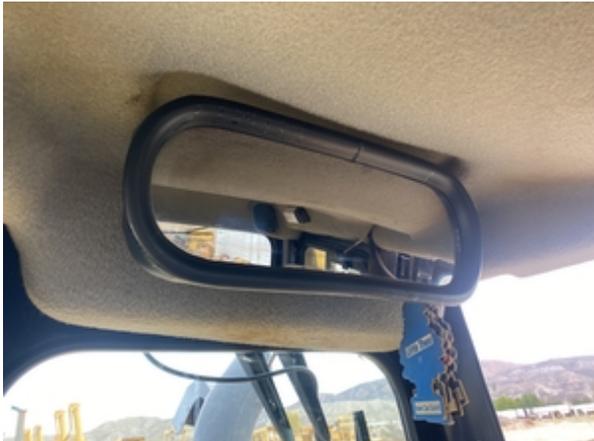
Mirrors	3 - Normal Wear & Tear	
Mirror Condition Notes	Mirrors present and intact, no visible damage	
Mirrors Photos

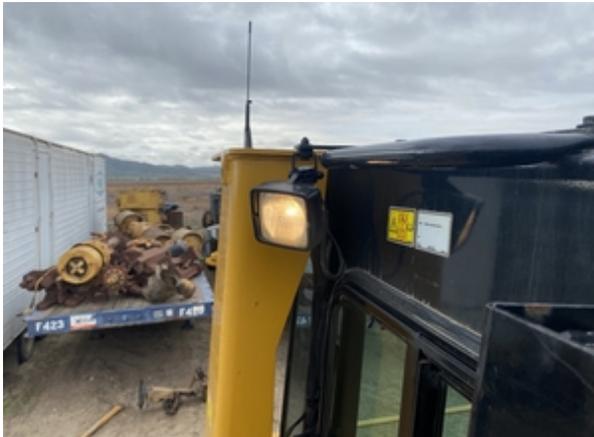
Lighting System	3 - Normal Wear & Tear	
Lighting System Condition	No visible damage, lighting system is operational	
Lighting System Photos

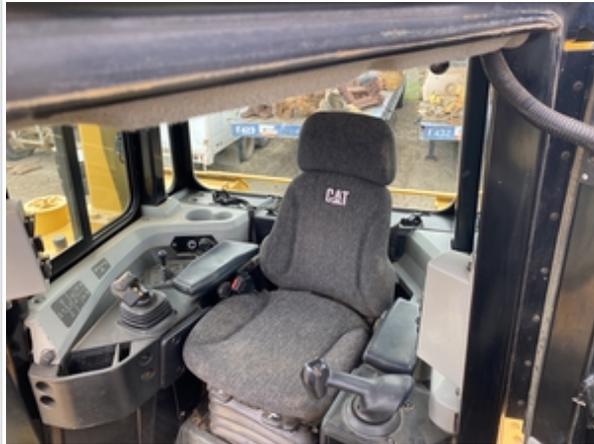
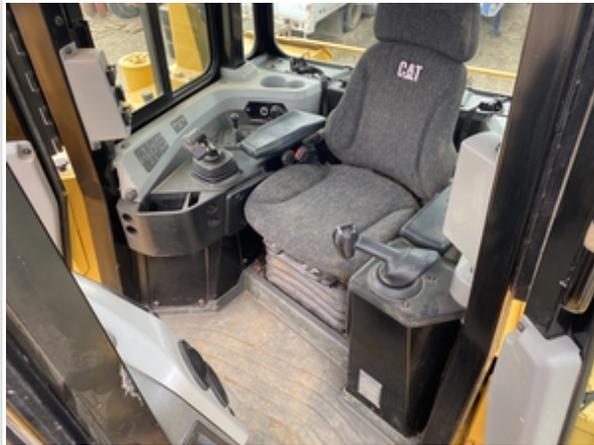
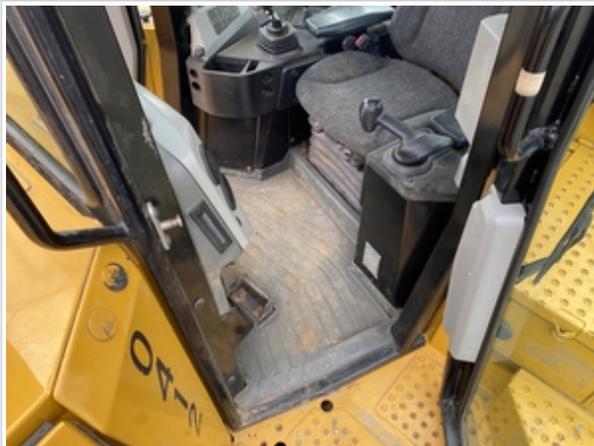
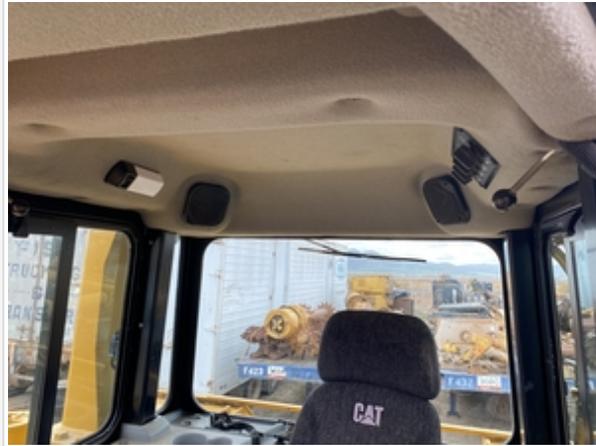
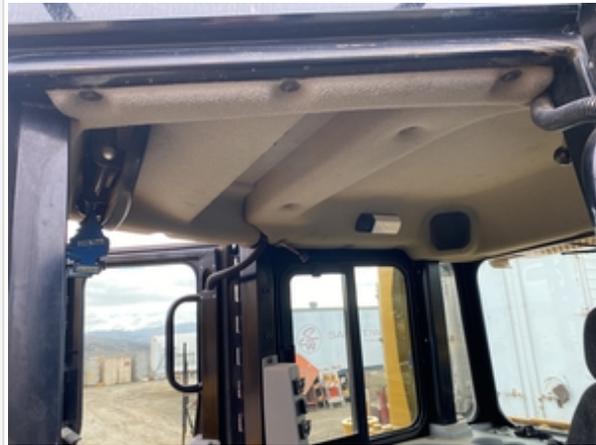
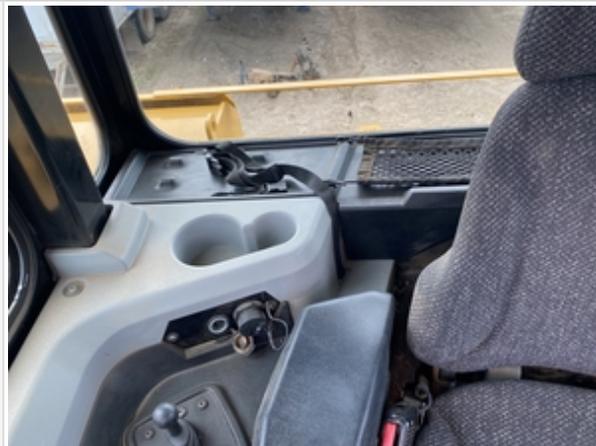
Operator Cabin Photos

Operator Cabin Overall	3 - Normal Wear & Tear
Operator Cabin Overall Condition	Good cabin appearance, solid floors, panels, and ceiling

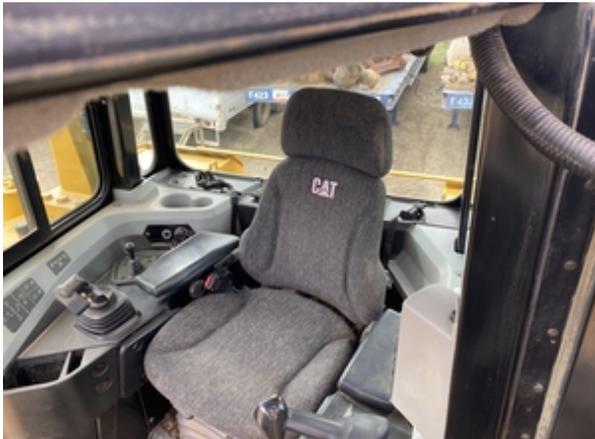
Operator's Seat & Arm Rests	3 - Normal Wear & Tear
Operator's Seat & Arm Rests Condition	Seat(s) in good condition, no stains or tears in upholstery
Operator's Seat & Arm Rests Photos

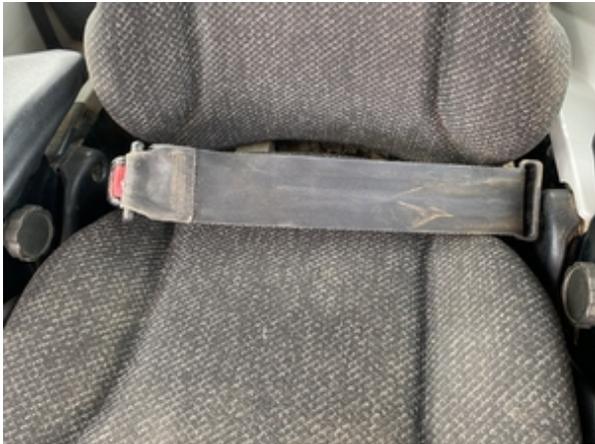
Seat Belt Photos

Seat Belt	3 - Normal Wear & Tear
Seat Belt Condition	Seat belt secures properly. Belt is intact and in good condition

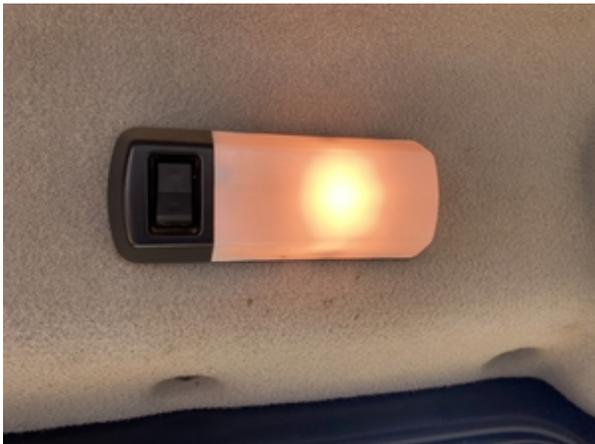
Cabin Lights	3 - Normal Wear & Tear
Cabin Lights Condition	Cabin lights are installed with all light covers in place, bulbs are installed and working properly
Cabin Lights Photos

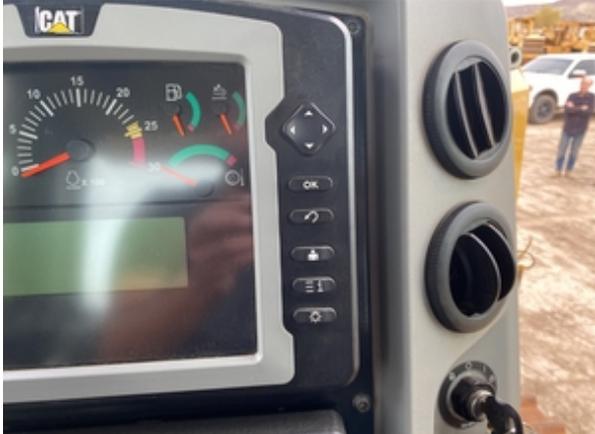
Safety Lock Out / Stop	3 - Normal Wear & Tear
Safety Lock Out / Stop Condition	Safety lock out device is present, in good condition, and functional
Controls & Switches	3 - Normal Wear & Tear
Controls & Switches Condition	All switches are installed and functional
Controls & Switches Photos

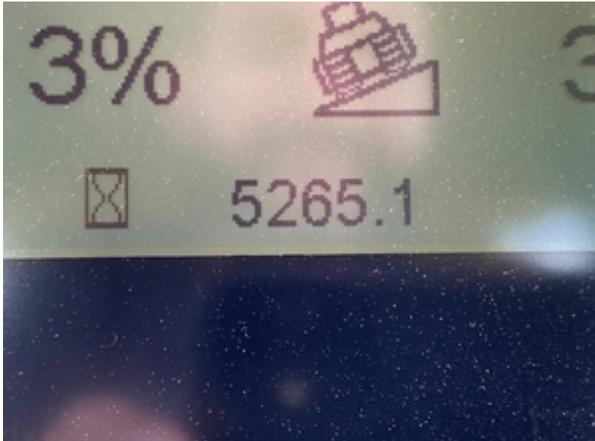
Hour Meter Activity	3 - Normal Wear & Tear
Hour Meter Condition	Hour meter is functional and in good condition
Hour Meter Activity Photos

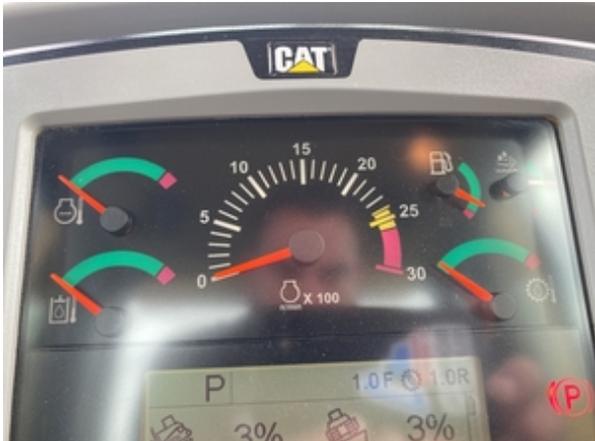
Other Gauge Activity	3 - Normal Wear & Tear
Other Gauge Condition	All cockpit gauges are functional and in good condition
Other Gauge Activity Photos

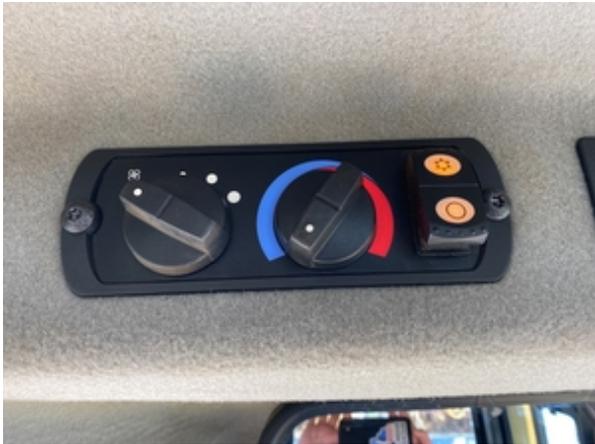
<p>Heater & A/C Photos</p>

Heater & A/C	3 - Normal Wear & Tear
Heater & A/C Condition	Heater and A/C work and transition through full temperature range

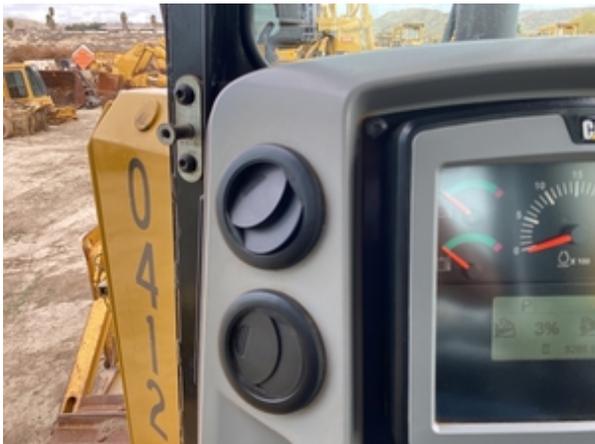
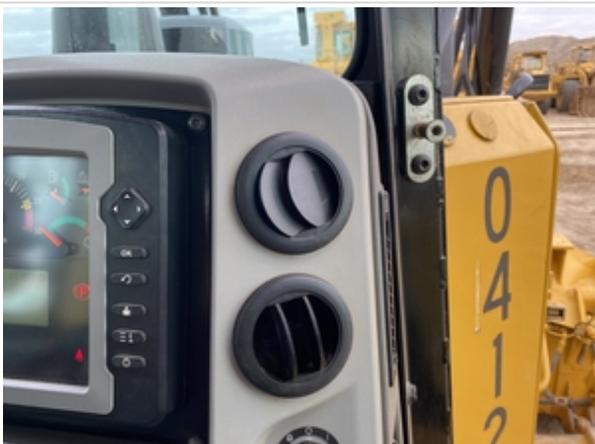
<p>Fans / Vents</p>	<p>3 - Normal Wear & Tear</p>
<p>Fans / Vents Condition</p>	<p>Fan vents are functional, in good condition, and move through a full adjustable range of motion</p>
<p>Fans / Vents Photos</p>

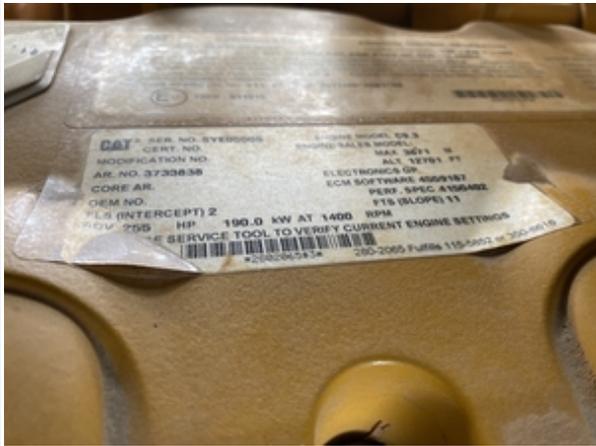
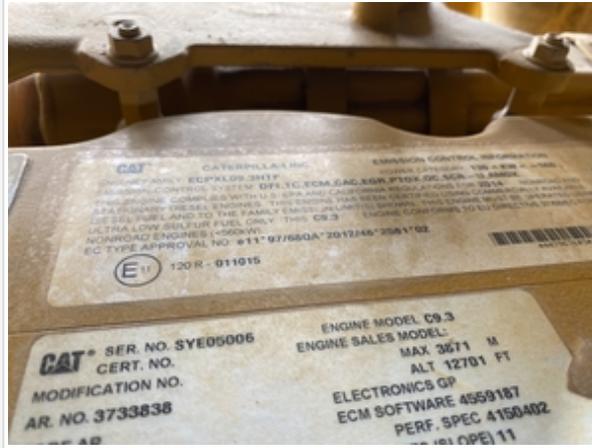
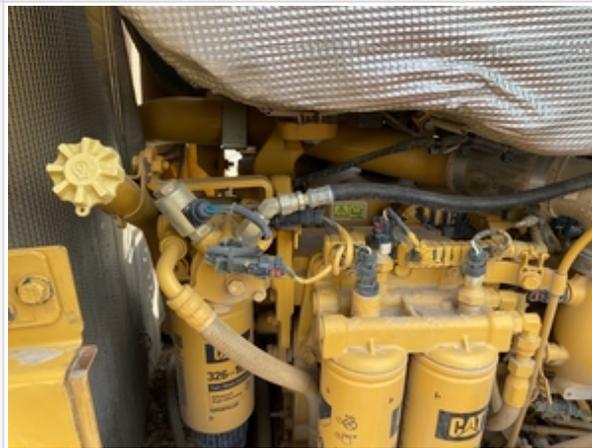
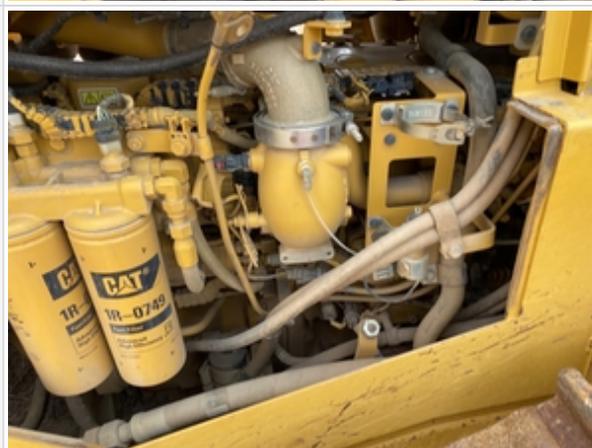
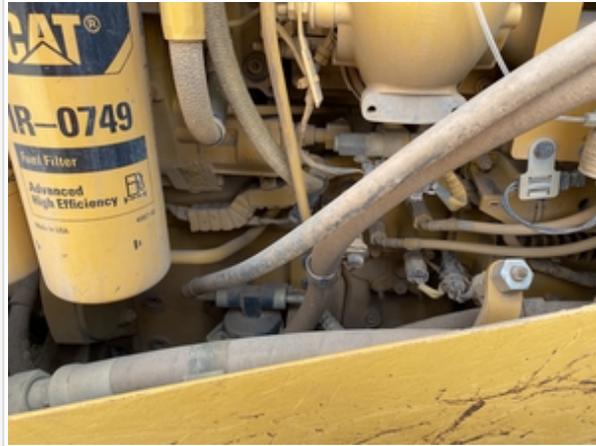
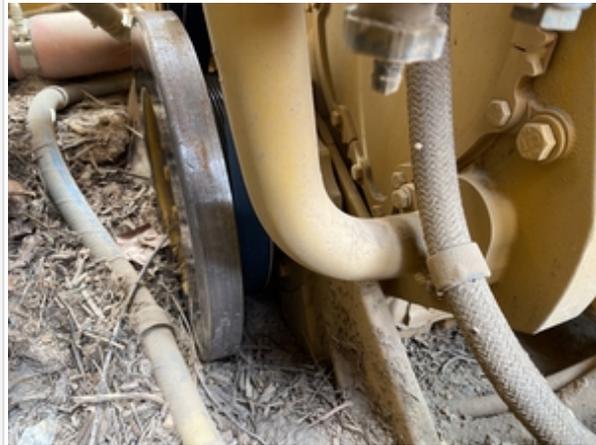
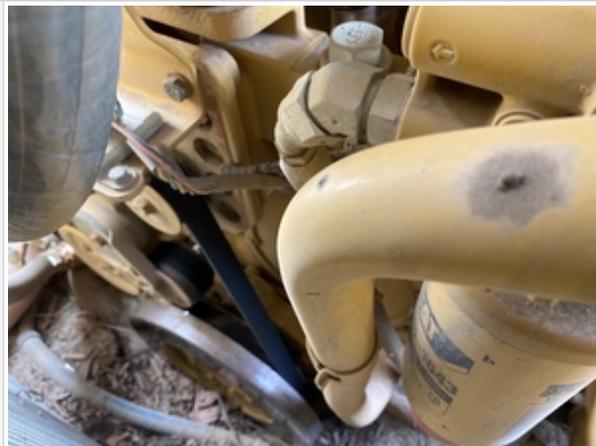
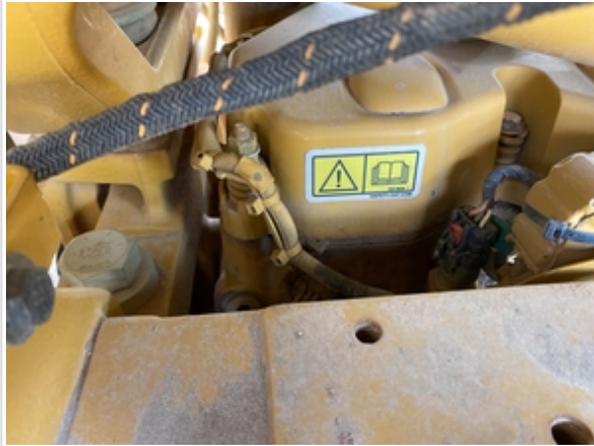
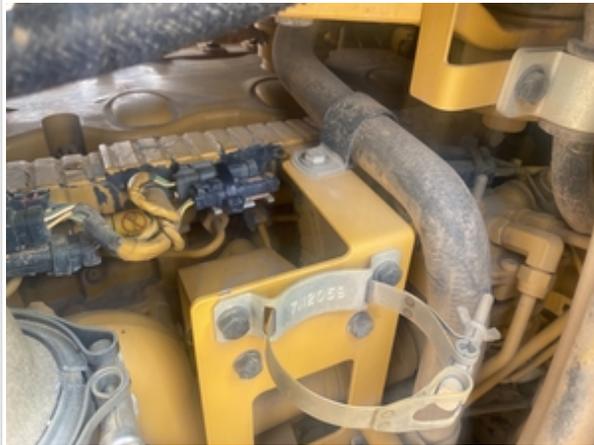
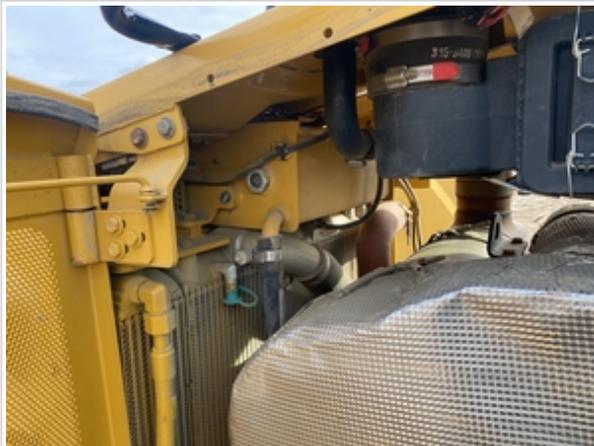
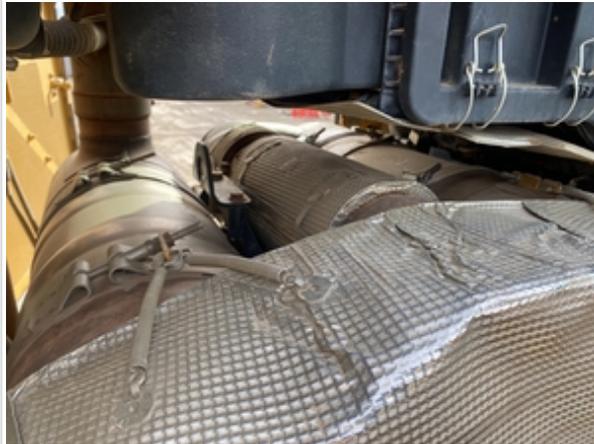
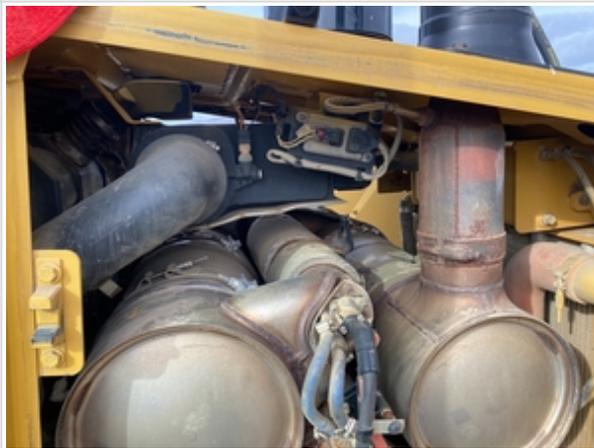
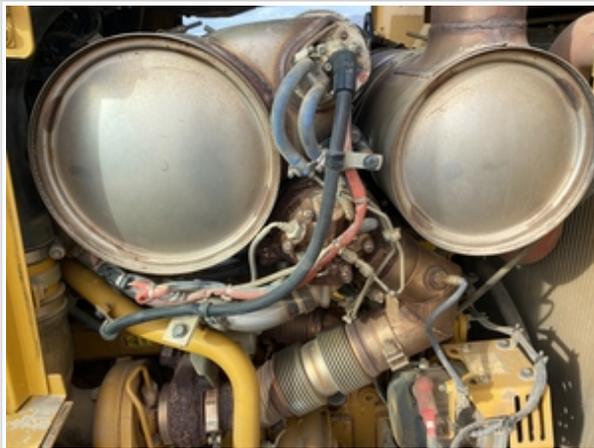
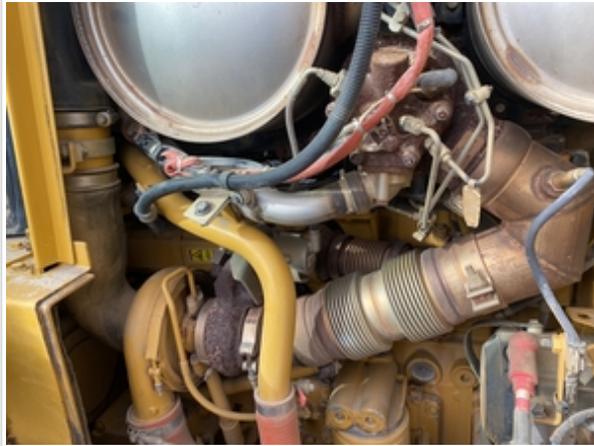
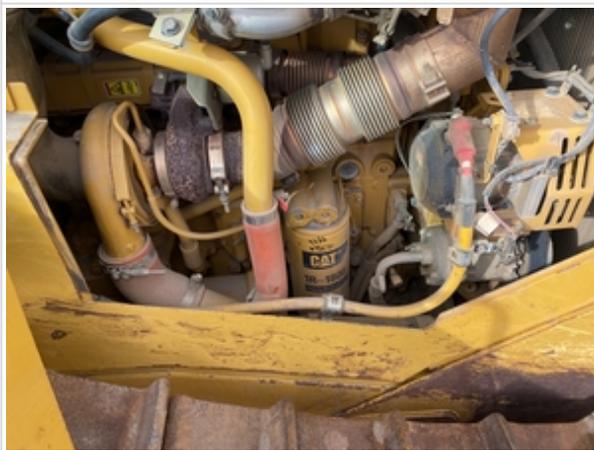
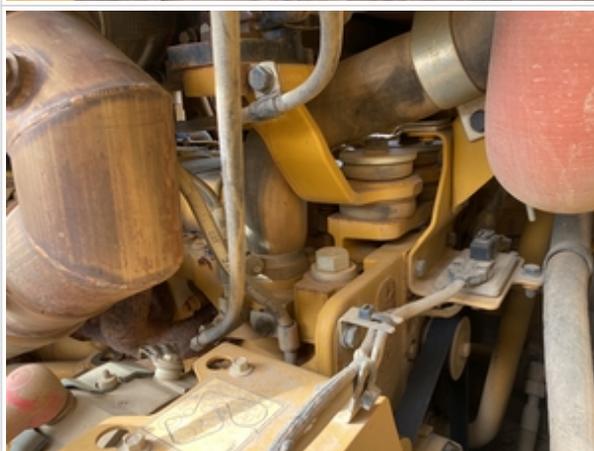
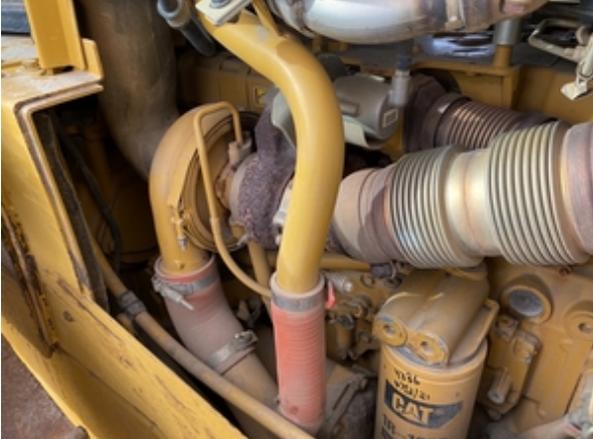
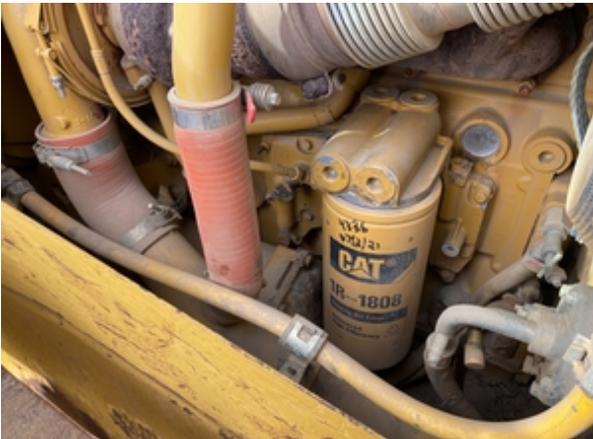
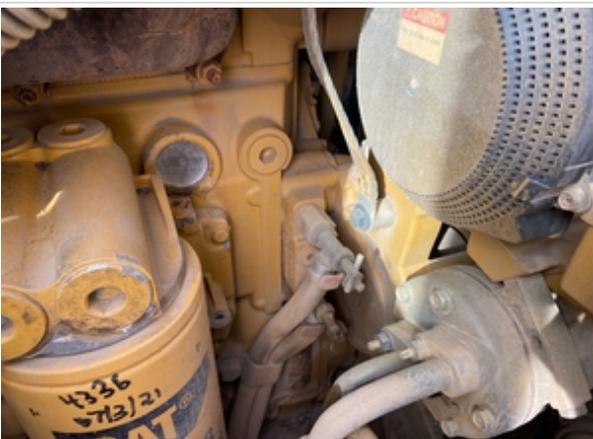
Engine Type (Make, Model, Cylinders, Hp)	CAT - C9.3 - 255HP - 6Cyl. - 9L
Emissions Tier	Tier 4F
Engine Serial Number	SYE05006
Engine Fuel Type	Diesel
Engine Photos

Blow-by (Visual Observation Check)	No
Unusual Noises (Upon Start-up, Idle, Shutdown)	No
Unusual Noise Notes	No unusual noises heard
Engine Smoke (Upon Start-up, Idle, Shutdown)	No
Engine Smoke Notes	No engine smoke issues observed
Engine Exhaust Color	Clear

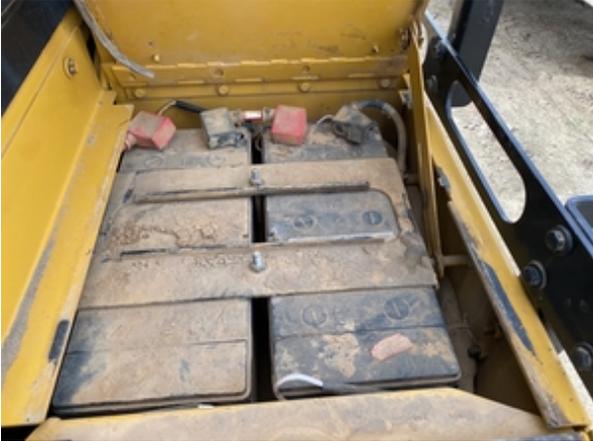
Battery	3 - Normal Wear & Tear
Battery Condition	Dusty & dirty appearance, Other (see comments)
Comments	Batteries in good condition
Battery Condition Photos

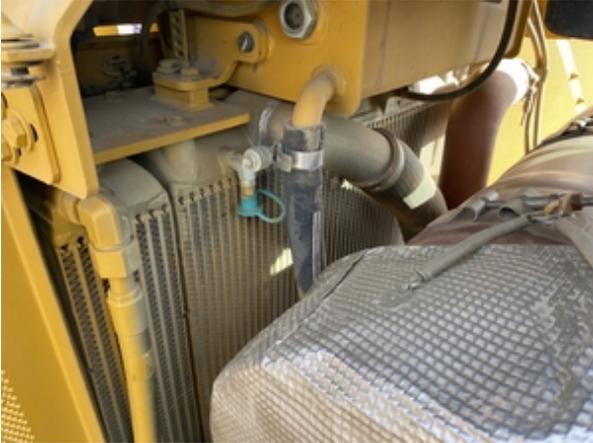
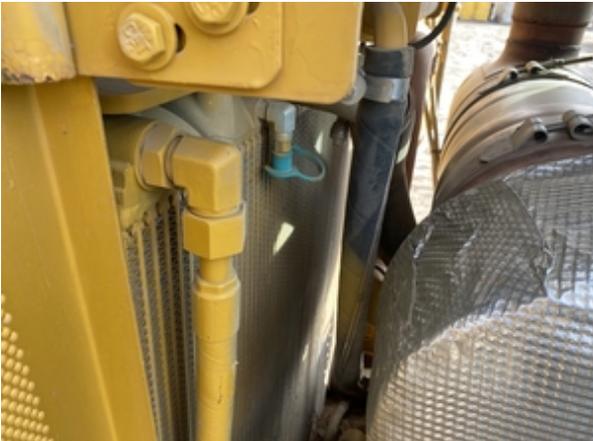
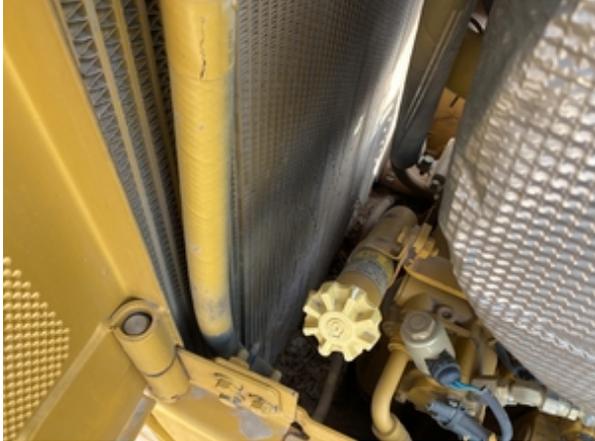
Radiator	3 - Normal Wear & Tear
Radiator Condition	Radiator fins & components appear to be in good working order, no signs of damage or leaks
Radiator Photos

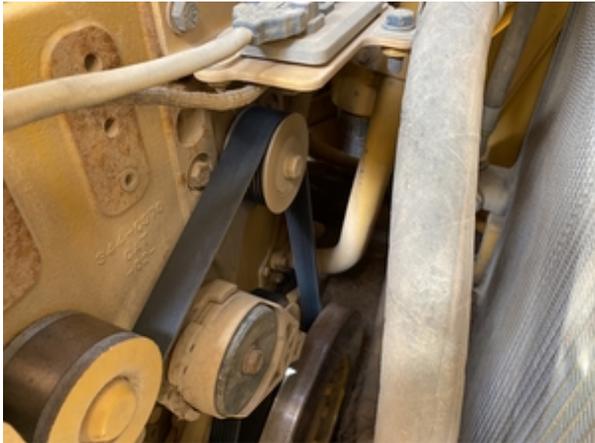
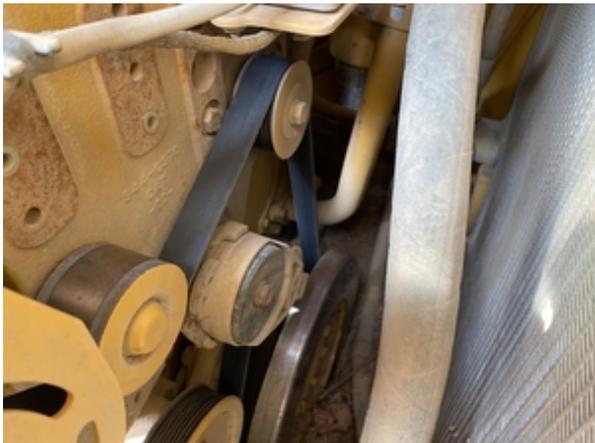
Belts	3 - Normal Wear & Tear
Belt Condition	Belts appear in good condition & alignment with proper tension
Belt Photos

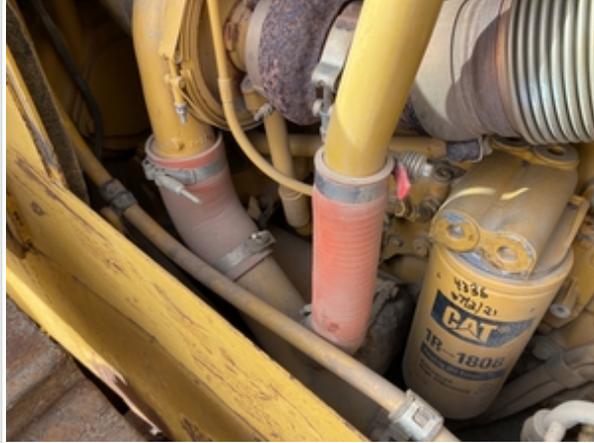
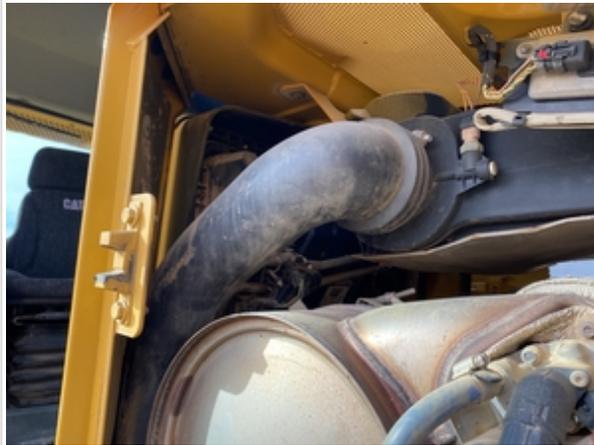
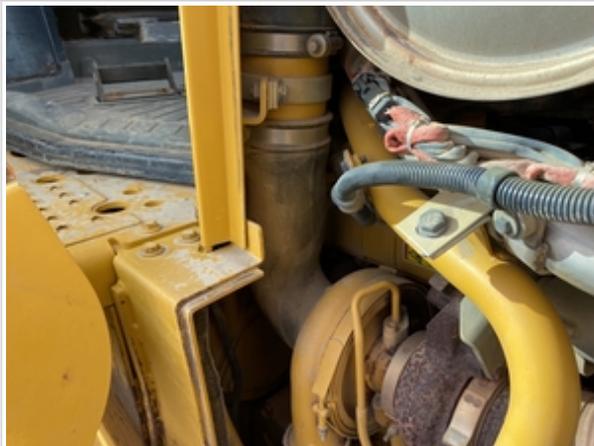
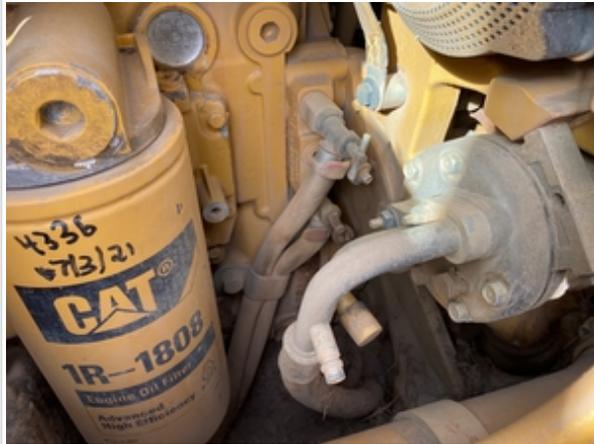
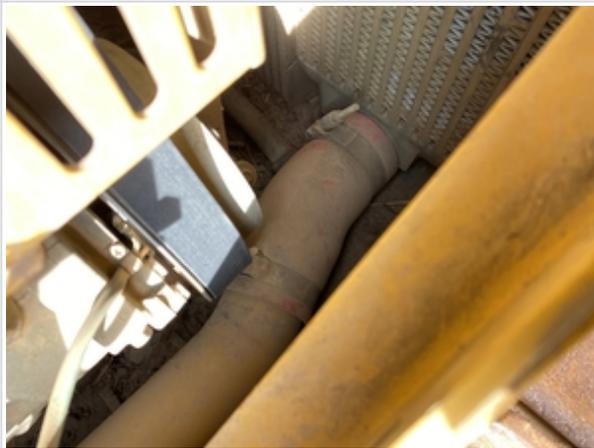
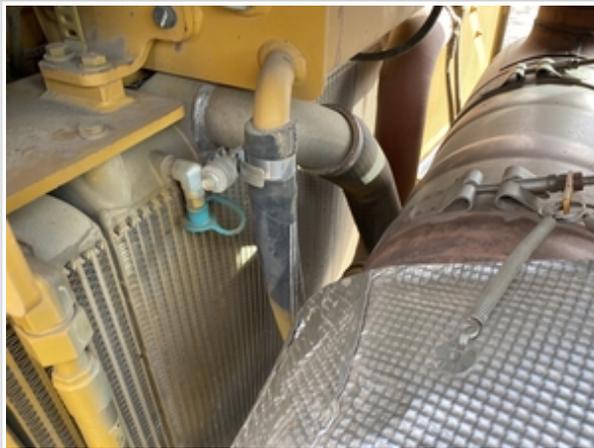
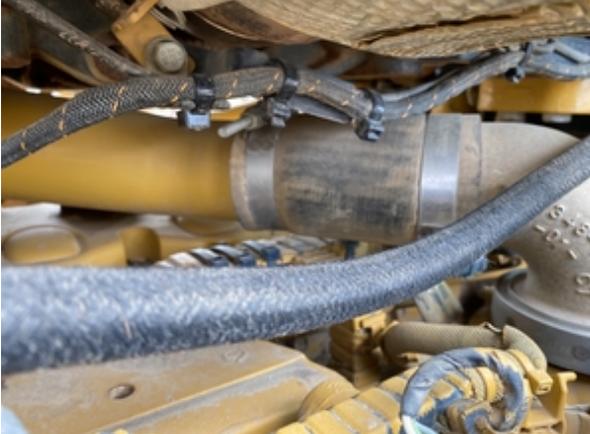
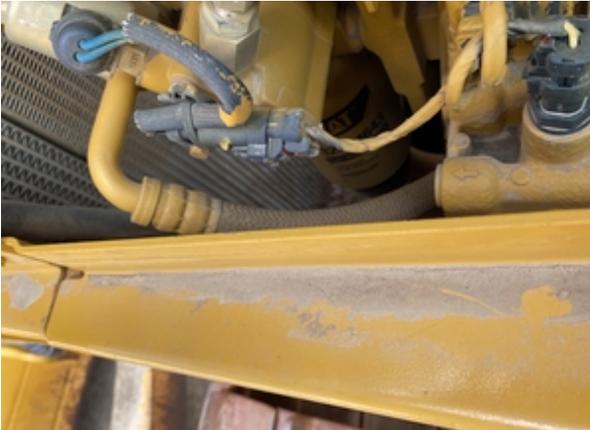
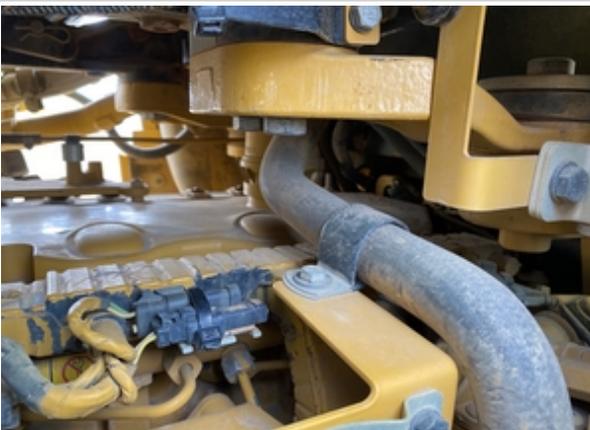
Hose Photos

Hoses	3 - Normal Wear & Tear
Hose Condition	Firm, pliant hoses with no signs of wear or leaks

Water Pump	3 - Normal Wear & Tear	
Water Pump Condition	No unusual pump noises heard	
Cooling System Leaks	No	
Coolant Color / Appearance	3 - Normal Wear & Tear	
Coolant Color/Appearance Notes	Normal Translucent appearance, no visual signs of contamination	
Oil Leaks	No	
Oil Color / Appearance	3 - Normal Wear & Tear

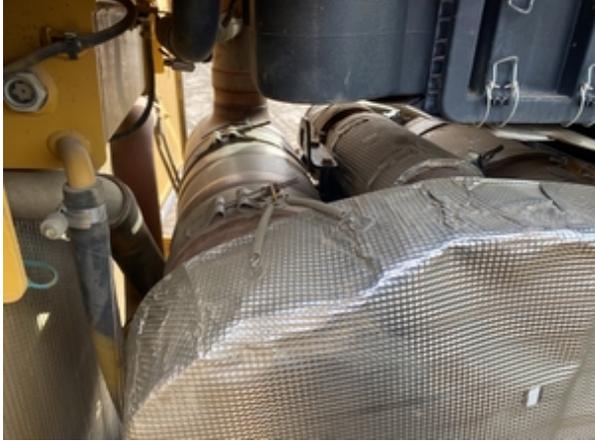
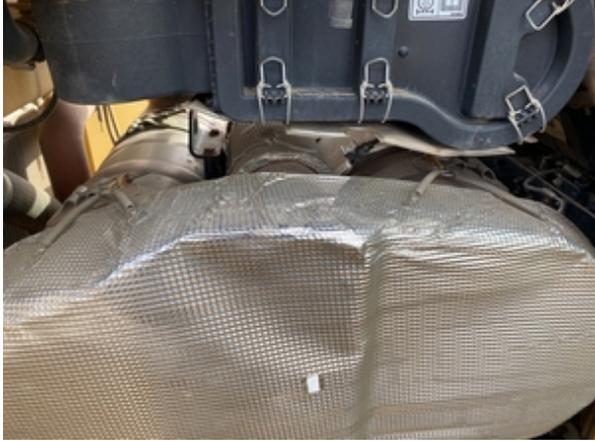
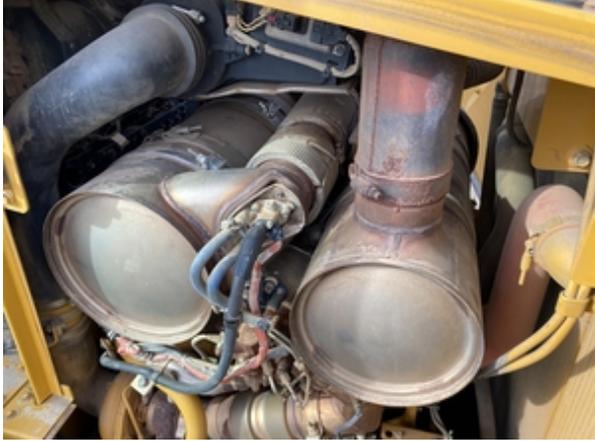
Oil Color / Appearance Notes	Clean oil appearance, no signs of cross contamination, Appropriate oil level
Fuel Leaks	No
Equipped with DPF (Diesel Particulate Filter)	Yes
DPF Condition	3 - Normal Wear & Tear
DPF Condition Notes	Filter housing is intact with no signs of damage or malfunction, DPF indicator is not illuminated
DPF Photos

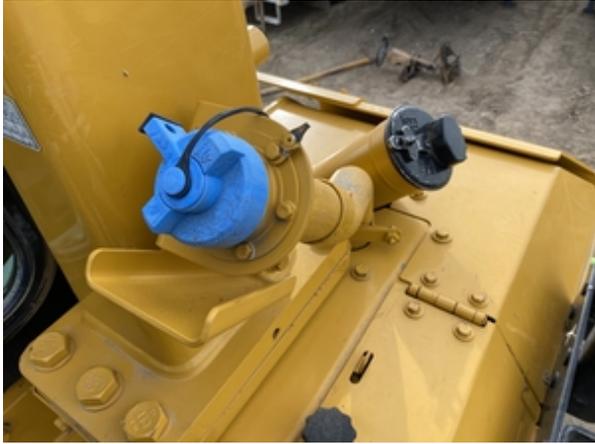
DEF Tank	3 - Normal Wear & Tear
DEF Tank Condition	Area around DEF tank cap is clean, fluid is clear & appears free of contaminants
DEF Tank Photos

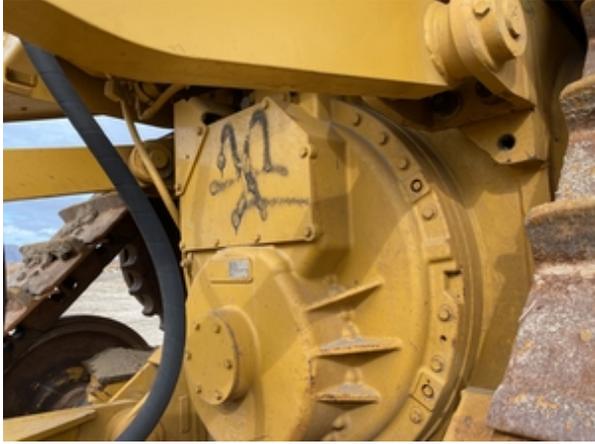
Transmission Info	Powershift 3FWD&3REV. SN#D1X01062 Trans Arrangement # 384-4139
Clutch	3 - Normal Wear & Tear
Transmission	3 - Normal Wear & Tear
Transmission Photos

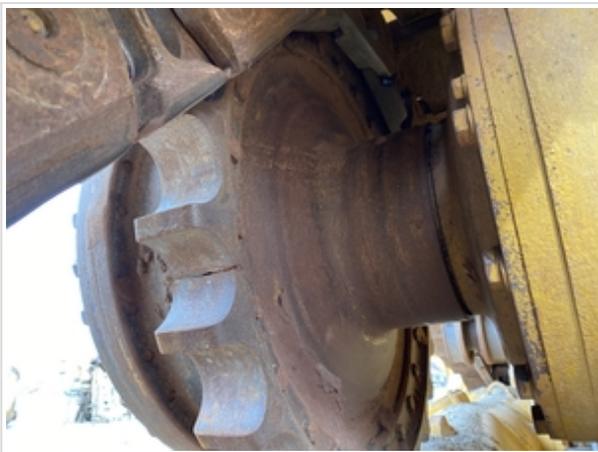
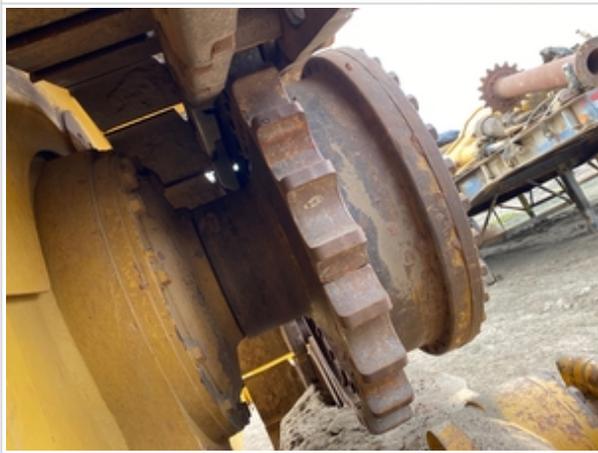
Left Drive Motor	3 - Normal Wear & Tear
Left Final Drive	3 - Normal Wear & Tear
Left Final Drive Photos
