Inspection Report (Bulldozer)

Year	2015
Make	CAT
Model	D6T XL
Serial Number	KMR00412
Hour Meter Reading	5,264 Hours
Previous Application (e.g., earth moving, mining, demolition, etc)	General Construction

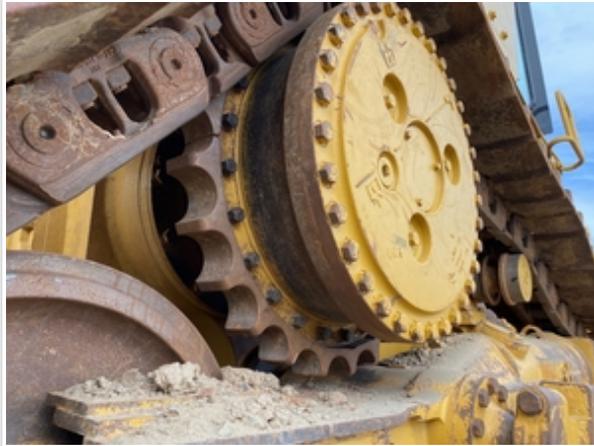
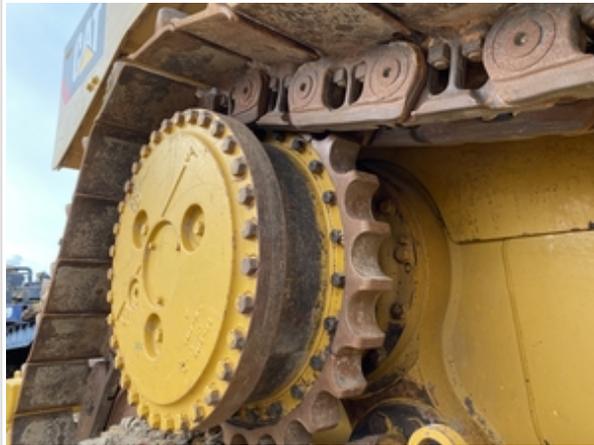
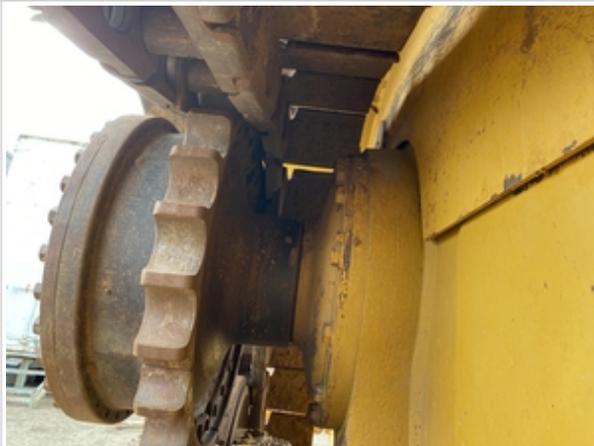
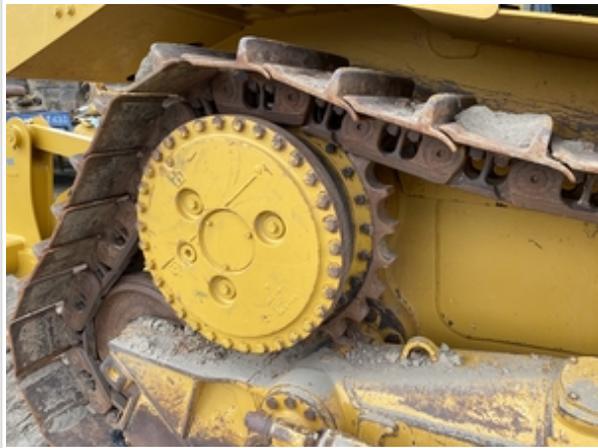
<p>Right Final Drive</p>	<p>3 - Normal Wear & Tear</p>	
<p>Right Final Drive Photos</p>

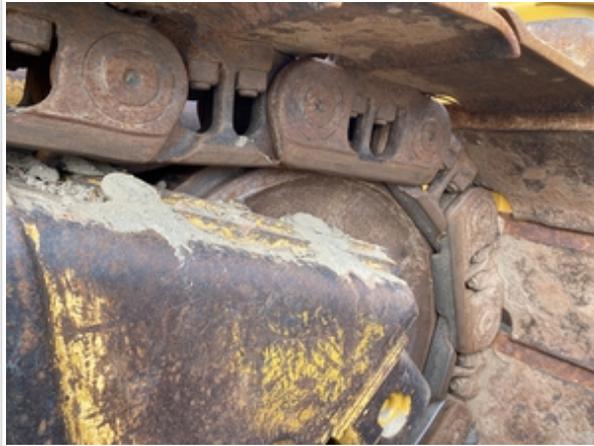
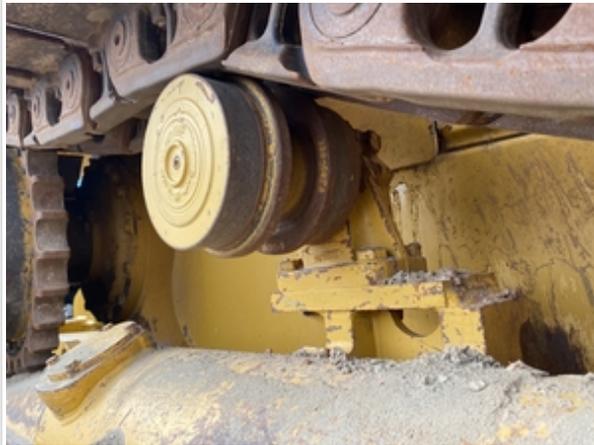
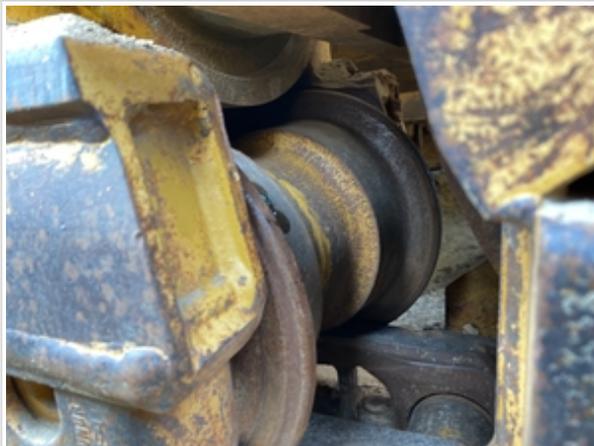
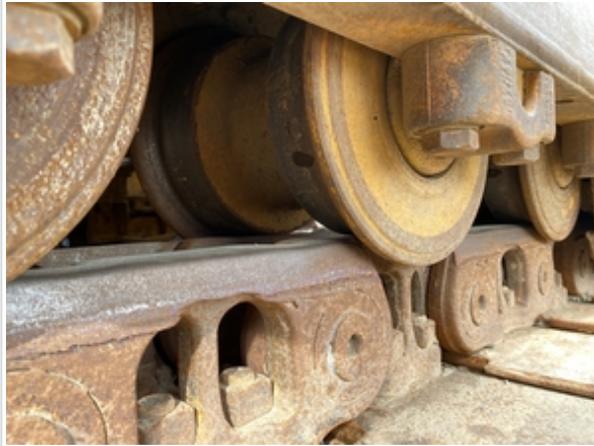
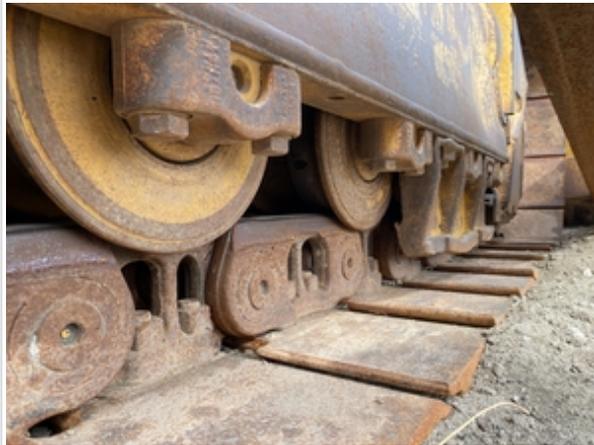
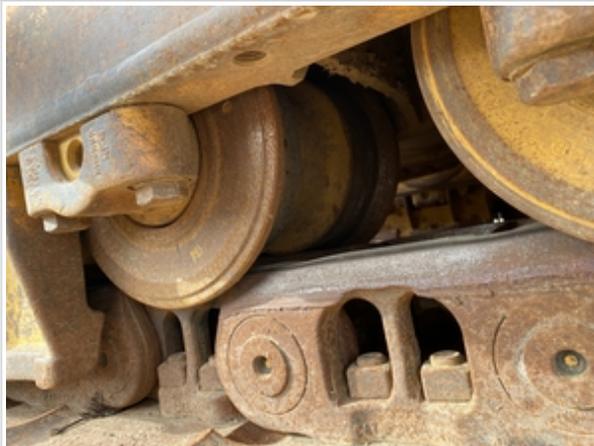
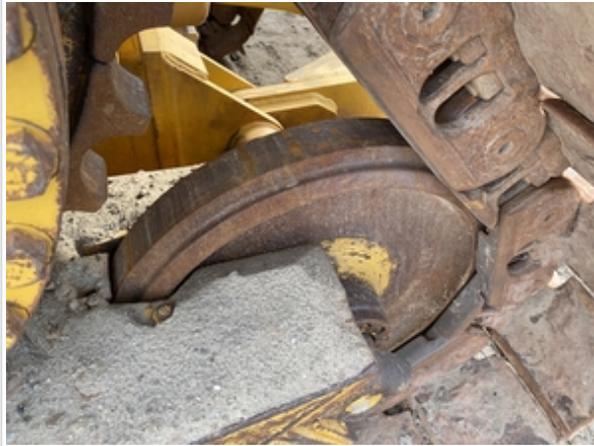
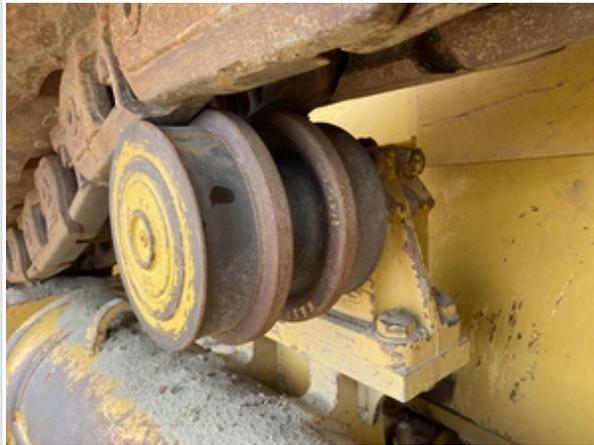
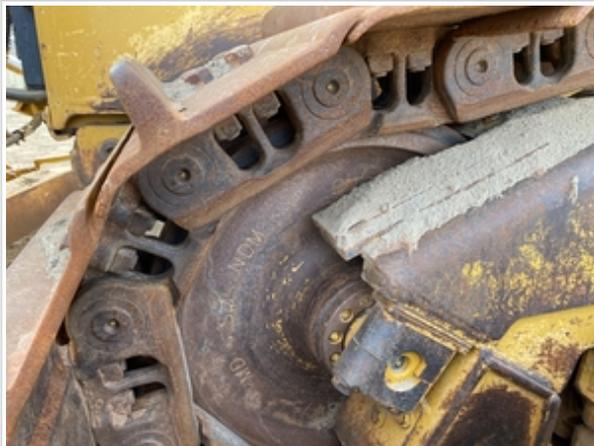
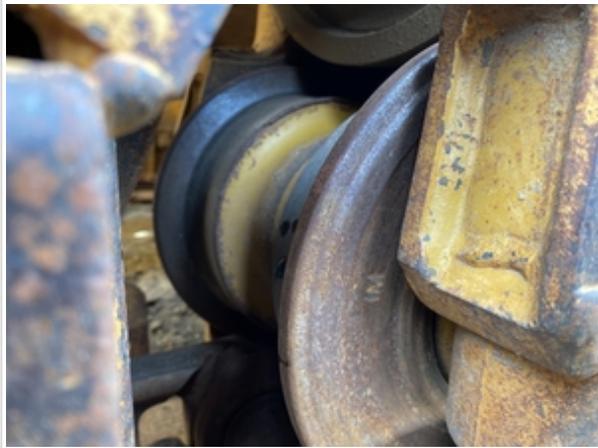
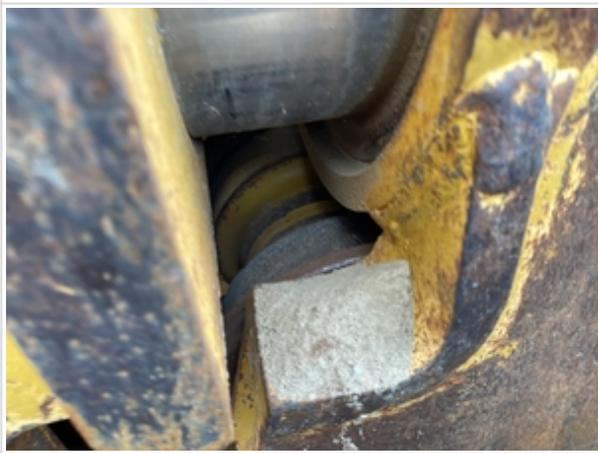
Undercarriage Overall Condition	3 - Normal Wear & Tear	
Comments	Overall thorough track inspection displays about an average of 65% of track wear left	
Undercarriage Overall Photos

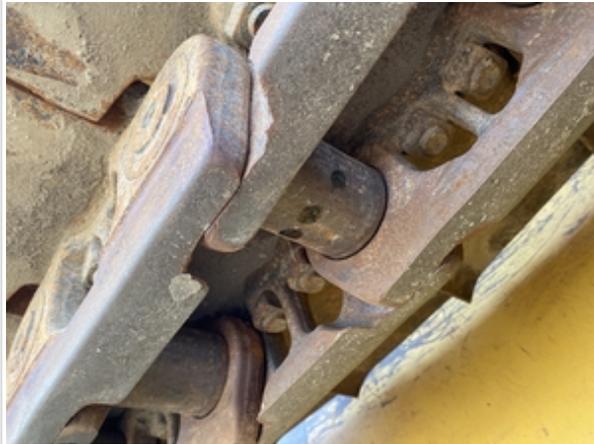
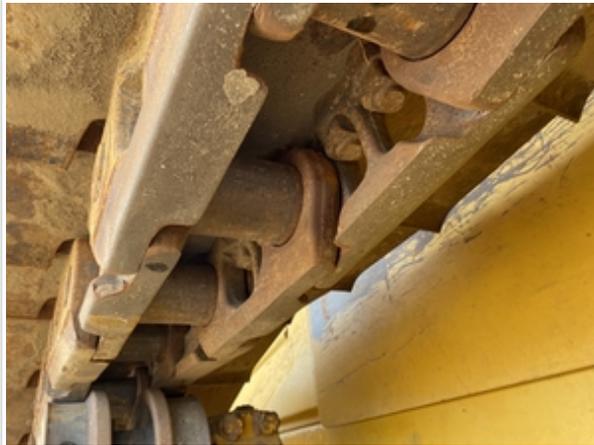
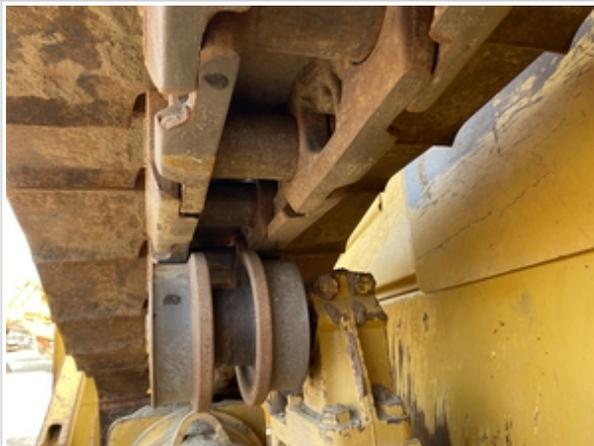
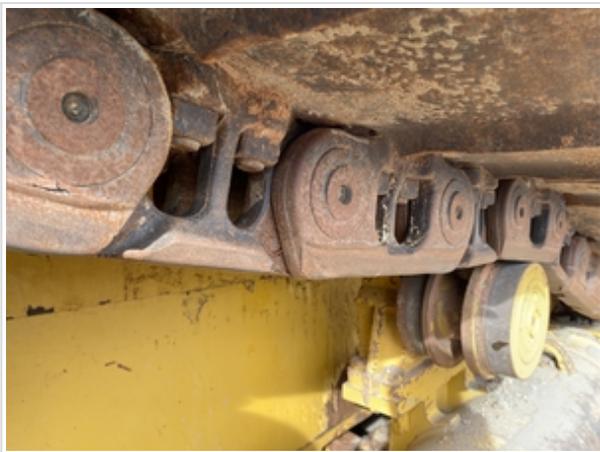
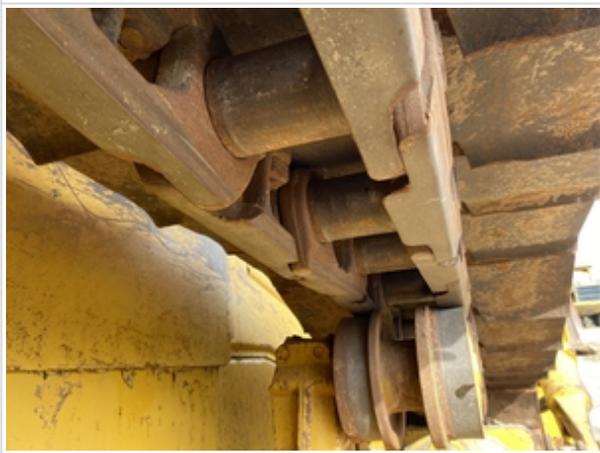
<p>Pin & Bushings</p>	<p>3 - Normal Wear & Tear</p>
<p>Pin & Bushings Photos</p>

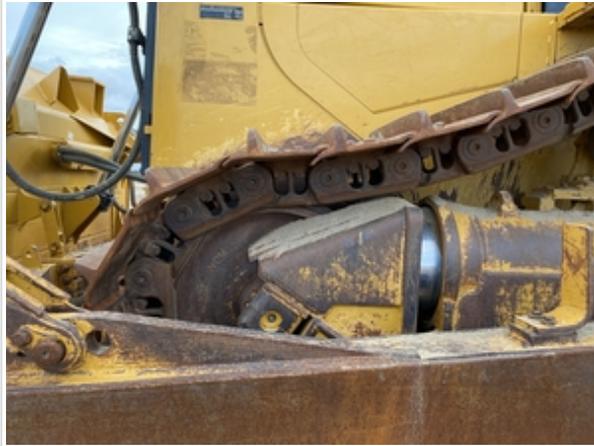
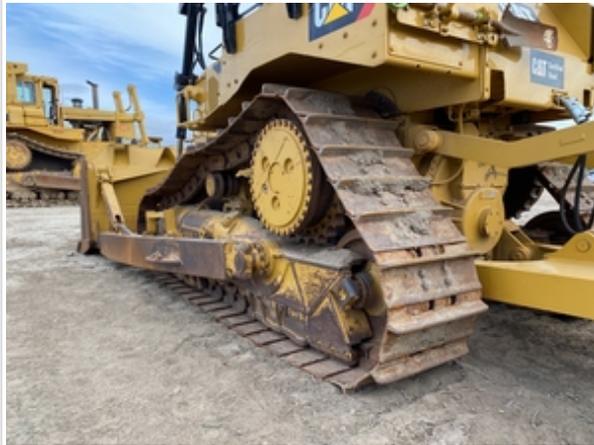
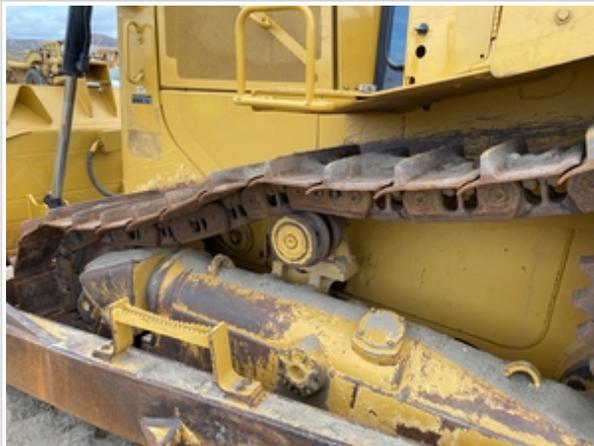
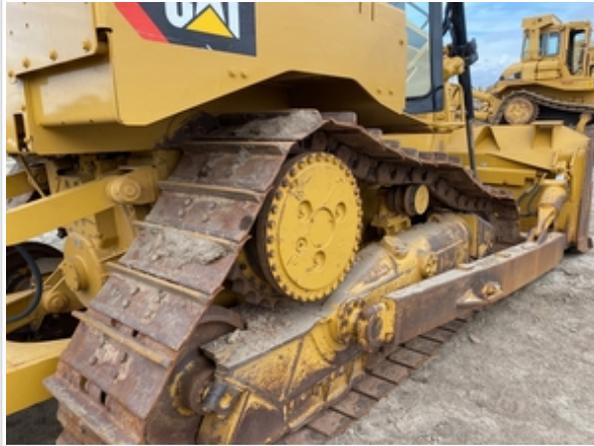
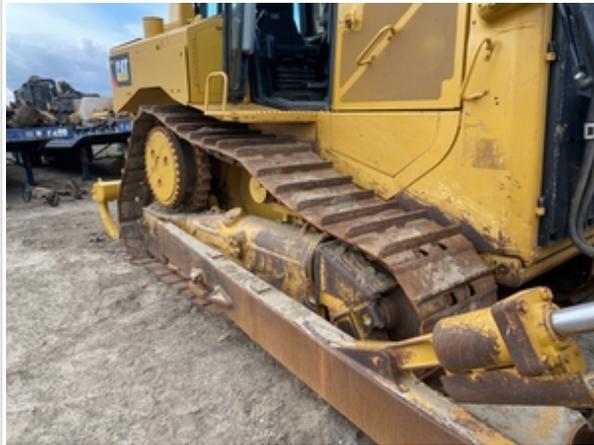
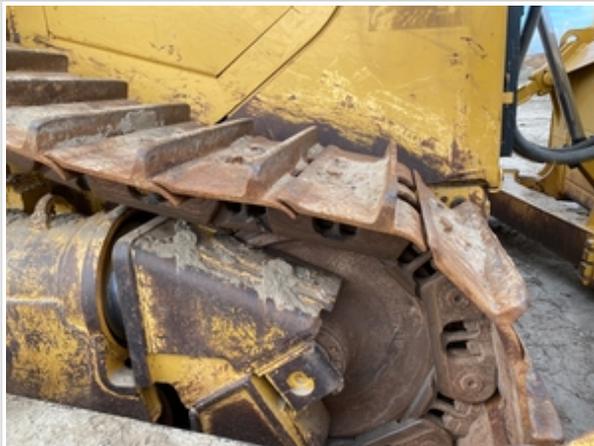
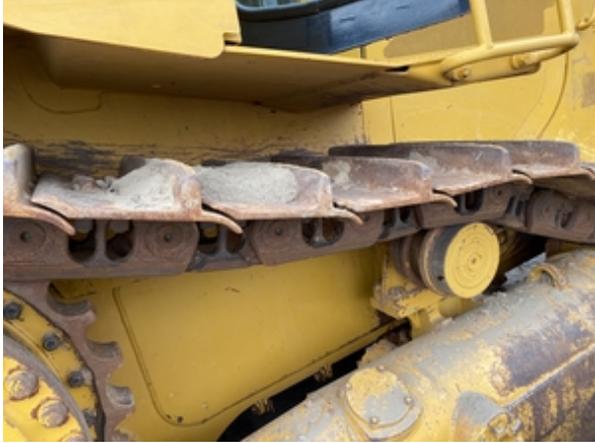
<p>Tracks</p>	<p>3 - Normal Wear & Tear</p>	
<p>Tracks Photos</p>

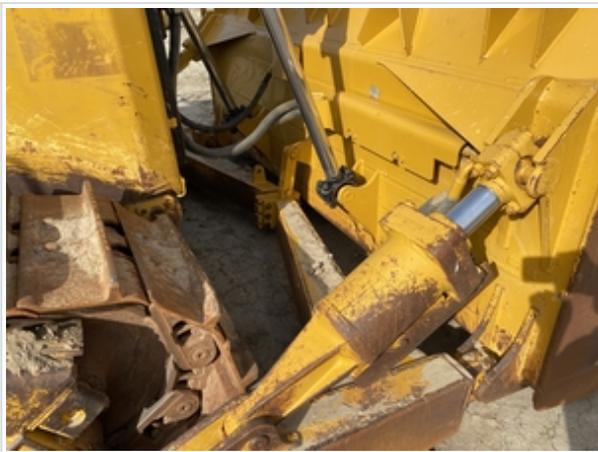
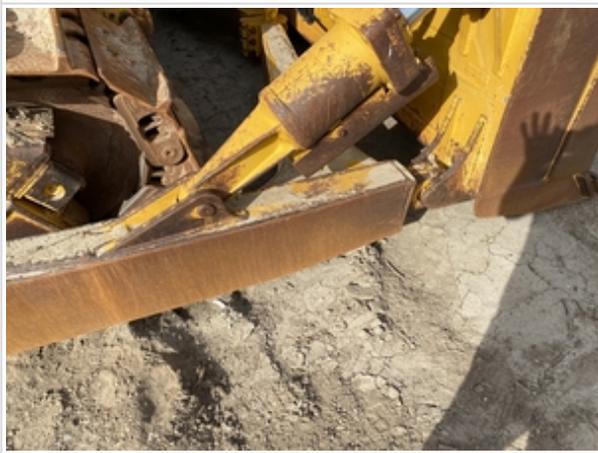
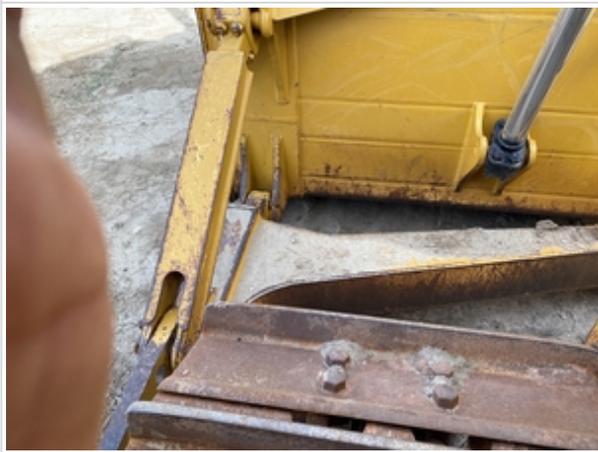
Push Arm / C-Frame Condition	3 - Normal Wear & Tear
Push Arm / C-Frame Photos

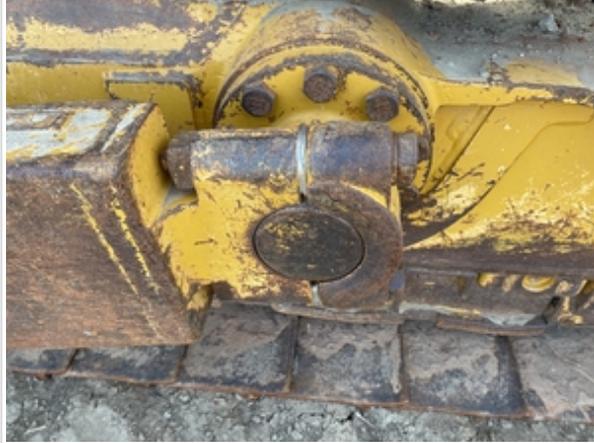
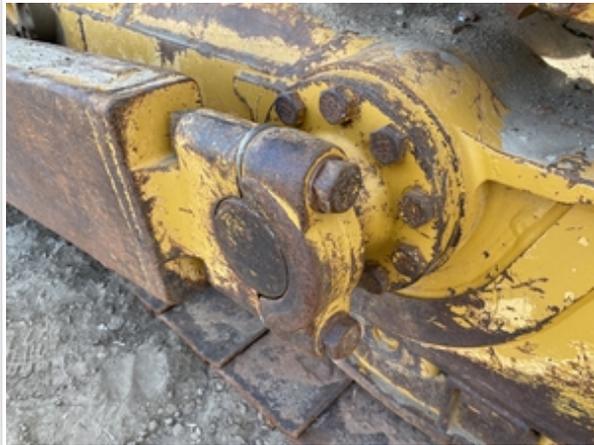
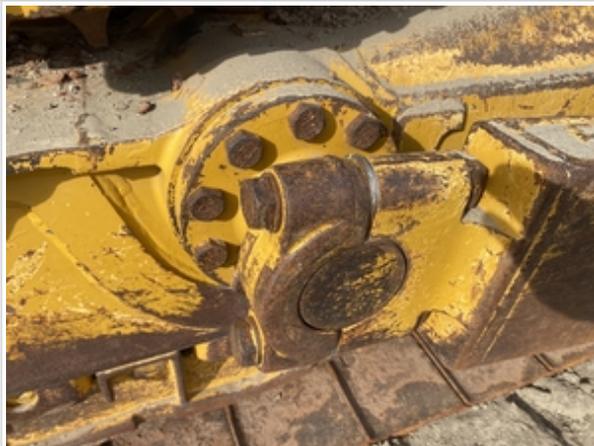
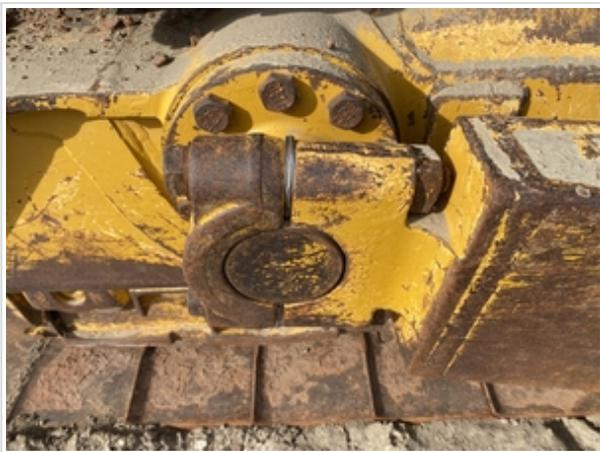
Push Arm Pivot / C-Frame
Trunnions Photos

<p>Push Arm Pivot / C-Frame Trunnions Condition</p>	<p>3 - Normal Wear & Tear</p>

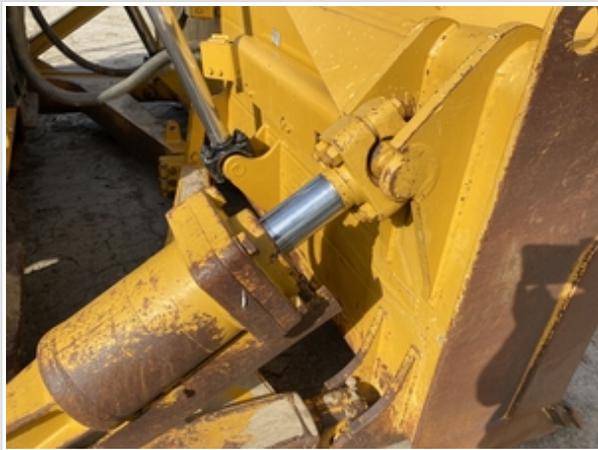
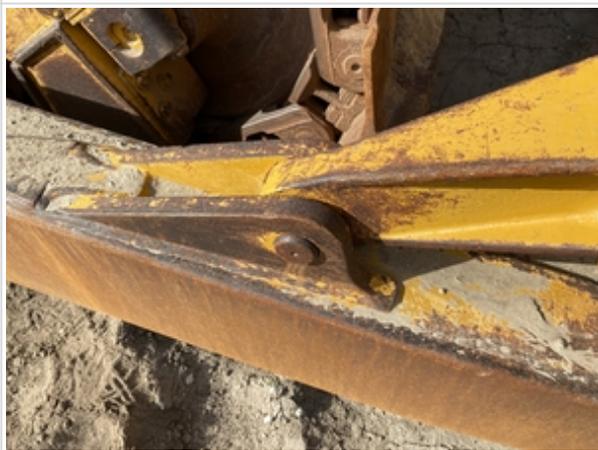
<p>Tilt Linkage Pin & Bushings</p>	<p>3 - Normal Wear & Tear</p>	
<p>Tilt Linkage Pin & Bushings Photos</p>

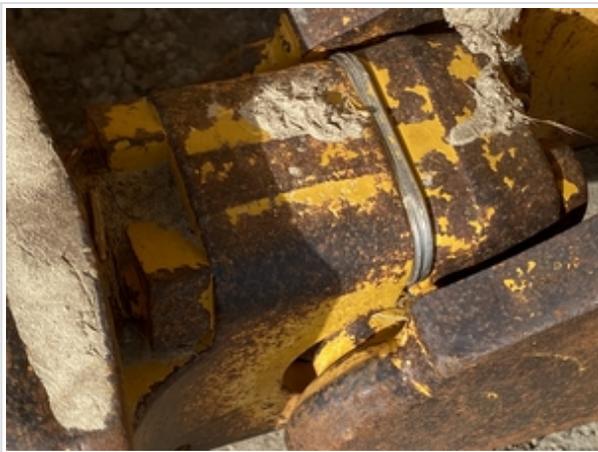
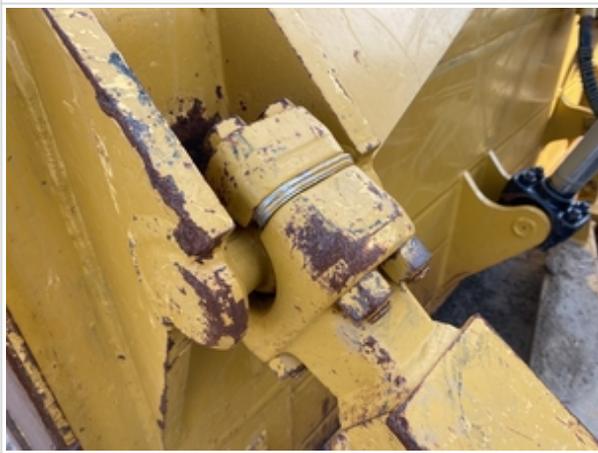
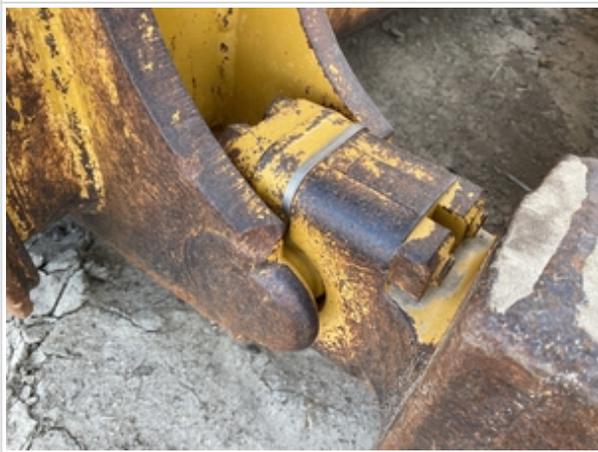
Angle Linkage Pin & Bushings	3 - Normal Wear & Tear	
Blade Trunnions / Bushings	3 - Normal Wear & Tear	
Blade Trunnions / Bushings Photos

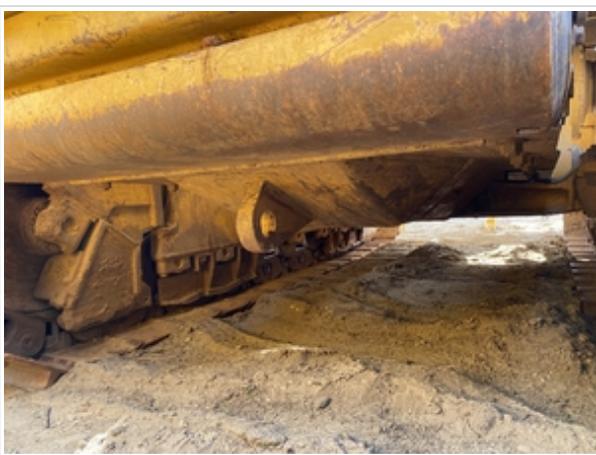
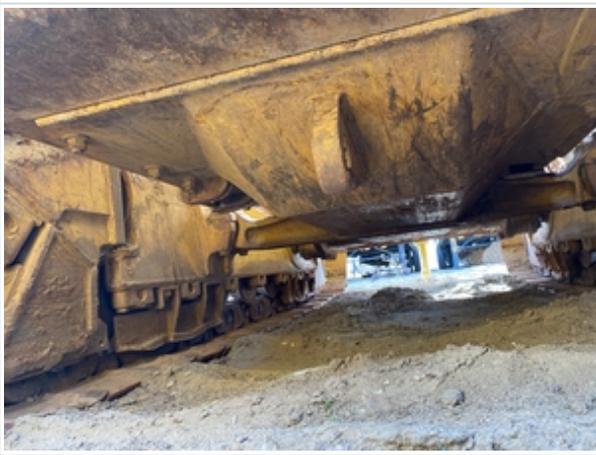
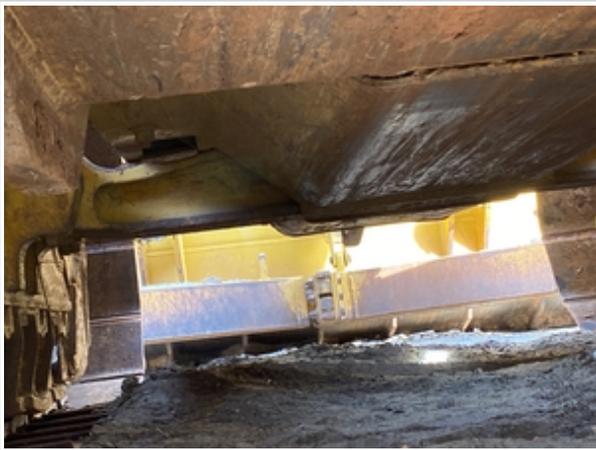
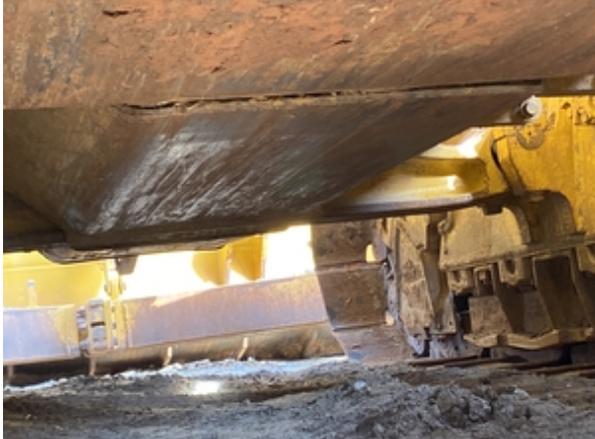
<p>Frame Photos</p>

<p>Frame Condition</p>	<p>3 - Normal Wear & Tear</p>

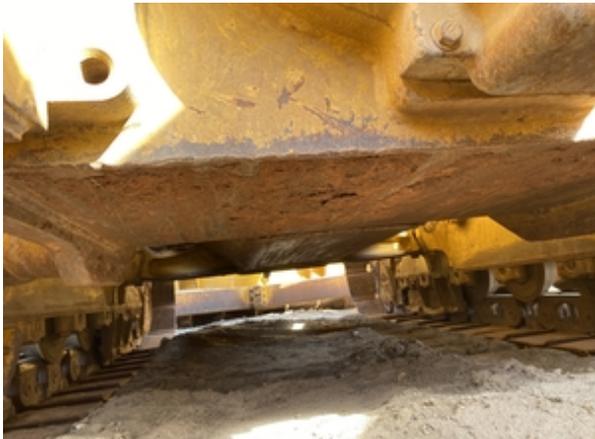
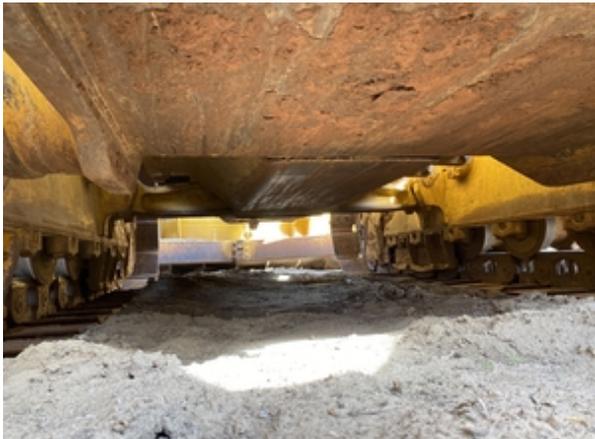
Belly Pans	3 - Normal Wear & Tear	
Belly Pans Photos

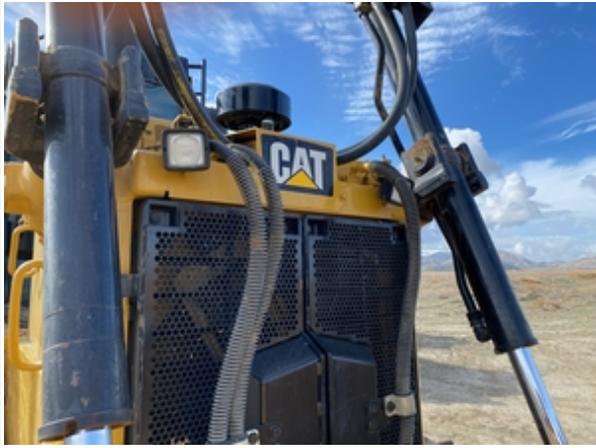
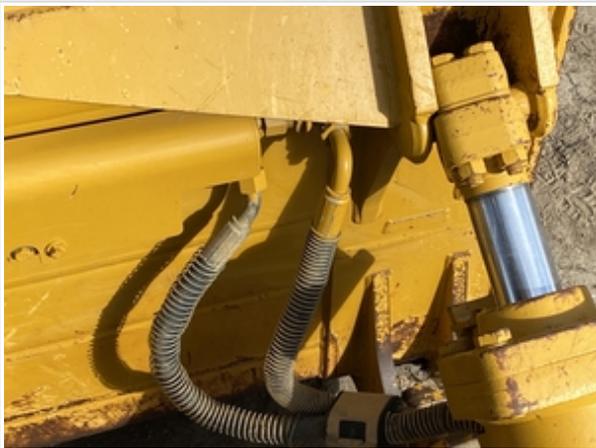
Appearance of Hydraulic Lines / Fittings	3
Hydraulic Lines / Fittings Condition	Hydraulic lines & fittings are clean and in good condition
Appearance of Hydraulic Lines / Fittings Photos

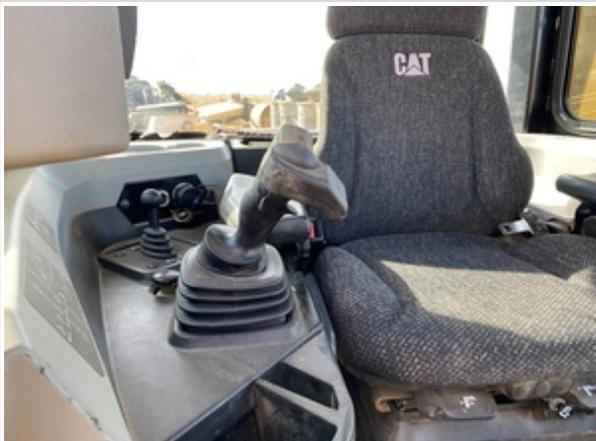
Unusual Noises (Hydraulic Pump)	No	
Hydraulic Pump Notes	No unusual noises heard during operation	
External Controls / Levers	3	
External Controls / Levers Condition	Good function & condition of hydraulic controls	
External Controls / Levers Photos

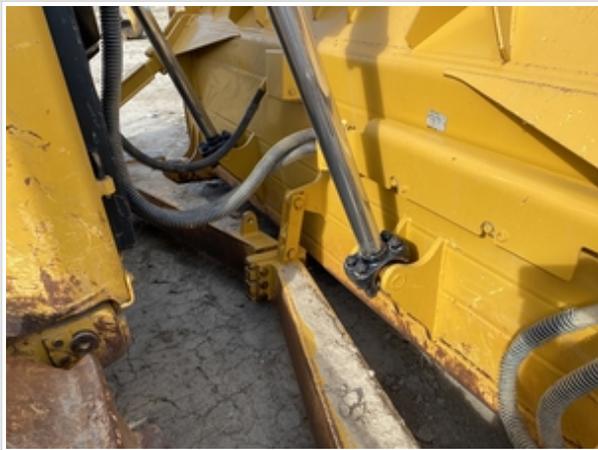
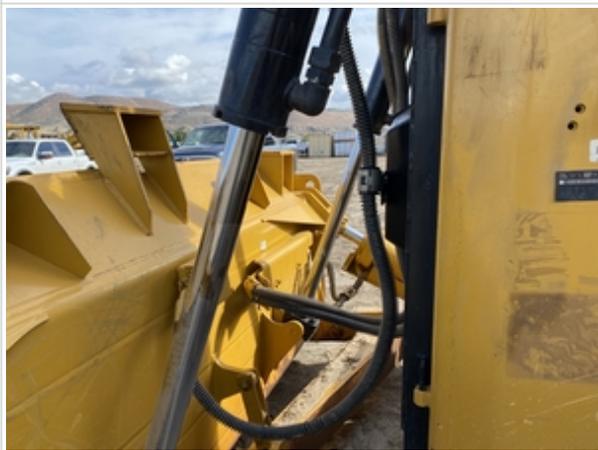
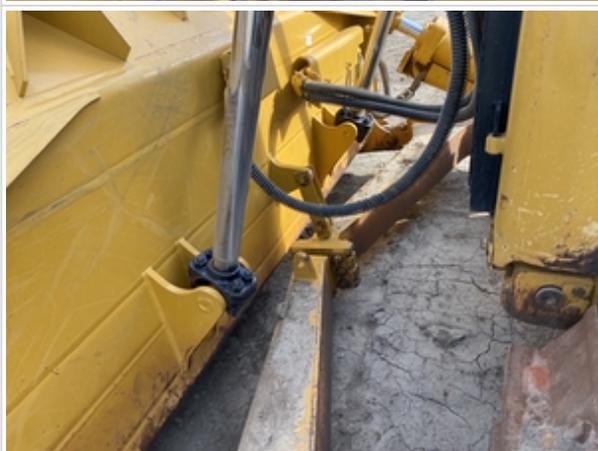
Lift Cylinder	Check the lift cylinder. Note any wear, pitting, discoloration, etc. Take photos.
Lift Cylinder: Mounting Pin	3

Lift Cylinder: Oil Leaks	No
Lift Cylinder Photos

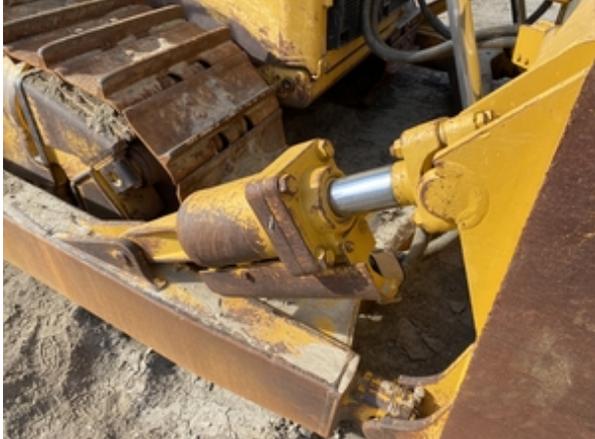
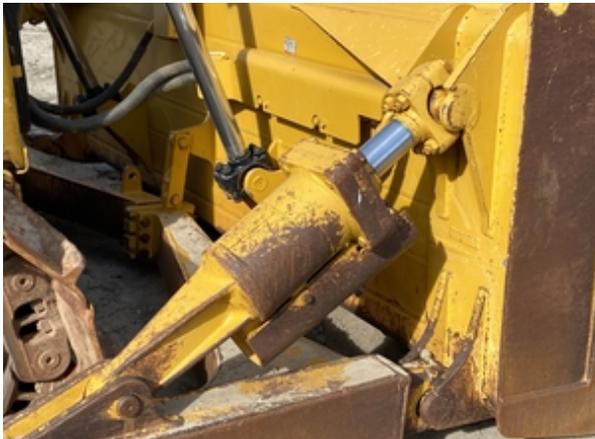
Tilt Cylinder Photos

Tilt Cylinder	Check the tilt cylinder. Note any wear, pitting, discoloration, etc. Take photos.
Tilt Cylinder: Mounting Pin	3
Tilt Cylinder: Oil Leaks	No

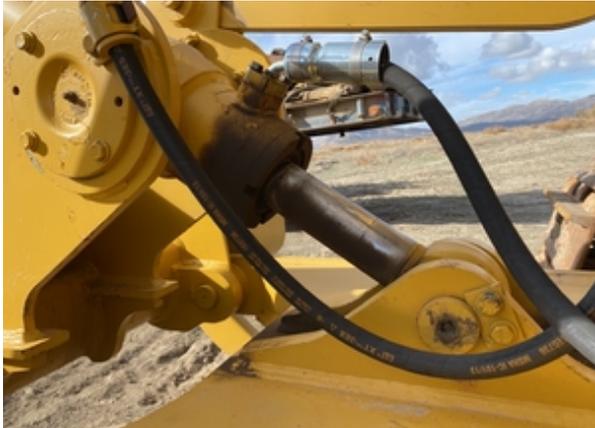
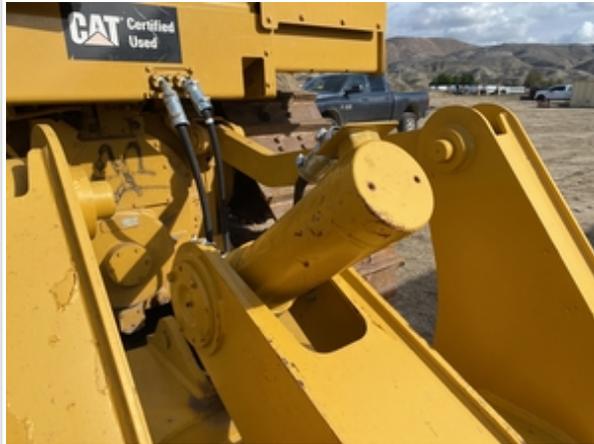
Angle Cylinder	Check the angle cylinder. Note any wear, pitting, discoloration, etc. Take photos.
Angle Cylinder: Mounting Pin	0
Angle Cylinder: Oil Leaks	No
Ripper	Check the ripper cylinders. Note any wear, pitting, discoloration, etc. Take photos.
Ripper Cylinder: Mounting Pin	3
Ripper Cylinder: Oil Leaks	No
Comments	Residual oil seen on R/S Cylinder seems to have been a previously leak from the o-ring on the hydraulic hose not he cylinder rod seal
Ripper Cylinder Photos

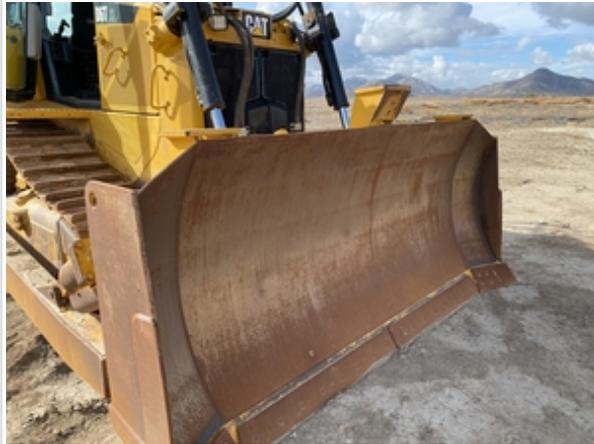
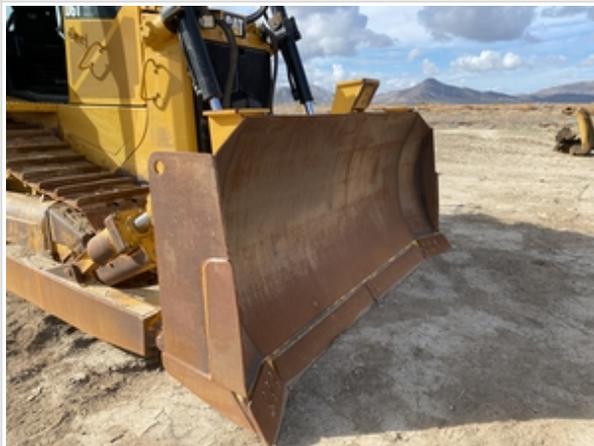
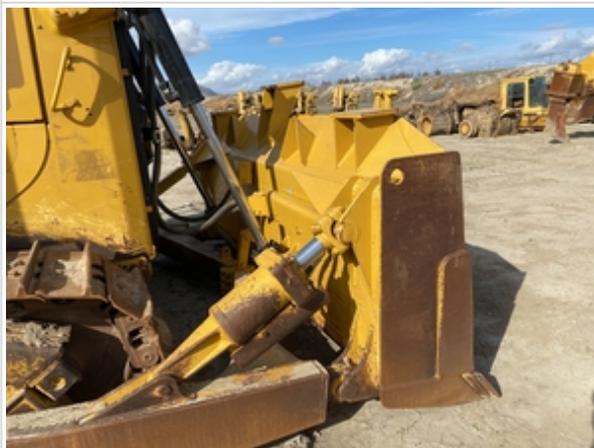
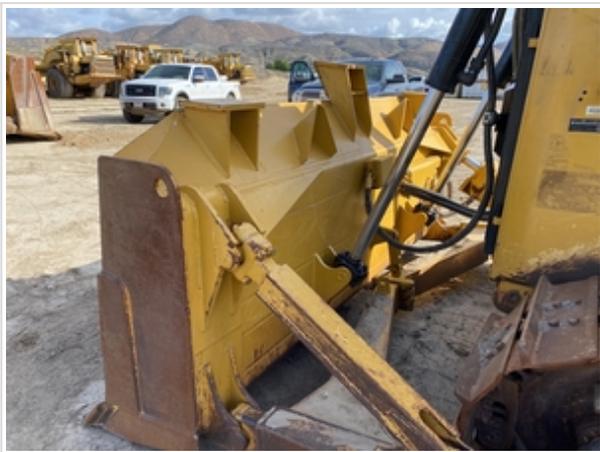
Blade Photos

Blade Condition	3 - Normal Wear & Tear
-----------------	------------------------

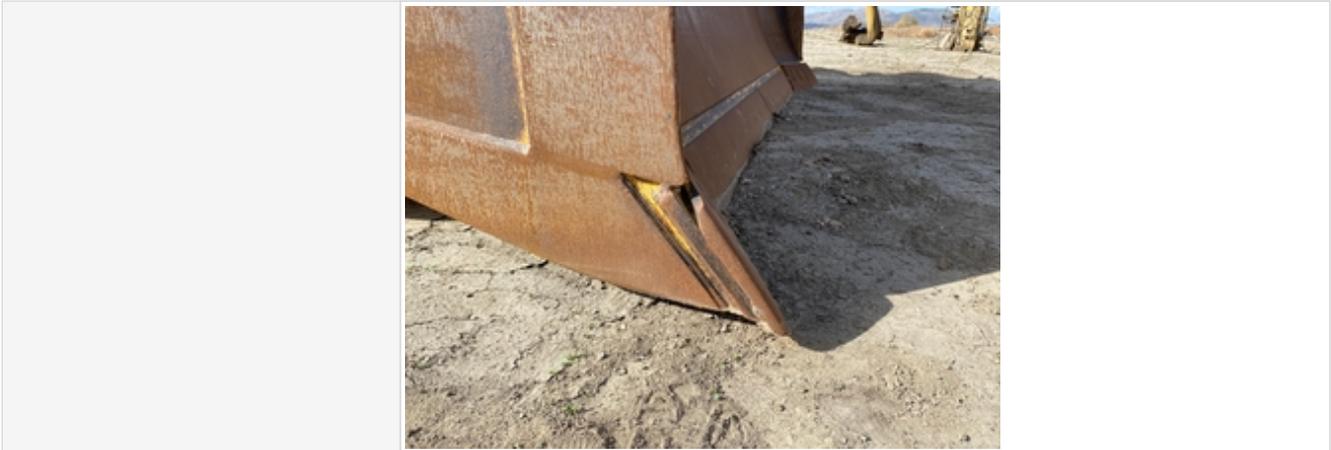
<p>Blade Edge</p>	<p>3 - Normal Wear & Tear</p>	
<p>Blade Edge Photos</p>

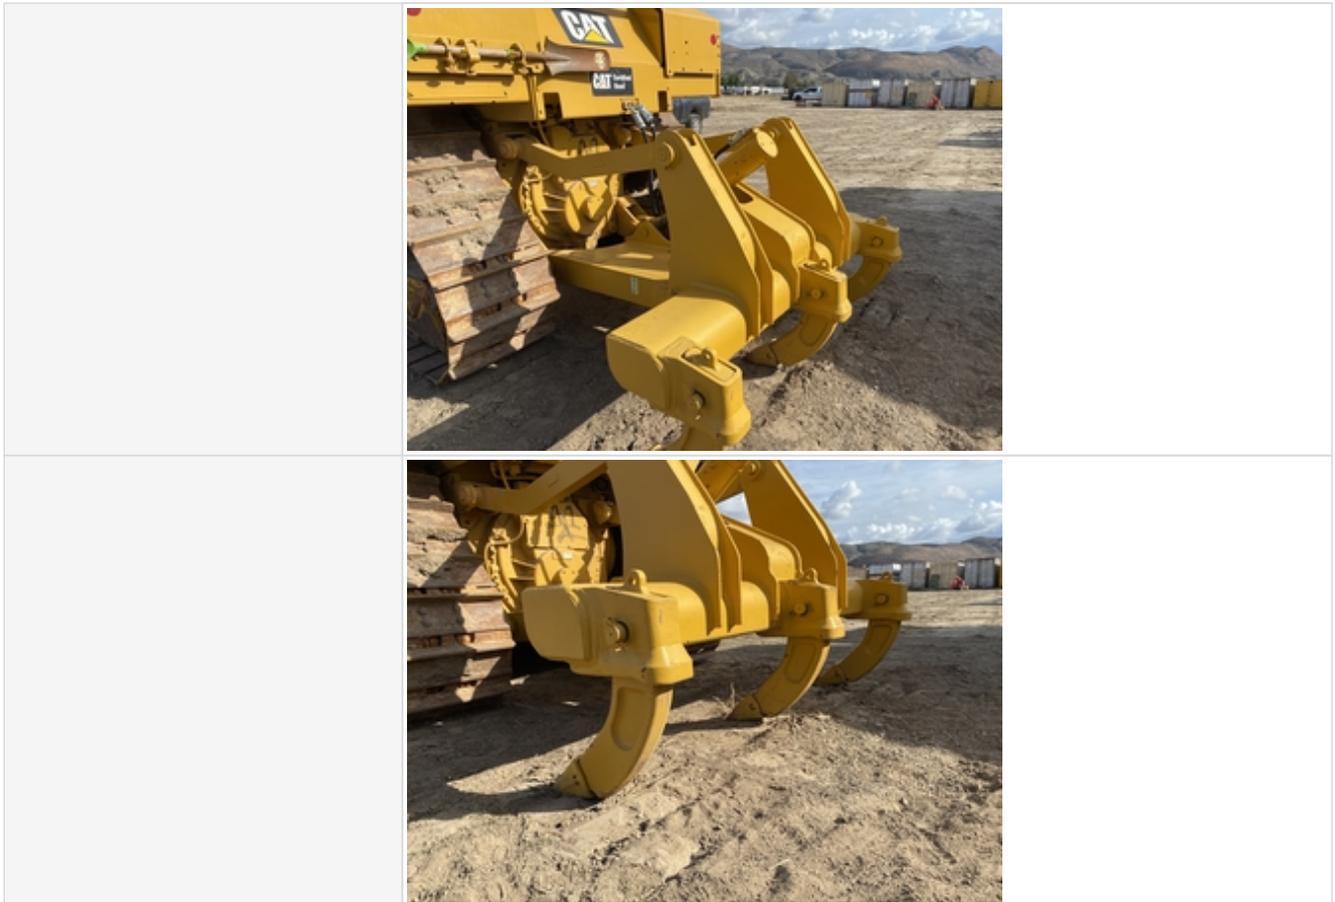
Ripper Condition	3 - Normal Wear & Tear
Ripper Photos
