Inspection Report (Boom Lift)

Year	2019
Make	Platform Basket
Model	PB22.10
Serial Number	PB11078
Hour Meter Reading	345.0
Previous Application (e.g., earth moving, mining, demolition, etc)	Tree Services Contractor

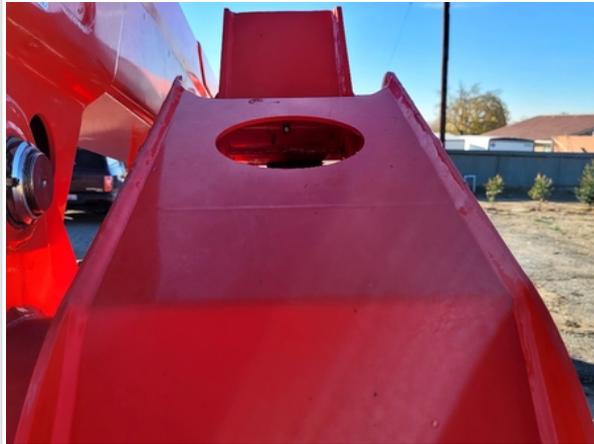
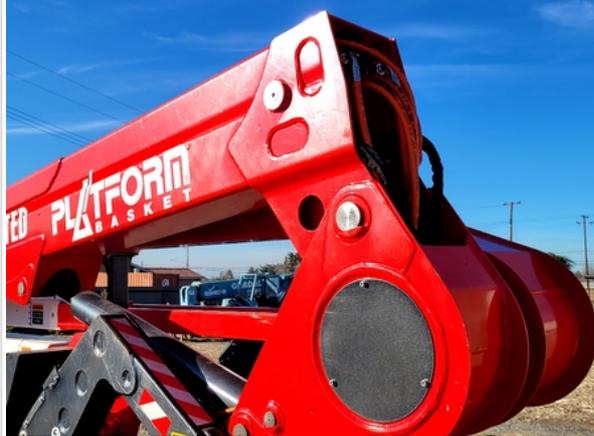
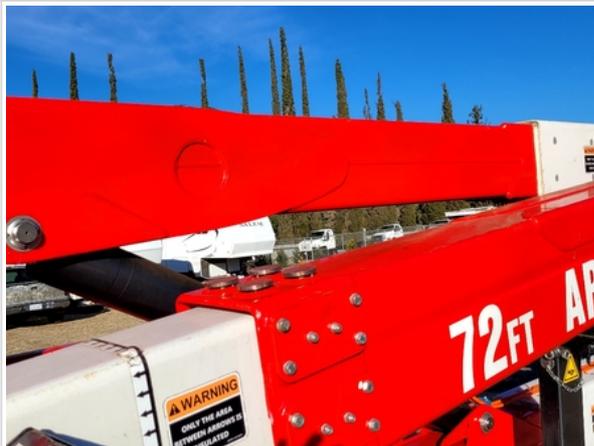
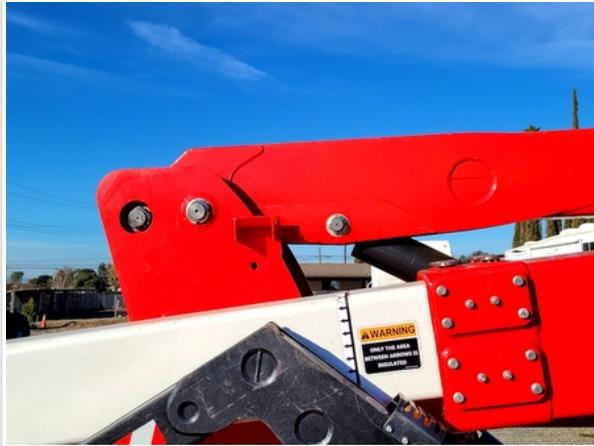
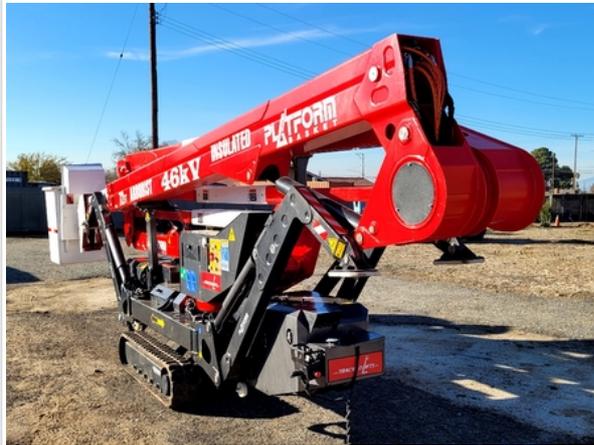
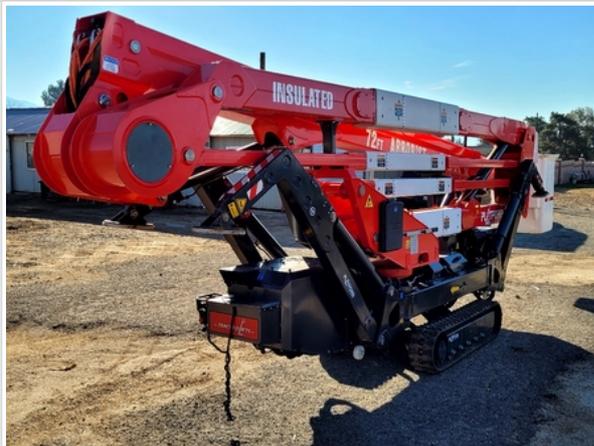
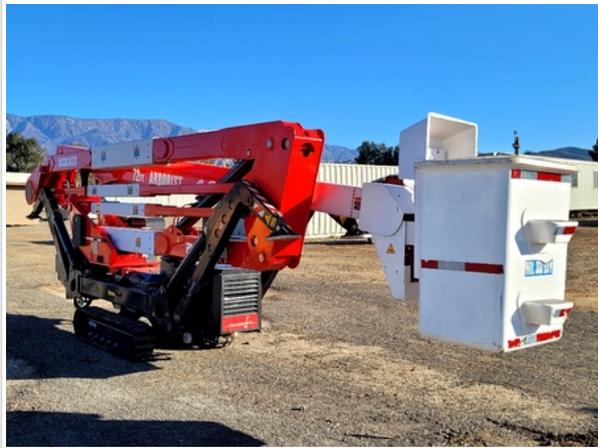
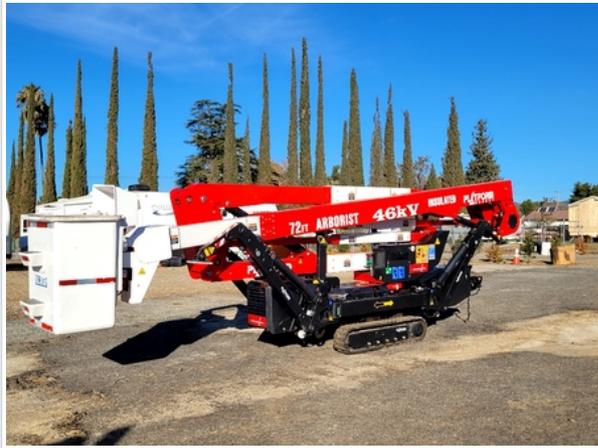
Front	4 - Like New, Recently Replaced
Front Photos

Rear	4 - Like New, Recently Replaced
Left	4 - Like New, Recently Replaced
Right	4 - Like New, Recently Replaced
Upper	4 - Like New, Recently Replaced
Body Panels (Any Damage?)	4 - Like New, Recently Replaced
Hand Rails	0

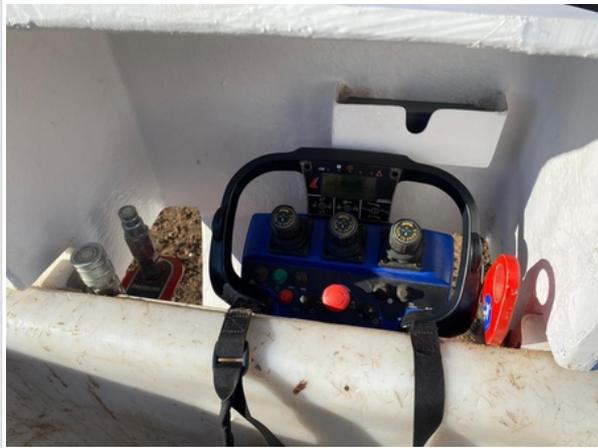
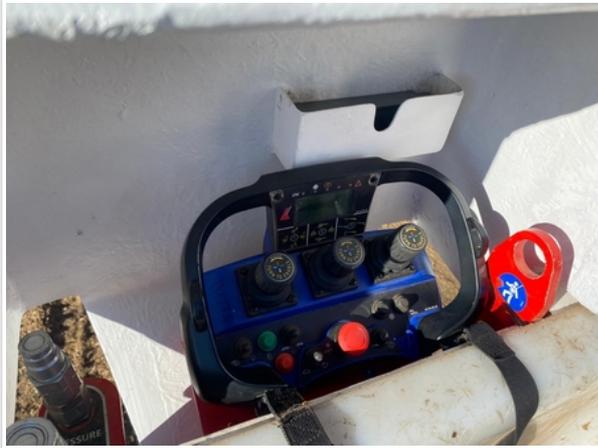
Hour Meter Activity	3 - Normal Wear & Tear
Other Gauge Activity	3 - Normal Wear & Tear
Controls & Switches	3 - Normal Wear & Tear
Horn	3 - Normal Wear & Tear
Travel Alarm	3 - Normal Wear & Tear
Swing Brake	3 - Normal Wear & Tear
Safety Lock Out / Stop	3 - Normal Wear & Tear
Platform Safety Rails & Appearance	0
Platform Floor	3 - Normal Wear & Tear
Platform Floor Photos

Platform Controls	3 - Normal Wear & Tear

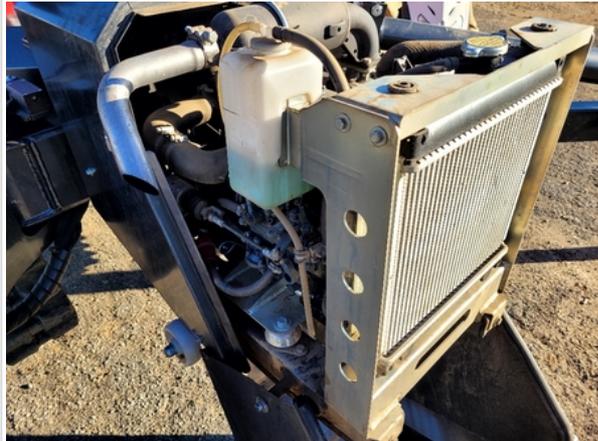
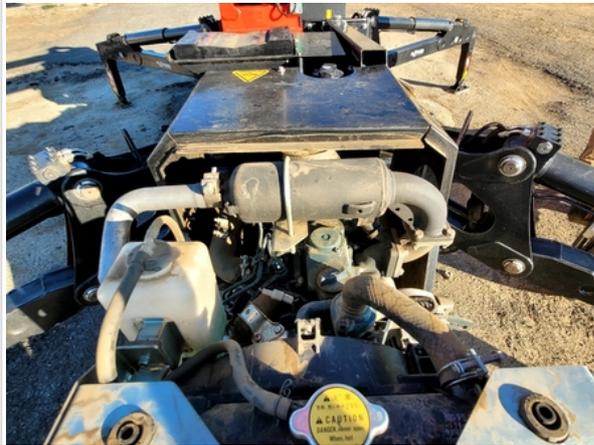
Engine Type (Make, Model, Cylinders, Hp)	Kubota - Z602-EF03 - 14HP - 2Cyl.
Emissions Tier	Tier 4F
Engine Serial Number	4KB8112
Engine Fuel Type	Diesel
Engine Photos

Battery	3 - Normal Wear & Tear
Battery Condition	Like new, recently replaced
Radiator	3 - Normal Wear & Tear
Belts	3 - Normal Wear & Tear
Hoses	3 - Normal Wear & Tear
Water Pump	3 - Normal Wear & Tear
Cooling System Leaks	No
Coolant Color / Appearance	3 - Normal Wear & Tear
Coolant Color/Appearance Notes	Normal Translucent appearance, no visual signs of contamination
Oil Leaks	No
Oil Color / Appearance	3 - Normal Wear & Tear
Fuel Leaks	No
Equipped with DPF (Diesel Particulate Filter)	No
Requires DEF (Diesel Exhaust Fluid)	No
Overall Engine Appearance	Clean & dry
Overall Engine Comments	Overall engine like new and well maintained

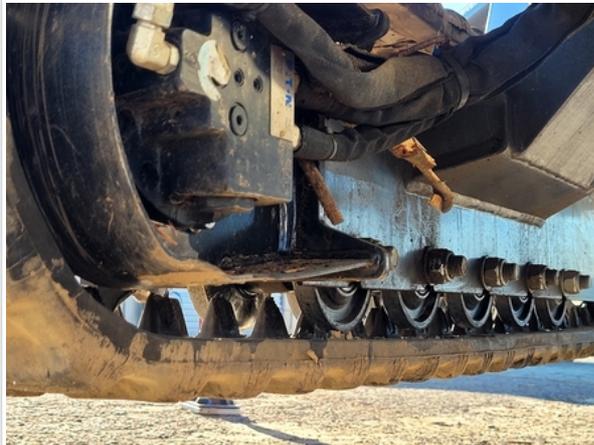
Hydrostatic Transmission?	Yes
2 Speed?	N/A
Hydrostatic Drive Configuration	Split Transmission
Drive Motors	2 - Above Average Wear
Drive Motor Photos

Hydrostatic Parking Brake	3 - Normal Wear & Tear
Hydrostatic Parking Brake Condition	Good brake function
Overall Drivetrain Comments	Overall drivetrain in great condition like new with no issues observed

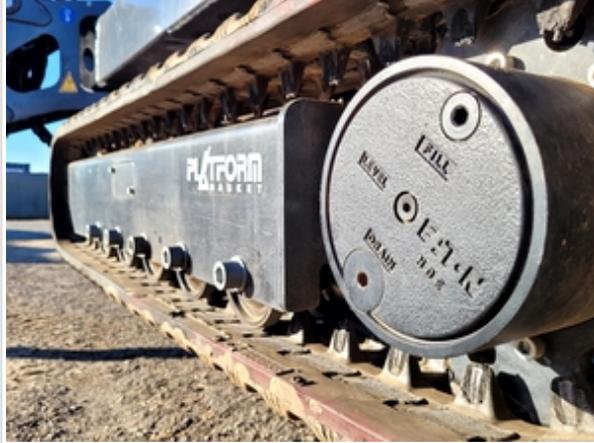
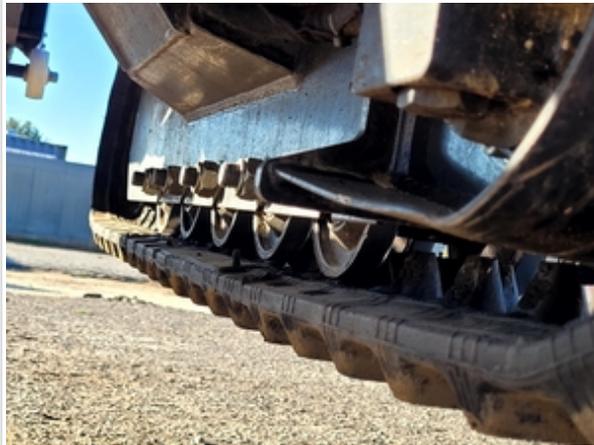
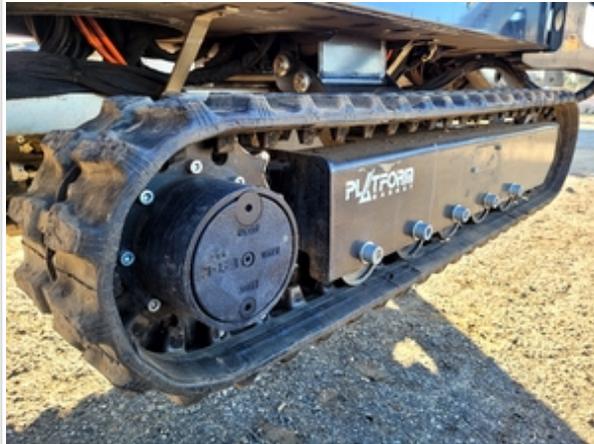
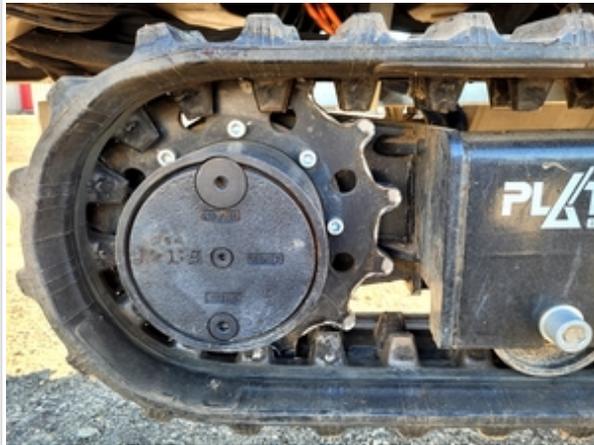
Wheels & Tires Photos

Frame	3 - Normal Wear & Tear
Stance	3 - Normal Wear & Tear
Front Axle Appearance	0
Rear Axle Appearance	0
Wheels & Tires	4 - Like New, Recently Replaced

Front Left Tire - Ratio Remaining	90%	
Rear Left Tire - Ratio Remaining	90%	
Front Right Tire - Ratio Remaining	90%	
Rear Right Tire - Ratio Remaining	90%	
Swivel Bearing	3 - Normal Wear & Tear	
Swivel Motor	3 - Normal Wear & Tear	
Swivel Joint	3 - Normal Wear & Tear	
Boom Condition	3 - Normal Wear & Tear	
Boom Condition Photos

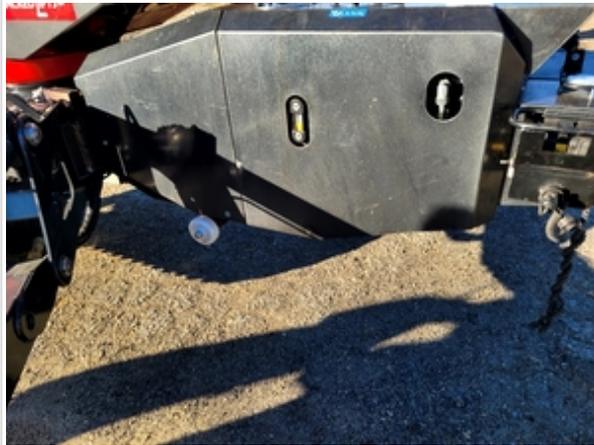
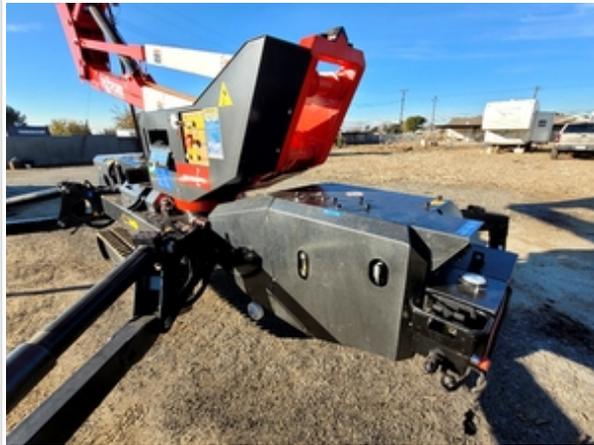
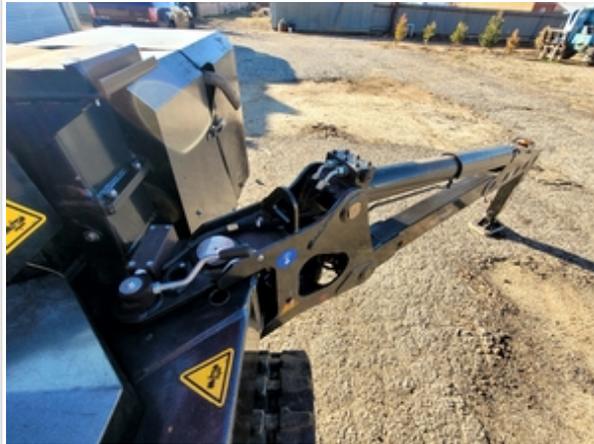
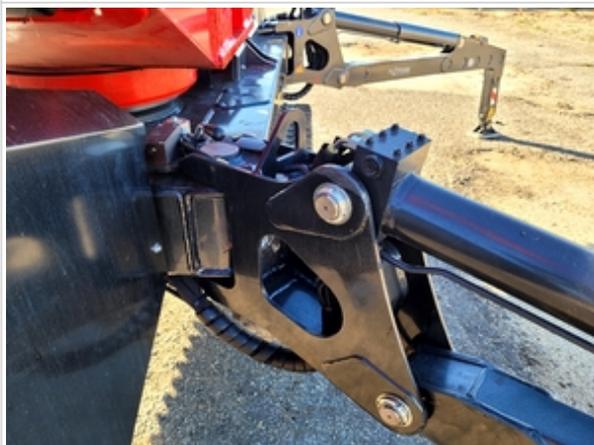
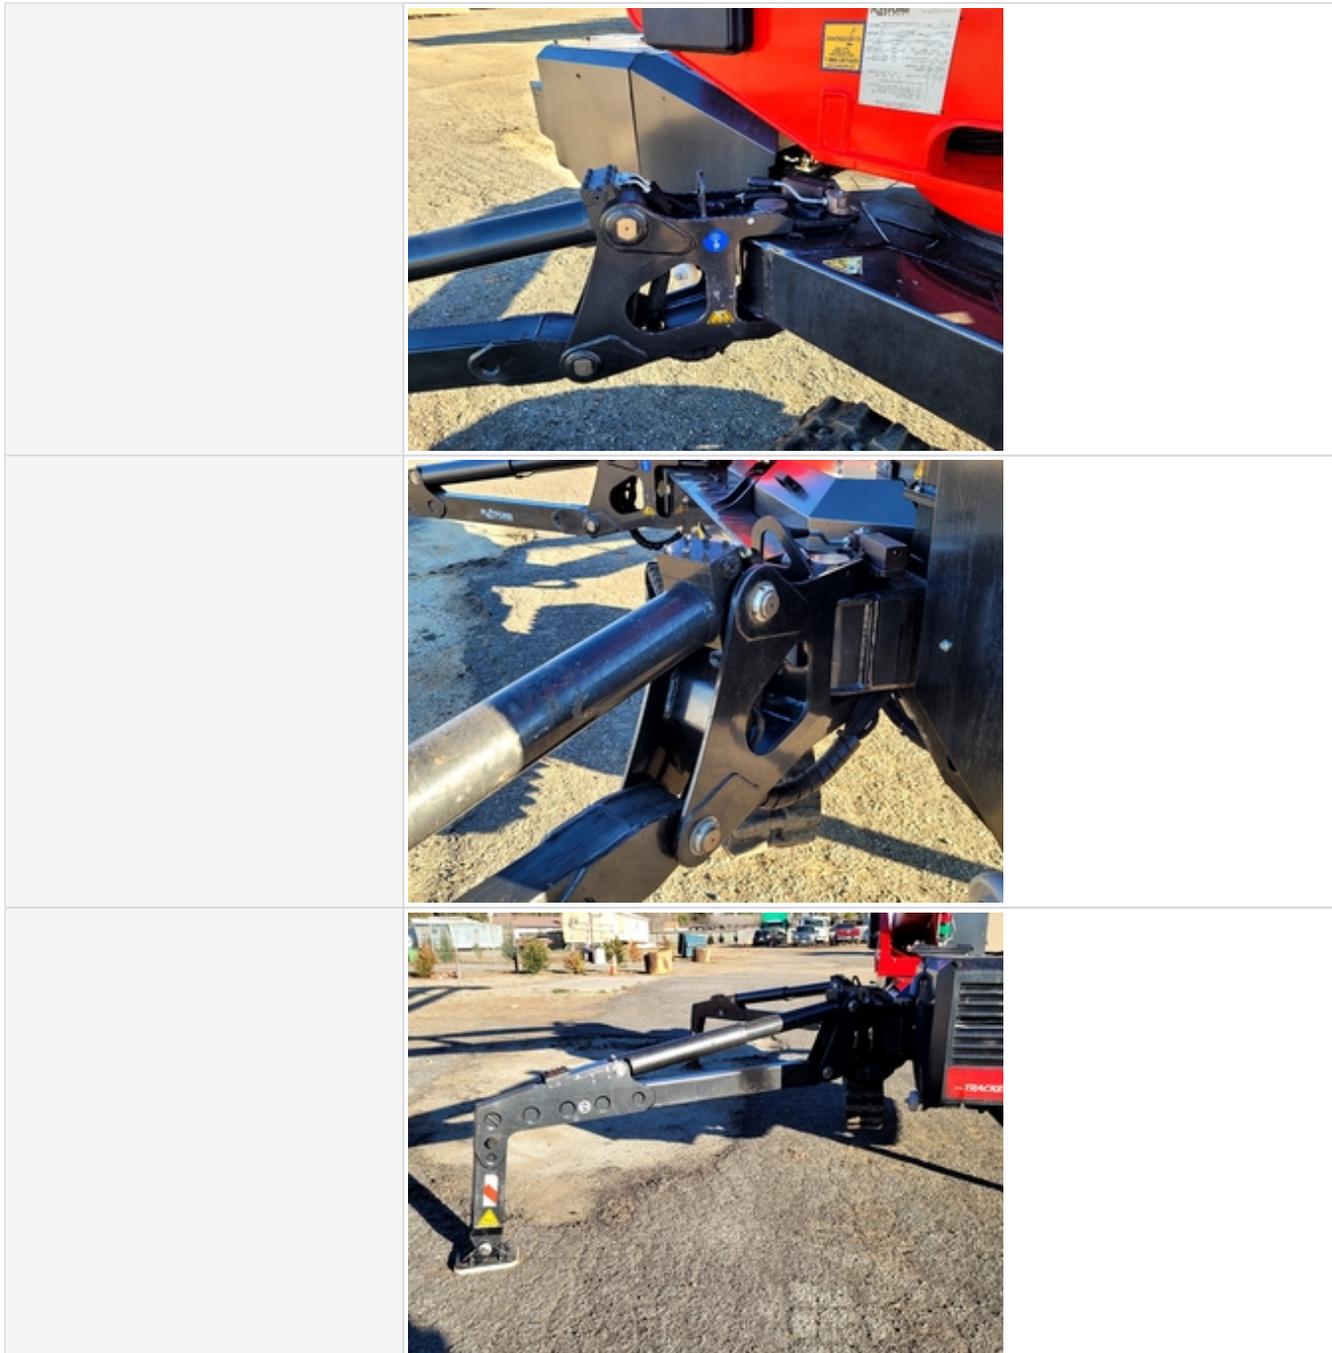
Boom Wear Guides	3 - Normal Wear & Tear	
Jib Condition	3 - Normal Wear & Tear	
Outriggers	3 - Normal Wear & Tear	
Outriggers Photos

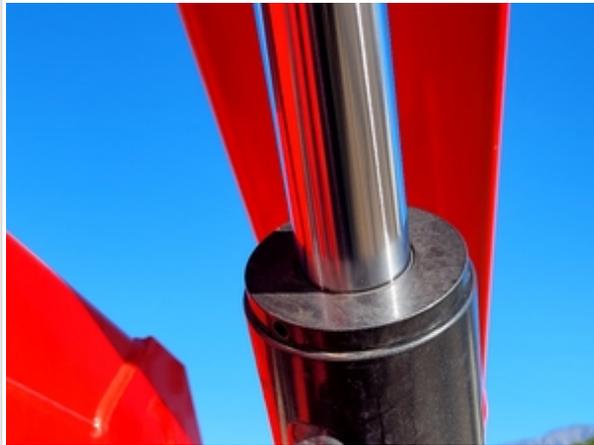
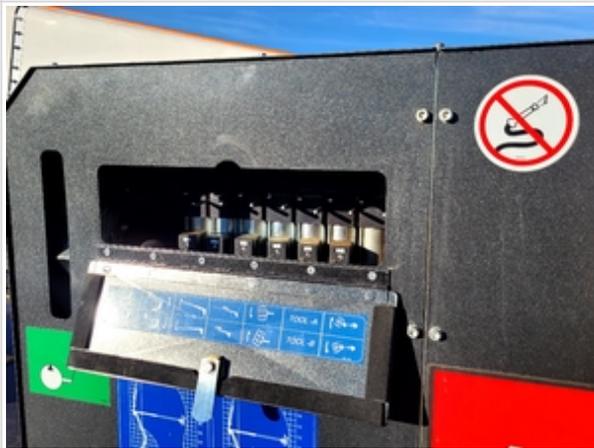
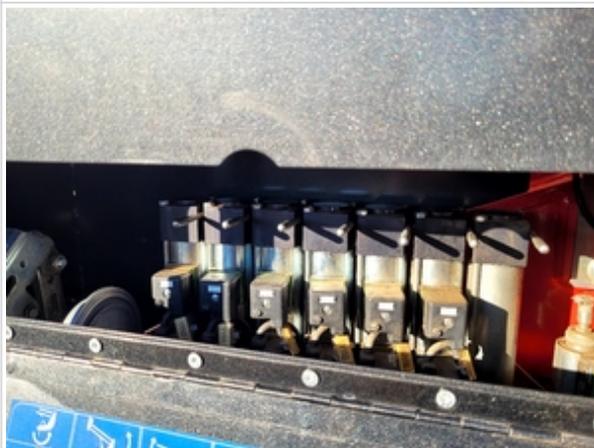
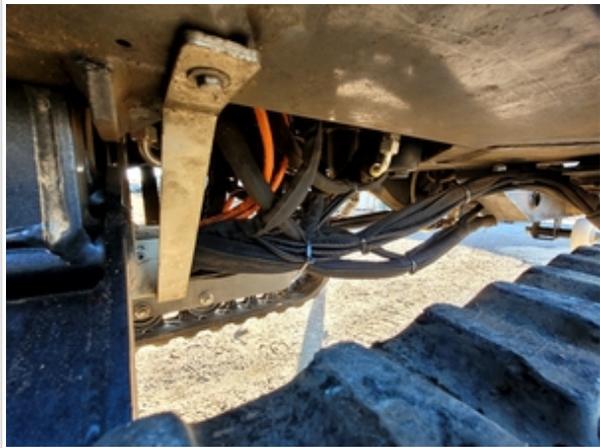
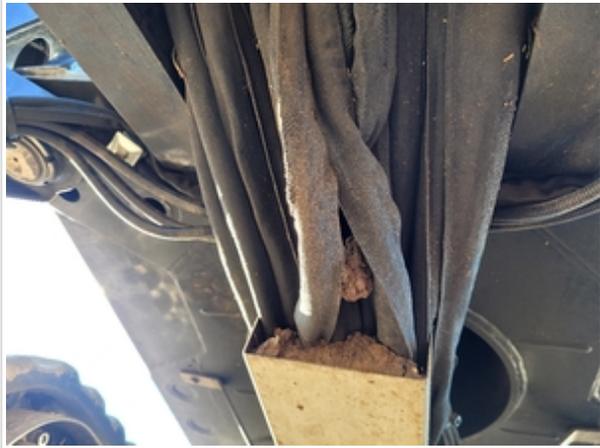
<p>Hydraulic Lines / Fittings Condition</p>	<p>Hydraulic lines & fittings are clean and in good condition</p>
<p>Appearance of Hydraulic Lines / Fittings Photos</p>
