Inspection Report (Rough Terrain Crane)

Year	1978
Make	Grove
Model	RT518
Serial Number	42259
Hour Meter Reading	910hrs.
Previous Application (e.g., earth moving, mining, demolition, etc)	Yard Crane

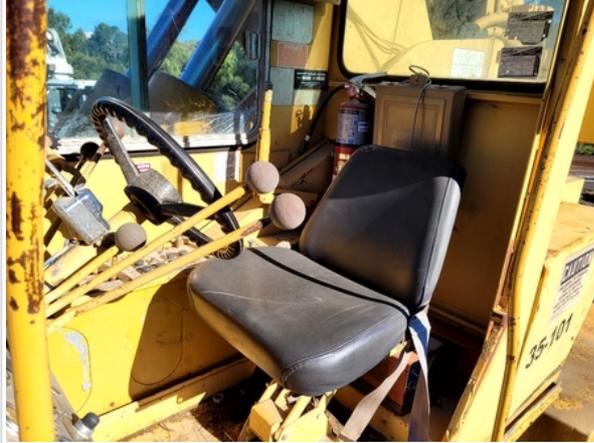
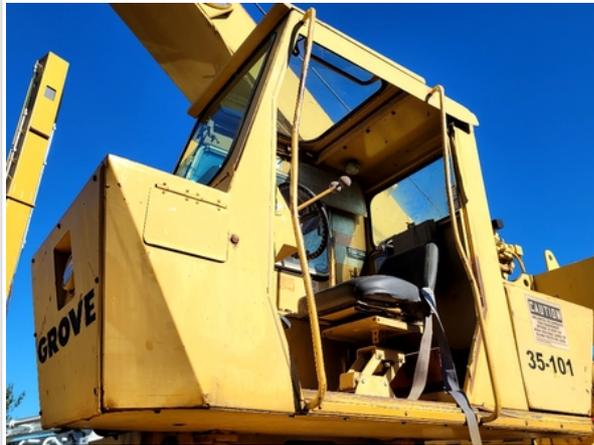
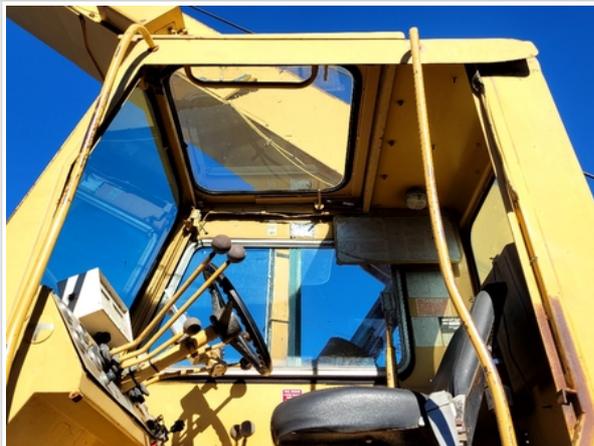
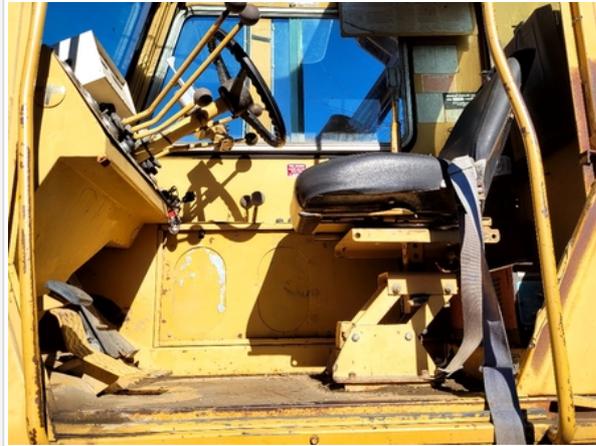
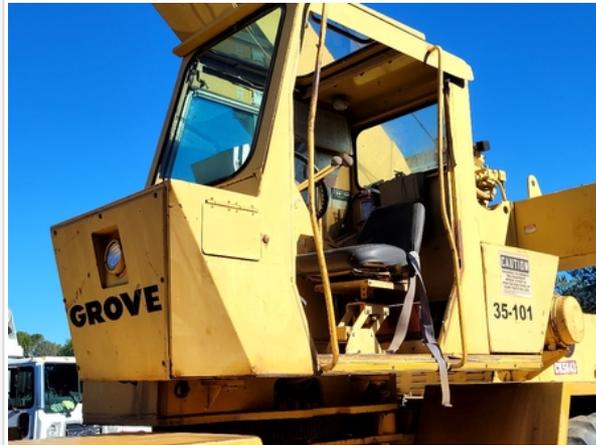
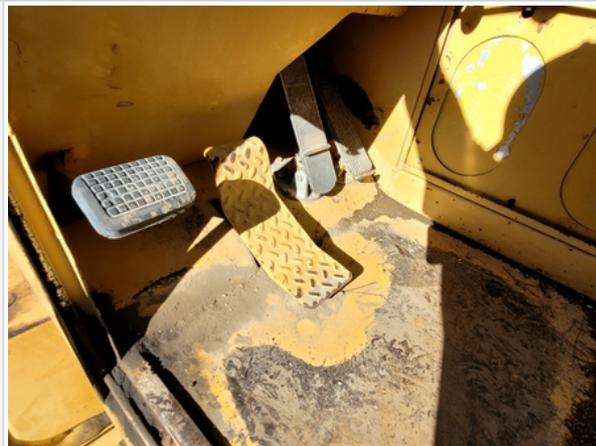
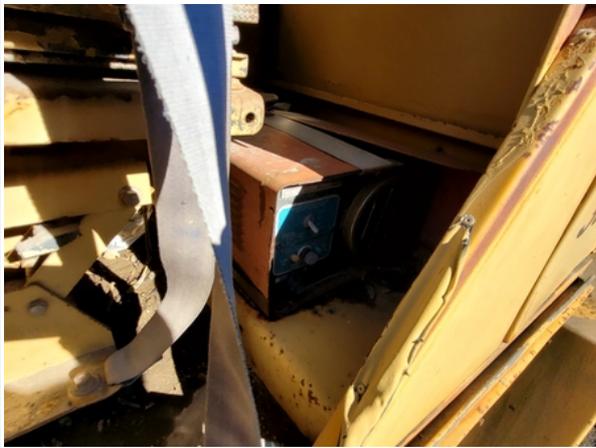
Operator Cabin Overall	3 - Normal Wear & Tear
Operator Cabin Overall Condition	Good cabin appearance, solid floors, panels, and ceiling, Minor cosmetic wear to cabin surfaces, floors, panels, and ceiling
Operator Seat	3 - Normal Wear & Tear
Operator Seat Condition	Seat(s) in good condition, no stains or tears in upholstery
Cabin Lights	0
Safety Lock Out / Stop	3 - Normal Wear & Tear
Safety Lock Out / Stop Condition	Safety lock out device is present, in good condition, and functional
Controls & Switches	3 - Normal Wear & Tear
Controls & Switches Condition	All switches are installed and functional
Hour Meter Activity	3 - Normal Wear & Tear
Hour Meter Condition	Hour meter is functional and in good condition
Hour Meter Activity Photos

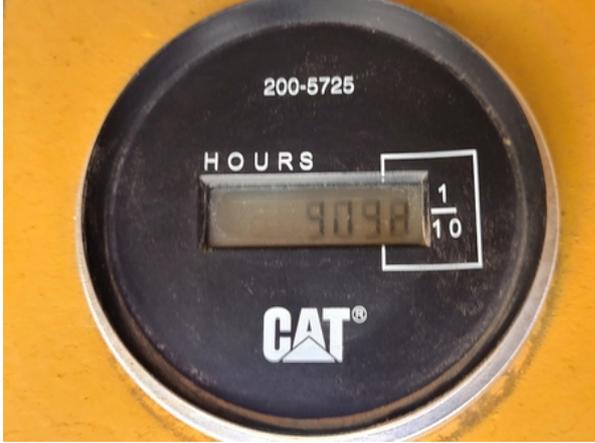
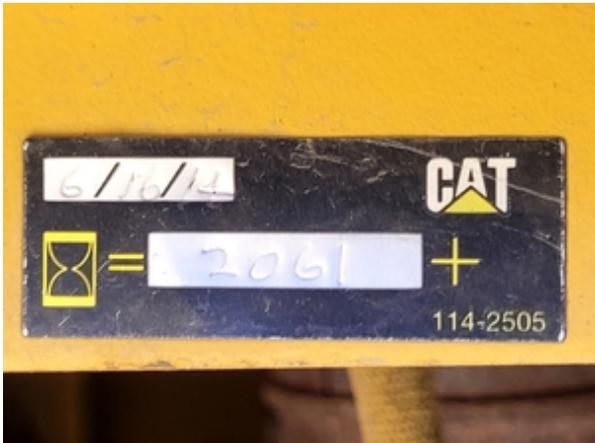
Other Gauge Activity	3 - Normal Wear & Tear
Other Gauge Condition	All cockpit gauges are functional and in good condition
Heater & A/C	3 - Normal Wear & Tear
Heater & A/C Condition	Other (see comments)
Comments	heater unit in place (did not test)
Travel Alarm	2 - Above Average Wear
Travel Alarm Condition	Travel alarm is installed and functioning as expected, Other (see comments)
Comments	alarm works but speaker sound not loud
Horn	3 - Normal Wear & Tear
Horn Condition	Horn is installed and functioning as expected
Backup Camera	0
Anti Two Block System	3 - Normal Wear & Tear
Load Movement Indicator (LMI)	3 - Normal Wear & Tear

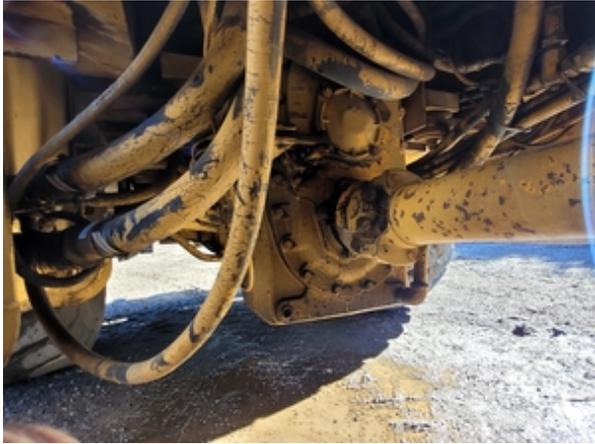
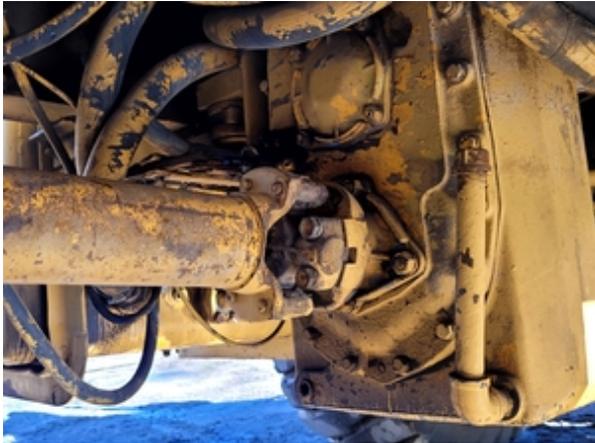
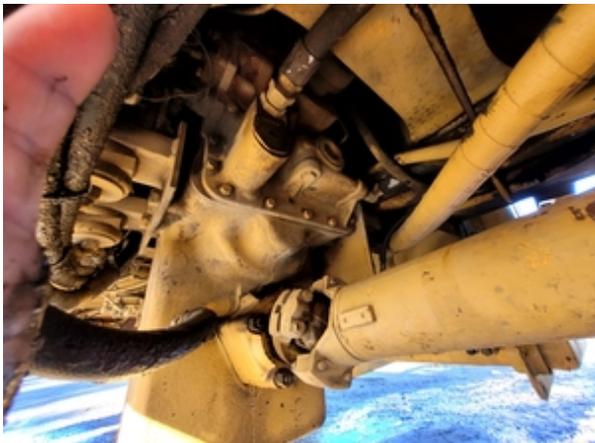
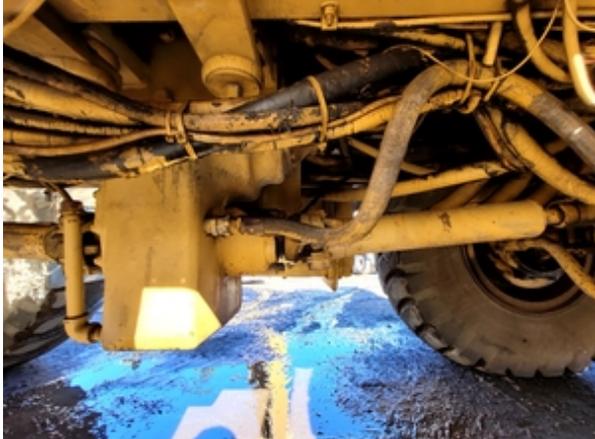
Drivetrain	Take close-up photos of the drivetrain components including transmission housing, drive shaft, drive motors, fittings, and hoses. Note any damage or wear.
Drivetrain Photos

Hydrostatic Transmission?	No	
Transmission Info (Make/Model/Speeds)	Powershift - 3 Speed	
Transmission	3 - Normal Wear & Tear	
Transmission Condition	No unusual noises or vibrations	
Clutch	0	
Shift Lever	3 - Normal Wear & Tear	
Shift Lever Condition	Good forward and reverse function	
Foot Brake	3 - Normal Wear & Tear	
Inching Brake	0	
Parking Brake	3 - Normal Wear & Tear	
Parking Brake Condition	Good brake function	
Parking Brake Photos

Overall Drivetrain Comments	Overall Drivetrain in good working condition.

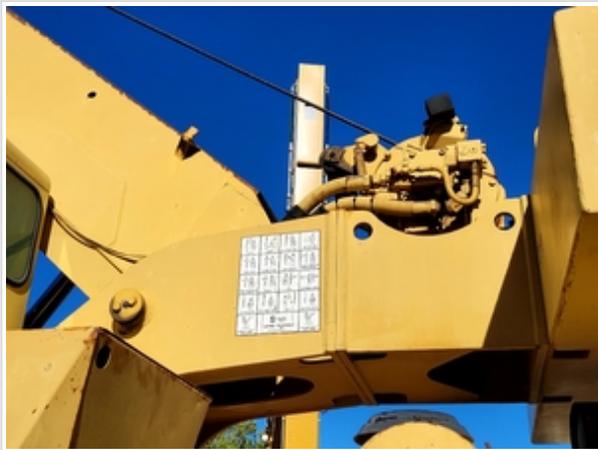
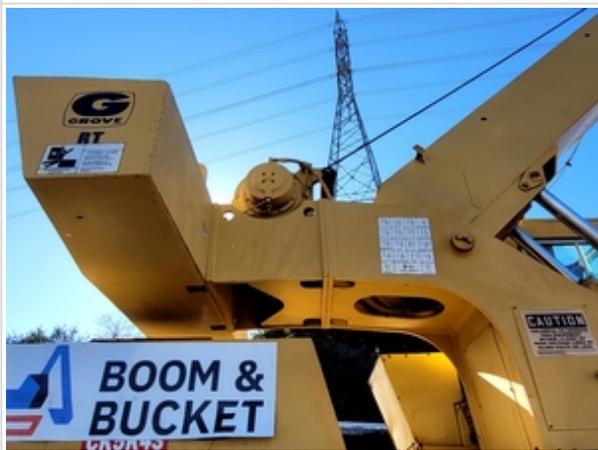
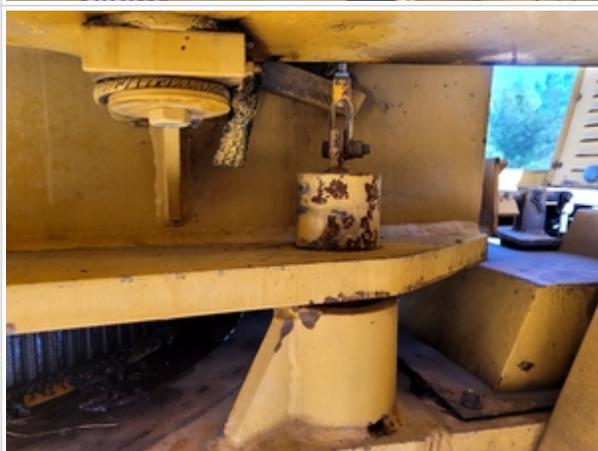
Frame Photos

Frame	3 - Normal Wear & Tear
-------	------------------------

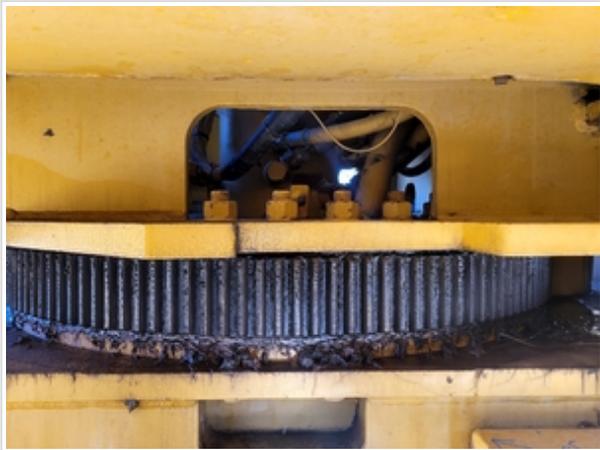
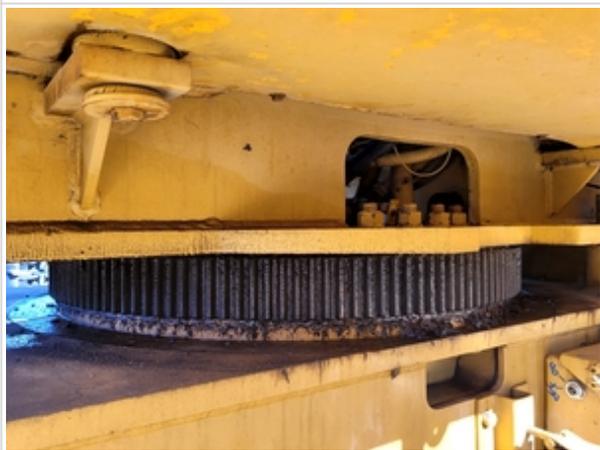
<p>Turntable Bearing Photos</p>

Stance	3 - Normal Wear & Tear
Turntable Bearing	3 - Normal Wear & Tear

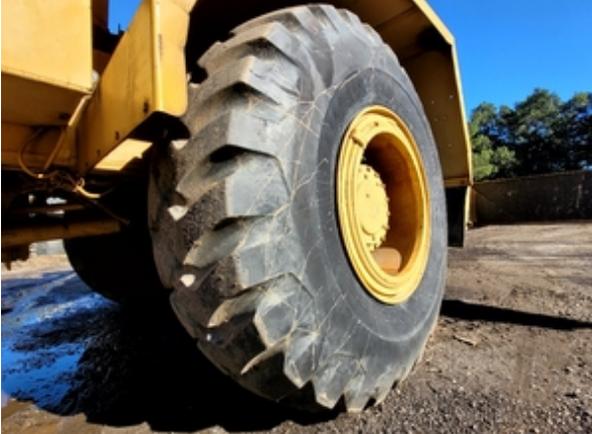
<p>Front Right Tire - Ratio Remaining</p>	<p>50%</p>
<p>Front Right Tire Photos</p>

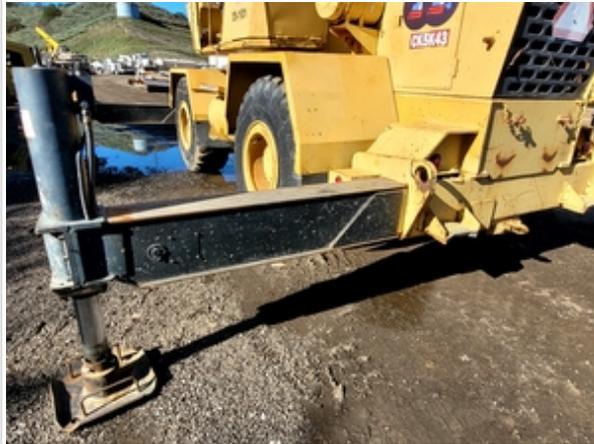
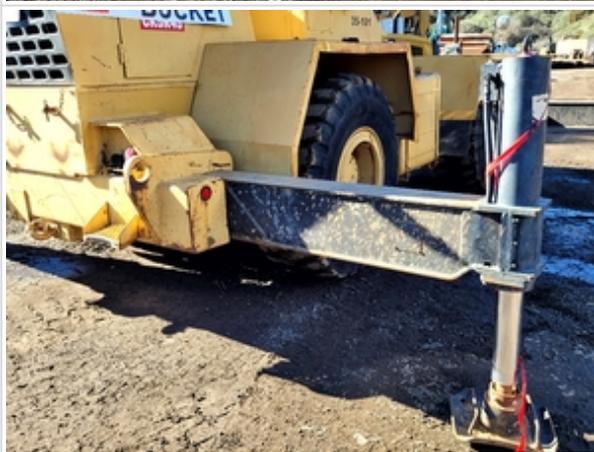
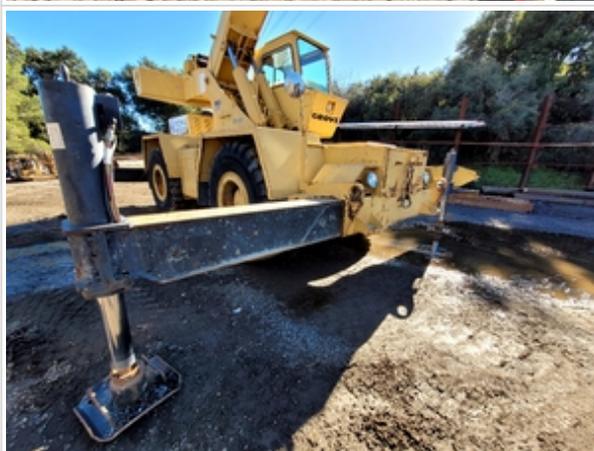
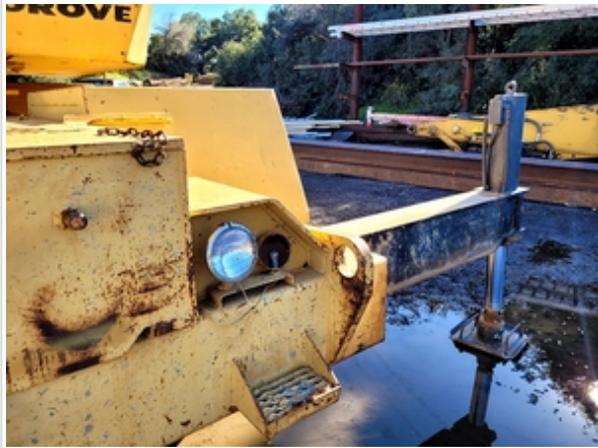
Outrigger Photos

Outrigger Condition	3 - Normal Wear & Tear

Outrigger Floats/Pads Condition	3 - Normal Wear & Tear
Overall Chassis	3 - Normal Wear & Tear
Overall Chassis Comments	Overall chasis in solid condition with no problems or major repairs needed observed.

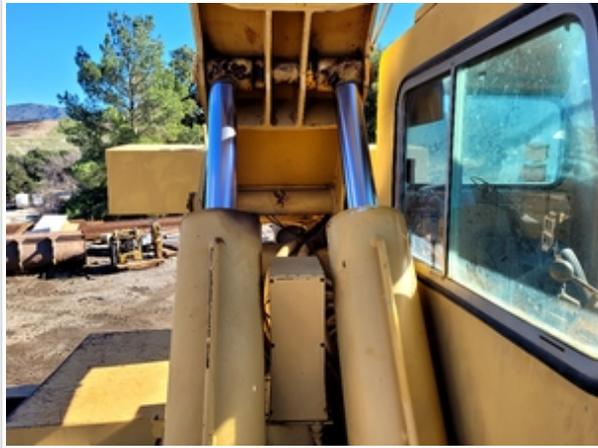
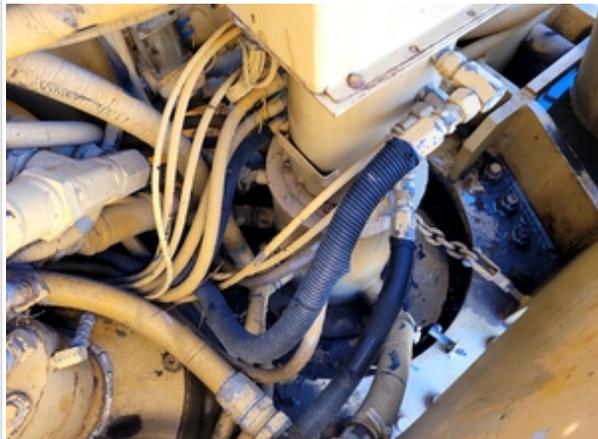
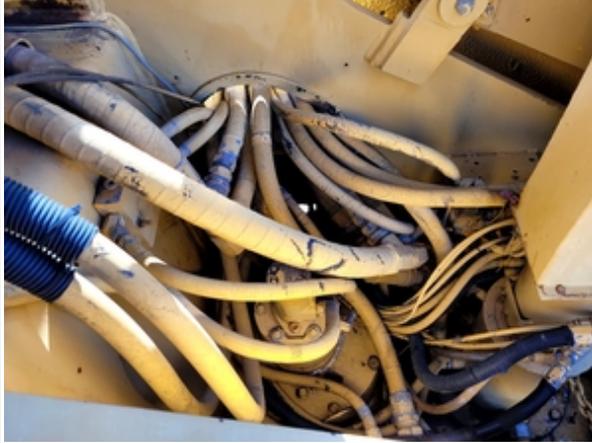
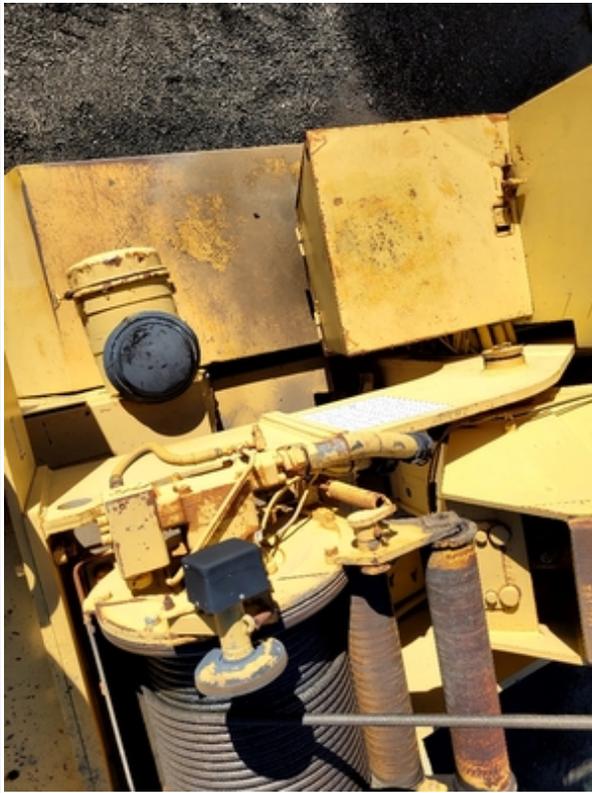
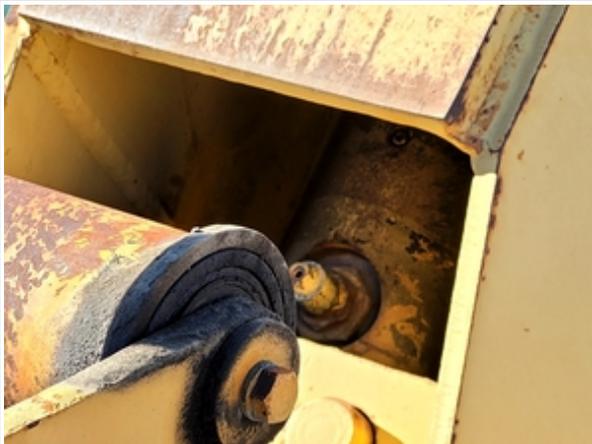
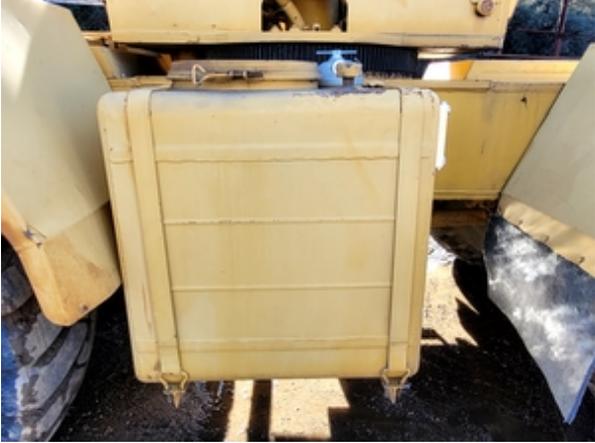
Hydraulic System	Take close-up photos of the hydraulic components including the pump, lines, fittings, controls, and levers. Note any damage, wear, or leaks.
Hydraulic System Photos

Wet or Damp Hydraulic Lines / Fittings	No
Appearance of Hydraulic Lines / Fittings	3 - Normal Wear & Tear
Hydraulic Lines / Fittings Condition	Hydraulic lines & fittings are clean and in good condition
Appearance of Hydraulic Lines / Fittings Photos

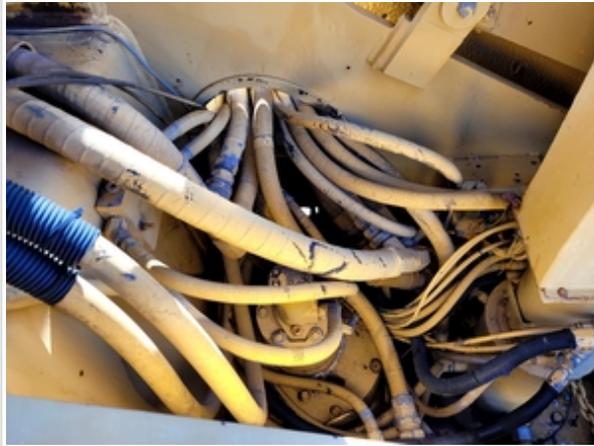
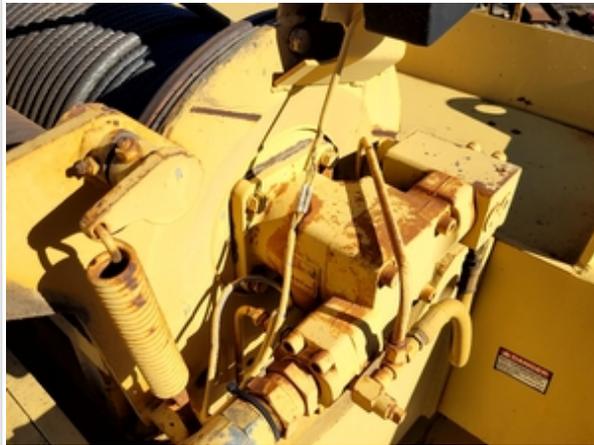
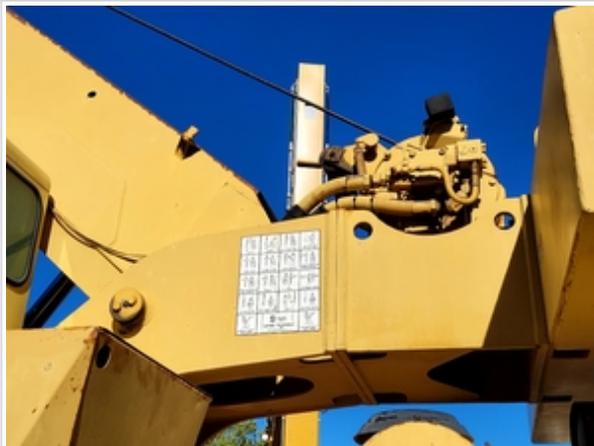
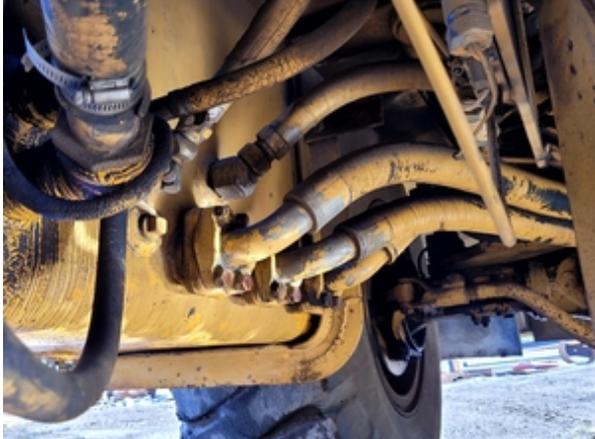
Unusual Noises (Hydraulic Pump)	No	
Hydraulic Pump Notes	No unusual noises heard during operation	
External Controls / Levers	3 - Normal Wear & Tear	
External Controls / Levers Condition	Good function & condition of hydraulic controls	
External Controls / Levers Photos

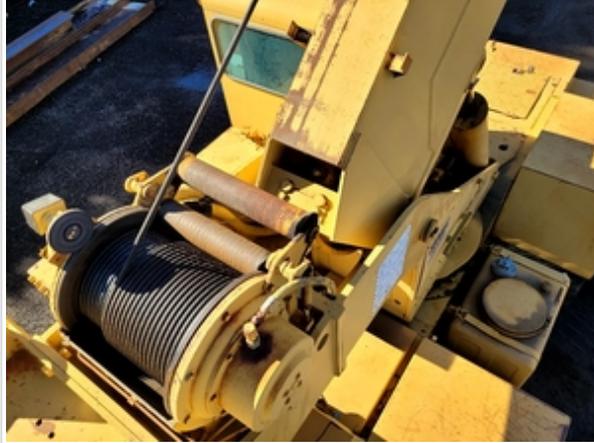
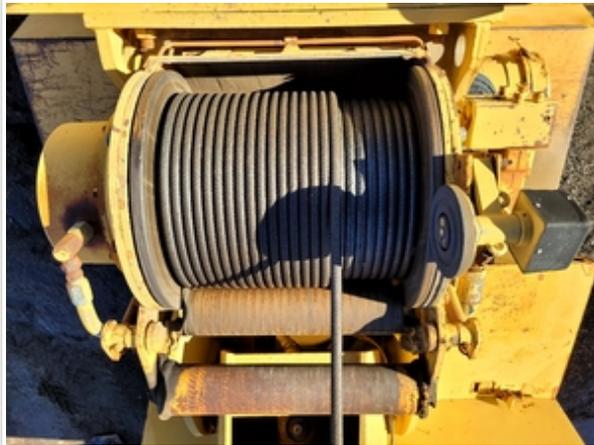
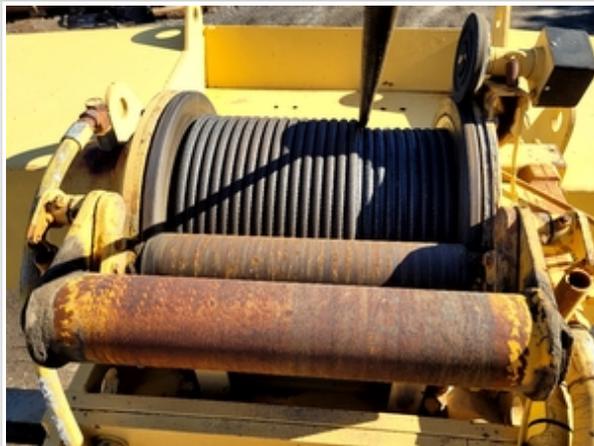
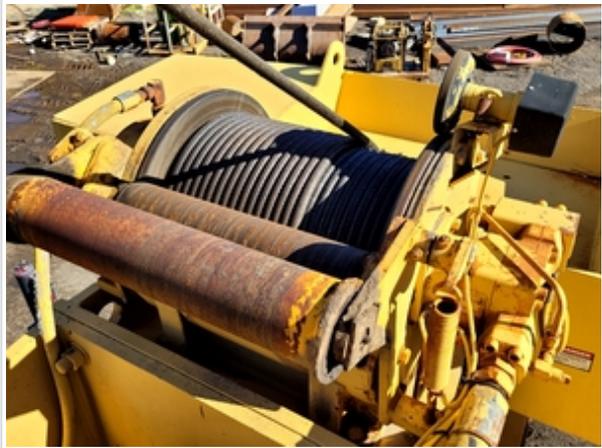
Main Hoist Photos

Main Hoist	3 - Normal Wear & Tear

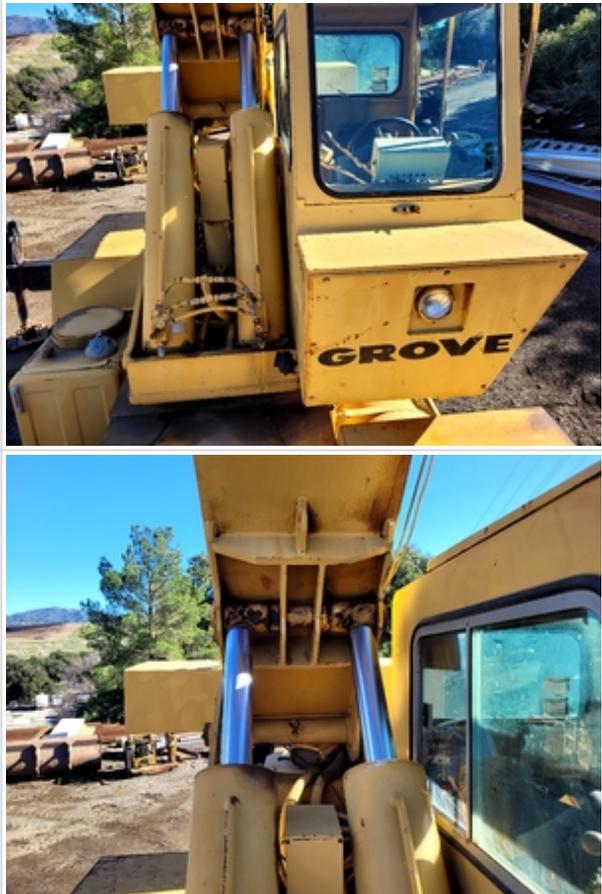
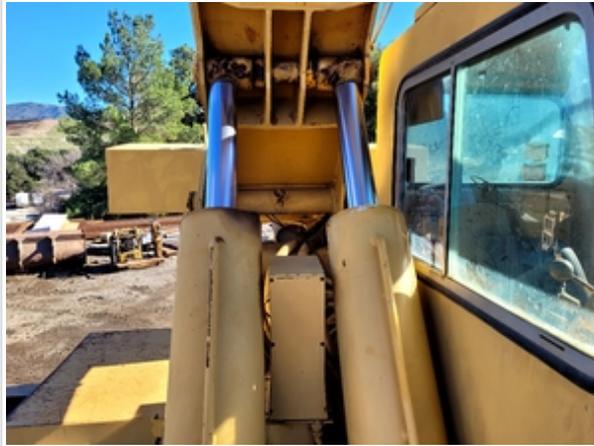
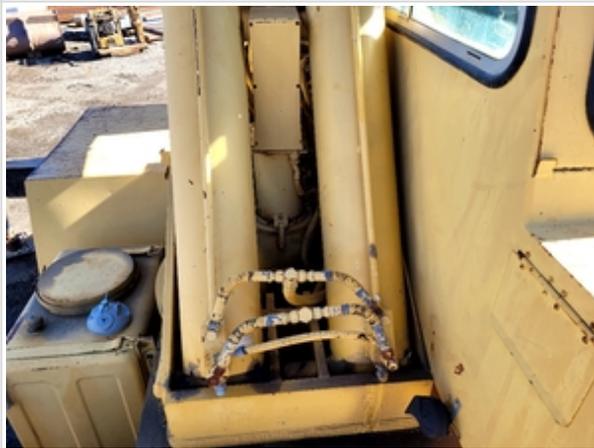
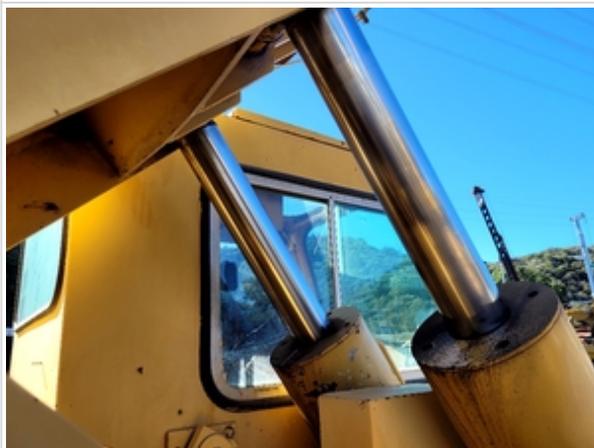
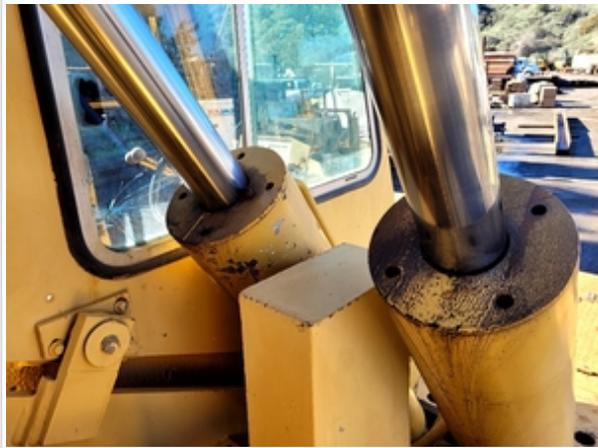
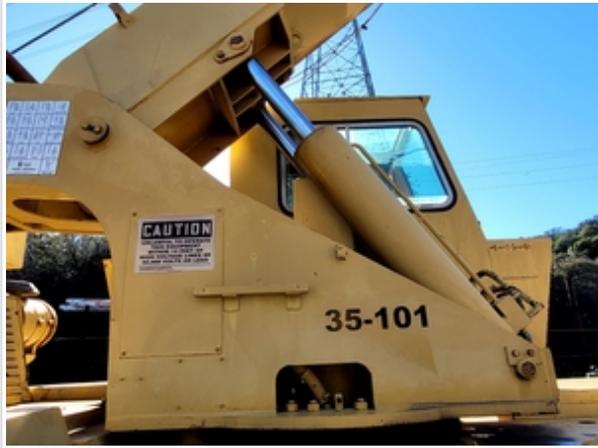
Lift Cylinder(s)	Check the lift cylinder. Note any wear, pitting, discoloration, etc. Take photos.	
Lift Cylinder(s): Mounting Pins	3	
Lift Cylinder(s): Oil Leaks	No	
Lift Cylinder(s) Photos

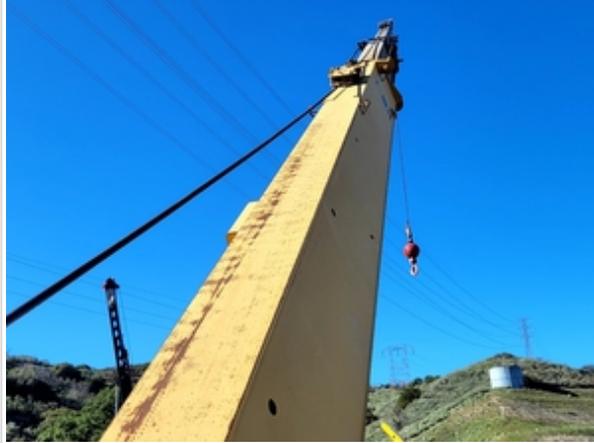
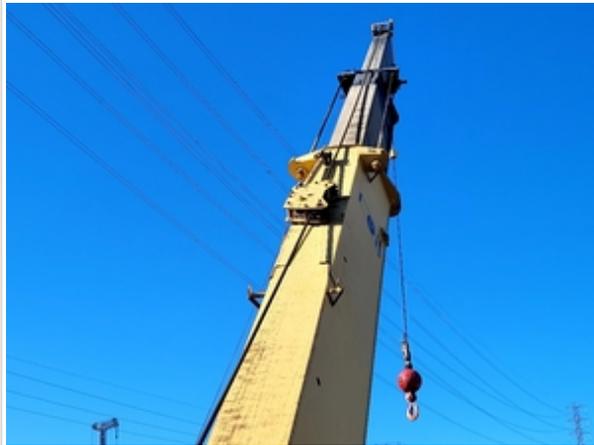
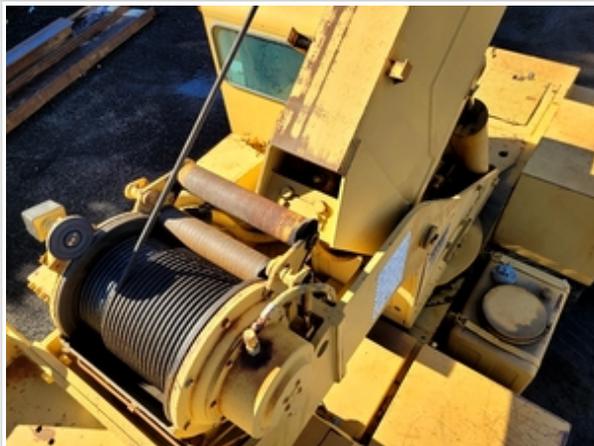
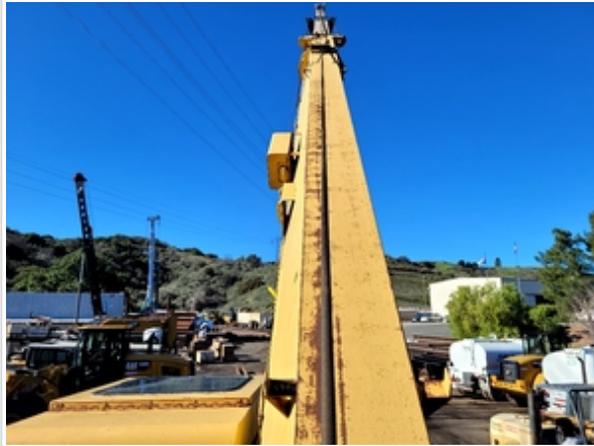
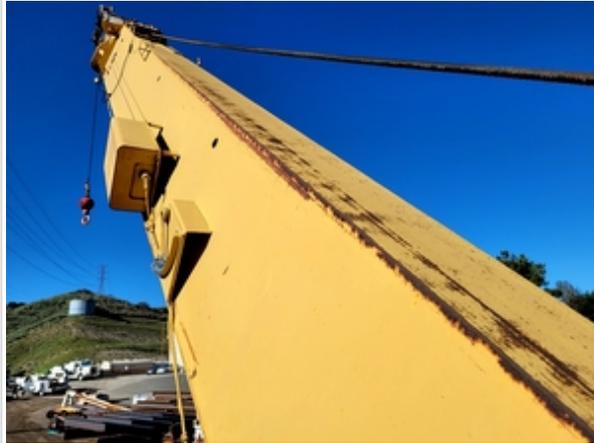
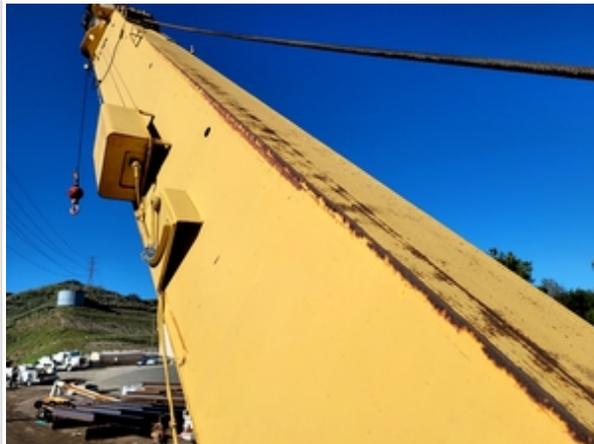
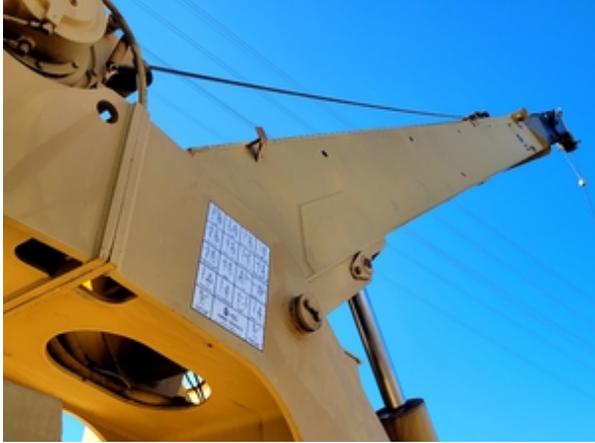
Main Boom Photos

Counterweight	3 - Normal Wear & Tear
Boom Angle Indicator	3 - Normal Wear & Tear
Main Boom Sections	3 - Normal Wear & Tear
