Inspection Report (Boom Lift)

Year	2014
Make	JLG
Model	600AJ
Serial Number	0300192692
Hour Meter Reading	2,377
Previous Application (e.g., earth moving, mining, demolition, etc)	Equipment Rentals

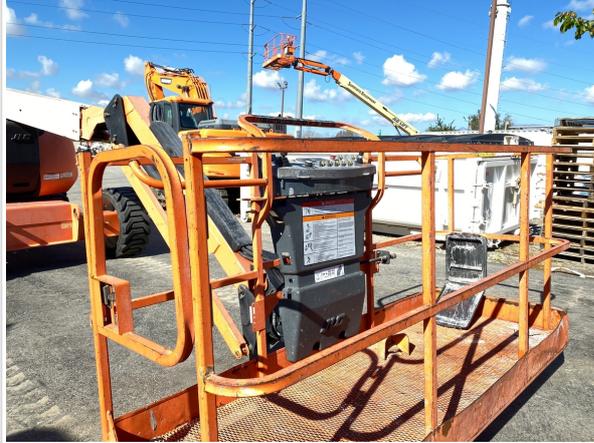
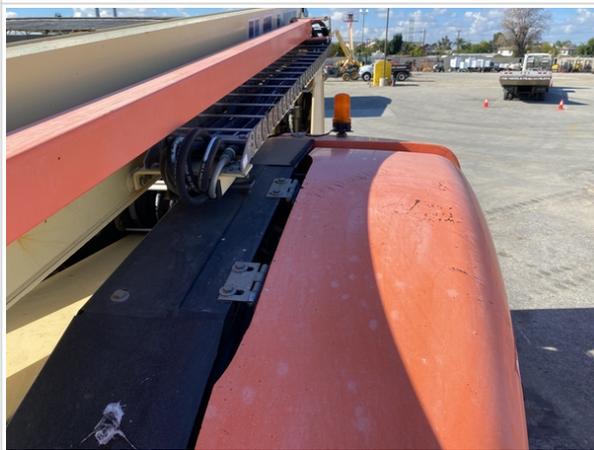
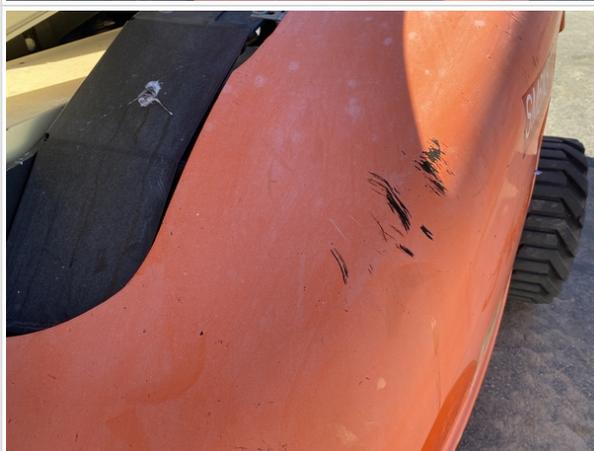
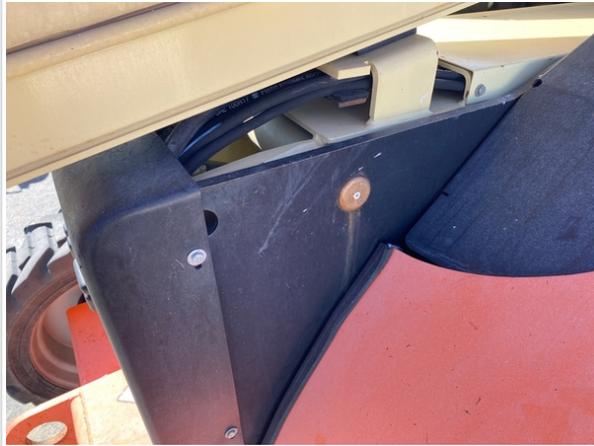
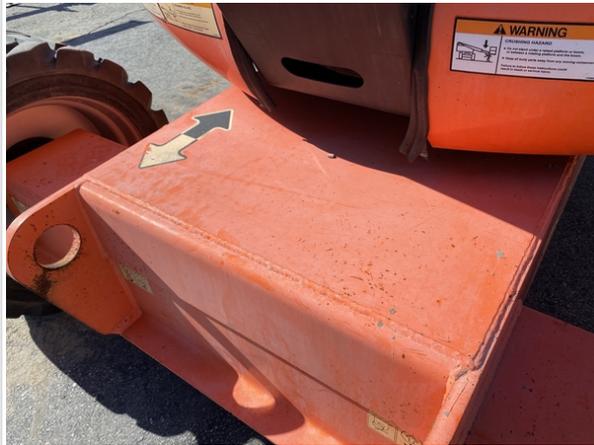
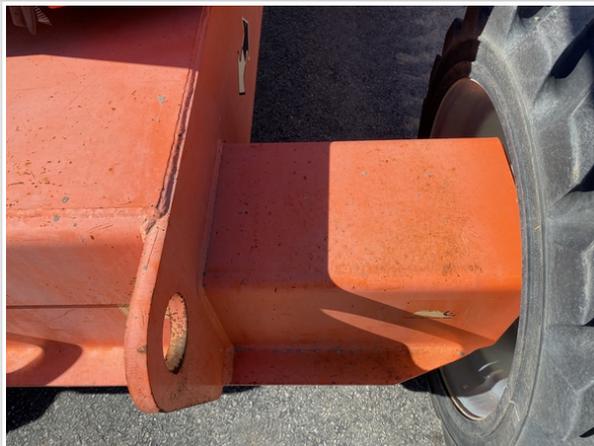
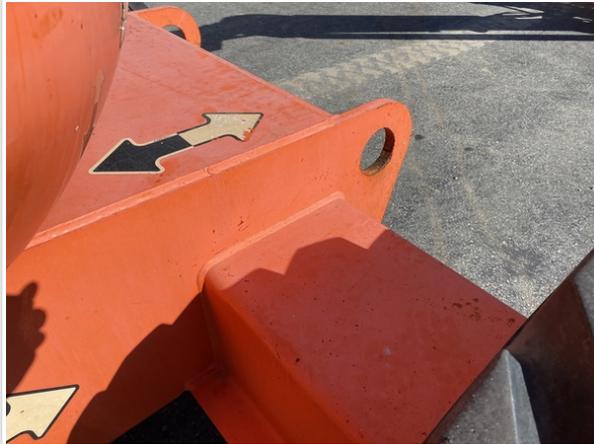
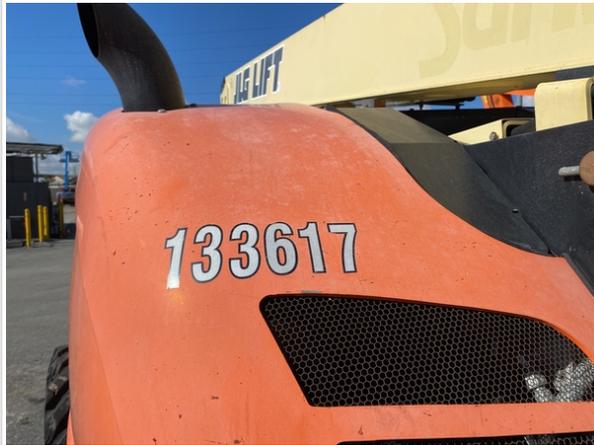
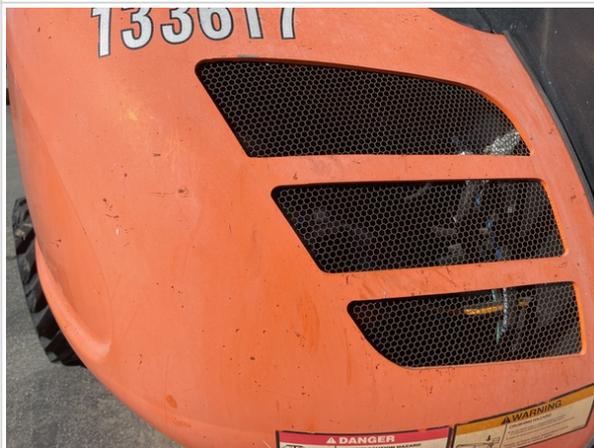
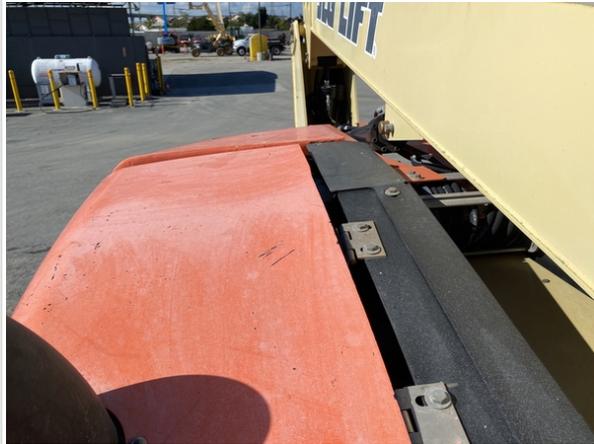
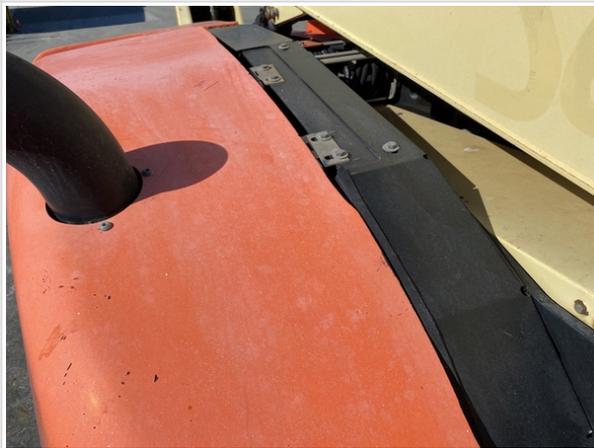
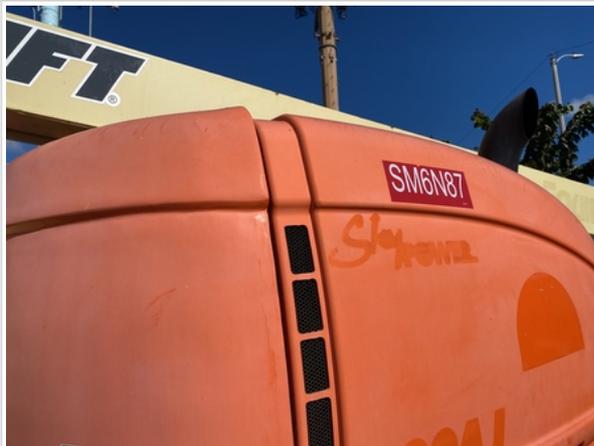
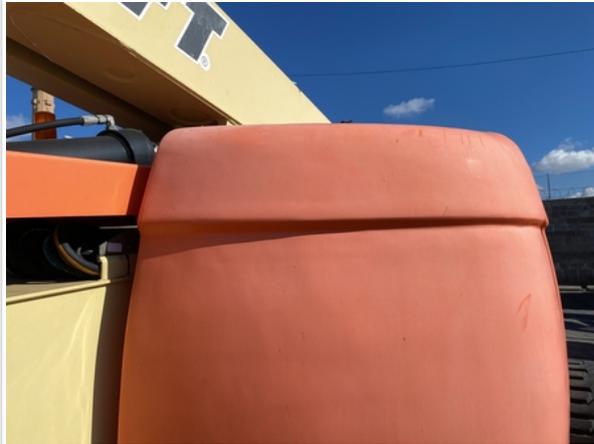
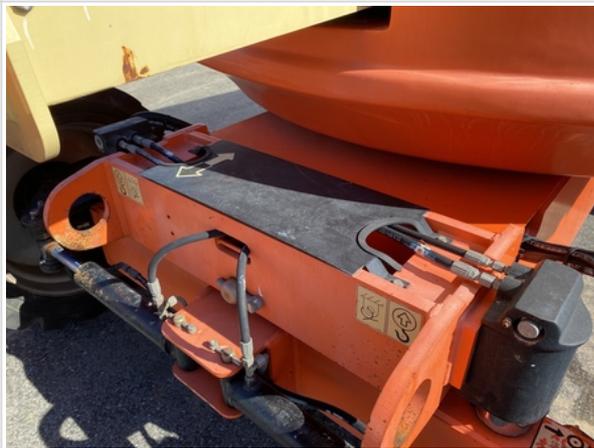
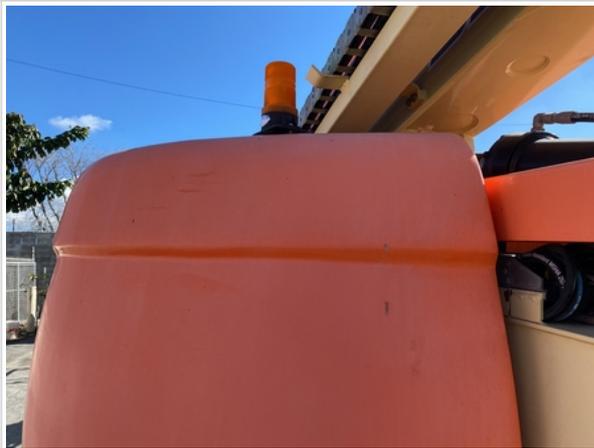
Close-up Exterior Photos

Body Panels	3 - Normal Wear & Tear
Body Panel Condition	No visible damage, good paint condition and panel fitment, Other (see comments)
Comments	Minor scuff marks on hoods
Doors / Canopy Latches	3 - Normal Wear & Tear
Doors / Canopy Latches Condition	No visible damage
Steps / Ladders	0
Handrails	3 - Normal Wear & Tear
Handrails Condition	Handrails are fully intact and appear structurally sound
Glass	0
Mirrors	0
Exterior Lights	0

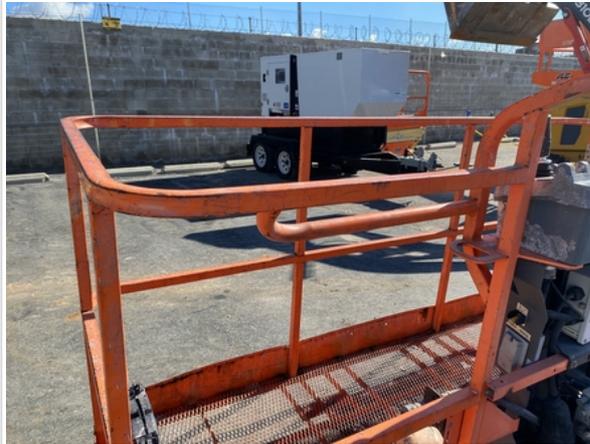
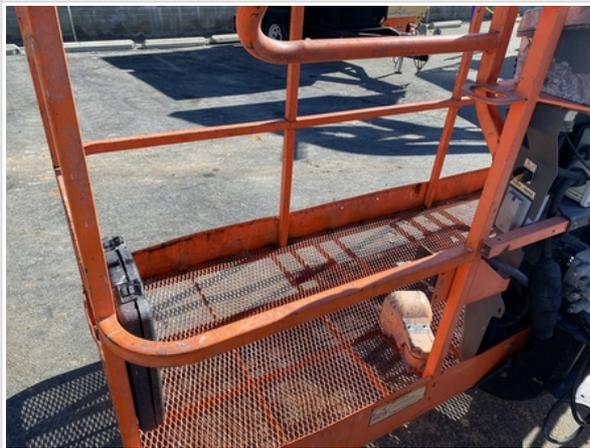
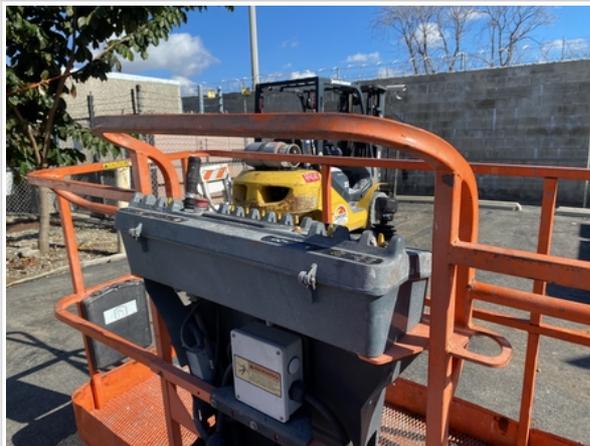
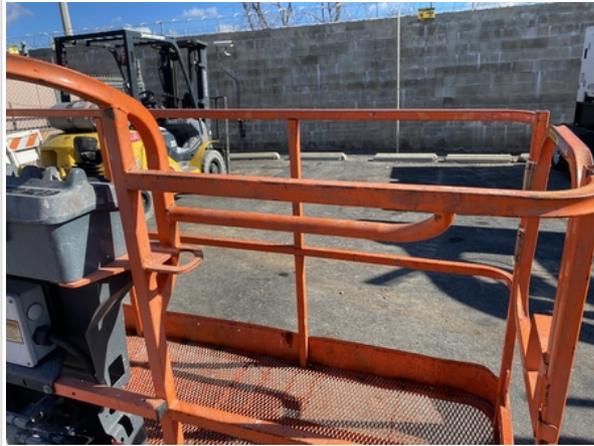
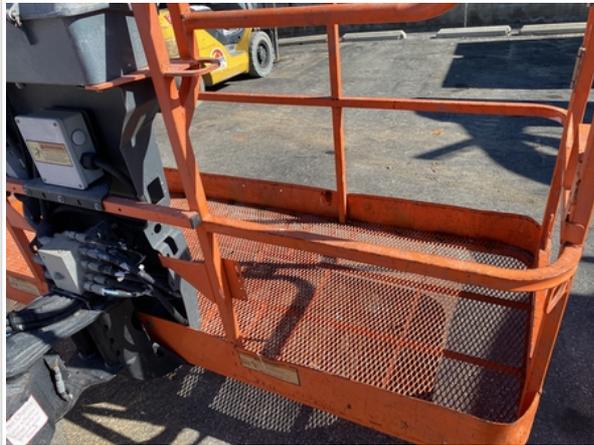
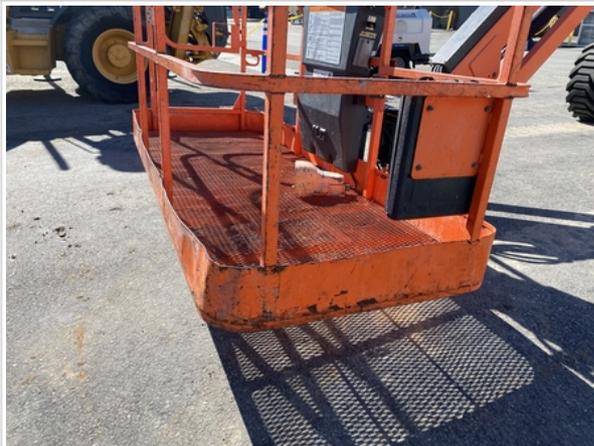
Platform Safety Rails & Appearance Photos

Horn	3 - Normal Wear & Tear	
Travel Alarm	3 - Normal Wear & Tear	
Swing Brake	3 - Normal Wear & Tear	
Safety Lock Out / Stop	3 - Normal Wear & Tear	
Platform Safety Rails & Appearance	3 - Normal Wear & Tear

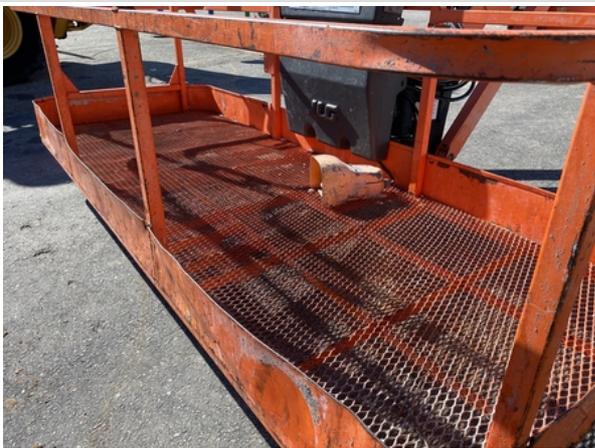
Platform Floor Photos

Platform Floor

3 - Normal Wear & Tear

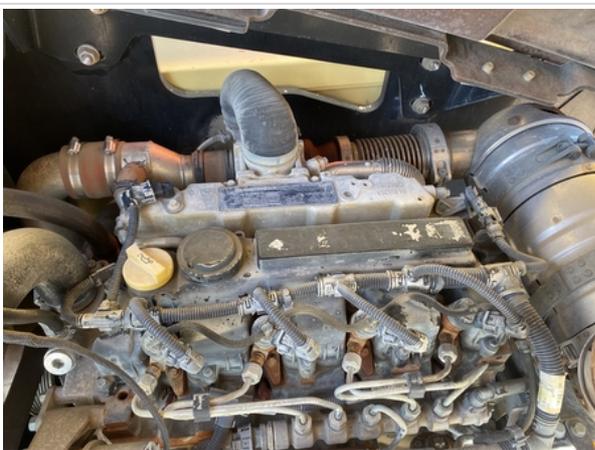
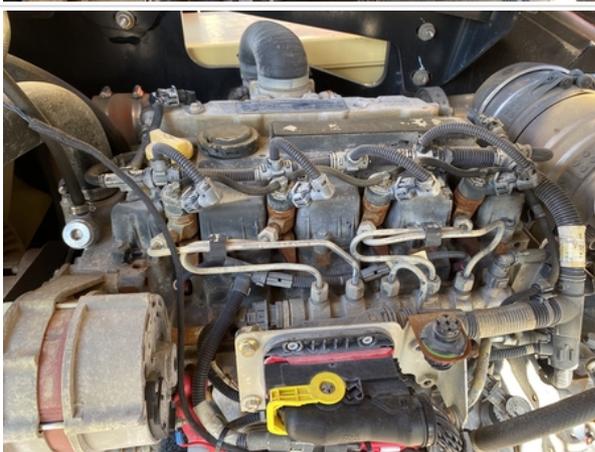
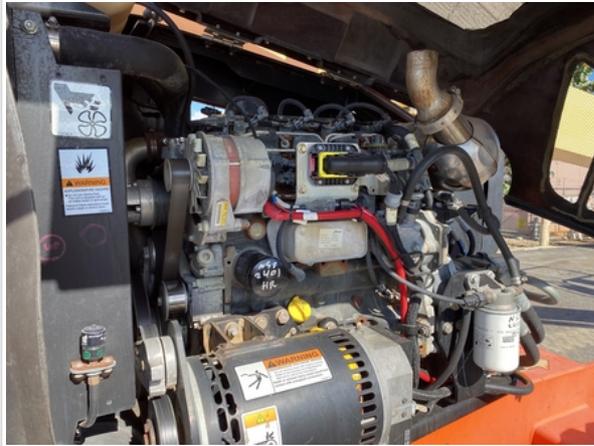
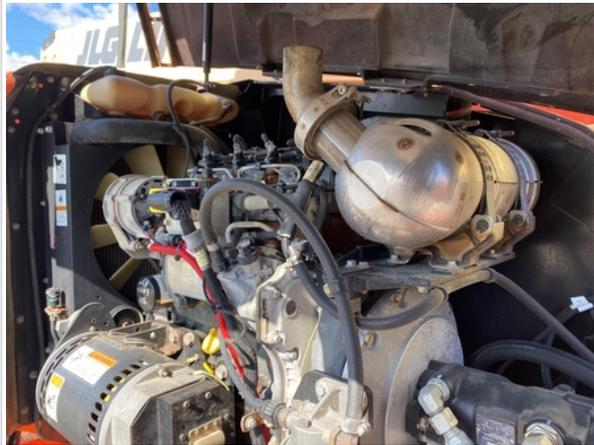
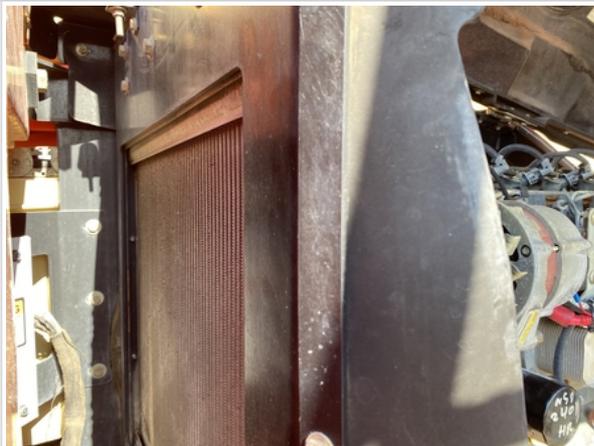
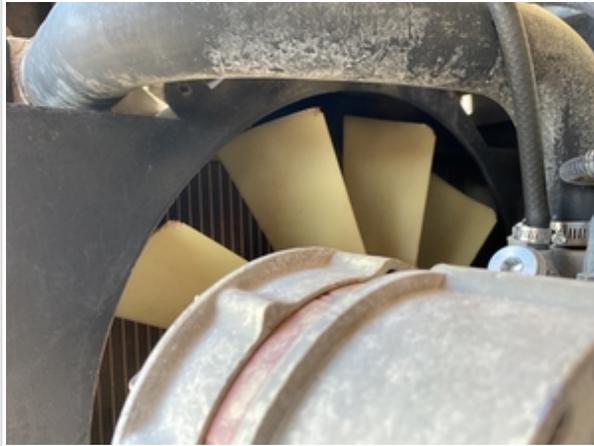
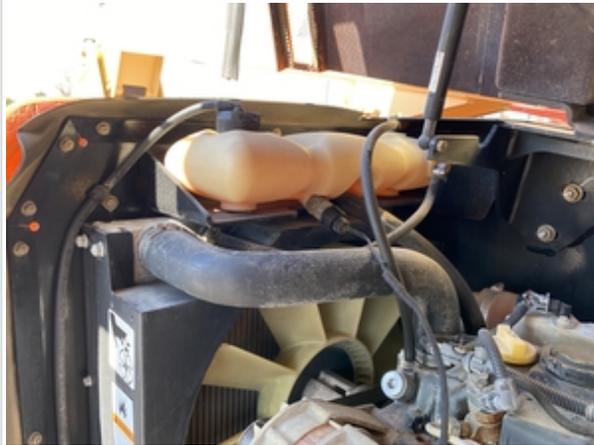
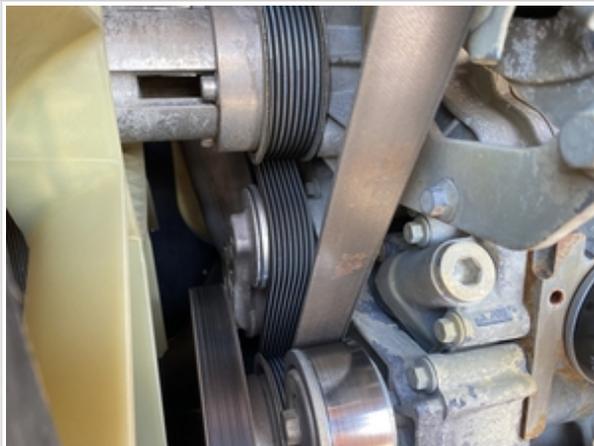
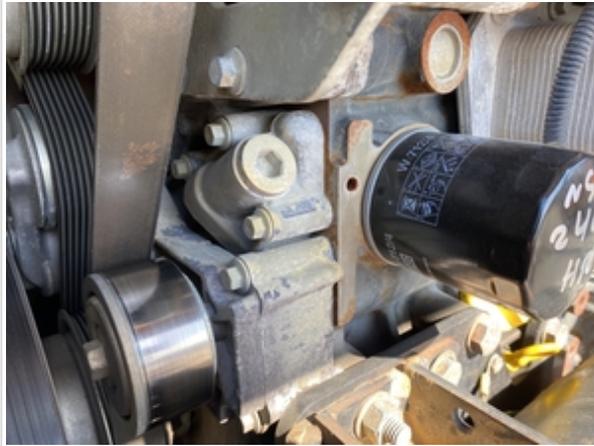
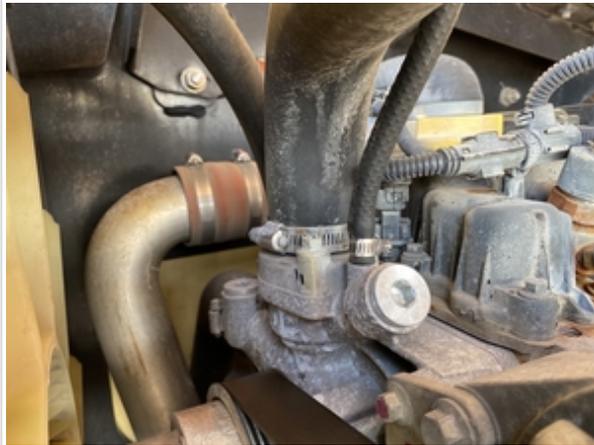
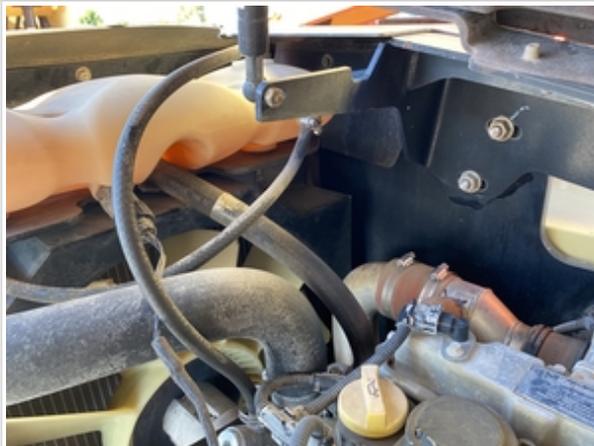
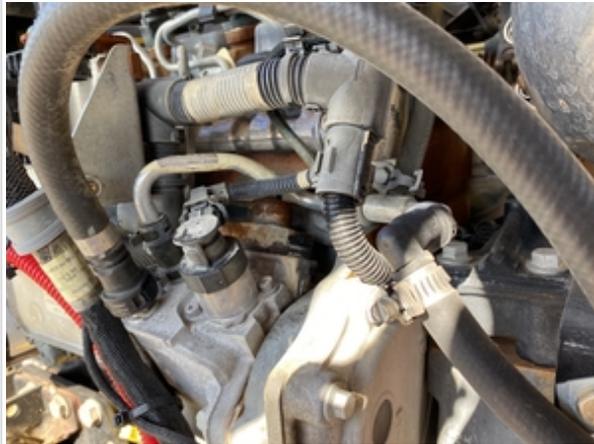
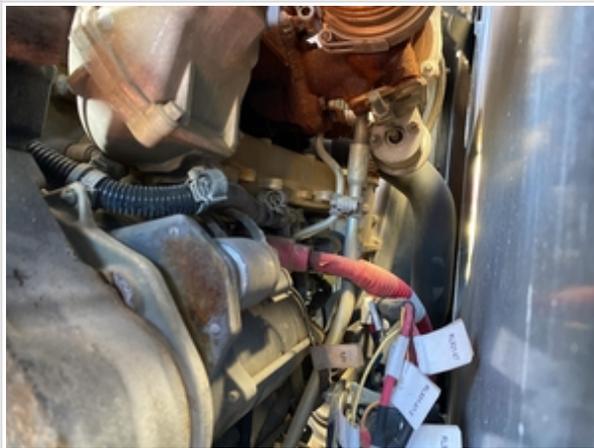
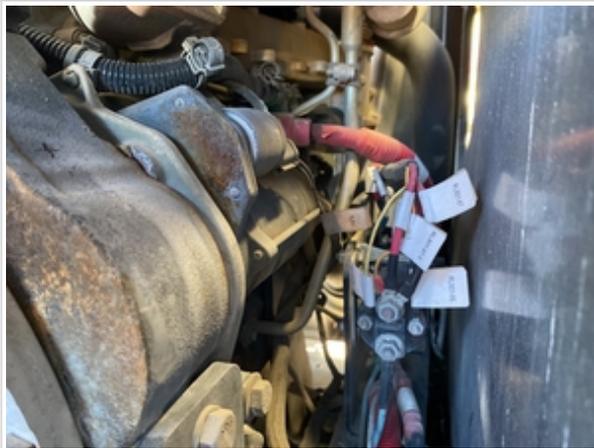
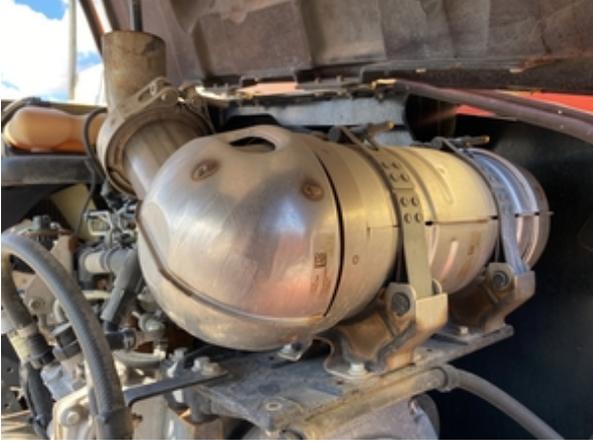
Engine Photos

Blow-by (Visual Observation Check)	No
Unusual Noises (Upon Start-up, Idle, Shutdown)	No
Unusual Noise Notes	No unusual noises heard
Engine Smoke (Upon Start-up, Idle, Shutdown)	No
Engine Smoke Notes	No engine smoke issues observed
Engine Exhaust Color	Clear
Battery	3 - Normal Wear & Tear
Battery Condition	Like new, recently replaced, Other (see comments)
Battery Condition Photos

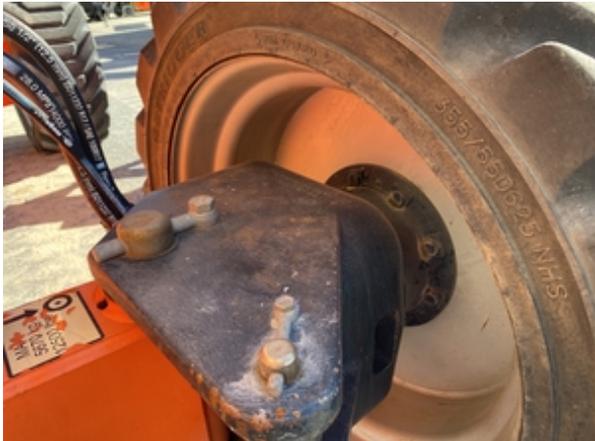
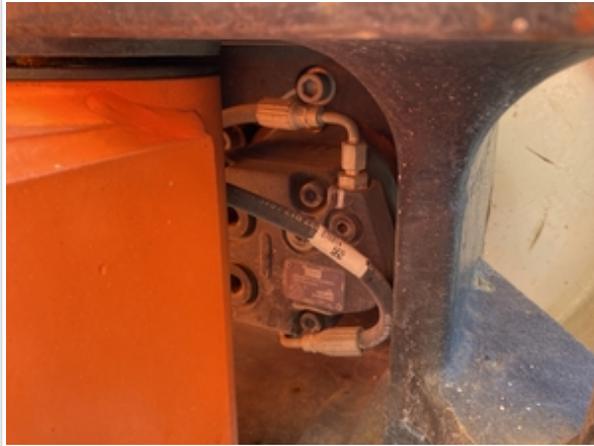
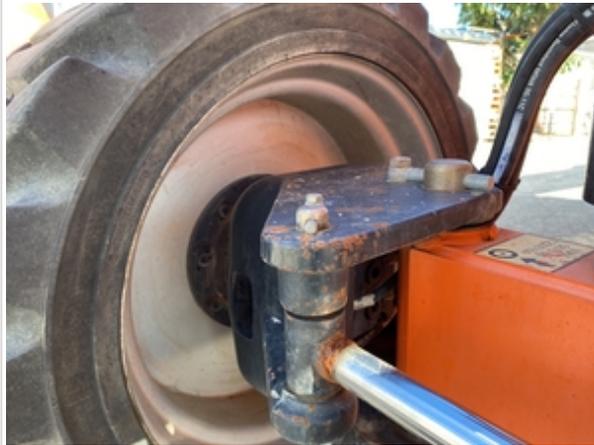
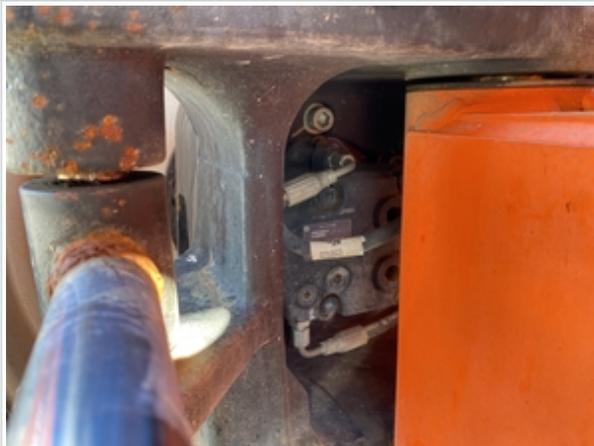
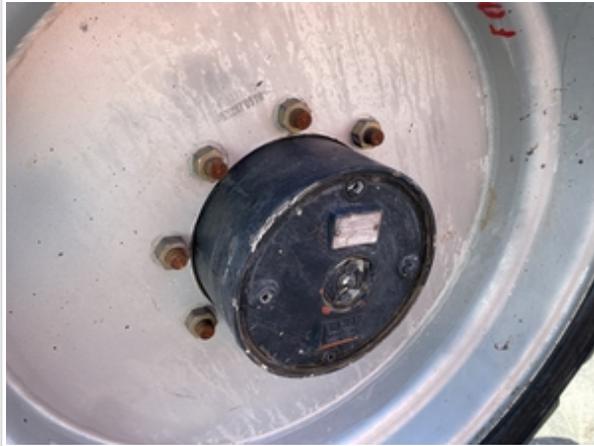
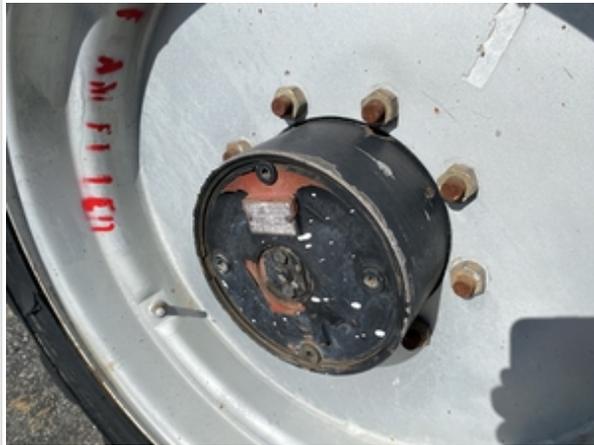
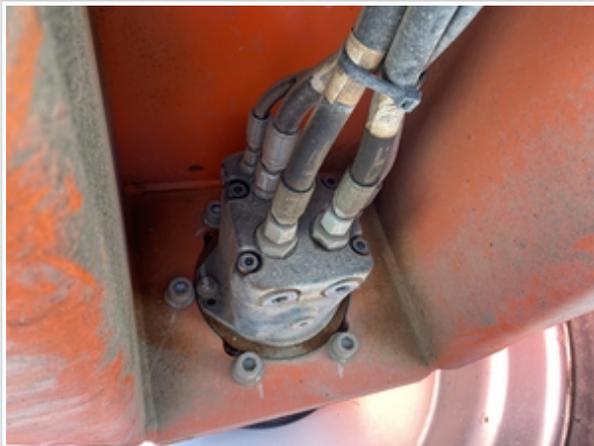
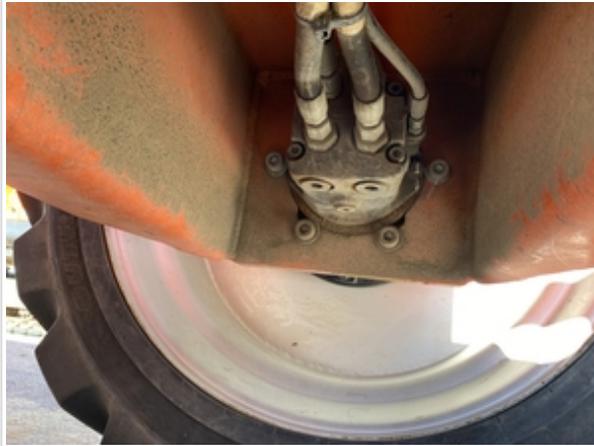
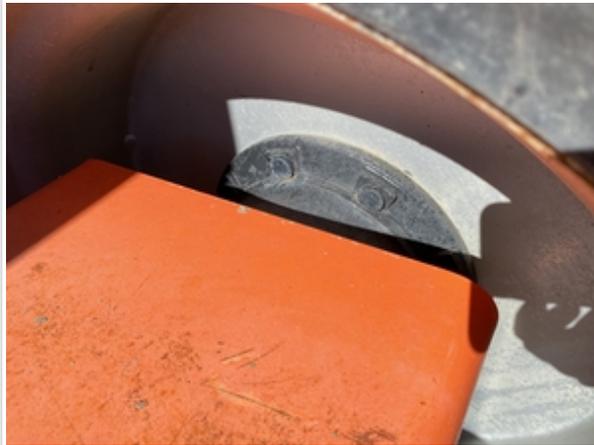
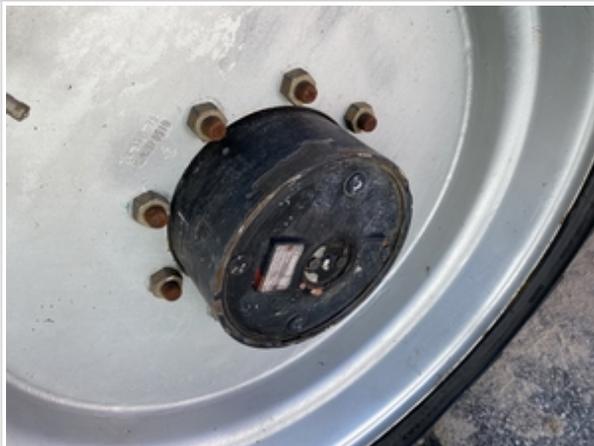
Drivetrain	Take close-up photos of the drivetrain components including transmission housing, drive shaft, drive motors, fittings, and hoses. Note any damage or wear.
Drivetrain Photos

Hydrostatic Transmission?	Yes	
2 Speed?	Yes	
Hydrostatic Drive Configuration	Split Transmission	
Drive Motors	4 - Like New, Recently Replaced	
Comments	All wheel drive	
Hydrostatic Parking Brake	3 - Normal Wear & Tear	
Hydrostatic Parking Brake Condition	Good brake function	
Overall Drivetrain Comments	Overall drivetrain looks and operates well with no active leaks observed.

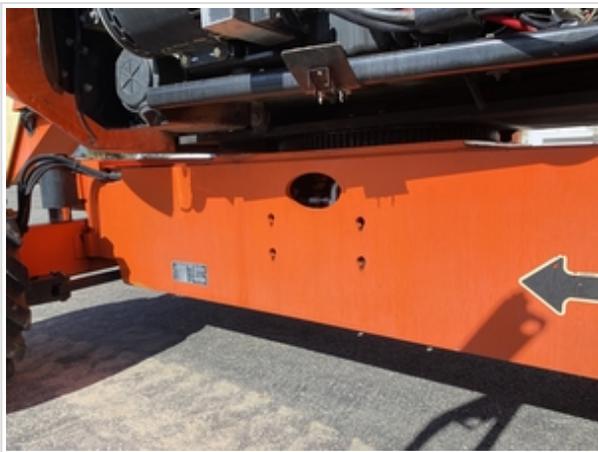
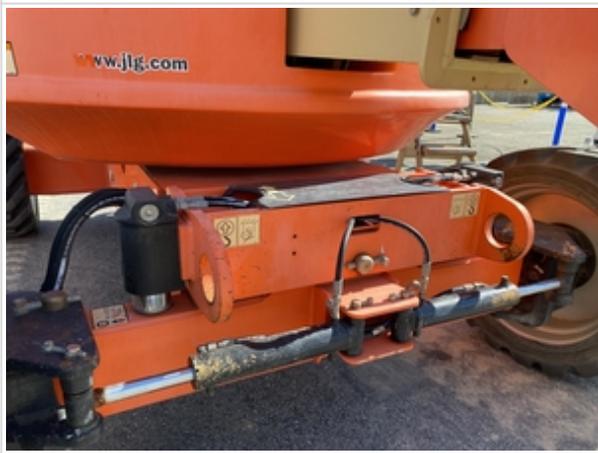
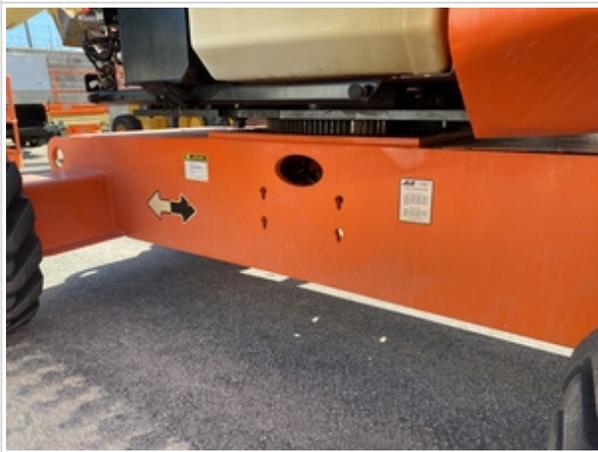
Frame	3 - Normal Wear & Tear	
Frame Photos

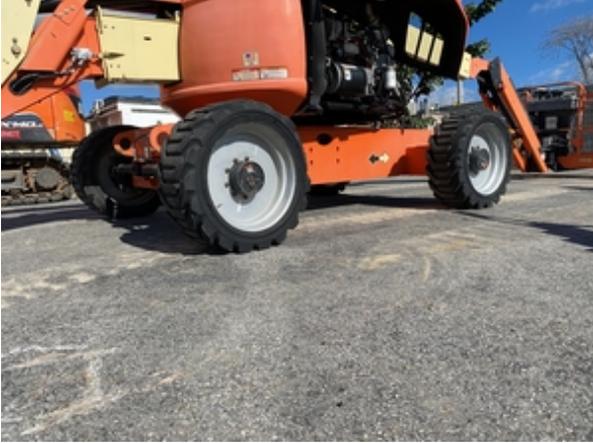
Stance Photos

<p>Stance</p>	<p>3 - Normal Wear & Tear</p>

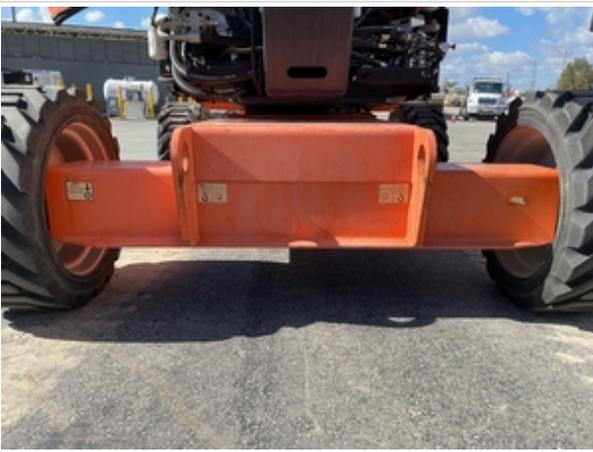
Front Axle Appearance	3 - Normal Wear & Tear
Front Axle Appearance Photos

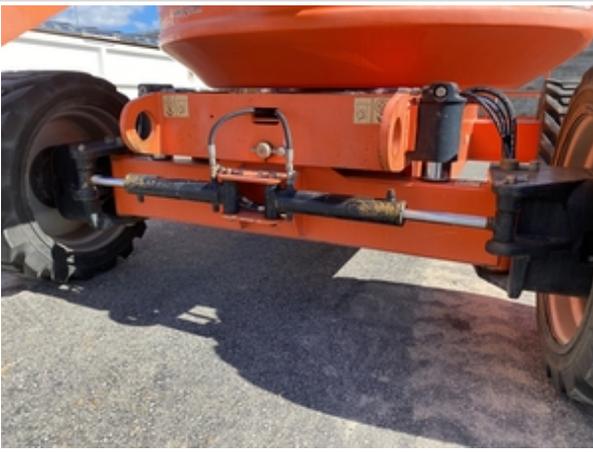
Rear Axle Appearance	3 - Normal Wear & Tear
Rear Axle Appearance Photos

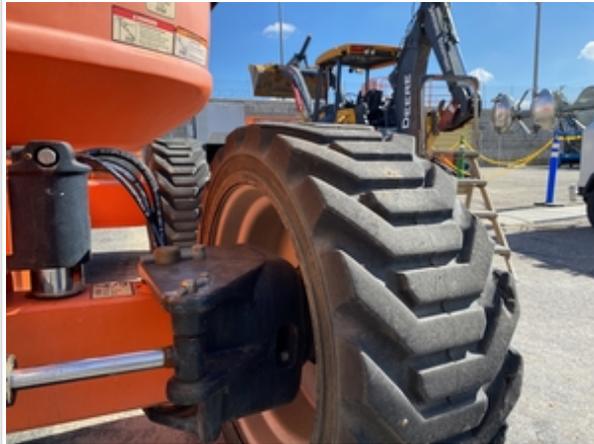
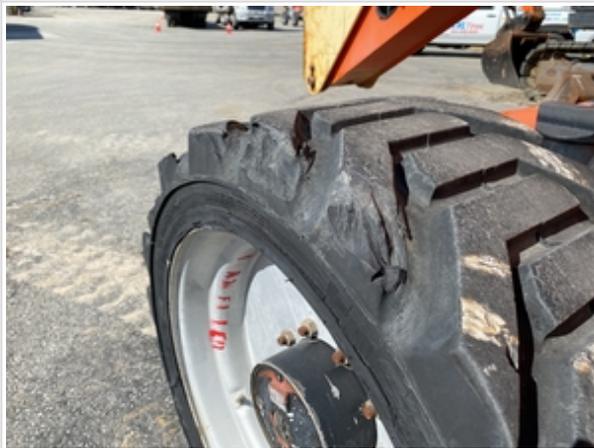
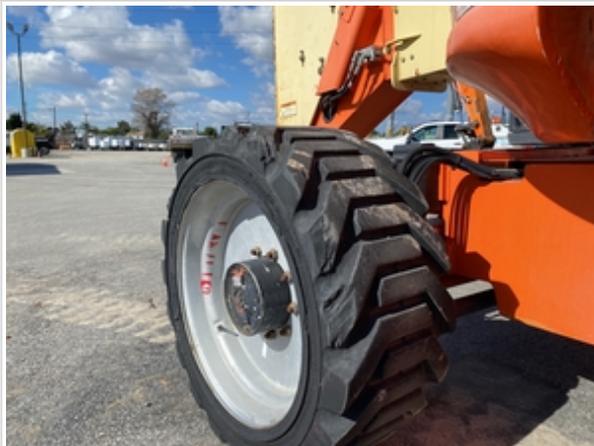
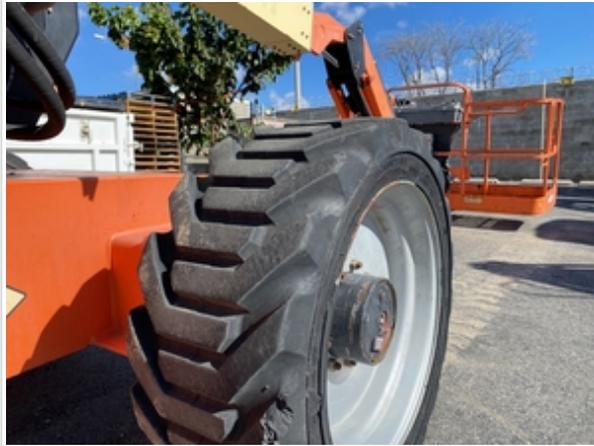
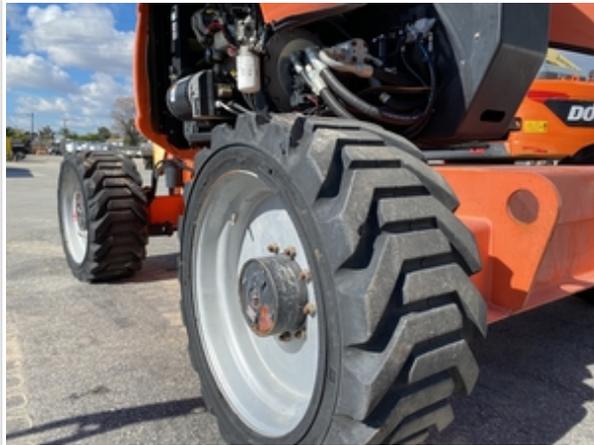
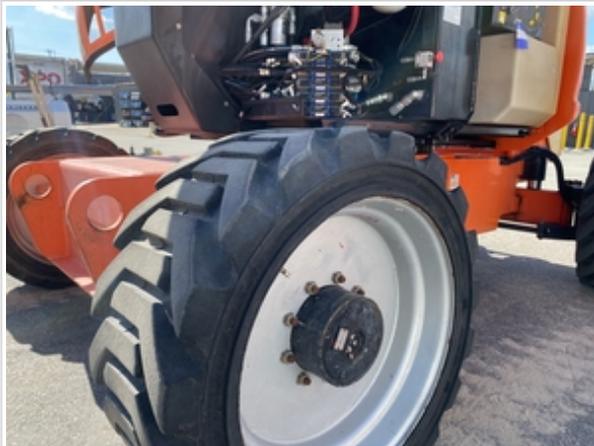
Wheels & Tires Photos

Wheels & Tires	3 - Normal Wear & Tear
Comments	Foam Filled, a bit chewed up on the side edges but above 70% below 90%

Tire Brand	OTR - Outrigger
Tire Size	355/55D625 NHS
Front Left Tire - Ratio Remaining	70%
Rear Left Tire - Ratio Remaining	70%
Front Right Tire - Ratio Remaining	70%
Rear Right Tire - Ratio Remaining	70%
Swivel Bearing	3 - Normal Wear & Tear

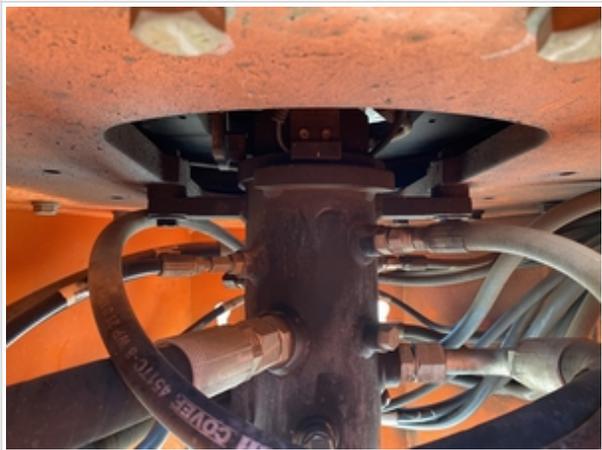
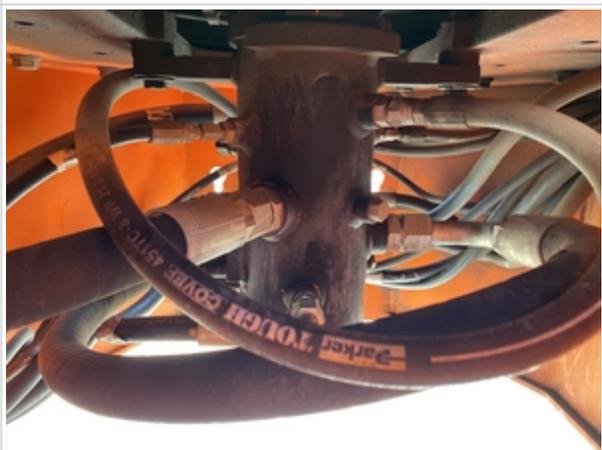
Swivel Motor	3 - Normal Wear & Tear	
Swivel Bearing Photos

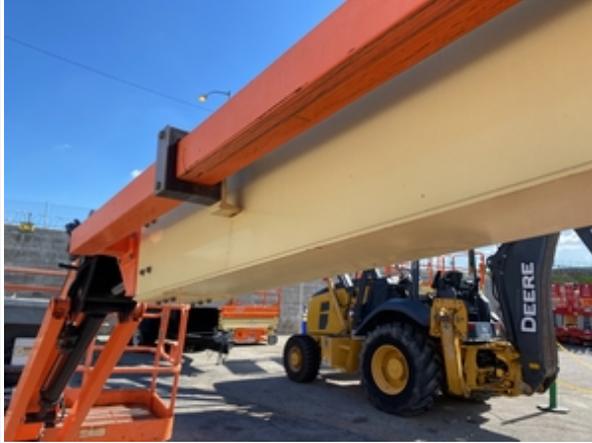
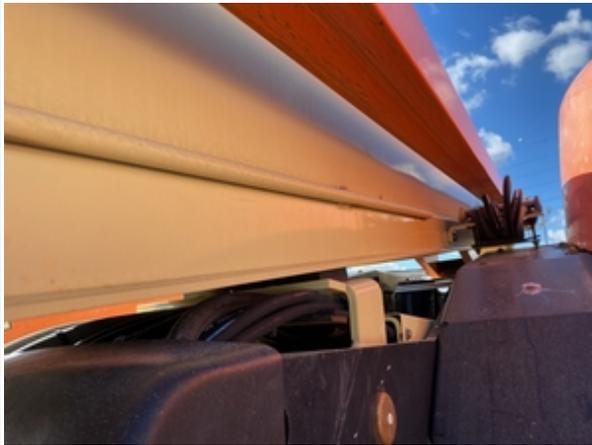
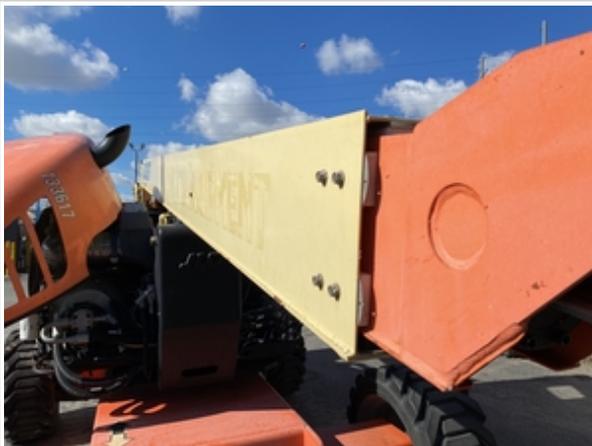
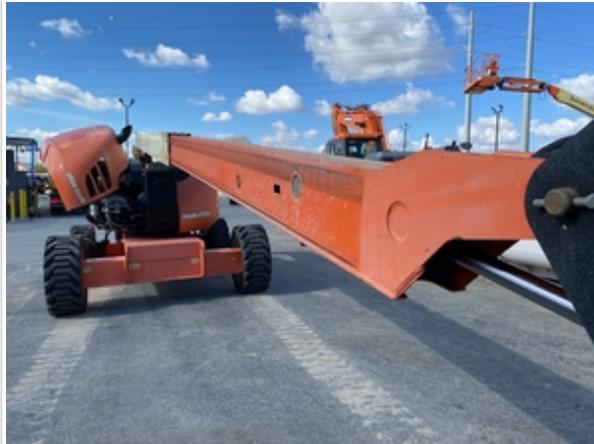
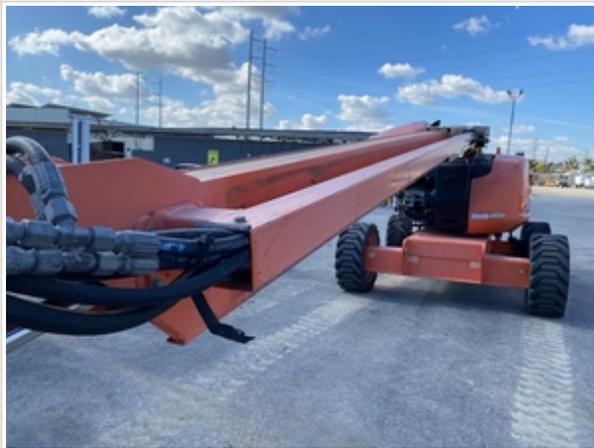
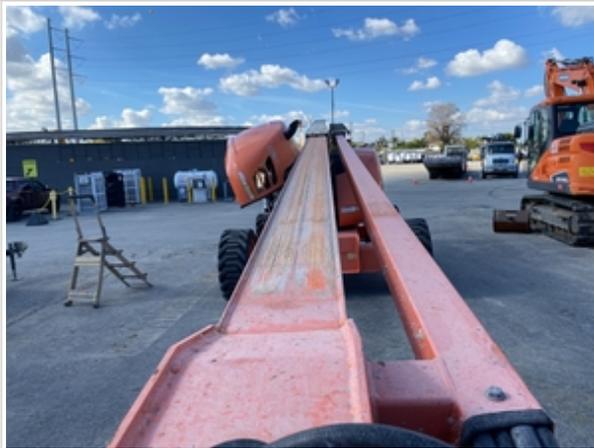
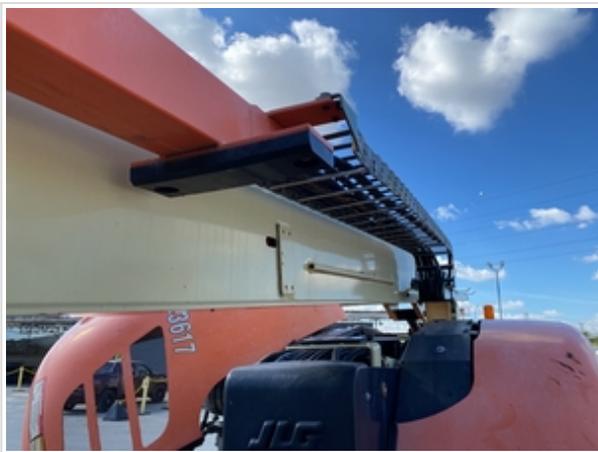
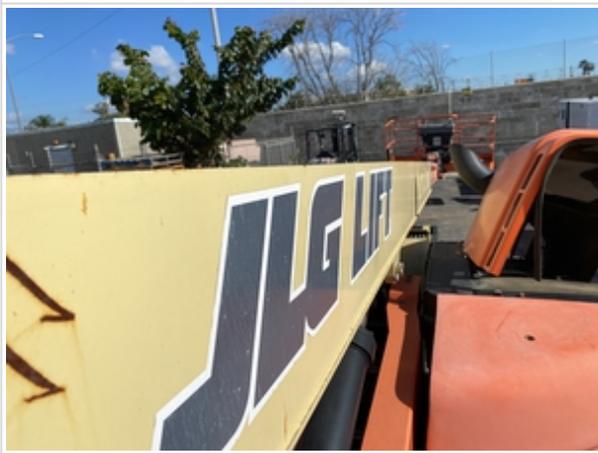
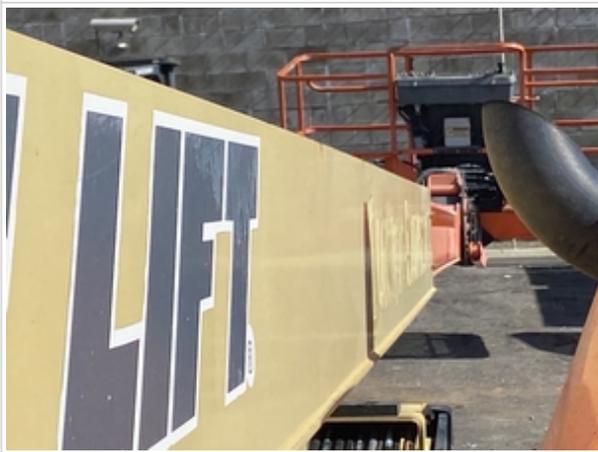
Boom Condition Photos

Boom Condition	3 - Normal Wear & Tear

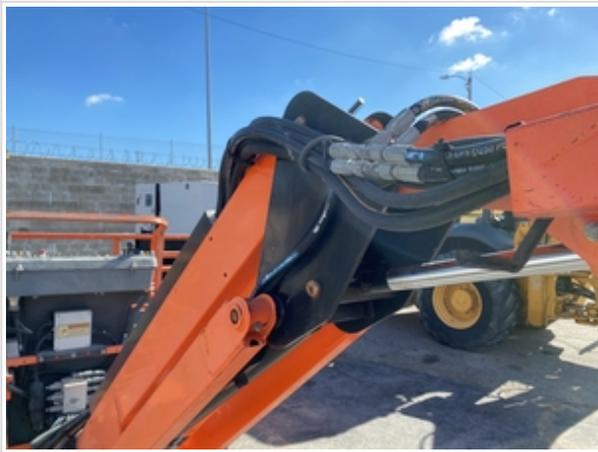
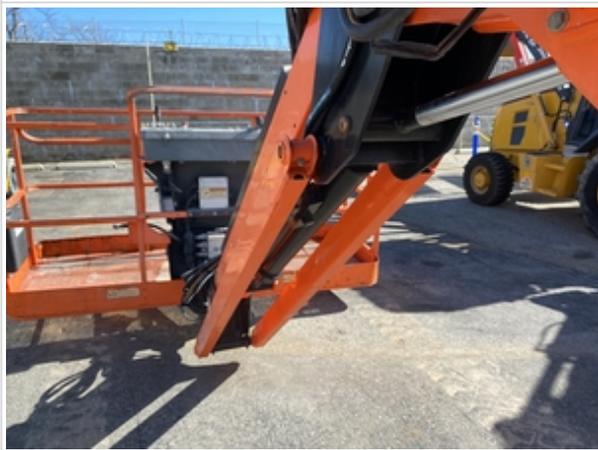
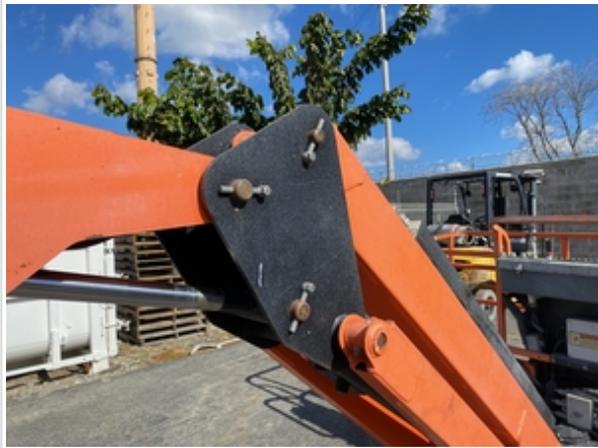
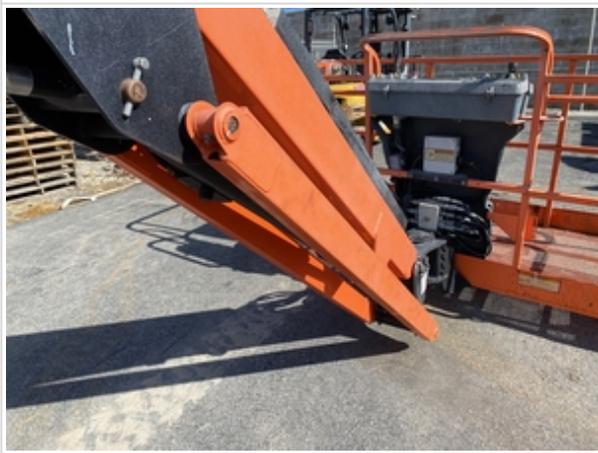
<p>Jib Condition</p>	<p>3 - Normal Wear & Tear</p>
<p>Jib Condition Photos</p>

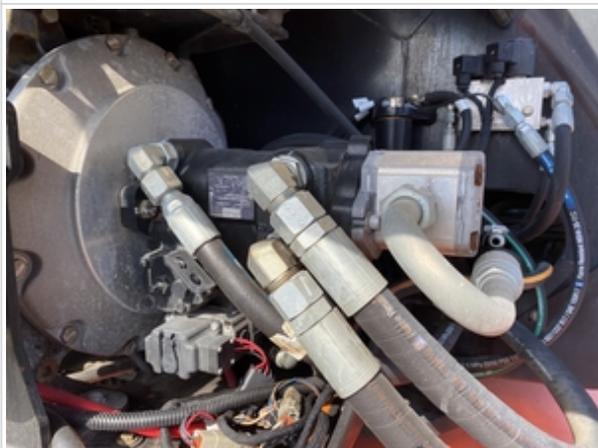
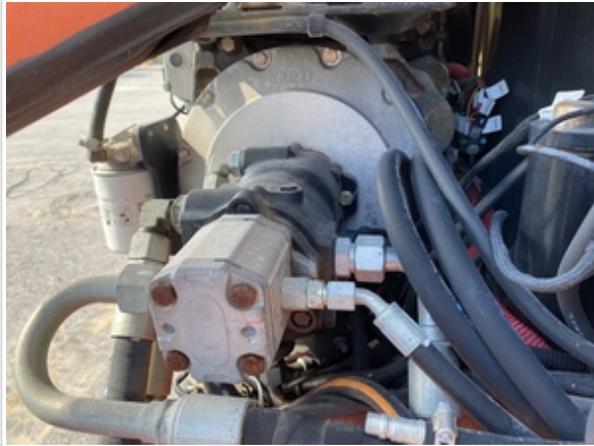
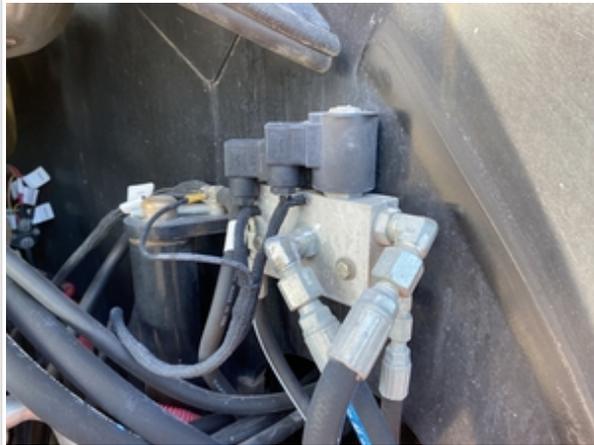
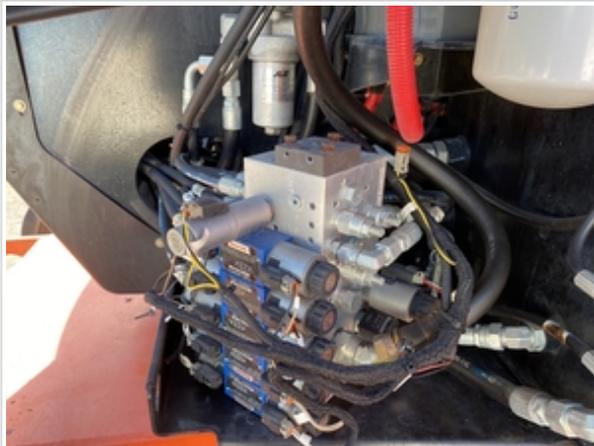
Hydraulic System	Take close-up photos of the hydraulic components including the pump, lines, fittings, controls, and levers. Note any damage, wear, or leaks.	
Hydraulic System Photos

Wet or Damp Hydraulic Lines / Fittings	No
Appearance of Hydraulic Lines / Fittings	3 - Normal Wear & Tear
Hydraulic Lines / Fittings Condition	Hydraulic lines & fittings are clean and in good condition
Unusual Noises (Hydraulic Pump)	No
Hydraulic Pump Notes	No unusual noises heard during operation
Comments	Hydraulics visual in prestine condition

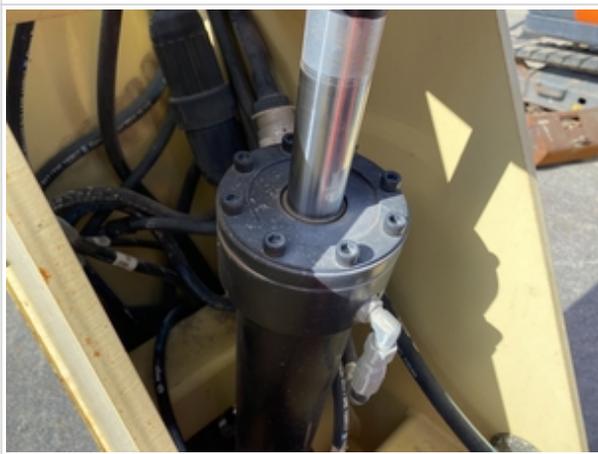
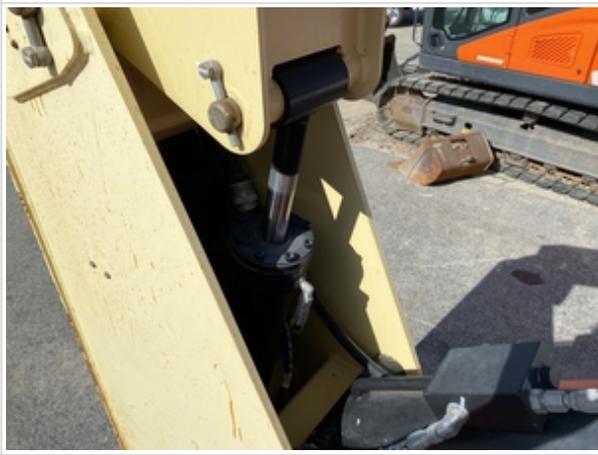
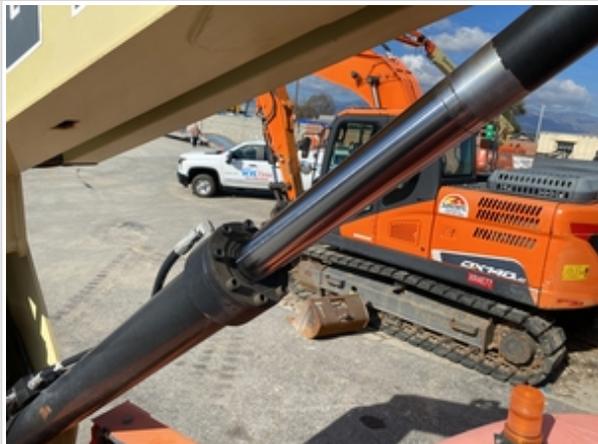
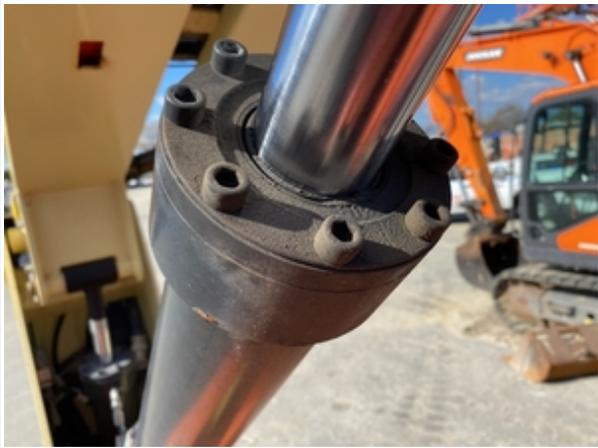
Boom Lift Cylinders	Check the boom lift cylinders. Note any wear, pitting, discoloration, etc. Take photos.
Boom Lift Cylinders: Mounting Pin	3
Boom Lift Cylinders: Oil Leaks	No
Boom Lift Cylinders Photos
