Inspection Report (Boom Lift)

Year	2014
Make	JLG
Model	600AJ
Serial Number	0300192692
Hour Meter Reading	2,377
Previous Application (e.g., earth moving, mining, demolition, etc)	Equipment Rentals

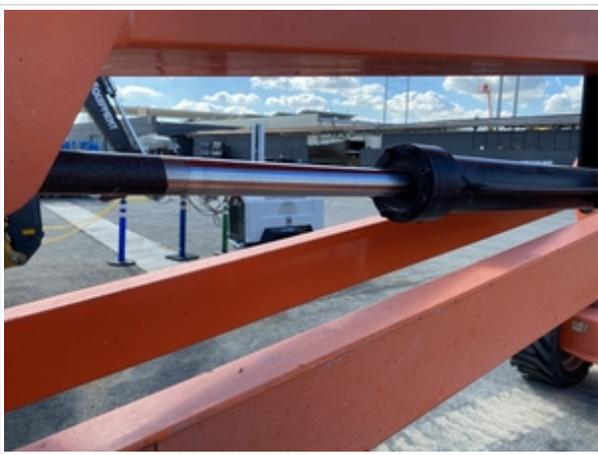
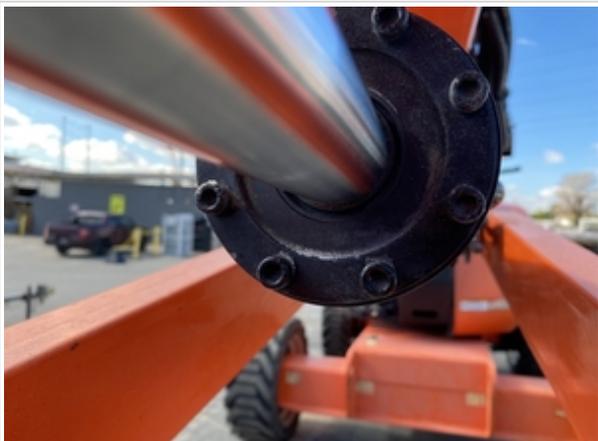
Boom Extension Cylinder	Check the boom extension cylinder. Note any wear, pitting, discoloration, etc. Take photos.	
Boom Extension Cylinder: Mounting Pin	3	
Boom Extension Cylinder: Oil Leaks	No	
Jib Cylinder	Check the jib cylinder. Note any wear, pitting, discoloration, etc. Take photos.	
Jib Cylinder: Oil Leaks	No	
Jib Cylinder: Mounting Pin	3	
Jib Cylinder Photos

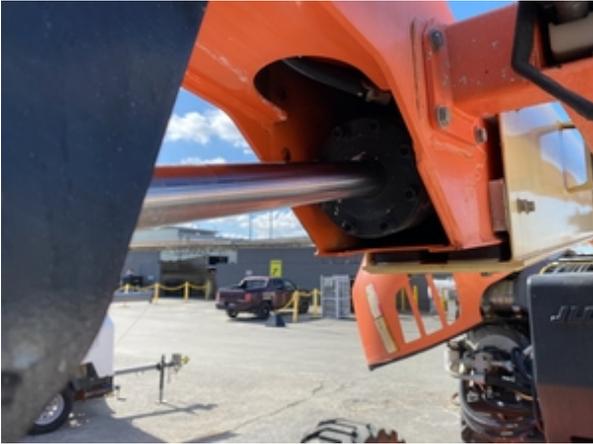
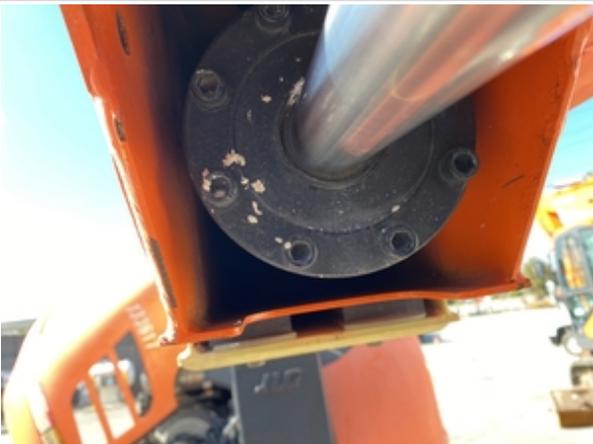
Basket Tilt Cylinder	Check the basket tilt cylinders. Note any wear, pitting, discoloration, etc. Take photos.
Basket Tilt Cylinder: Mounting Pin	3
Basket Tilt Cylinder: Oil Leaks	No
Basket Tilt Cylinder Photos

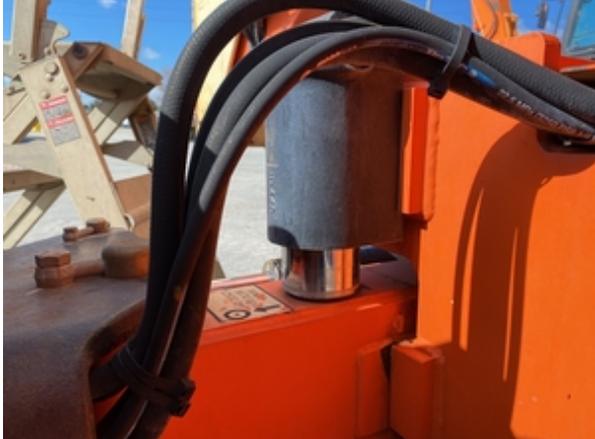
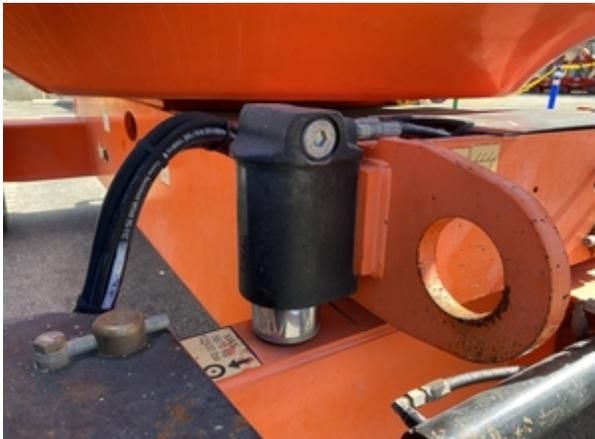
Frame Leveling Cylinders Photos

Frame Leveling Cylinders	Check the frame leveling cylinders. Note any wear, pitting, discoloration, etc. Take photos.
Frame Leveling Cylinders: Mounting Pin	3
Frame Leveling Cylinders: Oil Leaks	No

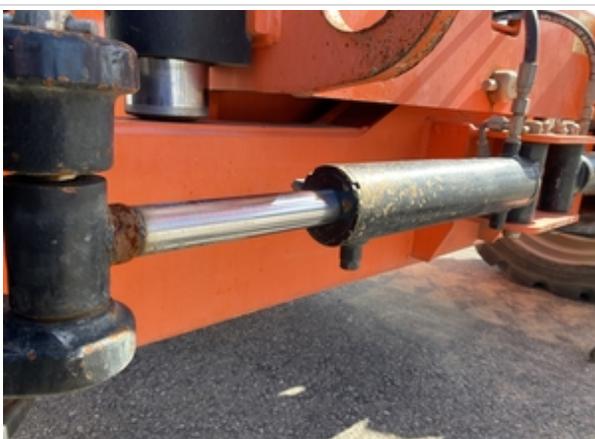
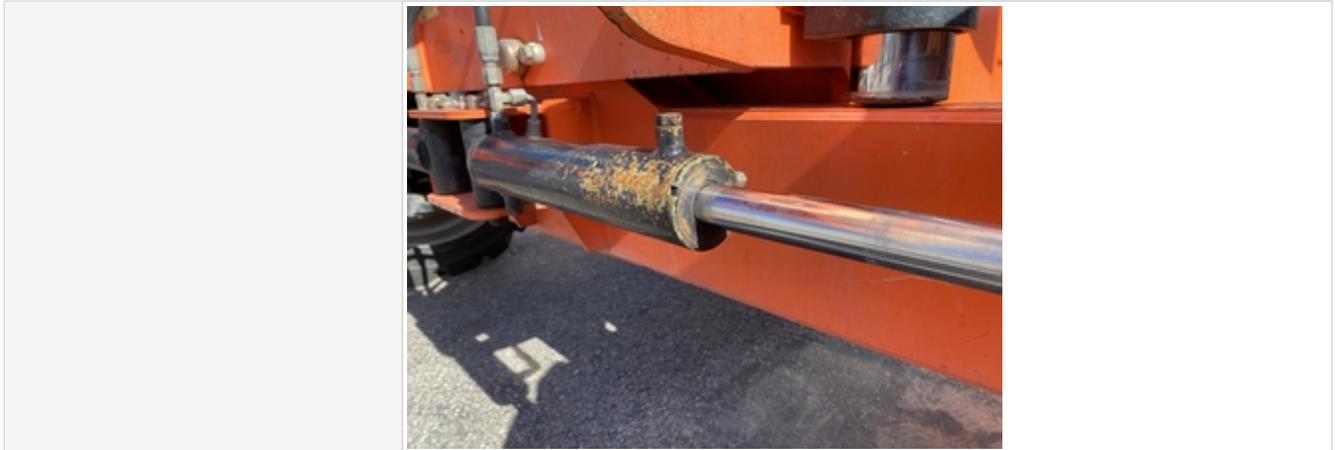
Outrigger Cylinders	Check the outrigger cylinders. Note any wear, pitting, discoloration, etc. Take photos.
Steering Cylinders	Check the steering cylinders. Note any wear, pitting, discoloration, etc. Take photos.
Steering Cylinders: Mounting Pin	3
Steering Cylinders: Oil Leaks	No
Steering Cylinders Photos
