## Inspection Report (Telehandler)

Year	2013
Make	JLG
Model	G12-55
Serial Number	0160051257
Hour Meter Reading	5,988
Previous Application (e.g., earth moving, mining, demolition, etc)	Equipment Rentals

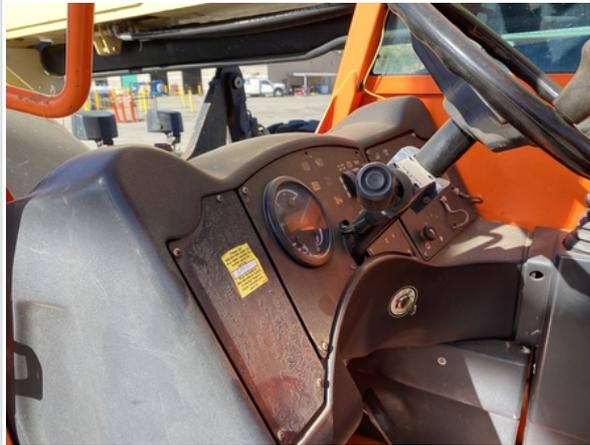
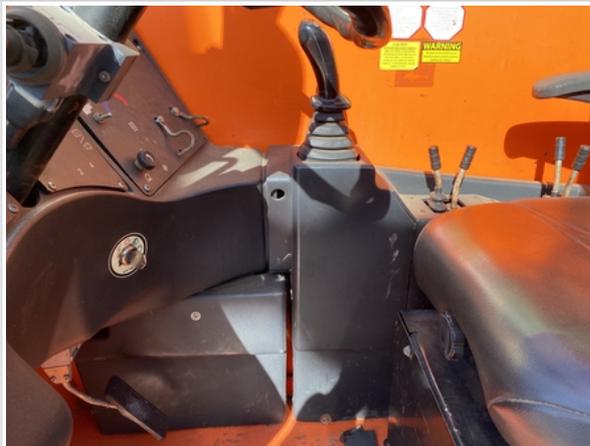
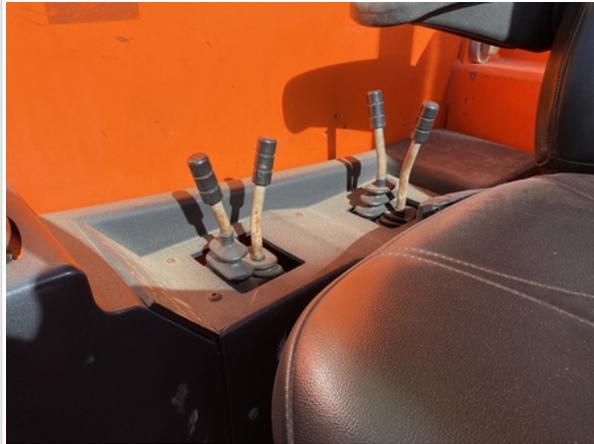
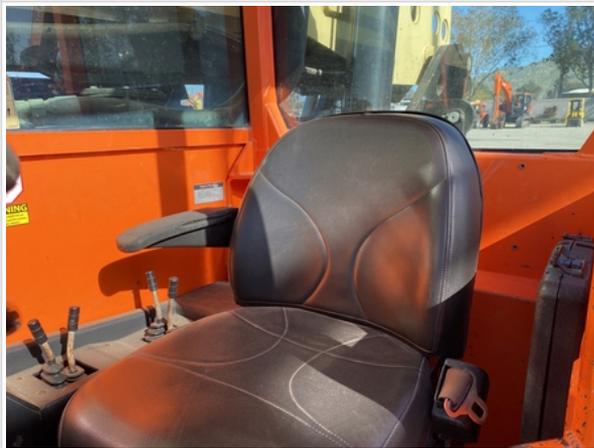
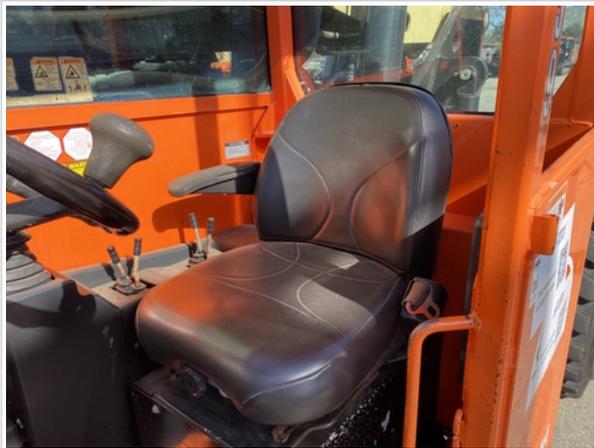
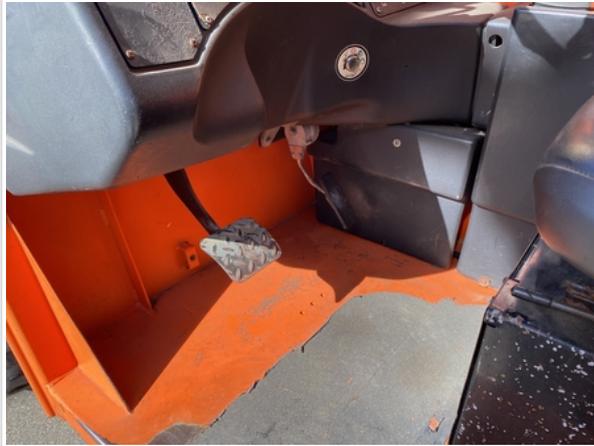
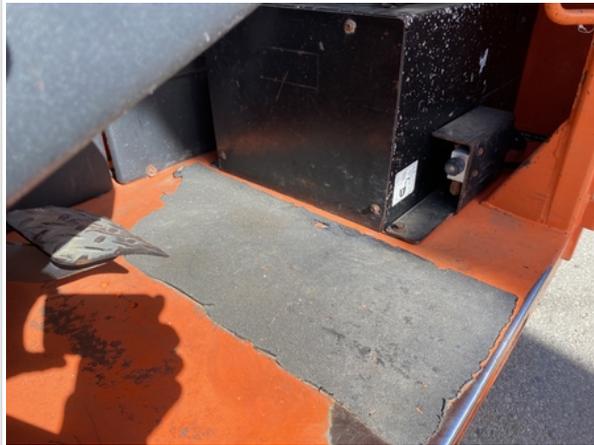
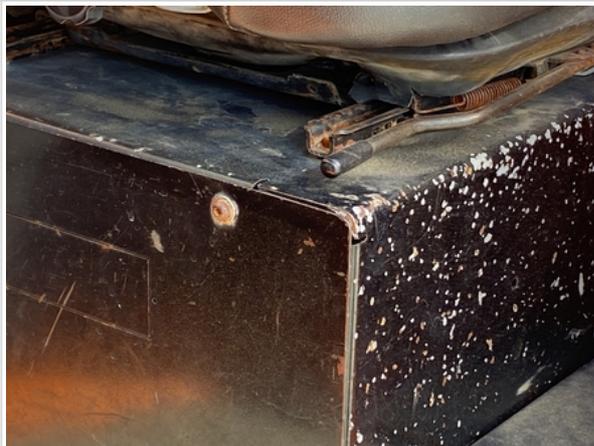
Operator Cabin Photos

<b>Operator Cabin Overall</b>	3 - Normal Wear & Tear
<b>Operator Cabin Overall Condition</b>	Good cabin appearance, solid floors, panels, and ceiling
<b>Operator Seat</b>	3 - Normal Wear & Tear
<b>Operator Seat Condition</b>	Seat(s) in good condition, no stains or tears in upholstery
<b>Cabin Lights</b>	0
<b>Safety Lock Out / Stop</b>	3 - Normal Wear & Tear
<b>Safety Lock Out / Stop Condition</b>	Safety lock out device is present, in good condition, and functional

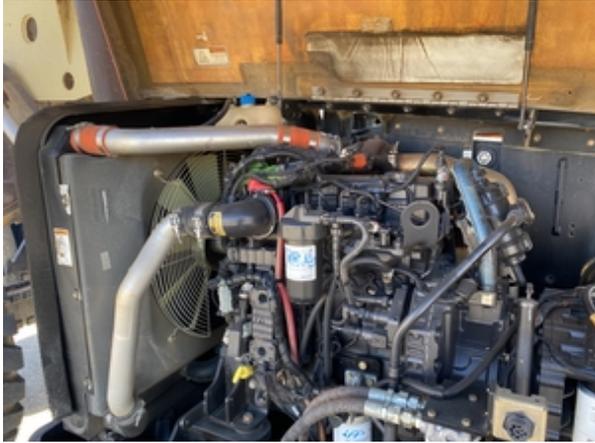
Engine Type (Make, Model, Cylinders, Hp)	Cummins - 4Cyl. - QSB4.5L - 130HP
Emissions Tier	Tier 3
Engine Serial Number	735G1496
Engine Fuel Type	Diesel
Engine Photos

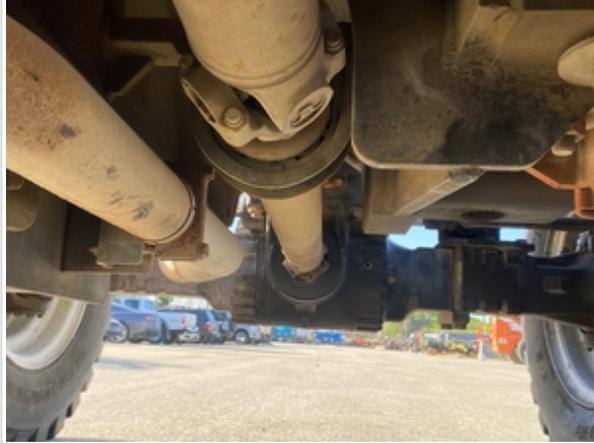
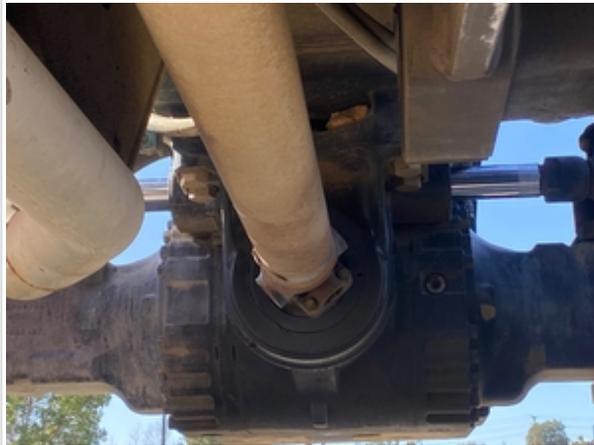
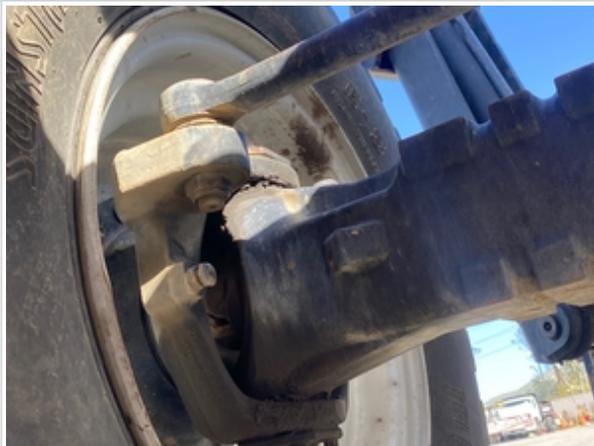
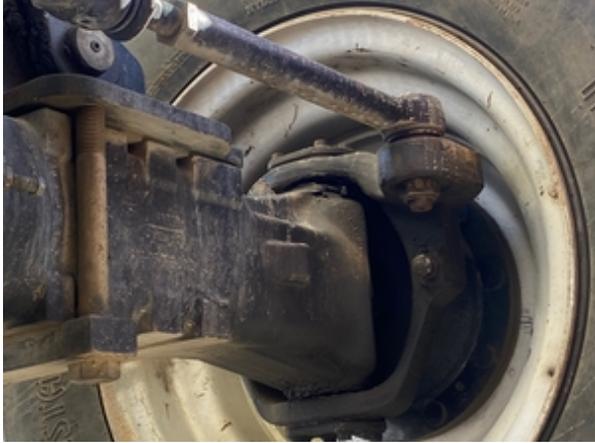
Hydrostatic Transmission?	No
Transmission Info (Make/Model/Speeds)	Powershift 4 Speed Forward 3 Speed reverse
Transmission	3 - Normal Wear & Tear
Transmission Condition	No unusual noises or vibrations
Clutch	0
Shift Lever	3 - Normal Wear & Tear
Shift Lever Condition	Good forward and reverse function
Foot Brake	3 - Normal Wear & Tear
Foot Brake Condition	Good brake function
Inching Brake	0
Parking Brake	3 - Normal Wear & Tear
Parking Brake Condition	Good brake function
Overall Drivetrain Comments	Overall drivetrain in good condition

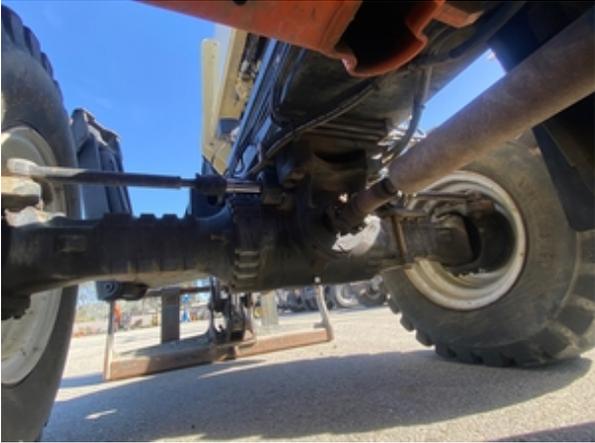
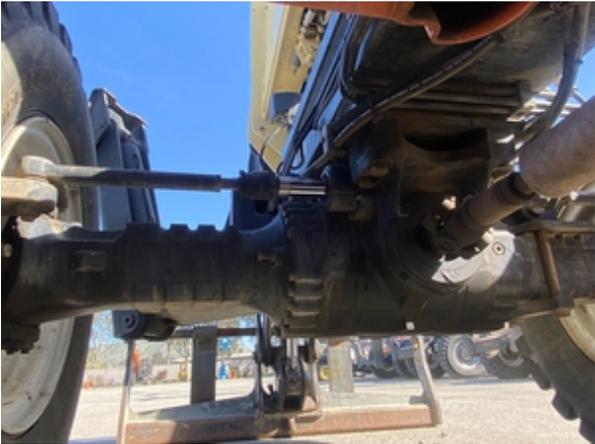
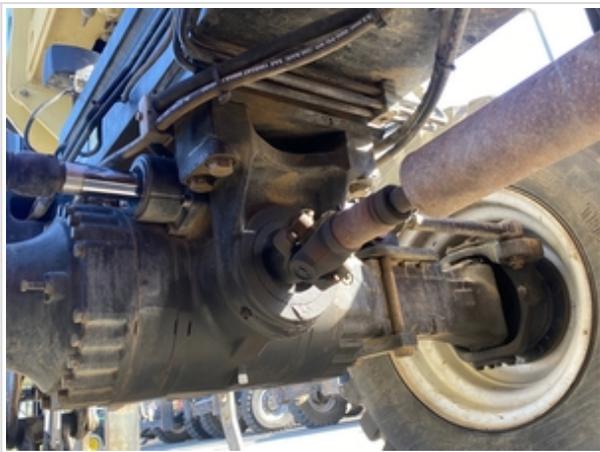
<b>Stance</b>	3 - Normal Wear & Tear	
<b>Front Axle Appearance</b>	3 - Normal Wear & Tear	
<b>Front Axle Appearance Photos</b>

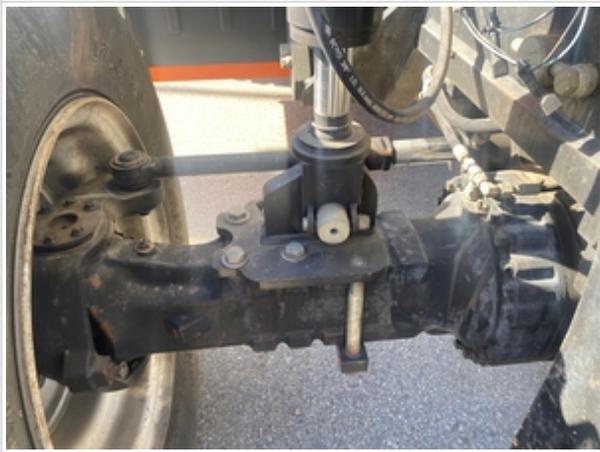
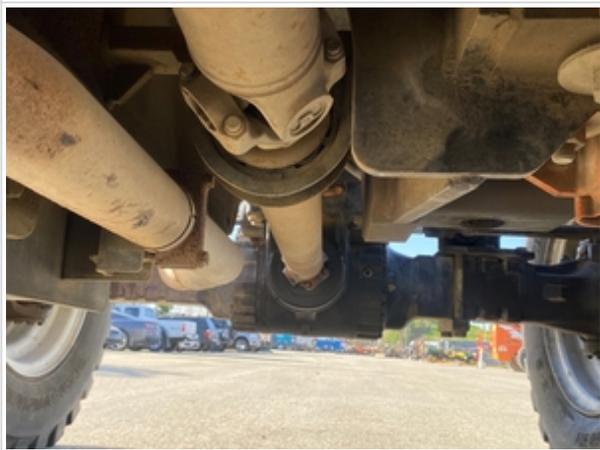
<p><b>Rear Axle Appearance</b></p>	<p>3 - Normal Wear &amp; Tear</p>	
<p><b>Rear Axle Appearance Photos</b></p>

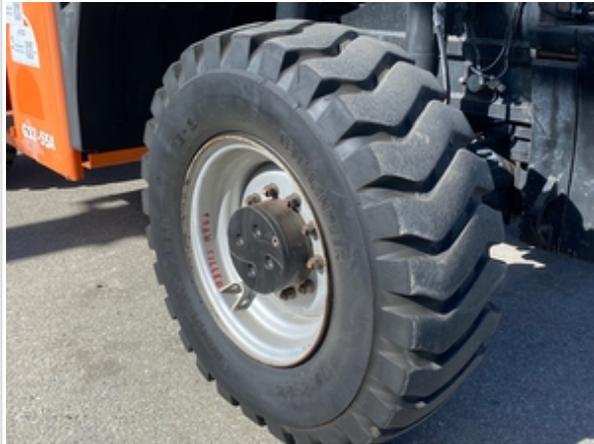
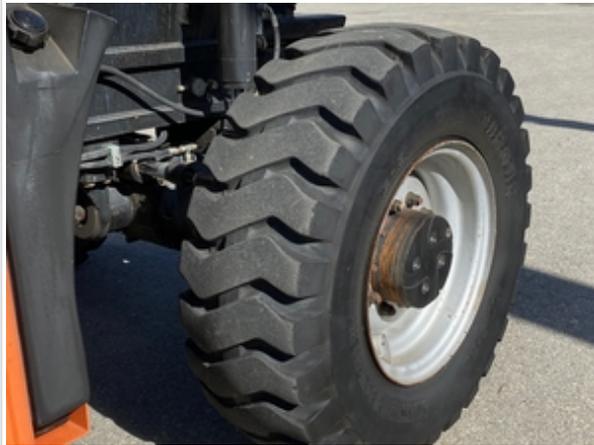
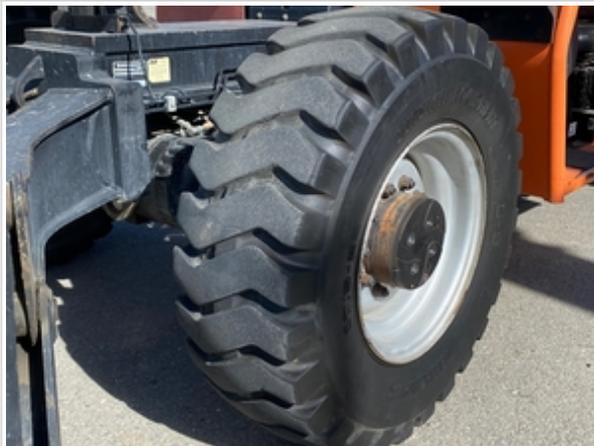
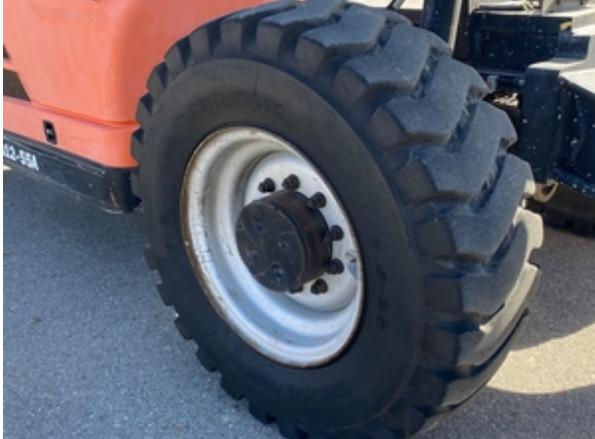
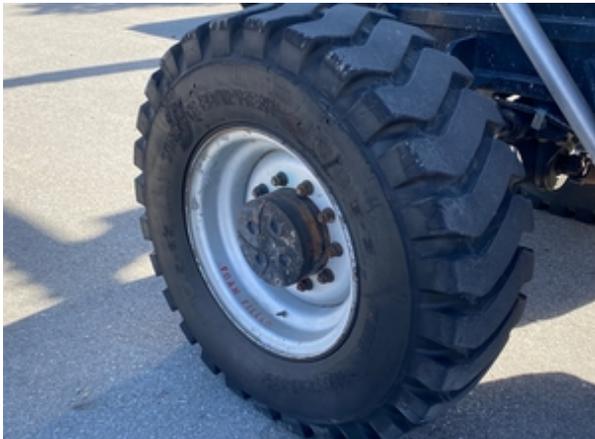
Wheels & Tires Photos

<b>Oscillating Pin Appearance</b>	3 - Normal Wear & Tear	
<b>Wheels &amp; Tires</b>	3 - Normal Wear & Tear	
<b>Comments</b>	Tires are foam filled and in great condition

Tire Brand	Sunstate Equipment
Tire Size	17.5-25
Front Left Tire - Ratio Remaining	50%
Rear Left Tire - Ratio Remaining	50%
Front Right Tire - Ratio Remaining	50%
Rear Right Tire - Ratio Remaining	50%
Boom Condition	3 - Normal Wear & Tear
Boom Condition Photos

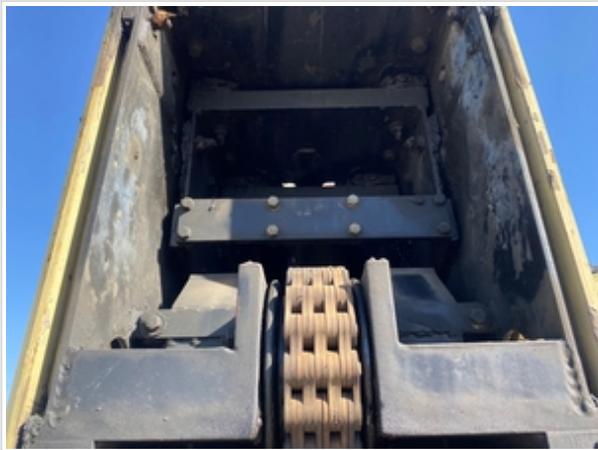
<b>Chain / Tensioners Photos</b>

<p>Chain / Tensioners</p>	<p>3 - Normal Wear &amp; Tear</p>

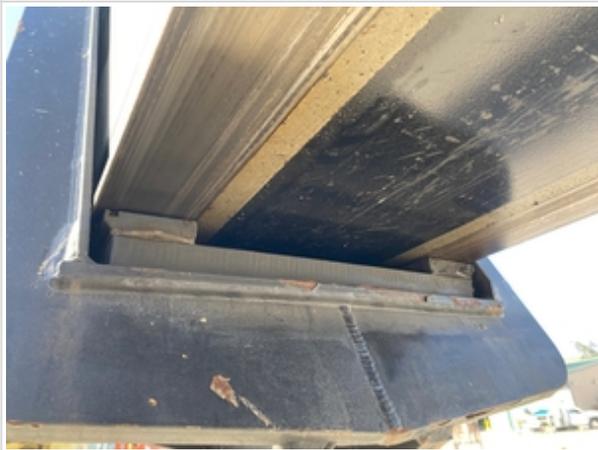
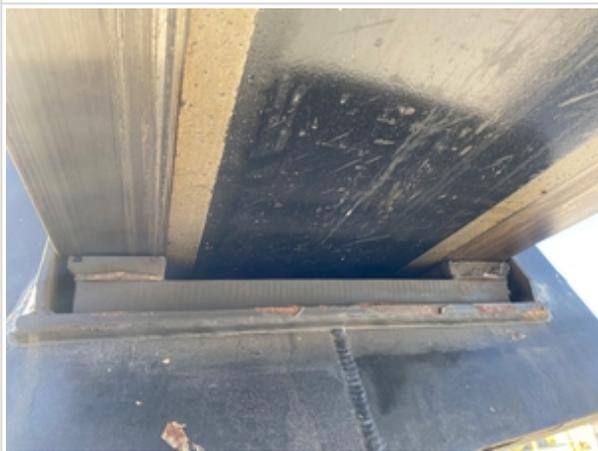
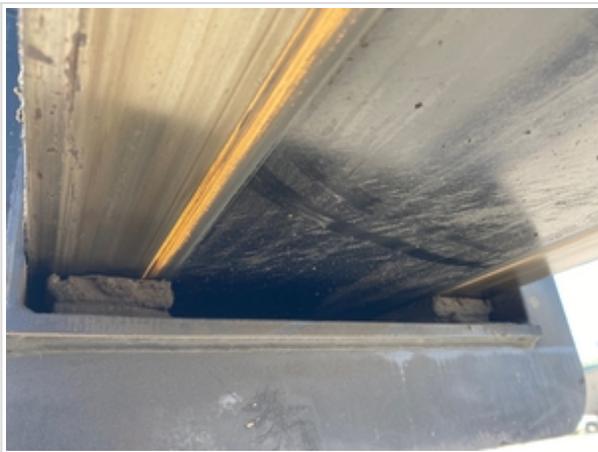
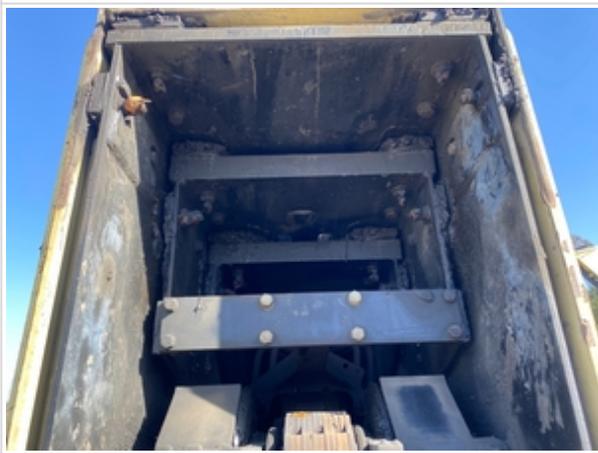
<b>Rollers &amp; Guides</b>	3 - Normal Wear & Tear
<b>Boom Wear Guides</b>	3 - Normal Wear & Tear
<b>Boom Wear Guides Photos</b>

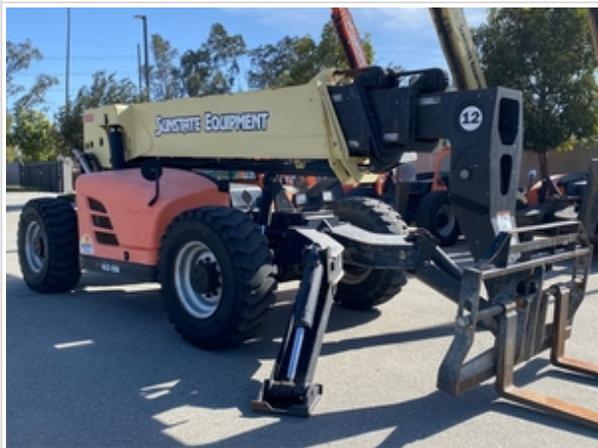
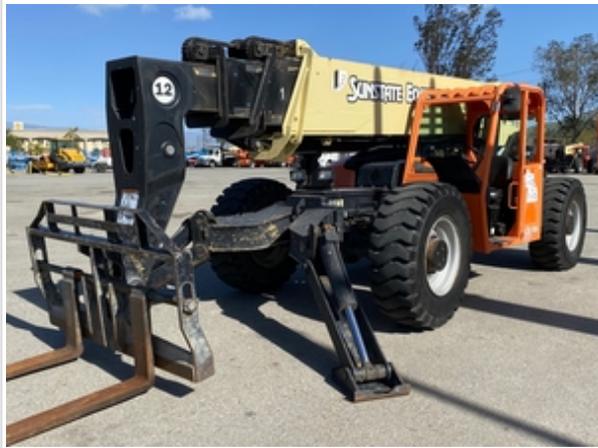
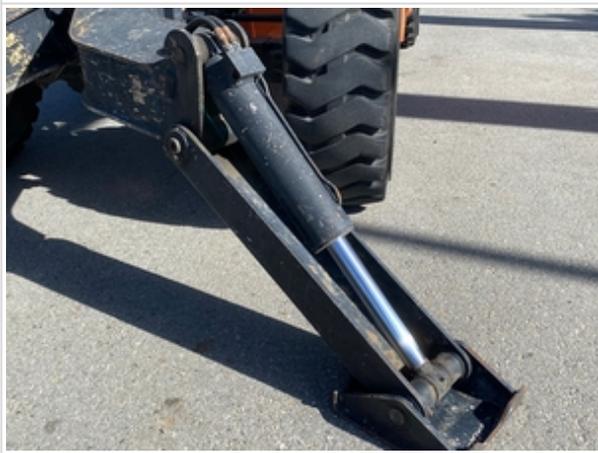
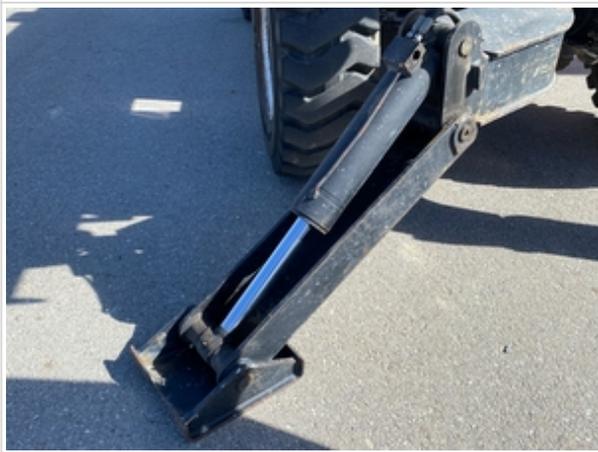
<p>Outriggers</p>	<p>3 - Normal Wear &amp; Tear</p>	
<p>Outriggers Photos</p>

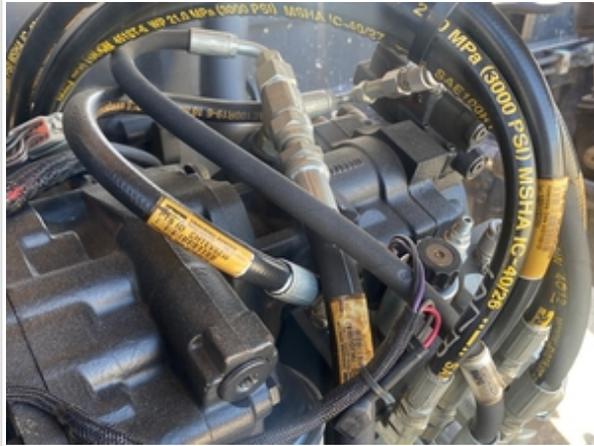
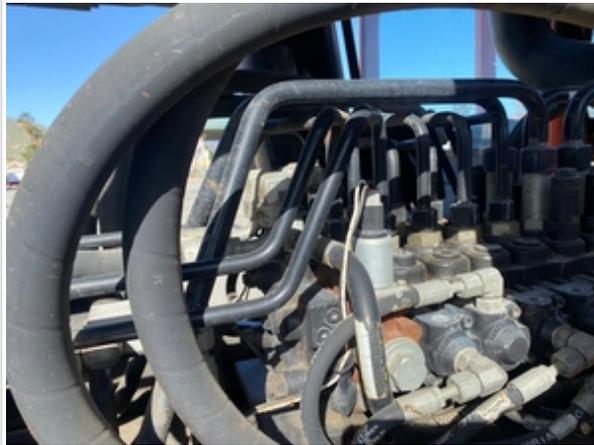
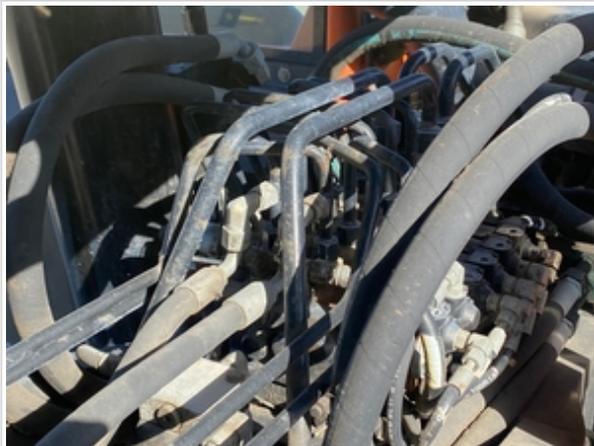
Hydraulic System Photos

<b>Wet or Damp Hydraulic Lines / Fittings</b>	No
<b>Appearance of Hydraulic Lines / Fittings</b>	3 - Normal Wear & Tear
<b>Hydraulic Lines / Fittings Condition</b>	Hydraulic lines & fittings are clean and in good condition
<b>Unusual Noises (Hydraulic Pump)</b>	No
<b>Hydraulic Pump Notes</b>	No unusual noises heard during operation

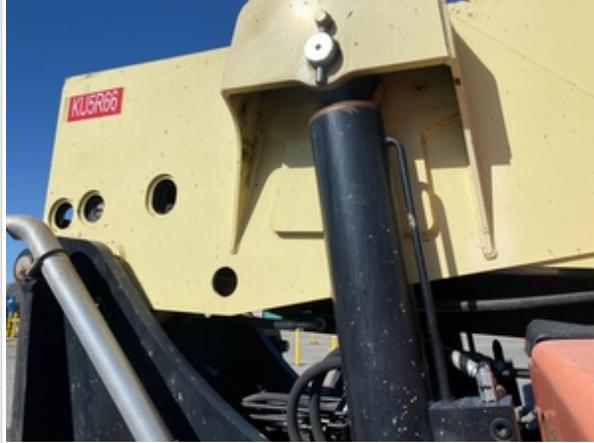
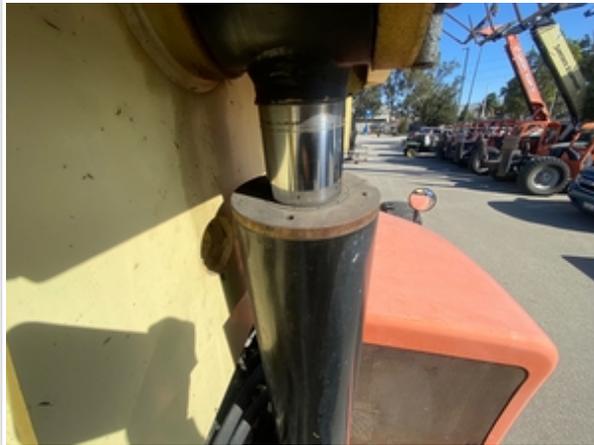
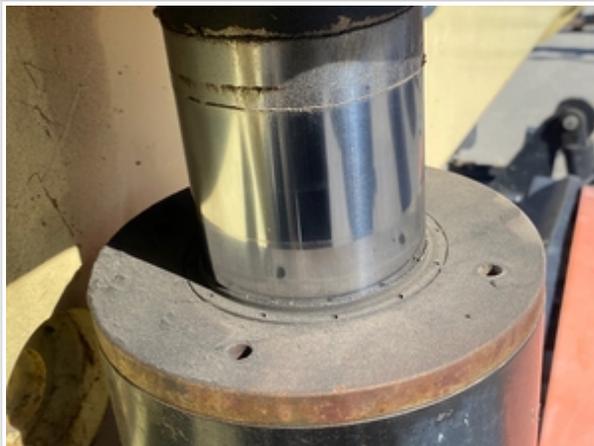
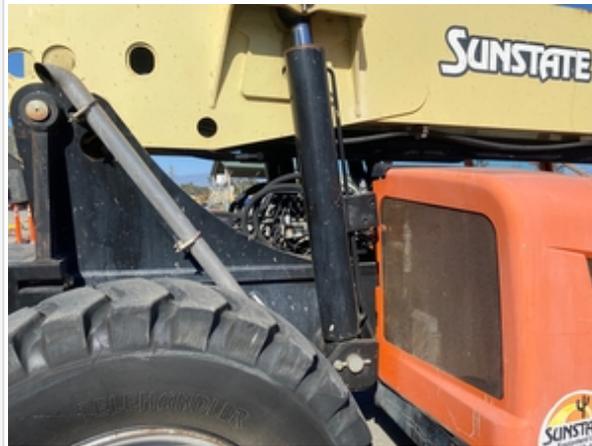
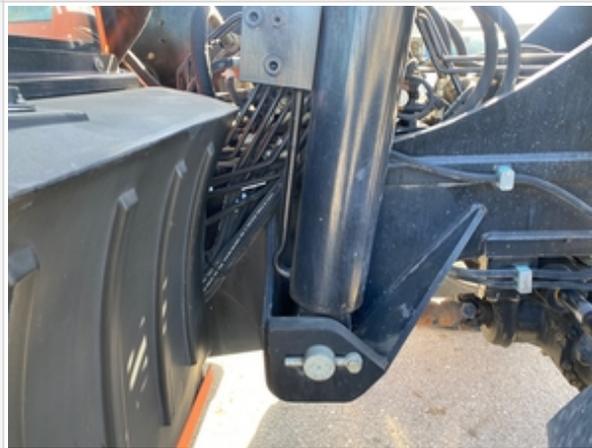
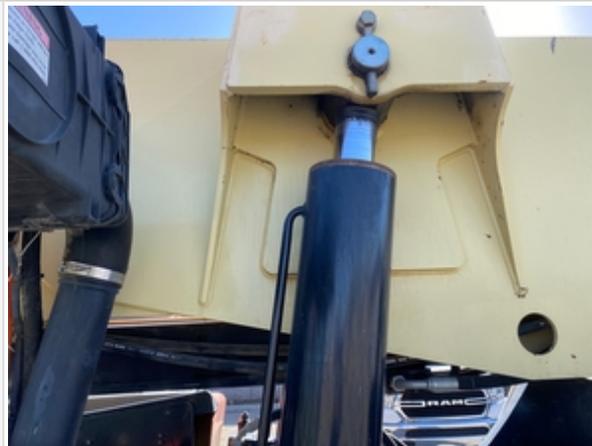
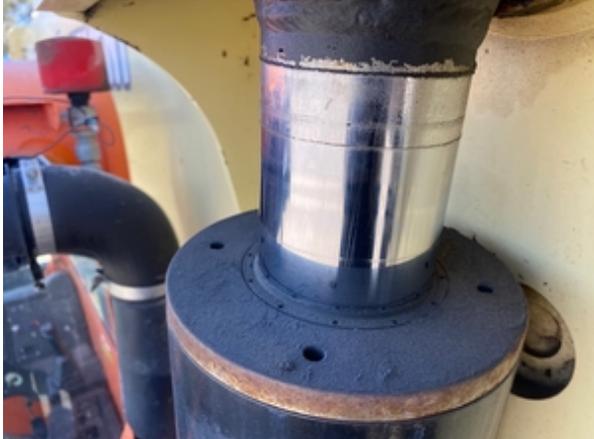
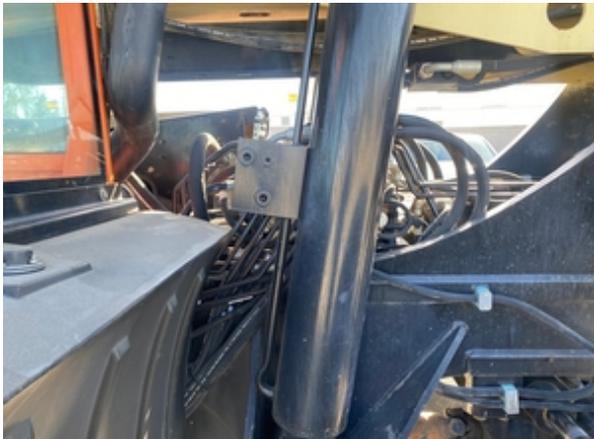
Boom Lift Cylinders Photos

<b>Boom Lift Cylinders</b>	Check the boom lift cylinders. Note any wear, pitting, discoloration, etc. Take photos.
<b>Boom Lift Cylinders: Mounting Pin</b>	3 - Normal Wear & Tear
<b>Boom Lift Cylinders: Oil Leaks</b>	No

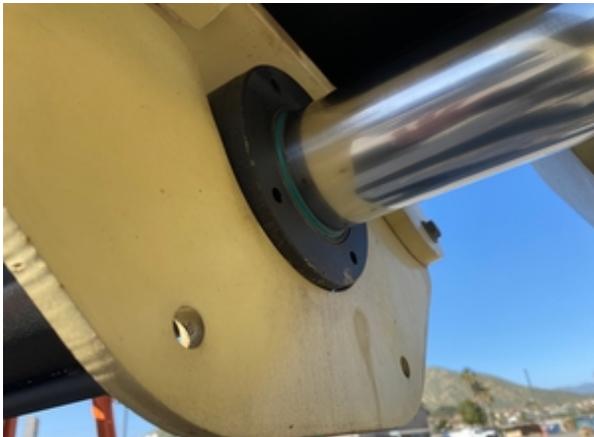
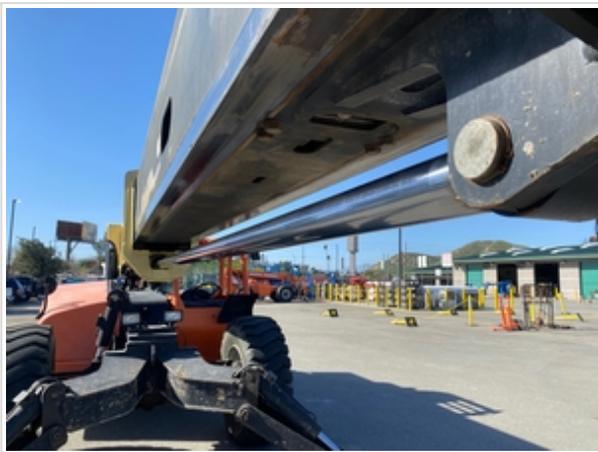
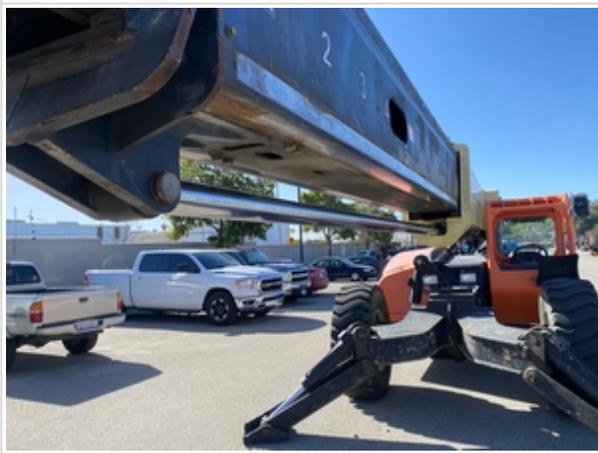
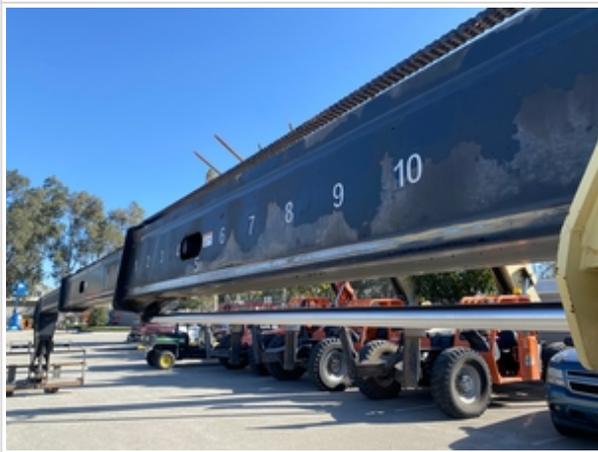
<b>Telescopic Boom Cylinders</b>	Check the telescopic boom cylinders. Note any wear, pitting, discoloration, etc. Take photos.	
<b>Telescopic Boom Cylinders: Mounting Pin</b>	3 - Normal Wear & Tear	
<b>Telescopic Boom Cylinders: Oil Leaks</b>	No	
<b>Telescopic Boom Cylinders Photos</b>

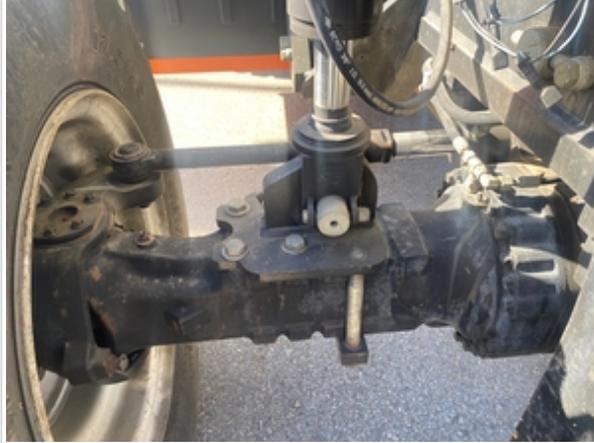
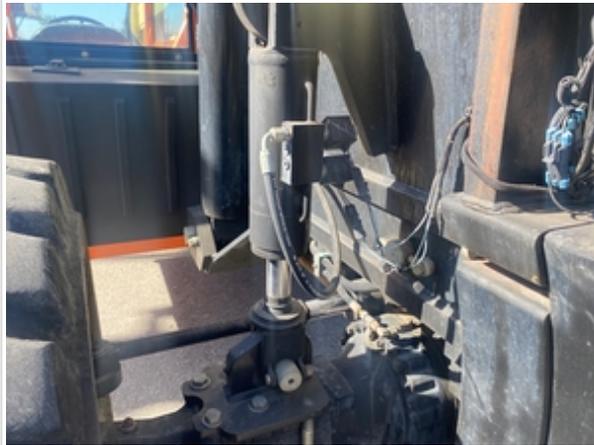
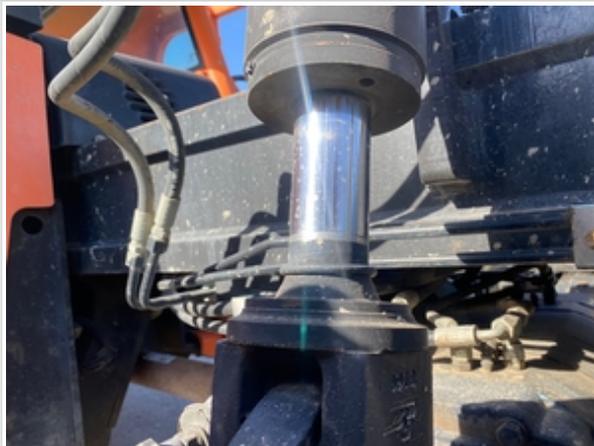
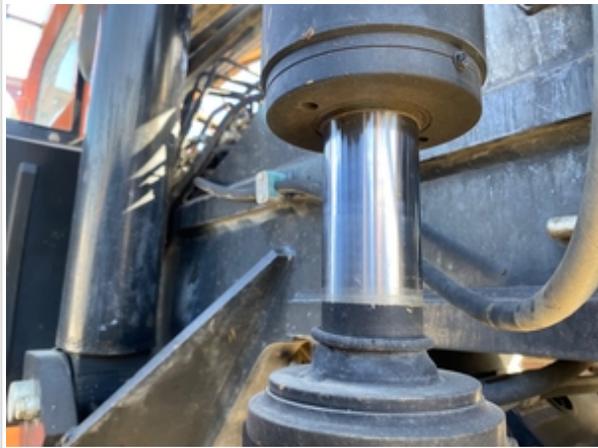
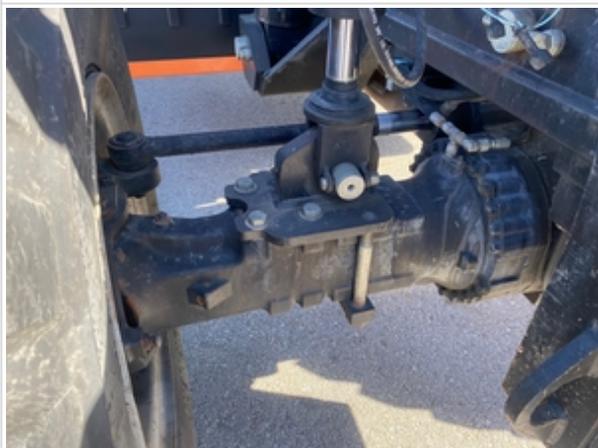
Frame Leveling Cylinders Photos

<b>Frame Leveling Cylinders</b>	Check the frame leveling cylinders. Note any wear, pitting, discoloration, etc. Take photos.
<b>Frame Leveling Cylinders: Mounting Pin</b>	3 - Normal Wear & Tear
<b>Frame Leveling Cylinders: Oil Leaks</b>	No

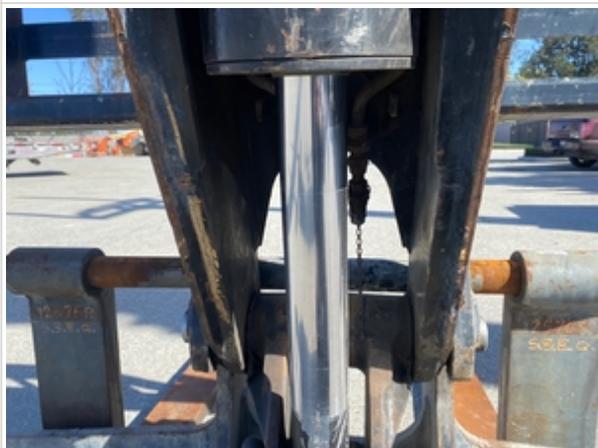
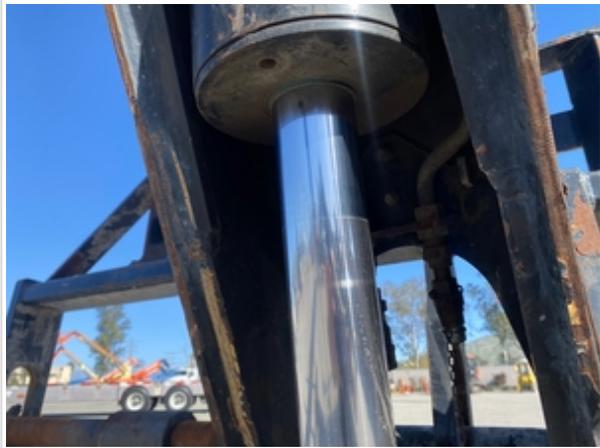
<b>Carriage Tilt Cylinder</b>	Check the carriage tilt cylinders. Note any wear, pitting, discoloration, etc. Take photos.	
<b>Carriage Tilt Cylinder: Mounting Pin</b>	3 - Normal Wear & Tear	
<b>Carriage Tilt Cylinder: Oil Leaks</b>	No	
<b>Carriage Tilt Cylinder Photos</b>

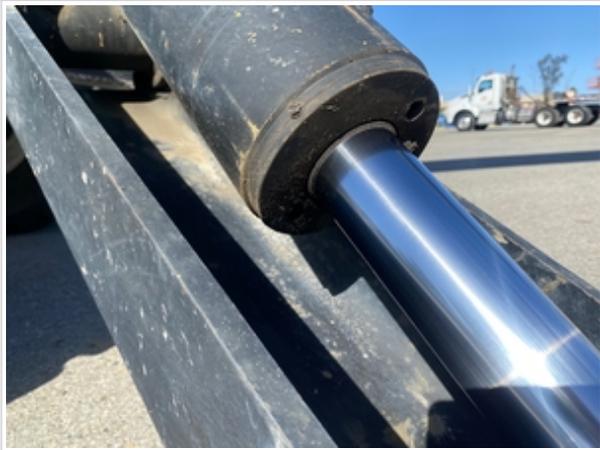
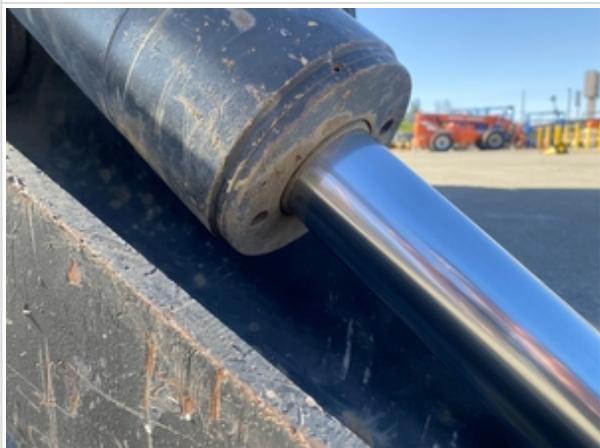
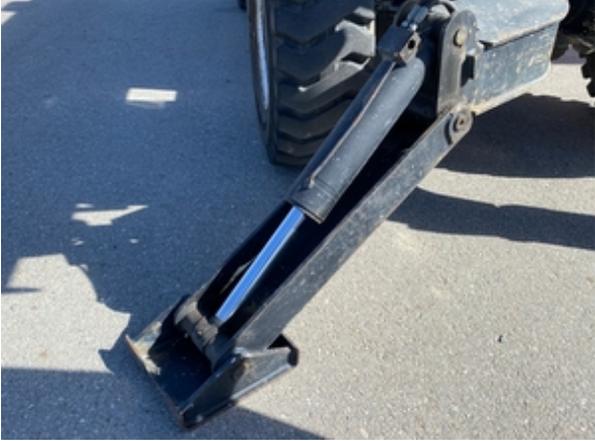
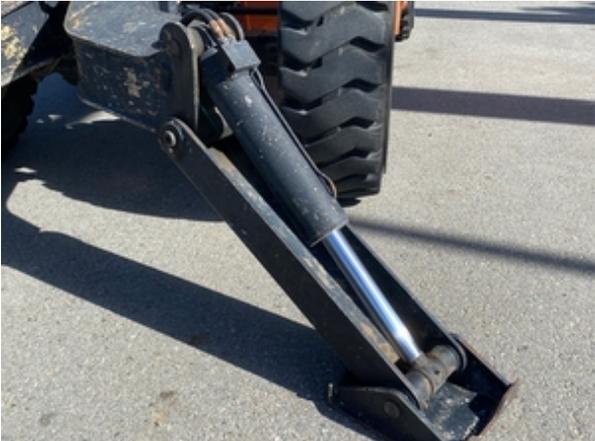
<b>Side Shift Cylinder</b>	Check the side shift cylinder. Note any wear, pitting, discoloration, etc. Take photos.	
<b>Outrigger Cylinders</b>	Check the outrigger cylinders. Note any wear, pitting, discoloration, etc. Take photos.	
<b>Outrigger Cylinders: Mounting Pin</b>	3 - Normal Wear & Tear	
<b>Outrigger Cylinders: Oil Leaks</b>	No	
<b>Outrigger Cylinders Photos</b>

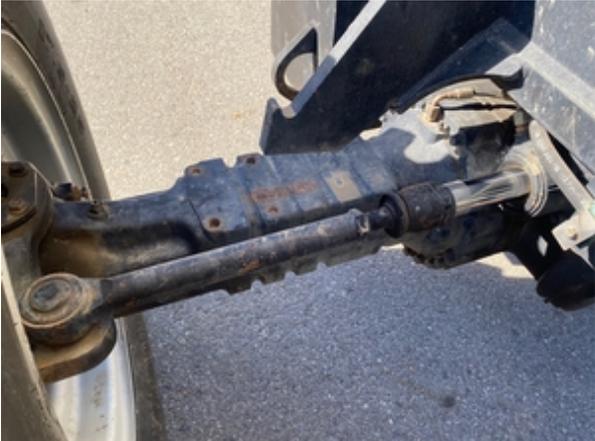
<b>Steering Cylinders</b>	Check the steering cylinders. Note any wear, pitting, discoloration, etc. Take photos.	
<b>Steering Cylinders: Mounting Pin</b>	3 - Normal Wear & Tear	
<b>Steering Cylinders: Oil Leaks</b>	No	
<b>Steering Cylinders Photos</b>

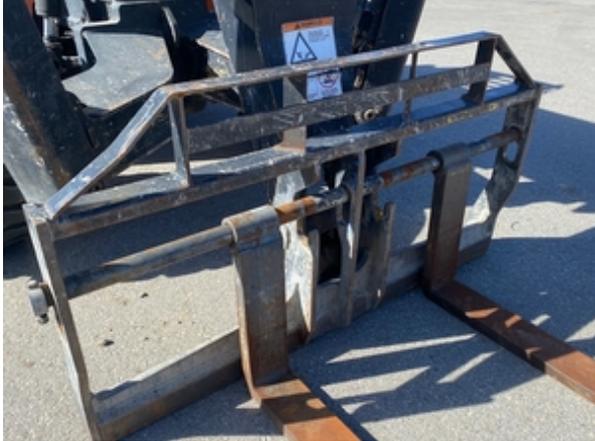
<b>Back Rest Photos</b>

Back Rest Condition	3 - Normal Wear & Tear
