Inspection Report (On-Highway Service Truck)

Year	2015
Make	Chevrolet
Model	2500
Serial Number	1GB2CUEG2FZ547955
Truck Odometer Reading	182,741
Current Inspection / State Cert / DOT	N/A
Previous Application (e.g., earth moving, mining, demolition, etc)	Billboard Services

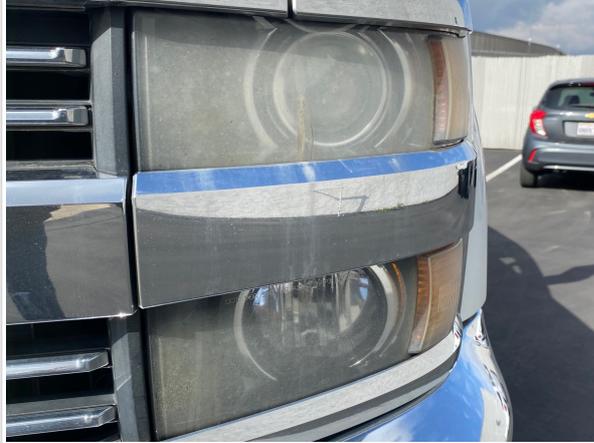
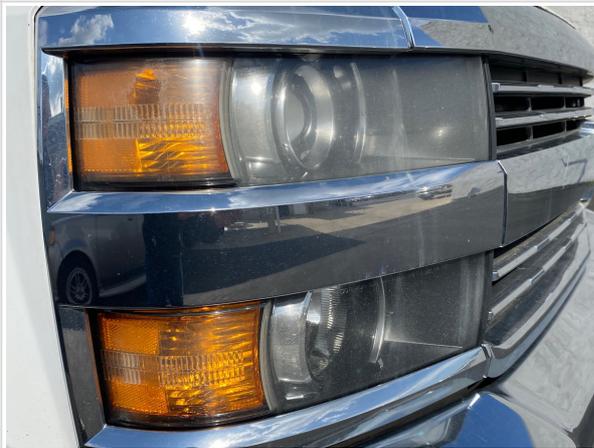
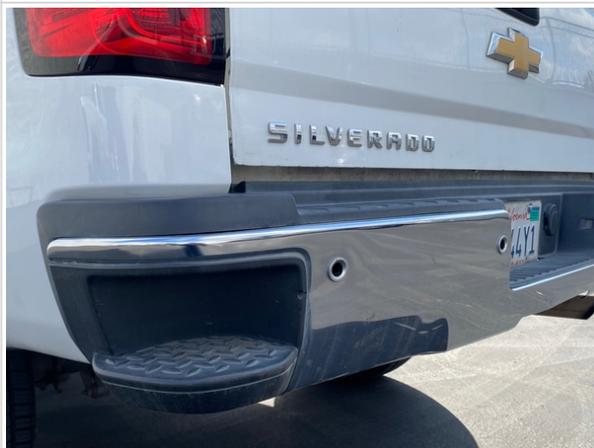
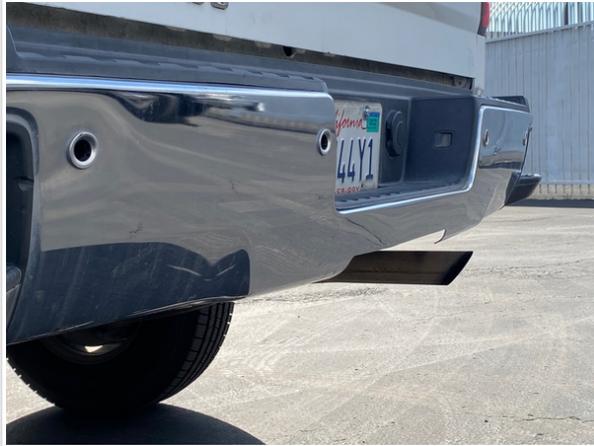
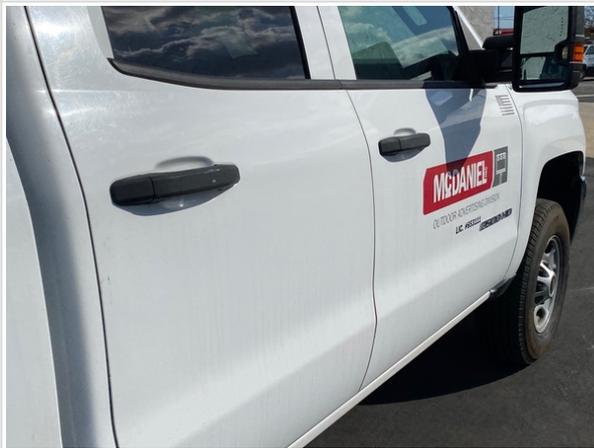
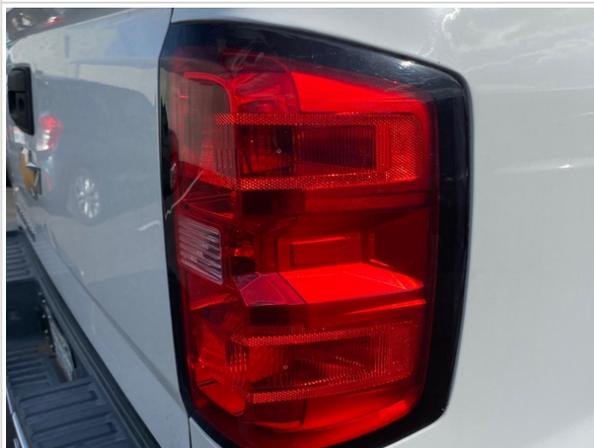
Close-up Exterior Photos

Body Panels	3 - Normal Wear & Tear
Body Panel Condition	No visible damage, good paint condition and panel fitment, Other (see comments)
Doors / Canopy Latches	3 - Normal Wear & Tear
Doors / Canopy Latches Condition	No visible damage
Steps / Ladders	0
Handrails	0
Glass	3 - Normal Wear & Tear
Glass Condition	Glass intact, no visible damage
Mirrors	3 - Normal Wear & Tear
Mirror Condition	Mirrors present and intact, no visible damage
Exterior Lights	3 - Normal Wear & Tear
Exterior Lights Condition	No visible damage, lighting system is operational

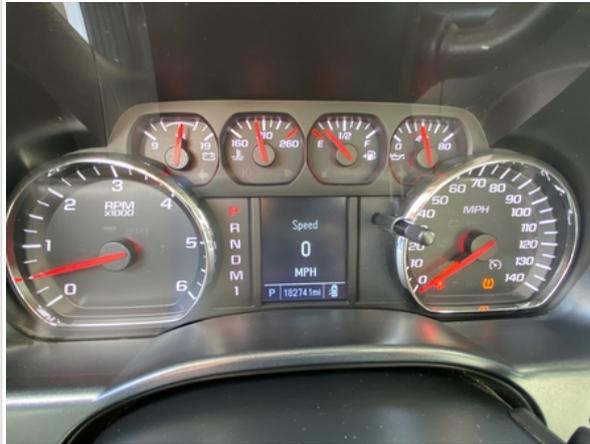
Odometer Photo

Odometer Activity	3 - Normal Wear & Tear	
Odometer Condition	Odometer is working and in good condition	
Controls/Switches/Gauges	3 - Normal Wear & Tear	
Controls/Switches/Gauges Condition	All switches/gauges are in good condition and functioning	
Brake System Type	Hydraulic	
Clutch	0	
Horn	3 - Normal Wear & Tear	
Horn Condition	Horn is functioning as expected	
Reverse Alarm / Backup Camera	0	
Heater & A/C	3 - Normal Wear & Tear	
Heat & A/C Condition	Heater and A/C work as expected	
Interior Lights	3 - Normal Wear & Tear	
Interior Lights Condition	All interior lights are installed and functioning	
Seats/Seat Belts	3 - Normal Wear & Tear	
Seats/Seat Belt Condition	Seat(s) in good condition, no stains or tears in upholstery	
Cab Interior Overall Rating	3 - Normal Wear & Tear

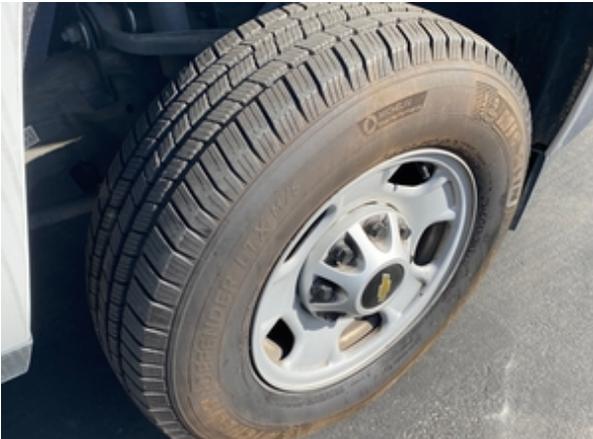
Front Right Tire Photos

Front Right Tire - Ratio Remaining	90%

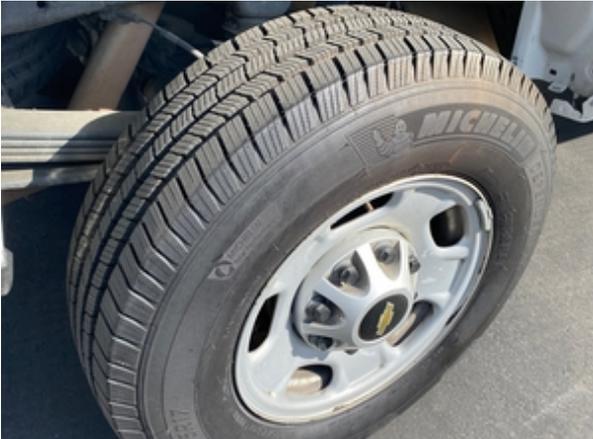
Rear Right Tire - Ratio Remaining	90%
Rear Right Tire Photos
