## Inspection Report (On-Highway Truck Cab + Chassis)

Year	2014
Make	Kenworth
Model	T800
Serial Number	1XKDDP9X2EJ404499
Truck Odometer Reading	328,968
Current Inspection / State Cert / DOT	Last Inspection Performed 11/2022
Previous Application (e.g., earth moving, mining, demolition, etc)	Rental Equipment Haul Tractor

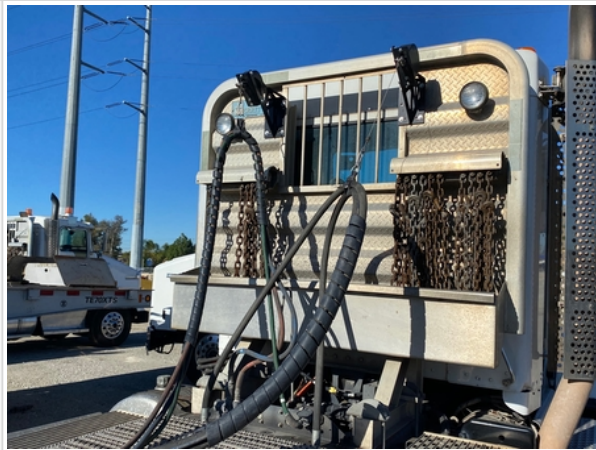
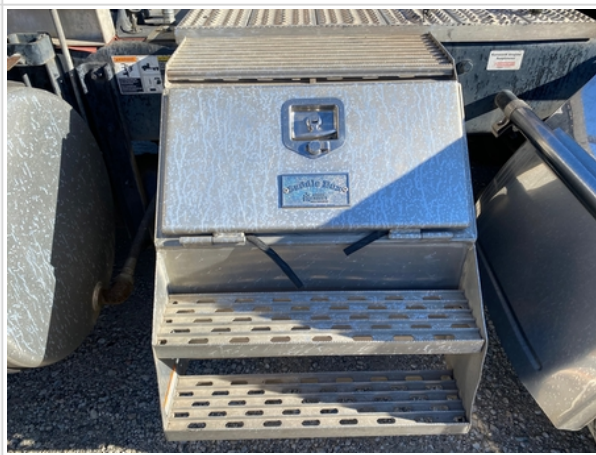
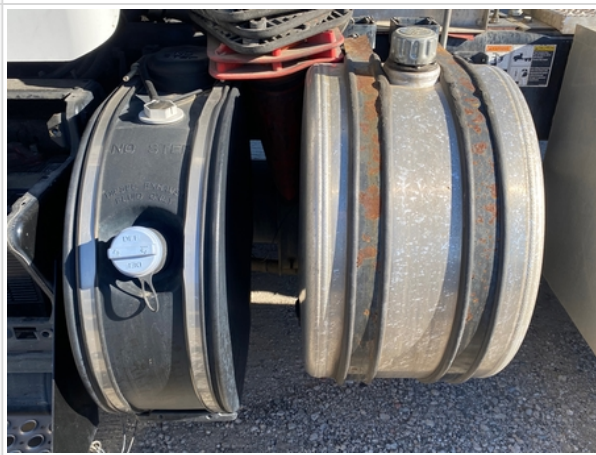
<b>Body Panels</b>	3 - Normal Wear & Tear
<b>Body Panel Condition</b>	No visible damage, good paint condition and panel fitment
<b>Doors / Canopy Latches</b>	3 - Normal Wear & Tear
<b>Doors / Canopy Latches Condition</b>	No visible damage
<b>Steps / Ladders</b>	3 - Normal Wear & Tear
<b>Steps / Ladders Condition</b>	Steps/ladders are fully intact and appear structurally sound
<b>Handrails</b>	3 - Normal Wear & Tear

Handrails Condition	Handrails are fully intact and appear structurally sound
Glass	3 - Normal Wear & Tear
Glass Condition	Glass intact, no visible damage
Mirrors	3 - Normal Wear & Tear
Mirror Condition	Mirrors present and intact, no visible damage
Exterior Lights	3 - Normal Wear & Tear
Exterior Lights Condition	No visible damage, lighting system is operational

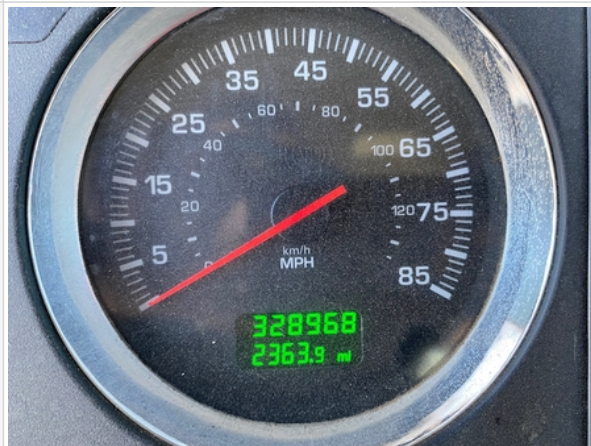
Odometer Photo

<b>Odometer Activity</b>	3 - Normal Wear & Tear
<b>Odometer Condition</b>	Odometer is working and in good condition
<b>Controls/Switches/Gauges</b>	3 - Normal Wear & Tear
<b>Controls/Switches/Gauges Condition</b>	All switches/gauges are in good condition and functioning
<b>Brake System Type</b>	Air Brakes
<b>Air Brakes Build Correct Pressure</b>	Yes
<b>Clutch</b>	3 - Normal Wear & Tear
<b>Clutch Function</b>	Clutch is functioning as expected
<b>Horn</b>	3 - Normal Wear & Tear
<b>Horn Condition</b>	Horn is functioning as expected
<b>Reverse Alarm / Backup Camera</b>	3 - Normal Wear & Tear
<b>Reverse Alarm / Backup Camera Condition</b>	Reverse alarm working as expected
<b>Heater &amp; A/C</b>	3 - Normal Wear & Tear
<b>Heat &amp; A/C Condition</b>	Heater and A/C work as expected
<b>Interior Lights</b>	3 - Normal Wear & Tear

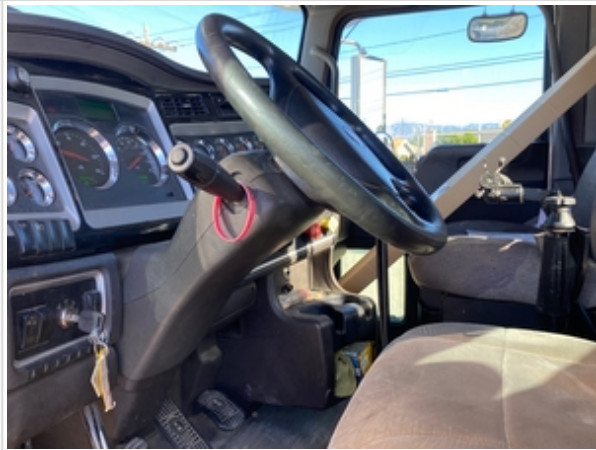
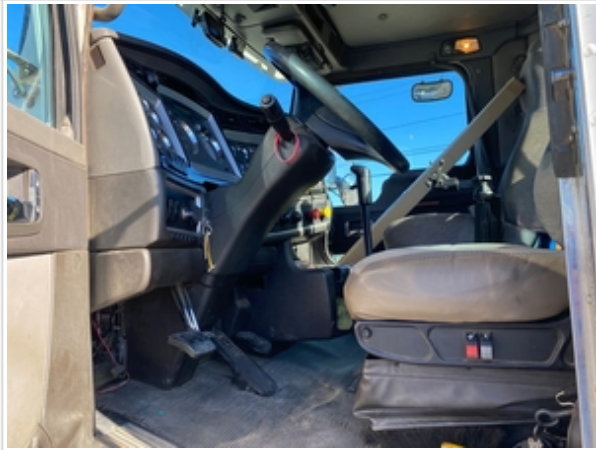
Interior Lights Condition	All interior lights are installed and functioning
Seats/Seat Belts	3 - Normal Wear & Tear
Seats/Seat Belt Condition	Seat(s) have minor surface staining or small tears, Seat belt secures properly
Cab Interior Overall Rating	3 - Normal Wear & Tear

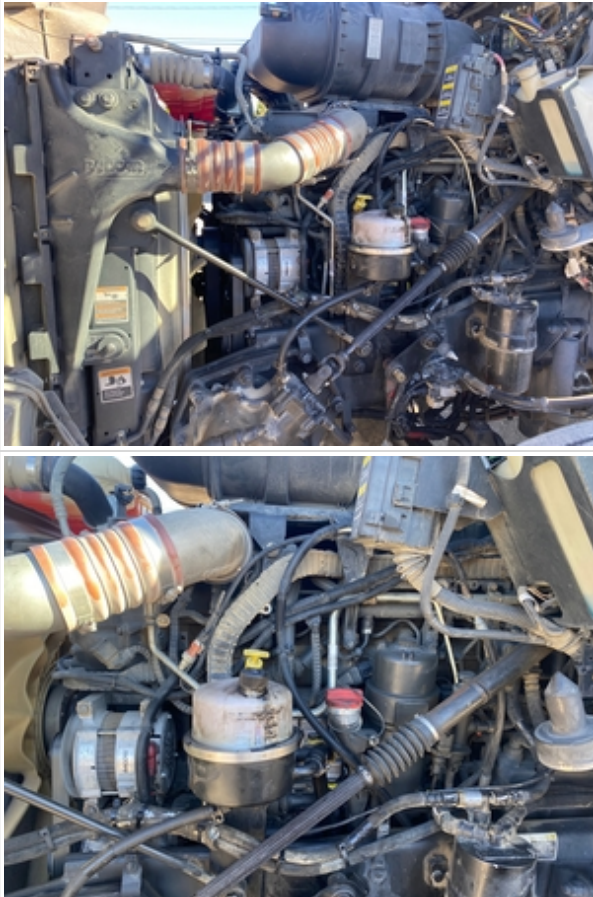
Engine Type (Make, Model, Cylinders, Hp)	PACCAR MX13 - 430HP - 6 Cyl. - 12.9L
Emissions Tier	Tier 4F
Engine Serial Number	Y030134
Engine Fuel Type	Diesel
Engine Photos

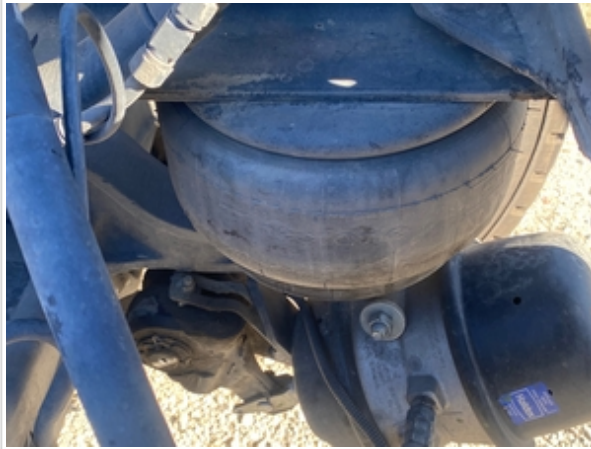
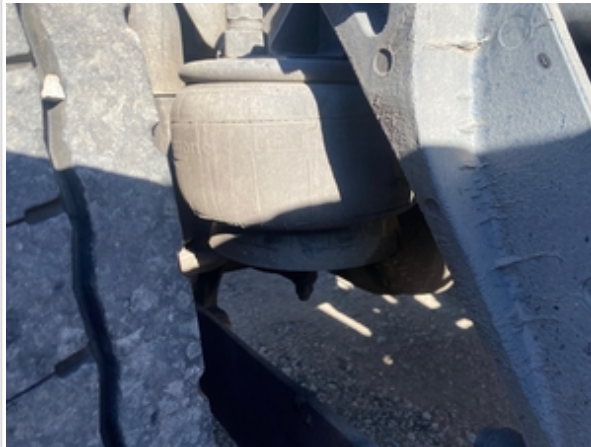
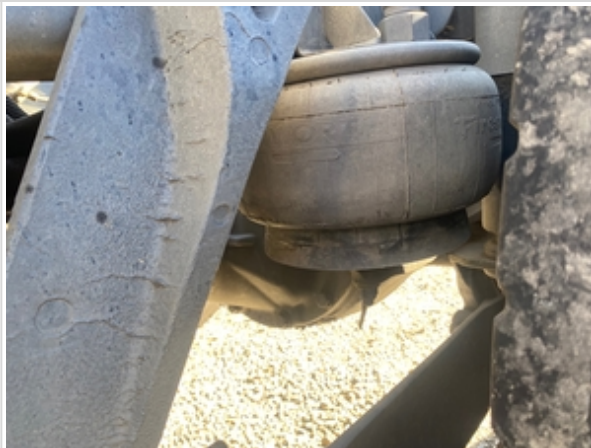
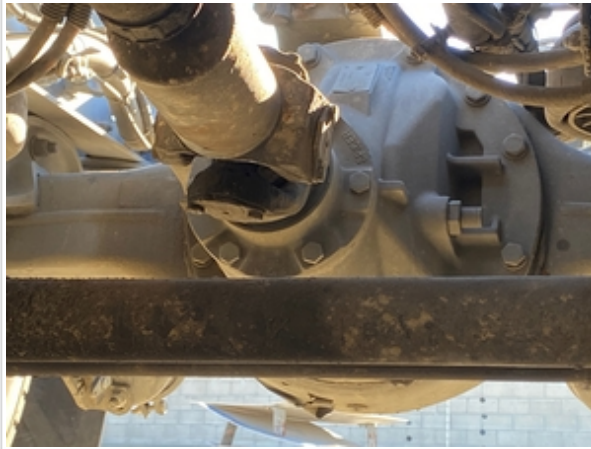
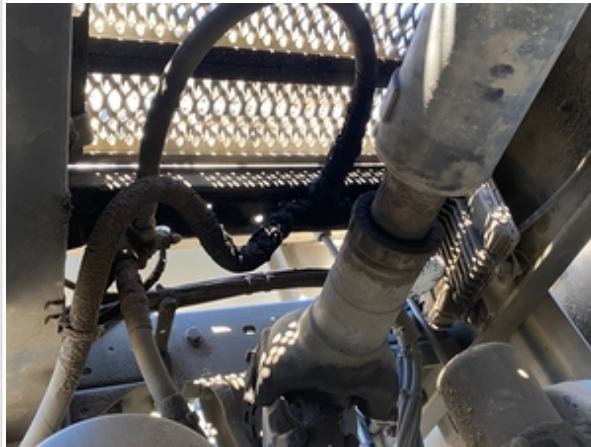
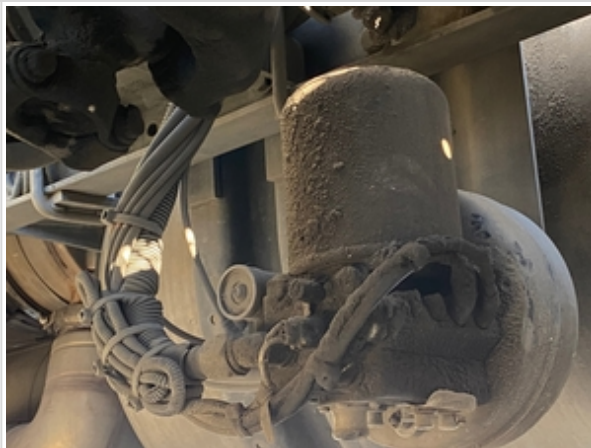
Chassis Inspection Points	Take photos of all undercarriage and chassis components including frame, suspension, axles, steering, and brake components. Note any damage or wear.	
Chassis & Undercarriage Photos

<b>Frame</b>	3 - Normal Wear & Tear	
<b>Suspension</b>	3 - Normal Wear & Tear	
<b>Steer Axle Condition</b>	3 - Normal Wear & Tear	
<b>Steering Components</b>	3 - Normal Wear & Tear	
<b>Overall Chassis Condition</b>	3 - Normal Wear & Tear	
<b>Overall Chassis Comments</b>	Overall chassis intact with some suspension showing signs of a possible issue. Front of tractor slightly leaning on the front right side and may be due to suspension and or leaf springs worn.
