Inspection Report (On-Highway Service Truck)

Year	2016
Make	Freightliner
Model	M2
Serial Number	3ALACXCYOGDHF7409
Truck Odometer Reading	11,925 Miles
Current Inspection / State Cert / DOT	N/A
Previous Application (e.g., earth moving, mining, demolition, etc)	Masonry General Construction

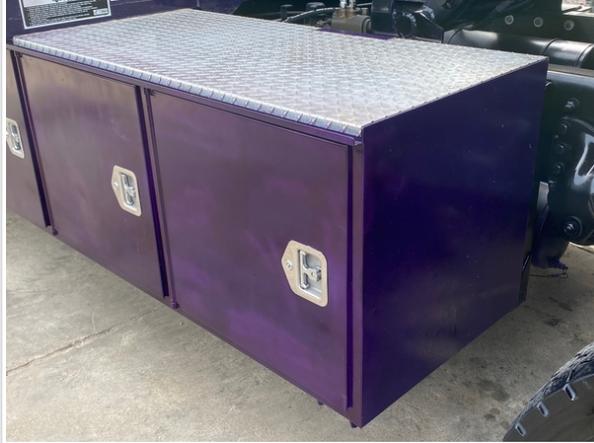
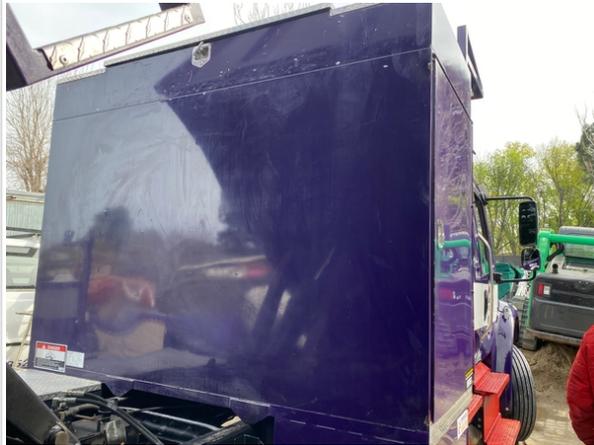
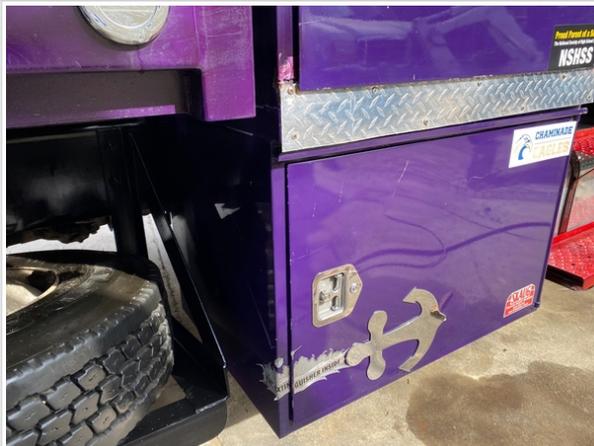
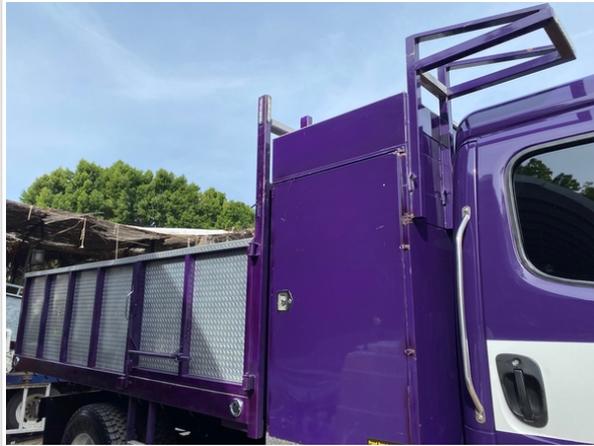
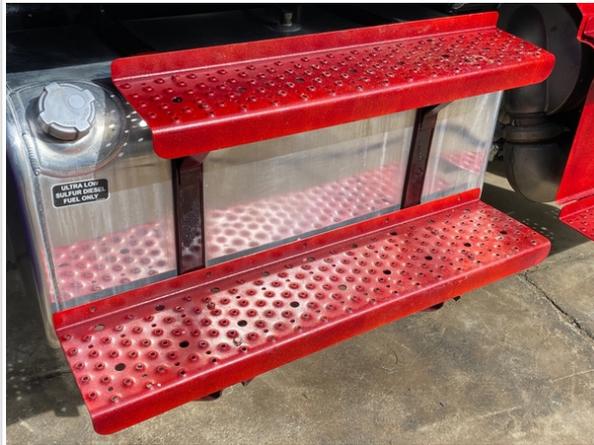
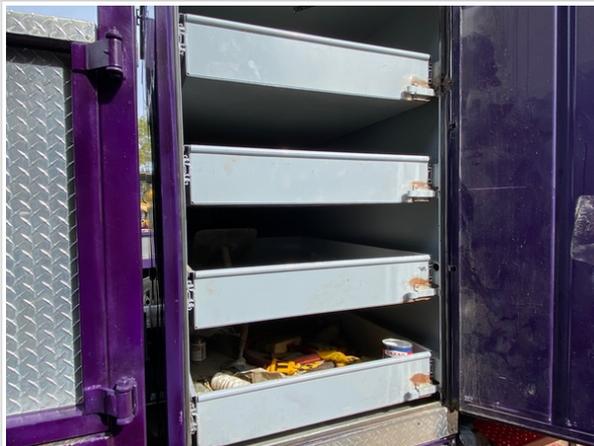
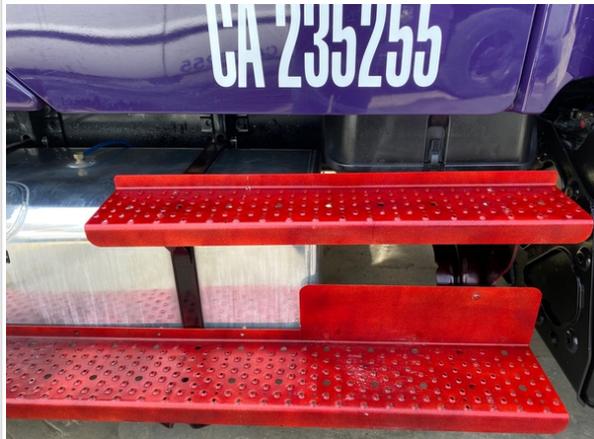
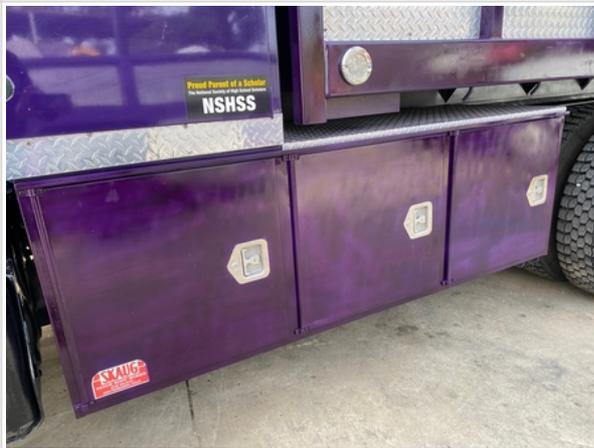
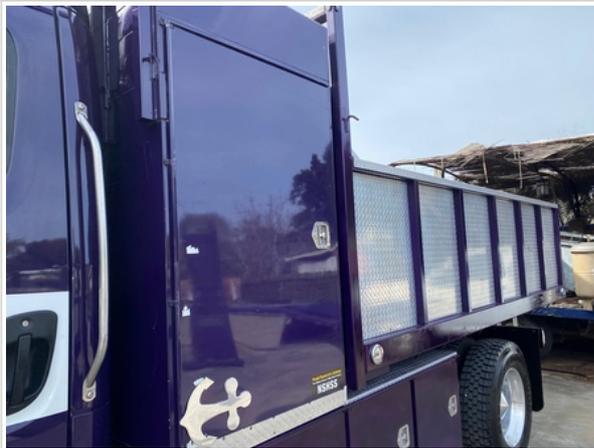
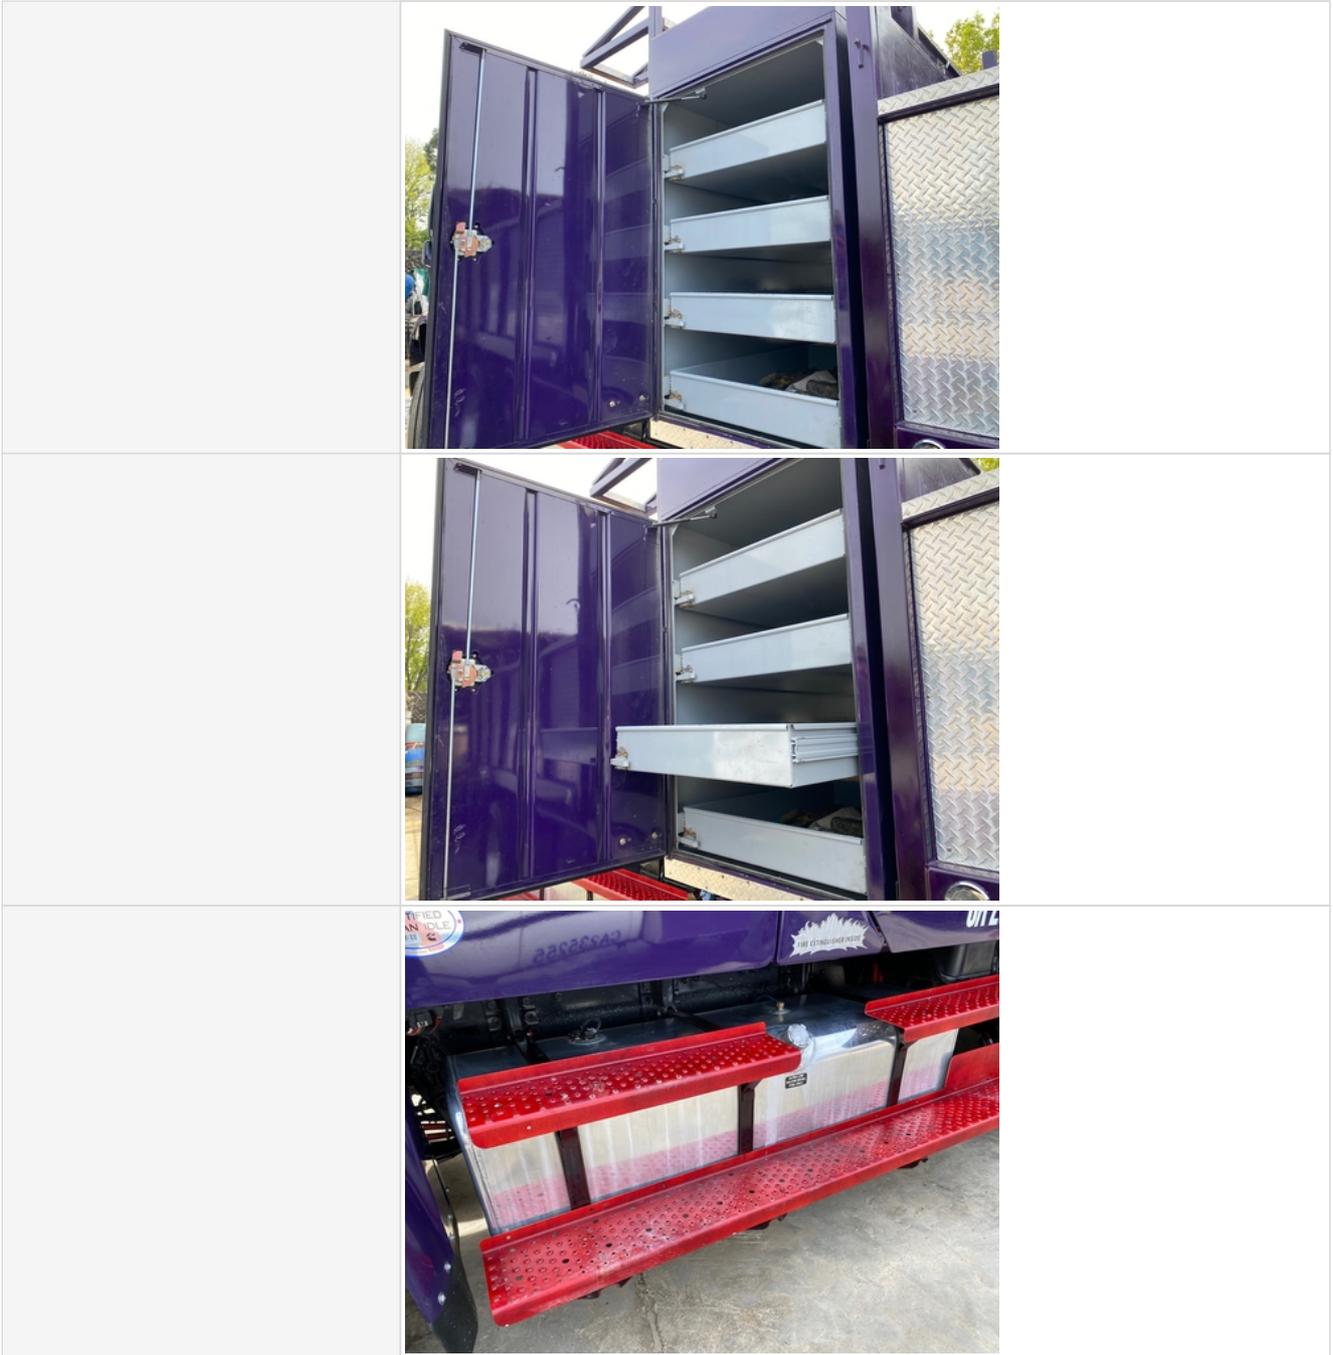
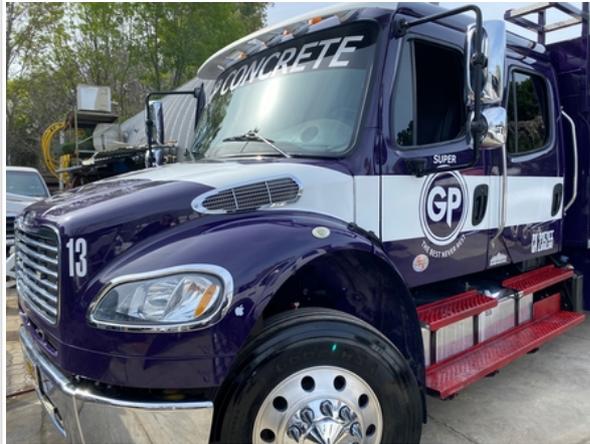
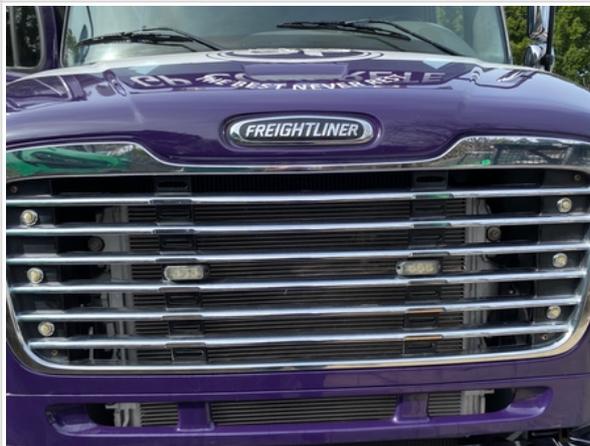
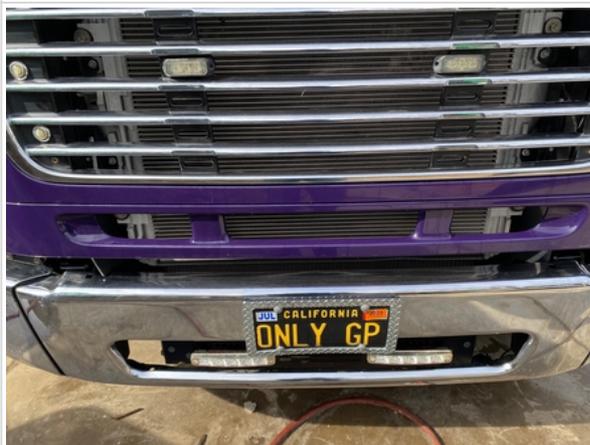
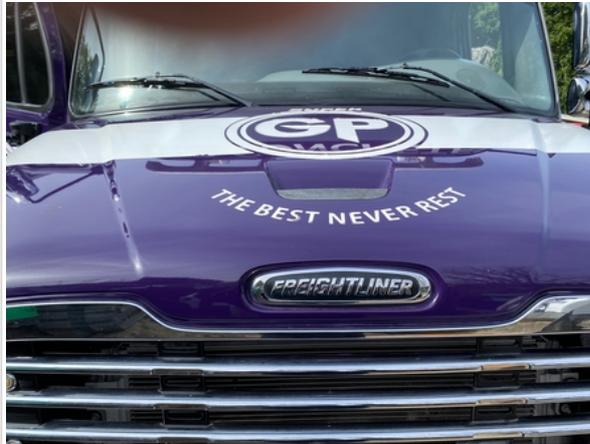
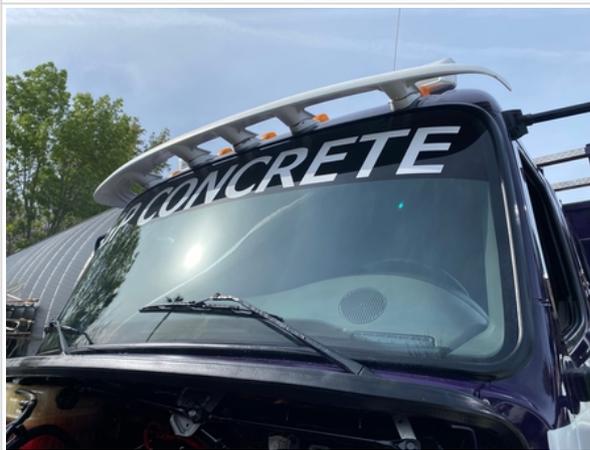
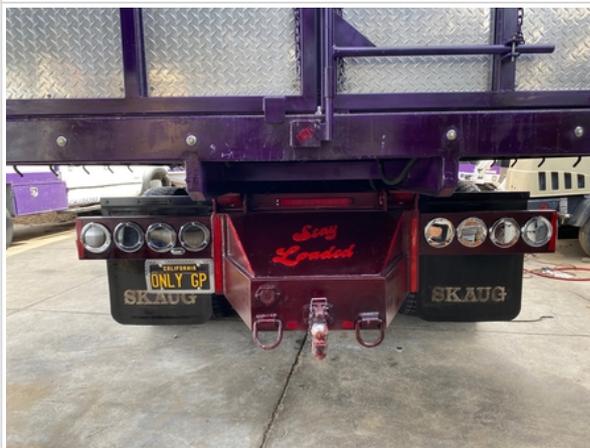
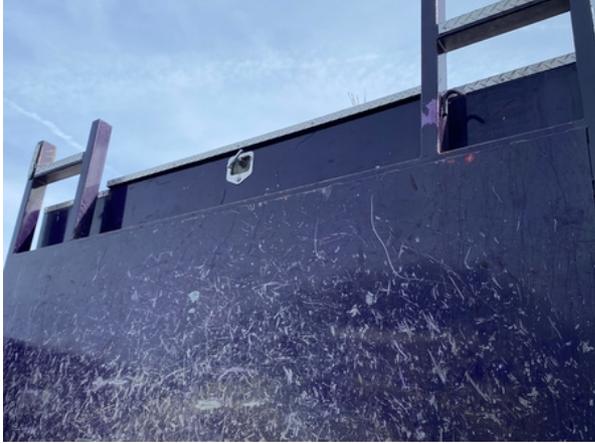
Close-up Exterior Photos

Body Panels	3 - Normal Wear & Tear
Body Panel Condition	No visible damage, good paint condition and panel fitment
Doors / Canopy Latches	3 - Normal Wear & Tear
Doors / Canopy Latches Condition	No visible damage
Steps / Ladders	3 - Normal Wear & Tear
Steps / Ladders Condition	Steps/ladders are fully intact and appear structurally sound
Handrails	3 - Normal Wear & Tear
Handrails Condition	Handrails are fully intact and appear structurally sound
Glass	3 - Normal Wear & Tear
Glass Condition	Glass intact, no visible damage
Mirrors	3 - Normal Wear & Tear
Mirror Condition	Mirrors present and intact, no visible damage
Exterior Lights	3 - Normal Wear & Tear
Exterior Lights Condition	No visible damage, lighting system is operational

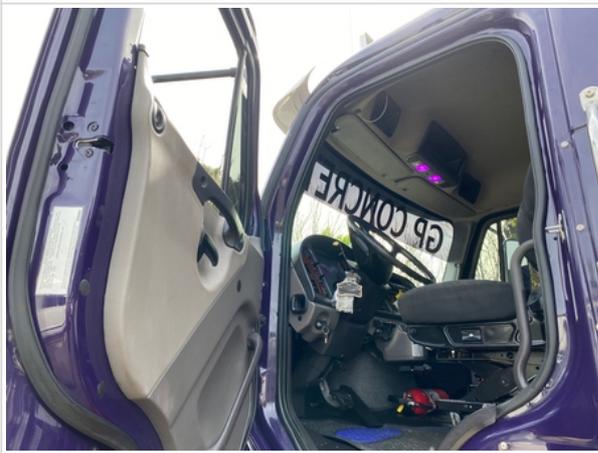
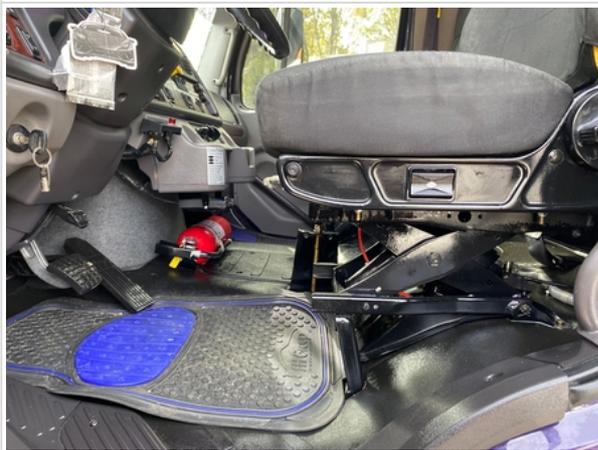
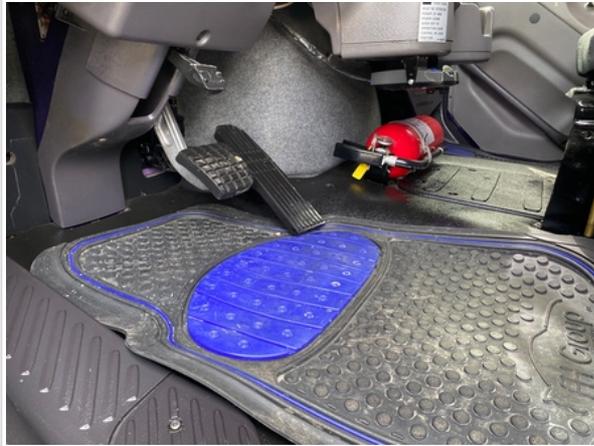
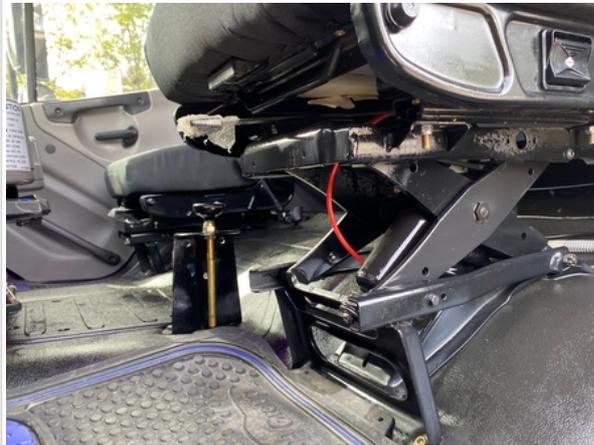
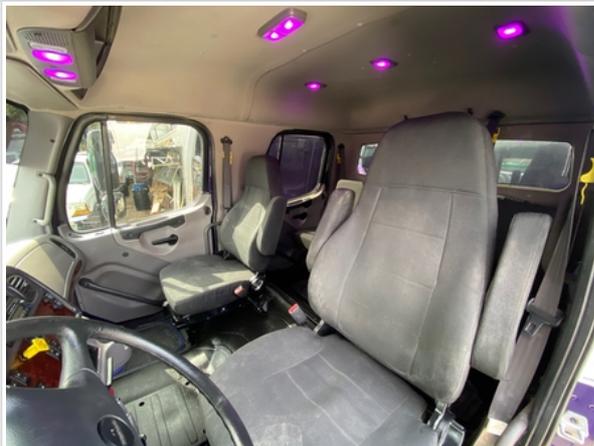
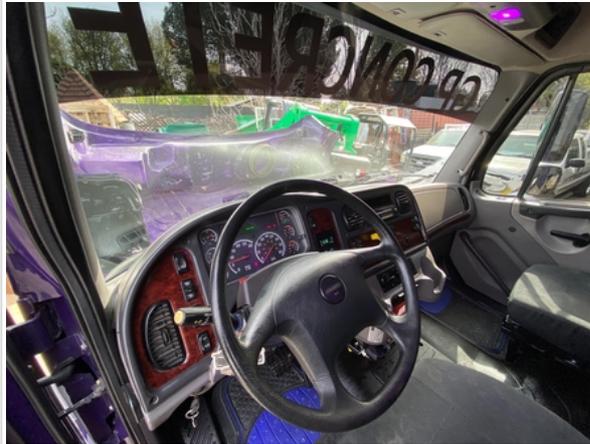
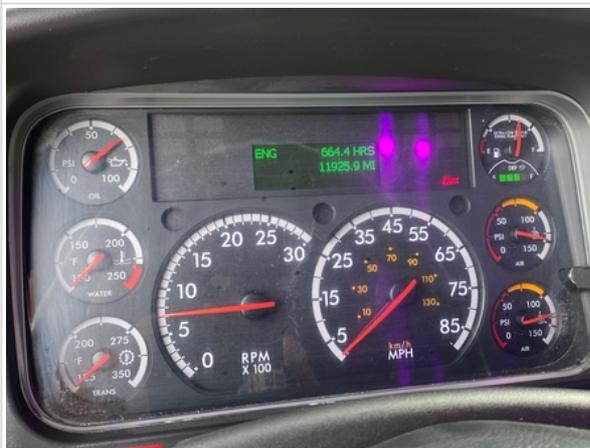
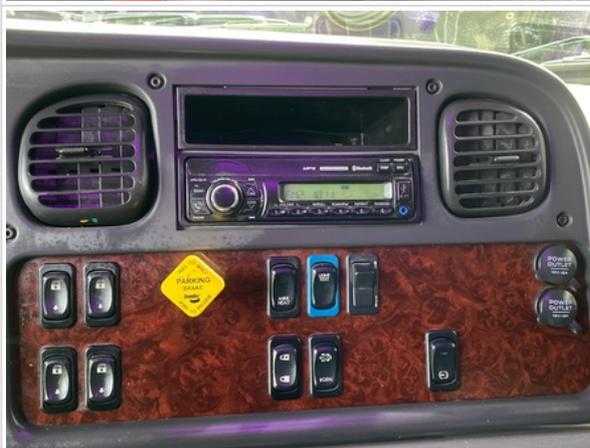
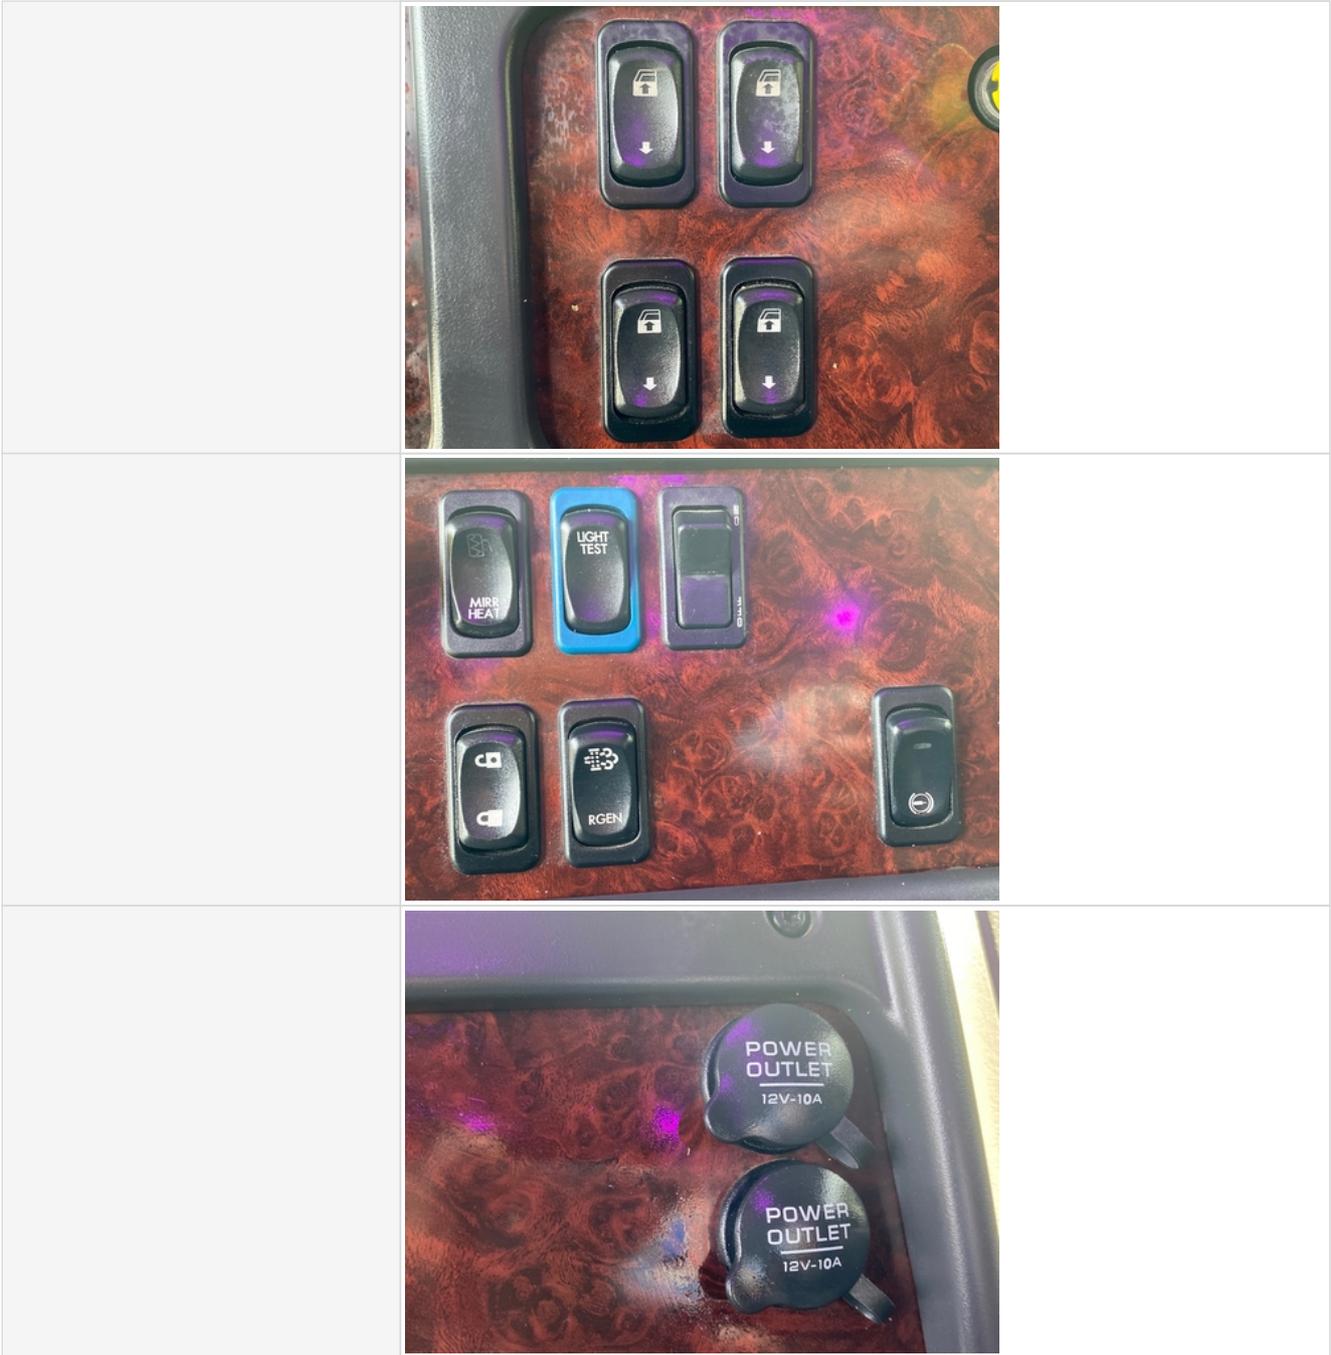
Seats/Seat Belts	3 - Normal Wear & Tear
Seats/Seat Belt Condition	Seat(s) in good condition, no stains or tears in upholstery, Seat belt secures properly
Cab Interior Overall Rating	3 - Normal Wear & Tear

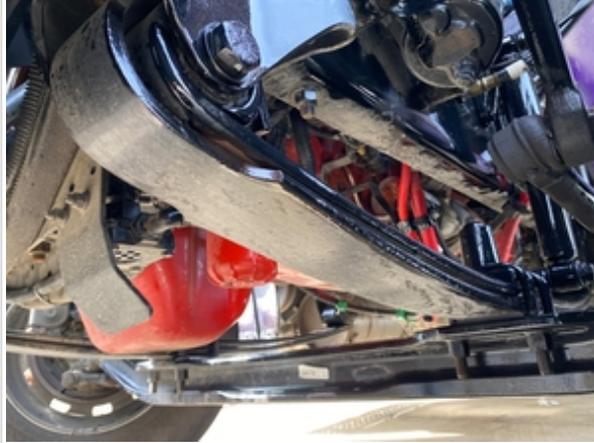
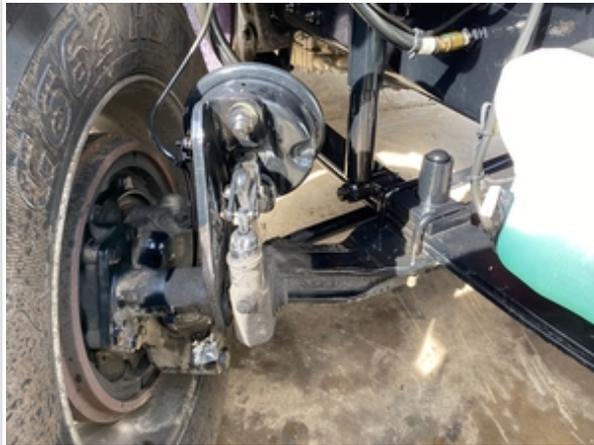
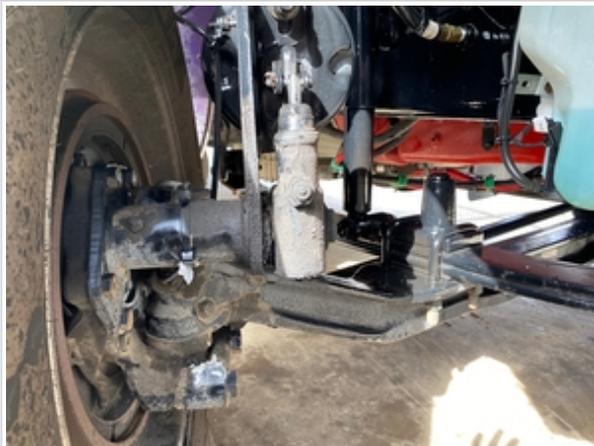
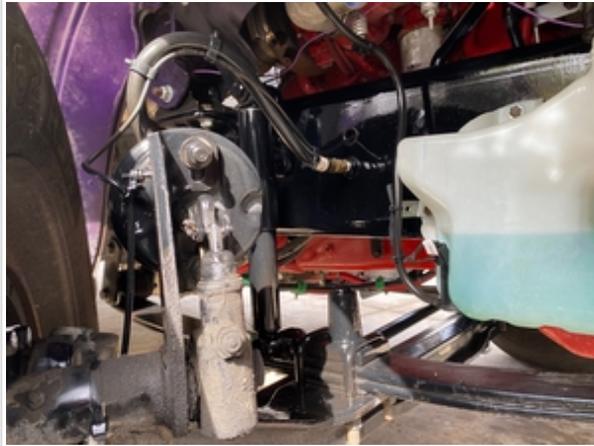
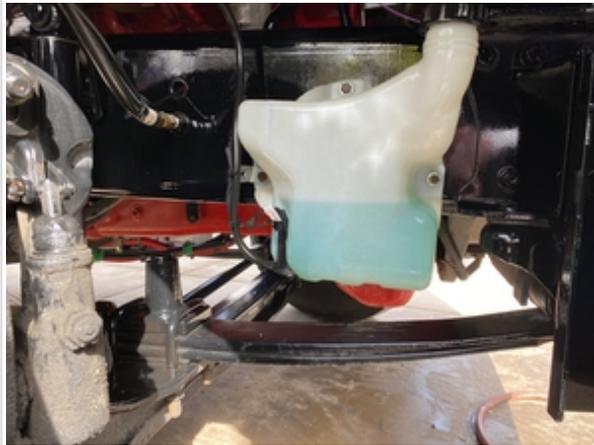
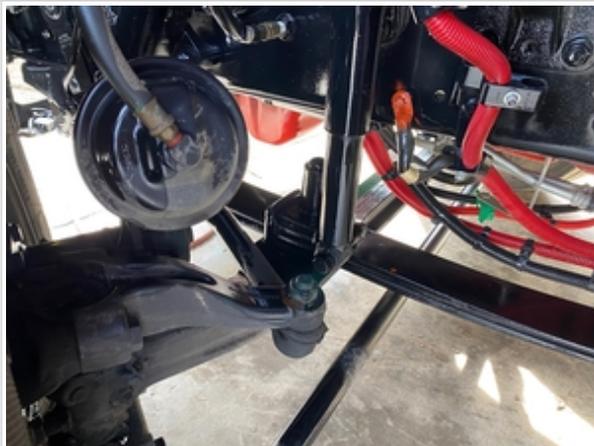
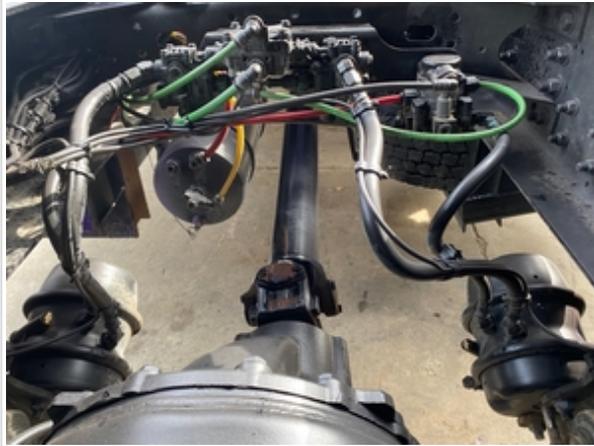
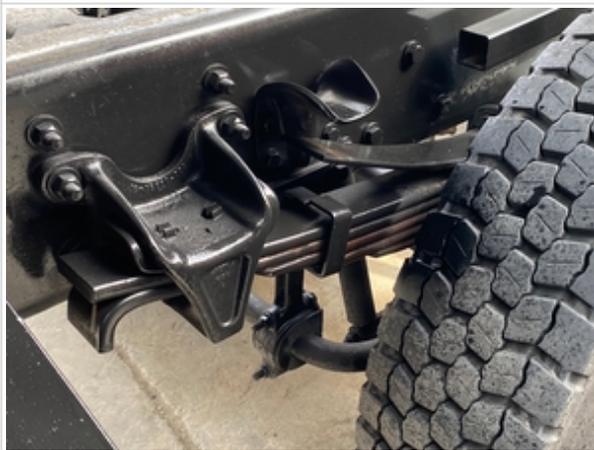
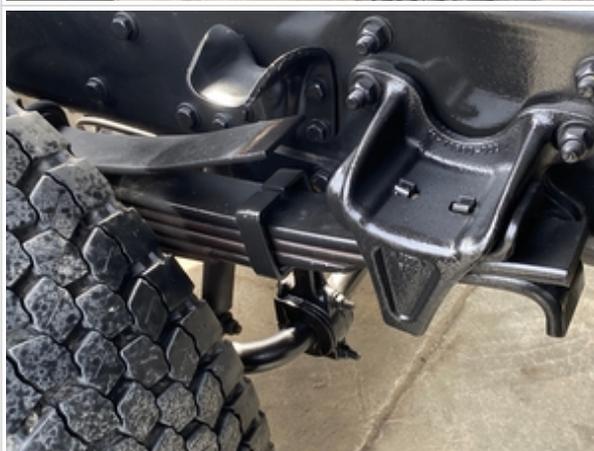
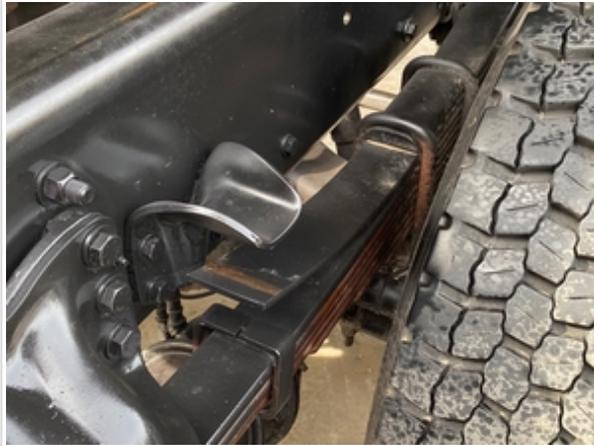
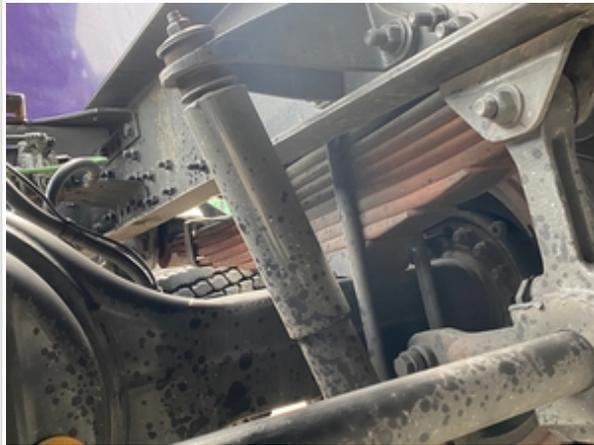
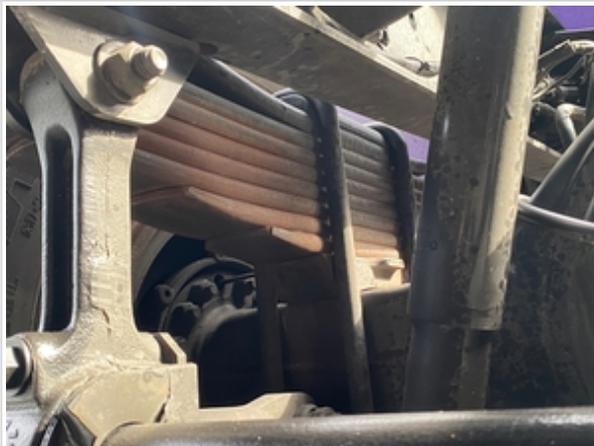
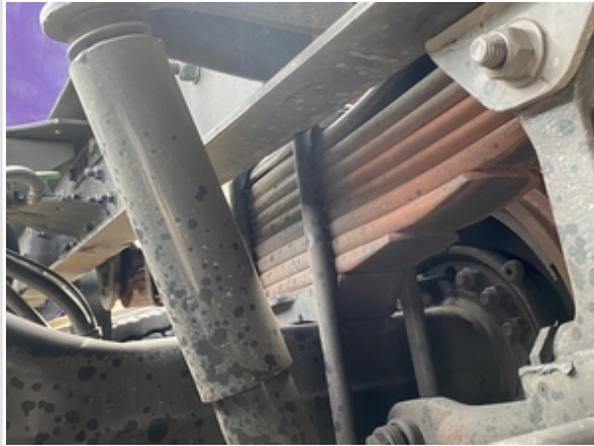
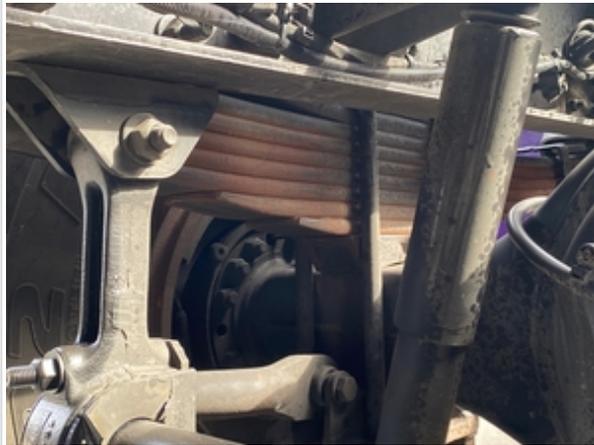
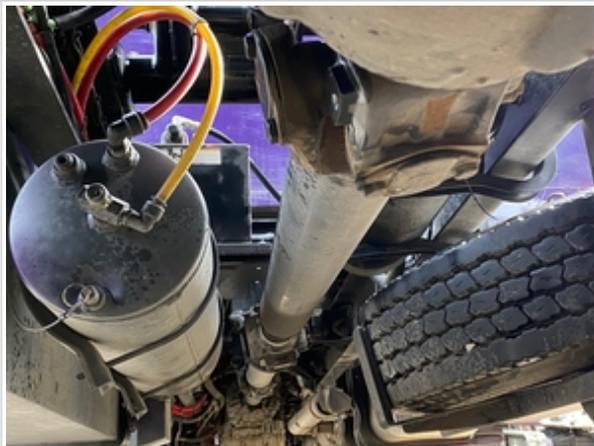
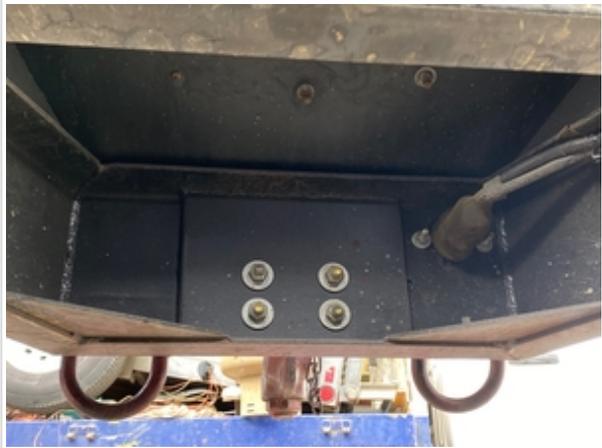
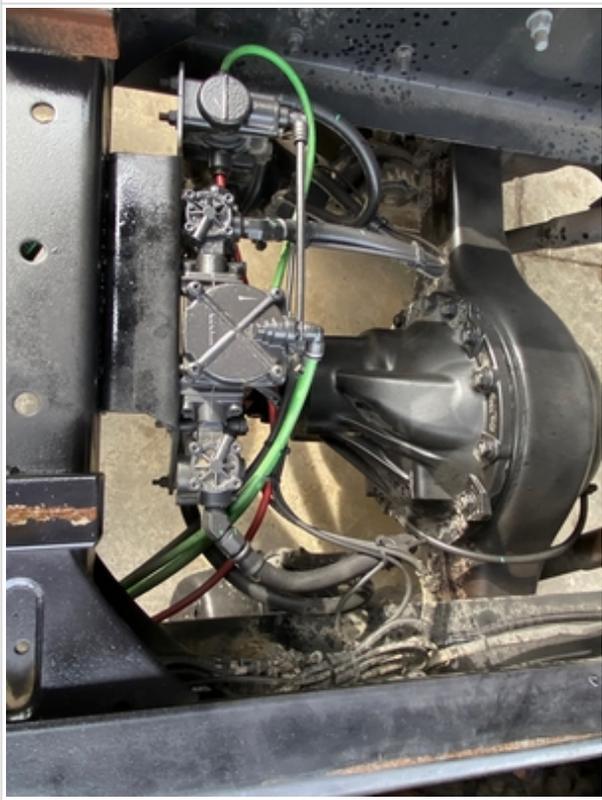
Chassis & Undercarriage Photos

Frame	3 - Normal Wear & Tear	
Suspension	3 - Normal Wear & Tear	
Steer Axle Condition	3 - Normal Wear & Tear	
Steering Components	3 - Normal Wear & Tear	
Overall Chassis Condition	3 - Normal Wear & Tear	
Overall Chassis Comments	Overall chassis in solid shape and all components look to be in low use condition. No problems seen with Chassis due the inspection.

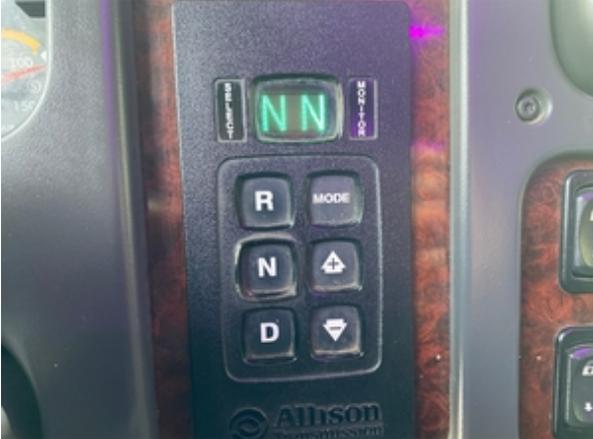
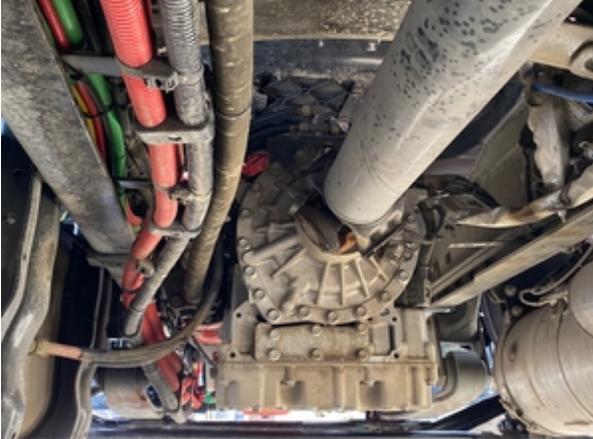
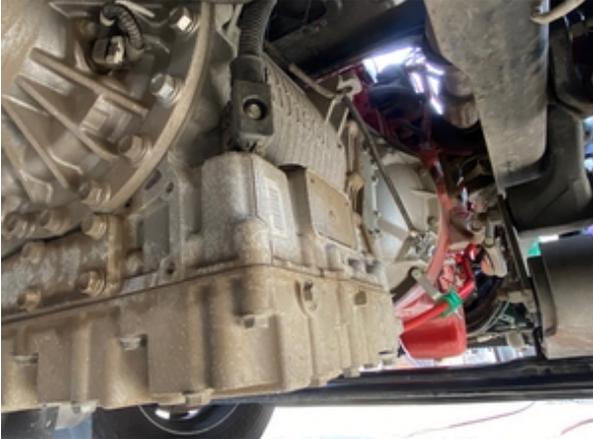
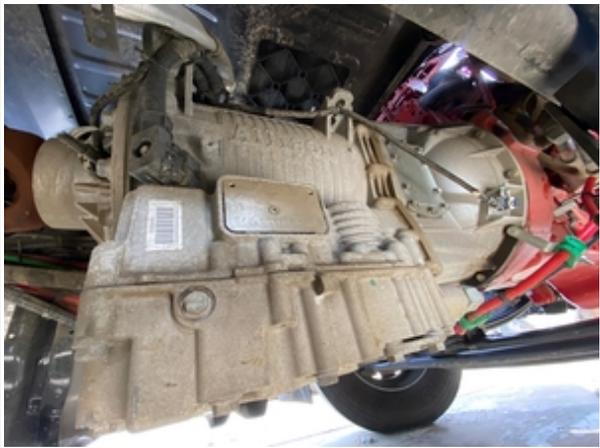
Transmission Condition	No unusual noises or vibrations
Transmission Condition Photos

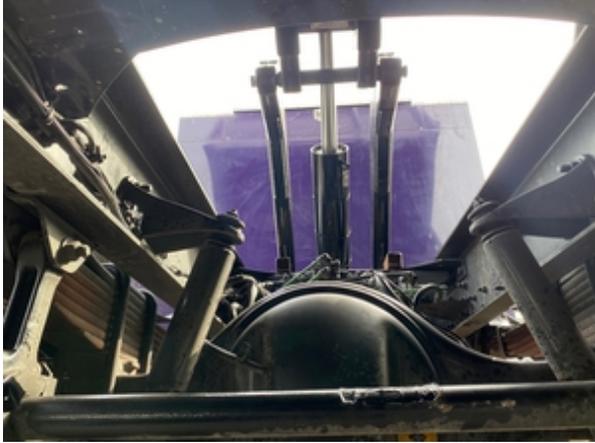
PTO	3 - Normal Wear & Tear	
Differential	Check condition of the differential(s). Take photos and notes as relevant.	
Rear Differential	3 - Normal Wear & Tear	
Rear Differential Condition	Dry housing appearance, no unusual noises heard during operation	
Rear Differential Photos

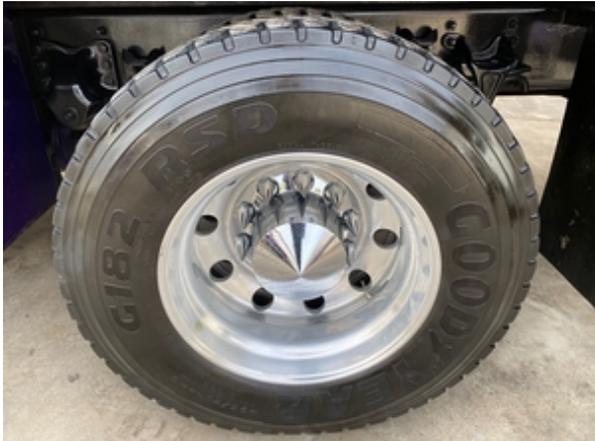
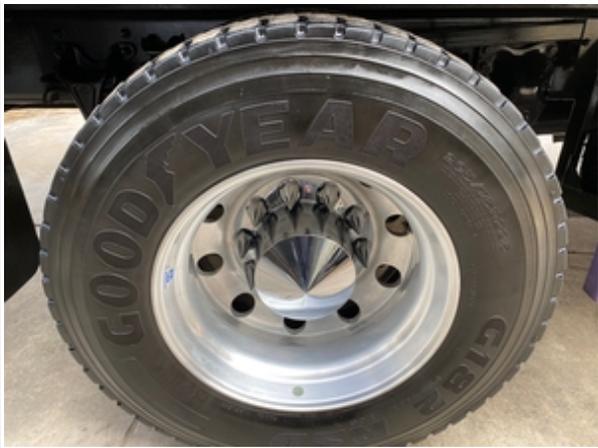
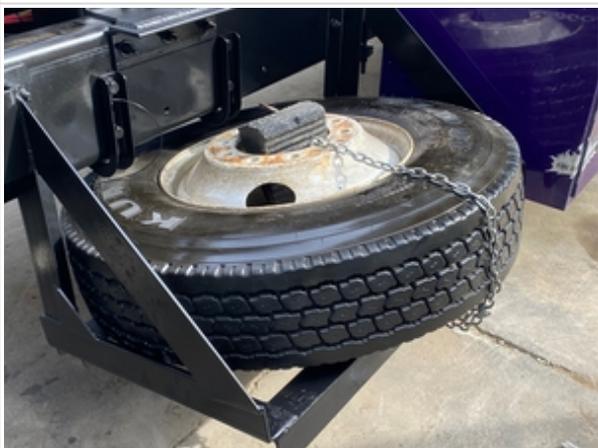
Wheels & Hub Condition	3
Wheels & Hub Photos

Wheel Seal Leaks	No	
Tire Brand	Goodyear	
Tire Size	295/75R/22.5	
Front Left Tire - Ratio Remaining	70%	
Front Left Tire Photos

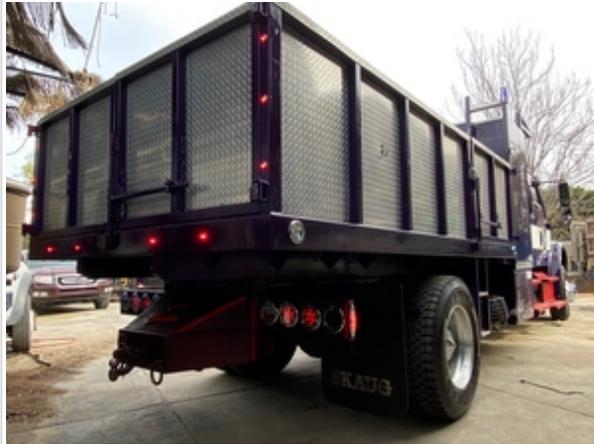
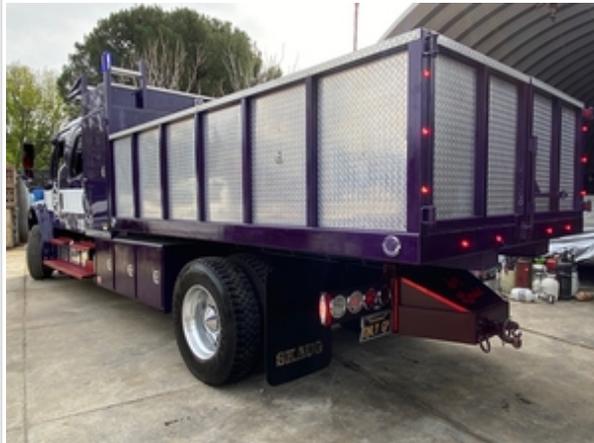
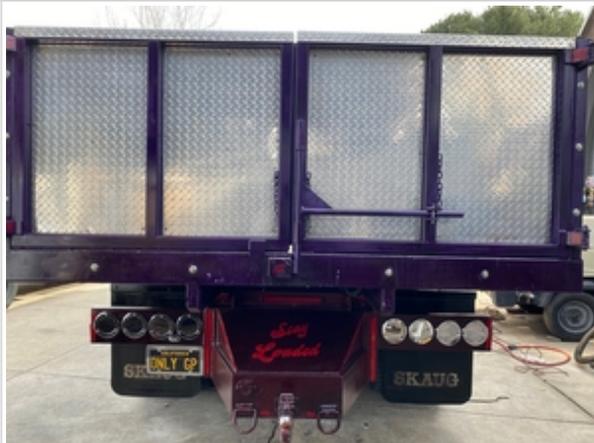
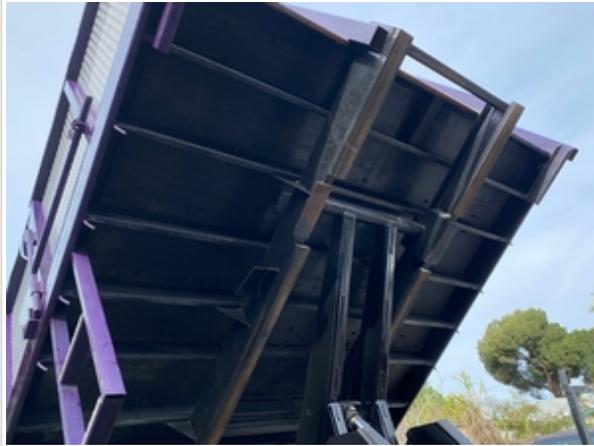
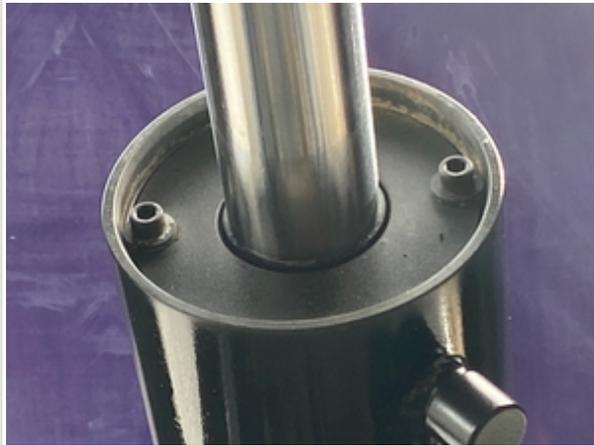
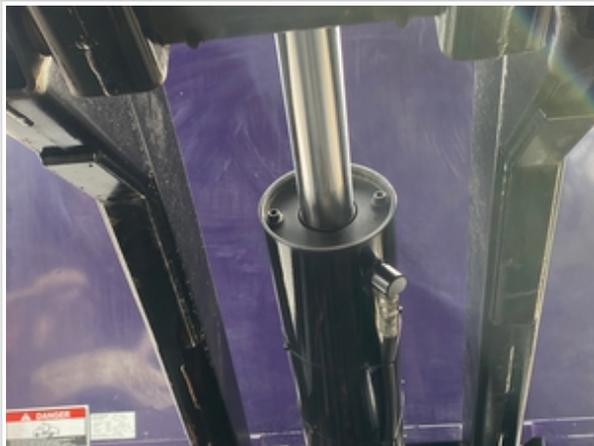
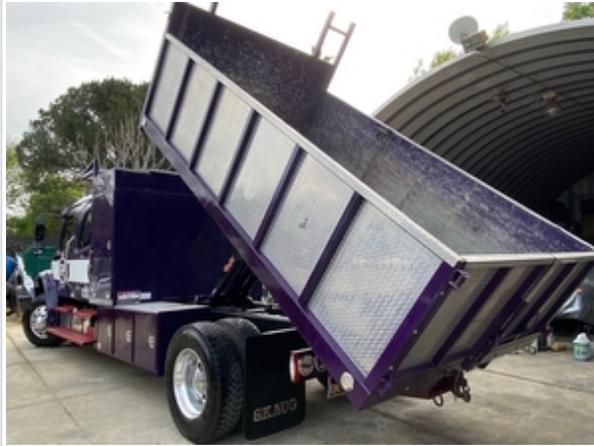
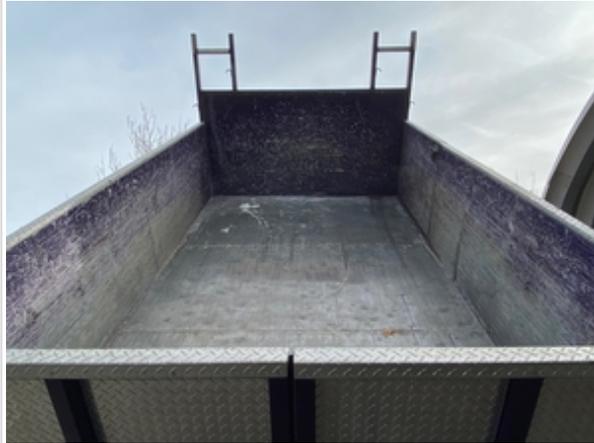
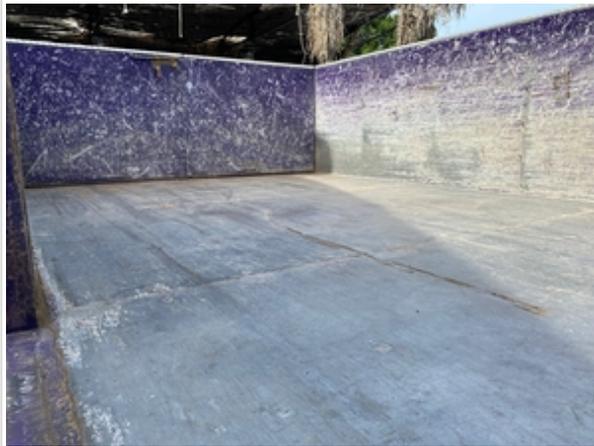
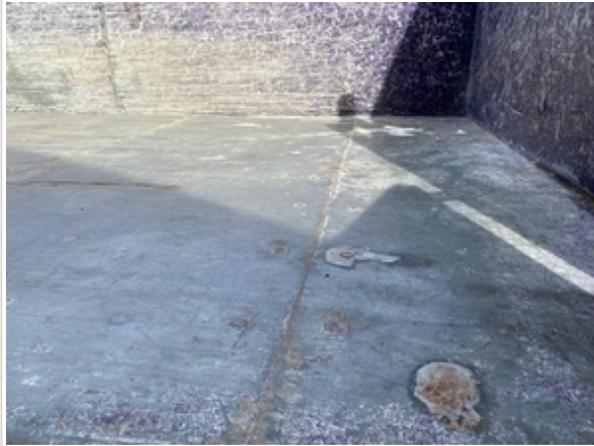
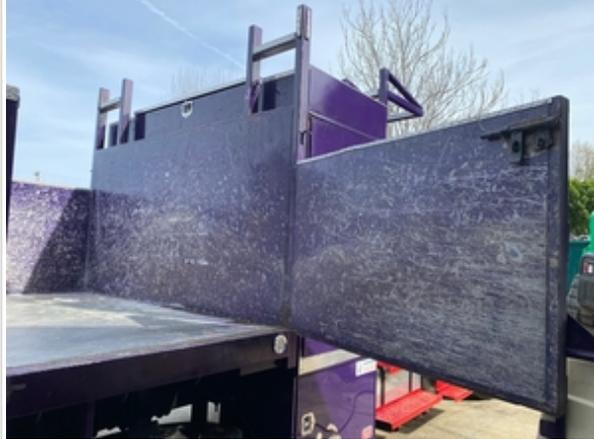
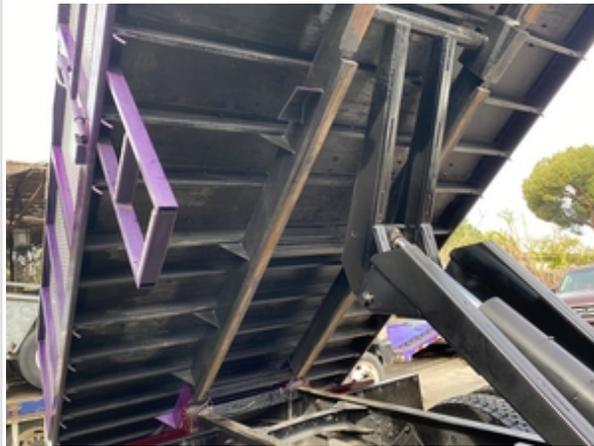
Bed Body Photos

Tool Truck Body	Check the condition of the tool truck bed body, tool boxes (interior and exterior), and lift gate (if equipped).
Bed Body	3
Comments	Bed body 13'Lx8'Wx3'6"H (7'3" Dump Height)
