Inspection Report (On-Highway Service Truck)

Year	2016
Make	Freightliner
Model	M2
Serial Number	3ALACXCYOGDHF7409
Truck Odometer Reading	11,925 Miles
Current Inspection / State Cert / DOT	N/A
Previous Application (e.g., earth moving, mining, demolition, etc)	Masonry General Construction

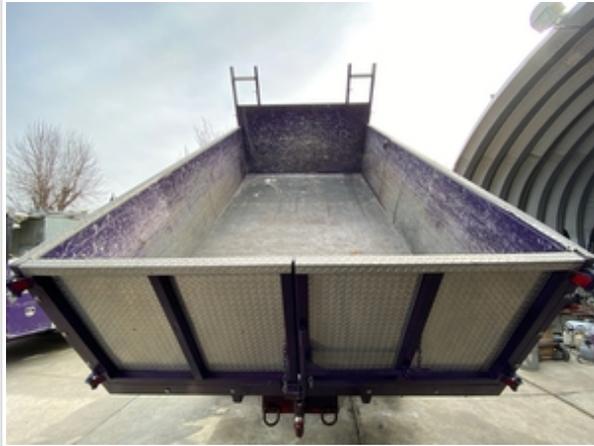
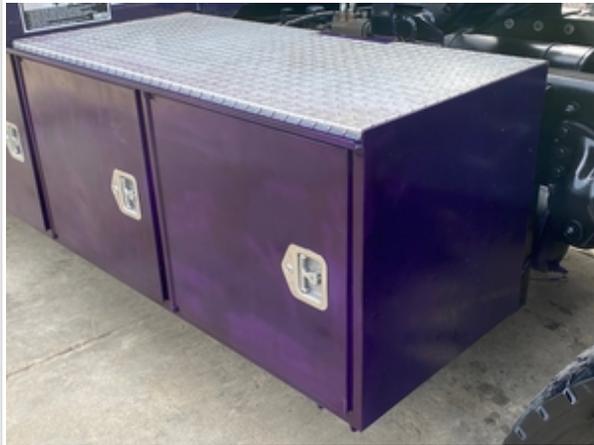
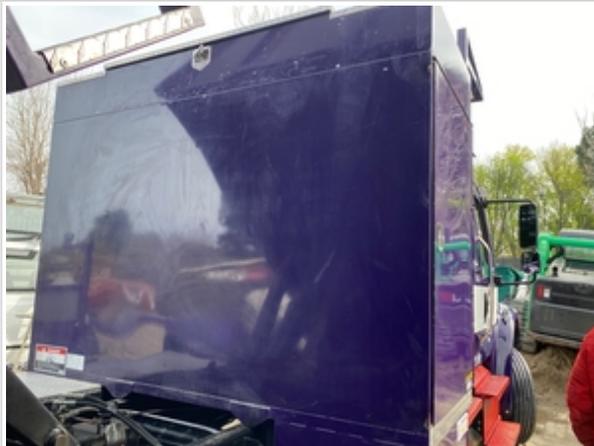
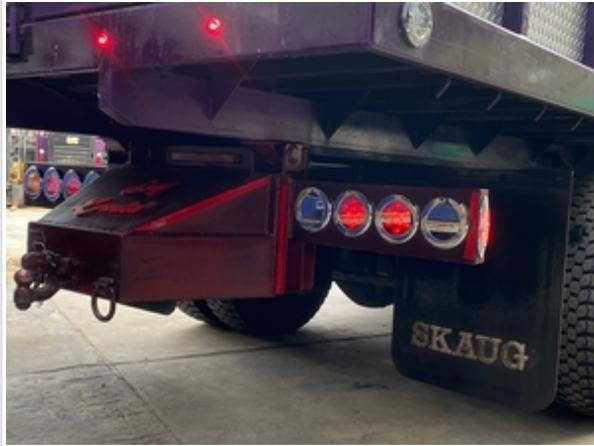
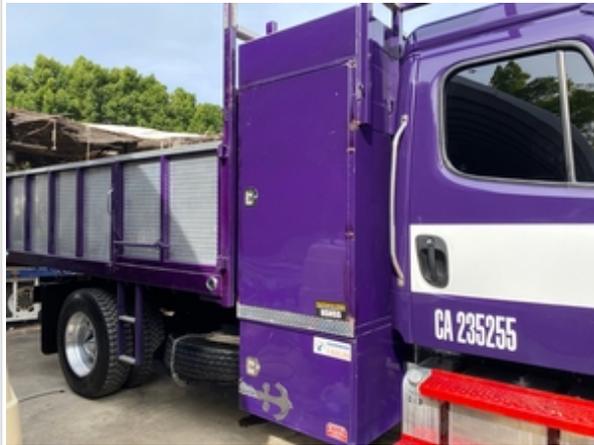
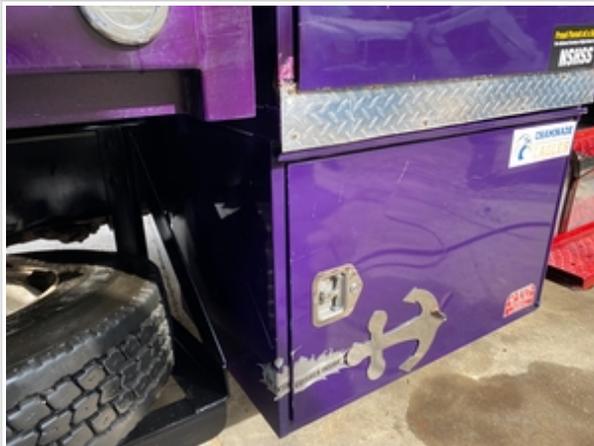
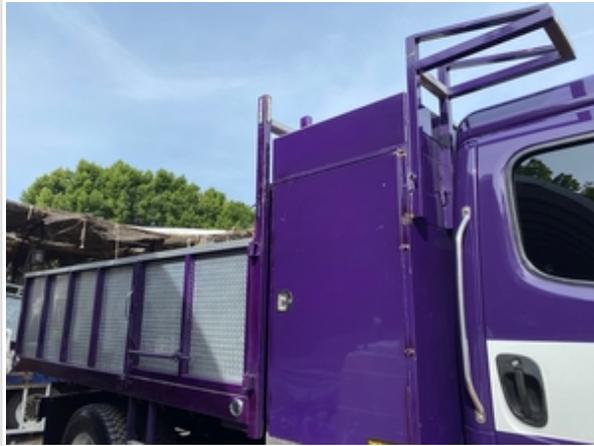
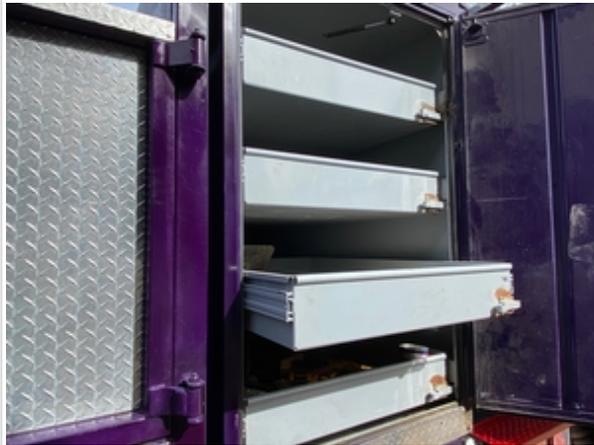
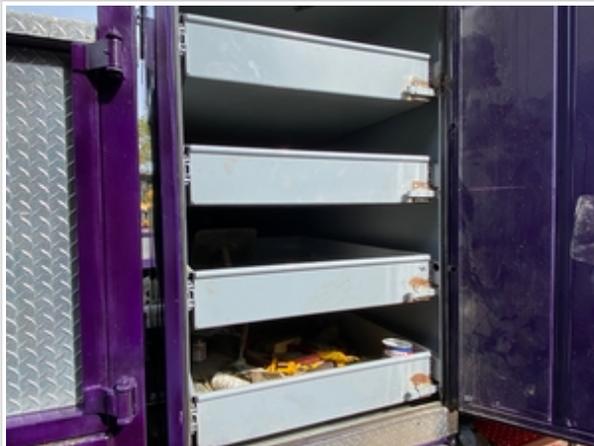
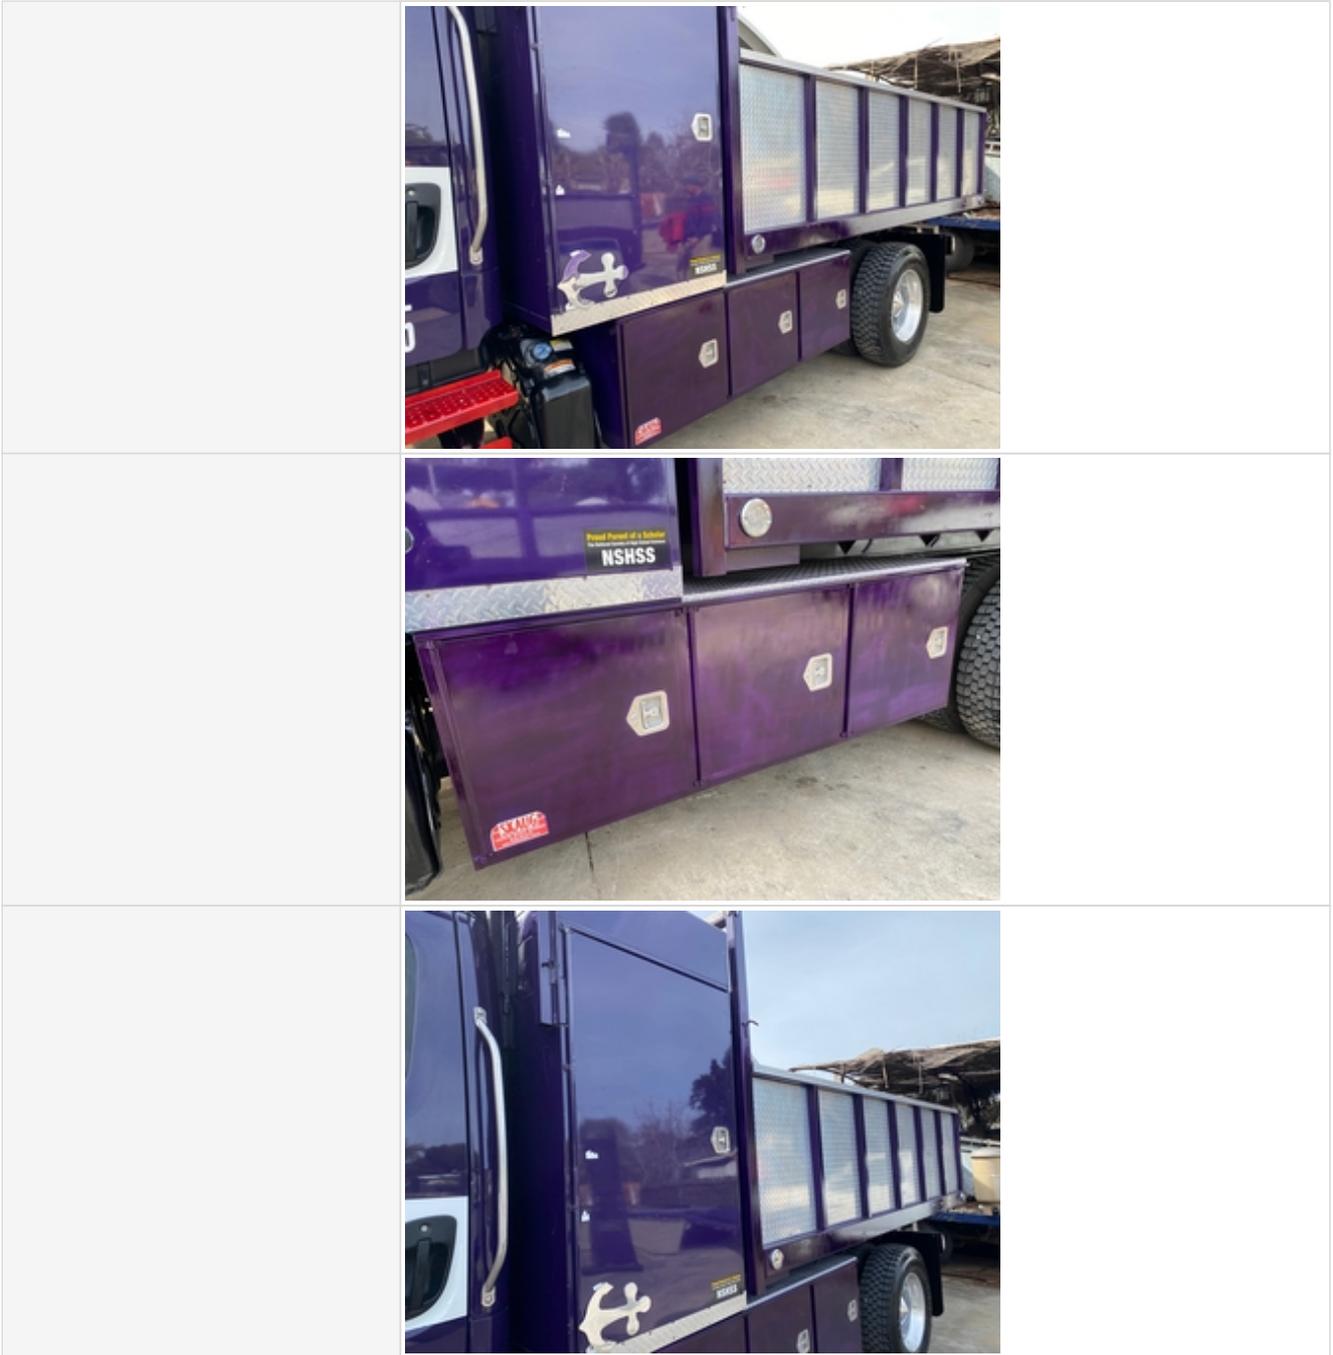
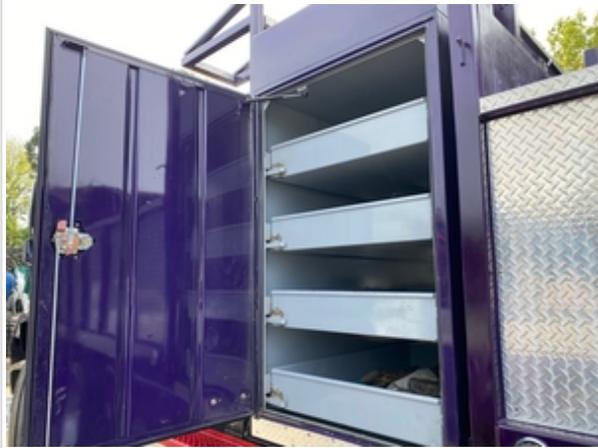
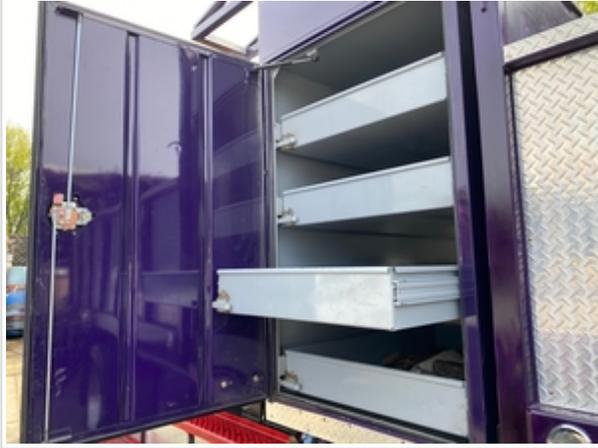
Tool Truck Body	Check the condition of the tool truck bed body, tool boxes (interior and exterior), and lift gate (if equipped).
Bed Body	3
Comments	Bed body 13'Lx8'Wx3'6"H (7'3" Dump Height)

Toolboxes	3
Liftgate Function	0
