Inspection Report (Excavator)

Year	2013
Make	CAT
Model	320E
Serial Number	*CATO320ELTFX00642*
Hour Meter Reading	3,680 Hrs.
Previous Application (e.g., earth moving, mining, demolition, etc)	Masonry General Construction

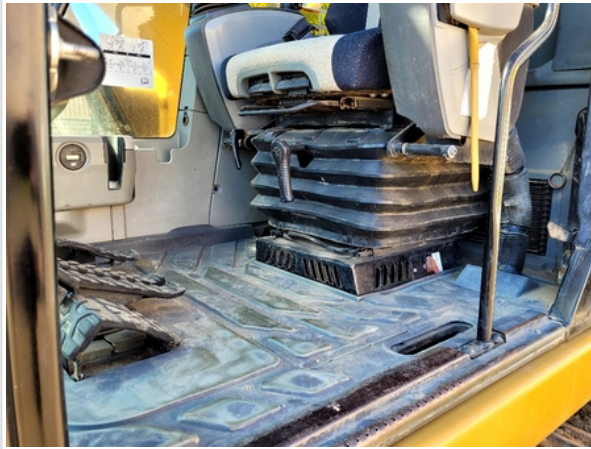
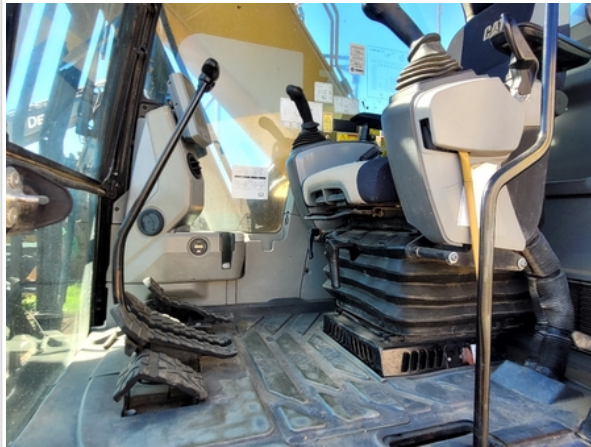
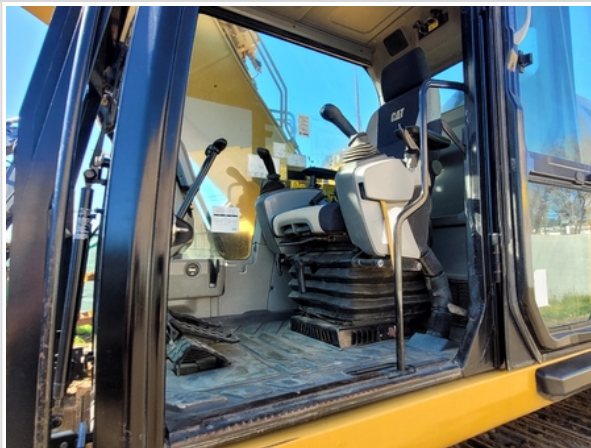
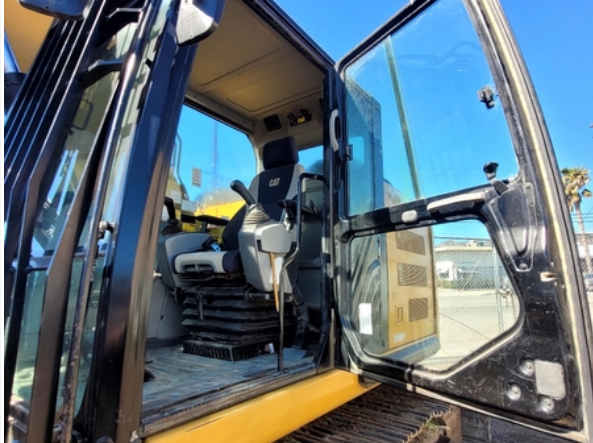
Operator Cabin Overall	3 - Normal Wear & Tear
Operator Cabin Overall Condition	Good cabin appearance, solid floors, panels, and ceiling
Operator Seat	3 - Normal Wear & Tear
Operator Seat Condition	Seat(s) in good condition, no stains or tears in upholstery, Seat(s) have minor surface staining or small tears
Cabin Lights	3 - Normal Wear & Tear
Cabin Lights Condition	Cabin lights are installed with all light covers in place, bulbs are installed and working properly
Safety Lock Out / Stop	3 - Normal Wear & Tear
Safety Lock Out / Stop Condition	Safety lock out device is present, in good condition, and functional
Controls & Switches	3 - Normal Wear & Tear
Controls & Switches Condition	All switches are installed and functional
Hour Meter Activity	3 - Normal Wear & Tear
Hour Meter Condition	Hour meter is functional and in good condition
Hour Meter Activity Photos	 
Other Gauge Activity	3 - Normal Wear & Tear

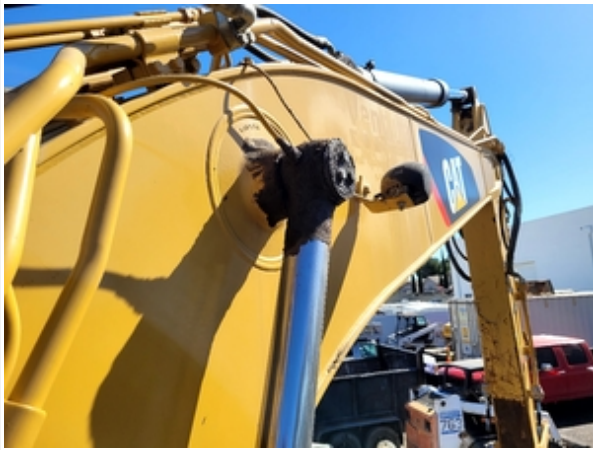
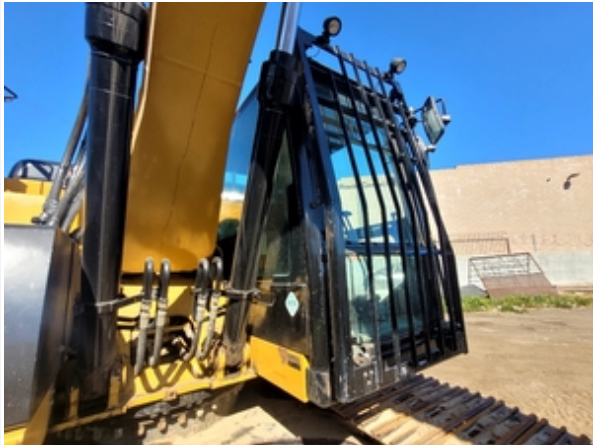
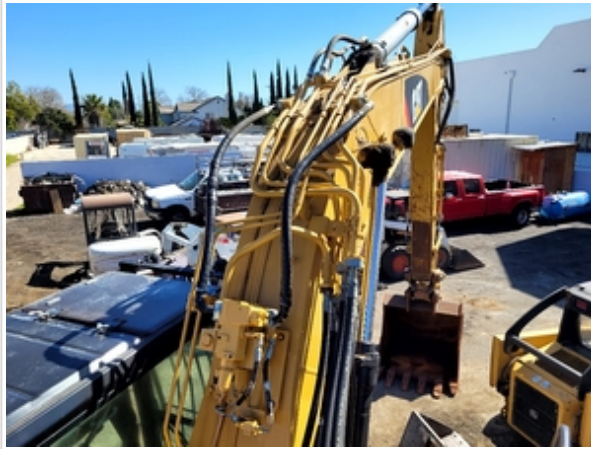
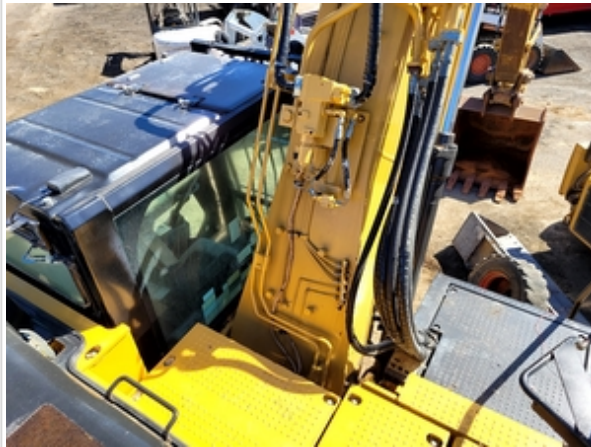
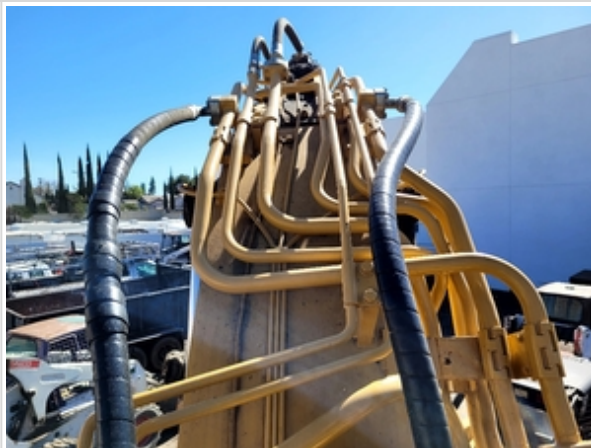
Boom Condition	3 - Normal Wear & Tear
Boom Photos

Overall Chassis	3 - Normal Wear & Tear
Overall Chassis Comments	Chassis in solid shape from the implements to the main frame. Normal wear and tear seen throughout the machine but no obvious major issues observed during the inspection.

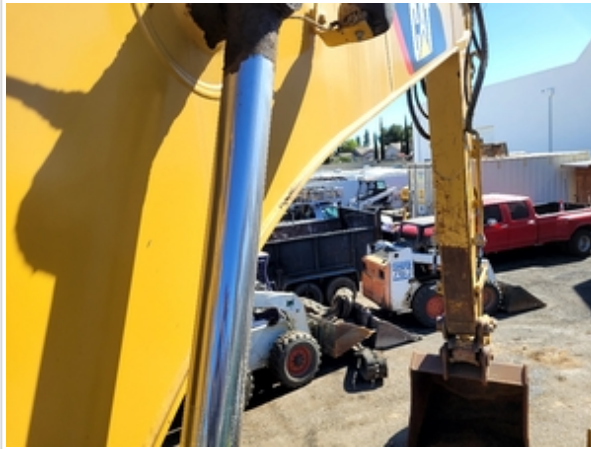
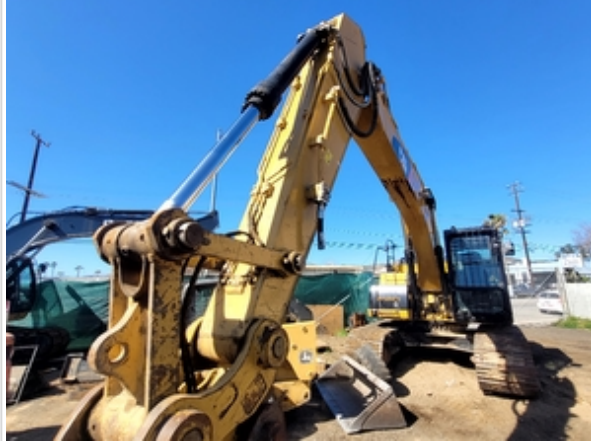
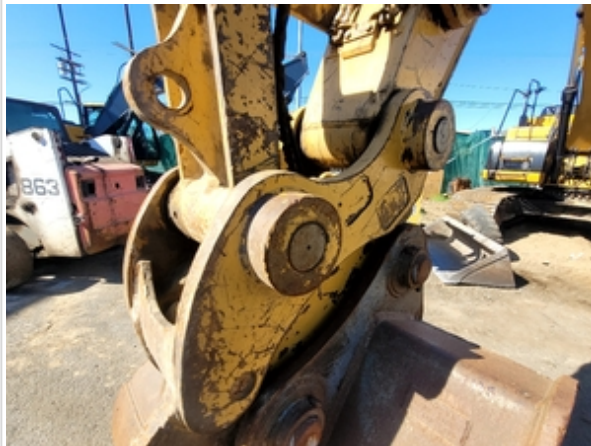
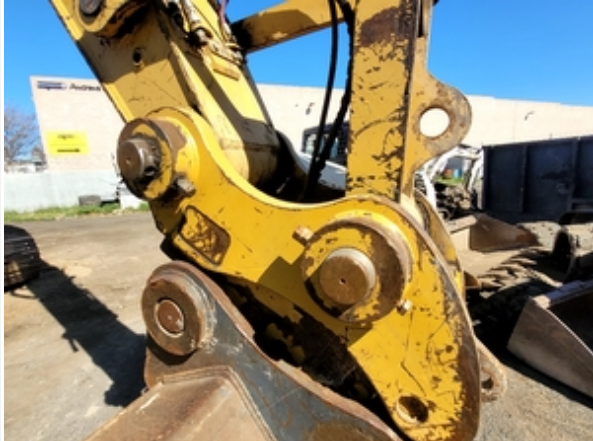
Stick Photos

Stick Condition

3 - Normal Wear & Tear

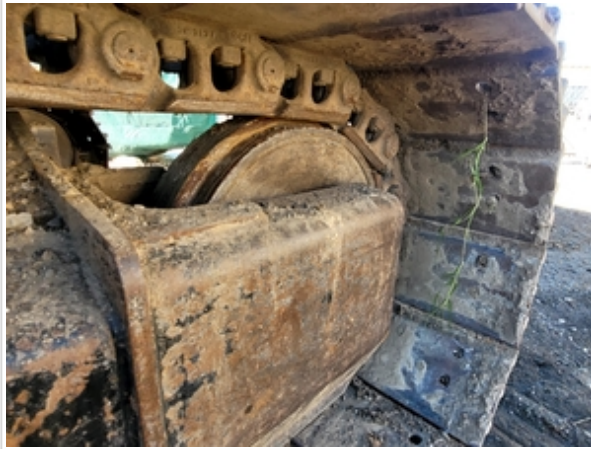
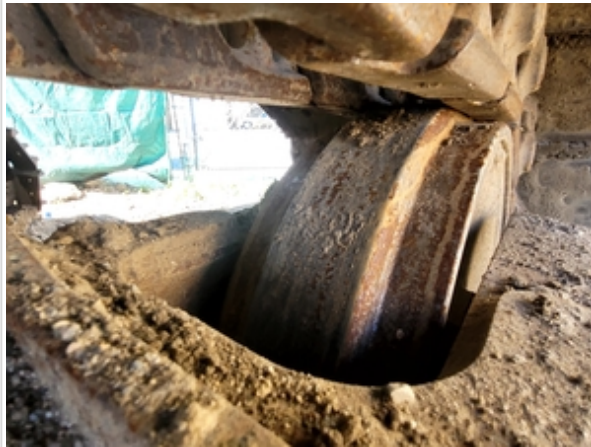
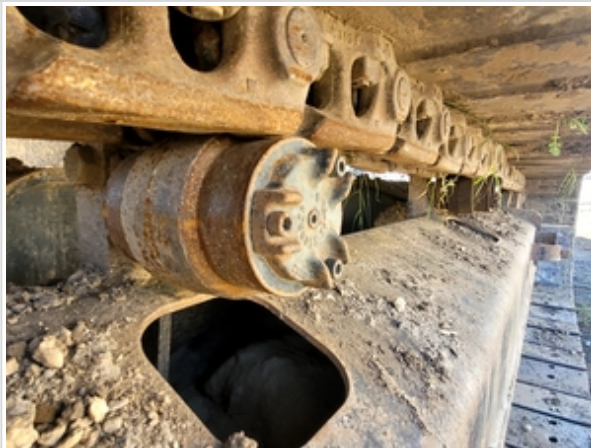
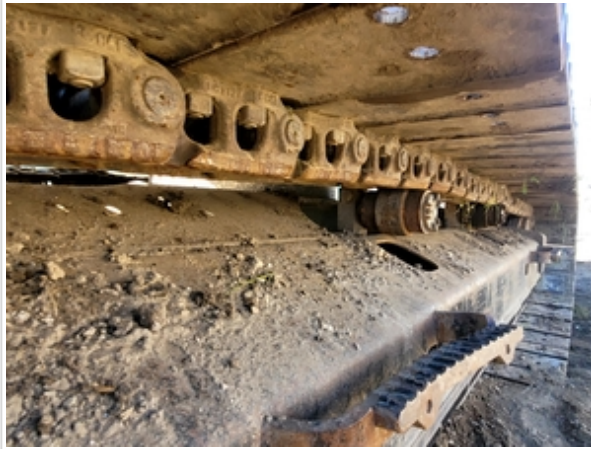
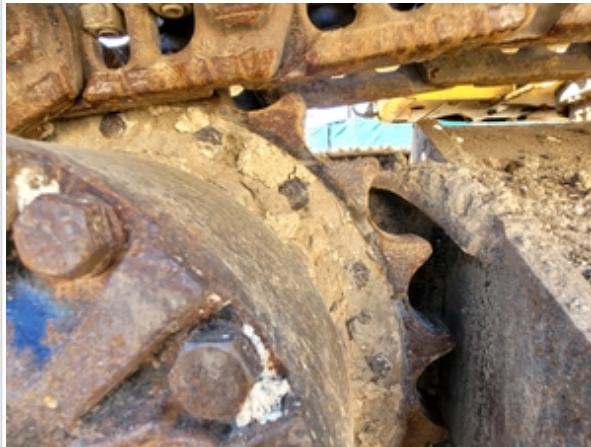
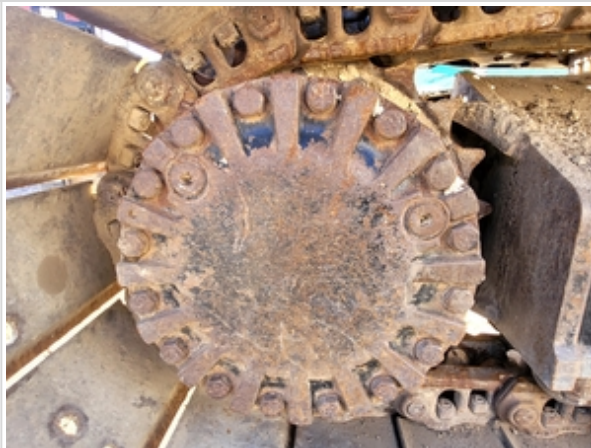
Undercarriage Overall Condition	3 - Normal Wear & Tear
Comments	Overall track undercarriage, visually, in solid shape with plenty of life left. from the main tracks to the idlers and rollers all look to have low use.
Undercarriage Overall Photos

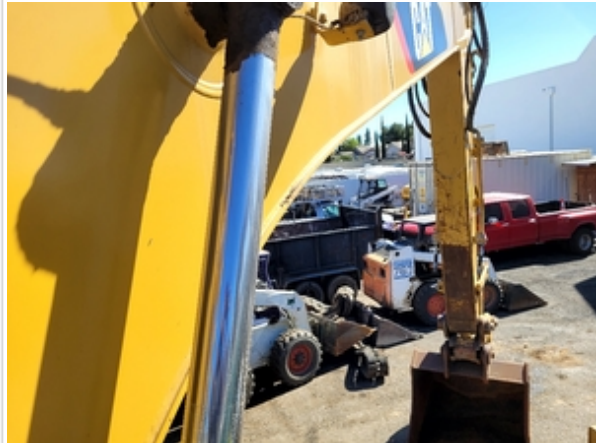
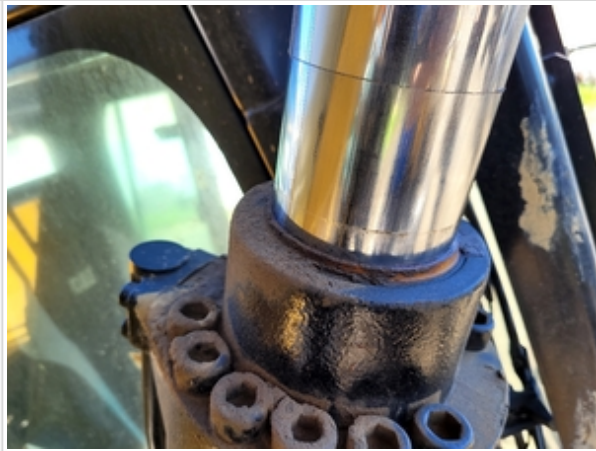
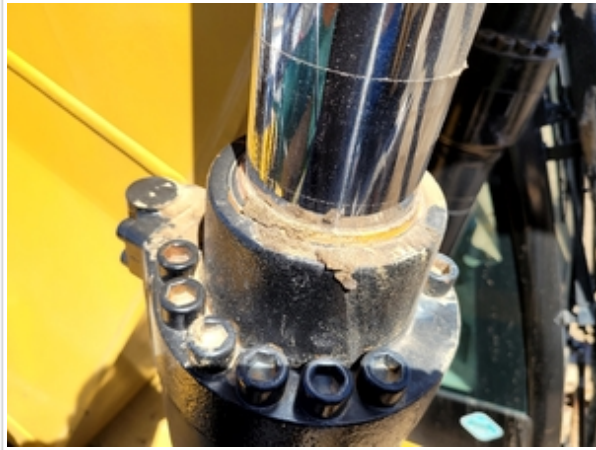
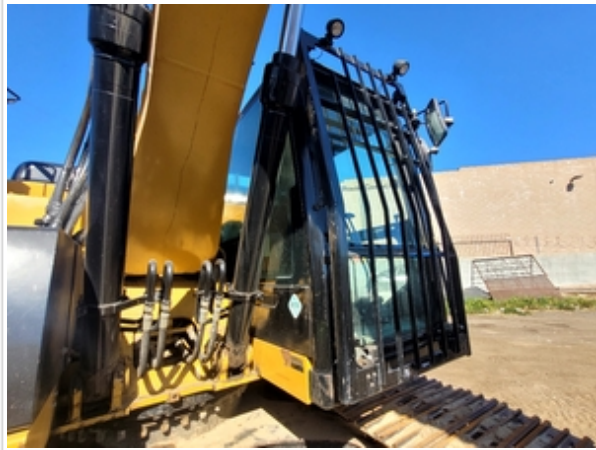
Boom Cylinder	Check the boom cylinder. Note any wear, pitting, discoloration, etc. Take photos.
Boom Cylinder: Mounting Pin	3
Boom Cylinder: Oil Leaks	No
Boom Cylinder Photos

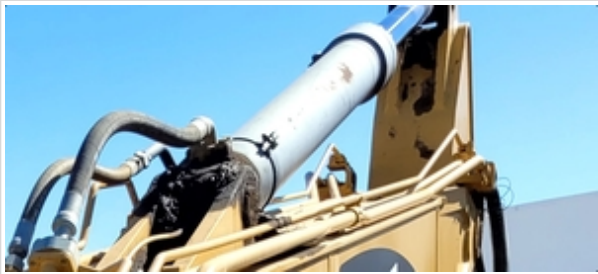
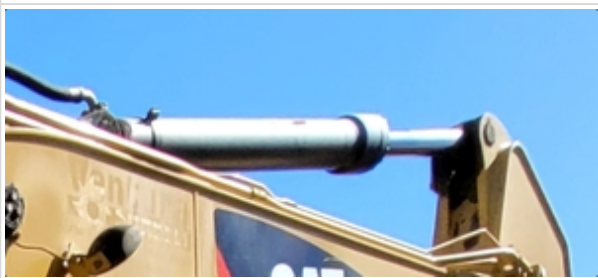
Stick Cylinder Photos

Stick Cylinder	Check the stick cylinder. Note any wear, pitting, discoloration, etc. Take photos.
Stick Cylinder: Mounting Pin	3
Stick Cylinder: Oil Leaks	No

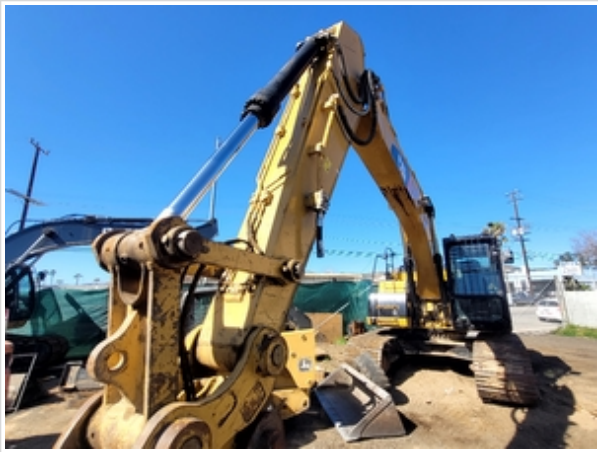
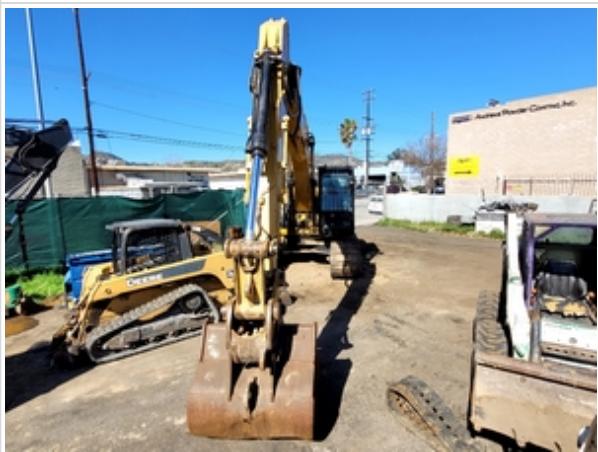
Bucket Cylinder	Check the bucket cylinder. Note any wear, pitting, discoloration, etc. Take photos.	
Bucket Cylinder: Mounting Pin	3	
Bucket Cylinder: Oil Leaks	No	
Bucket Cylinder Photos

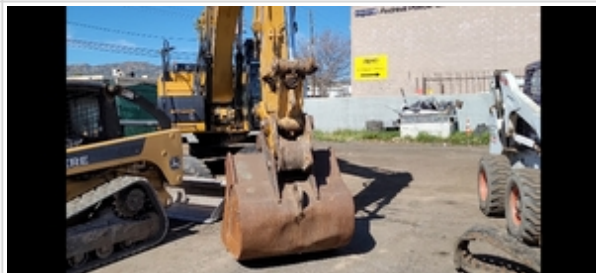
Bucket Condition	3 - Normal Wear & Tear
Comments	large dent at bottom rear side of bucket & outer tooth missing
Bucket Photos
