Inspection Report (Wood Chipper)

Year	2006
Make	Morbark
Model	2070XL
Serial Number	4S8SZ15134W070501
Hour Meter Reading	N/A
Previous Application (e.g., earth moving, mining, demolition, etc)	Inhouse Property Landscape Maintenance

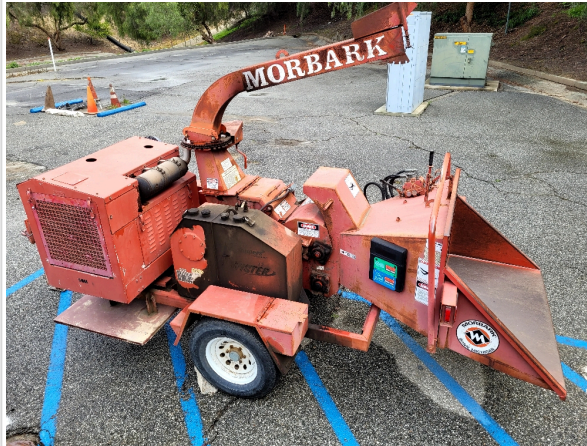
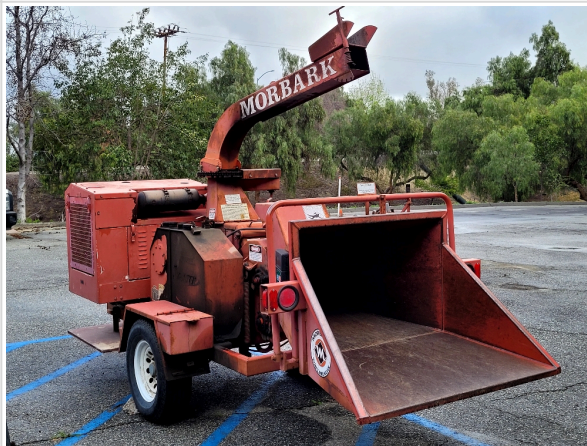
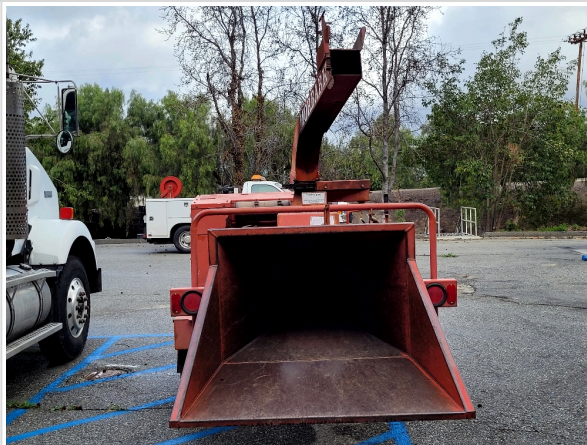
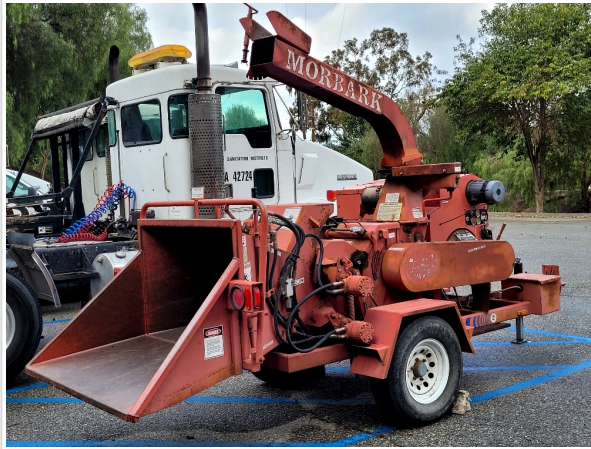
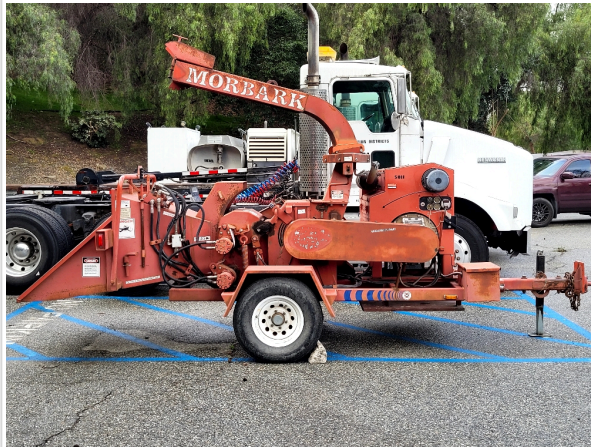
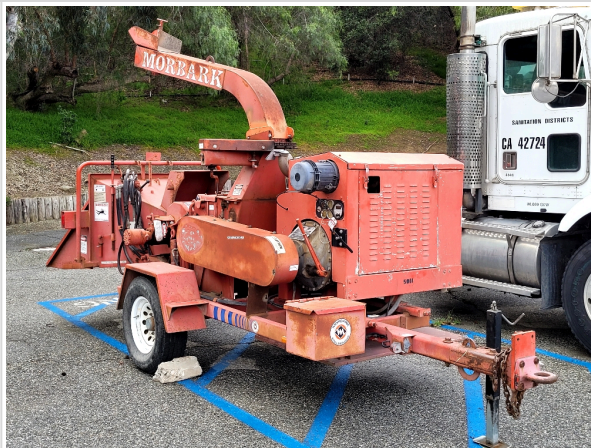
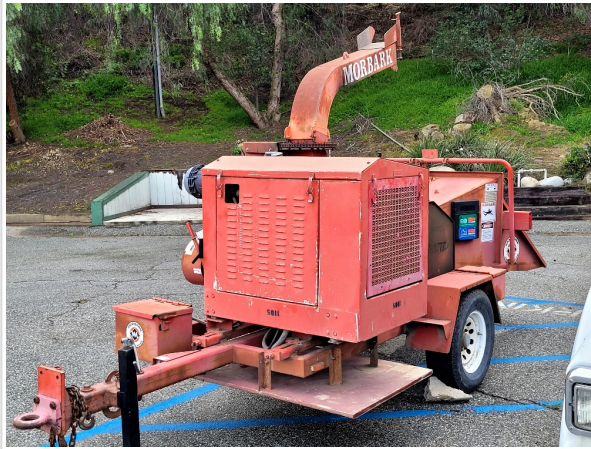
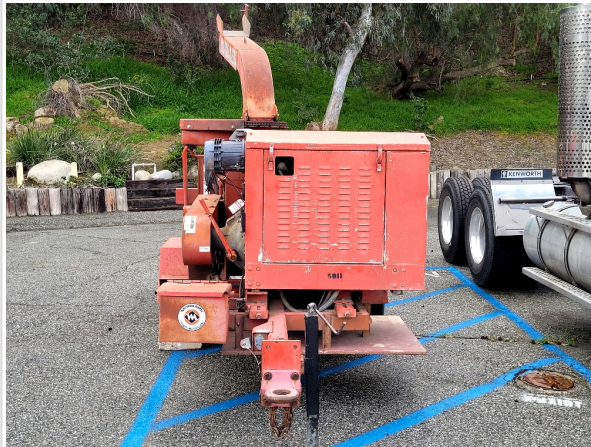
Exterior Walkaround Photos

General Appearance Rating	3 - Normal Wear & Tear
General Appearance Comments	Exterior paint faded

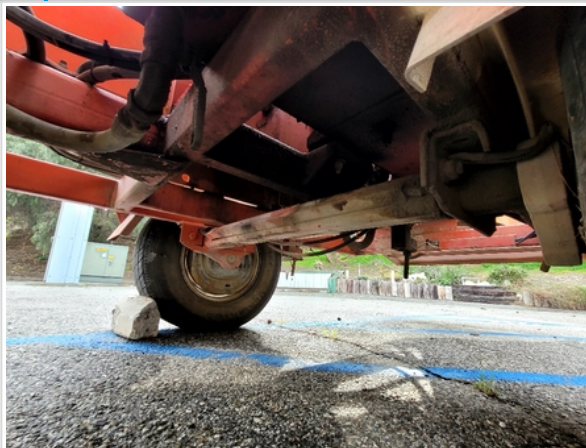
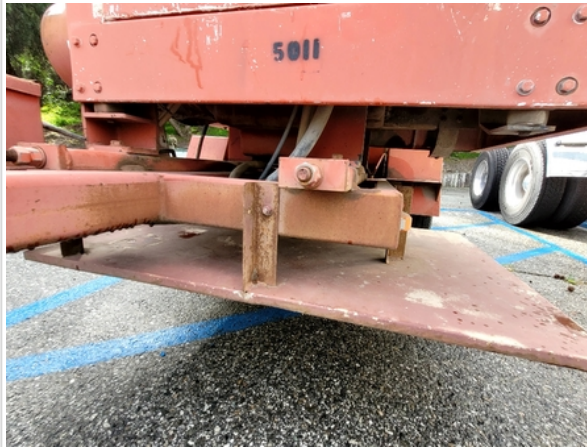
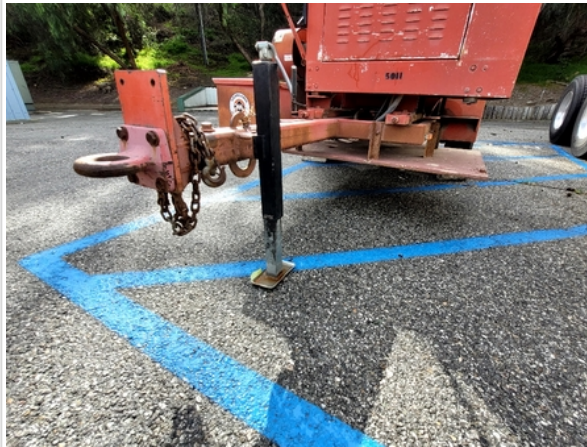
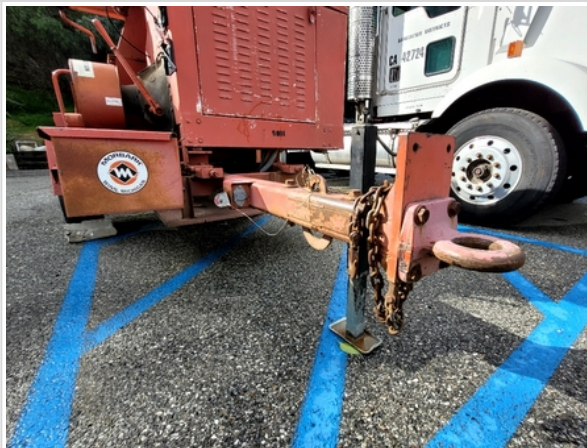
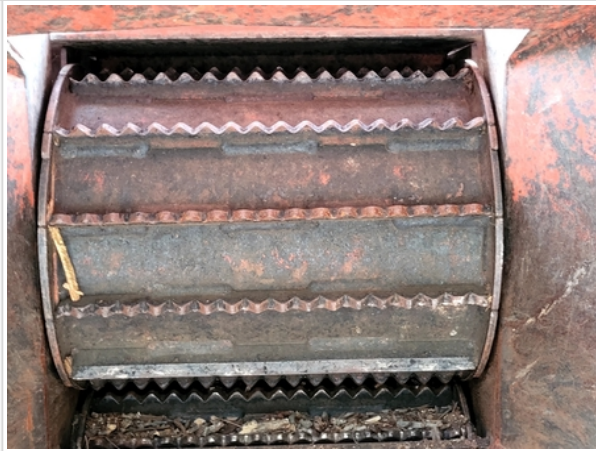
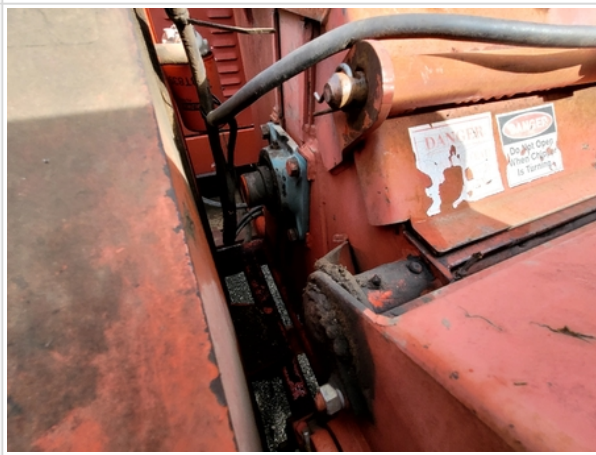
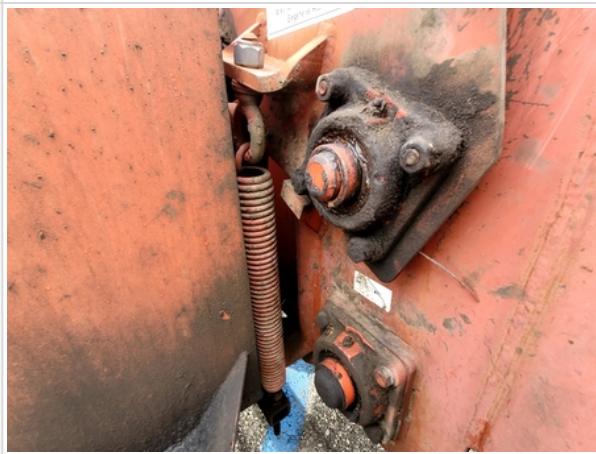
Chassis & Chipper Component Photos

<p>Frame</p>	<p>3 - Normal Wear & Tear</p>
<p>Loading Arm</p>	<p>3 - Normal Wear & Tear</p>

Infeed	3 - Normal Wear & Tear
Chipper Drum	3 - Normal Wear & Tear
Hopper	3 - Normal Wear & Tear

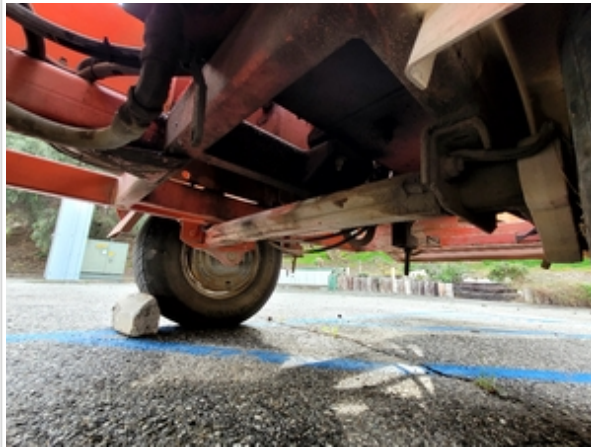
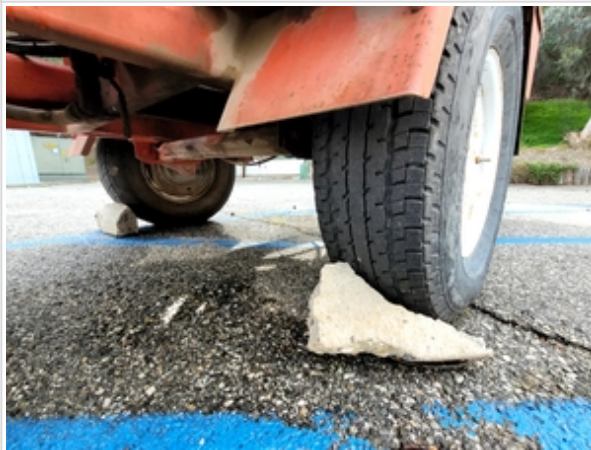
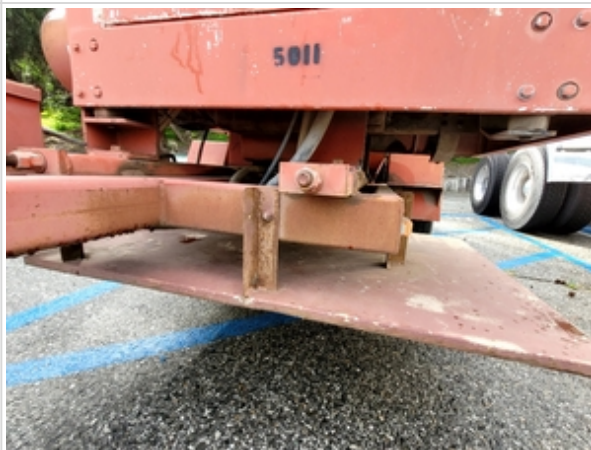
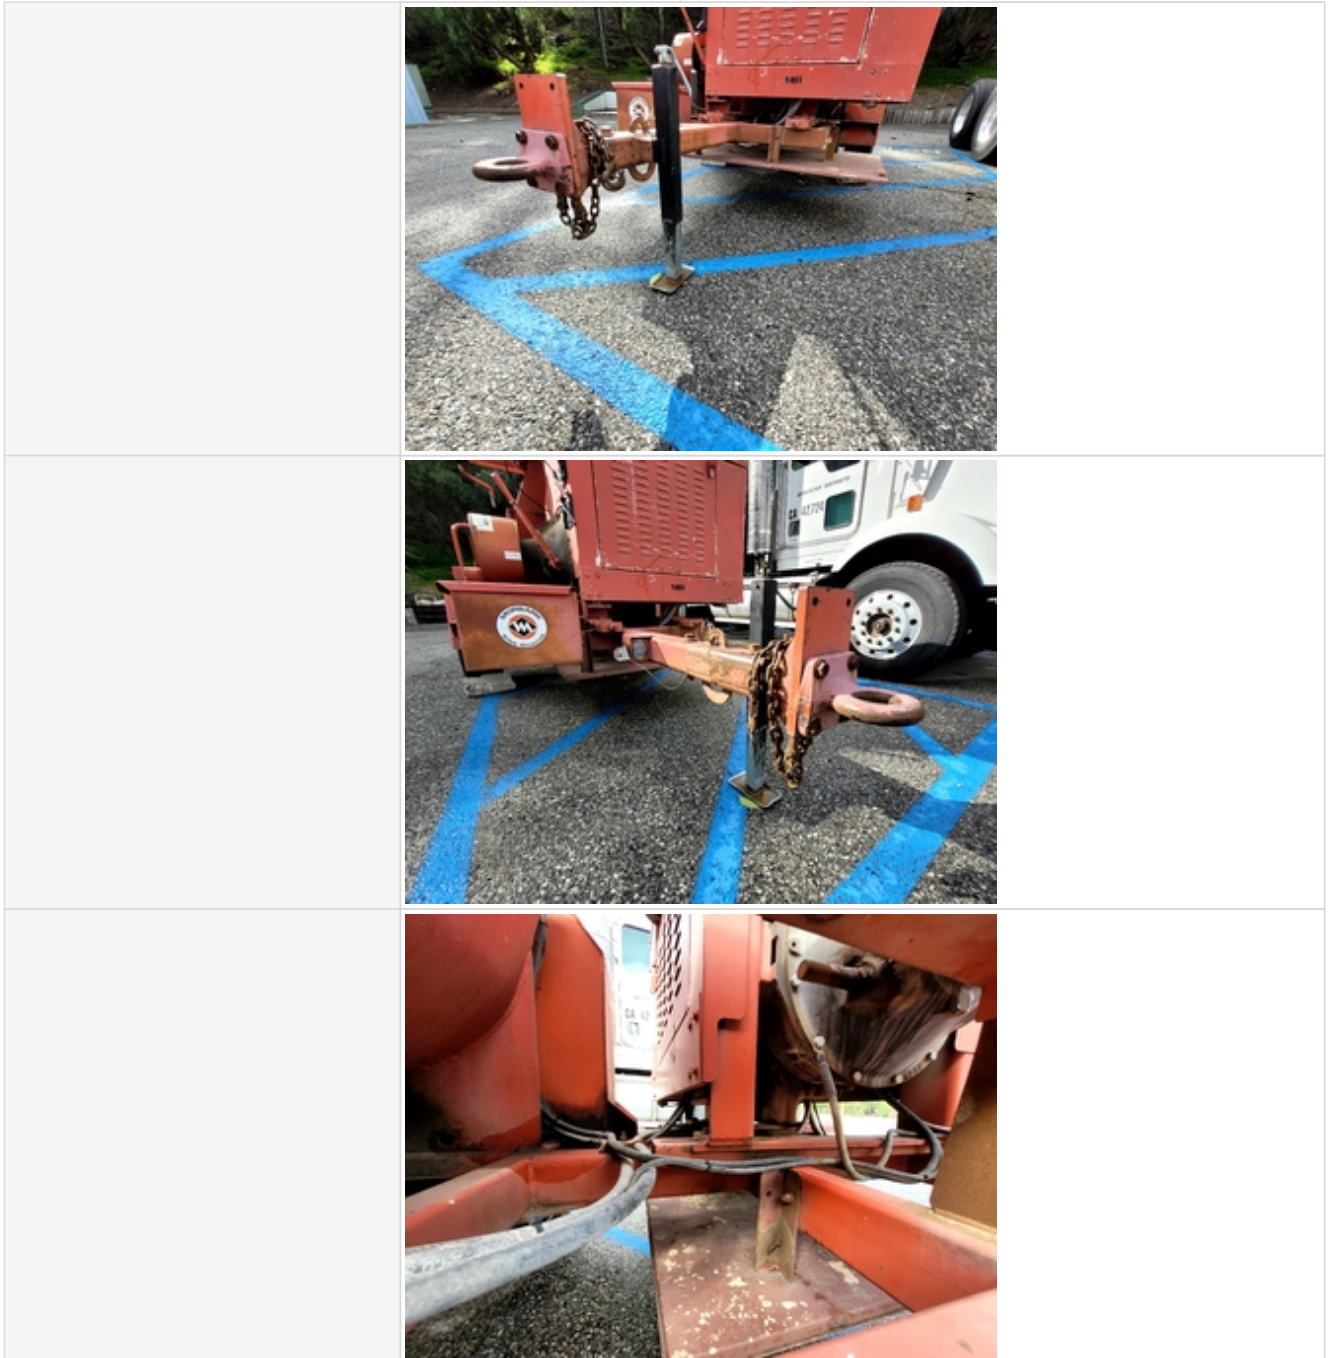
Overall Trailer & Undercarriage Photos

Overall Trailer Condition	3 - Normal Wear & Tear
Overall Trailer Comments	Brake shoes not visible. Electric brakes and lights were not tested but visually look okay.
Fuel Tank Condition	3 - Normal Wear & Tear

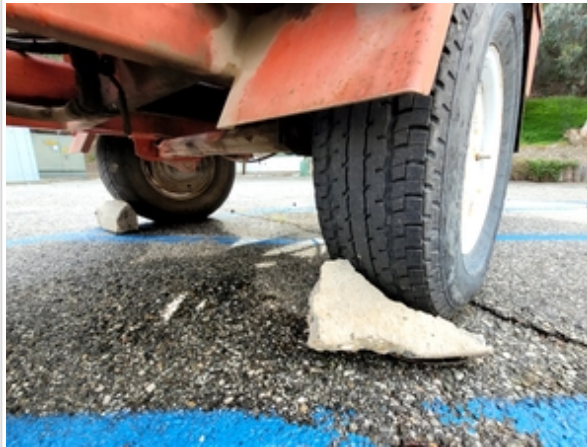
Front Right Tire Photos	 
-------------------------	--

Wheels & Hub Condition	3 - Normal Wear & Tear
Loose Lugs	No
Tire Brand	Gladiator
Tire Size	ST225/75R/15
Front Left Tire - Ratio Remaining	50%
