Inspection Report (Skid Steer)

Year	2013
Make	Bobcat
Model	S130
Serial Number	AU4Y13361
Hour Meter Reading	1,585 Hrs.
Previous Application (e.g., earth moving, mining, demolition, etc)	Waste water maintenance machine

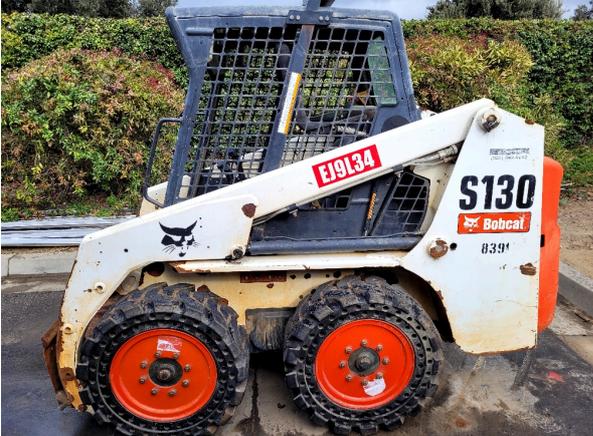
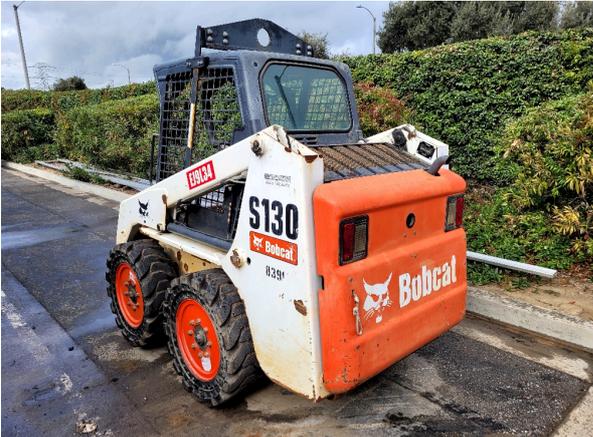
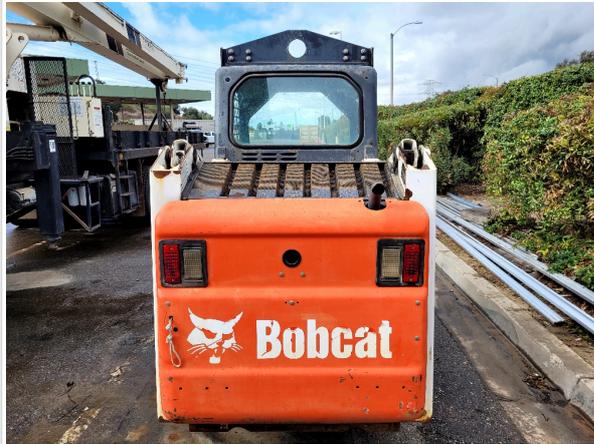
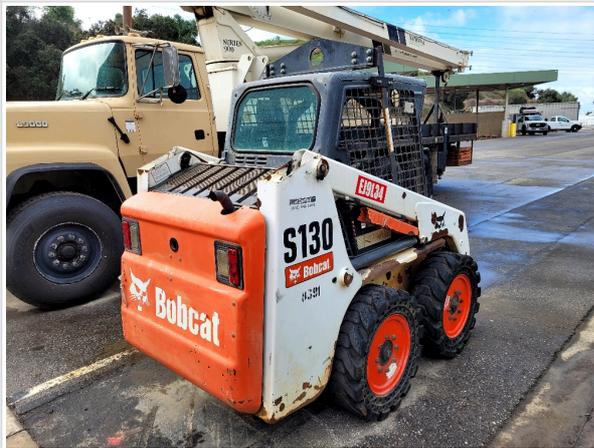
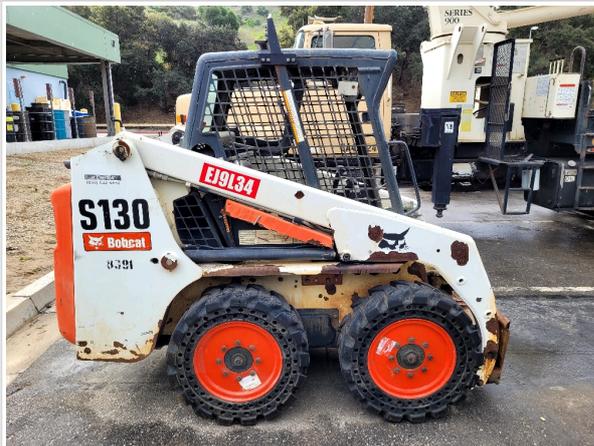
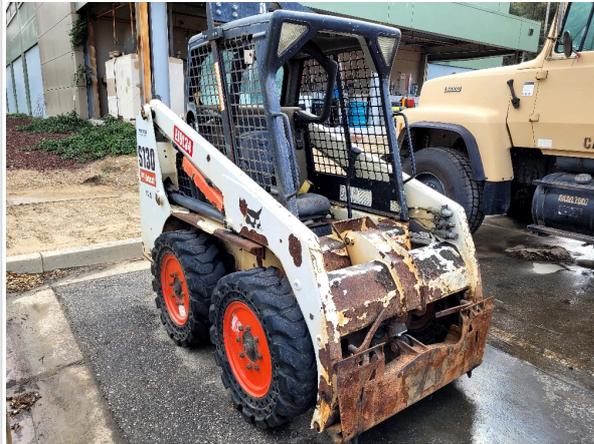
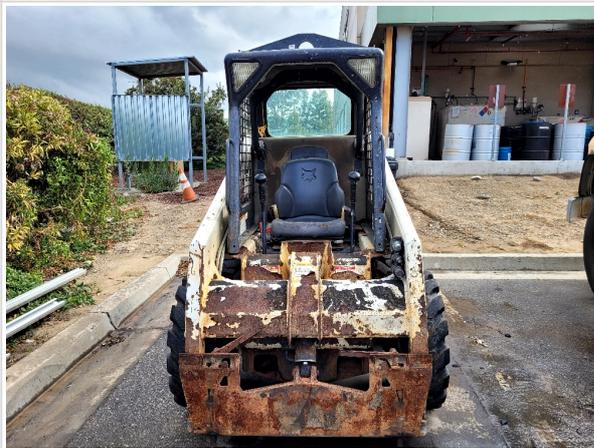
Exterior 360 Walkaround

Body Panels	3 - Normal Wear & Tear
Body Panel Condition	Areas of surface rust observed, Other (see comments)
Comments	surface rust all around exterior of machine
Doors / Canopy Latches	2 - Above Average Wear
Doors / Canopy Latches Condition	Loose or missing latches, hinges or handles, Other (see comments)
Comments	rear engine compartment door missing latch
Steps / Ladders	0
Handrails	3 - Normal Wear & Tear
Handrails Condition	Handrails are fully intact and appear structurally sound
Glass	3 - Normal Wear & Tear
Glass Condition	Glass intact, no visible damage
Mirrors	0
Exterior Lights	3 - Normal Wear & Tear
Exterior Lights Condition	No visible damage, lighting system is operational

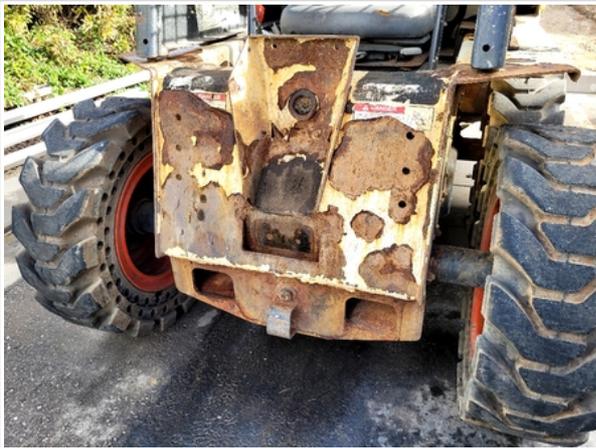
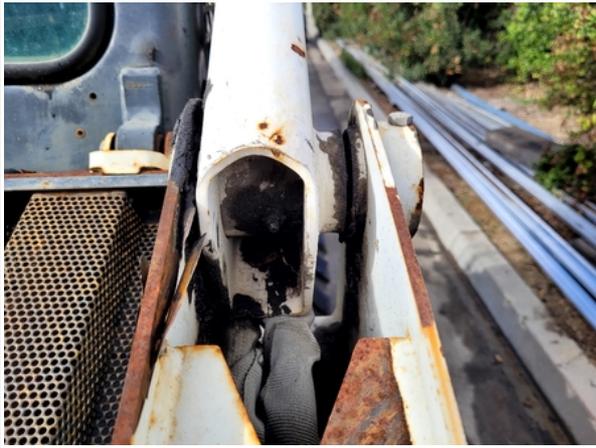
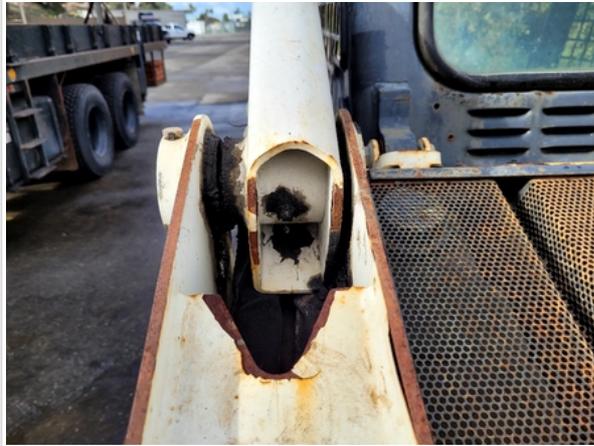
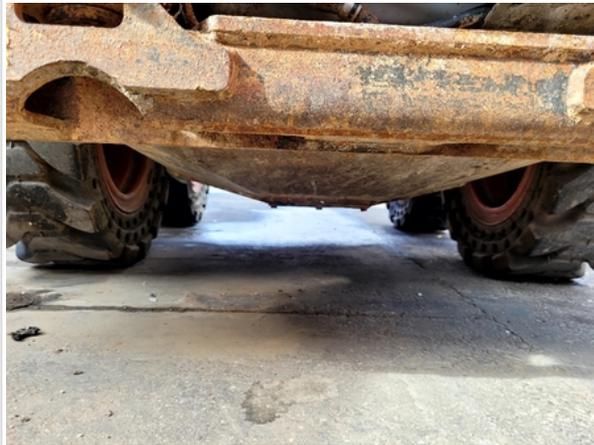
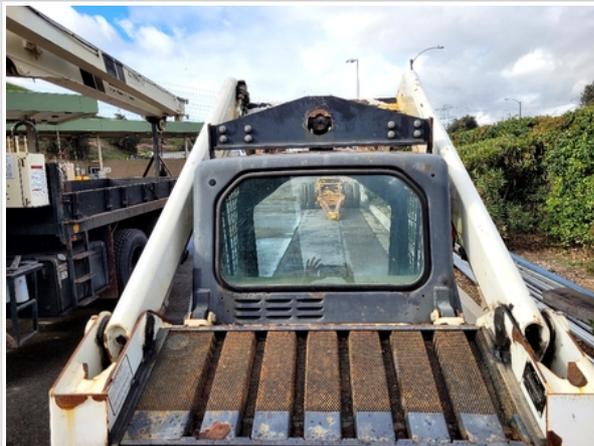
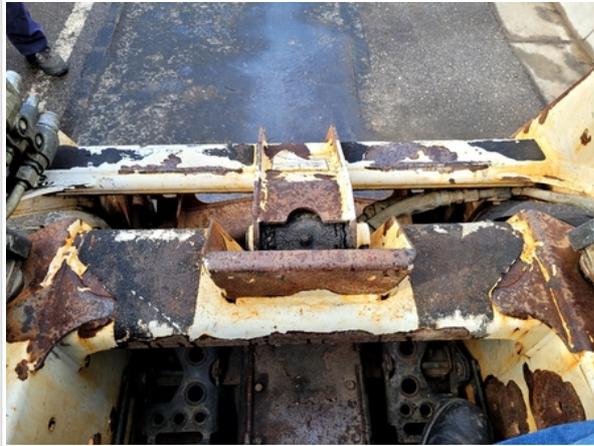
Frame	3 - Normal Wear & Tear
Frame Photos

Quick Coupler to Arms Pins	3 - Normal Wear & Tear
Overall Chassis	3 - Normal Wear & Tear
Overall Chassis Comments	Overall chassis in solid shape with all implements working well with no issues observed.

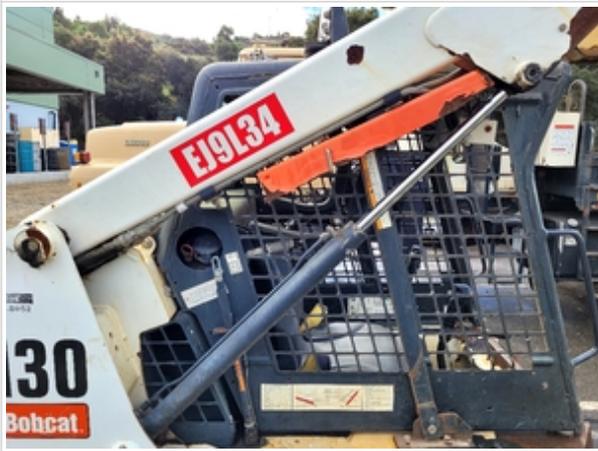
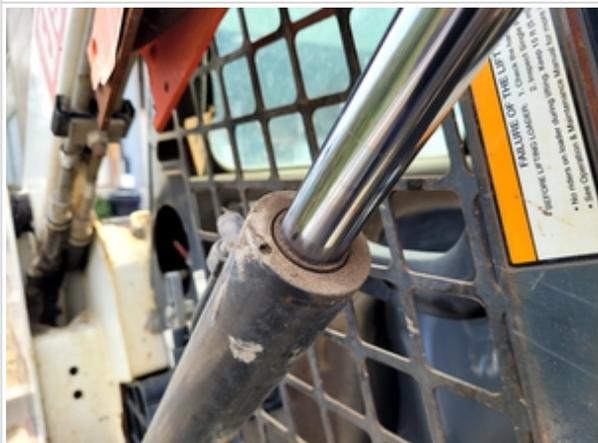
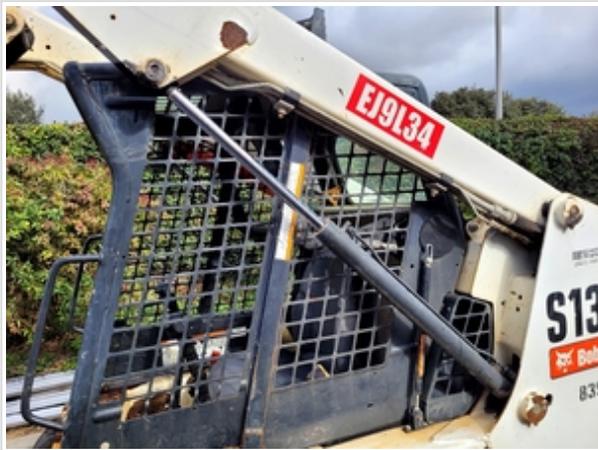
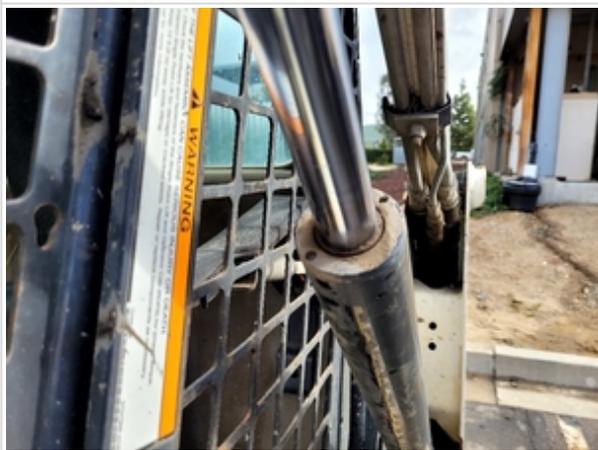
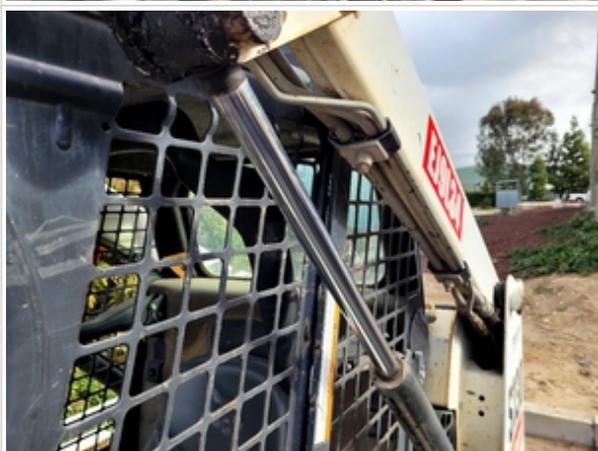
Lift Cylinder	Check the lift cylinder. Note any wear, pitting, discoloration, etc. Take photos.
Lift Cylinder: Mounting Pin	3
Lift Cylinder: Oil Leaks	No
Lift Cylinder Photos

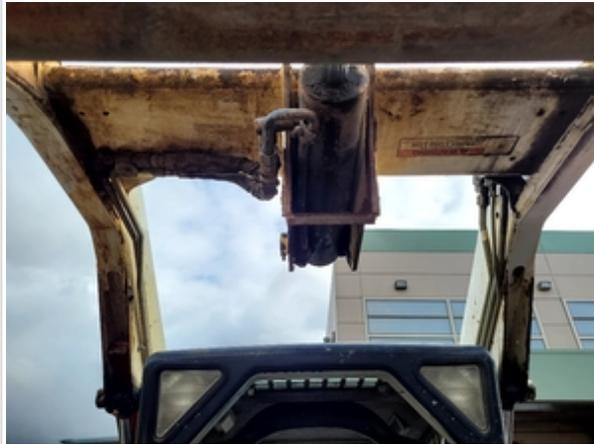
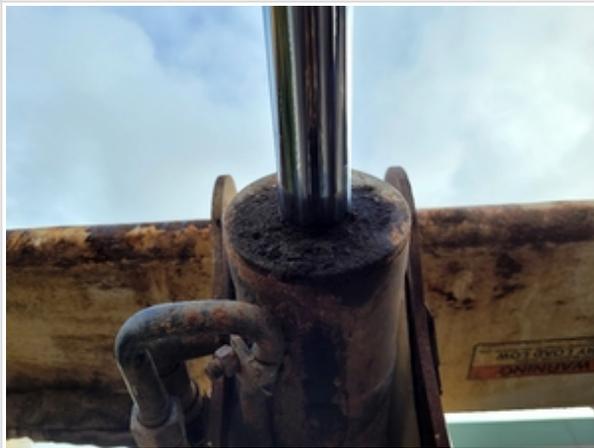
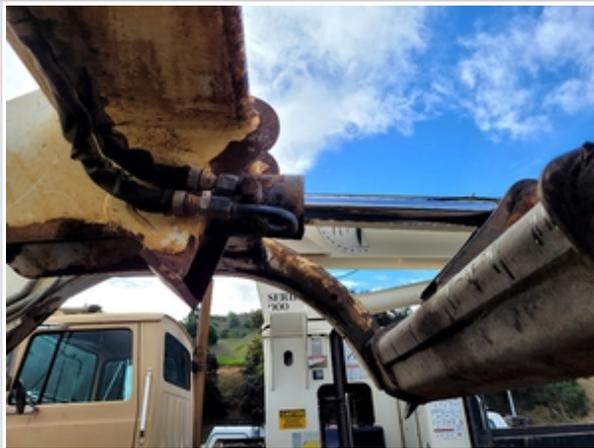
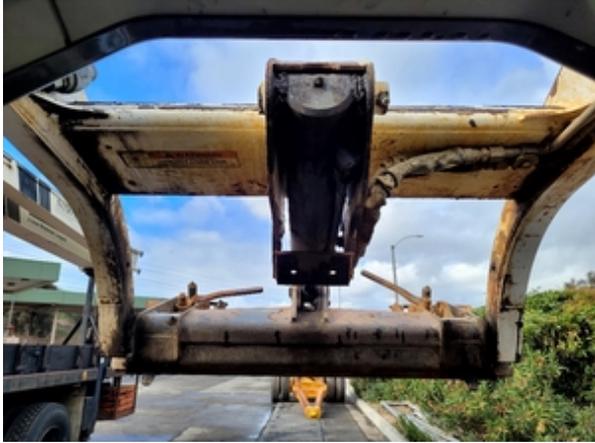
Bucket Cylinder Photos

Bucket Cylinder	Check the bucket cylinder. Note any wear, pitting, discoloration, etc. Take photos.
Bucket Cylinder: Mounting Pin	3
Bucket Cylinder: Oil Leaks	No
