## Inspection Report (Vibratory Compactor)

Year	2015
Make	JCB
Model	VM1500
Serial Number	JCBV1500EF2704941
Hour Meter Reading	2,478 Hrs.
Previous Application (e.g., earth moving, mining, demolition, etc)	Masonry General Construction

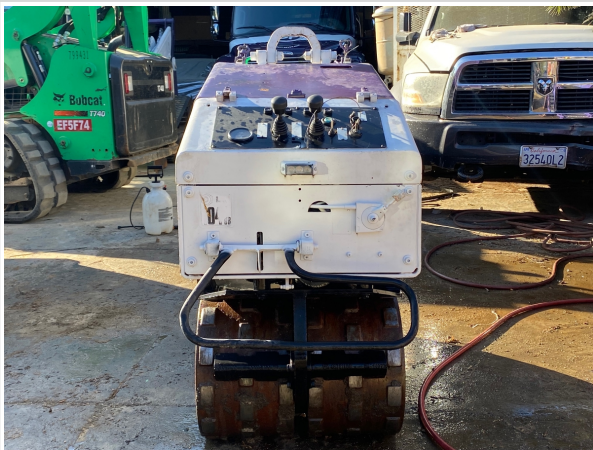
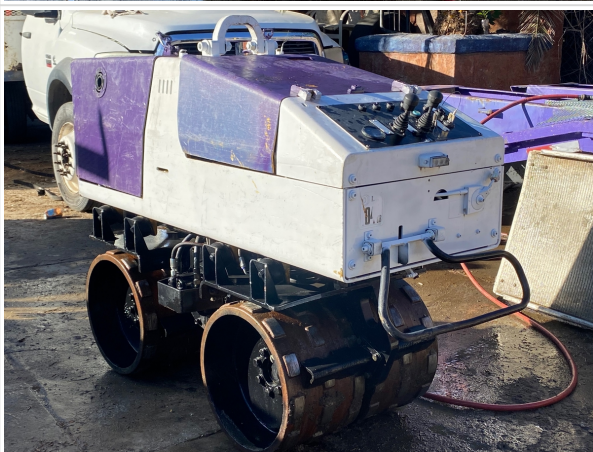
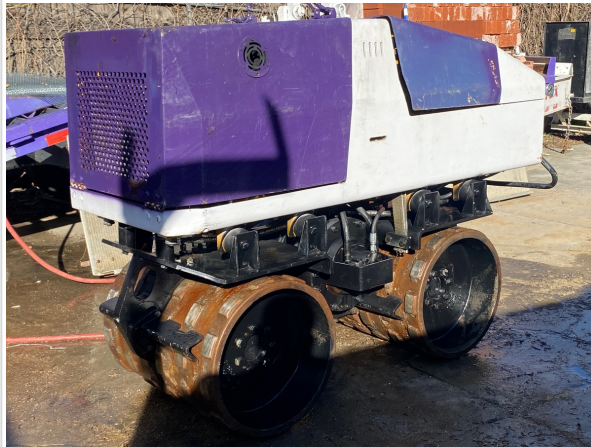
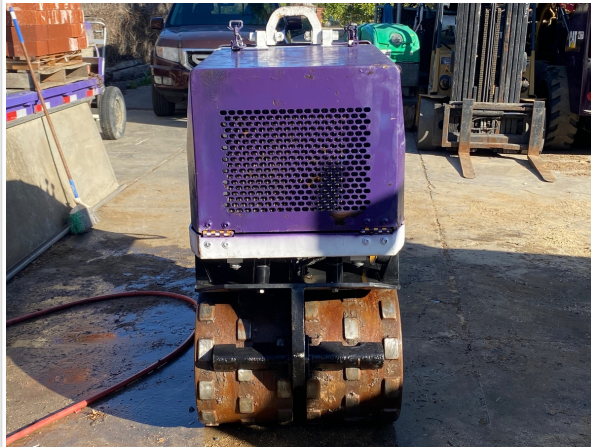
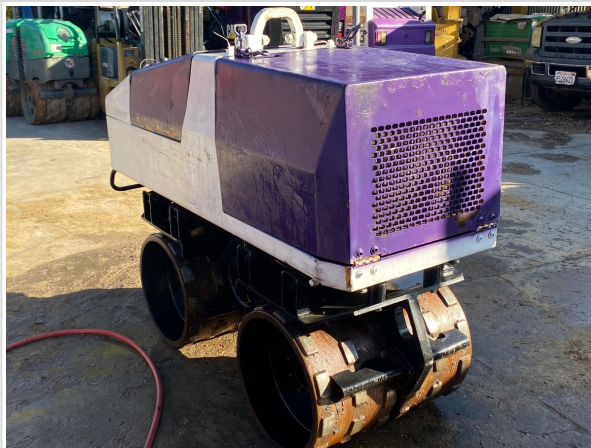
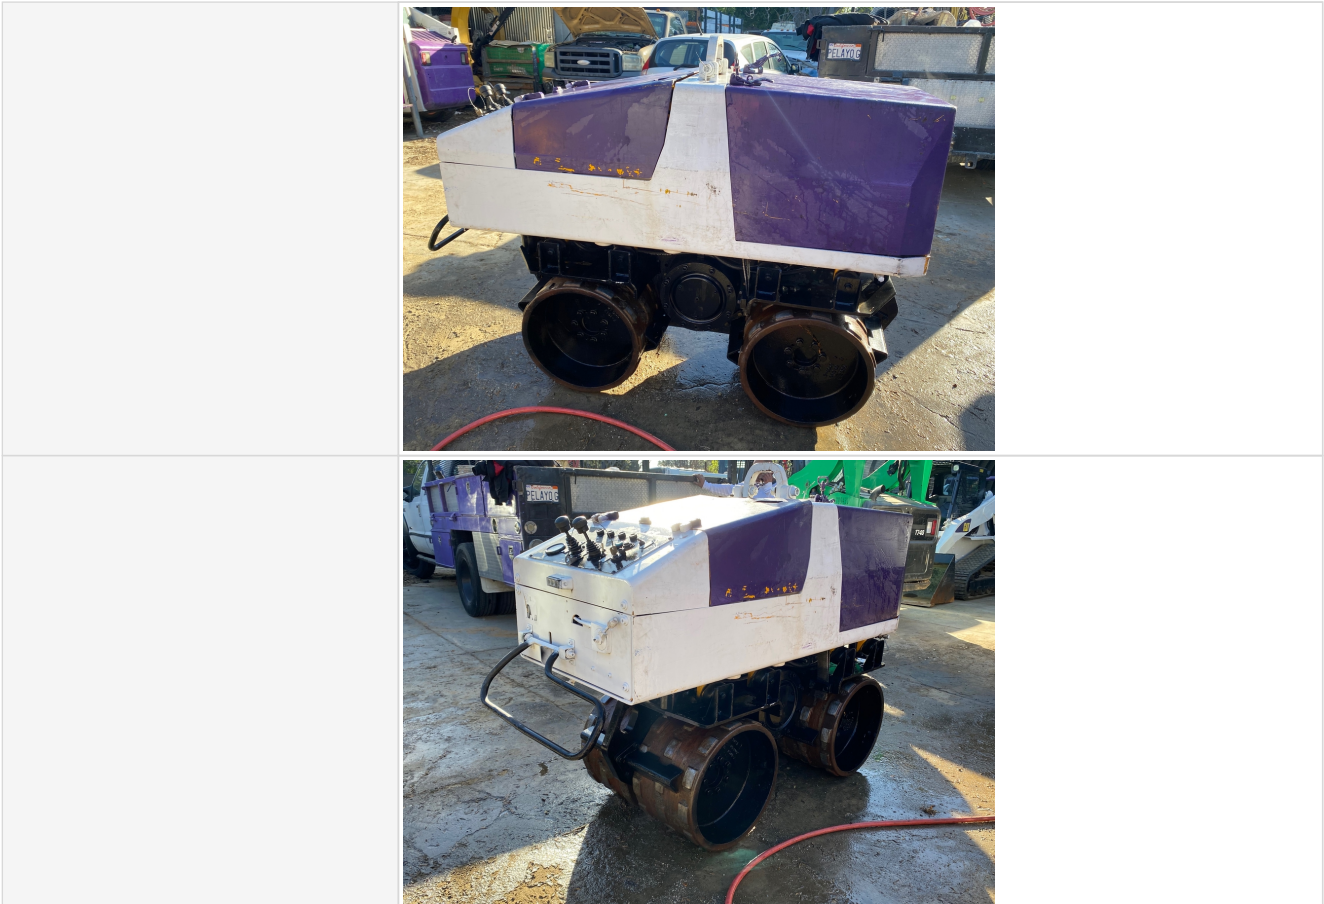
<b>Body Panels</b>	3 - Normal Wear & Tear
<b>Body Panel Condition</b>	No visible damage, good paint condition and panel fitment
<b>Doors / Canopy Latches</b>	3 - Normal Wear & Tear
<b>Doors / Canopy Latches Condition</b>	No visible damage
<b>Steps / Ladders</b>	0

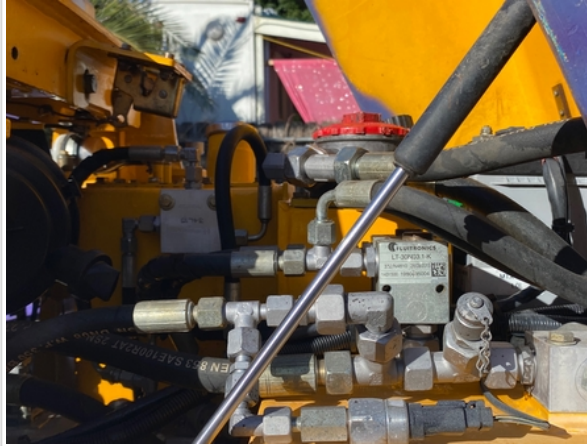
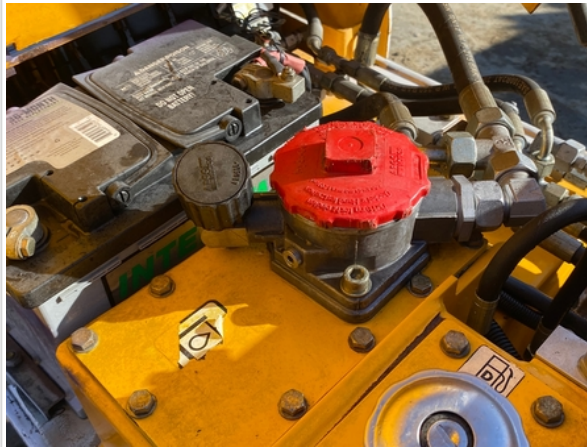
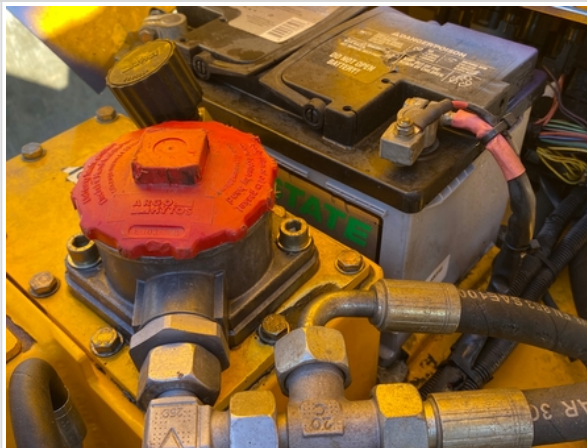
Hydraulic System Photos

<p>Main hydraulic pump highlighted in outline</p>
<b>Wet or Damp Hydraulic Lines / Fittings</b>	No
<b>Appearance of Hydraulic Lines / Fittings</b>	3 - Normal Wear & Tear
<b>Hydraulic Lines / Fittings Condition</b>	Hydraulic lines & fittings are clean and in good condition
<b>Unusual Noises (Hydraulic Pump)</b>	No
<b>Hydraulic Pump Notes</b>	No unusual noises heard during operation
