Inspection Report (On-Highway Lube Truck)

Year	2020
Make	Peterbilt
Model	337
Serial Number	2NP2HM6X0LM675179
Truck Odometer Reading	56,740 Miles
Current Inspection / State Cert / DOT	N/A
Previous Application (e.g., earth moving, mining, demolition, etc)	Concrete Cutting / Demolition

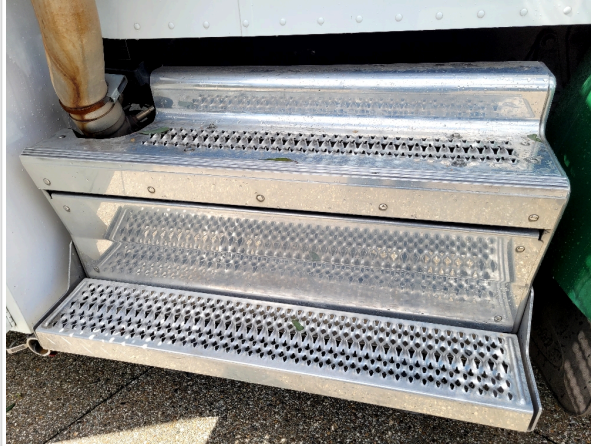
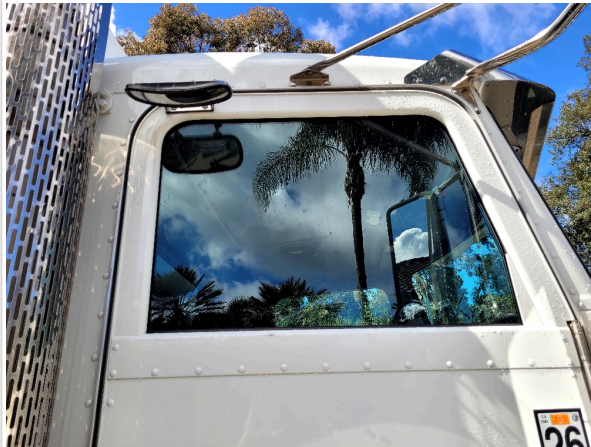
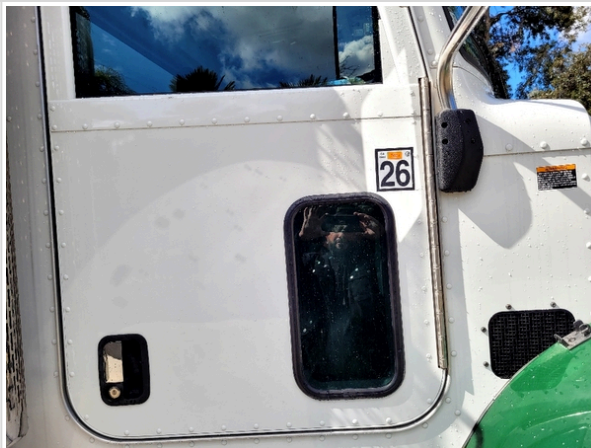
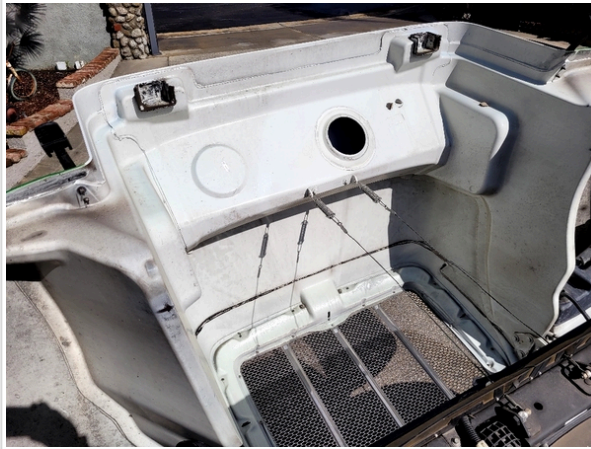
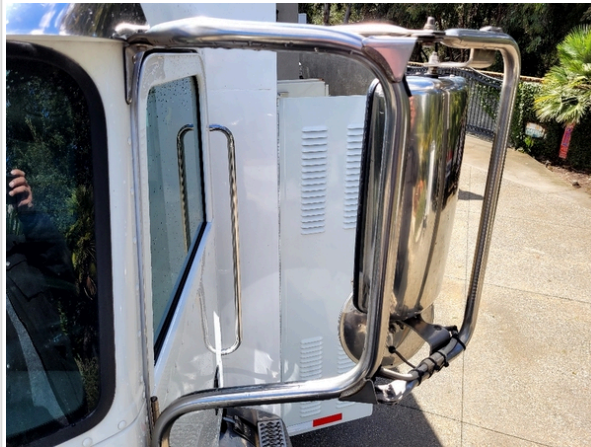
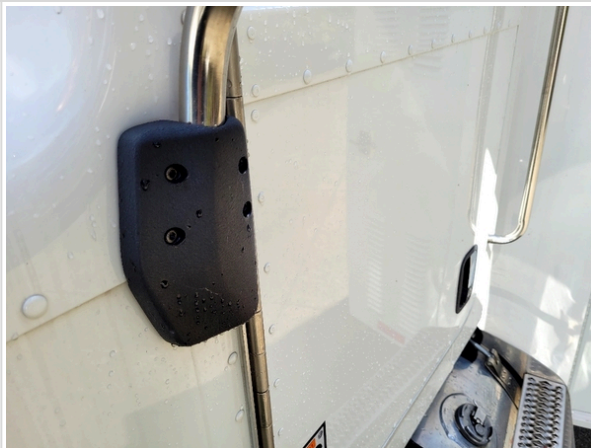
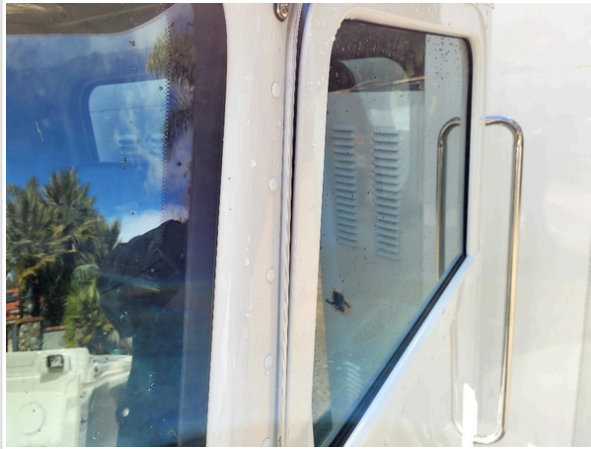
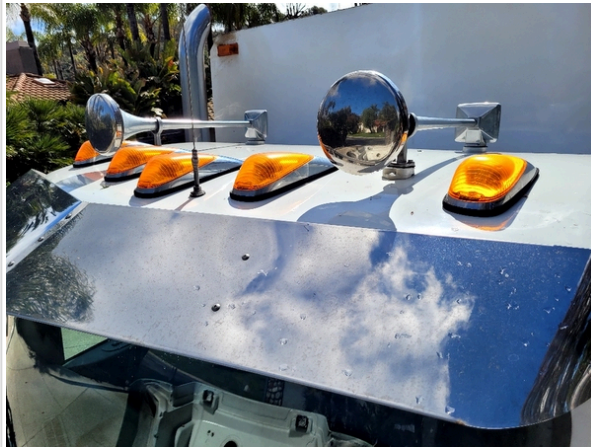
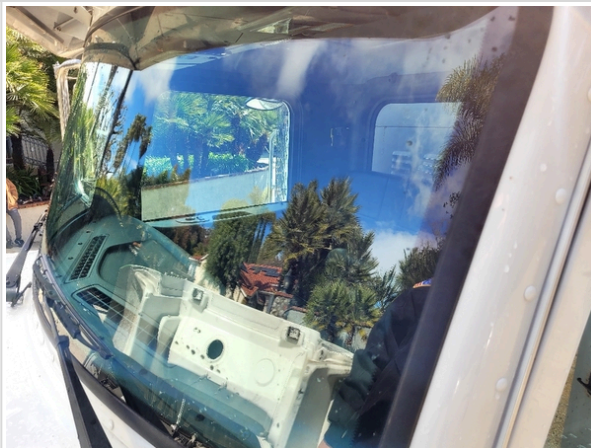
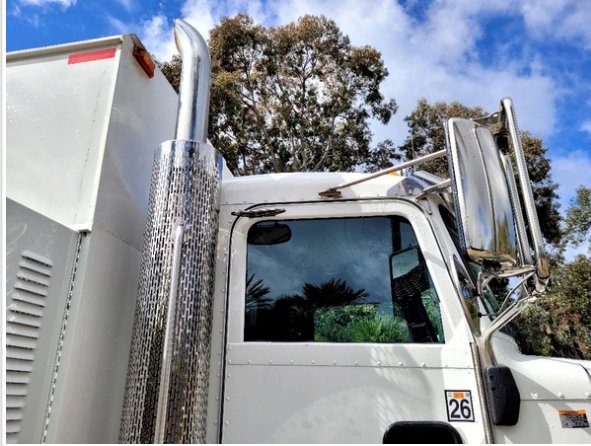
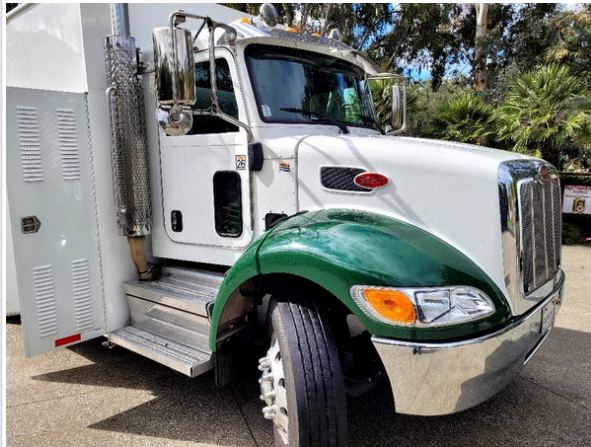
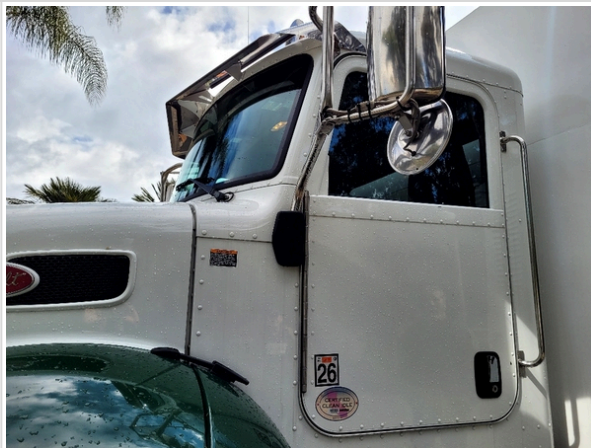
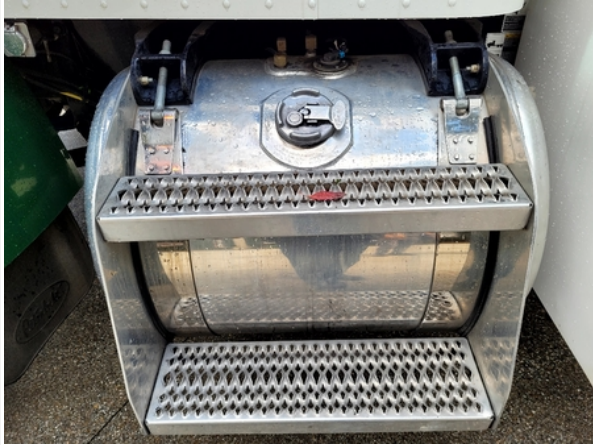
Close-up Exterior Photos

Body Panels	3 - Normal Wear & Tear
Body Panel Condition	No visible damage, good paint condition and panel fitment
Doors / Canopy Latches	3 - Normal Wear & Tear
Doors / Canopy Latches Condition	No visible damage
Steps / Ladders	3 - Normal Wear & Tear
Steps / Ladders Condition	Steps/ladders are fully intact and appear structurally sound
Handrails	3 - Normal Wear & Tear
Handrails Condition	Handrails are fully intact and appear structurally sound
Glass	3 - Normal Wear & Tear
Glass Condition	Glass intact, no visible damage
Mirrors	3 - Normal Wear & Tear
Mirror Condition	Mirrors present and intact, no visible damage
Exterior Lights	3 - Normal Wear & Tear
Exterior Lights Condition	No visible damage, lighting system is operational

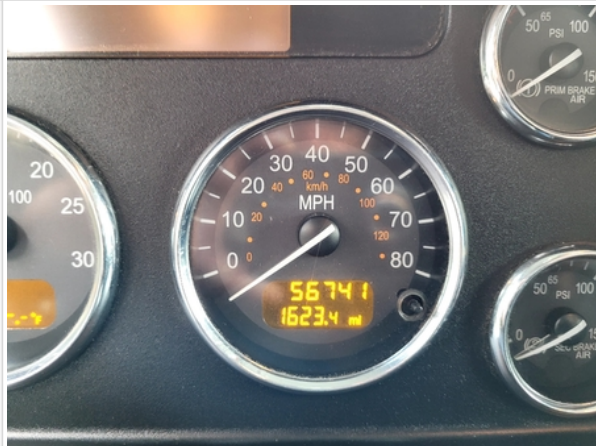
<p>Odometer Photo</p>

Odometer Activity	3 - Normal Wear & Tear
Odometer Condition	Odometer is working and in good condition
Controls/Switches/Gauges	3 - Normal Wear & Tear
Controls/Switches/Gauges Condition	All switches/gauges are in good condition and functioning
Brake System Type	Air Brakes
Air Brakes Build Correct Pressure	Yes
Clutch	0

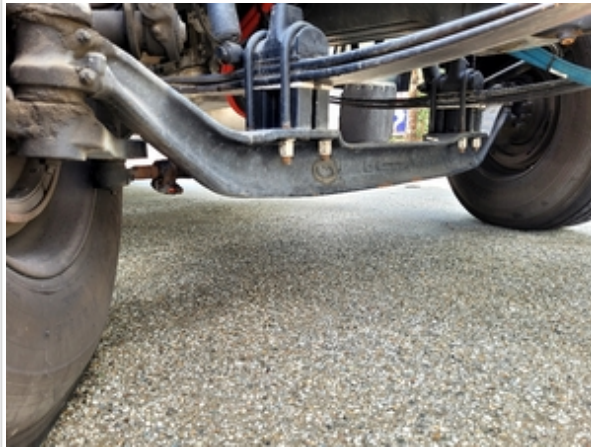
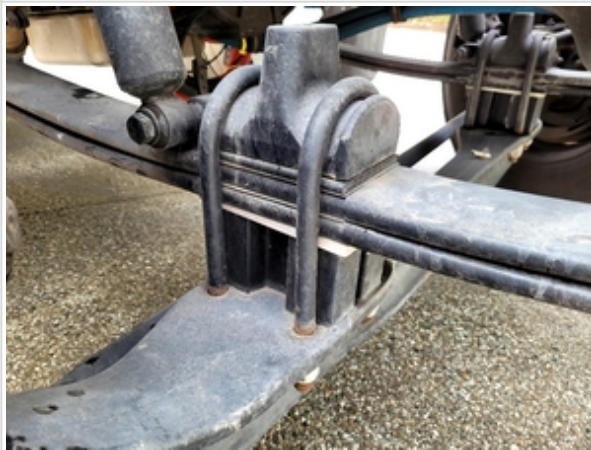
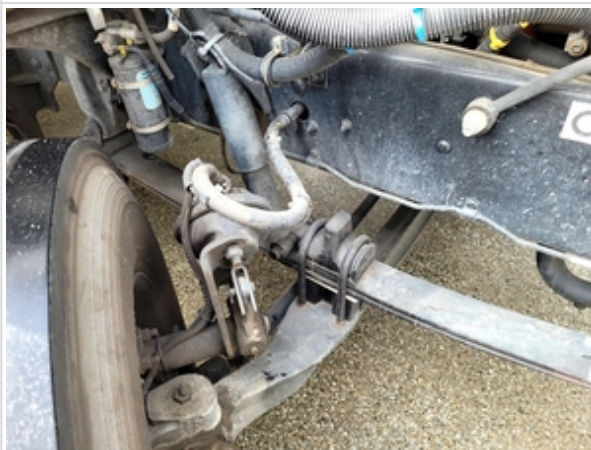
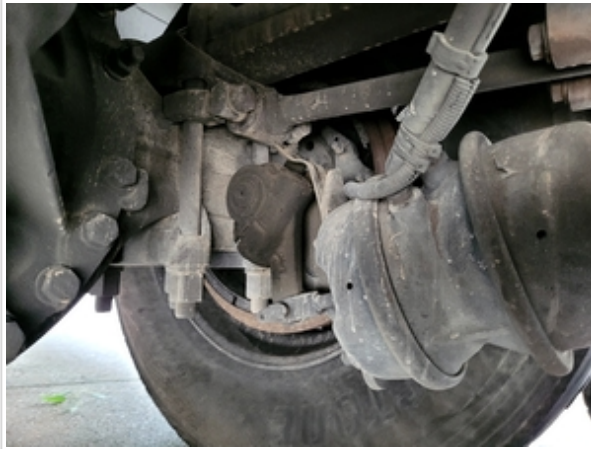
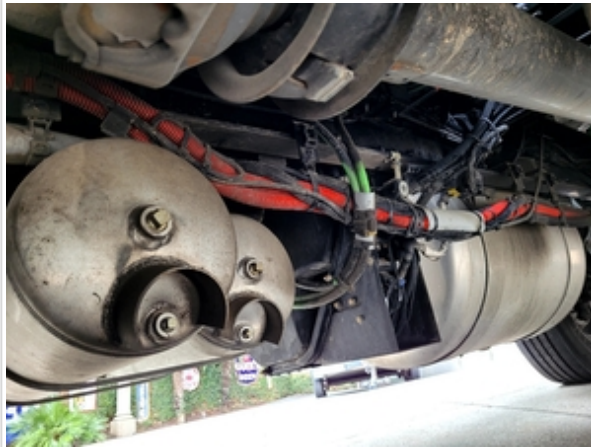
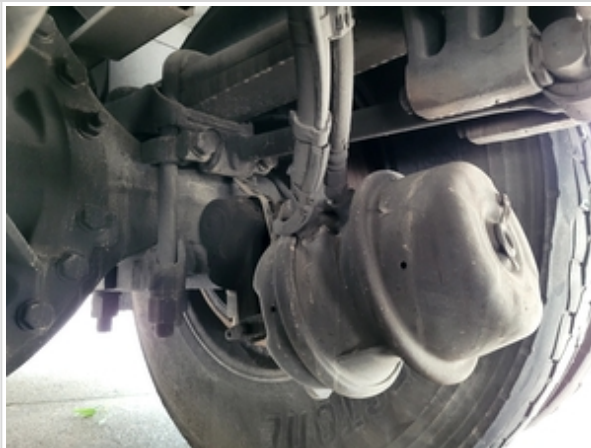
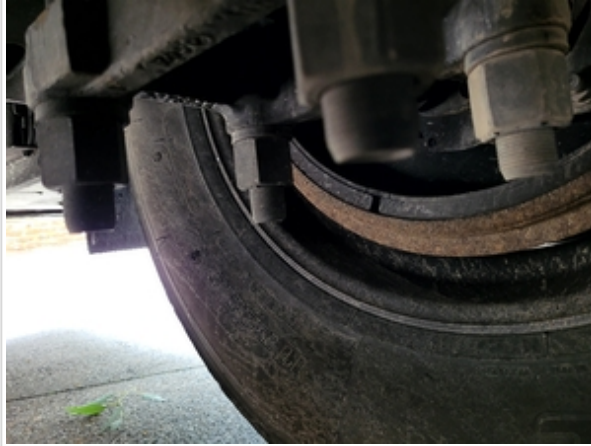
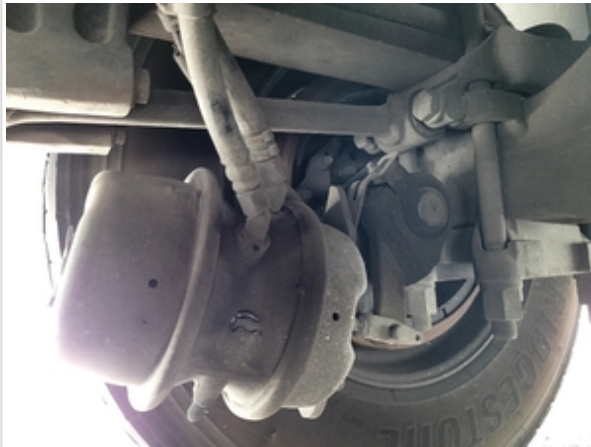
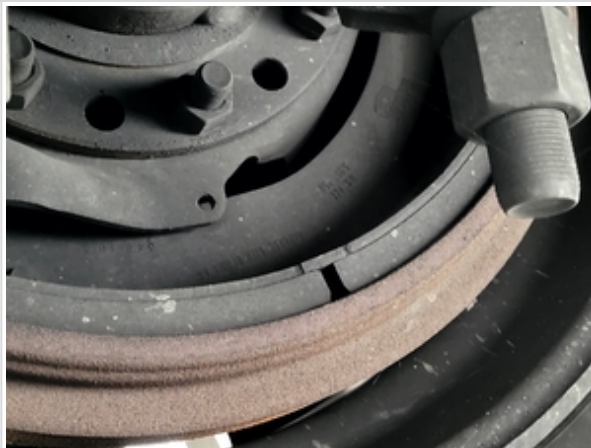
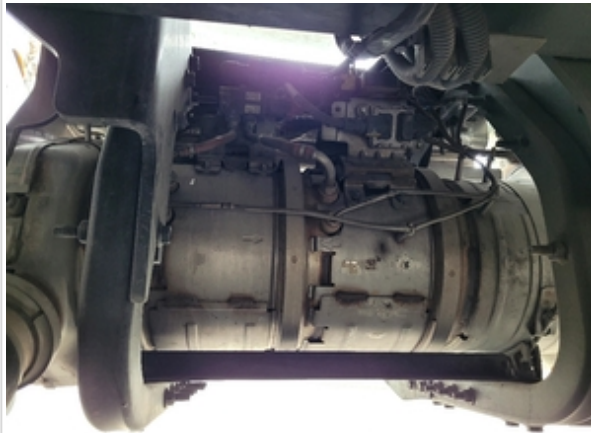
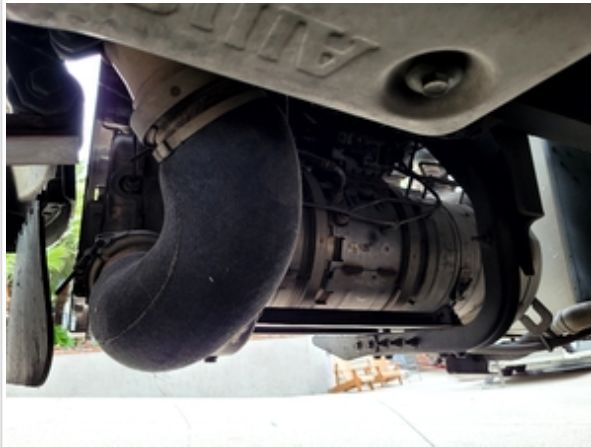
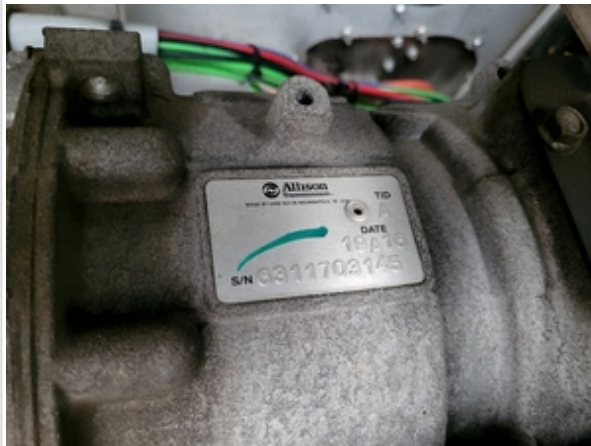
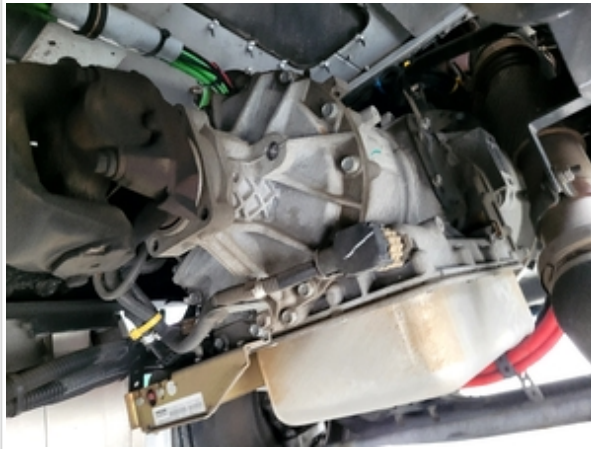
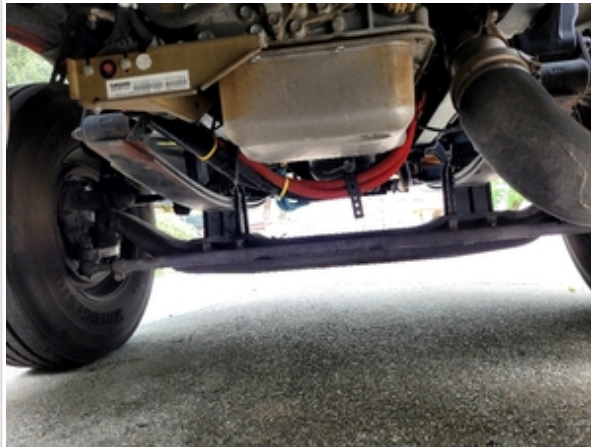
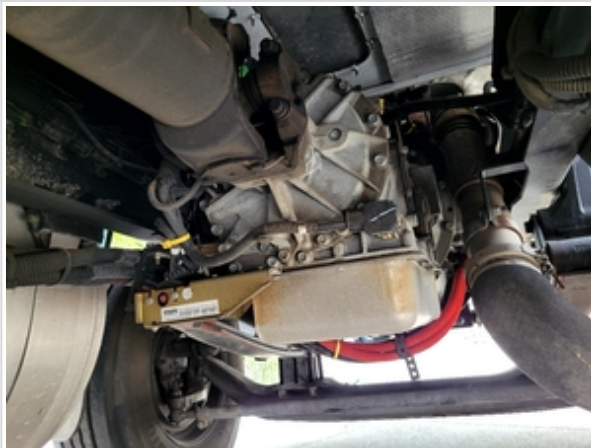
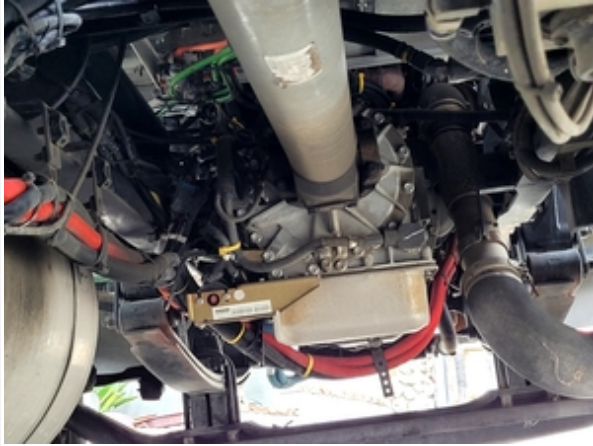
Frame	3 - Normal Wear & Tear
Suspension	3 - Normal Wear & Tear
Steer Axle Condition	3 - Normal Wear & Tear
Steering Components	3 - Normal Wear & Tear
Overall Chassis Condition	3 - Normal Wear & Tear
Overall Chassis Comments	Chassis in good condition. Rear tires showing small signs of abnormal wear possibly due to worn shocks and low tire tread.

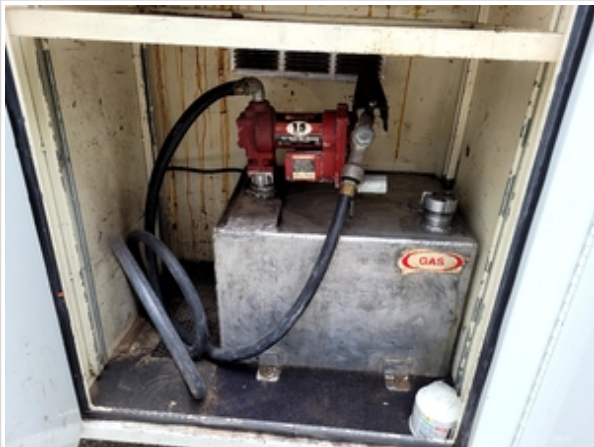
Fuel Tanks	Describe the number, configuration, capacity, and contents of all fuel tanks equipped on the vehicle
Number of Tanks	2
Fuel Tank(s) Contents & Capacity	20gal. Diesel Dispensing Fuel Tank, 15 Gal. Diesel Fuel Tank for (Mounted High Cycle Gen Set)
Fuel Tank(s) Exterior Condition	3
Comments	Aluminum custom made and inside tool box compartments
Fuel Tank Exterior Photos

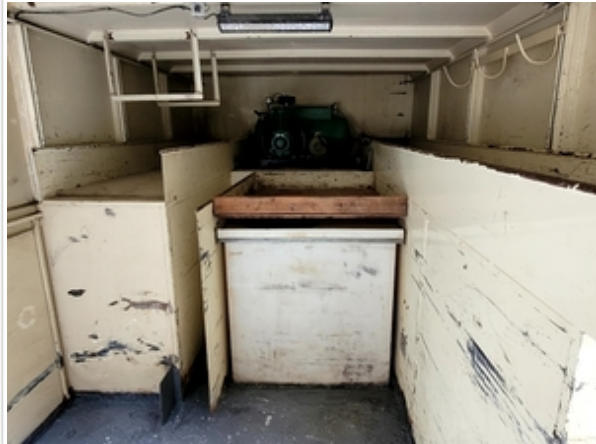
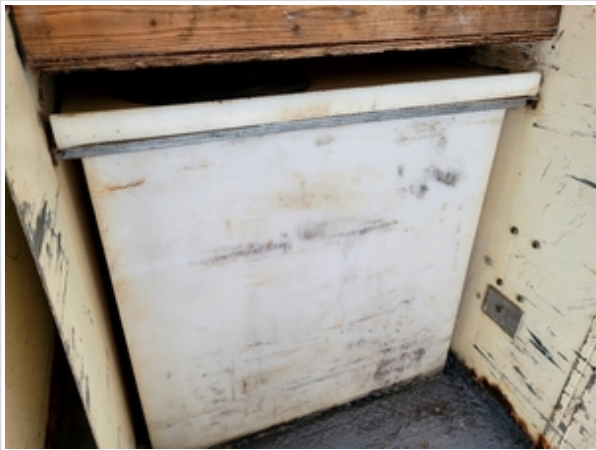
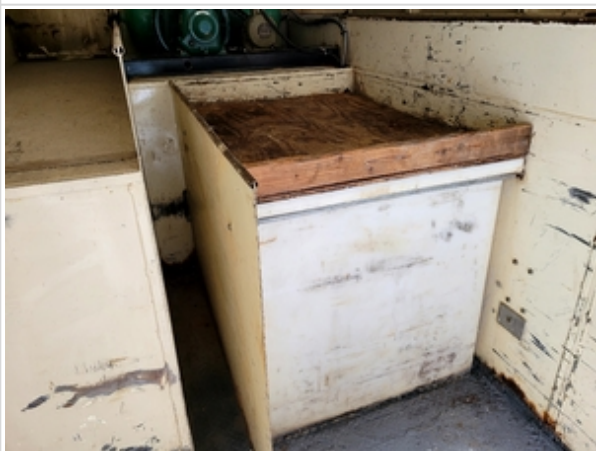
Oil & Fluid Reservoirs	Check the condition of the vehicle's hydraulic system
Number of Tanks	1
Pumps Installed on Tanks	Yes
Number of Pumps	1
Tank Configuration (Contents, Capacities)	Fixed mounted 200 Gallon Plastic water tank (electric pump mounted externally underneath truck)
Exterior Tank(s) Condition	3
Exterior Tank(s) Photos

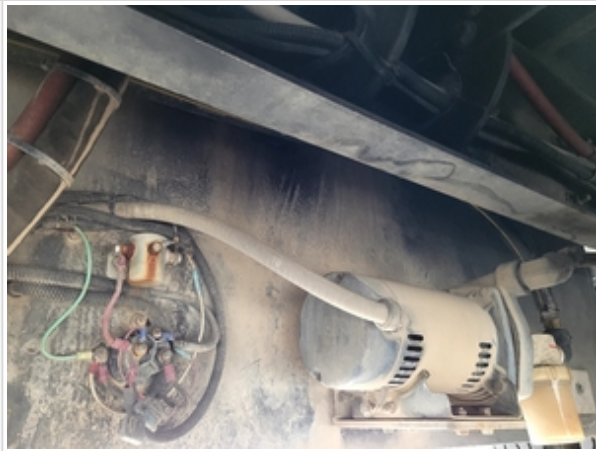
Mounting Bolts	3	
Interior Tank(s) Condition	0	
Pump(s) Appearance	3	
Comments	Water pump not tested during inspection	
Pump(s) Photos

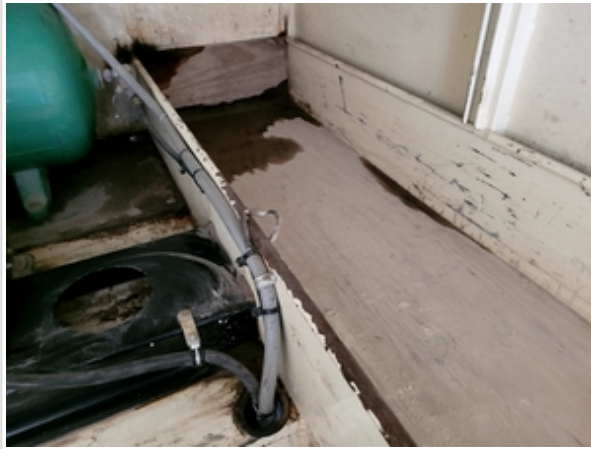
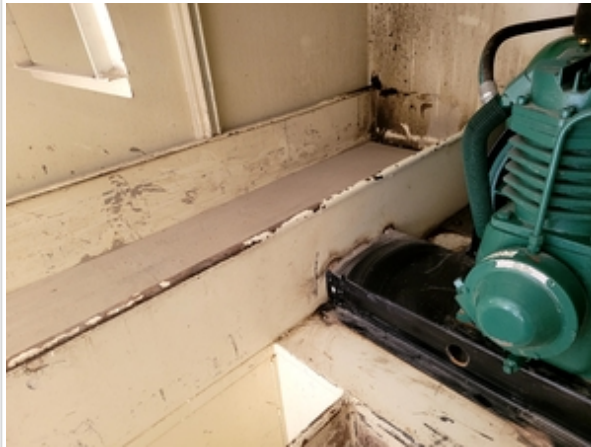
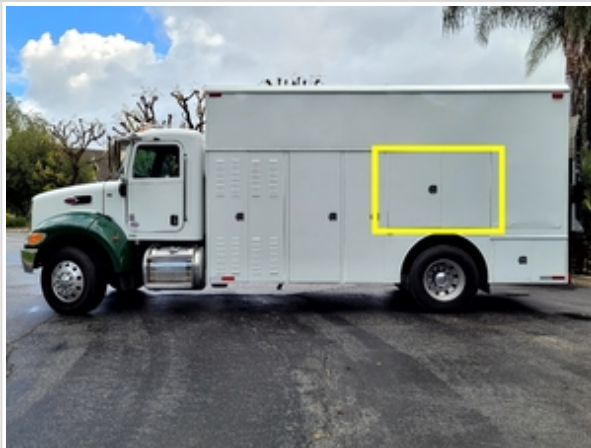
highlighted cabinet fixed shut

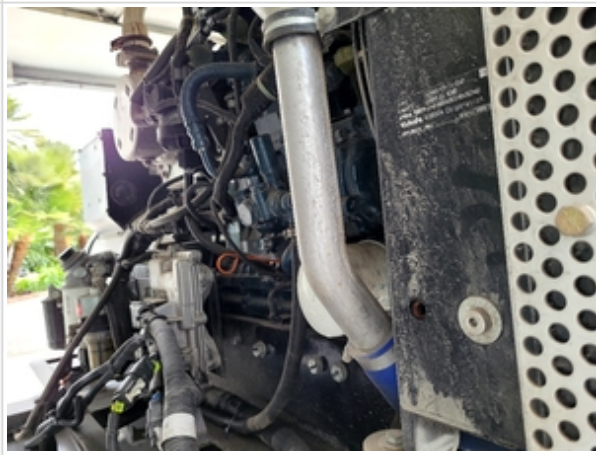
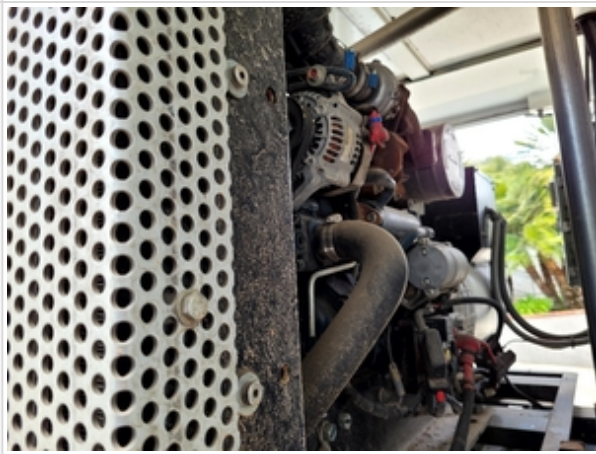
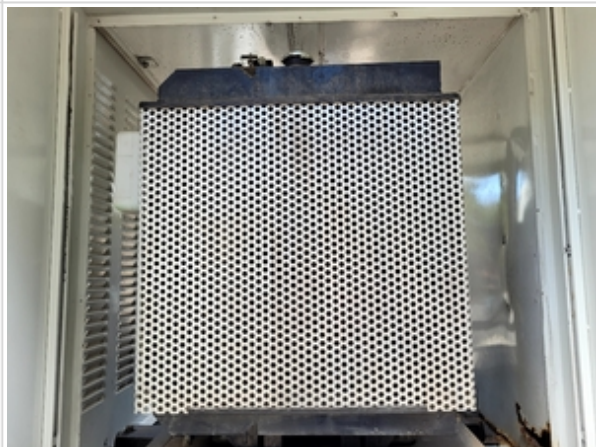
Attachment Type	High Cycle Gen. Set (For powering concrete cutting equipment) Onan compact generator at rear for low voltage uses & Champion electric powered 30 gallon capacity air compressor
Attachment Make	Mecc Alte High Cycle Gen. Set/Bollard MGC-22-HN 1(Custom)
Attachment Size / Specs	70kVA / 400Hz / 3 Phase / 120-240V
Attachment Condition	3 - Normal Wear & Tear
Comments	Unit Fixed Mounted in front side of tool storage
Attachment Photos
