## Inspection Report (On-Highway Service Truck)

Year	2015
Make	Ford
Model	F350
Serial Number	1FDBF3A64FEC15562
Truck Odometer Reading	130,495
Current Inspection / State Cert / DOT	N/A
Previous Application (e.g., earth moving, mining, demolition, etc)	Concrete Cutting General Contractor

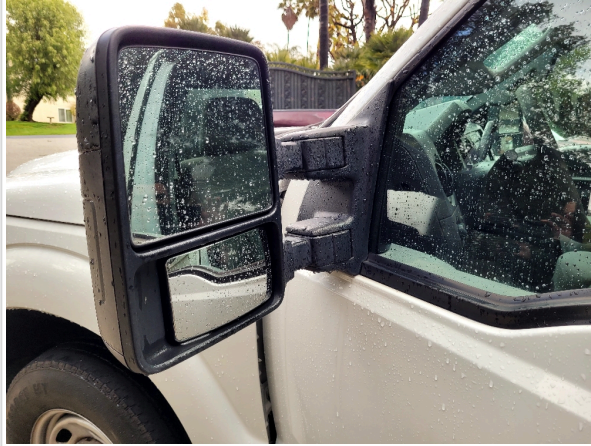
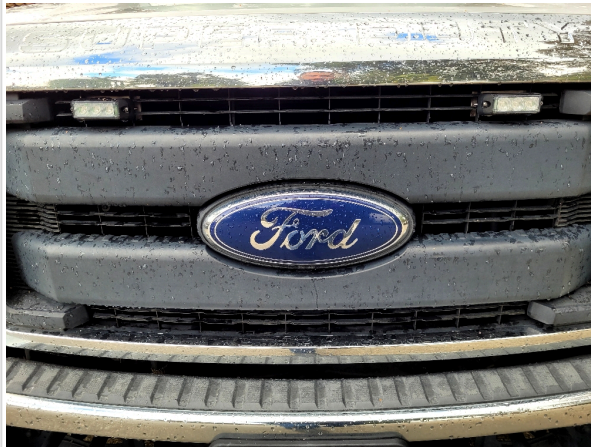
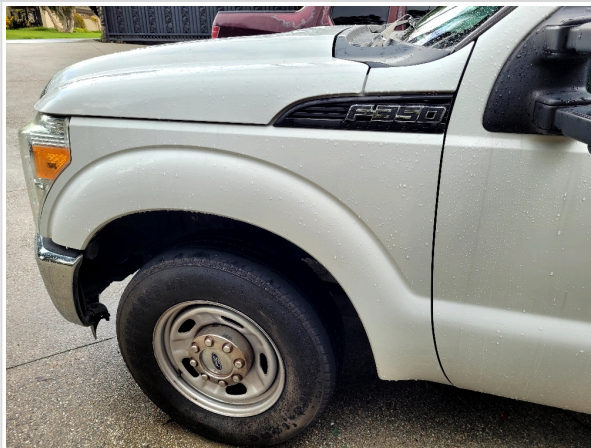
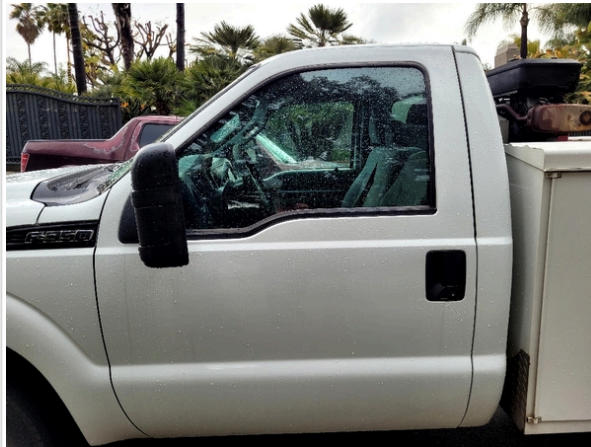
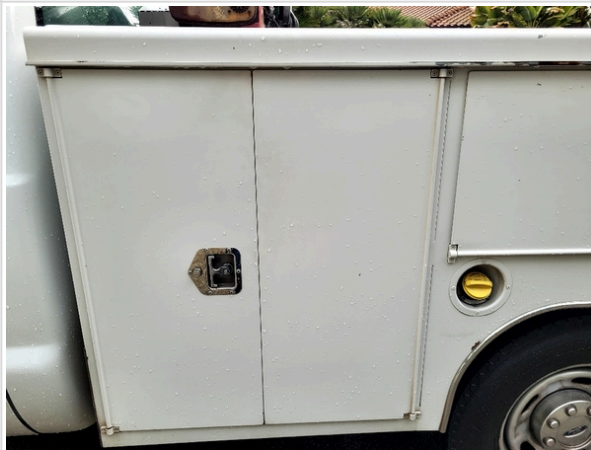
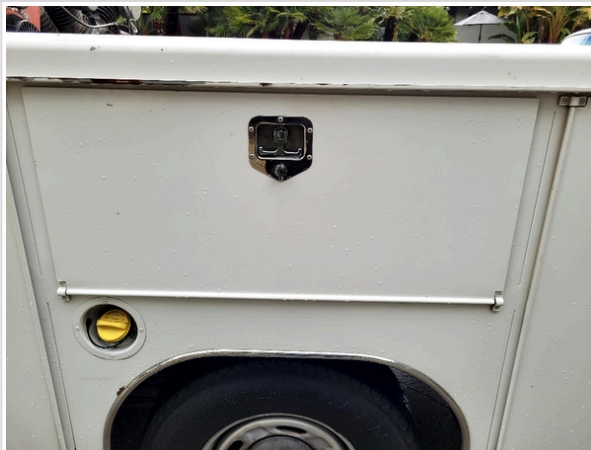
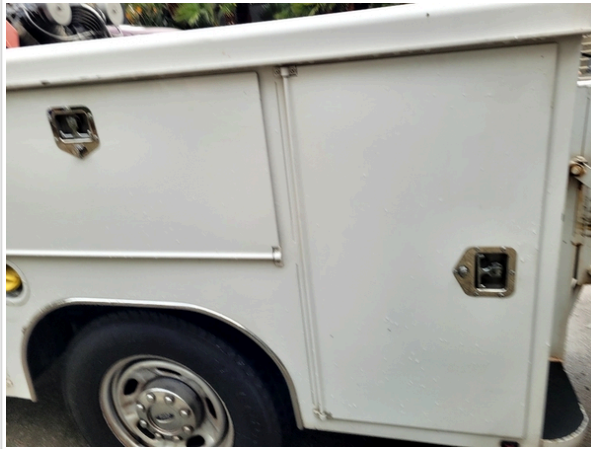
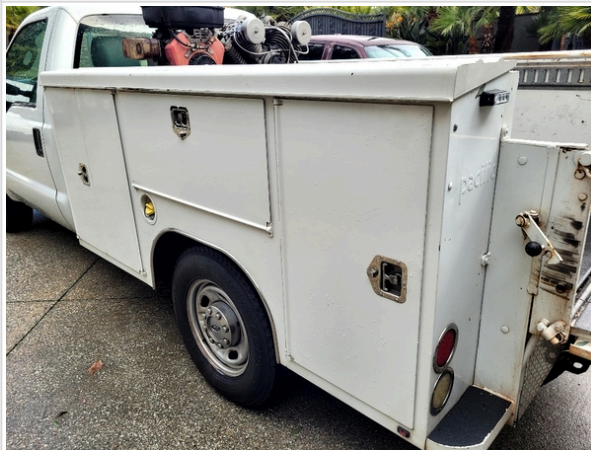
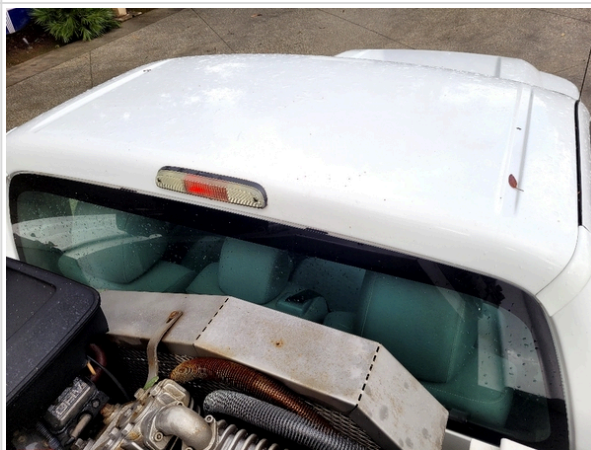
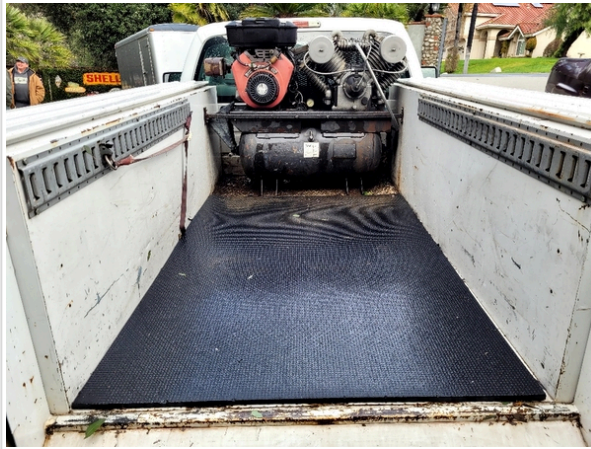
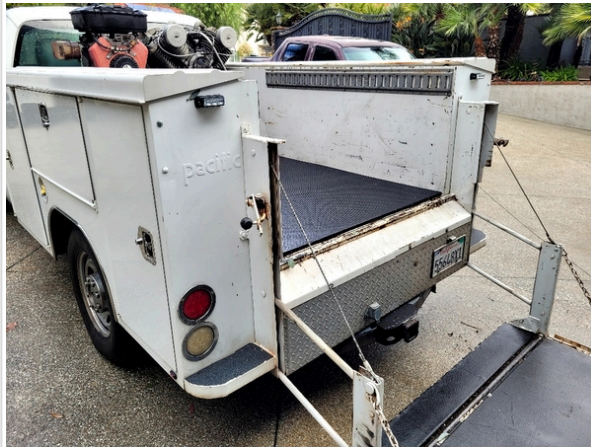
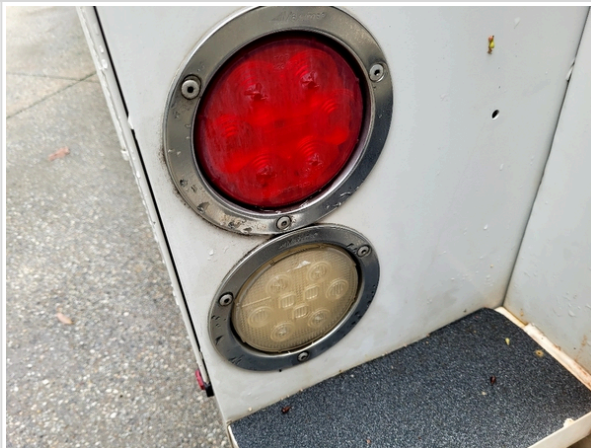
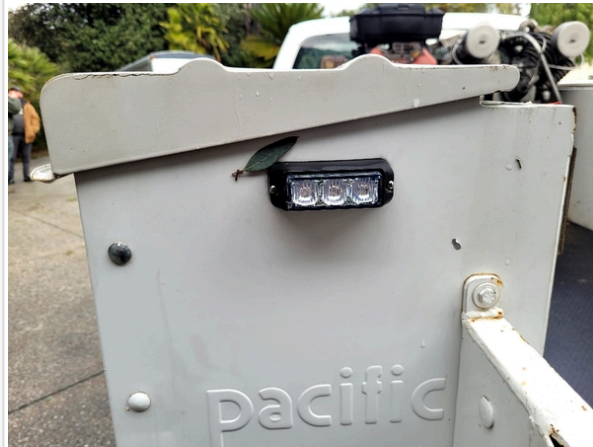
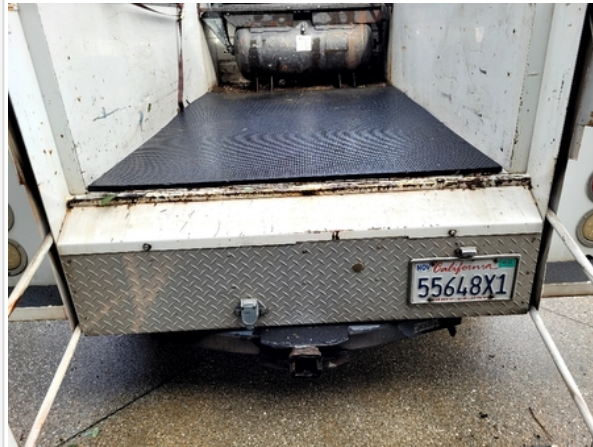
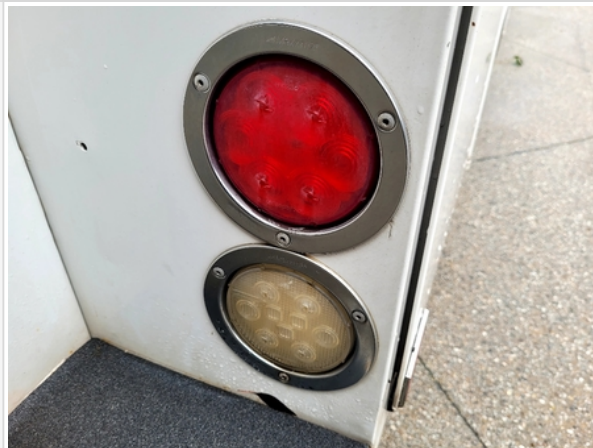
Close-up Exterior Photos

<b>Body Panels</b>	3 - Normal Wear & Tear	
<b>Body Panel Condition</b>	No visible damage, good paint condition and panel fitment	
<b>Doors / Canopy Latches</b>	3 - Normal Wear & Tear	
<b>Doors / Canopy Latches Condition</b>	No visible damage	
<b>Steps / Ladders</b>	3 - Normal Wear & Tear	
<b>Steps / Ladders Condition</b>	Steps/ladders are fully intact and appear structurally sound	
<b>Handrails</b>	3 - Normal Wear & Tear	
<b>Handrails Condition</b>	Handrails are fully intact and appear structurally sound	
<b>Glass</b>	3 - Normal Wear & Tear	
<b>Glass Condition</b>	Glass intact, no visible damage	
<b>Mirrors</b>	3 - Normal Wear & Tear	
<b>Mirror Condition</b>	Mirrors present and intact, no visible damage	
<b>Exterior Lights</b>	3 - Normal Wear & Tear	
<b>Exterior Lights Condition</b>	No visible damage, lighting system is operational

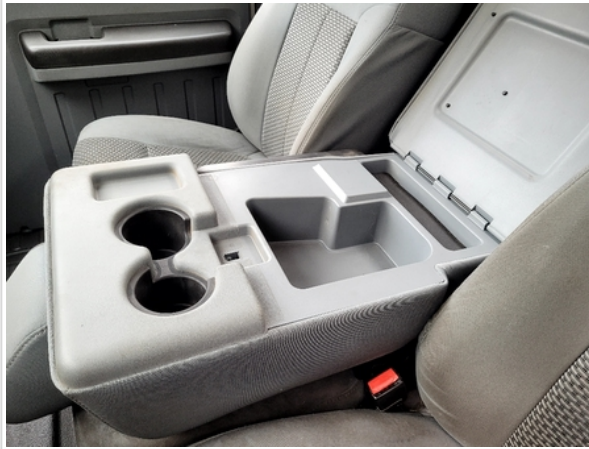
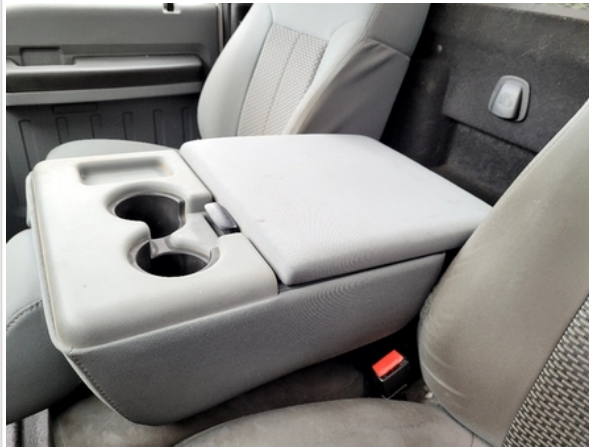
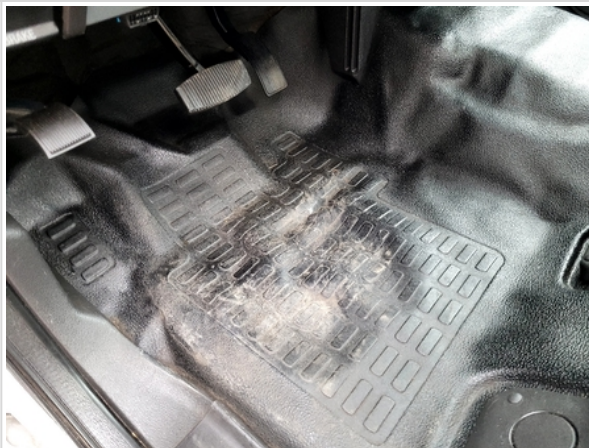
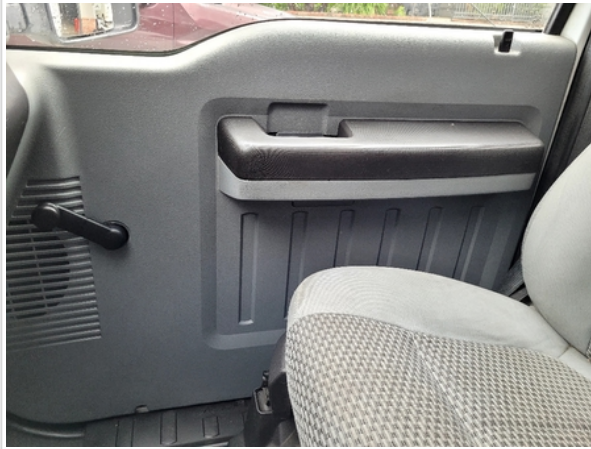
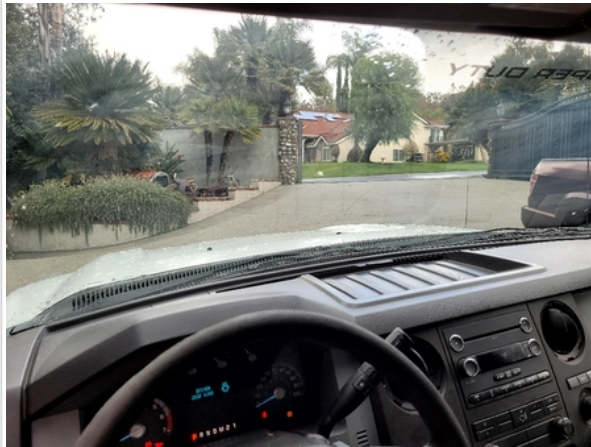
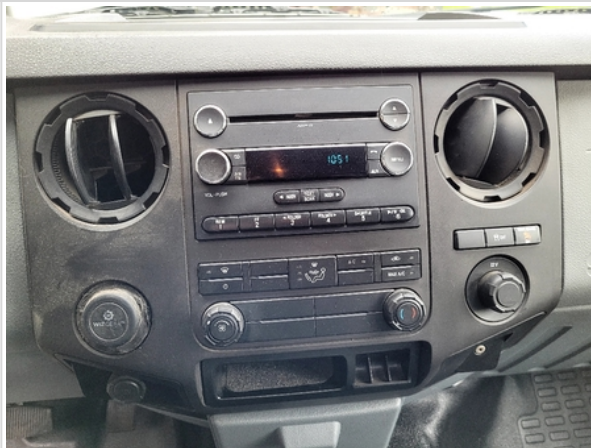
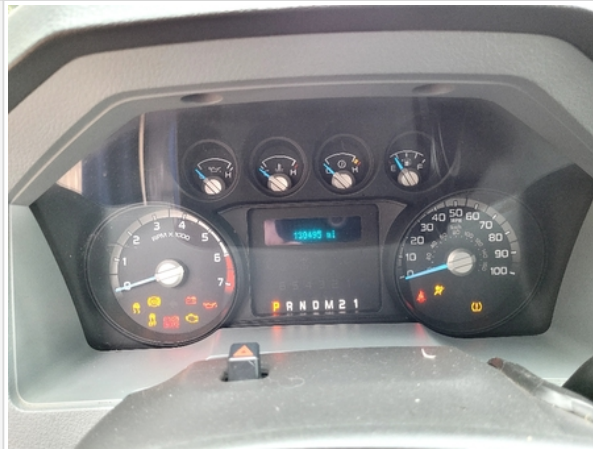
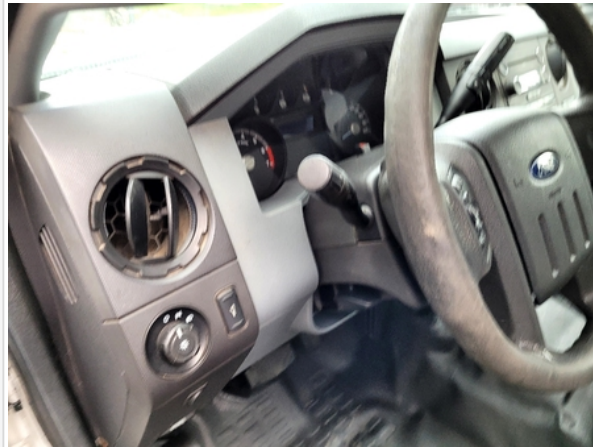
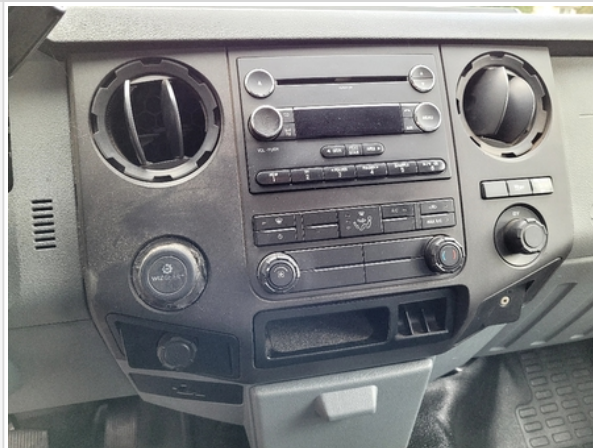
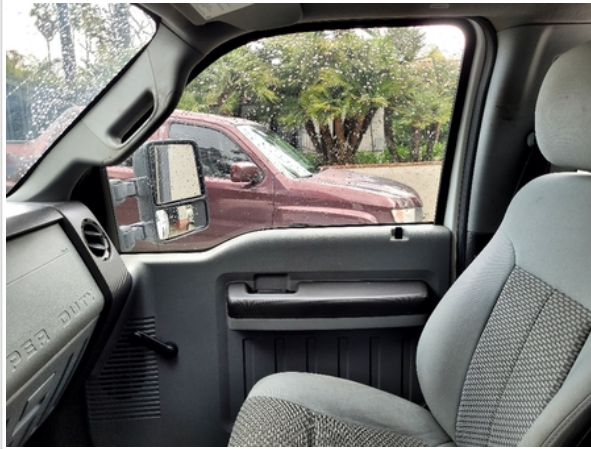
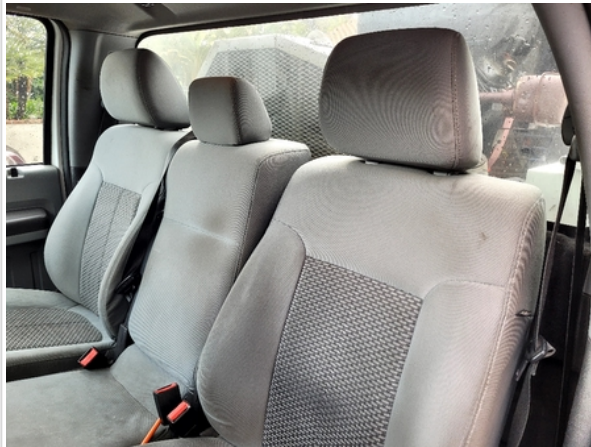
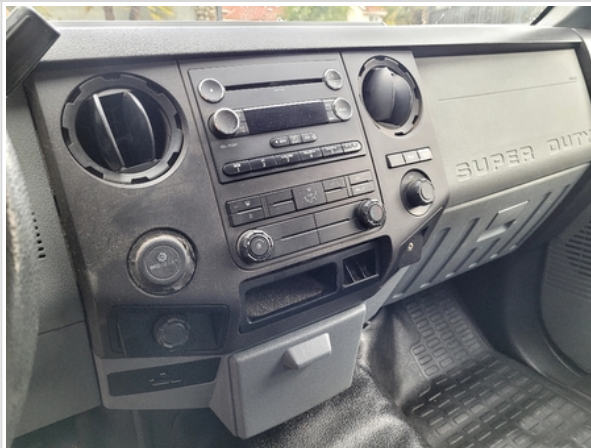
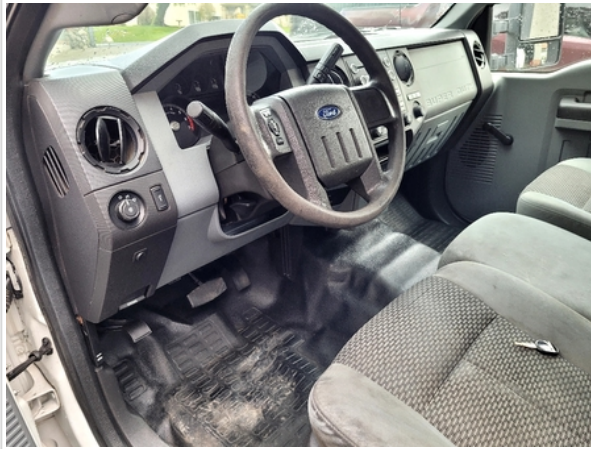
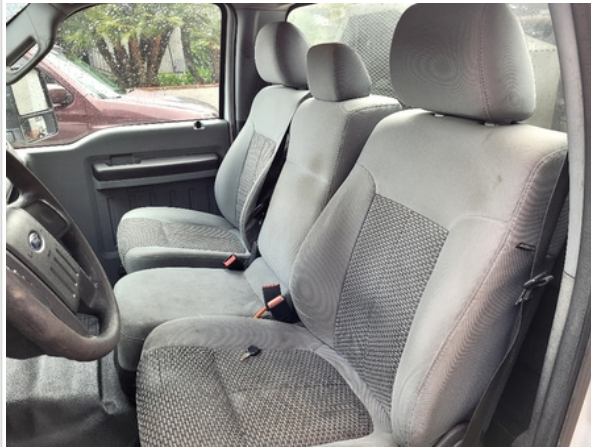
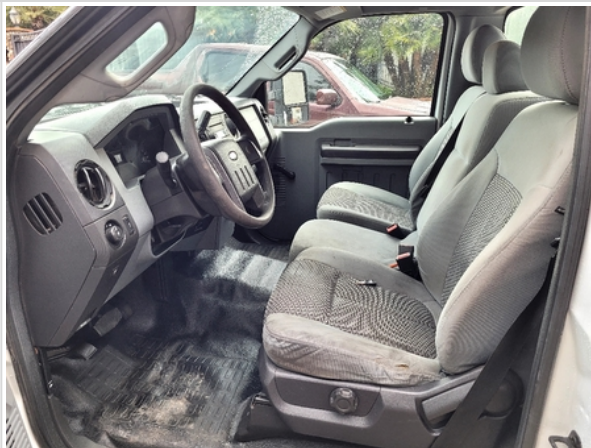
Odometer Activity	3 - Normal Wear & Tear
Odometer Condition	Odometer is working and in good condition
Controls/Switches/Gauges	3 - Normal Wear & Tear
Controls/Switches/Gauges Condition	All switches/gauges are in good condition and functioning
Brake System Type	Hydraulic
Clutch	0
Horn	3 - Normal Wear & Tear
Horn Condition	Horn is functioning as expected
Reverse Alarm / Backup Camera	0
Heater & A/C	3 - Normal Wear & Tear
Heat & A/C Condition	Heater and A/C work as expected
Interior Lights	3 - Normal Wear & Tear
Interior Lights Condition	All interior lights are installed and functioning
Seats/Seat Belts	3 - Normal Wear & Tear
Seats/Seat Belt Condition	Seat(s) in good condition, no stains or tears in upholstery
Cab Interior Overall Rating	3 - Normal Wear & Tear

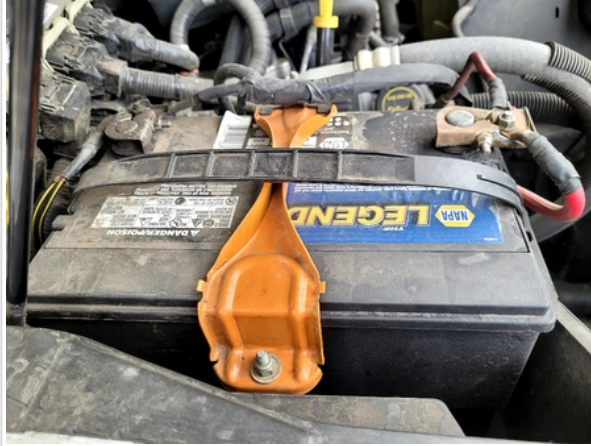
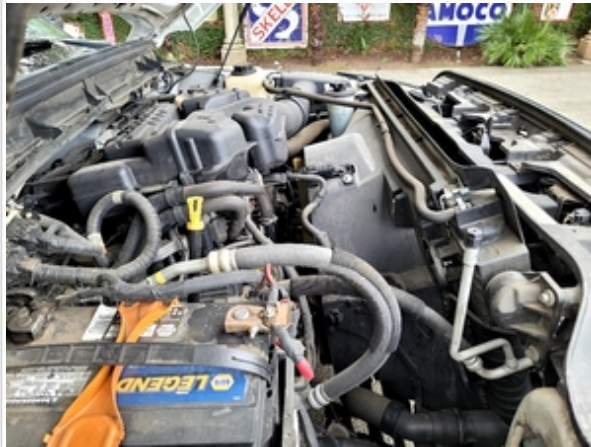
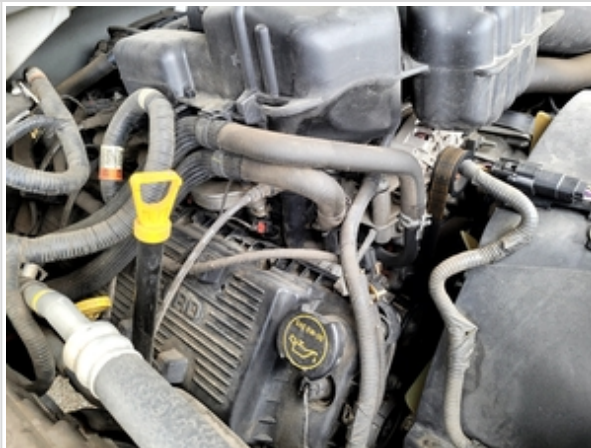
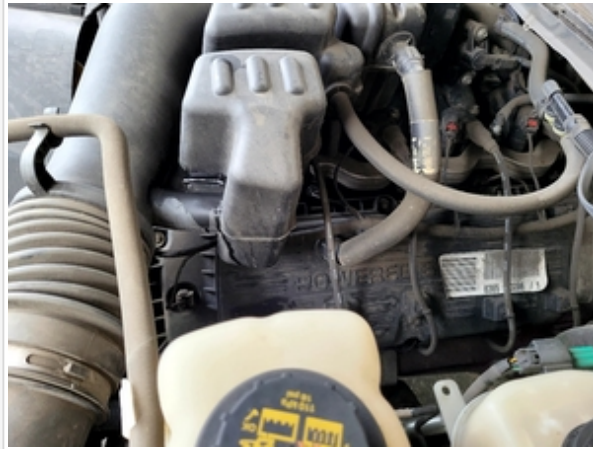
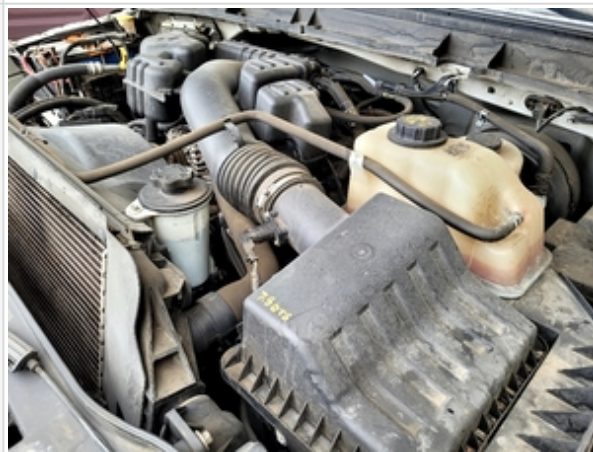
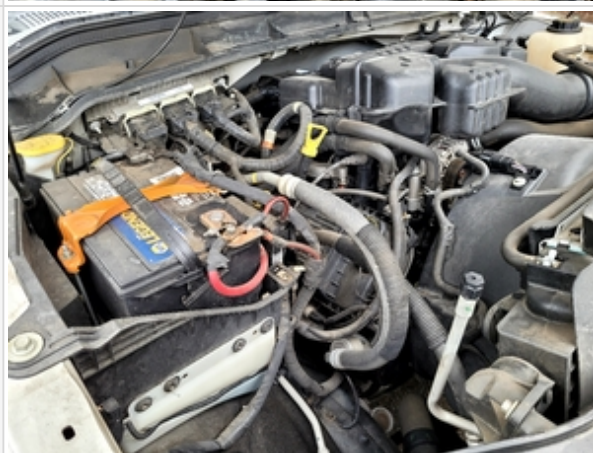
Engine Photos

Equipped with DPF (Diesel Particulate Filter)	No
Requires DEF (Diesel Exhaust Fluid)	No
Overall Engine Appearance	Clean & dry
Overall Engine Comments	Overall engine has well maintained appearance and no issues observed during inspection.

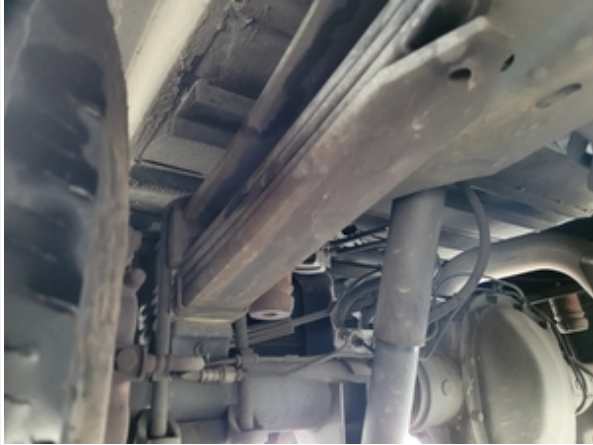
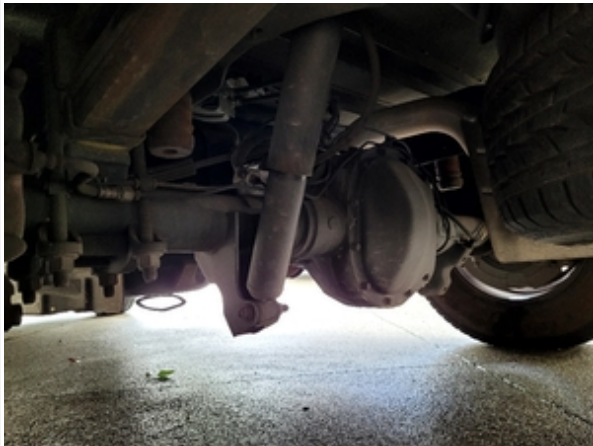
Chassis Inspection Points	Take photos of all undercarriage and chassis components including frame, suspension, axles, steering, and brake components. Note any damage or wear.	
Chassis & Undercarriage Photos

<b>Frame</b>	3 - Normal Wear & Tear	
<b>Suspension</b>	3 - Normal Wear & Tear	
<b>Steer Axle Condition</b>	0	
<b>Steering Components</b>	3 - Normal Wear & Tear	
<b>Overall Chassis Condition</b>	3 - Normal Wear & Tear	
<b>Overall Chassis Comments</b>	Overall Chassis in good shape. Suspension and rear axle have no signs of issues. Frame solid and steering components working well.

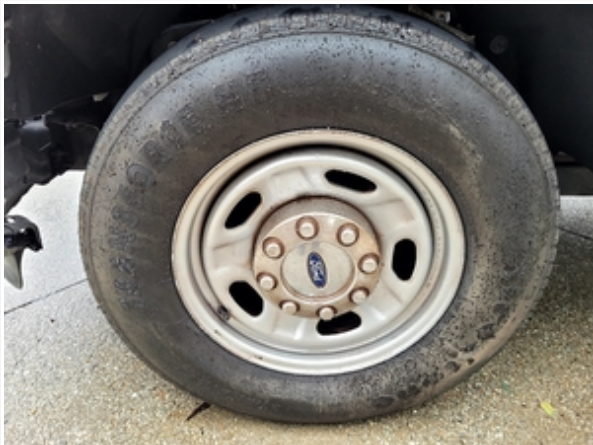
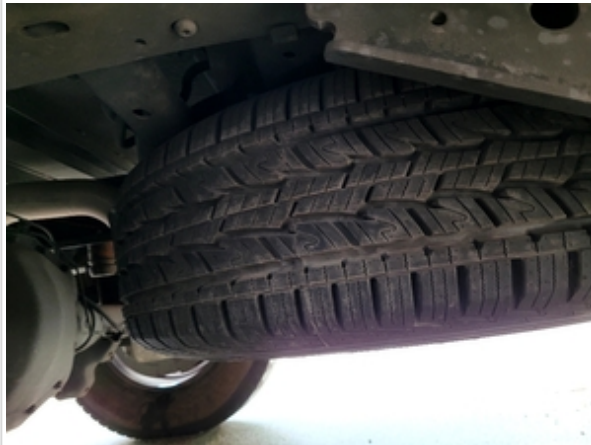
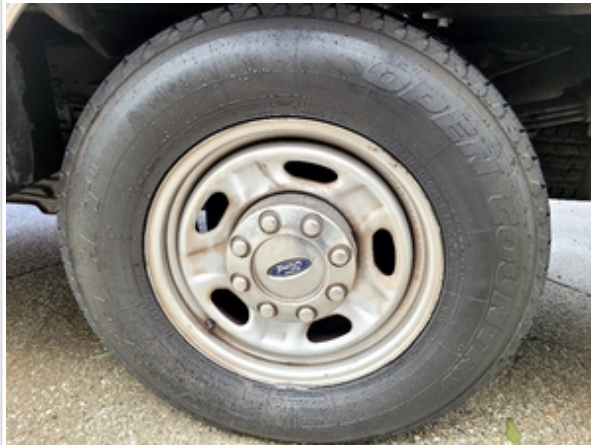
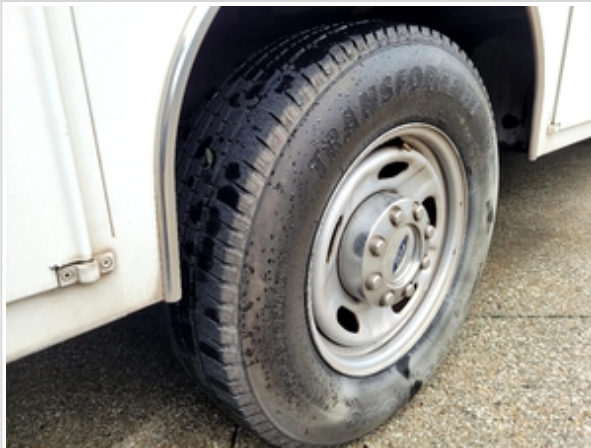
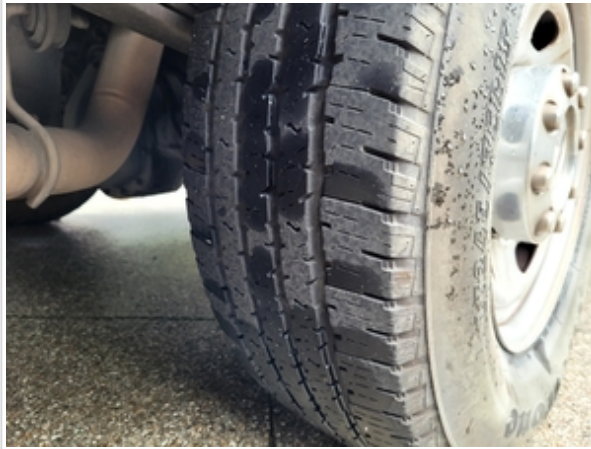
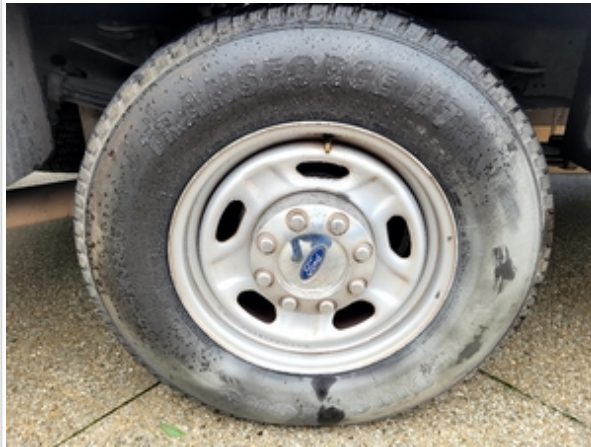
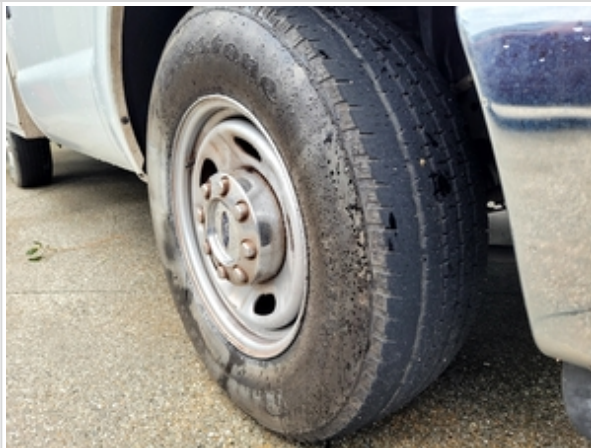
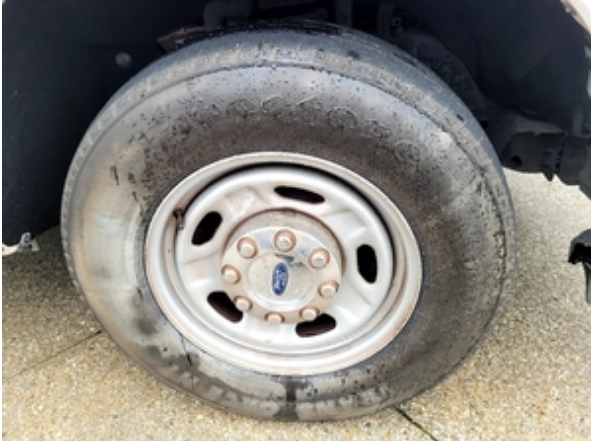
Wheels & Hub Condition	3
Wheels & Hub Photos

<b>Wheel Seal Leaks</b>	No
<b>Tire Brand</b>	Firestone
<b>Tire Size</b>	LT245/75R/17
<b>Front Left Tire - Ratio Remaining</b>	30%
<b>Front Left Tire Photos</b>

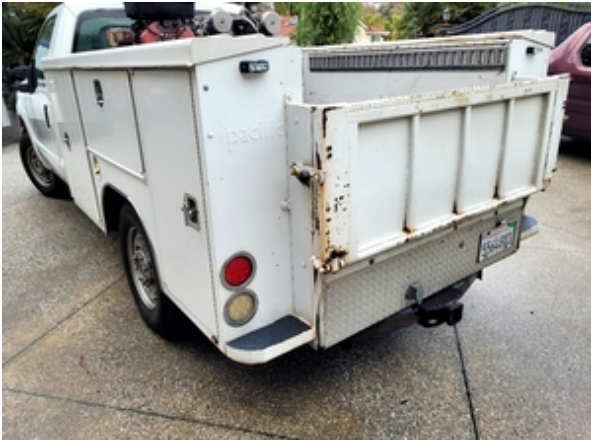
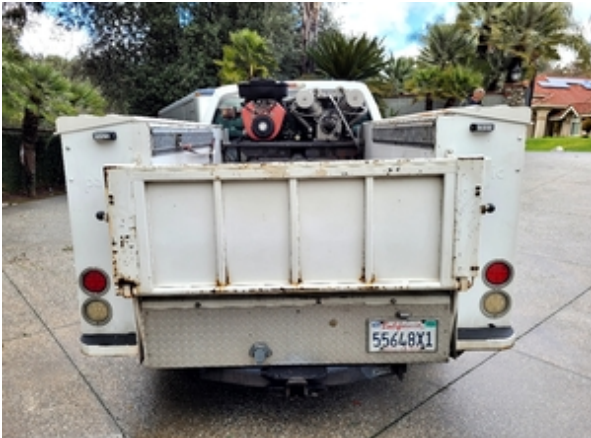
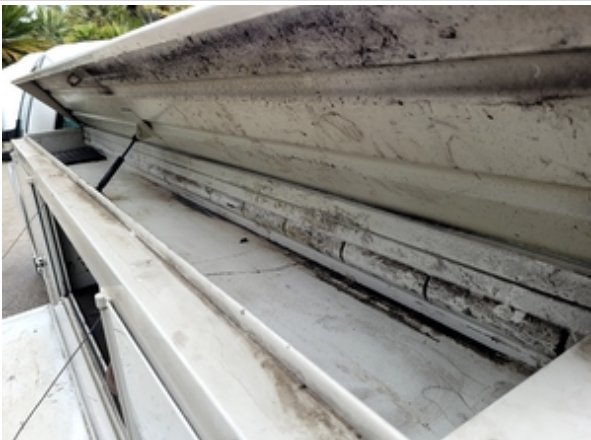
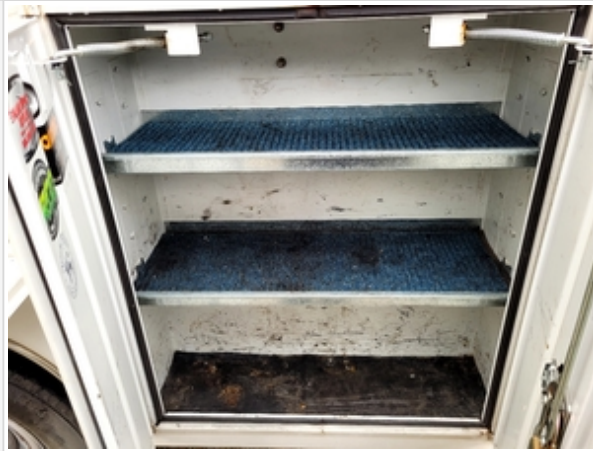
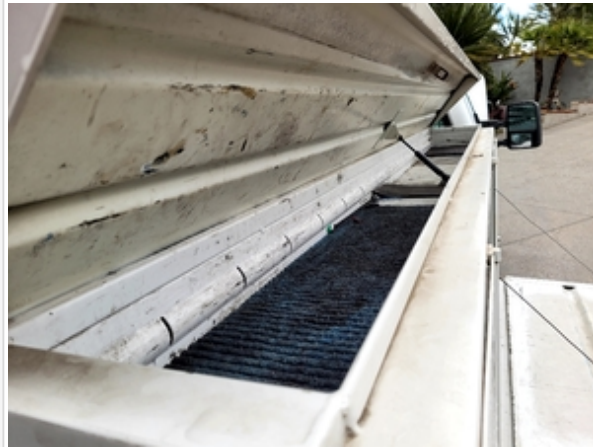
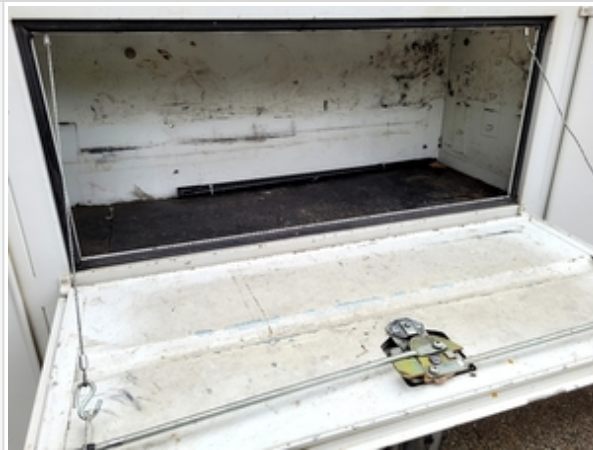
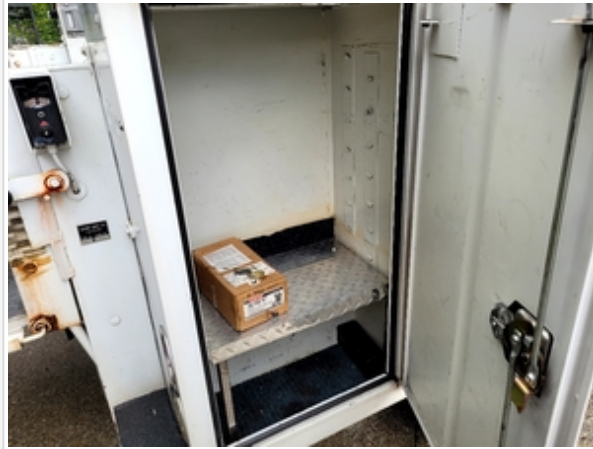
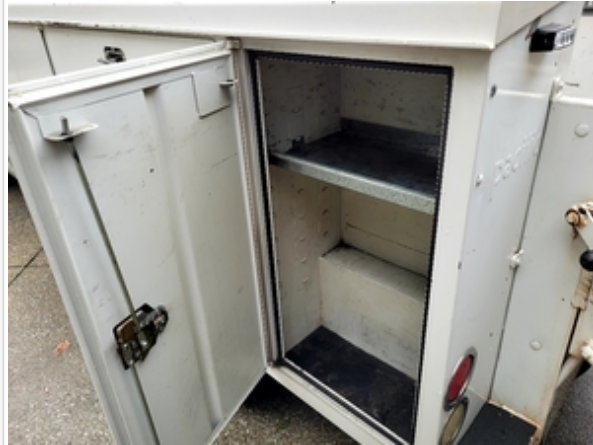
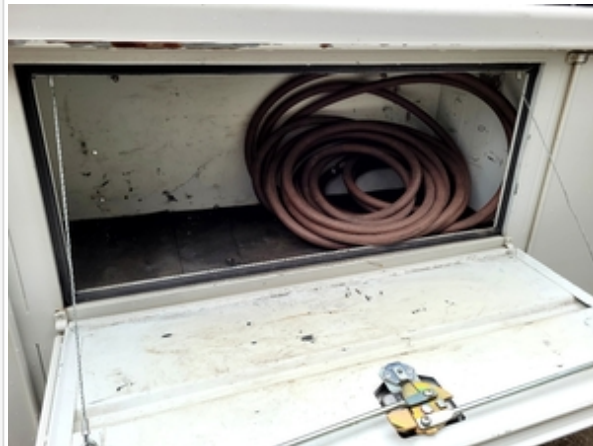
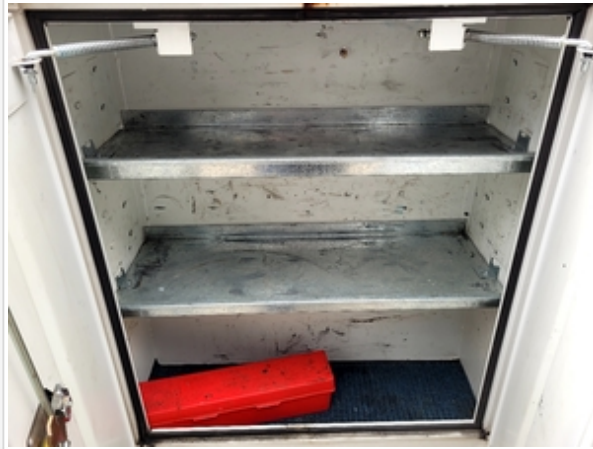
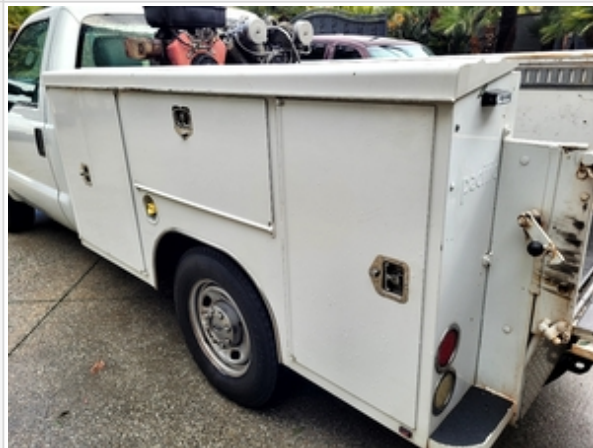
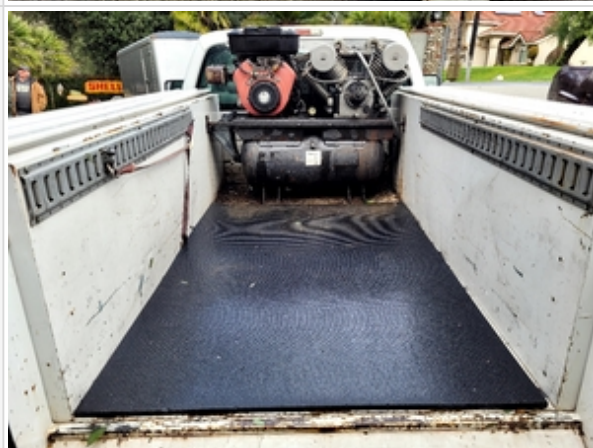
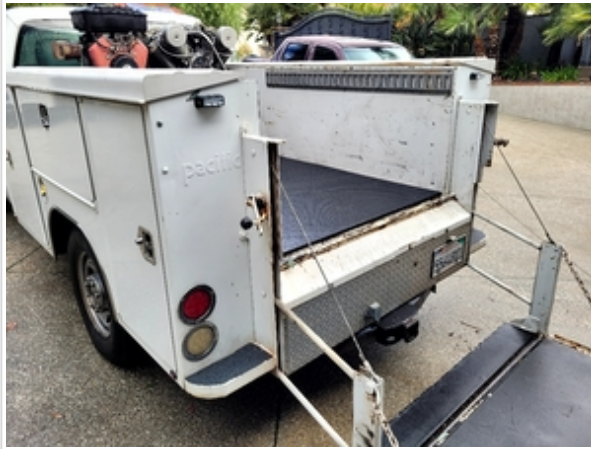
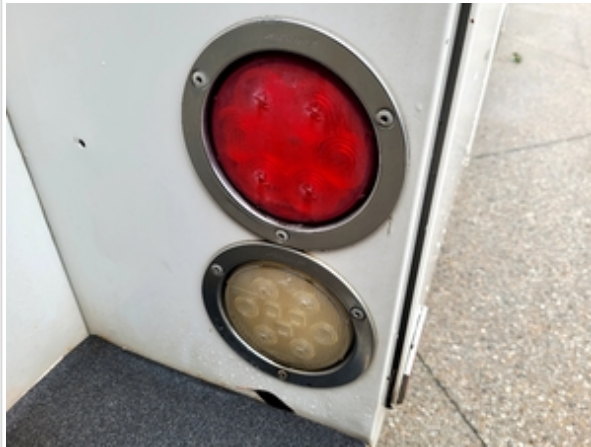
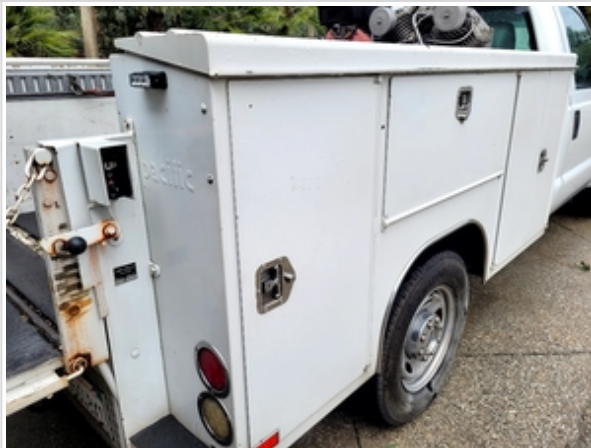
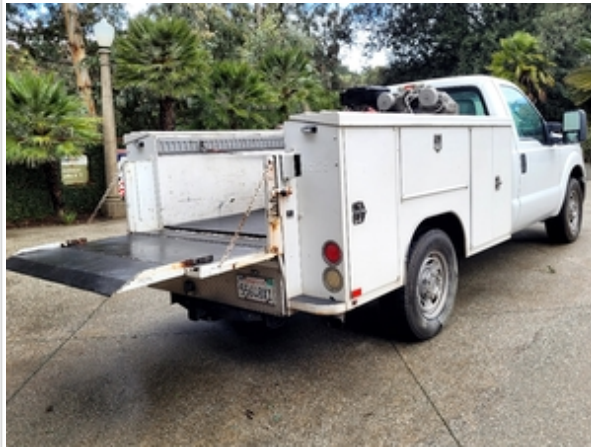
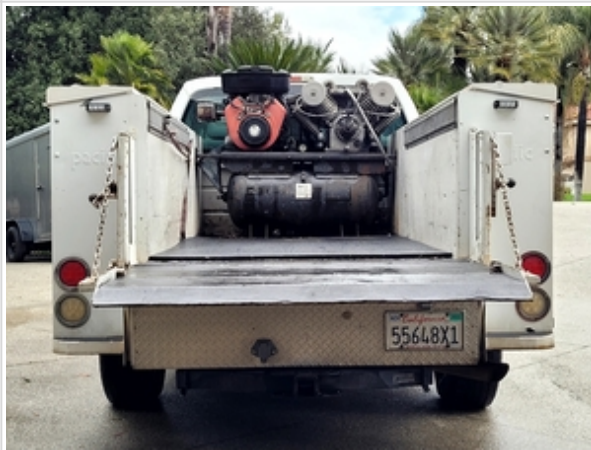
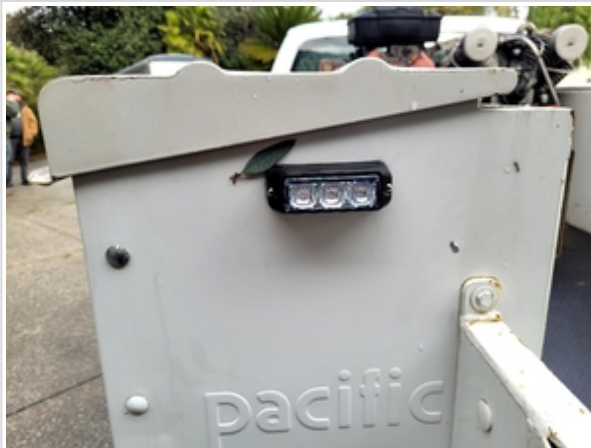
Tool Truck Body	Check the condition of the tool truck bed body, tool boxes (interior and exterior), and lift gate (if equipped).
Bed Body	3
Comments	Pacific 8' Utility Body with Top Storage Cabinets and Liftgate
Bed Body Photos

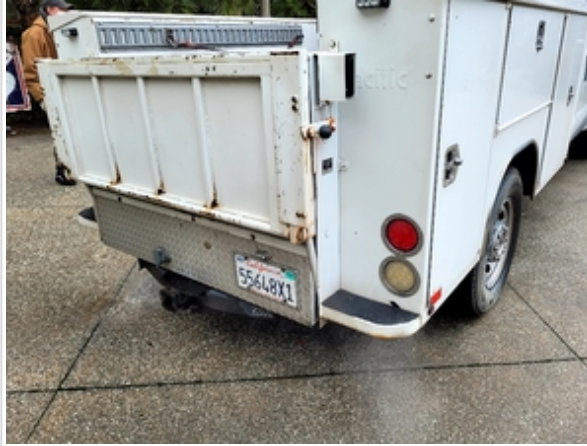
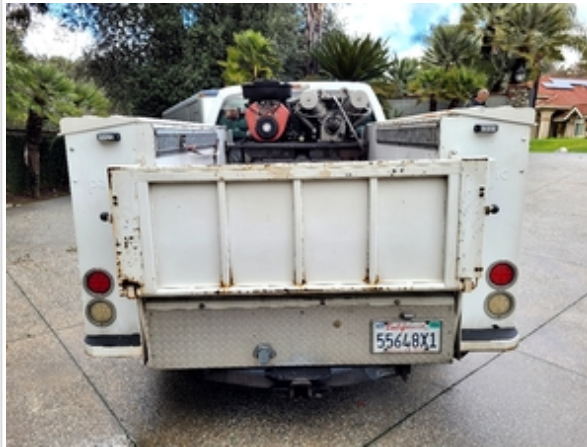
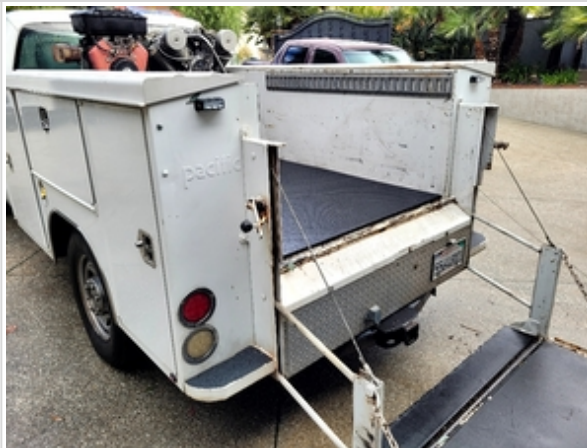
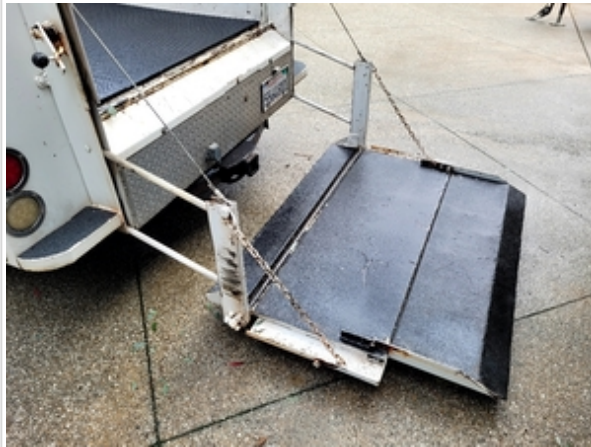
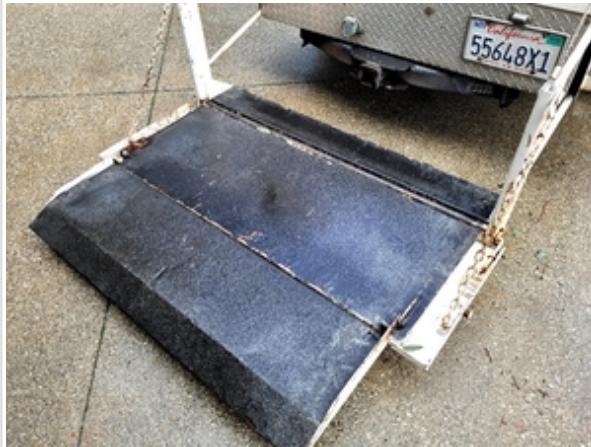
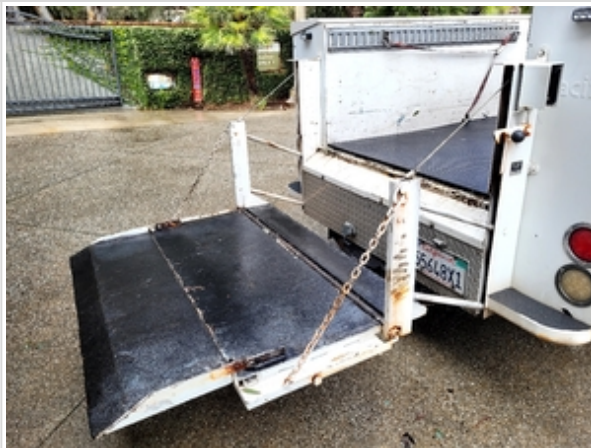
Liftgate Photos

Toolboxes	3
Liftgate Function	3
