Inspection Report (Skid Steer)

Year	2015
Make	Bobcat
Model	S530
Serial Number	ALR813107
Hour Meter Reading	2,660 Hours
Previous Application (e.g., earth moving, mining, demolition, etc)	Rental Equipment

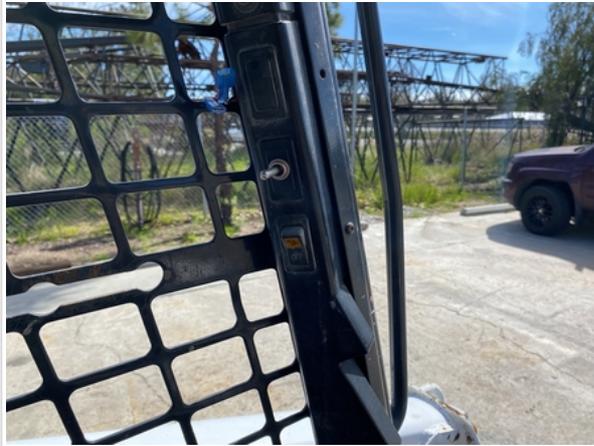
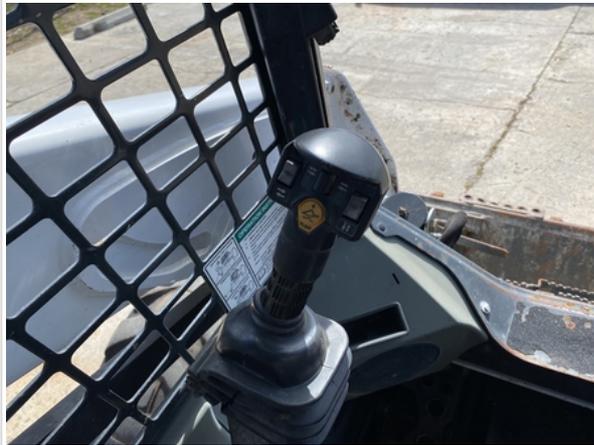
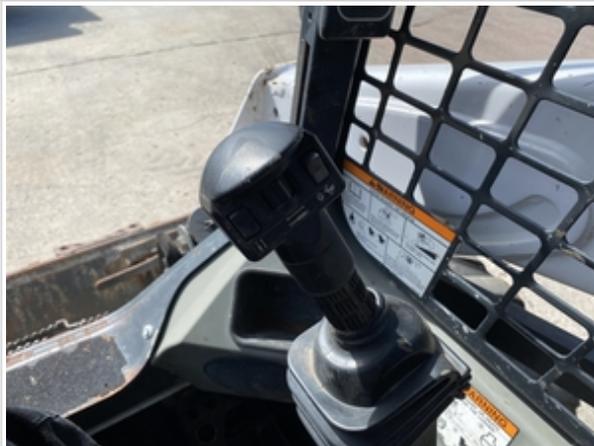
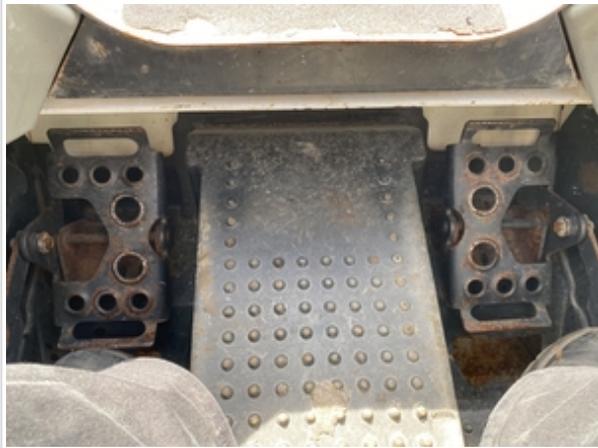
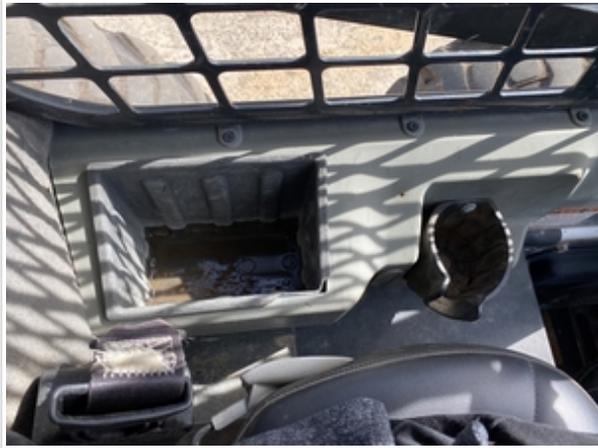
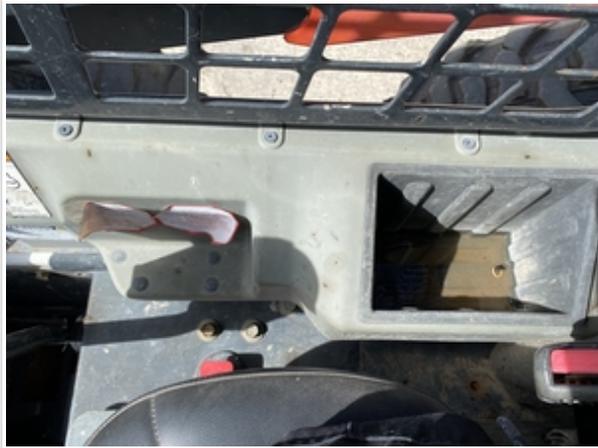
Operator Cabin Overall	3 - Normal Wear & Tear
Operator Cabin Overall Condition	Minor cosmetic wear to cabin surfaces, floors, panels, and ceiling
Comments	Normal wear and tear. Seat in good shape.
Operator Seat	3 - Normal Wear & Tear
Operator Seat Condition	Seat(s) in good condition, no stains or tears in upholstery

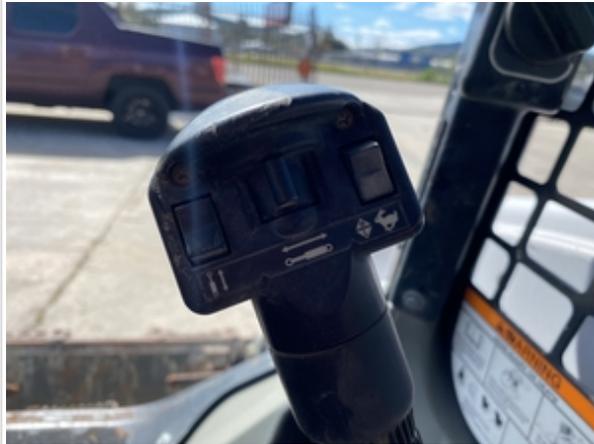
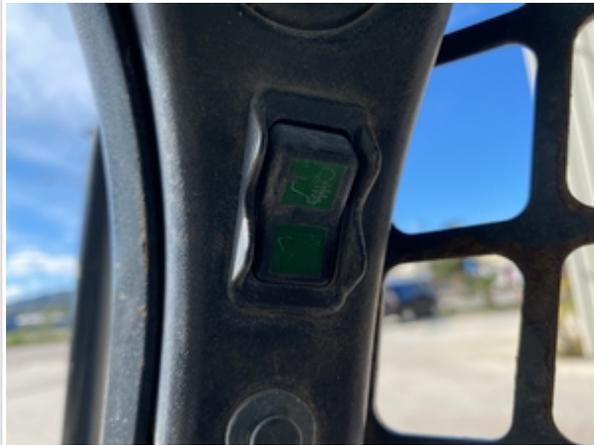
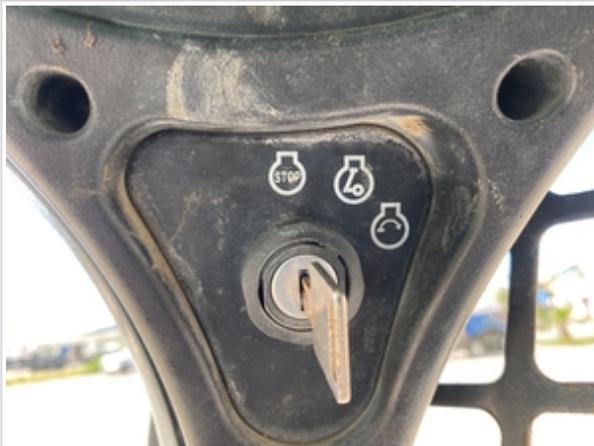
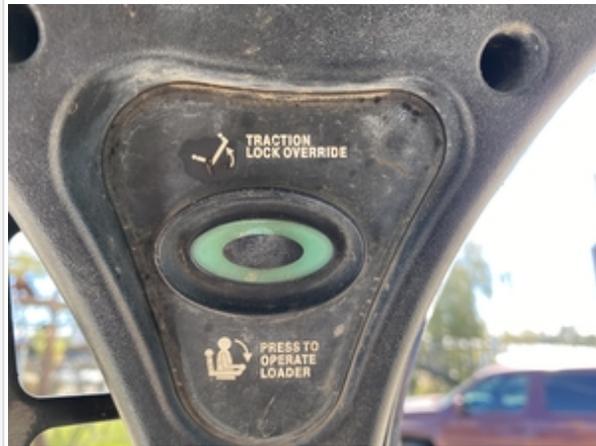
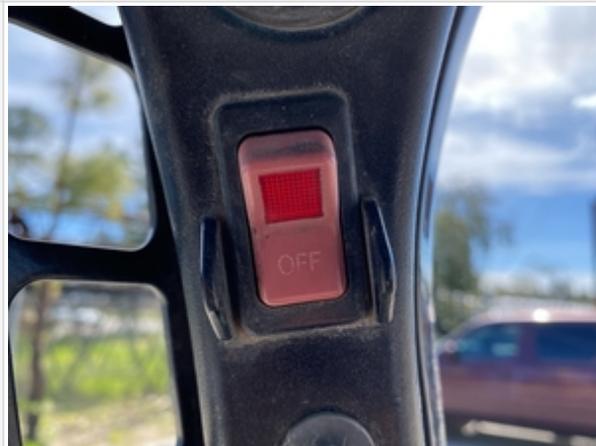
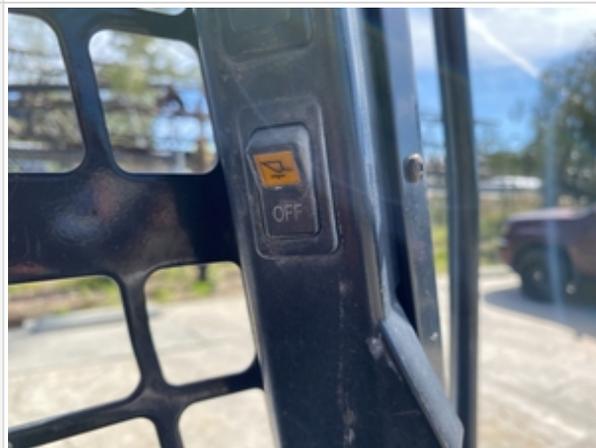
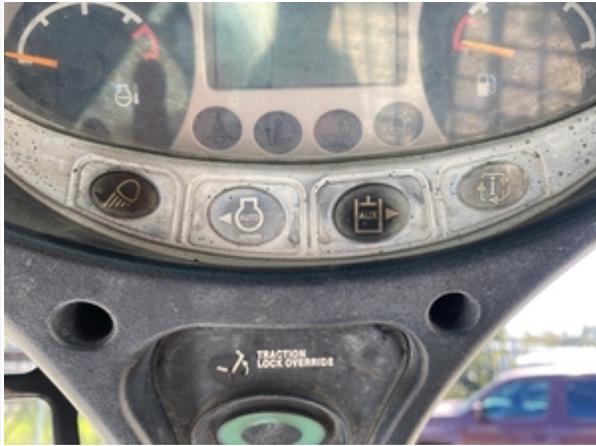
Safety Lock Out / Stop	3 - Normal Wear & Tear
Safety Lock Out / Stop Condition	Safety lock out device is present, in good condition, and functional
Controls & Switches	3 - Normal Wear & Tear
Controls & Switches Condition	All switches are installed and functional
Controls & Switches Photos

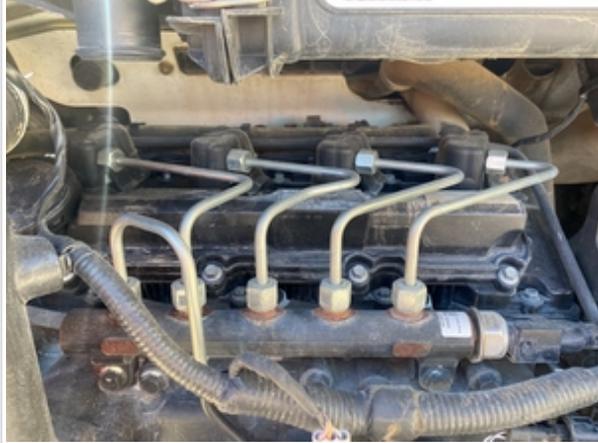
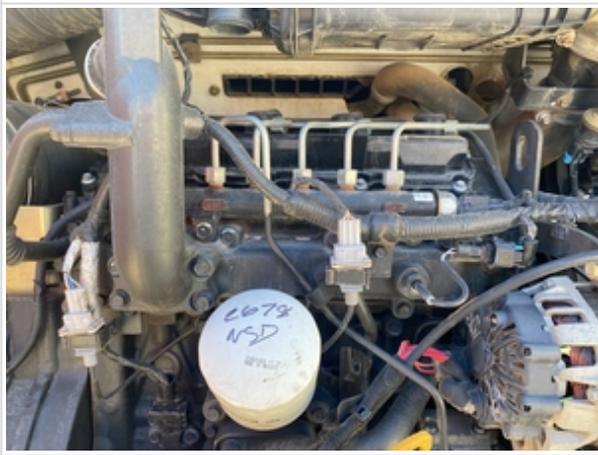
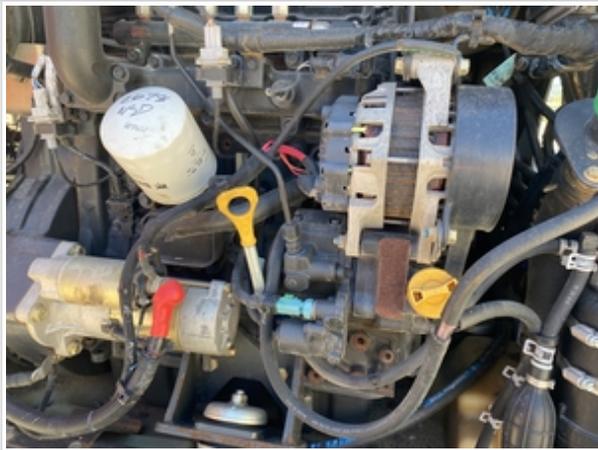
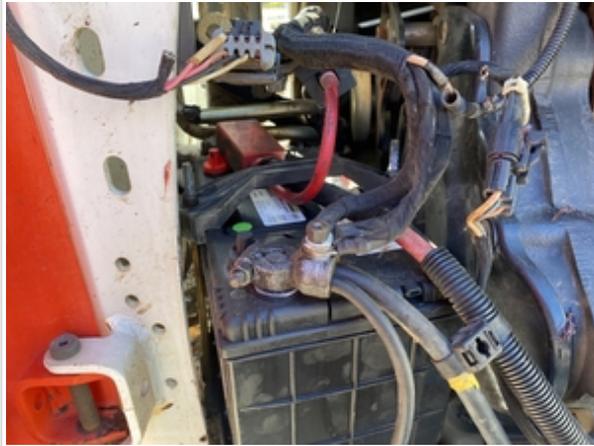
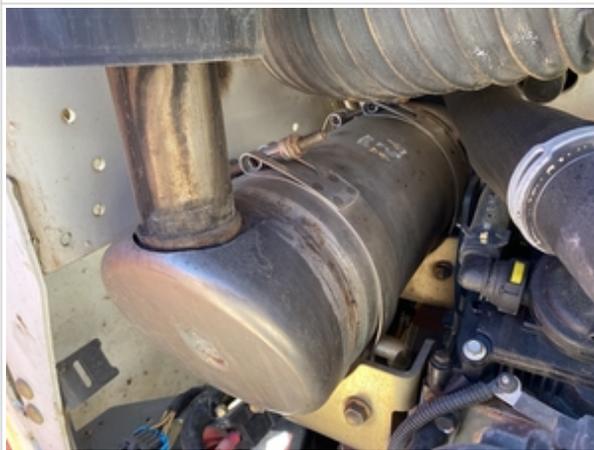
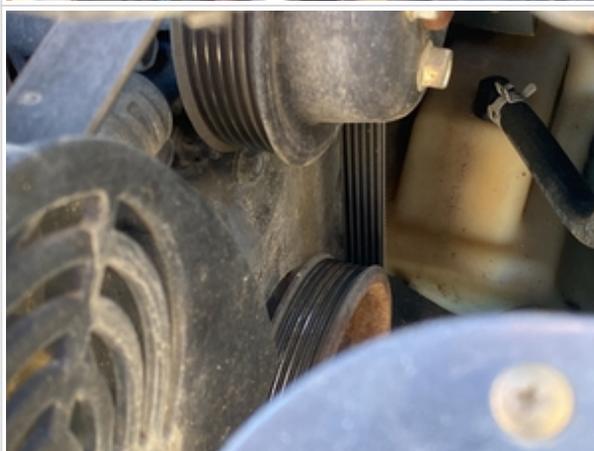
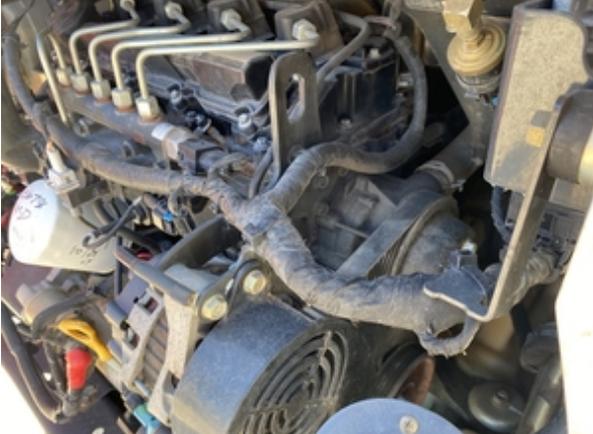
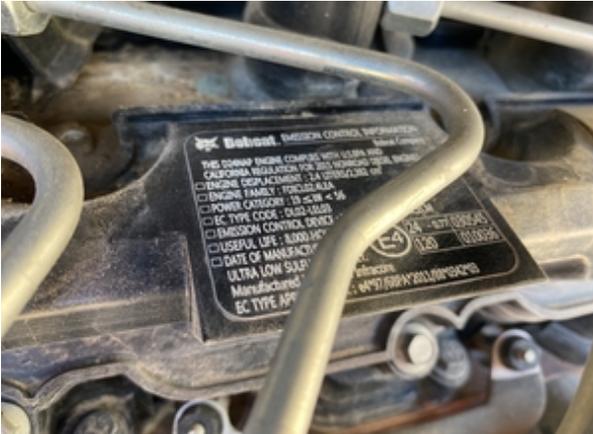
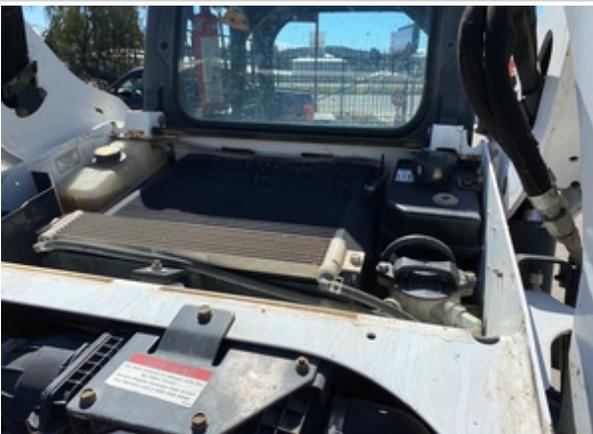
<p>Engine Photos</p>

Blow-by (Visual Observation Check)	No
Unusual Noises (Upon Start-up, Idle, Shutdown)	No
Unusual Noise Notes	No unusual noises heard
Engine Smoke (Upon Start-up, Idle, Shutdown)	No
Engine Smoke Notes	No engine smoke issues observed
Engine Exhaust Color	Clear

Battery	3 - Normal Wear & Tear
Battery Condition	Like new, recently replaced
Radiator	3 - Normal Wear & Tear
Radiator Condition	Radiator fins & components appear to be in good working order, no signs of damage or leaks
Belts	3 - Normal Wear & Tear
Belt Condition	Belts appear in good condition & alignment with proper tension
Hoses	3 - Normal Wear & Tear
Hose Condition	Firm, pliant hoses with no signs of wear or leaks
Water Pump	3 - Normal Wear & Tear
Water Pump Condition	No unusual pump noises heard
Cooling System Leaks	No
Coolant Color / Appearance	3 - Normal Wear & Tear
Coolant Color/Appearance Notes	Normal Translucent appearance, no visual signs of contamination
Oil Leaks	No
Oil Color / Appearance	3 - Normal Wear & Tear
Oil Color / Appearance Notes	Clean oil appearance, no signs of cross contamination, Appropriate oil level
Fuel Leaks	No
Requires DEF (Diesel Exhaust Fluid)	No
Overall Engine Appearance	Clean & dry

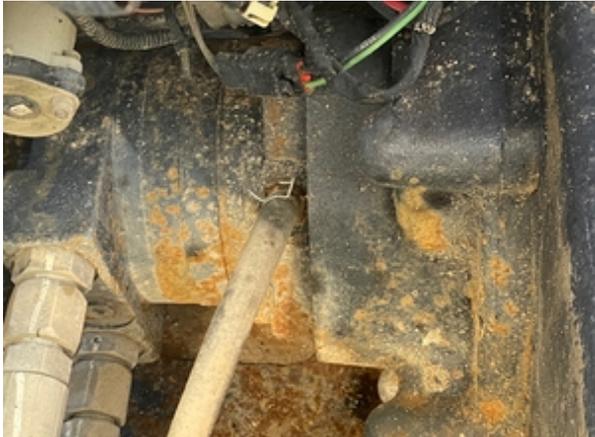
Hydrostatic Transmission?	Yes
2 Speed?	No
Hydrostatic Drive Configuration	Split Transmission
Drive Motors	2 - Above Average Wear
Hydrostatic Parking Brake	3 - Normal Wear & Tear
Hydrostatic Parking Brake Condition	Good brake function
Overall Drivetrain Comments	Machine travels well in all directions and parking brake works normally.

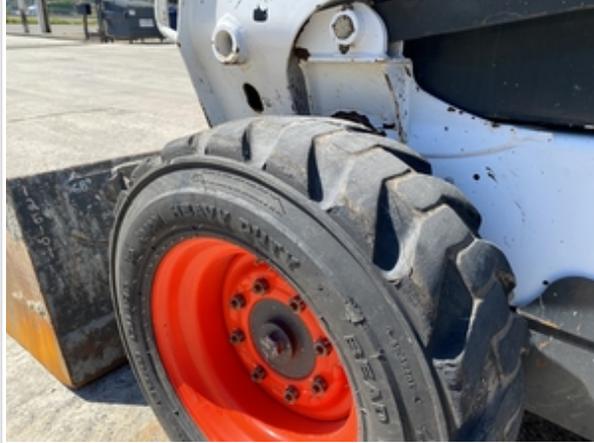
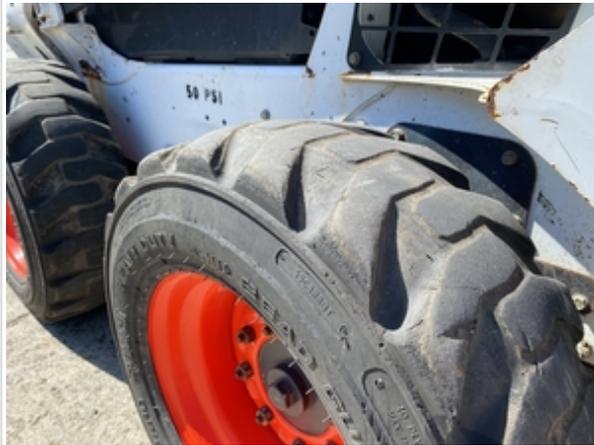
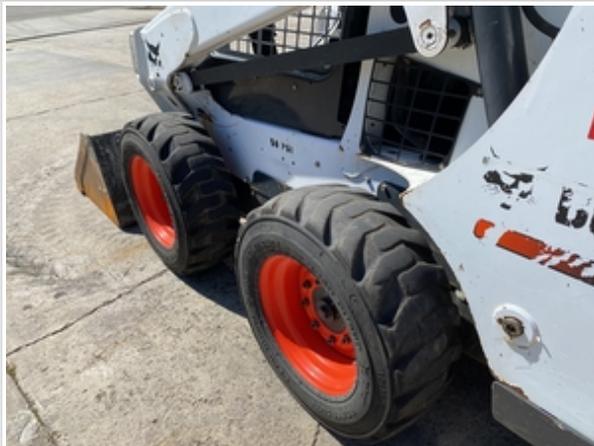
Wheels & Tires Photos

Wheels & Tires	2 - Above Average Wear
Comments	Most tires worn down to 10%

Tire Brand	Bobcat
Tire Size	10-16.5
Front Left Tire - Ratio Remaining	10%
Rear Left Tire - Ratio Remaining	10%
Front Right Tire - Ratio Remaining	10%
Rear Right Tire - Ratio Remaining	50%
Lift Arm	3 - Normal Wear & Tear

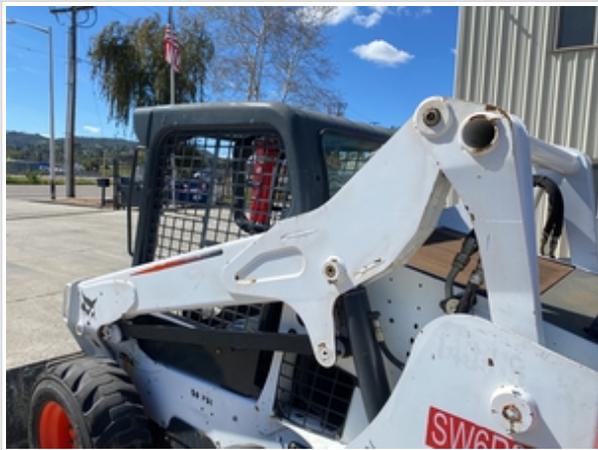
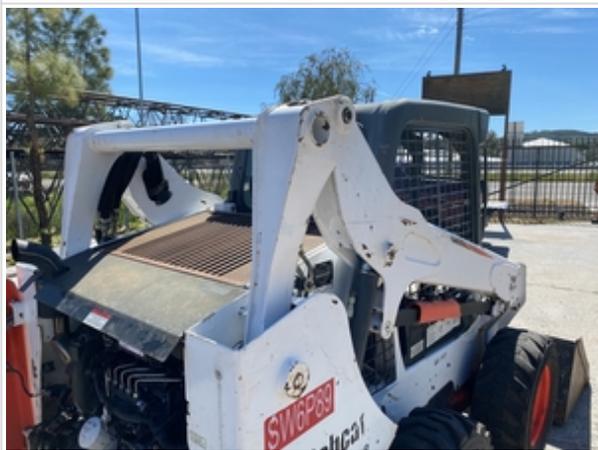
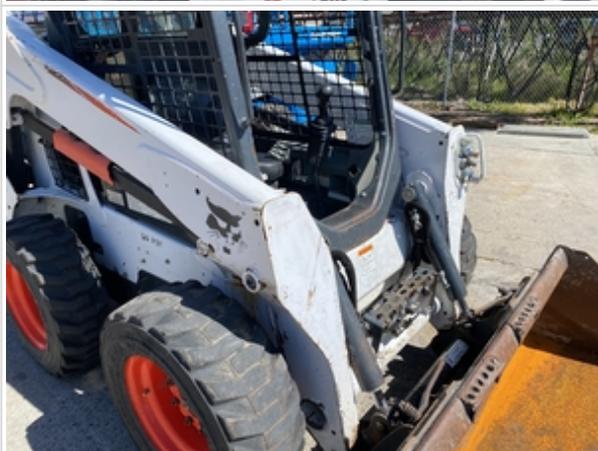
Lift Arm Photos

Chassis to Arm Pins	3 - Normal Wear & Tear
Quick Coupler	3 - Normal Wear & Tear

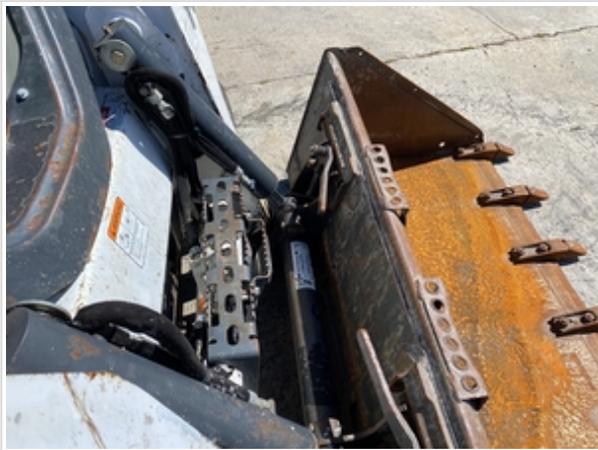
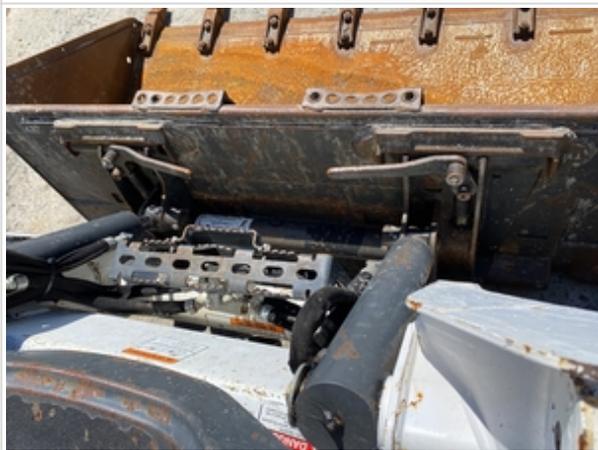
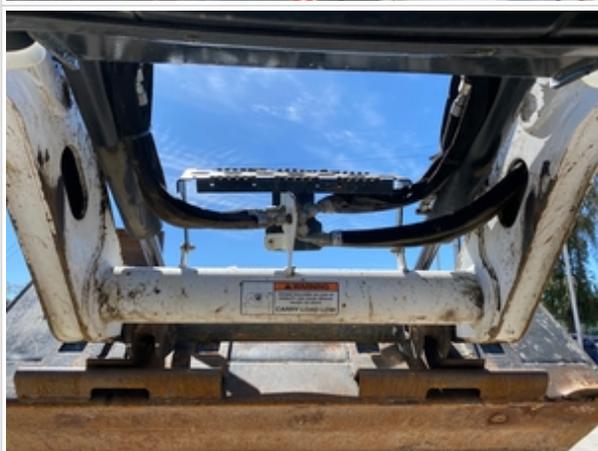
Quick Coupler Photos

Quick Coupler to Arms Pins	3 - Normal Wear & Tear	
Overall Chassis	3 - Normal Wear & Tear	
Overall Chassis Comments	Chassis in solid shape and all implements working well with no excessive play observed during the inspection.

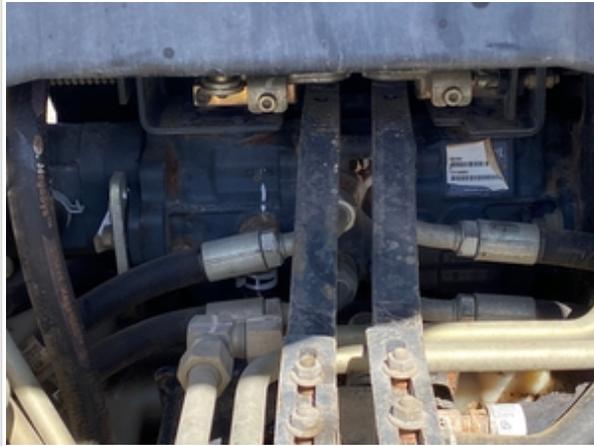
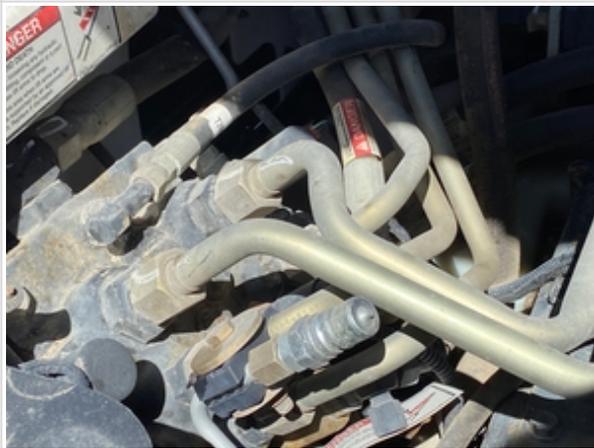
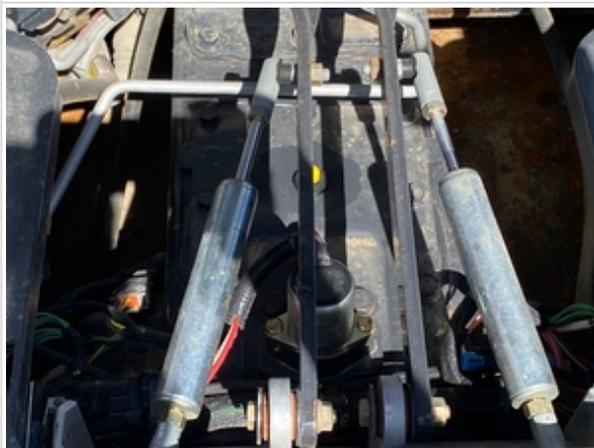
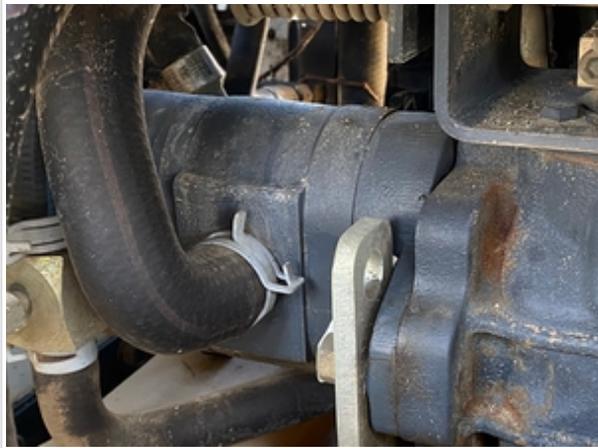
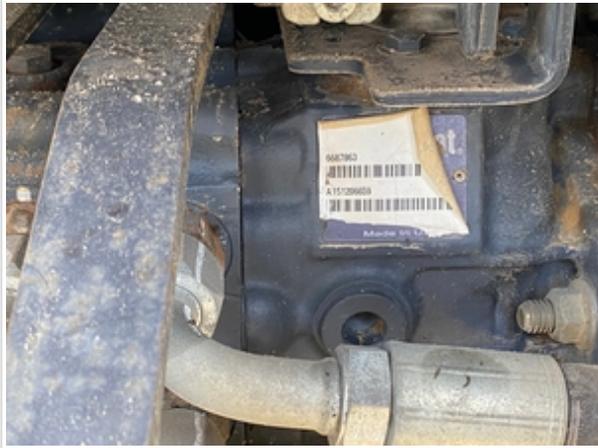
Hydraulic System Photos

Wet or Damp Hydraulic Lines / Fittings	No
Appearance of Hydraulic Lines / Fittings	3 - Normal Wear & Tear
Hydraulic Lines / Fittings Condition	Hydraulic lines & fittings are clean and in good condition
Unusual Noises (Hydraulic Pump)	No
Hydraulic Pump Notes	No unusual noises heard during operation

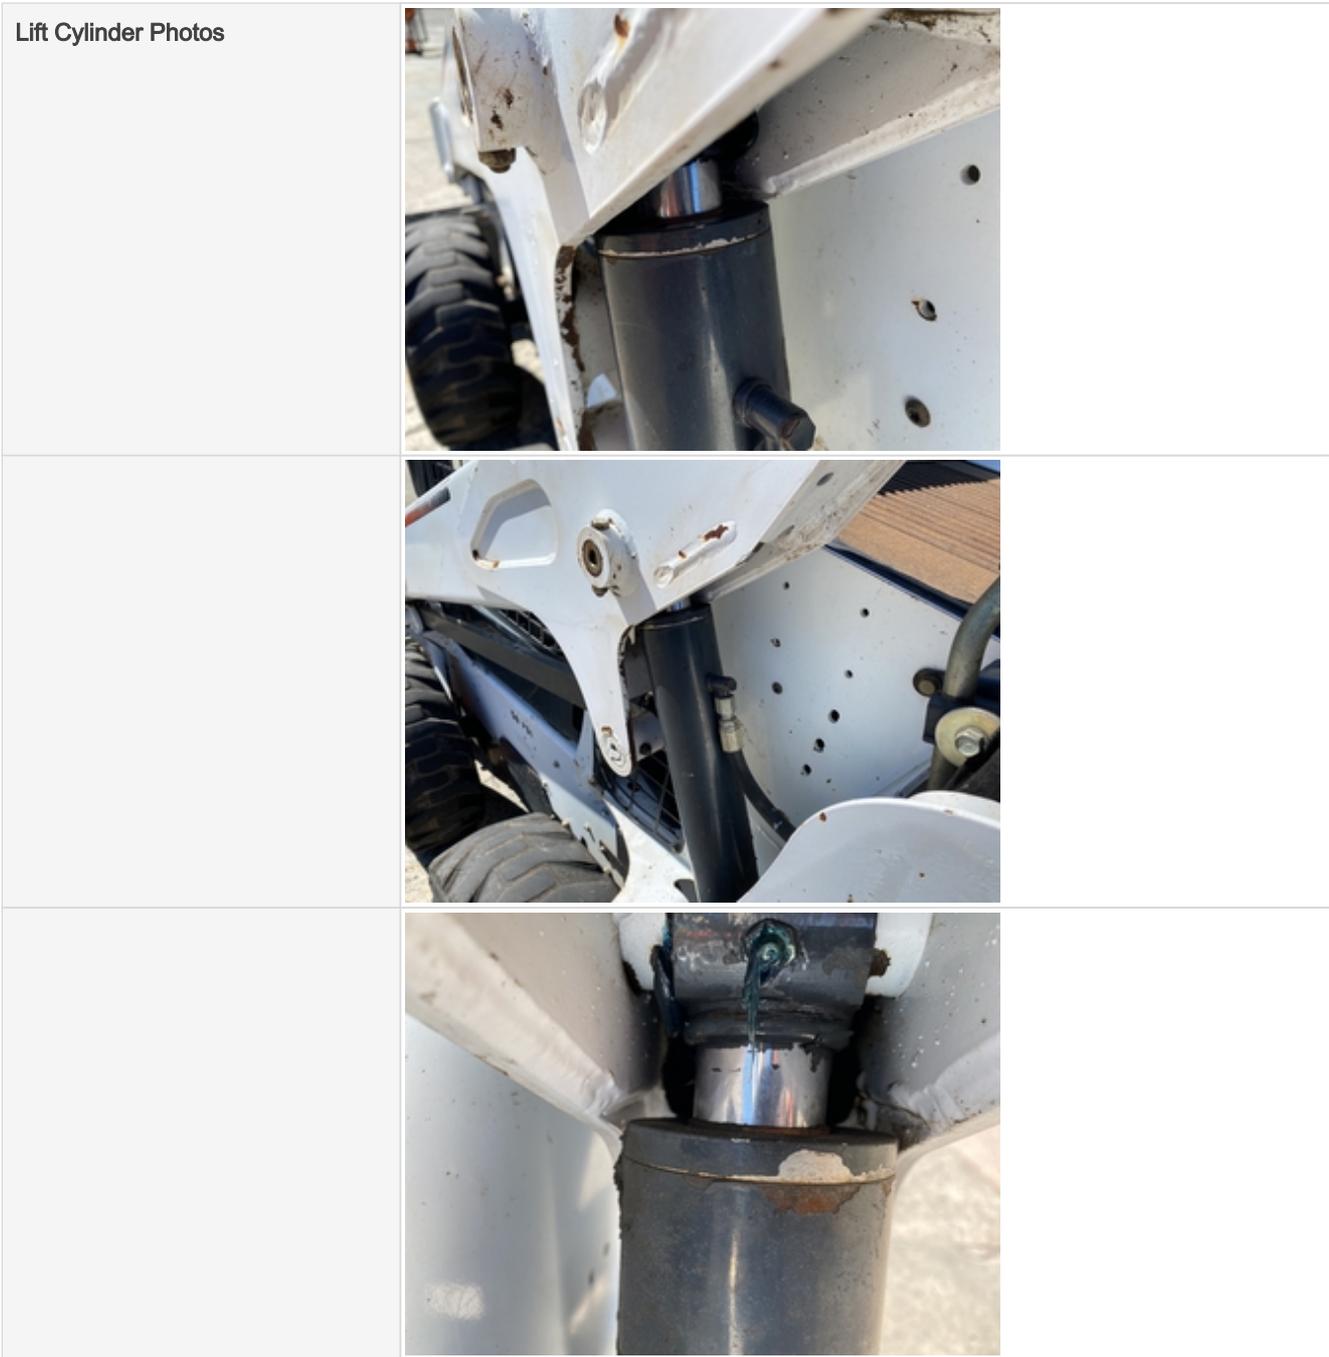
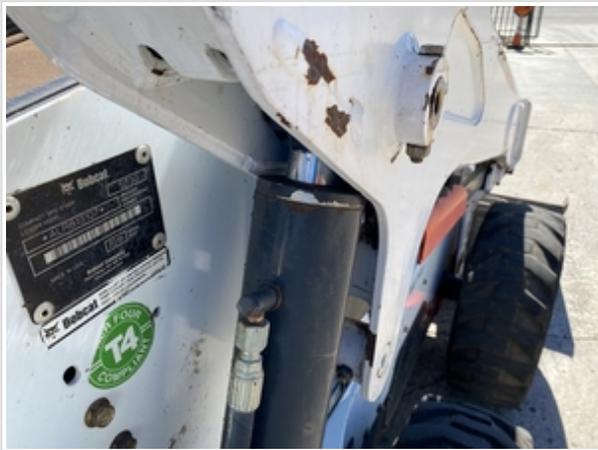
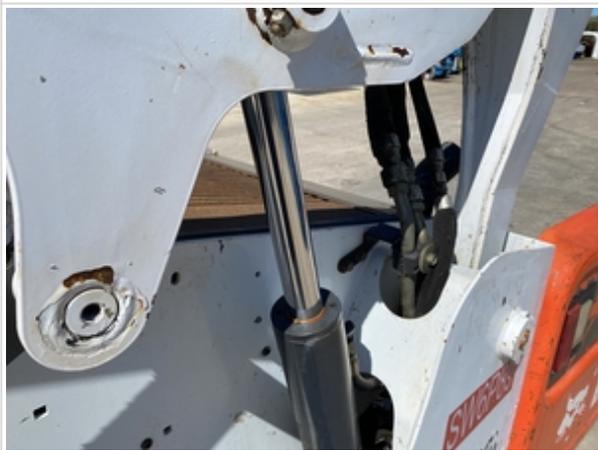
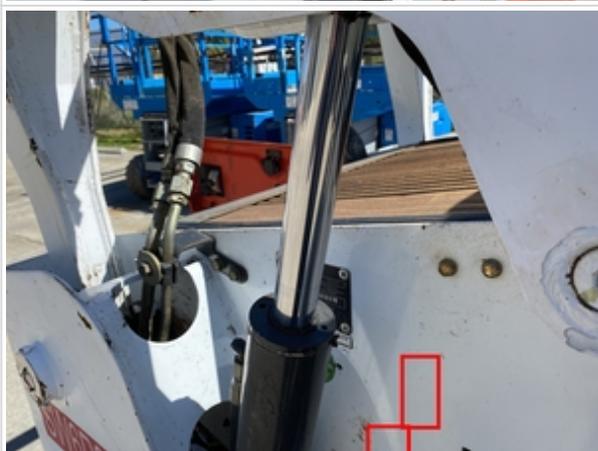
Lift Cylinder	Check the lift cylinder. Note any wear, pitting, discoloration, etc. Take photos.
Lift Cylinder: Mounting Pin	3
Lift Cylinder: Oil Leaks	No

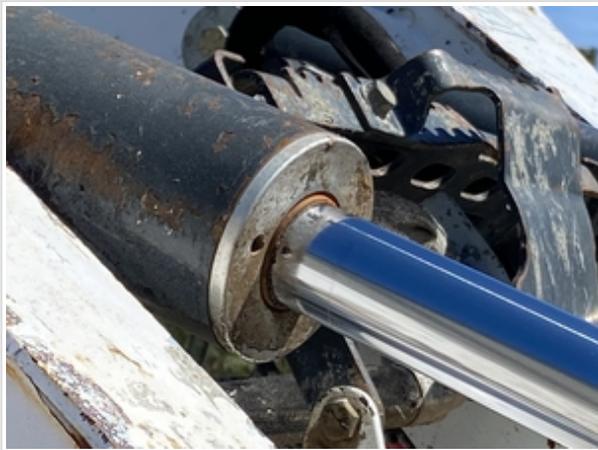
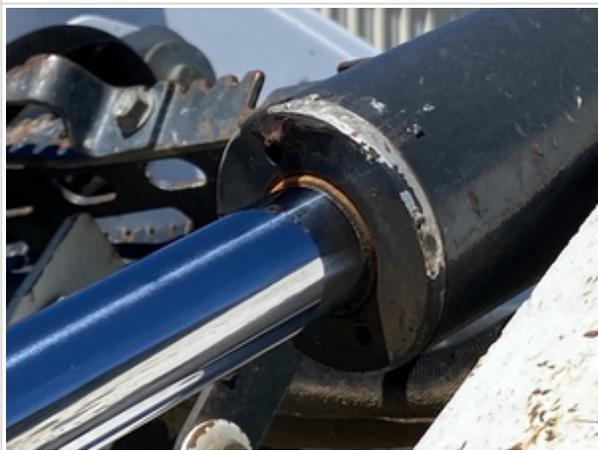
Bucket Cylinder Photos

Bucket Cylinder	Check the bucket cylinder. Note any wear, pitting, discoloration, etc. Take photos.
Bucket Cylinder: Mounting Pin	3
Bucket Cylinder: Oil Leaks	No

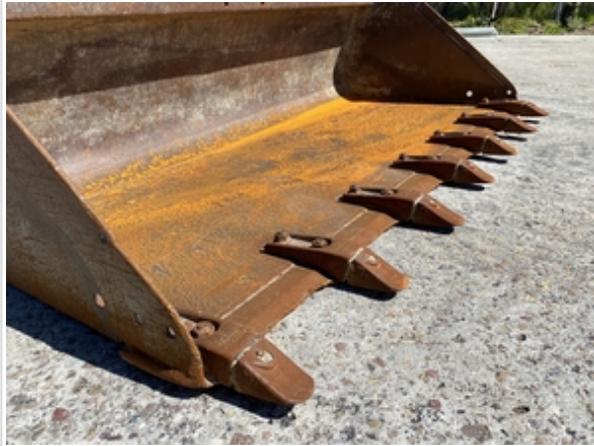
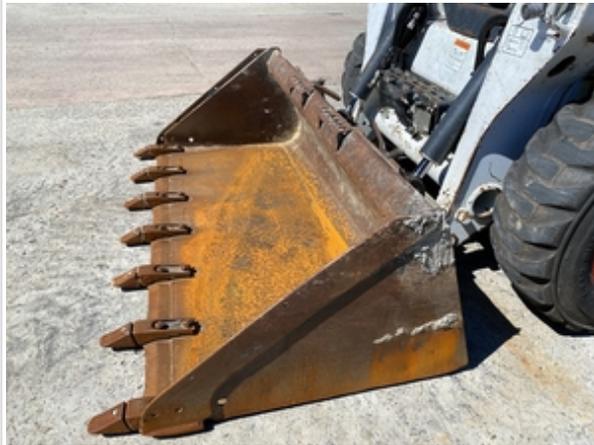
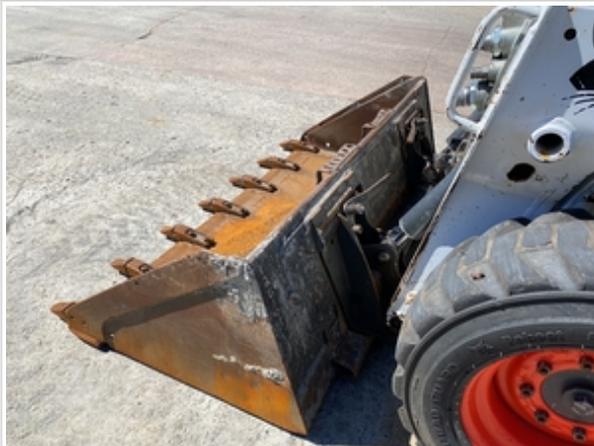
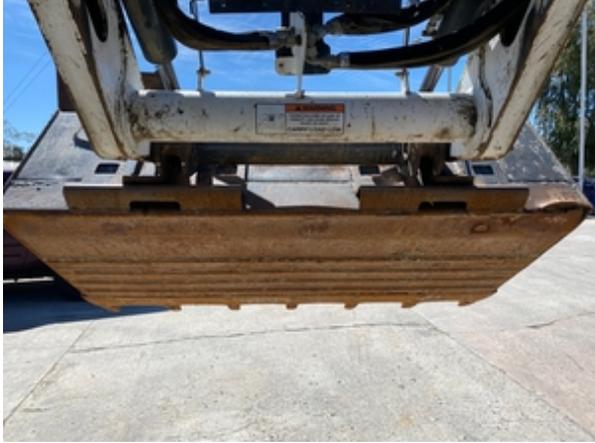
Bucket Condition	3 - Normal Wear & Tear
Comments	Normal wear & minor damage seen at bucket edges. Teeth getting low and will need to be replaced soon.
Bucket Photos

Bucket Edge / Deflectors	3 - Normal Wear & Tear
