Inspection Report (Scissor Lift)

Year	2012
Make	Genie
Model	GS-2669
Serial Number	GS6912-994
Hour Meter Reading	1,981Hrs.
Previous Application (e.g., earth moving, mining, demolition, etc)	Equipment Rental

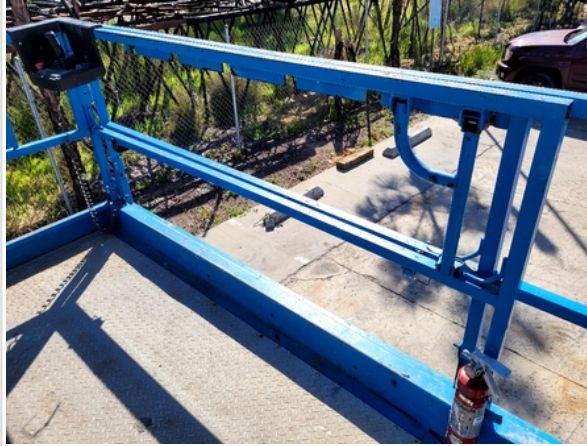
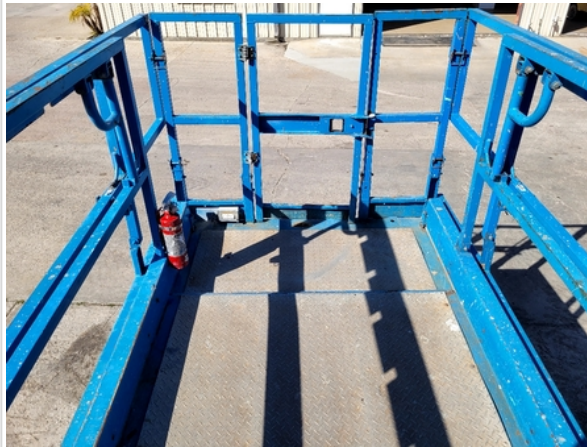
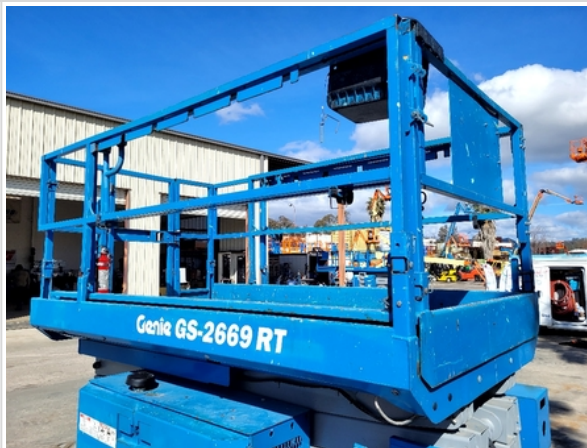
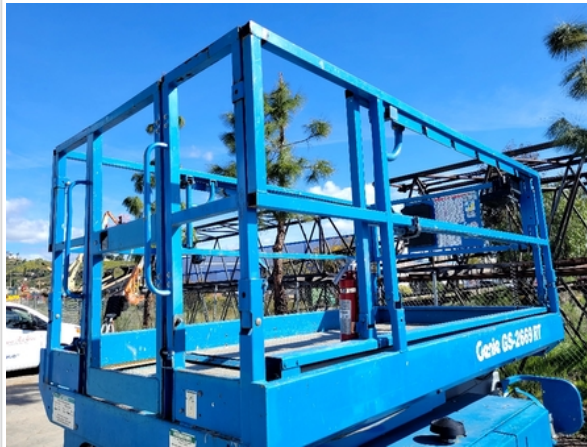
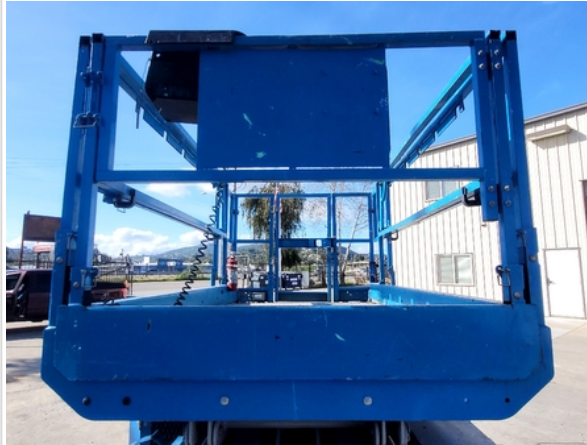
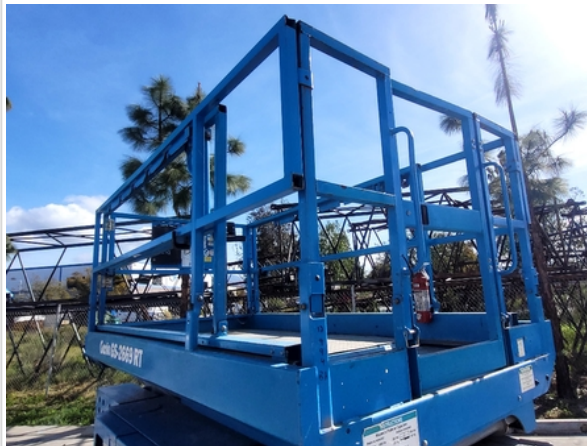
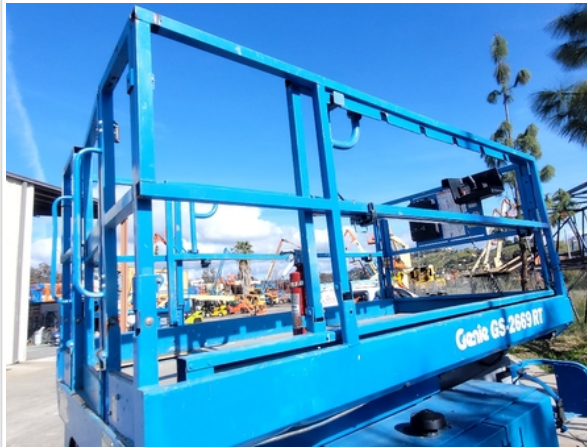
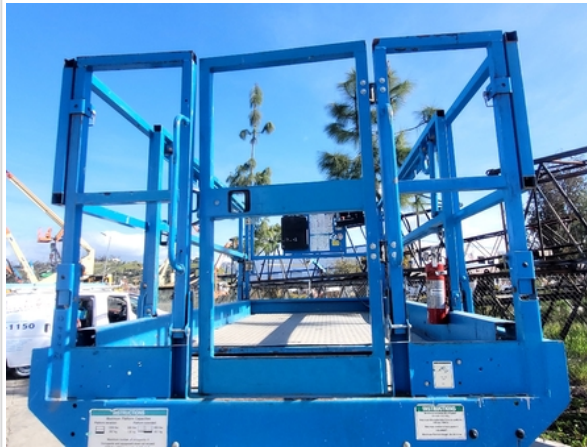
Platform Safety Rails & Appearance Photos

Horn	3 - Normal Wear & Tear
Travel Alarm	2 - Above Average Wear
Comments	Travel alarm weak and should be replaced
Safety Lock Out / Stop	3 - Normal Wear & Tear
Platform Safety Rails & Appearance	3 - Normal Wear & Tear

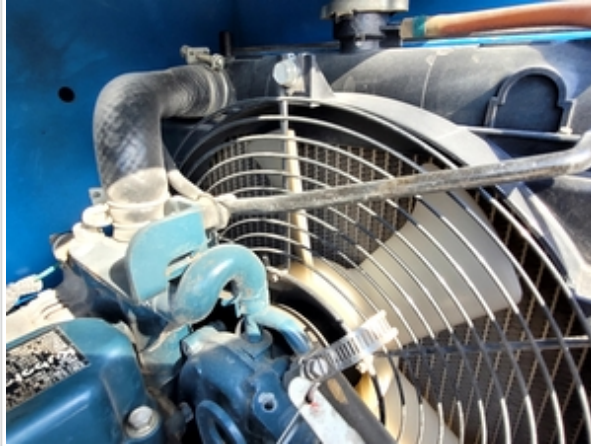
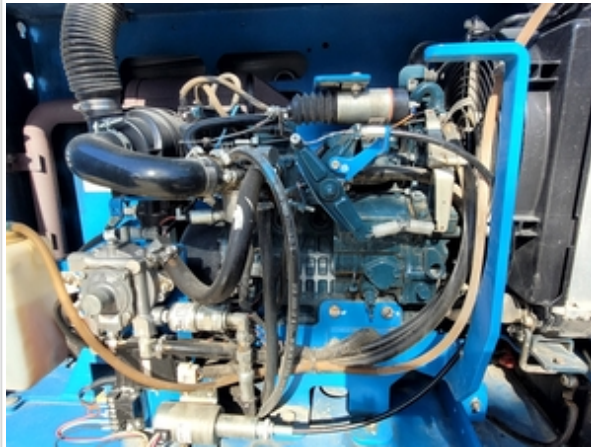
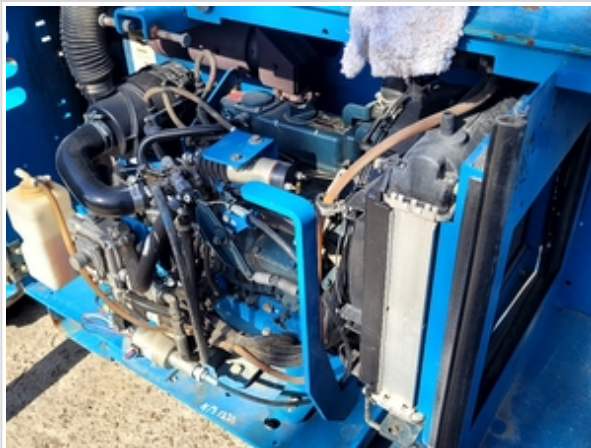
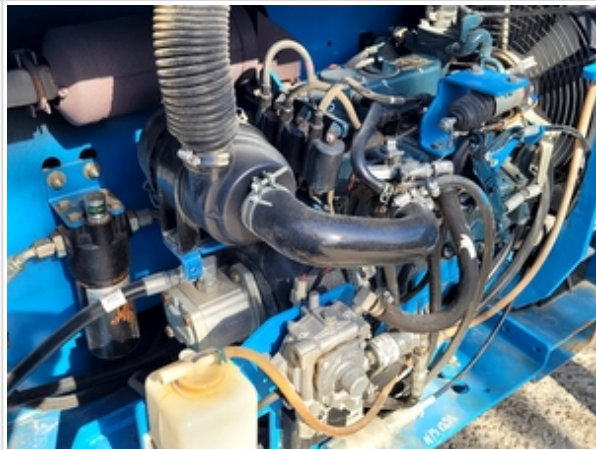
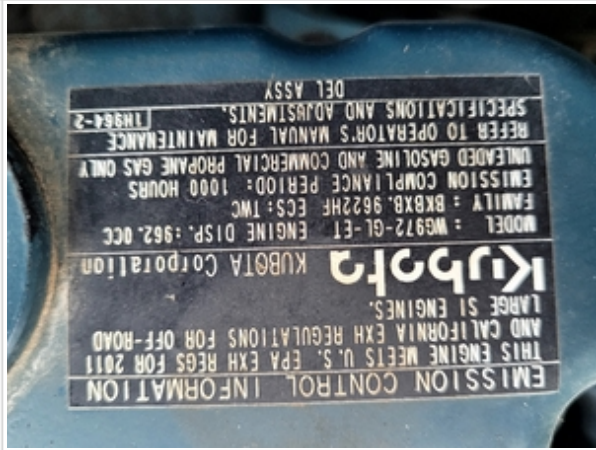
Blow-by (Visual Observation Check)	No
Unusual Noises (Upon Start-up, Idle, Shutdown)	No
Unusual Noise Notes	No unusual noises heard
Engine Smoke (Upon Start-up, Idle, Shutdown)	No
Engine Smoke Notes	No engine smoke issues observed
Engine Exhaust Color	Clear
Battery	3 - Normal Wear & Tear
Battery Condition	Clean & dry appearance, tight connections
Radiator	3 - Normal Wear & Tear
Radiator Condition	Radiator fins & components appear to be in good working order, no signs of damage or leaks
Belts	3 - Normal Wear & Tear
Belt Condition	Belts appear in good condition & alignment with proper tension
Hoses	3 - Normal Wear & Tear
Hose Condition	Firm, pliant hoses with no signs of wear or leaks

Water Pump	3 - Normal Wear & Tear
Water Pump Condition	No unusual pump noises heard
Cooling System Leaks	No
Coolant Color / Appearance	3 - Normal Wear & Tear
Coolant Color/Appearance Notes	Normal Translucent appearance, no visual signs of contamination
Oil Leaks	No
Oil Color / Appearance	3 - Normal Wear & Tear
Oil Color / Appearance Notes	Clean oil appearance, no signs of cross contamination, Appropriate oil level
Fuel Leaks	No
Requires DEF (Diesel Exhaust Fluid)	No
Overall Engine Appearance	Clean & dry
Overall Engine Comments	Engine has well maintained appearance & operating well under load.

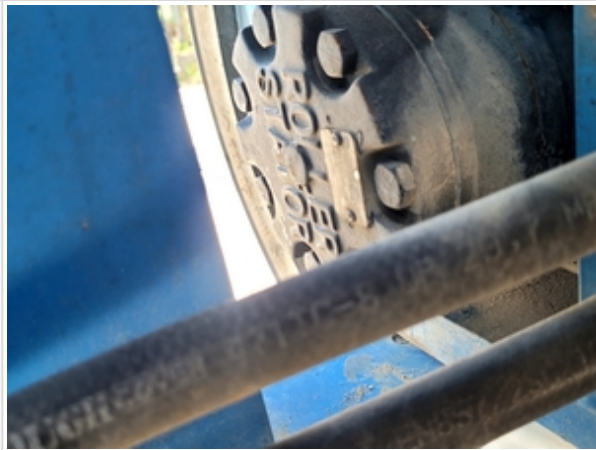
Hydrostatic Transmission?	Yes
2 Speed?	N/A
Hydrostatic Drive Configuration	Split Transmission
Drive Motors	4 - Like New, Recently Replaced
Hydrostatic Parking Brake	3 - Normal Wear & Tear
Hydrostatic Parking Brake Condition	Good brake function
Overall Drivetrain Comments	Drivetrain In good condition and no operating issues observed during inspection.

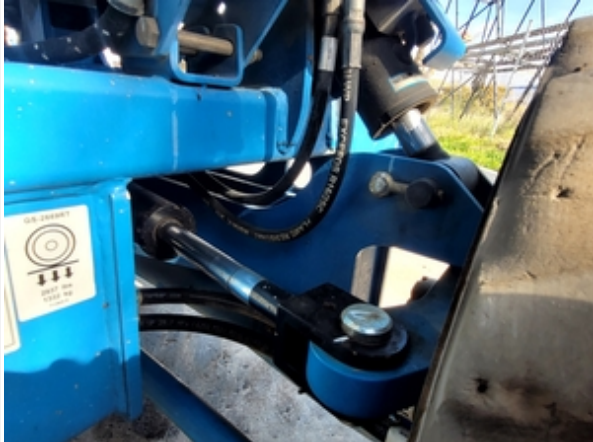
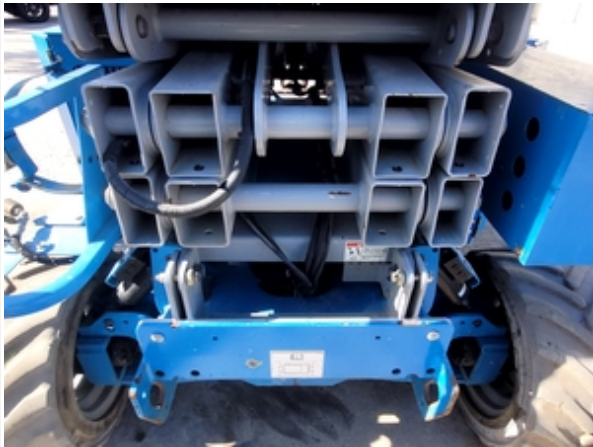
Frame	3 - Normal Wear & Tear
Frame Photos

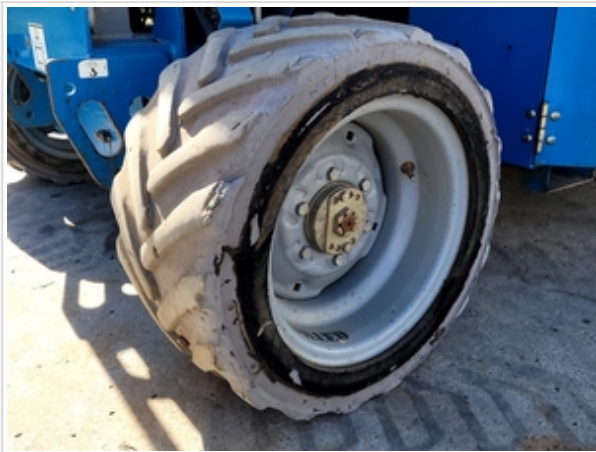
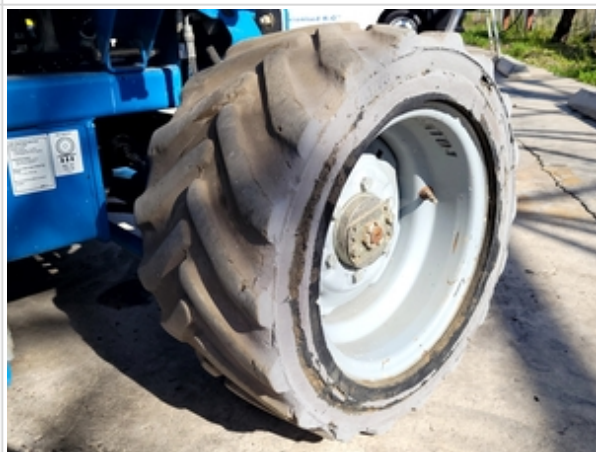
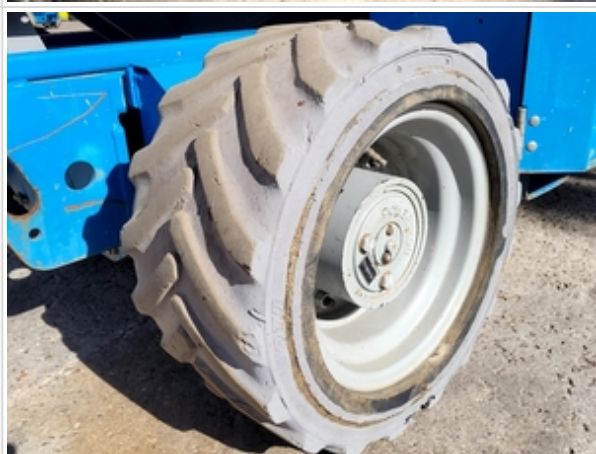
Wheels & Tires	3 - Normal Wear & Tear
Comments	Tires are foam filled
Wheels & Tires Photos

Tire Brand	OTR Outrigger	
Tire Size	26x12x380	
Front Left Tire - Ratio Remaining	30%	
Rear Left Tire - Ratio Remaining	30%	
Front Right Tire - Ratio Remaining	30%	
Rear Right Tire - Ratio Remaining	30%	
Overall Chassis	3 - Normal Wear & Tear

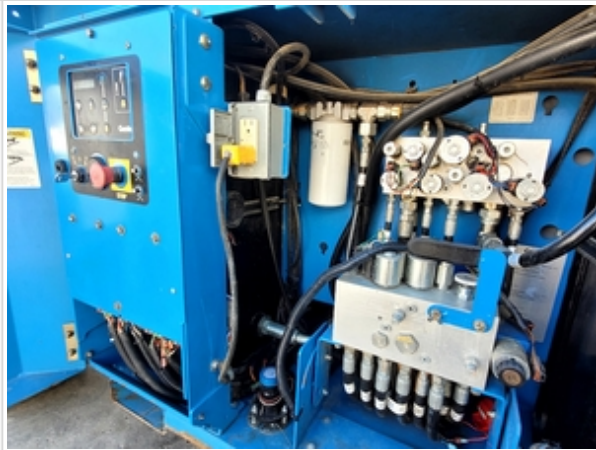
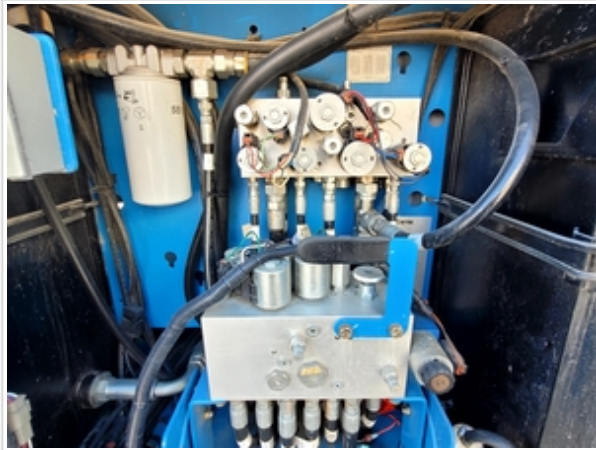
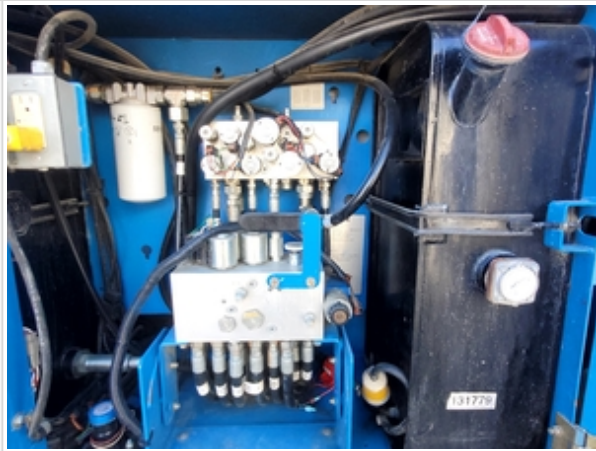
Wet or Damp Hydraulic Lines / Fittings	No
Appearance of Hydraulic Lines / Fittings	3 - Normal Wear & Tear
Hydraulic Lines / Fittings Condition	Hydraulic lines & fittings are clean and in good condition
Unusual Noises (Hydraulic Pump)	No
Hydraulic Pump Notes	No unusual noises heard during operation

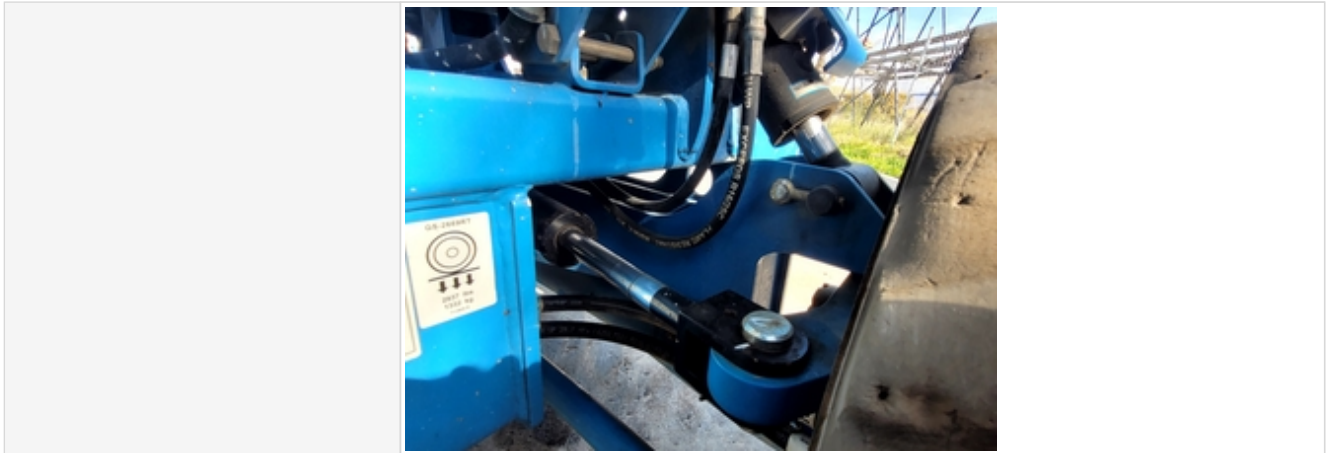
Outrigger Cylinders	Check the outrigger cylinders. Note any wear, pitting, discoloration, etc. Take photos.
Steering Cylinders	Check the steering cylinders. Note any wear, pitting, discoloration, etc. Take photos.
Steering Cylinders: Mounting Pin	3
Steering Cylinders: Oil Leaks	No
Steering Cylinders Photos
