Inspection Report (Skid Steer)

Year	2021
Make	Bobcat
Model	S64
Serial Number	B4SC12665
Hour Meter Reading	446 Hrs.
Previous Application (e.g., earth moving, mining, demolition, etc)	Asphalt General Construction

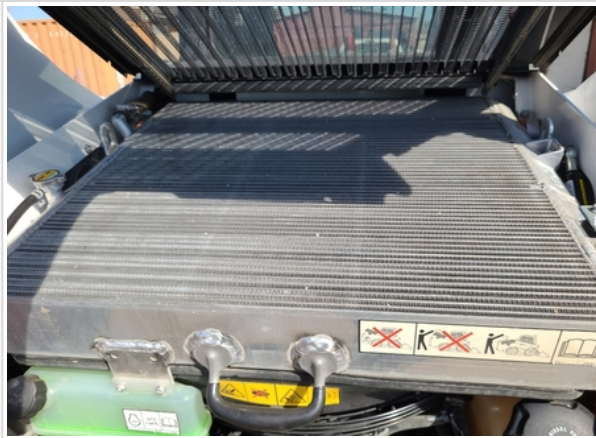
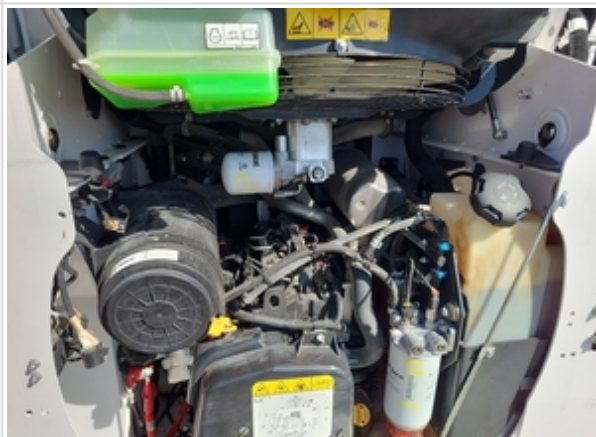
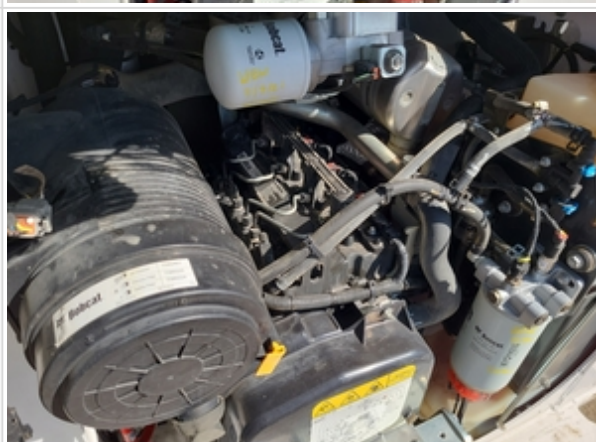
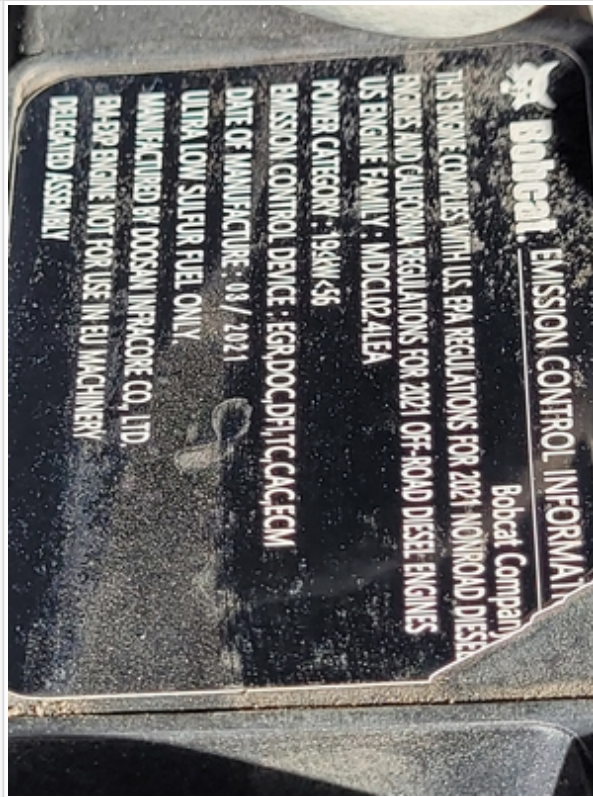
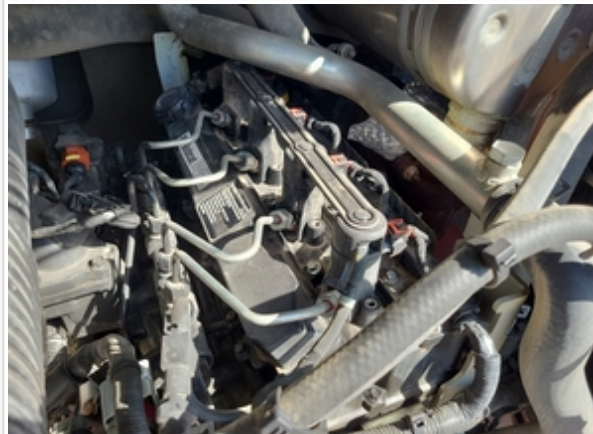
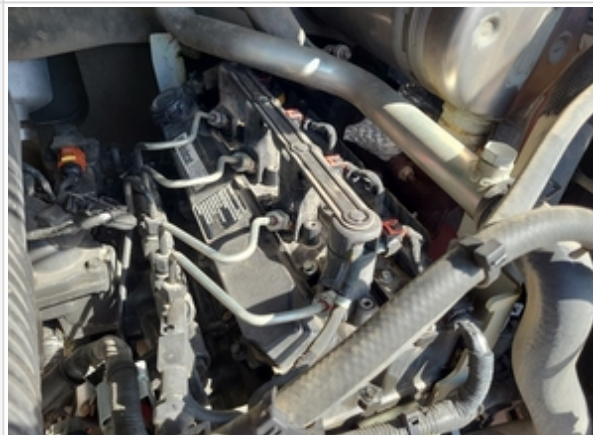
Engine Type (Make, Model, Cylinders, Hp)	Bobcat - 4Cyl. - 68HP - 2.4L
Emissions Tier	Tier 4F
Engine Serial Number	N/A
Engine Fuel Type	Diesel
Engine Photos

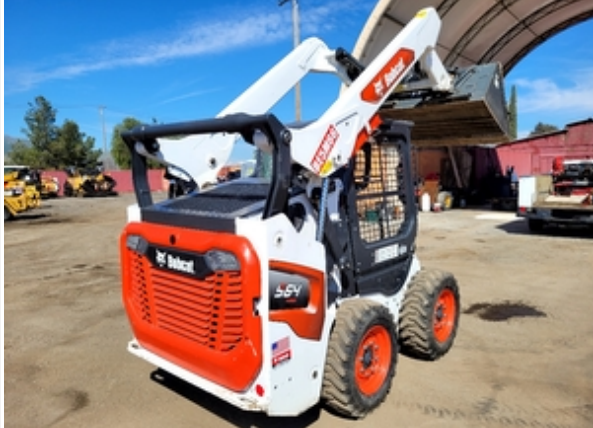
Tire Brand	Camso	
Tire Size	10-16.5	
Front Left Tire - Ratio Remaining	90%	
Rear Left Tire - Ratio Remaining	90%	
Front Right Tire - Ratio Remaining	90%	
Rear Right Tire - Ratio Remaining	90%	
Lift Arm	4 - Like New, Recently Replaced	
Lift Arm Photos

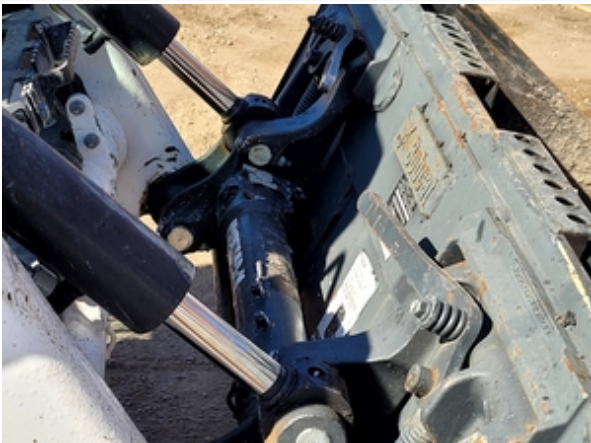
Chassis to Arm Pins	4 - Like New, Recently Replaced
Quick Coupler	4 - Like New, Recently Replaced
Quick Coupler Photos
