## Inspection Report (Boom Lift)

Year	2016
Make	JLG
Model	860SJ
Serial Number	300224791
Hour Meter Reading	1233.3
Previous Application (e.g., earth moving, mining, demolition, etc)	General construction

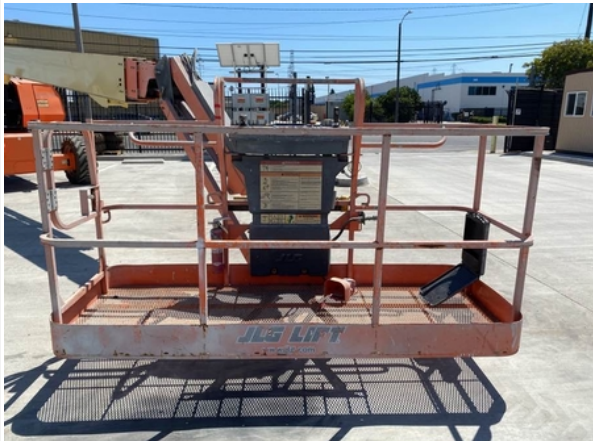
<b>Instructions</b>	<p>Evaluate the following on a 4 point scale (leave comments where an explanation is appropriate):</p> <p>4 = Like New, Recently Replaced          3 = Normal Wear &amp; Tear          2 = Above Average Wear          1 = Service Required</p> <p>Things to look for:</p> <ul style="list-style-type: none"> <li>- cosmetic damage</li> <li>- minor surface rust</li> <li>- repaint (and overspray)</li> <li>- cracked or damaged glass</li> <li>- major rust (cancer)</li> <li>- cracks / visible welds</li> </ul>
<b>Front</b>	3 - Normal Wear & Tear
<b>Comments</b>	Over spray on front of machine (paint)
<b>Front Photos</b>

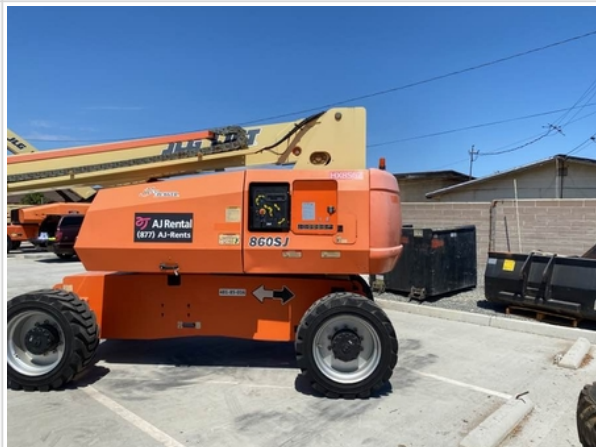
<p><b>Left</b></p>	<p>3 - Normal Wear &amp; Tear</p>	
<p><b>Comments</b></p>	<p>Left side key switch/operating panel small dent</p>	
<p><b>Left Photos</b></p>

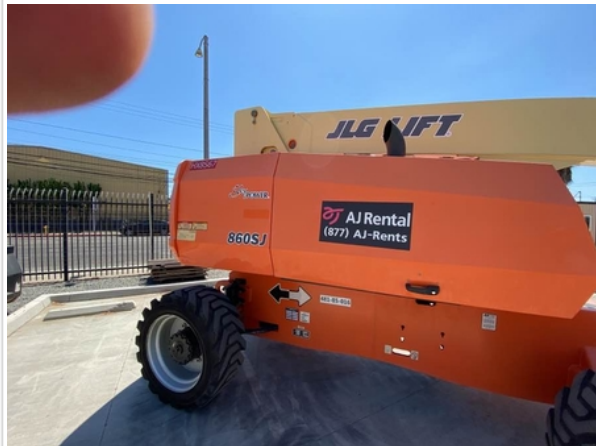
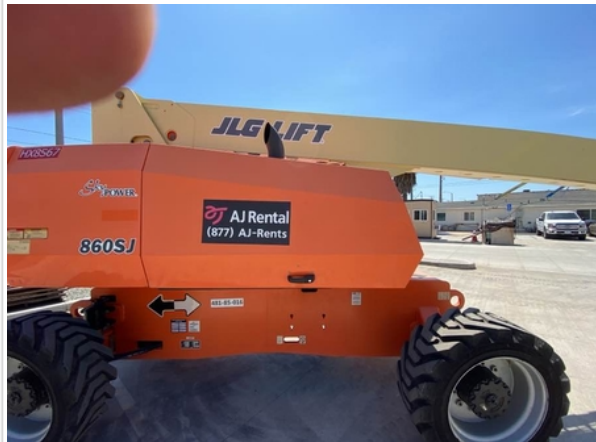
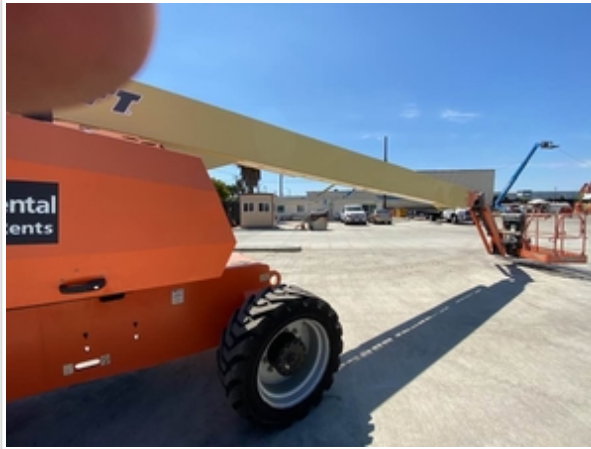
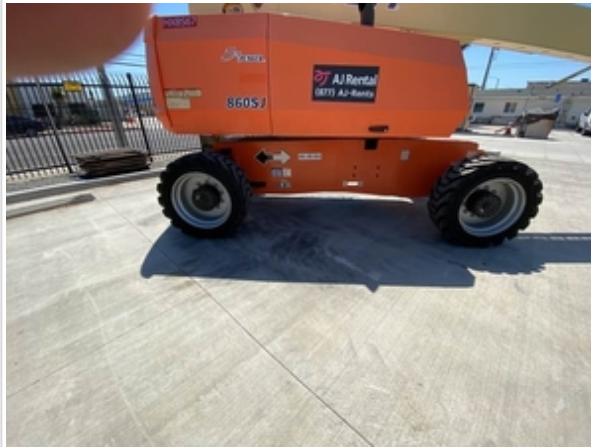
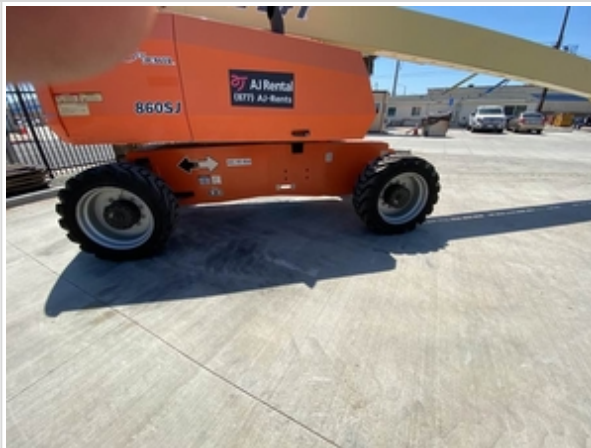
<p>Right</p>	<p>3 - Normal Wear &amp; Tear</p>	
<p>Right Photos</p>

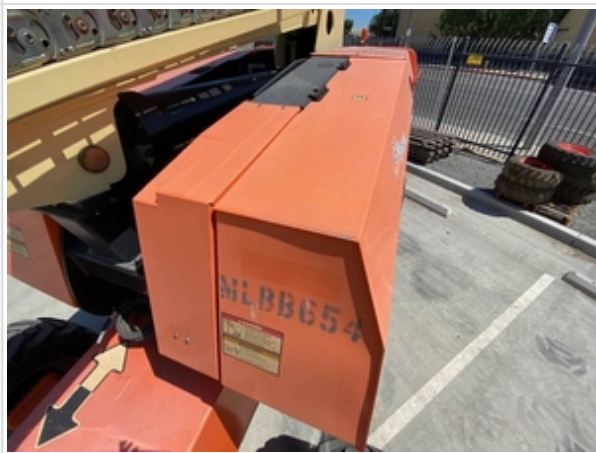
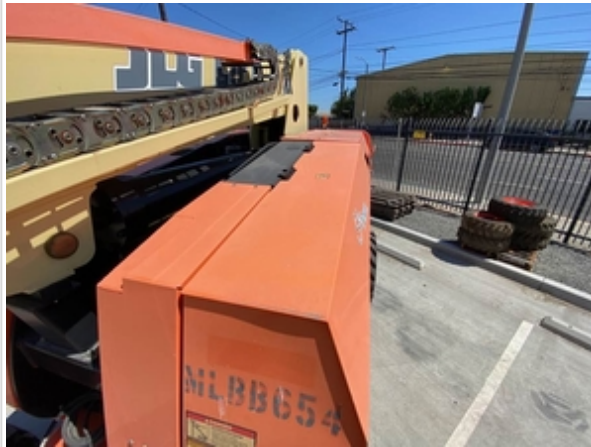
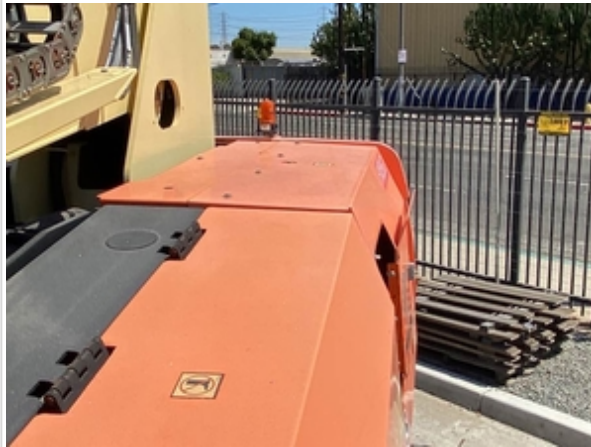
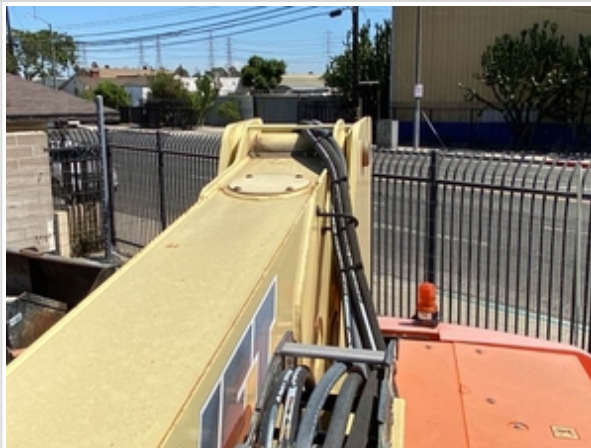
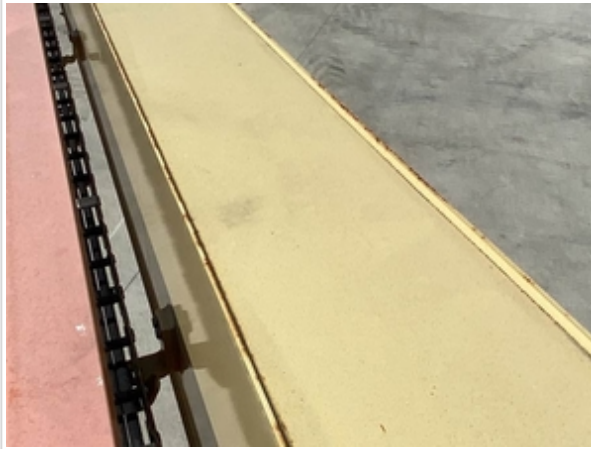
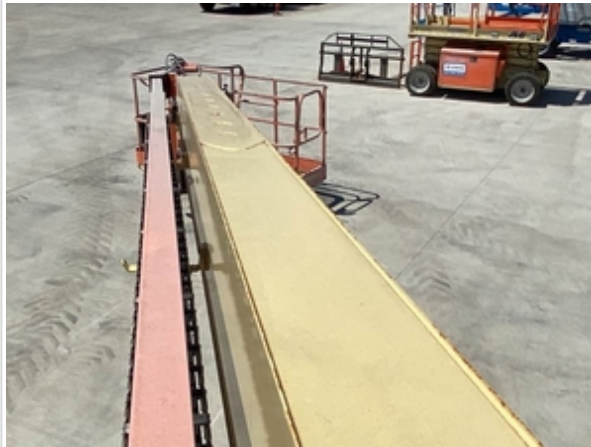
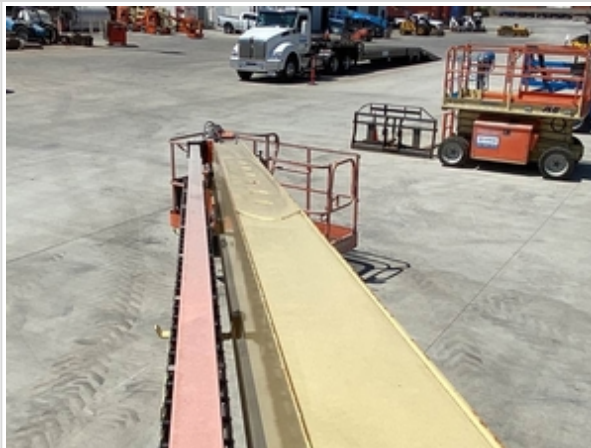
<p>Upper</p>	<p>3 - Normal Wear &amp; Tear</p>	
<p>Upper Photos</p>

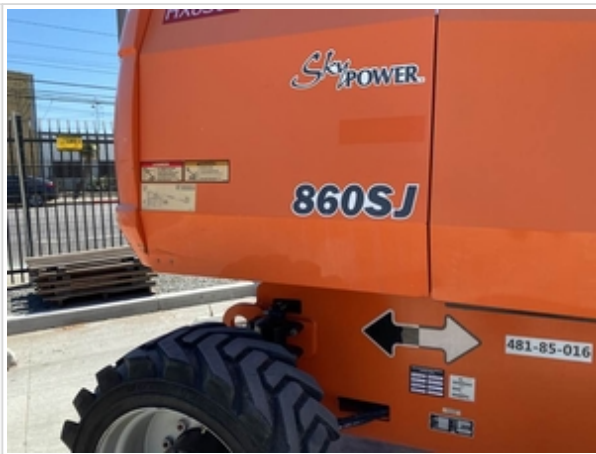
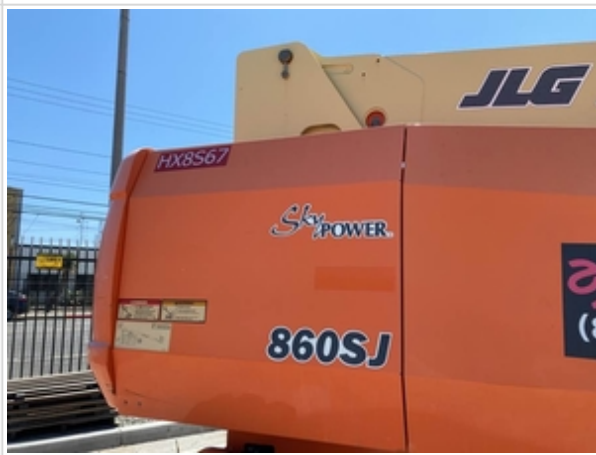
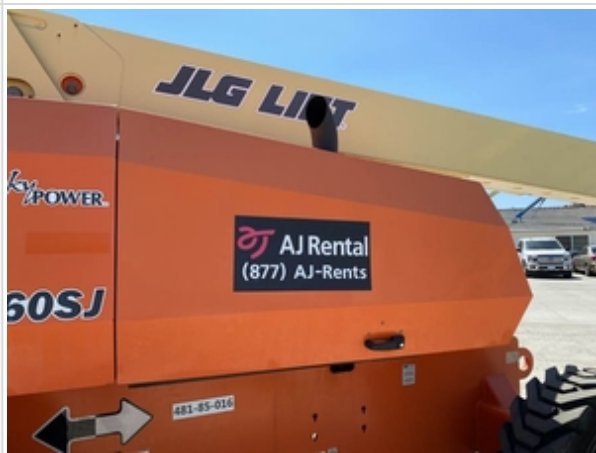
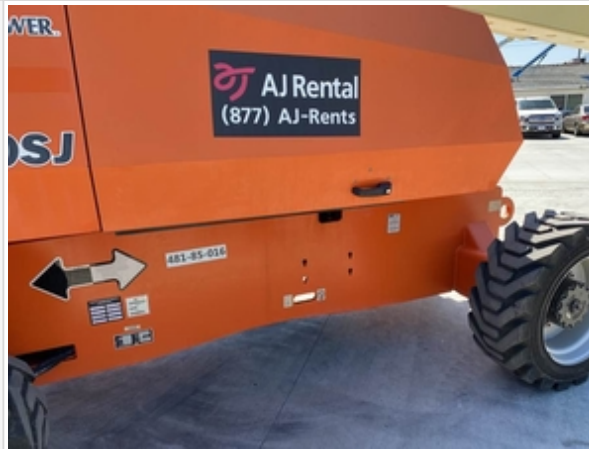
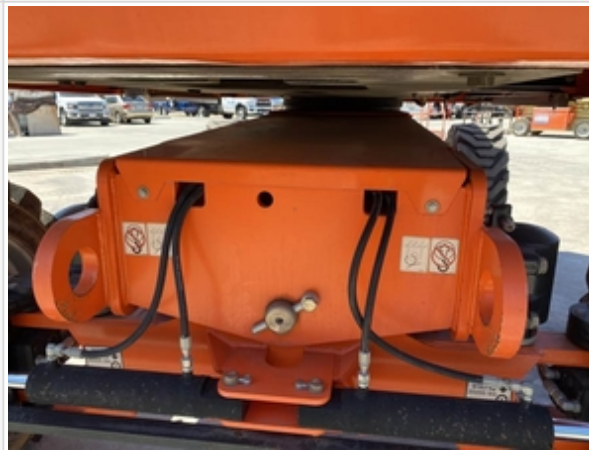
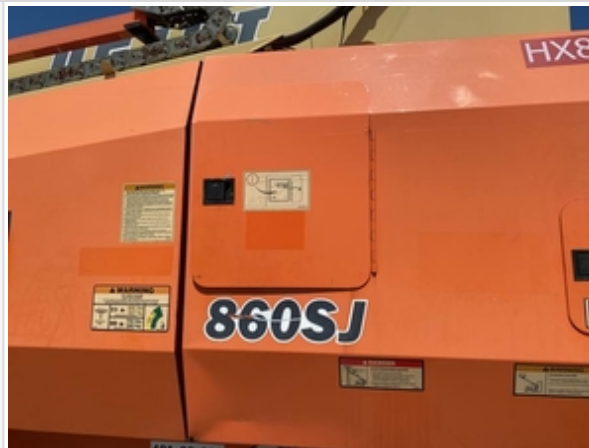
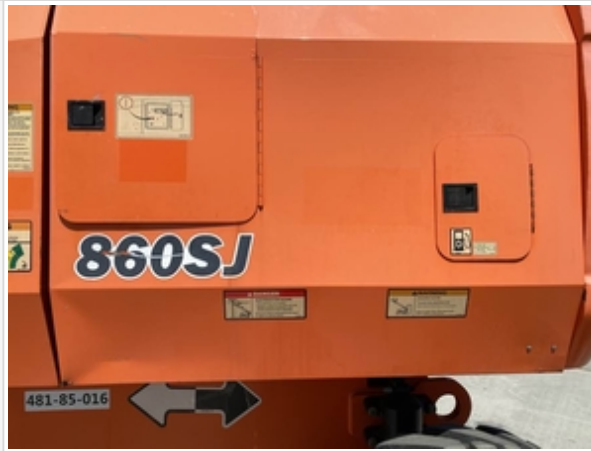
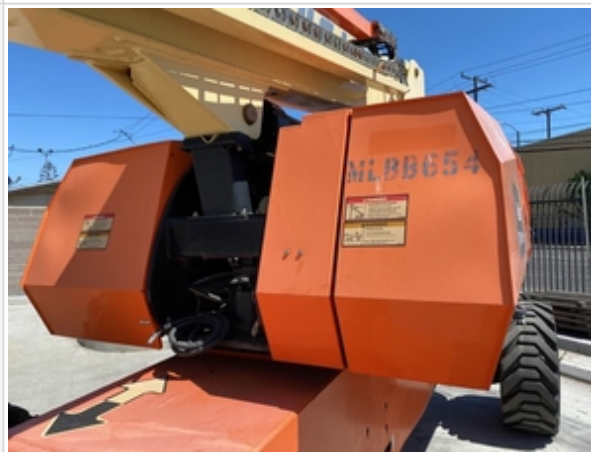
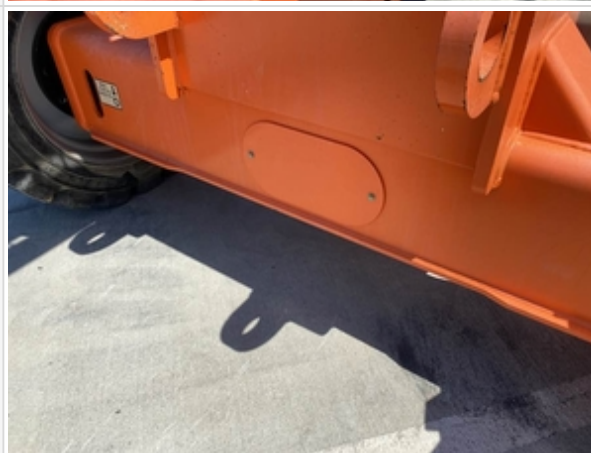
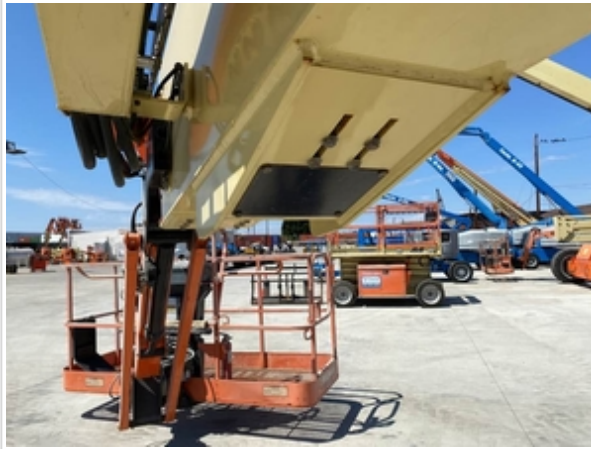
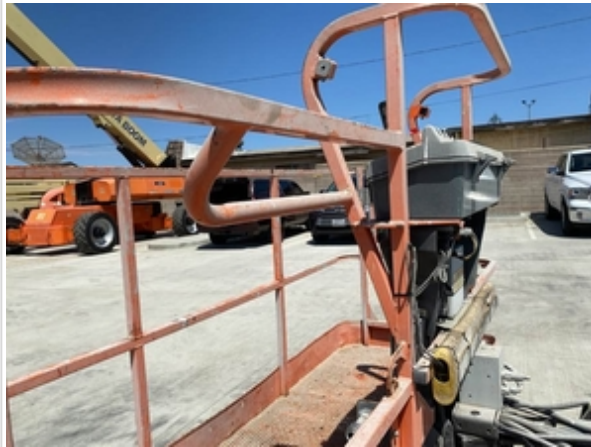
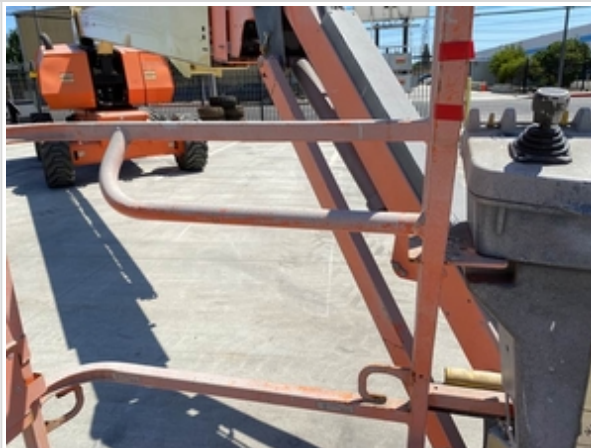
<p>Body Panels Photos</p>

<b>Body Panels (Any Damage?)</b>	3 - Normal Wear & Tear
<b>Comments</b>	Some small dents on left side

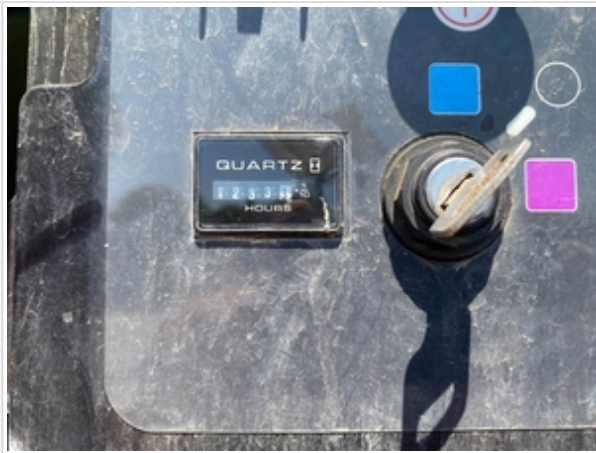
<p>Hour Meter Activity Photos</p>

<b>Hour Meter Activity</b>	3 - Normal Wear & Tear

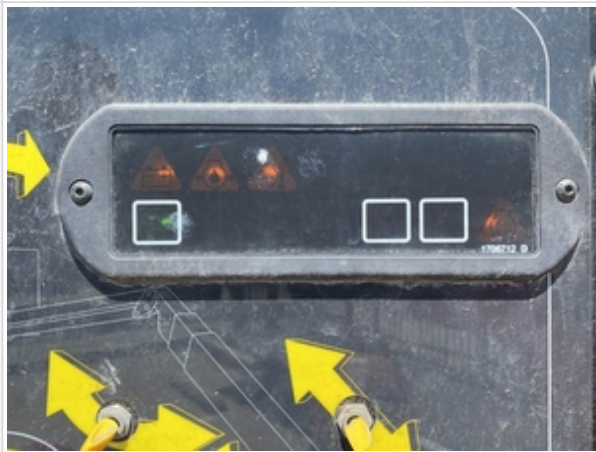
<p>Other Gauge Activity</p>	<p>3 - Normal Wear &amp; Tear</p>
<p>Other Gauge Activity Photos</p>

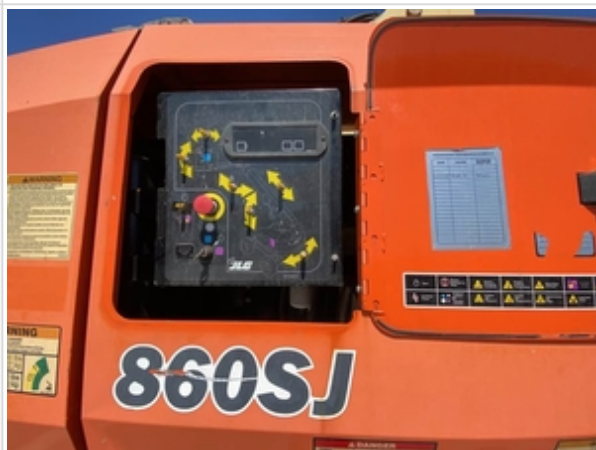
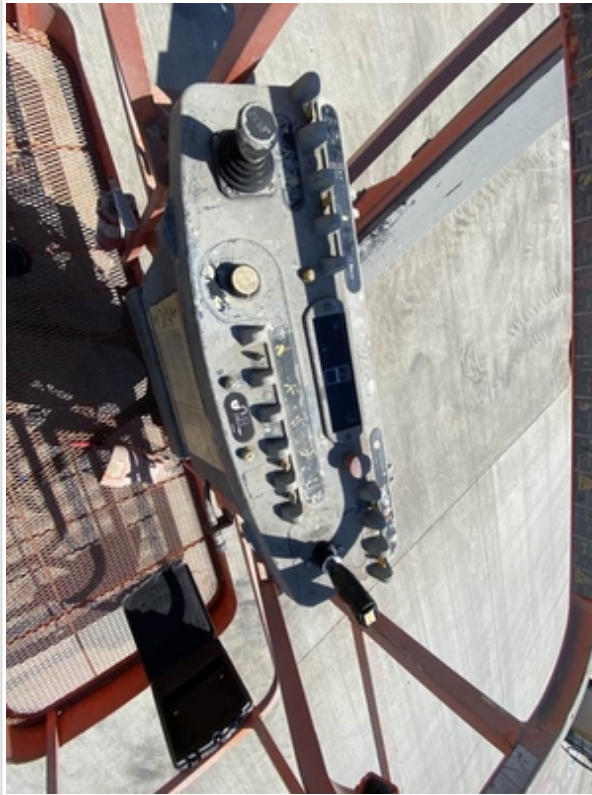
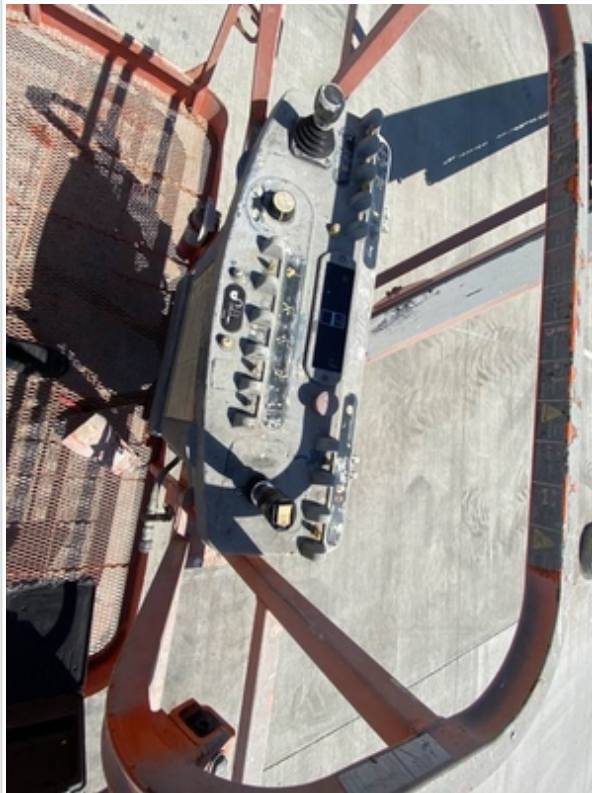
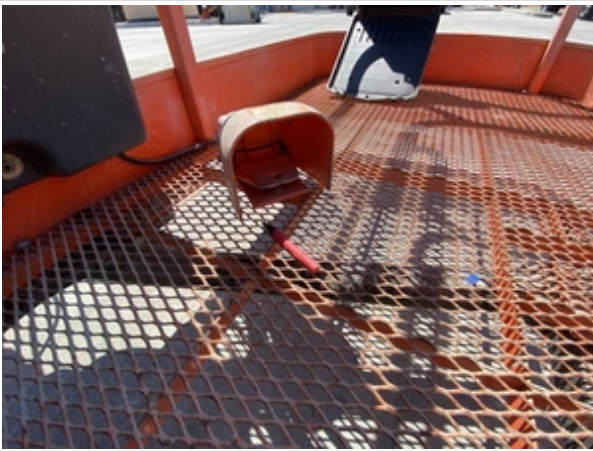
<p>Controls &amp; Switches</p>	<p>3 - Normal Wear &amp; Tear</p>
<p>Controls &amp; Switches Photos</p>

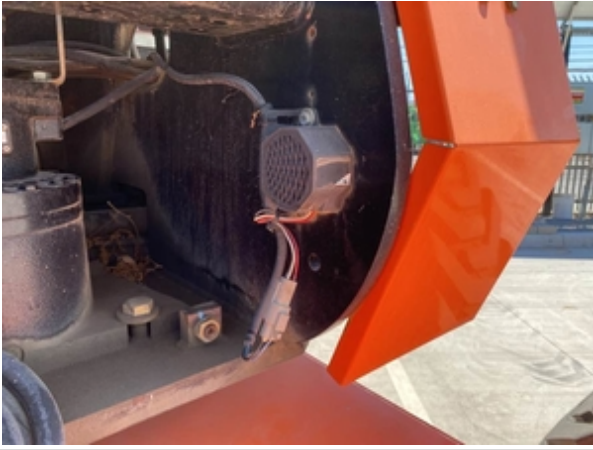
<b>Horn</b>	3 - Normal Wear & Tear	
<b>Horn Photos</b>

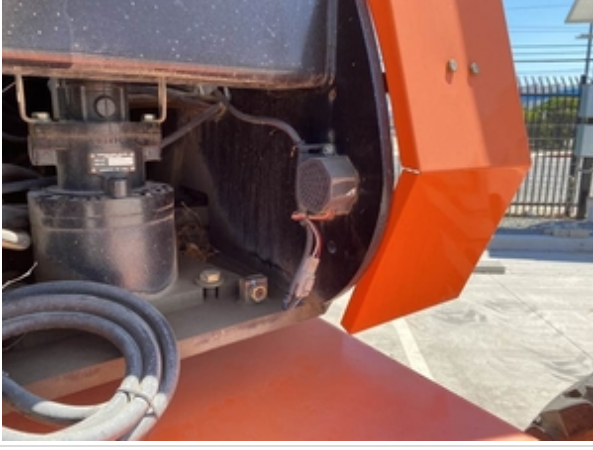
<b>Travel Alarm</b>	3 - Normal Wear & Tear	
<b>Travel Alarm Photos</b>

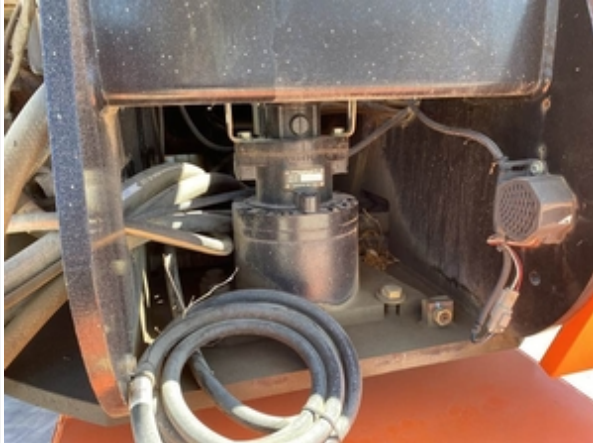
Swing Break Photos

<b>Swing Brake</b>	3 - Normal Wear & Tear

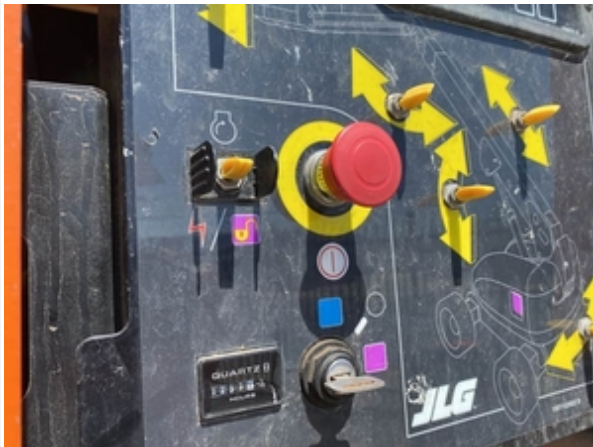
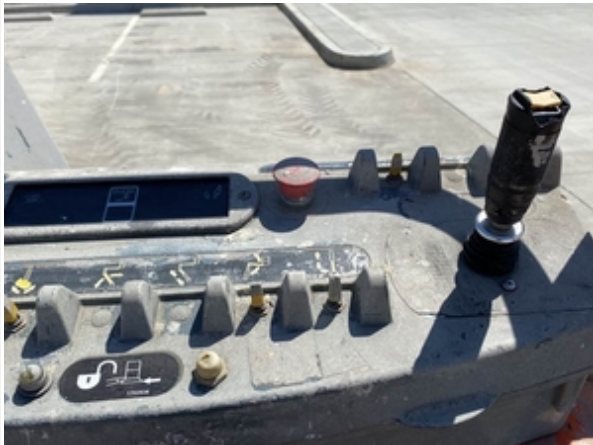
Safety Lock Out / Stop	3 - Normal Wear & Tear
Safety Lock Out / Stop Photos

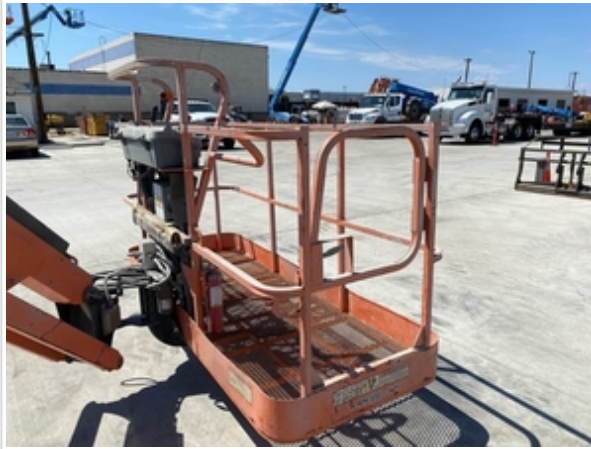
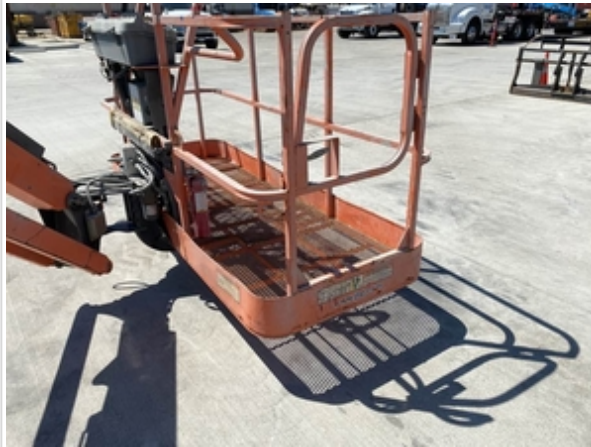
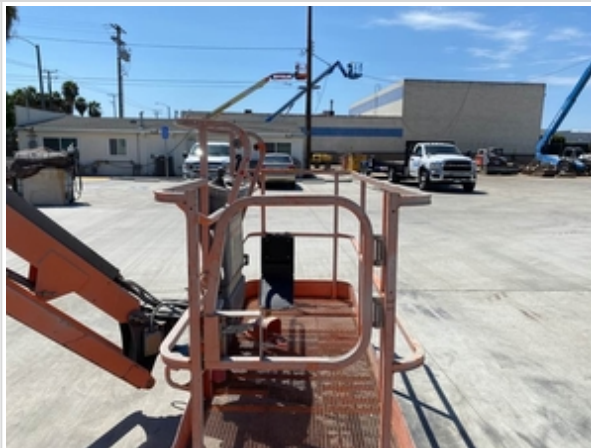
Platform Safety Rails & Appearance Photos

Platform Safety Rails & Appearance	3 - Normal Wear & Tear
Comments	Top back bar slightly bent

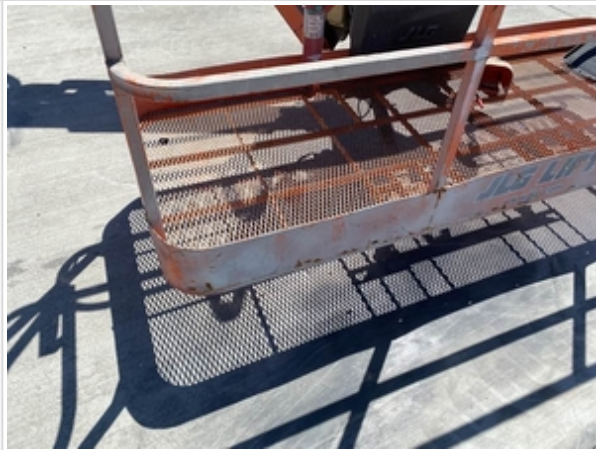
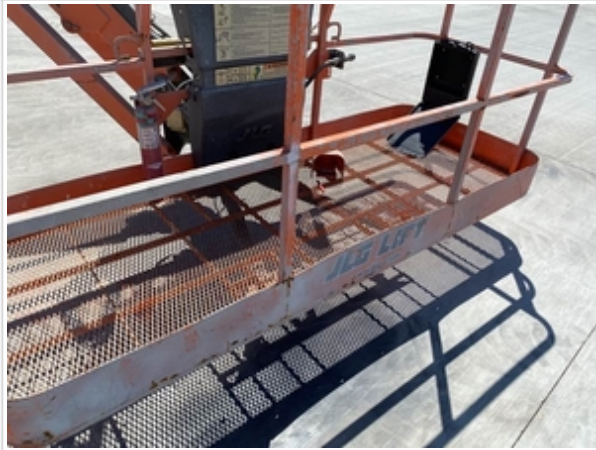
<b>Platform Floor</b>	3 - Normal Wear & Tear	
<b>Comments</b>	Nice and straight	
<b>Platform Floor Photos</b>

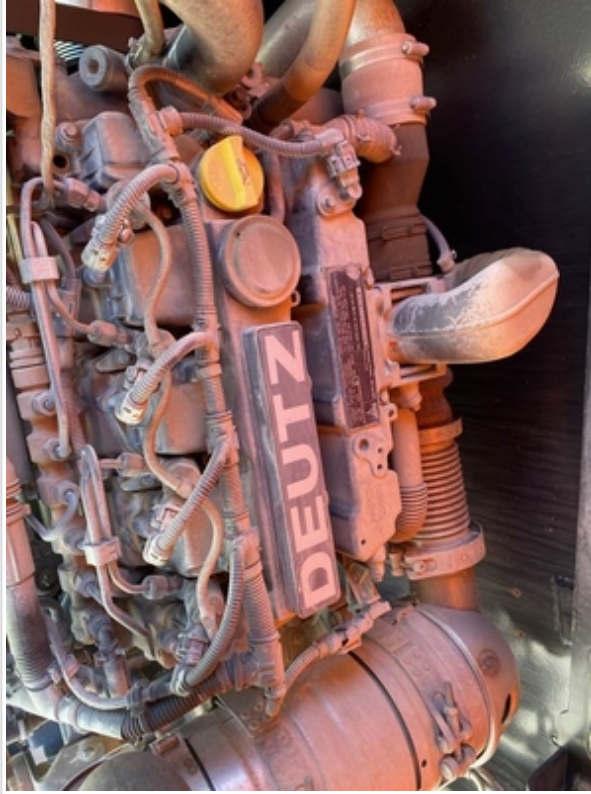
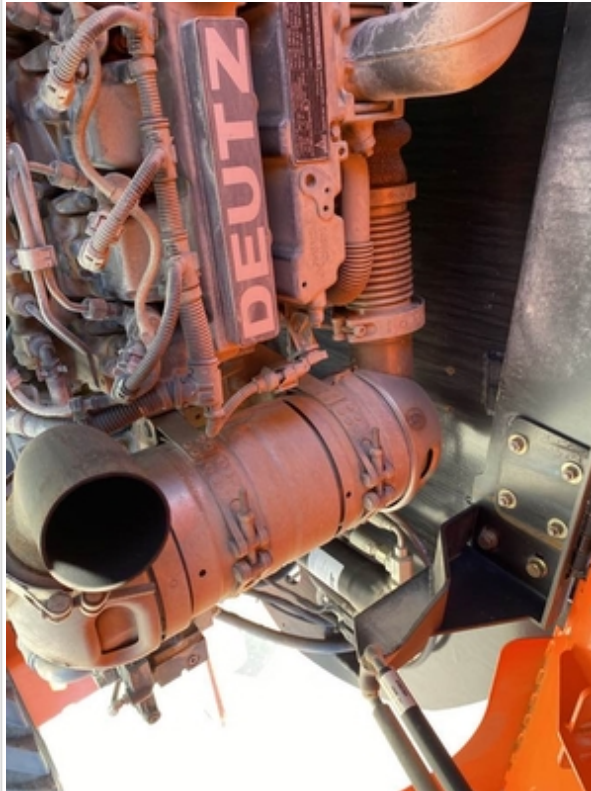
Engine Photos

<b>Requires DEF (Diesel Exhaust Fluid)</b>	No
<b>Overall Engine Appearance</b>	Clean & dry
<b>Overall Engine Comments</b>	Overall engine looks good with no major repairs needed from a visual

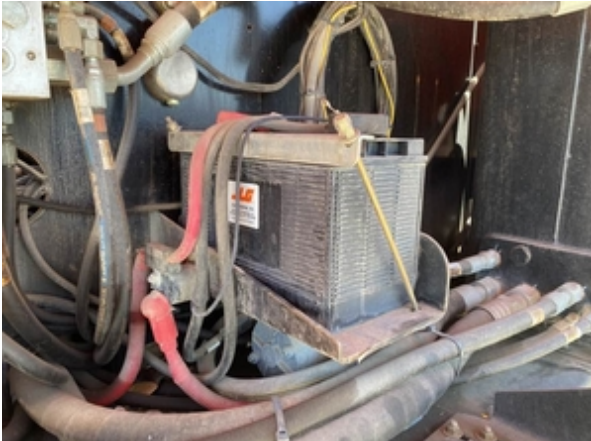
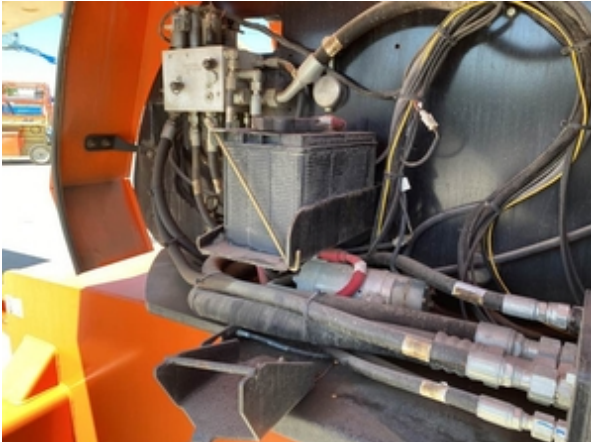
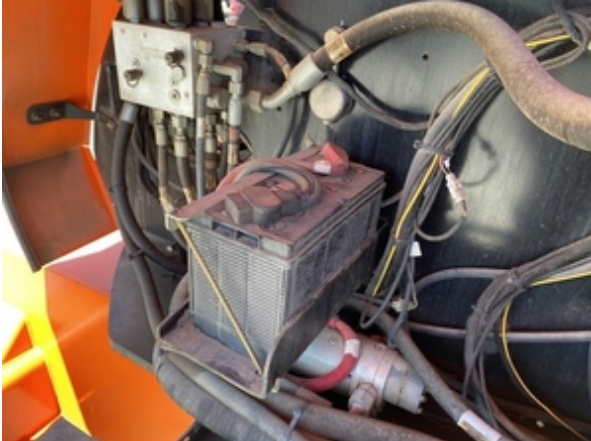
<b>Battery</b>	3 - Normal Wear & Tear
<b>Battery Condition</b>	Clean & dry appearance, tight connections, Dusty & dirty appearance
<b>Battery Condition Photos</b>

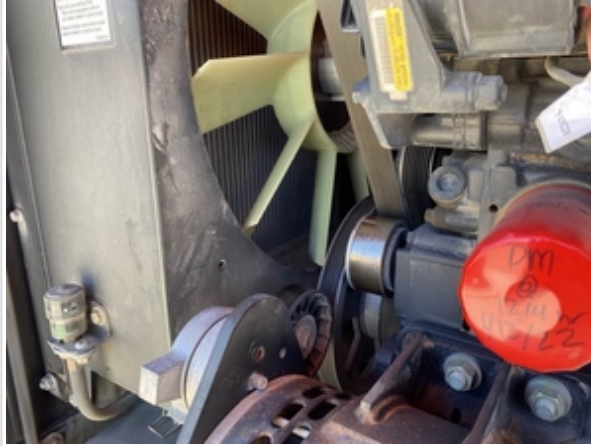
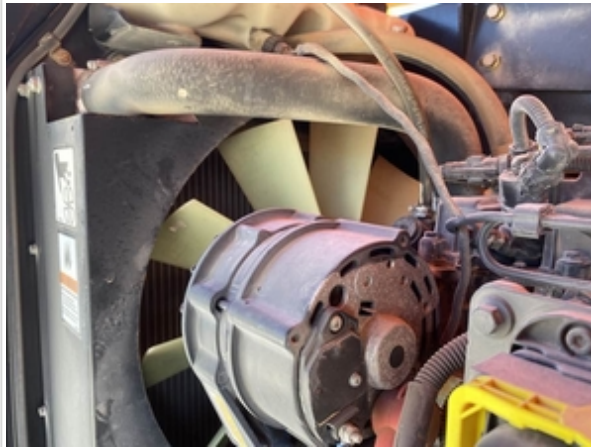
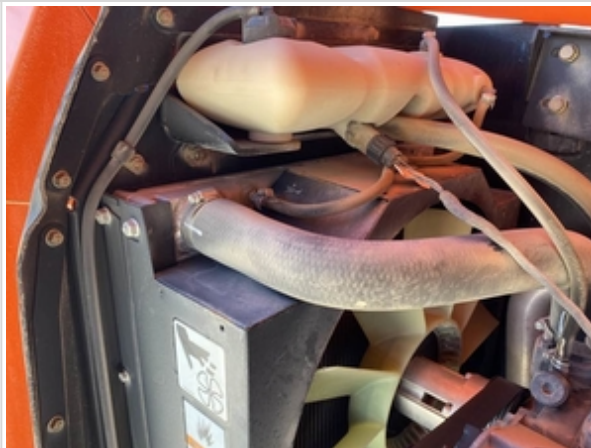
Radiator Photos

<b>Radiator</b>	3 - Normal Wear & Tear
<b>Radiator Condition</b>	Radiator fins & components appear to be in good working order, no signs of damage or leaks

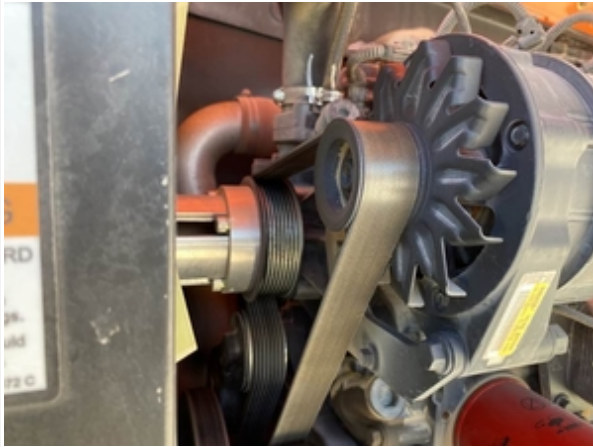
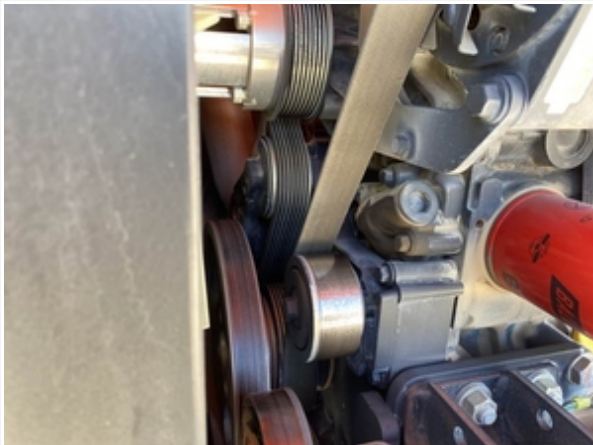
<b>Belts</b>	3 - Normal Wear & Tear
<b>Belt Condition</b>	Belts appear in good condition & alignment with proper tension
<b>Belt Photos</b>

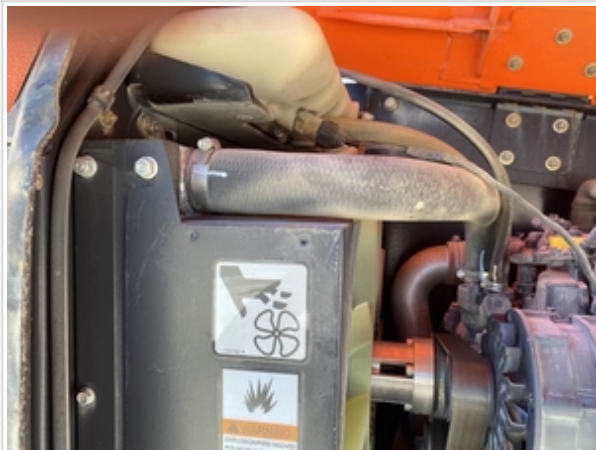
<b>Hoses</b>	3 - Normal Wear & Tear
<b>Hose Condition</b>	Firm, pliant hoses with no signs of wear or leaks, Other (See commentss
<b>Hose Photos</b>

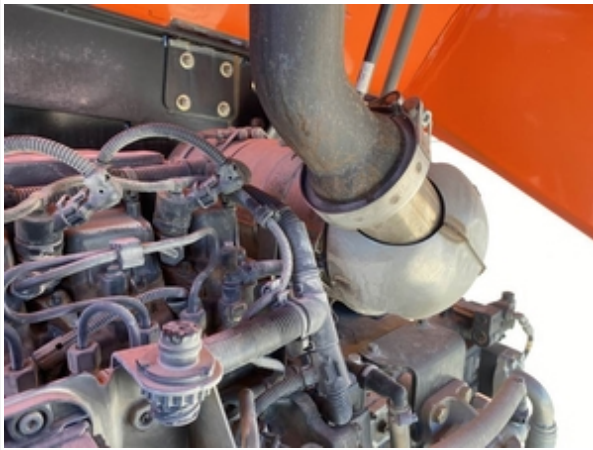
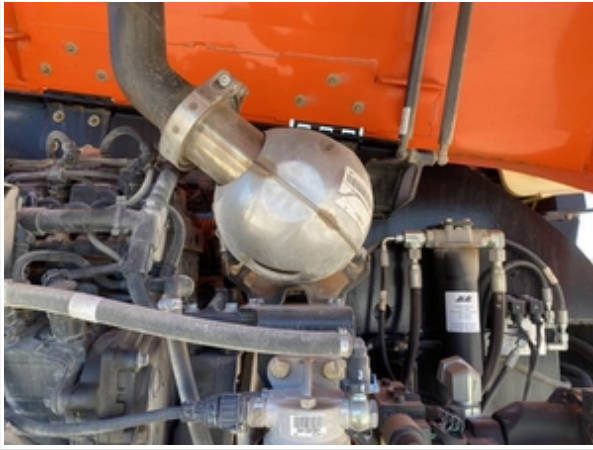
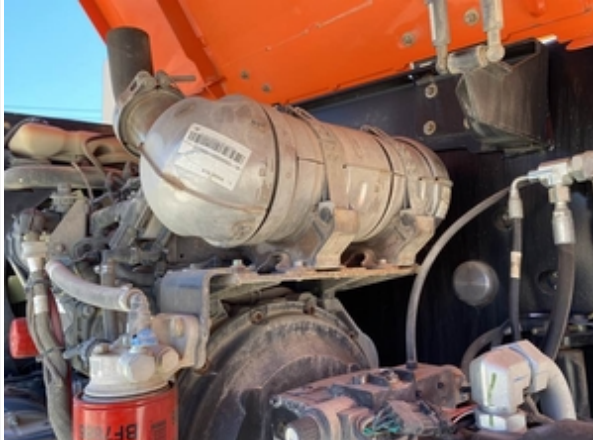
Oil Color / Appearance	3 - Normal Wear & Tear
Oil Color / Appearance Notes	Clean oil appearance, no signs of cross contamination, Appropriate oil level
Fuel Leaks	No
Equipped with DPF (Diesel Particulate Filter)	Yes
DPF Condition	3 - Normal Wear & Tear
DPF Condition Notes	Filter housing is intact with no signs of damage or malfunction, DPF indicator is not illuminated
DPF Photos

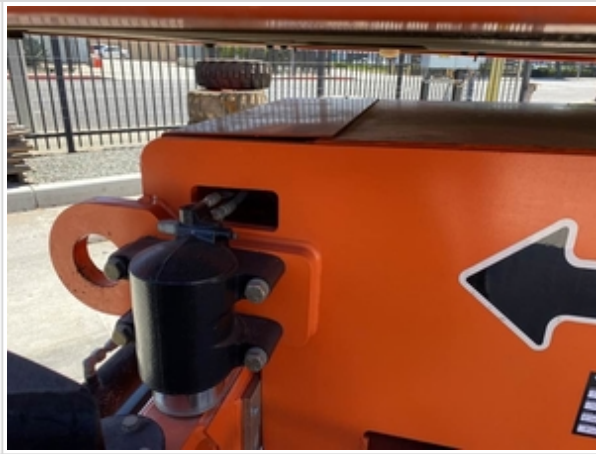
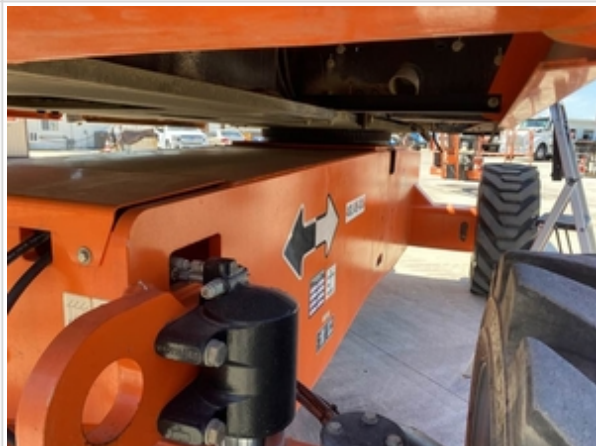
<b>Instructions</b>	Evaluate the following on a 4 point scale (leave comments where an explanation is appropriate):  4 = Like New, Recently Replaced 3 = Normal Wear & Tear 2 = Above Average Wear 1 = Service Required
<b>Frame</b>	3 - Normal Wear & Tear
<b>Frame Photos</b>

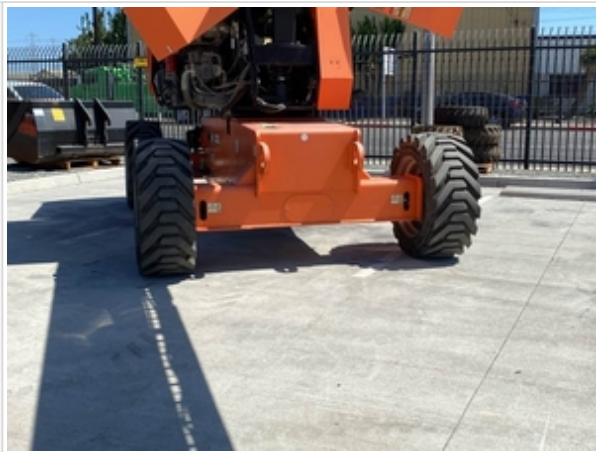
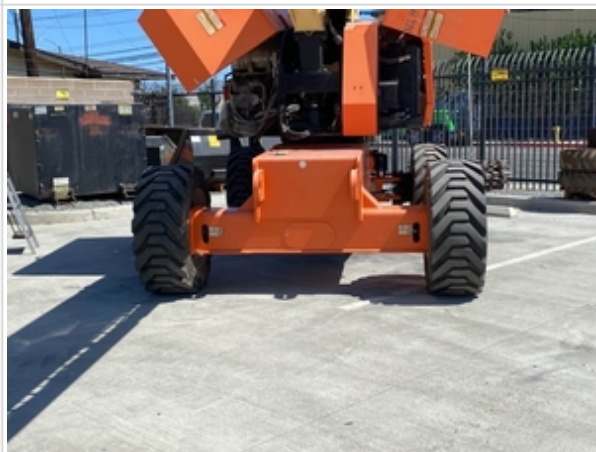
<p>Stance Photos</p>

<p>Stance</p>	<p>3 - Normal Wear &amp; Tear</p>

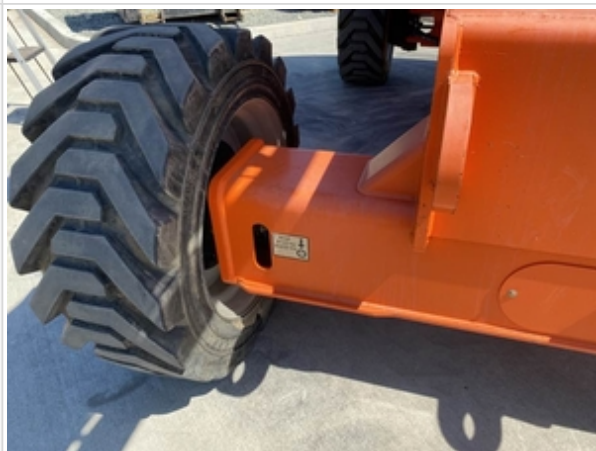
<p>Front Axle Appearance</p>	<p>3 - Normal Wear &amp; Tear</p>
<p>Front Axle Appearance Photos</p>

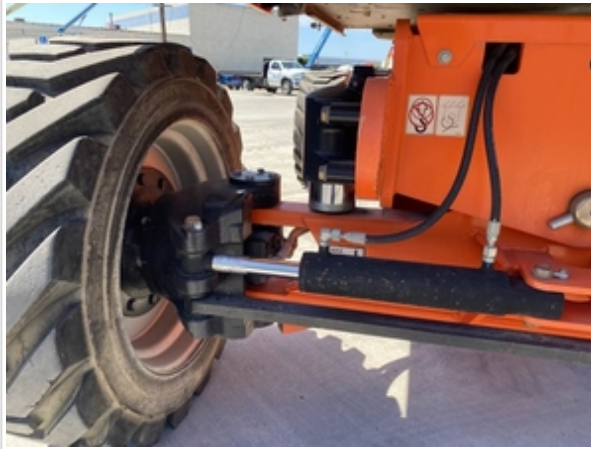
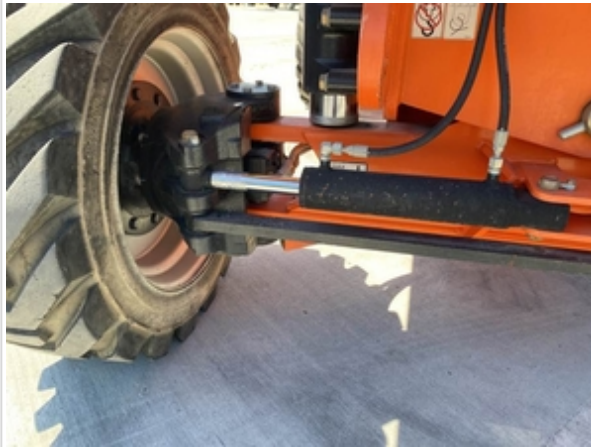
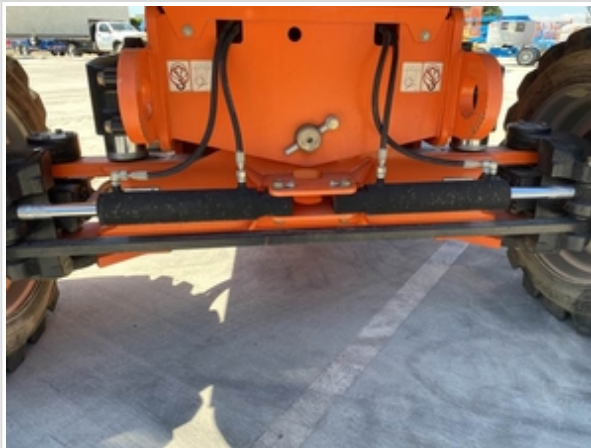
Rear Axle Appearance Photos

**Rear Axle Appearance**

3 - Normal Wear & Tear

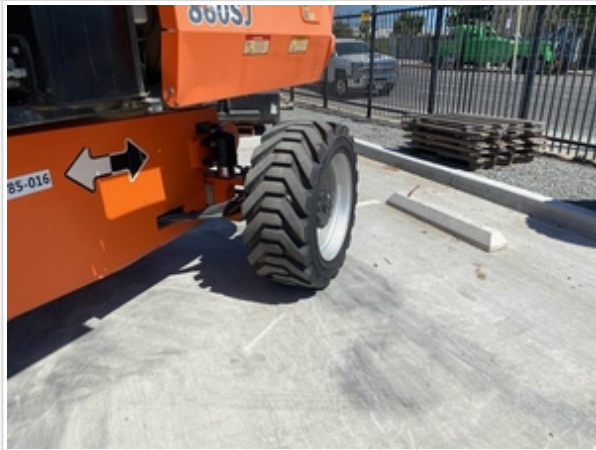
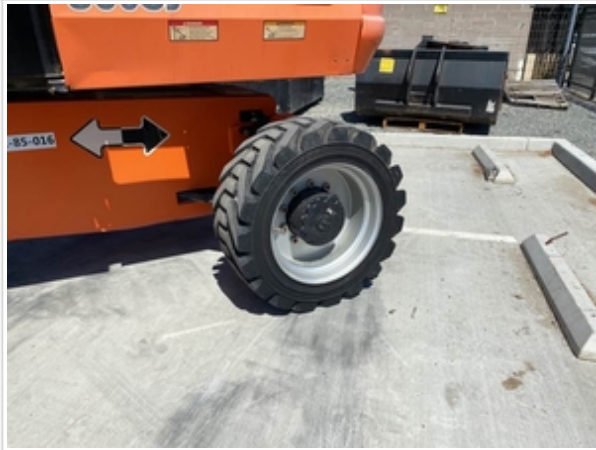
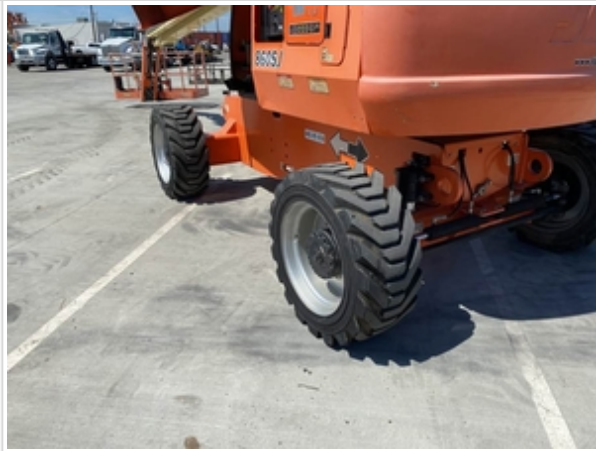
<b>Wheels &amp; Tires</b>	4 - Like New, Recently Replaced	
<b>Comments</b>	Like new, a few minor cuts here and there but	
<b>Wheels &amp; Tires Photos</b>

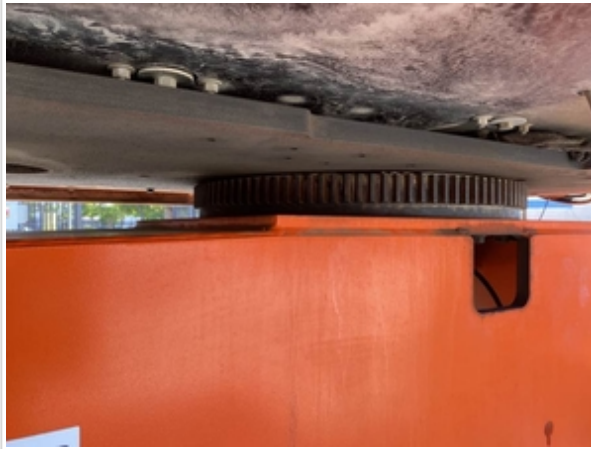
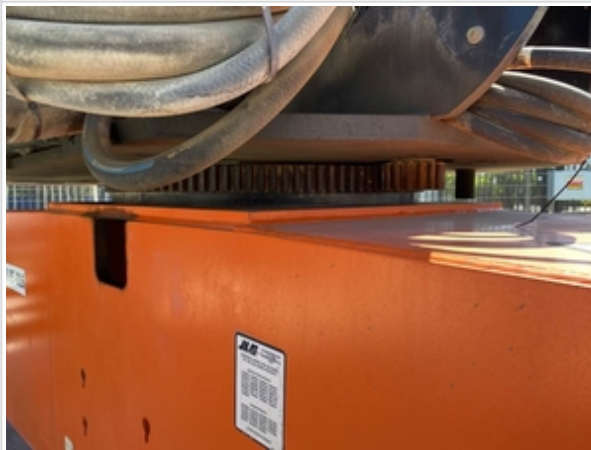
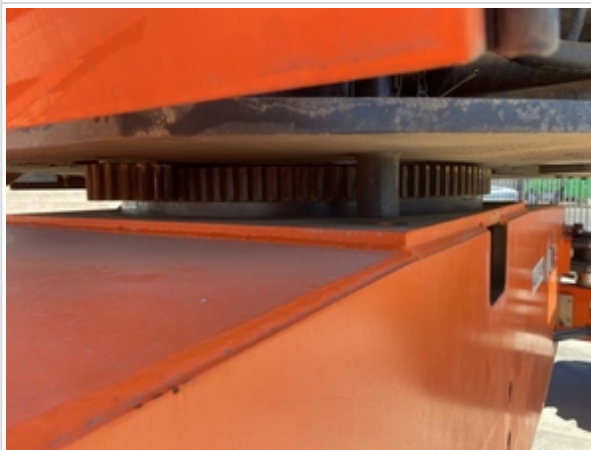
Swivel Bearing Photos

<b>Tire Brand</b>	OTR Outrigger
<b>Tire Size</b>	15-625NHS
<b>Front Left Tire - Ratio Remaining</b>	90%
<b>Rear Left Tire - Ratio Remaining</b>	90%
<b>Front Right Tire - Ratio Remaining</b>	90%
<b>Rear Right Tire - Ratio Remaining</b>	90%
<b>Swivel Bearing</b>	3 - Normal Wear & Tear

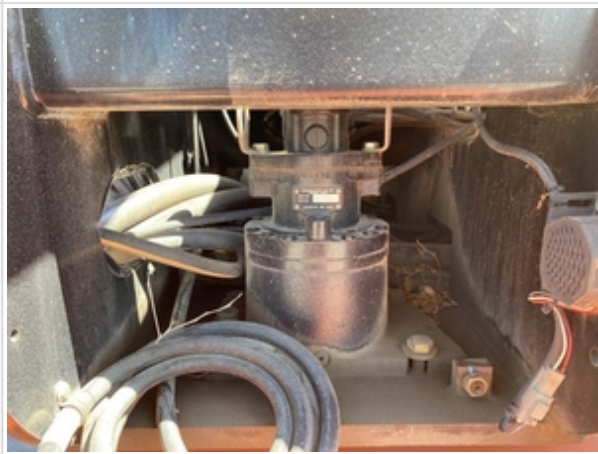
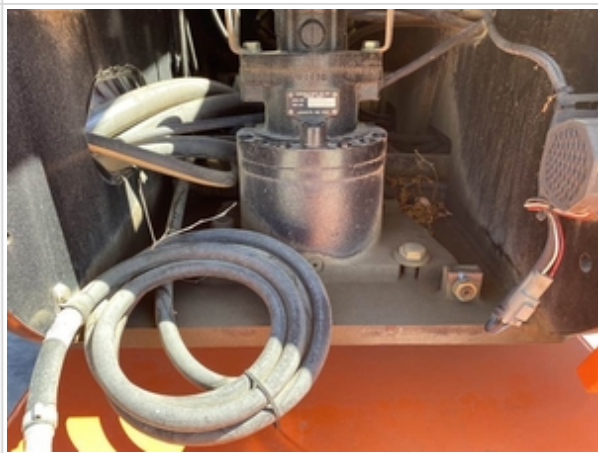
<p>Swivel Motor</p>	<p>3 - Normal Wear &amp; Tear</p>	
<p>Swivel Bearing Photos</p>

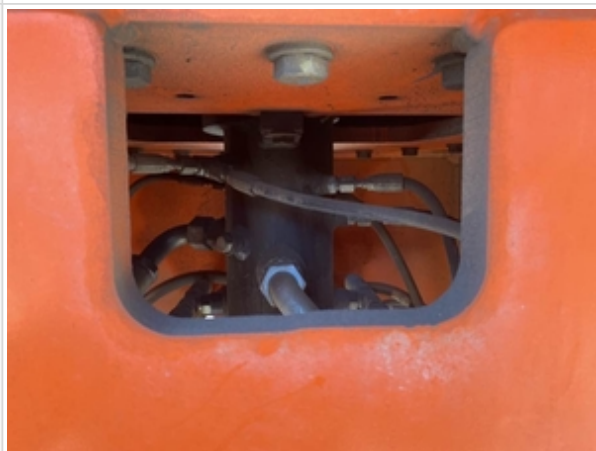
<p>Swivel Joint</p>	<p>3 - Normal Wear &amp; Tear</p>	
<p>Swivel Joint Photos</p>

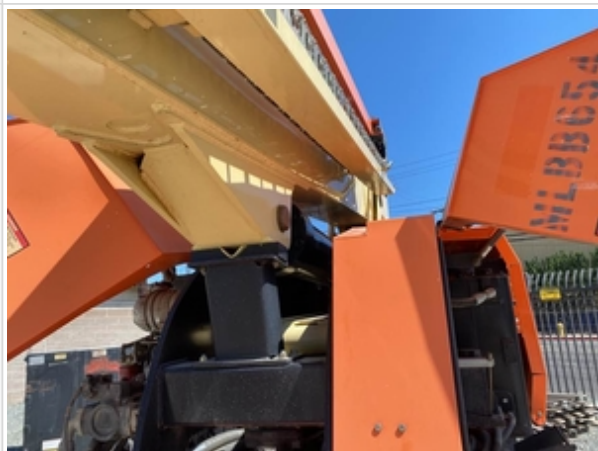
<p><b>Boom Condition</b></p>	<p>3 - Normal Wear &amp; Tear</p>	
<p><b>Boom Condition Photos</b></p>

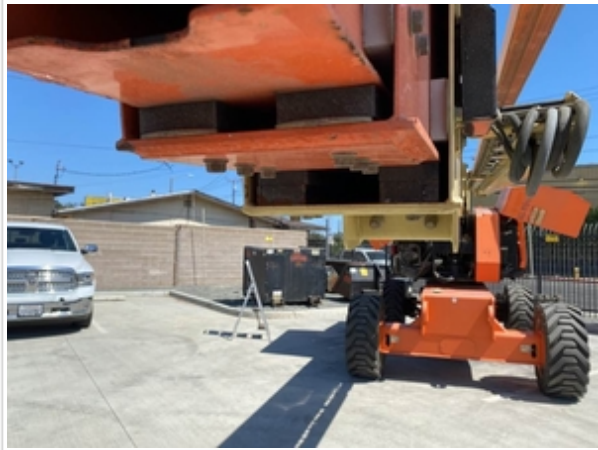
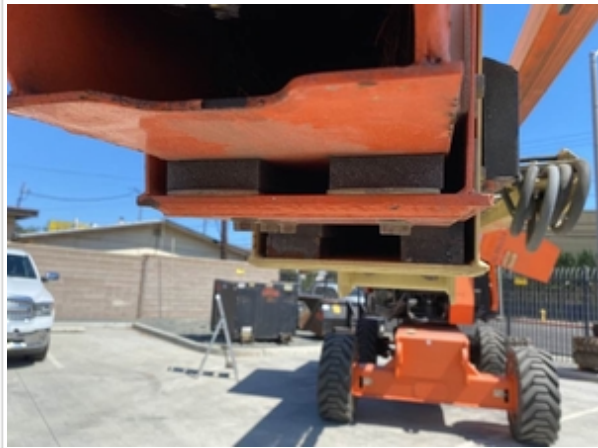
<p><b>Boom Wear Guides</b></p>	<p>3 - Normal Wear &amp; Tear</p>	
<p><b>Boom Wear Guides Photos</b></p>

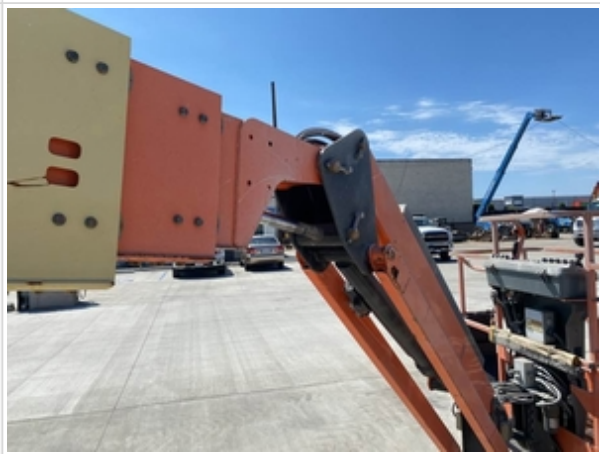
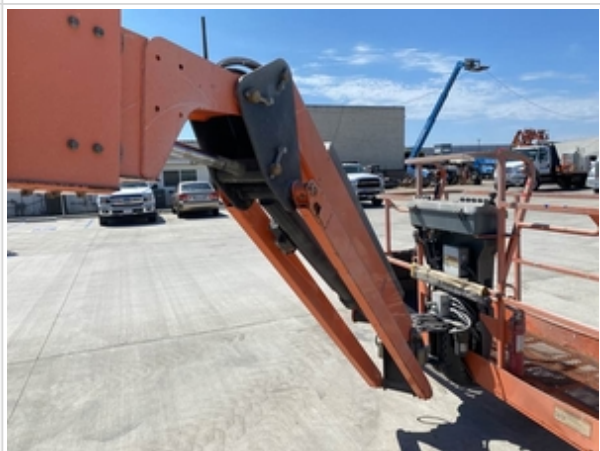
<p>Jib Condition</p>	<p>3 - Normal Wear &amp; Tear</p>	
<p>Jib Condition Photos</p>
