## Inspection Report (Boom Lift)

Year	2016
Make	JLG
Model	860SJ
Serial Number	300224791
Hour Meter Reading	1233.3
Previous Application (e.g., earth moving, mining, demolition, etc)	General construction

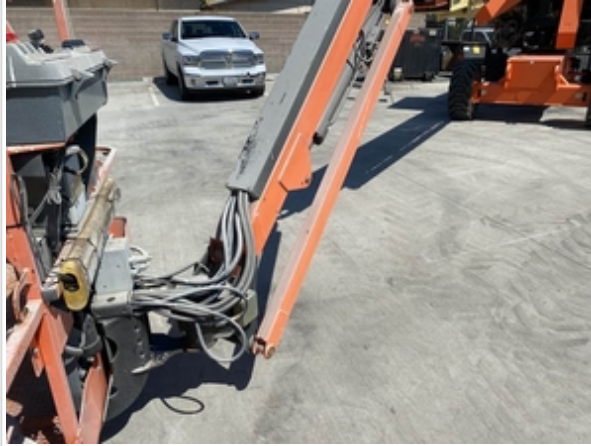
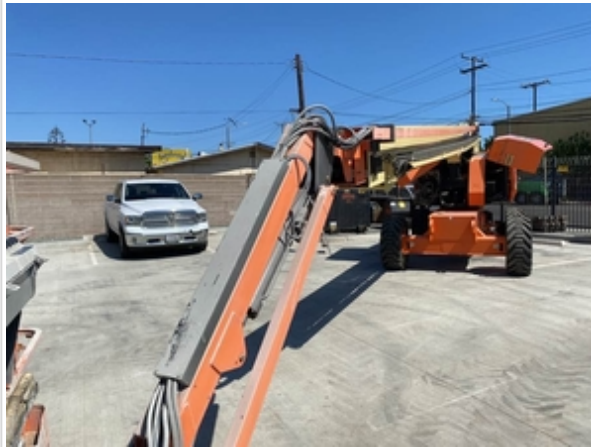
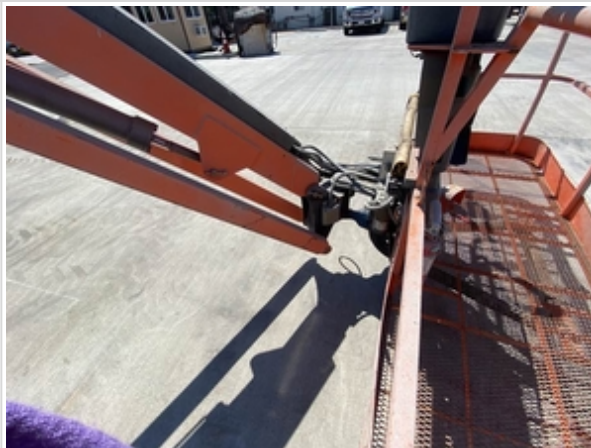
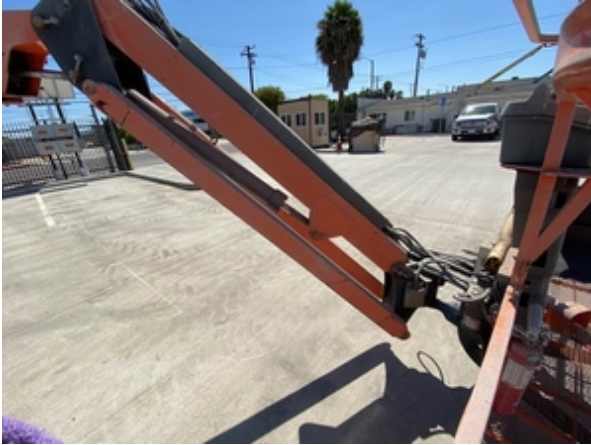
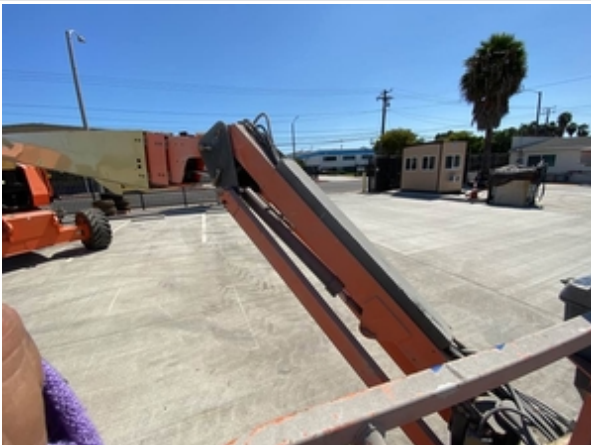
<p>Jib Condition</p>	<p>3 - Normal Wear &amp; Tear</p>	
<p>Jib Condition Photos</p>

<b>Comments</b>	Jib functionality proper
<b>Overall Chassis</b>	4 - Like New, Recently Replaced
<b>Overall Chassis Comments</b>	Overall everything intact and in good working condition

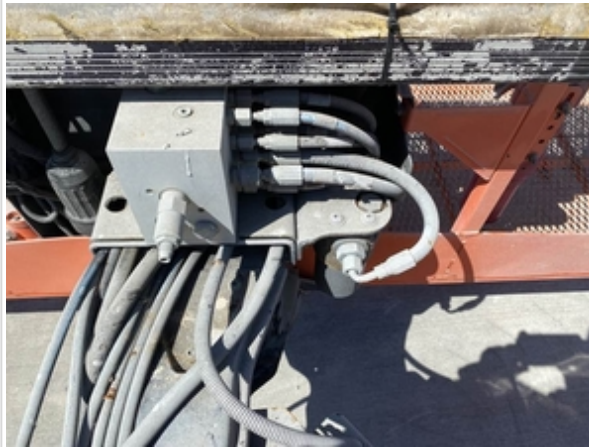
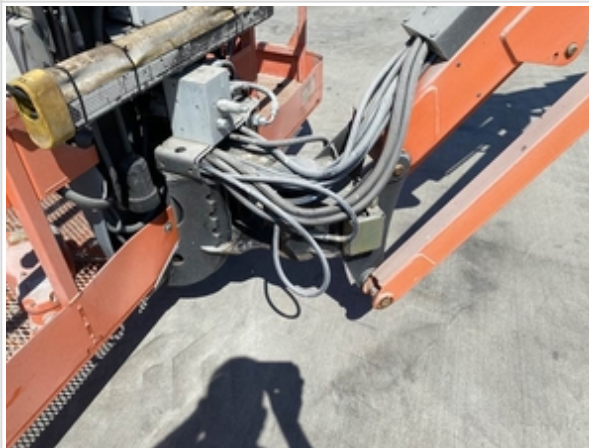
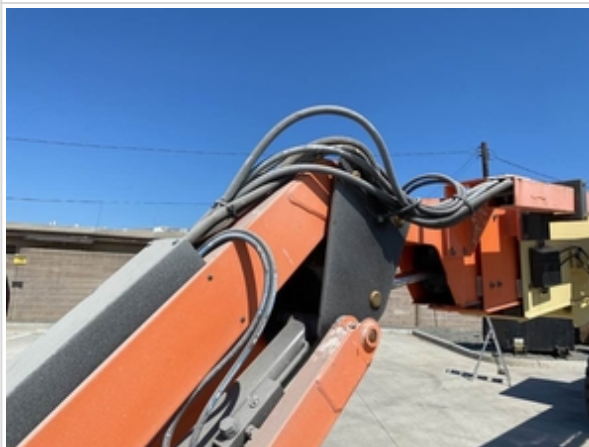
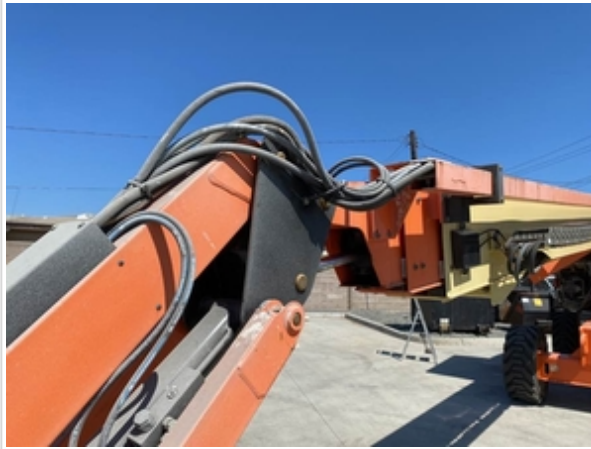
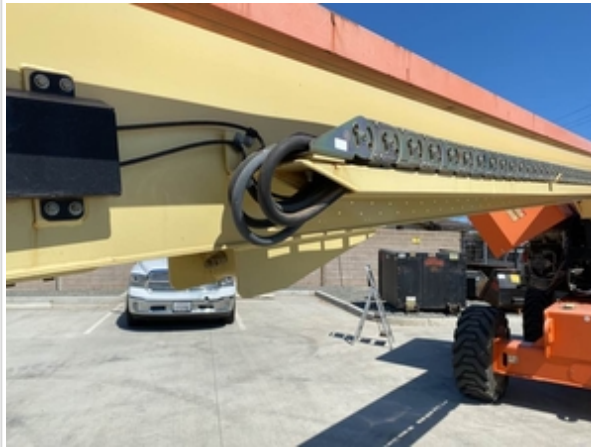
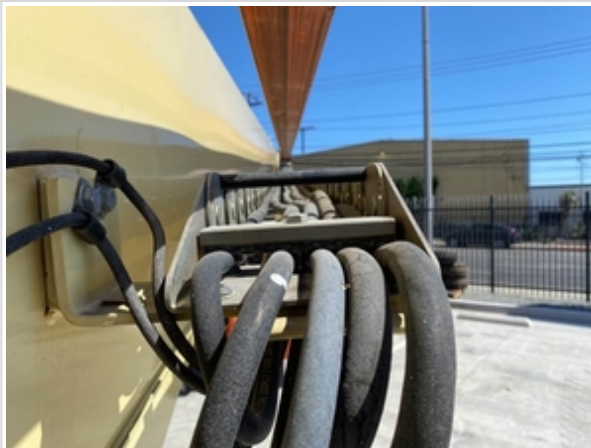
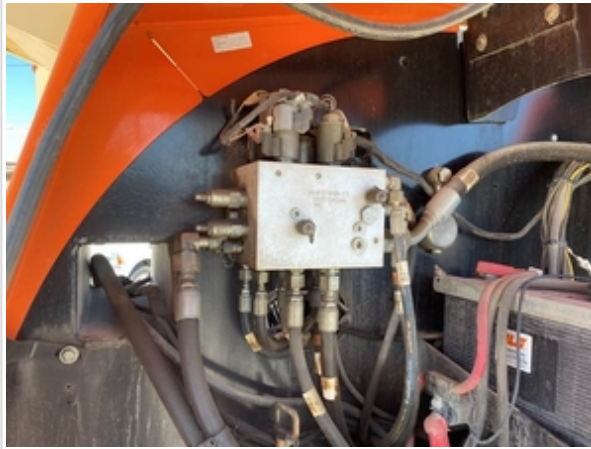
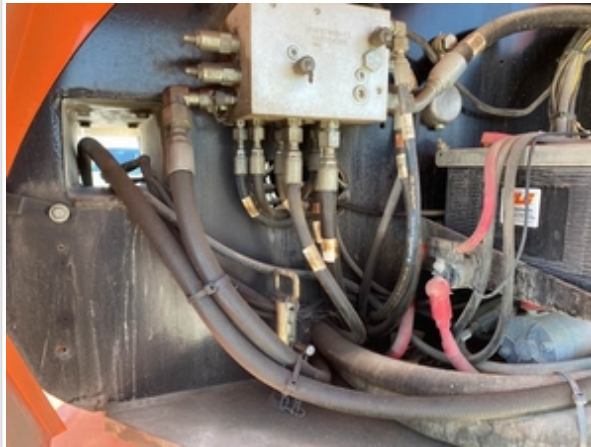
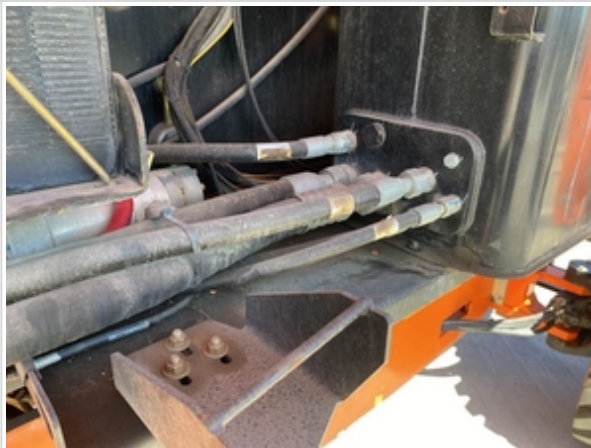
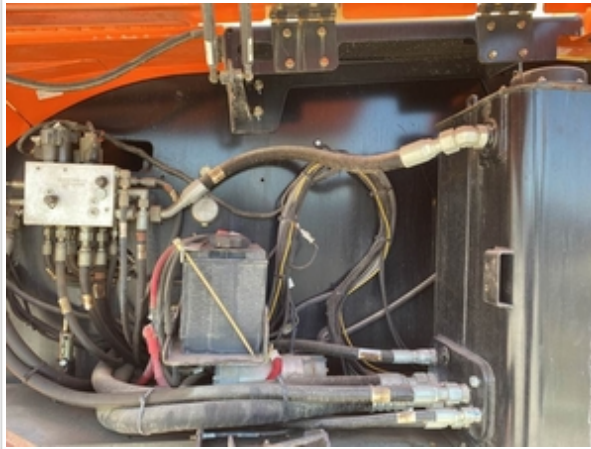
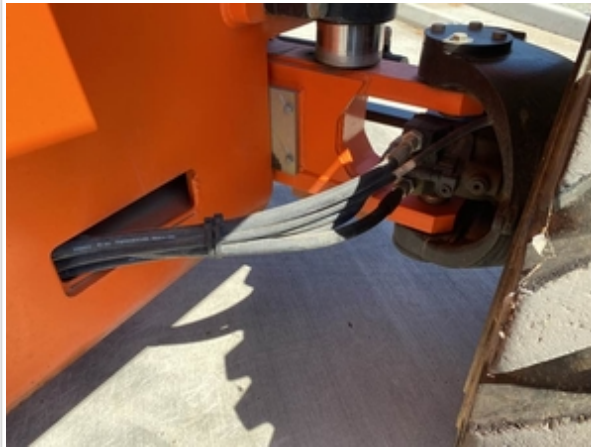
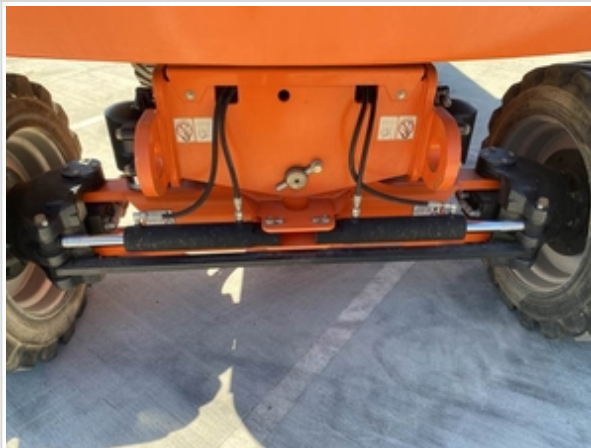
Appearance of Hydraulic Lines /  
Fittings Photos

<b>Wet or Damp Hydraulic Lines / Fittings</b>	No
<b>Appearance of Hydraulic Lines / Fittings</b>	3
<b>Hydraulic Lines / Fittings Condition</b>	Hydraulic lines & fittings are clean and in good condition

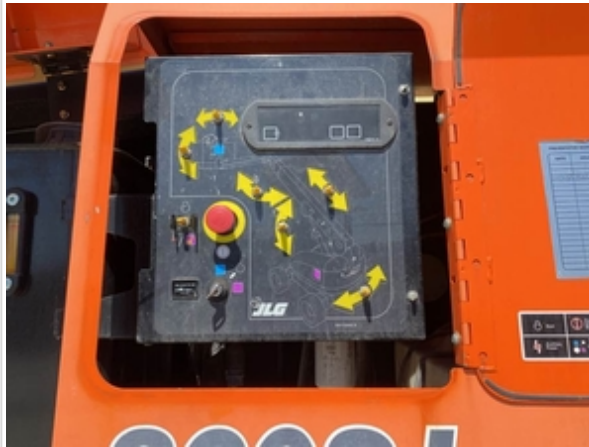
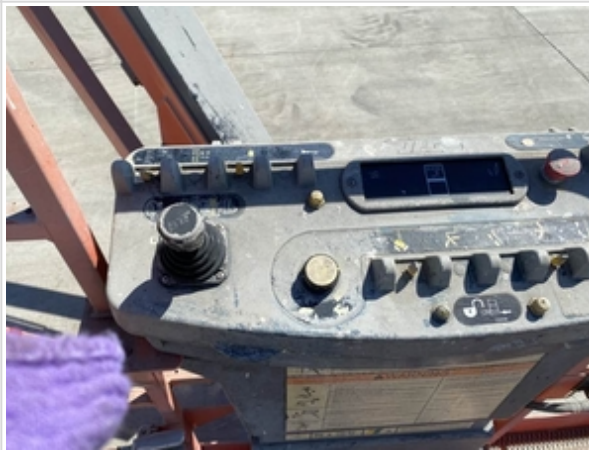
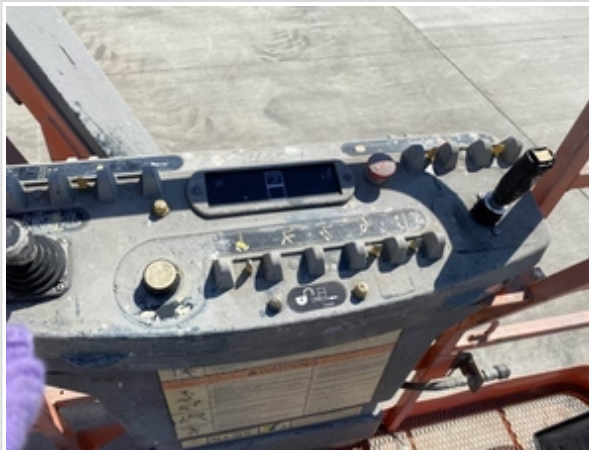
External Controls / Levers Photos

<b>Unusual Noises (Hydraulic Pump)</b>	No	
<b>Hydraulic Pump Notes</b>	No unusual noises heard during operation	
<b>External Controls / Levers</b>	3	
<b>External Controls / Levers Condition</b>	Good function & condition of hydraulic controls

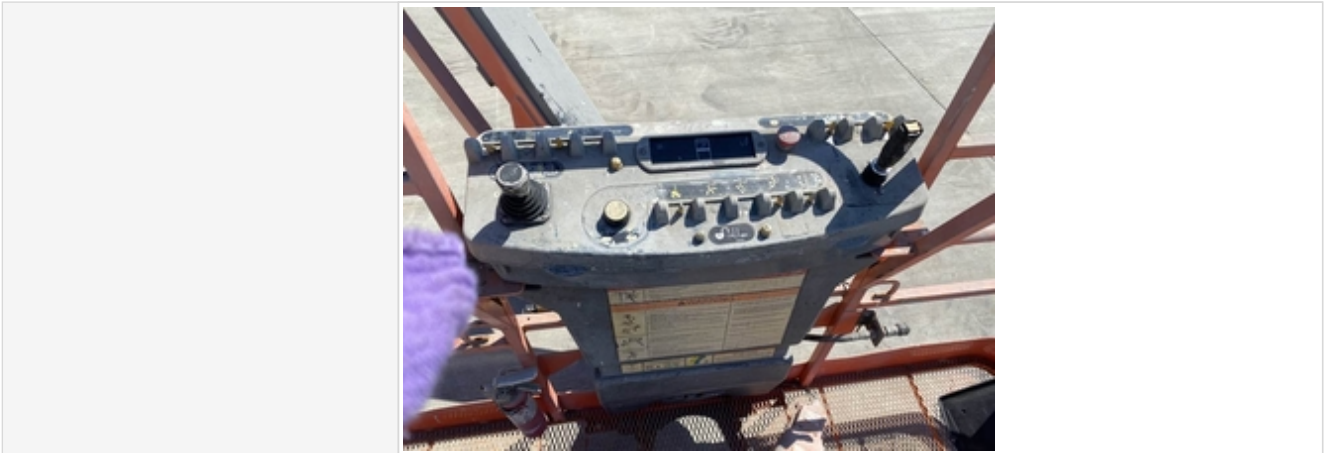
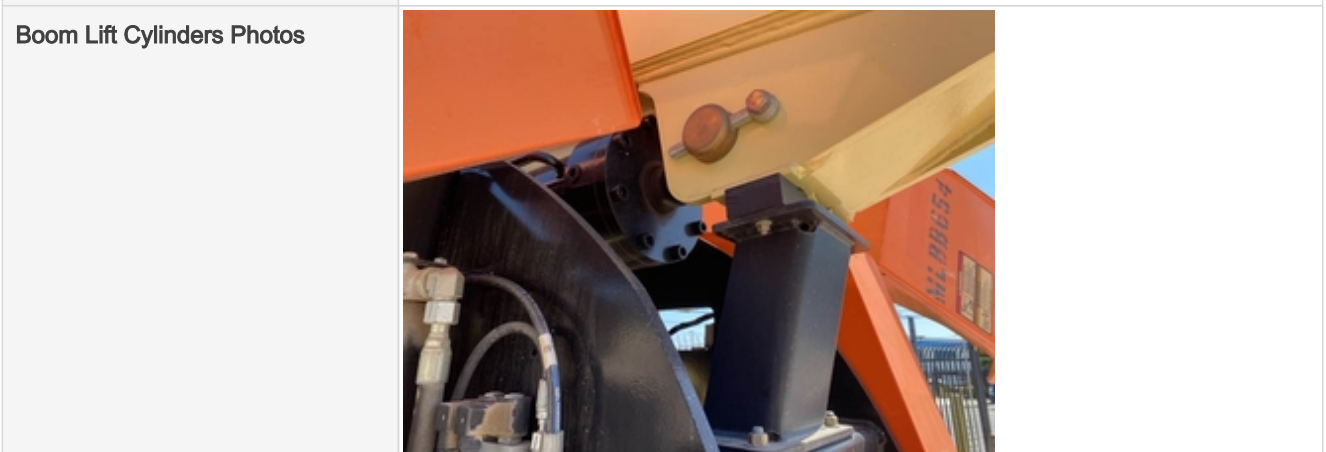
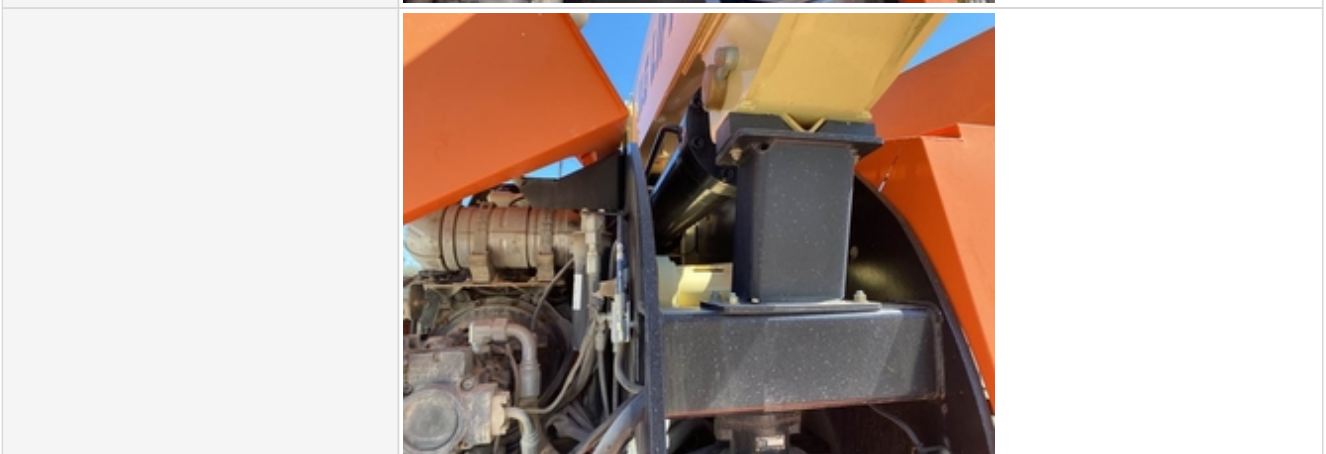
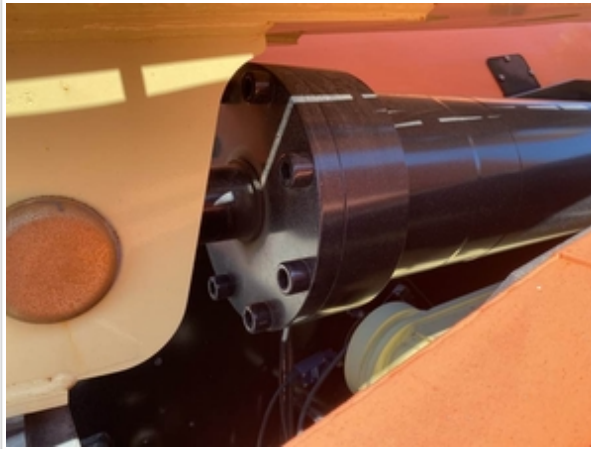
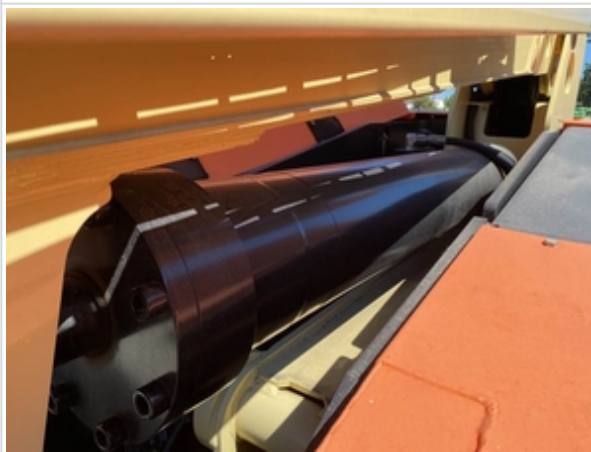
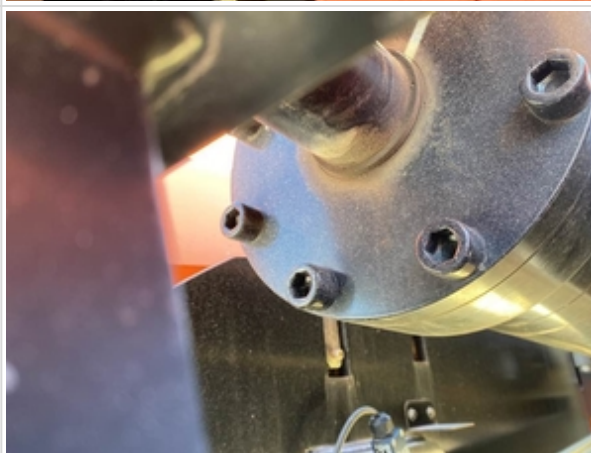
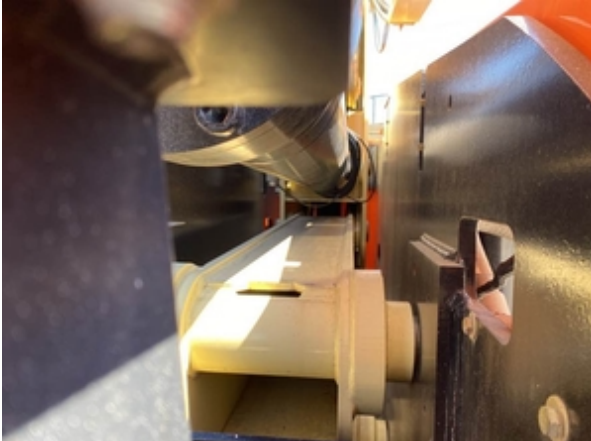
Boom Lift Cylinders	Check the boom lift cylinders. Note any wear, pitting, discoloration, etc. Take photos.
Boom Lift Cylinders: Mounting Pin	4
Boom Lift Cylinders: Oil Leaks	No

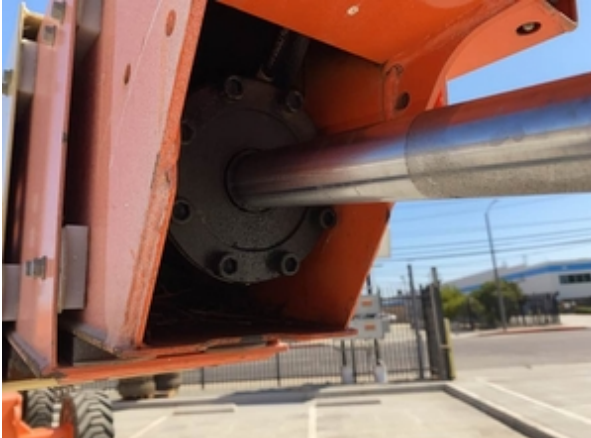
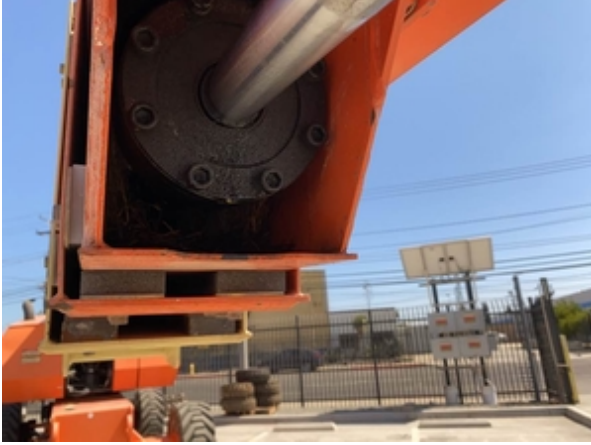
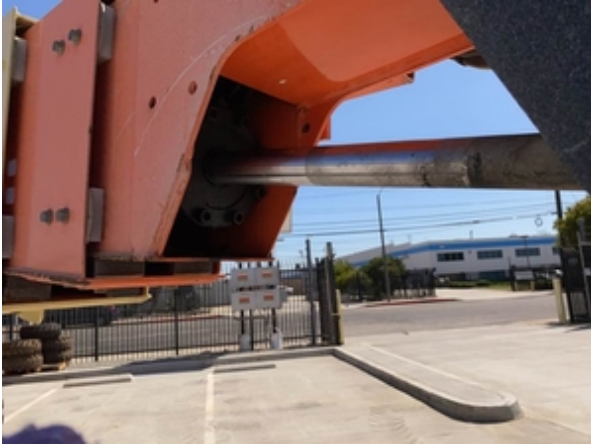
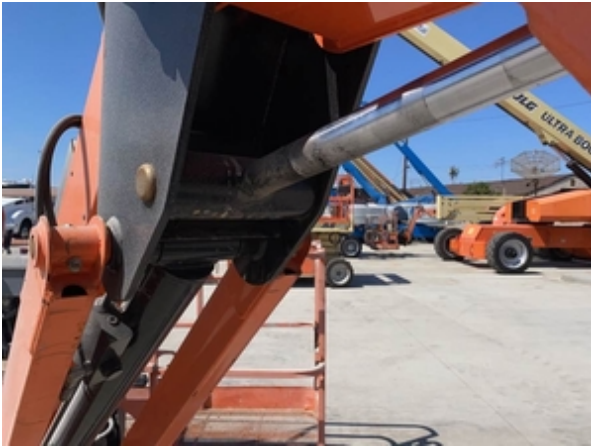
<b>Boom Extension Cylinder</b>	Check the boom extension cylinder. Note any wear, pitting, discoloration, etc. Take photos.
<b>Boom Extension Cylinder: Mounting Pin</b>	3
<b>Boom Extension Cylinder: Oil Leaks</b>	No
<b>Comments</b>	Unable to capture clear picture, visually looks normal with no leaks present
<b>Jib Cylinder</b>	Check the jib cylinder. Note any wear, pitting, discoloration, etc. Take photos.
<b>Jib Cylinder: Oil Leaks</b>	Yes
<b>Jib Cylinder: Mounting Pin</b>	4
<b>Comments</b>	Minor seepage coming from job cylinder
<b>Jib Cylinder Photos</b>

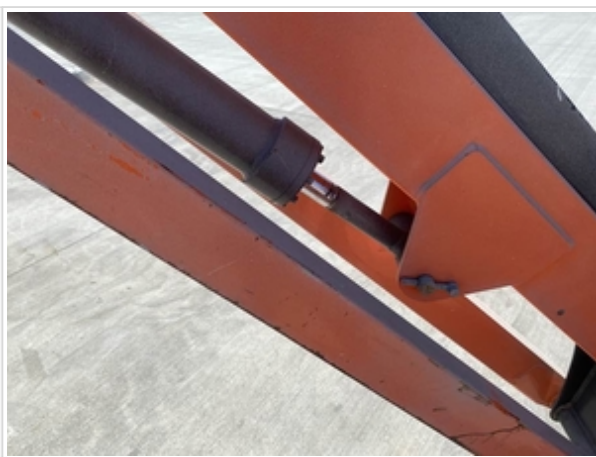
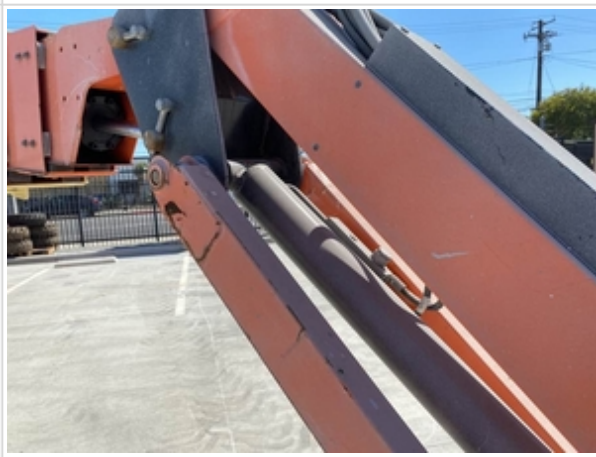
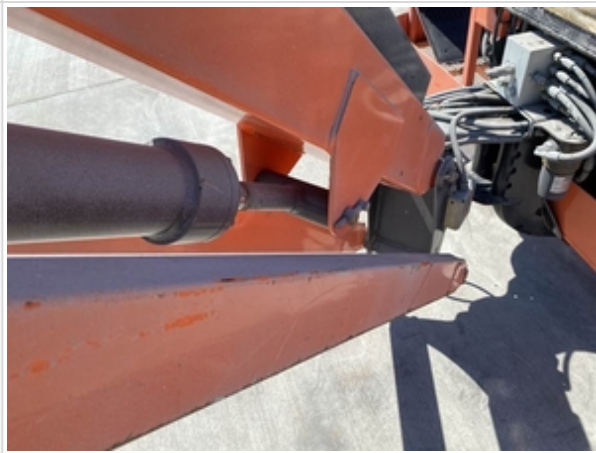
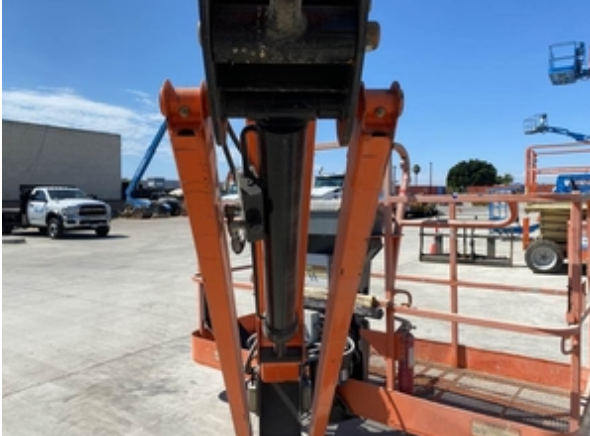
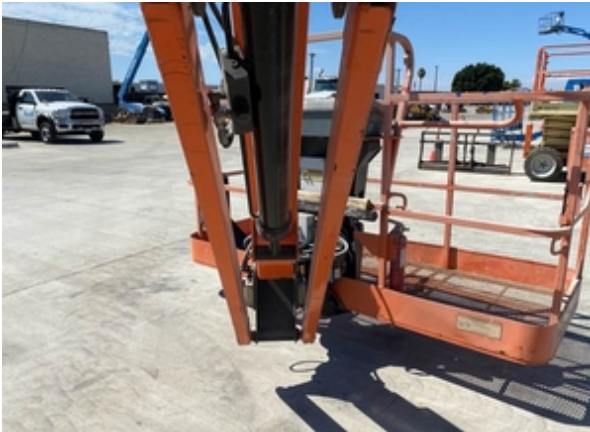
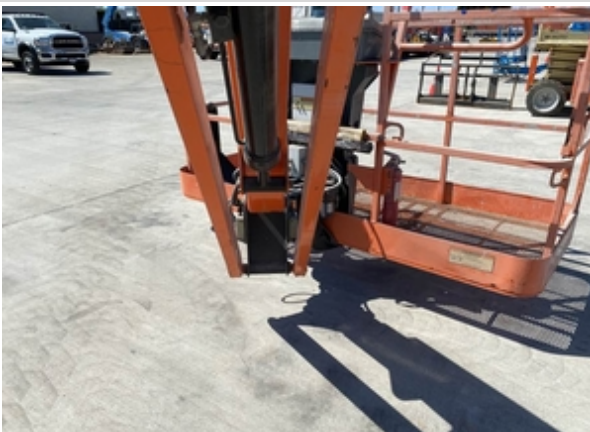
<p>Basket Tilt Cylinder Photos</p>

<b>Basket Tilt Cylinder</b>	Check the basket tilt cylinders. Note any wear, pitting, discoloration, etc. Take photos.
<b>Basket Tilt Cylinder: Mounting Pin</b>	4
<b>Basket Tilt Cylinder: Oil Leaks</b>	No

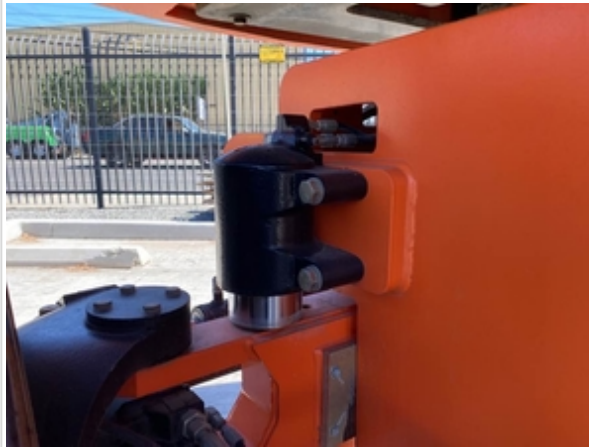
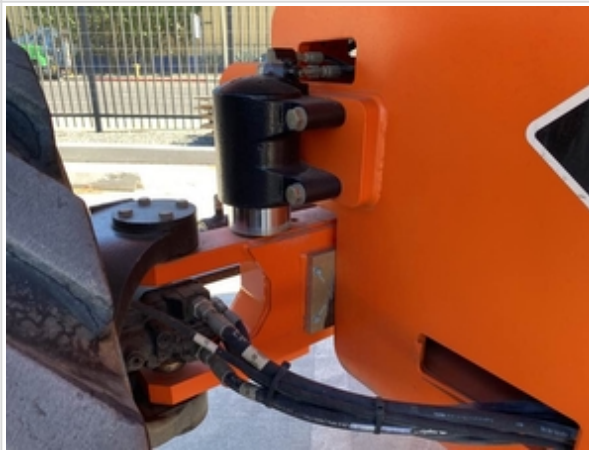
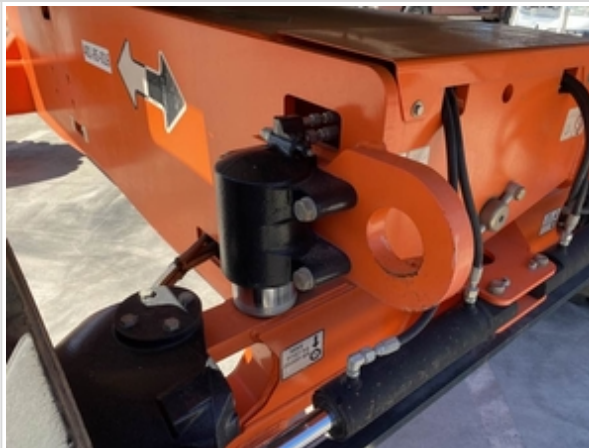
Frame Leveling Cylinders Photos

<b>Frame Leveling Cylinders</b>	Check the frame leveling cylinders. Note any wear, pitting, discoloration, etc. Take photos.	
<b>Frame Leveling Cylinders: Mounting Pin</b>	4	
<b>Frame Leveling Cylinders: Oil Leaks</b>	No

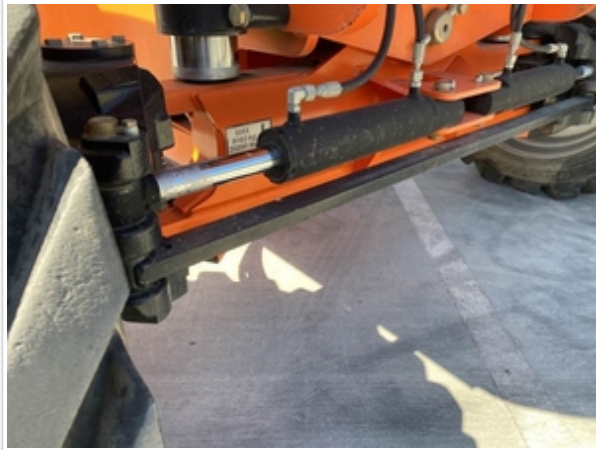
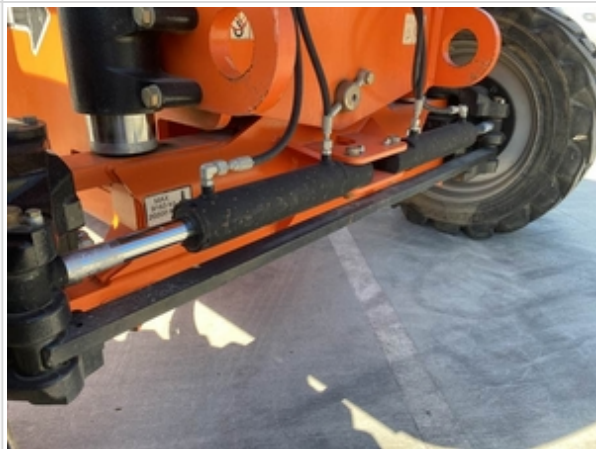
<b>Outrigger Cylinders</b>	Check the outrigger cylinders. Note any wear, pitting, discoloration, etc. Take photos.
<b>Steering Cylinders</b>	Check the steering cylinders. Note any wear, pitting, discoloration, etc. Take photos.
<b>Steering Cylinders: Mounting Pin</b>	4
<b>Steering Cylinders: Oil Leaks</b>	No
<b>Steering Cylinders Photos</b>
