## Inspection Report (Vibratory Compactor)

Year	2005
Make	Ingersoll-Rand
Model	DD-158HFA
Serial Number	181360
Hour Meter Reading	2,491 Hours
Previous Application (e.g., earth moving, mining, demolition, etc)	Asphalt Paving Construction

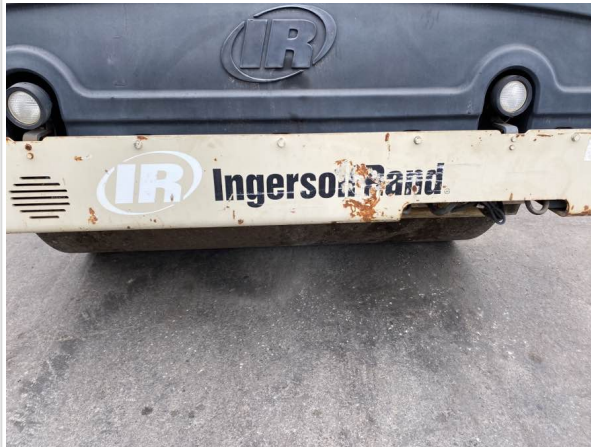
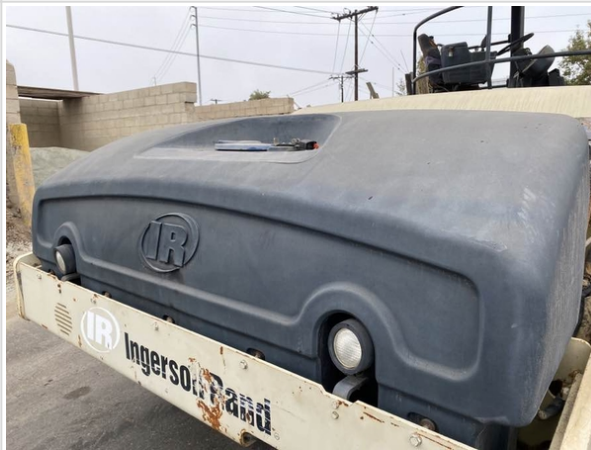
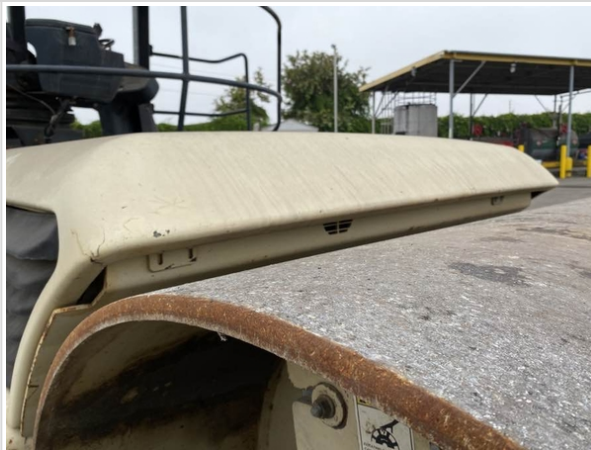
Front Photos

Front	3 - Normal Wear & Tear
Front Condition	No visible damage, Visible chipped paint or dents, Other (see comments)
Comments	Small scuff marks on front bumper

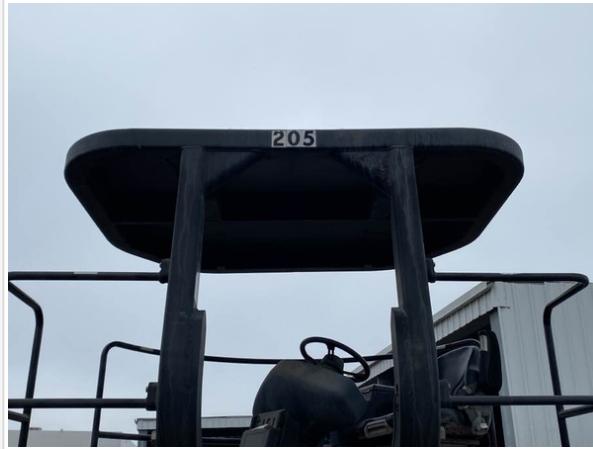
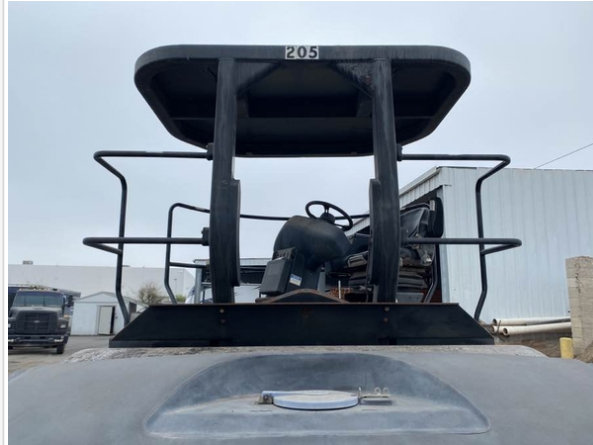
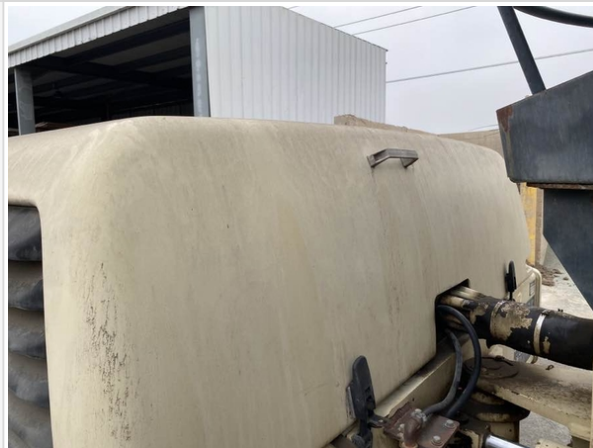
Rear	3 - Normal Wear & Tear	
Rear Condition	No visible damage, Visible chipped paint or dents, Other (see comments)	
Comments	Scuff marks present	
Rear Photos

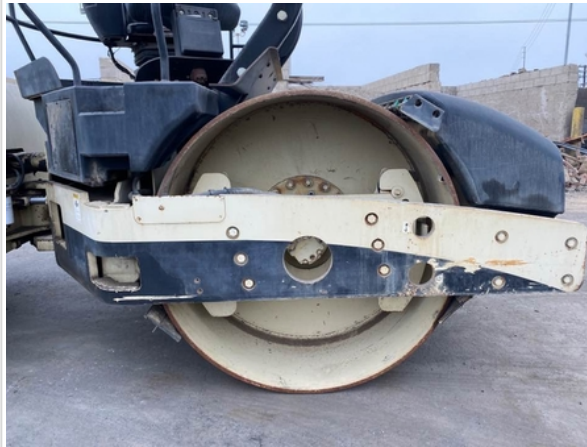
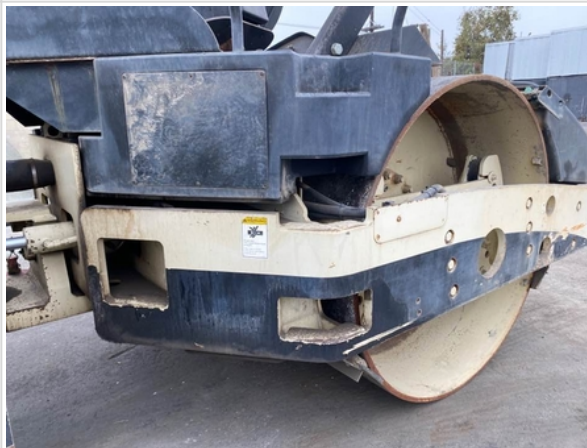
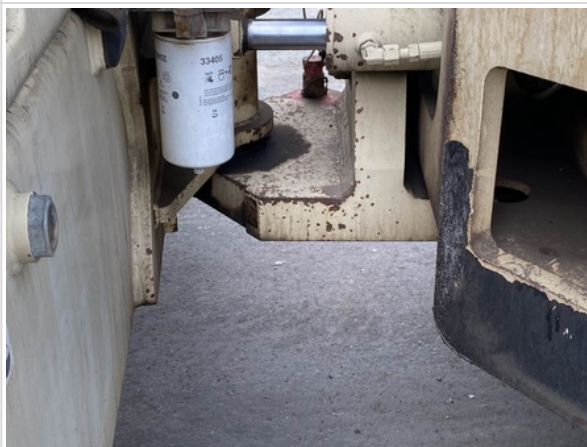
Left Photos

<b>Left</b>	3 - Normal Wear & Tear
<b>Left Condition</b>	No visible damage, Visible chipped paint or dents, Other (see comments)
<b>Comments</b>	Small paint chipped areas present

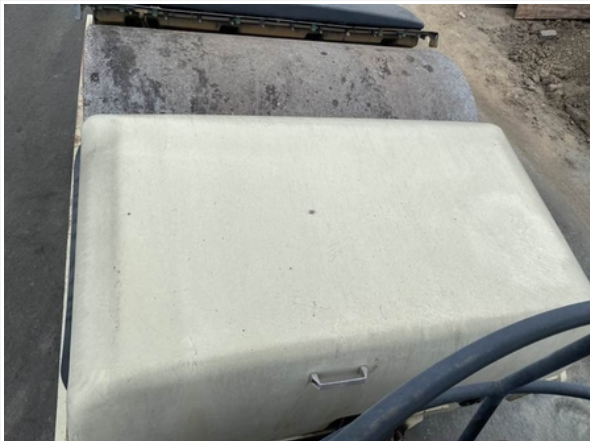
Upper	3 - Normal Wear & Tear	
Upper Condition	No visible damage	
Upper Photos

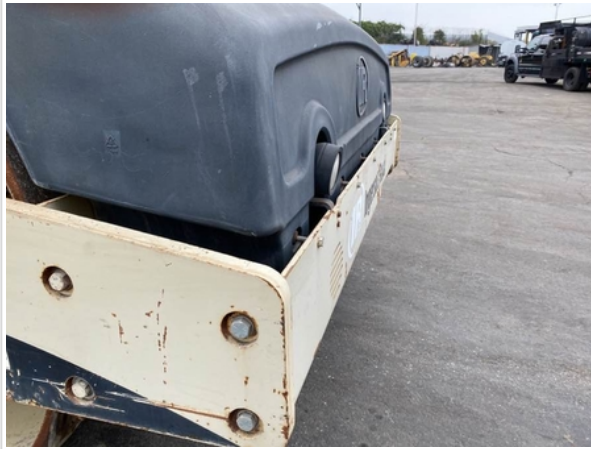
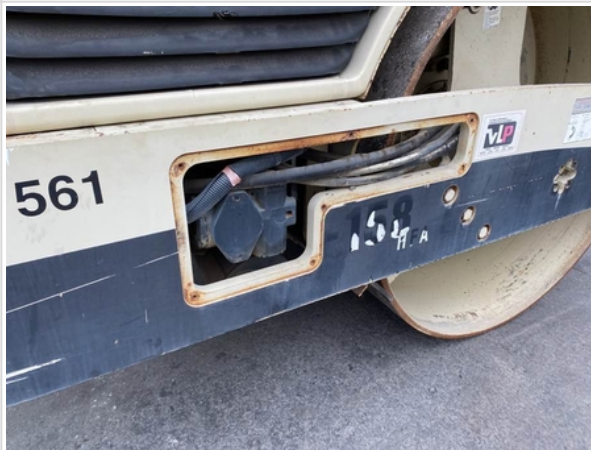
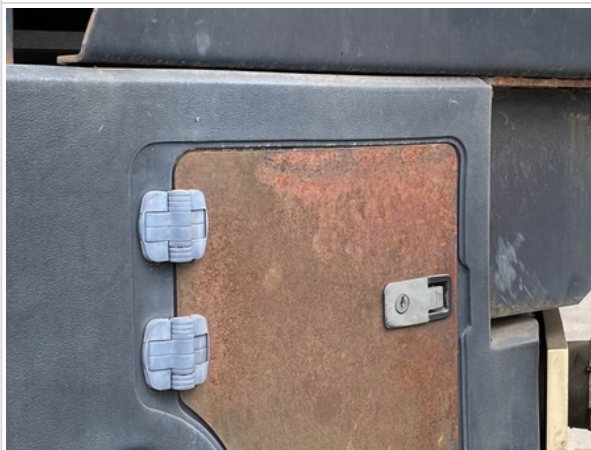
<b>Body Panels (Any Rust Damage?)</b>	3 - Normal Wear & Tear
<b>Body Panel Condition</b>	No visible damage, good paint condition and panel fitment, Other (see comments)
<b>Comments</b>	Body panel missing on r/s
<b>Body Panels Photos</b>

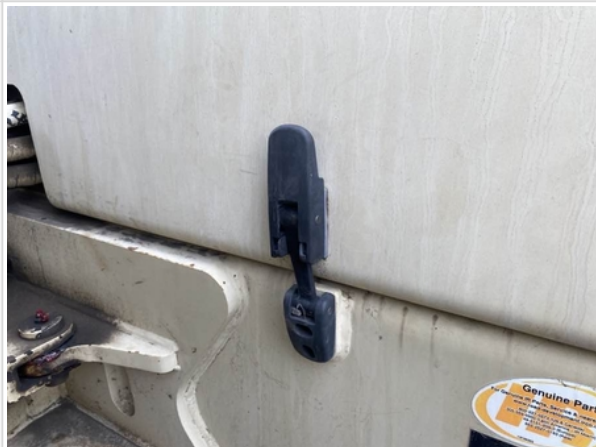
<b>Doors / Canopy Latches</b>	3 - Normal Wear & Tear
<b>Doors / Canopy Latches Condition</b>	No visible damage
<b>Doors / Canopy Latches Photos</b>

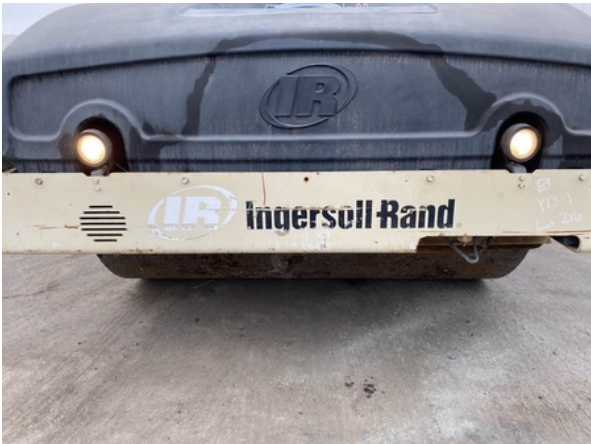
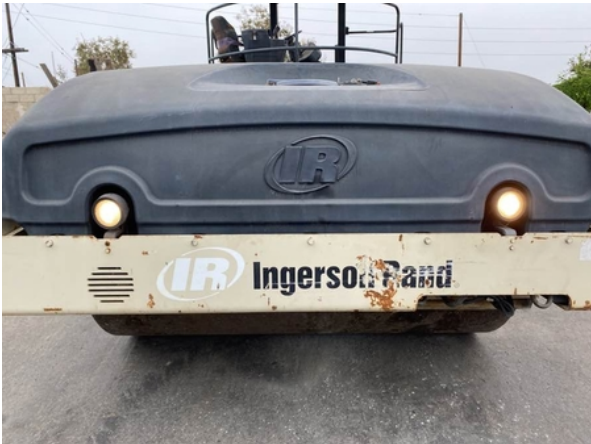
Glass Condition	0	
Mirrors	0	
Lighting System	3 - Normal Wear & Tear	
Lighting System Condition	No visible damage, lighting system is operational	
Lighting System Photos

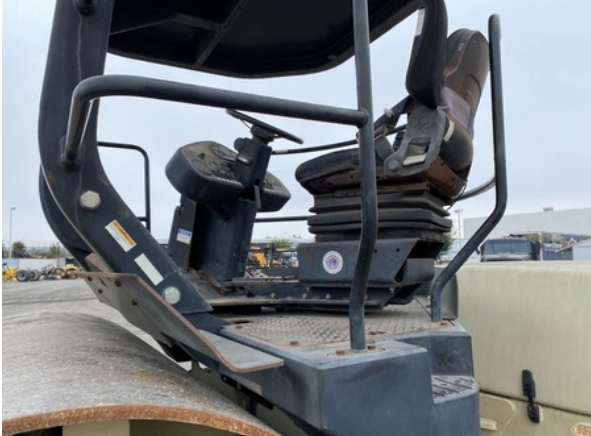
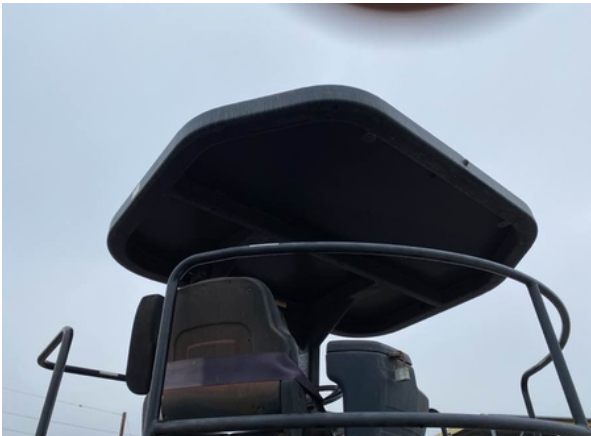
<p> <b>IR Ingersoll Rand</b>          SHIPPENSBURG, PA. 17257 ASSEMBLED IN USA          MODEL NO. DD-158HFA MFG. CODE SEP          PRODUCT IDENTIFICATION NO. 181350          OPERATING WEIGHT (LBS.)          13198288       </p>
Operator Cabin Overall	3 - Normal Wear & Tear
Operator Cabin Overall Condition	Good cabin appearance, solid floors, panels, and ceiling, Minor cosmetic wear to cabin surfaces, floors, panels, and ceiling
Operator Cabin Photos

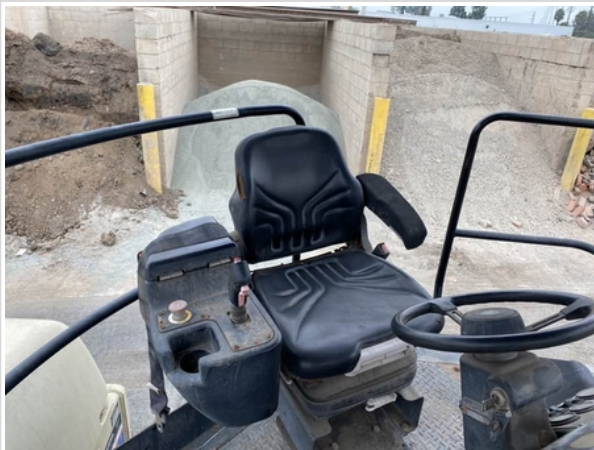
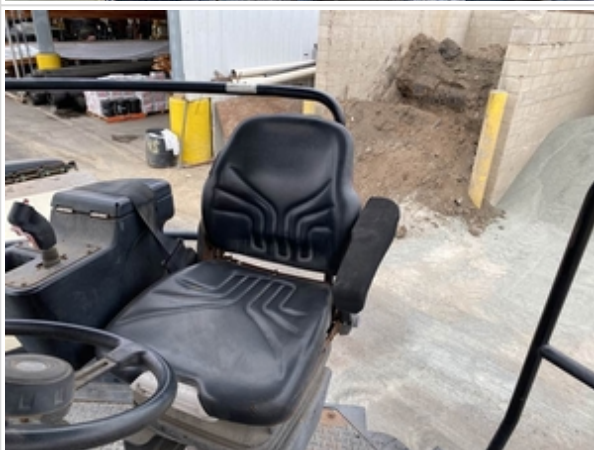
<b>Operator's Seat &amp; Arm Rests</b>	3 - Normal Wear & Tear	
<b>Operator's Seat &amp; Arm Rests Condition</b>	Seat(s) in good condition, no stains or tears in upholstery, Seat(s) have minor surface staining or small tears	
<b>Operator's Seat &amp; Arm Rests Photos</b>

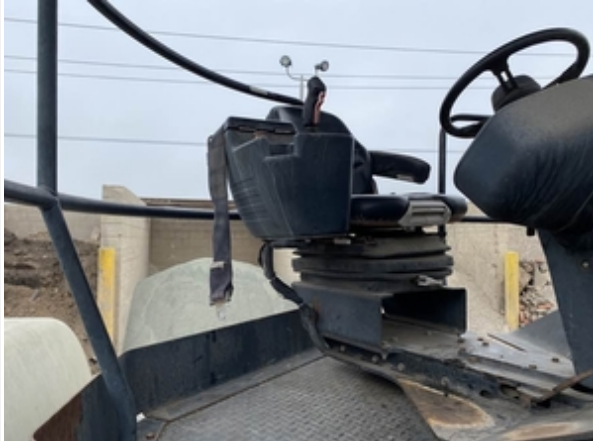
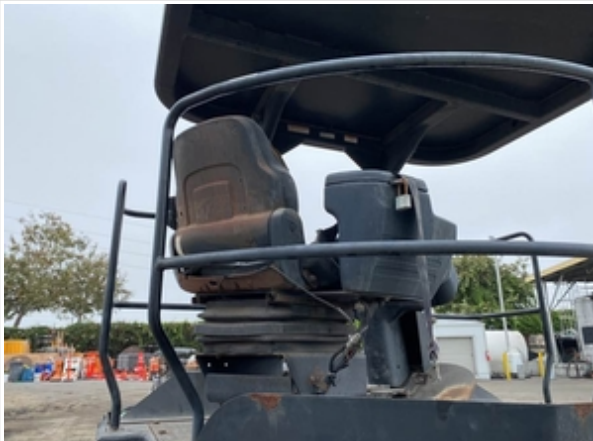
<b>Seat Belt</b>	1 - Service Required	
<b>Seat Belt Condition</b>	Seat belt is inoperative or not installed, Other (see comments)	
<b>Comments</b>	Seat belt locks in place but does not retract or extend properly	
<b>Seat Belt Photos</b>

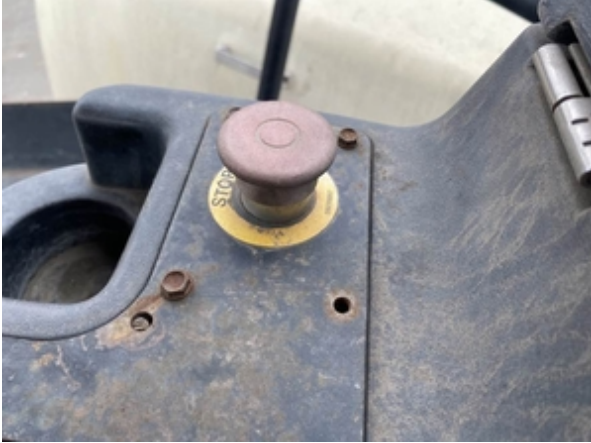
<b>Safety Lock Out / Stop Photos</b>

<b>Cabin Lights</b>	0	
<b>Safety Lock Out / Stop</b>	3 - Normal Wear & Tear	
<b>Safety Lock Out / Stop Condition</b>	Safety lock out device is present, in good condition, and functional

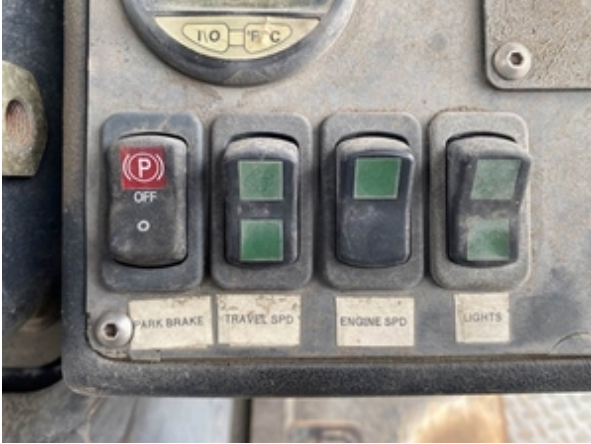
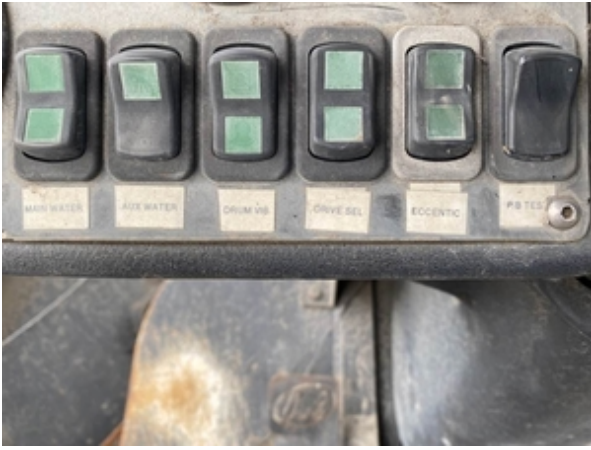
<b>Controls &amp; Switches</b>	3 - Normal Wear & Tear
<b>Controls &amp; Switches Condition</b>	All switches are installed and functional
<b>Controls &amp; Switches Photos</b>

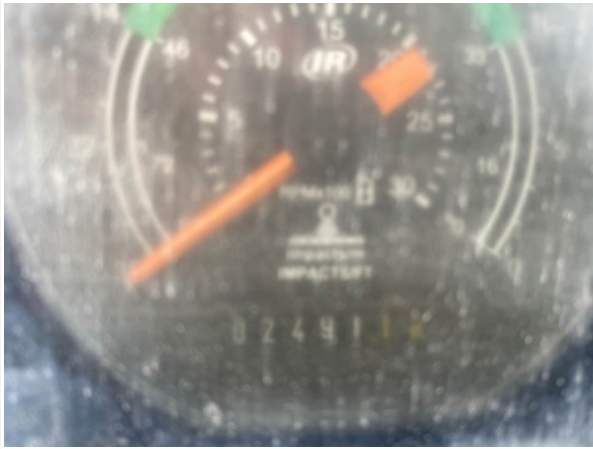
Hour Meter Activity Photos

<b>Hour Meter Activity</b>	3 - Normal Wear & Tear
<b>Hour Meter Condition</b>	Hour meter is functional and in good condition, Hour meter is functional, with some minor wear and/or cosmetic damage

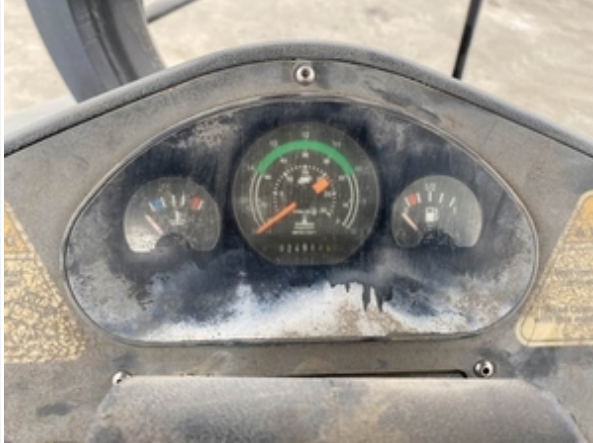
Other Gauge Activity	3 - Normal Wear & Tear
Other Gauge Condition	All cockpit gauges are functional and in good condition, Gauges are functional, with some wear and/or cosmetic damage
Other Gauge Activity Photos

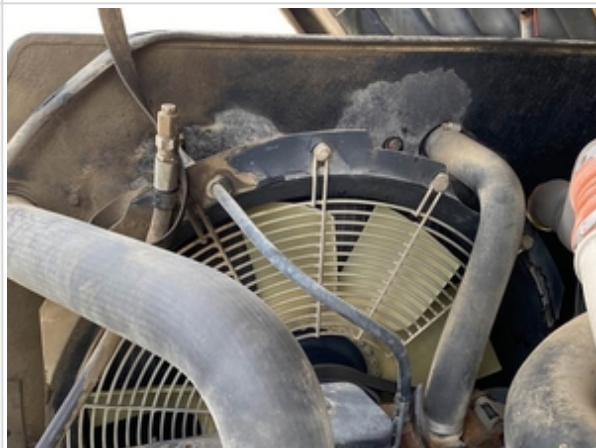
<b>Radiator</b>	3 - Normal Wear & Tear
<b>Radiator Condition</b>	Radiator fins & components appear to be in good working order, no signs of damage or leaks
<b>Radiator Photos</b>

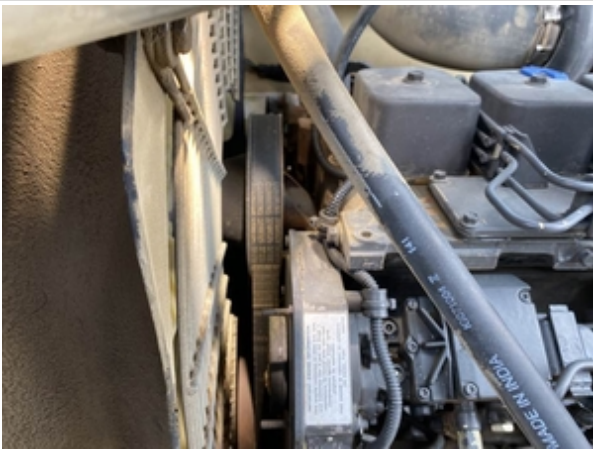
<b>Belts</b>	2 - Above Average Wear	
<b>Belt Condition</b>	Frayed belt edges observed, Other (see comments)	
<b>Comments</b>	Serpentine belt has wear cracks, should be replaced soon	
<b>Belt Photos</b>

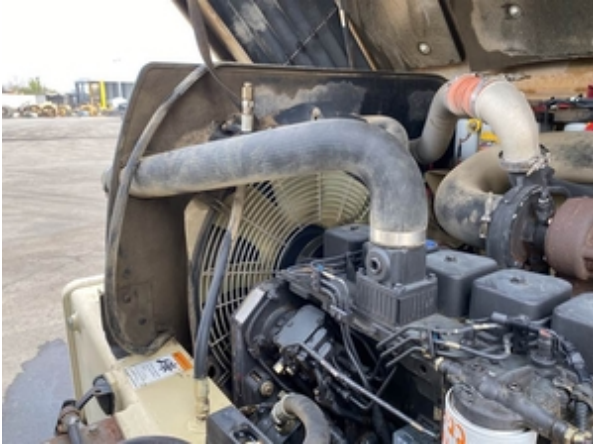
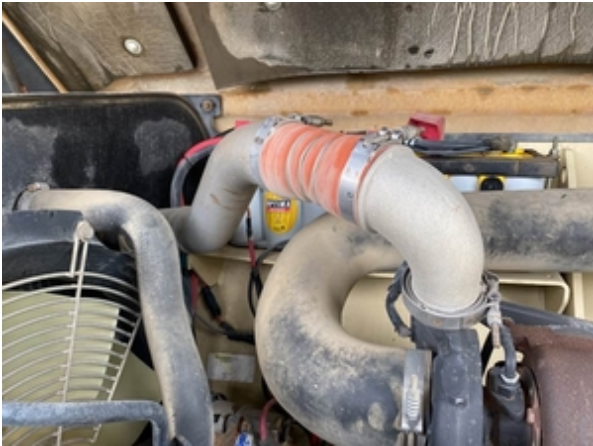
<b>Hoses</b>	3 - Normal Wear & Tear
<b>Hose Condition</b>	Firm, pliant hoses with no signs of wear or leaks
<b>Hose Photos</b>

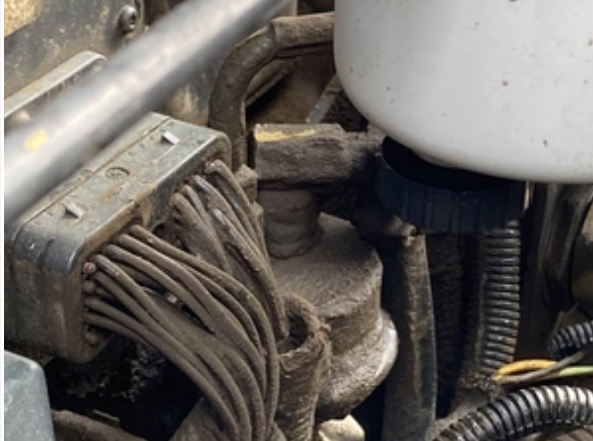
<b>Water Pump</b>	3 - Normal Wear & Tear	
<b>Water Pump Condition</b>	No unusual pump noises heard	
<b>Cooling System Leaks</b>	No	
<b>Coolant Color / Appearance</b>	3 - Normal Wear & Tear	
<b>Coolant Color/Appearance Notes</b>	Normal Translucent appearance, no visual signs of contamination	
<b>Oil Leaks</b>	No	
<b>Oil Color / Appearance</b>	3 - Normal Wear & Tear	
<b>Oil Color / Appearance Notes</b>	Clean oil appearance, no signs of cross contamination, Appropriate oil level, Other (see comments)	
<b>Comments</b>	Oil recently changed	
<b>Fuel Leaks</b>	Yes	
<b>Fuel Leak Notes</b>	Areas of accumulated dust & grime on fuel lines indicate a possible leak	
<b>Comments</b>	Seepage leaks from low pressure fuel lines and transfer pump	
<b>Fuel Leaks Photos</b>

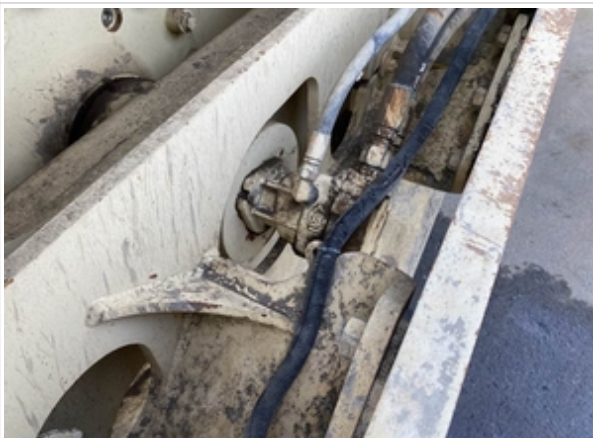
<b>Hydrostatic Transmission?</b>	Yes	
<b>2 Speed?</b>	Yes	
<b>Hydrostatic Drive Configuration</b>	Other (see comments)	
<b>Comments</b>	Hydraulic pump powered to drive motor	
<b>Drive Motors</b>	3 - Normal Wear & Tear	
<b>Drive Motor Photos</b>

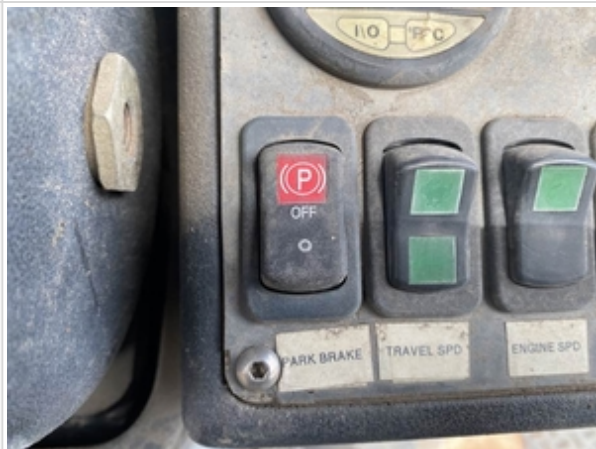
Hydrostatic Parking Brake	3 - Normal Wear & Tear
Hydrostatic Parking Brake Condition	Good brake function
Hydrostatic Parking Brake Photos

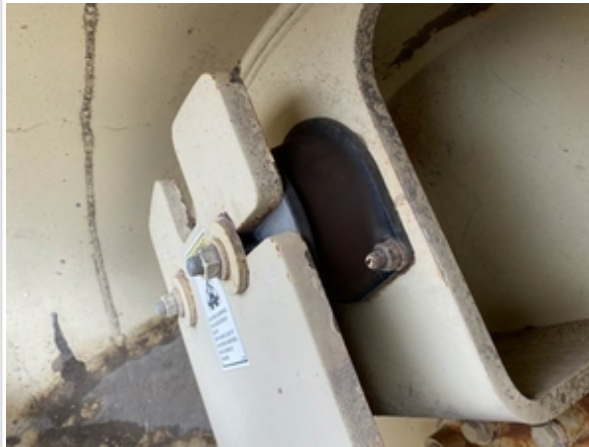
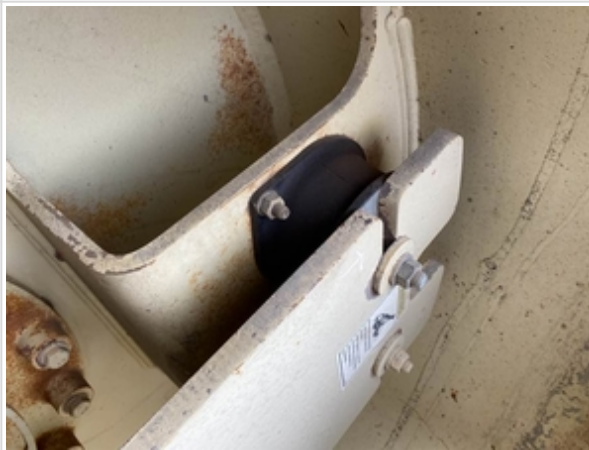
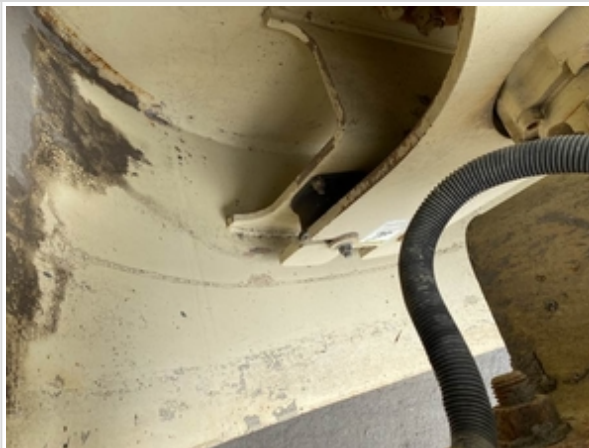
Vibratory Rubber Mounts (Front & Rear) Photos

<b>Vibratory Rubber Mounts (Front &amp; Rear)</b>	3 - Normal Wear & Tear	
<b>Comments</b>	Front left side drum isolator mounts all replaced all others except 1 in fair to good condition

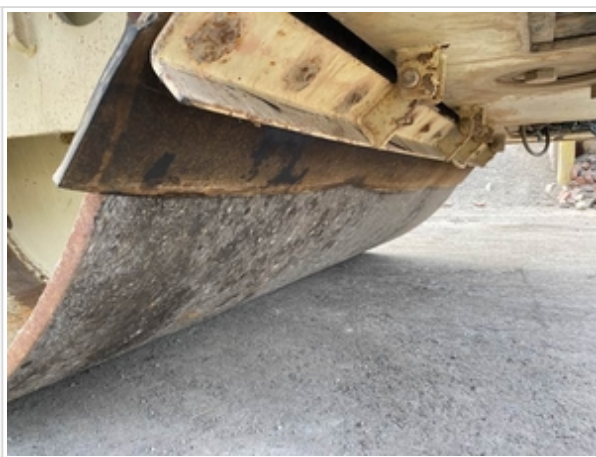
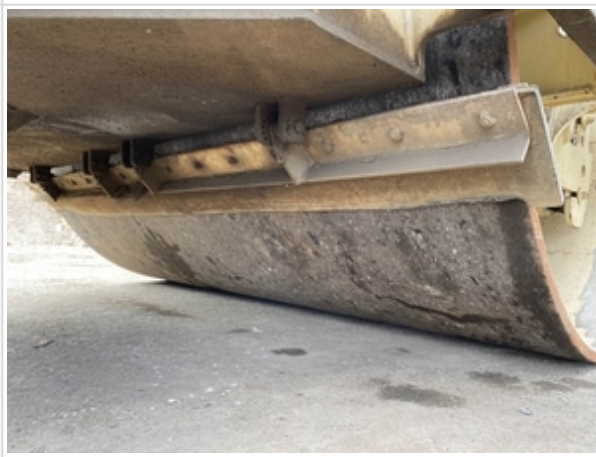
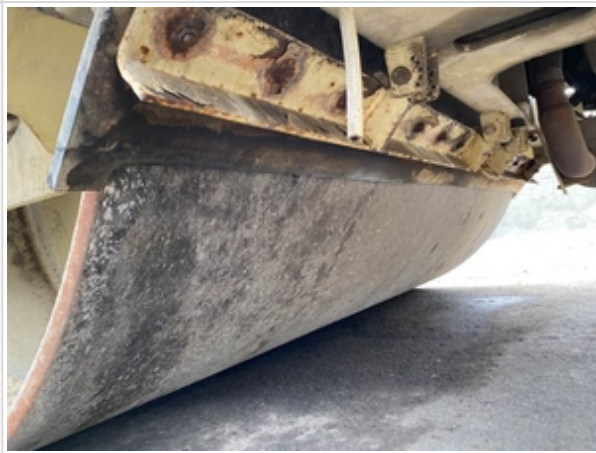
<p>Drum Scraper Photos</p>

<p>Drum Scraper</p>	<p>3 - Normal Wear &amp; Tear</p>

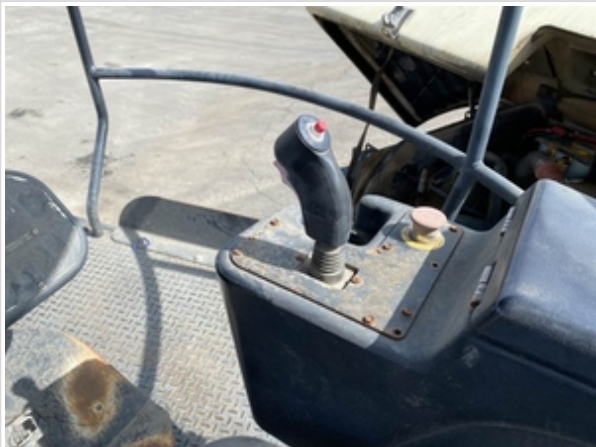
Unusual Noises (Hydraulic Pump)	No	
Hydraulic Pump Notes	No unusual noises heard during operation	
External Controls / Levers	3	
External Controls / Levers Condition	Good function & condition of hydraulic controls	
External Controls / Levers Photos

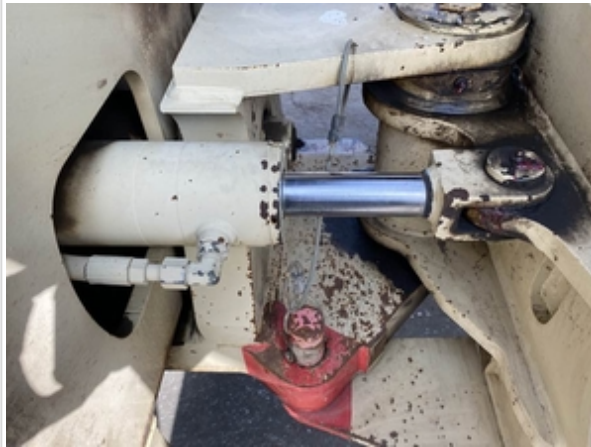
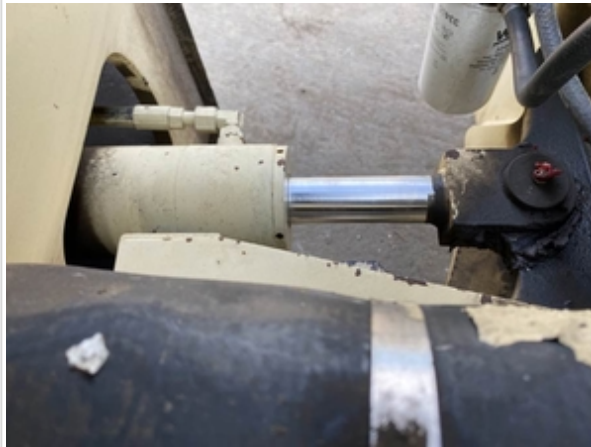
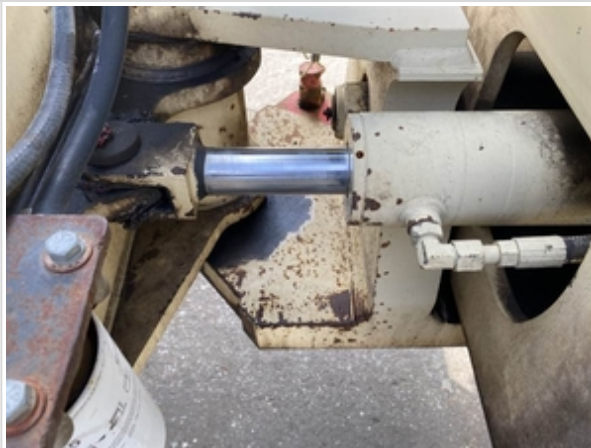
Steering Cylinders Photos

Steering Cylinders	Check the steering cylinder. Note any wear, pitting, discoloration, etc. Take photos.	
Steering Cylinders: Mounting Pin	3	
Steering Cylinders: Oil Leaks	No
