## Inspection Report (Generator)

Year	2021
Make	Sutech
Model	ST-CIOOGF
Serial Number	20210202B60
Hour Meter Reading	30
Previous Application (e.g., earth moving, mining, demolition, etc)	General Construction

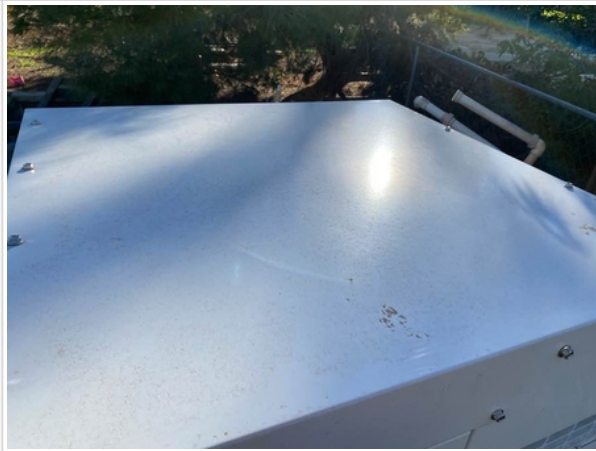
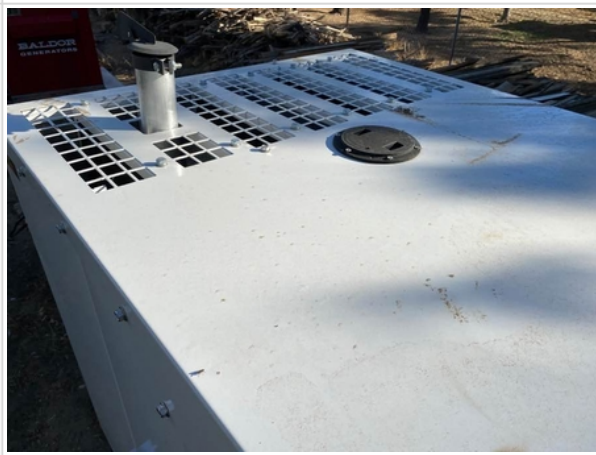
Upper	4 - Like New, Recently Replaced	
Upper Condition	No visible damage	
Upper Photos

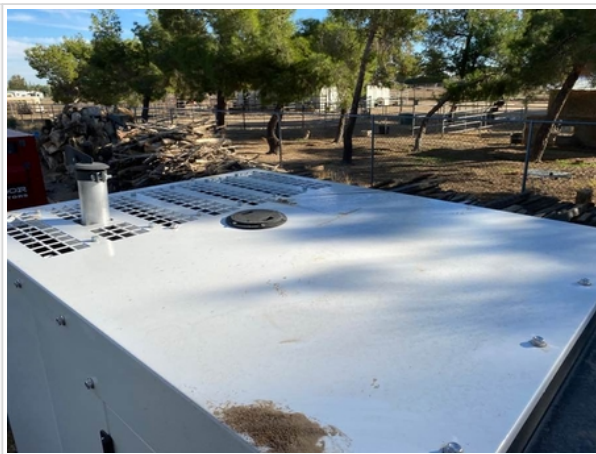
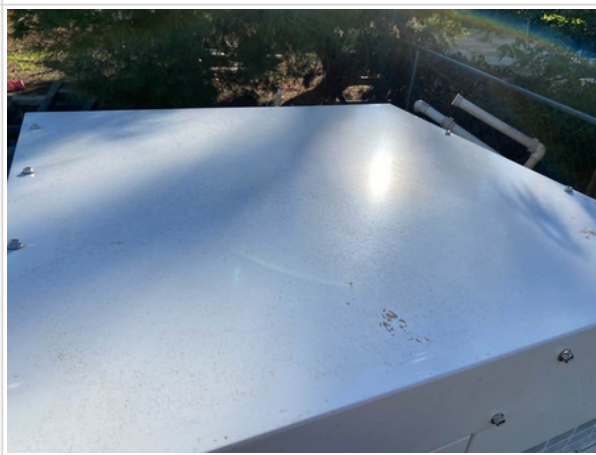
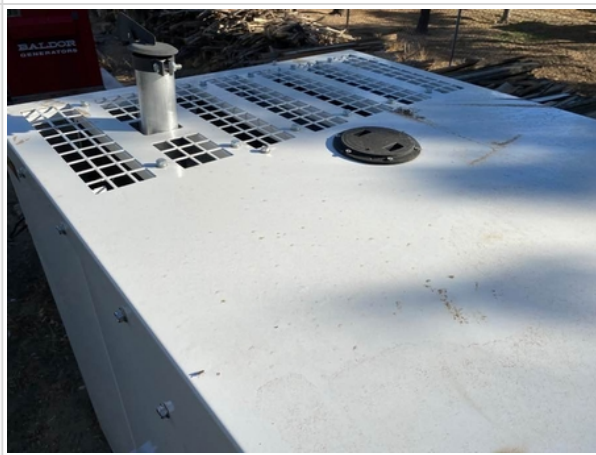
<b>Upper</b>	4 - Like New, Recently Replaced	
<b>Upper Condition</b>	No visible damage	
<b>Upper Photos</b>

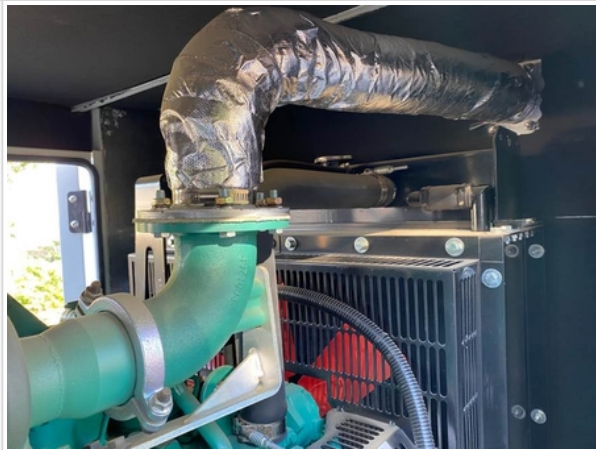
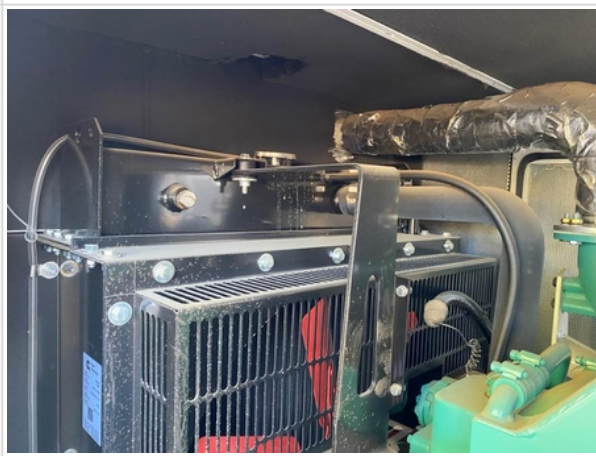
<b>Radiator</b>	4 - Like New, Recently Replaced
<b>Radiator Condition</b>	Radiator fins & components appear to be in good working order, no signs of damage or leaks
<b>Radiator Photos</b>

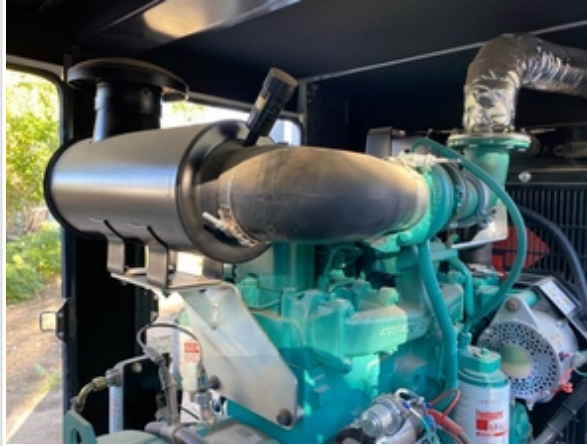
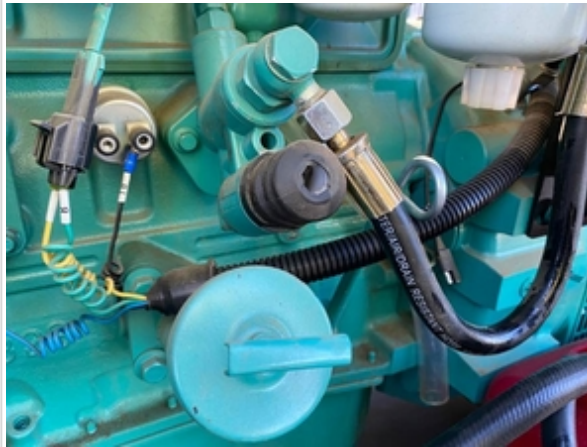
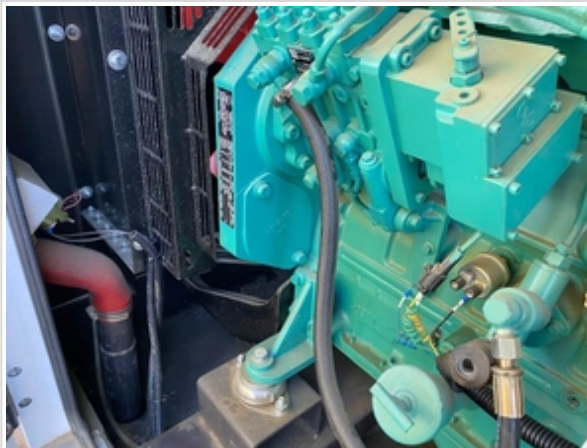
<b>Belts</b>	4 - Like New, Recently Replaced
<b>Belt Condition</b>	Belts appear in good condition & alignment with proper tension
<b>Hoses</b>	4 - Like New, Recently Replaced
<b>Hose Condition</b>	Firm, pliant hoses with no signs of wear or leaks
<b>Hose Photos</b>
