Inspection Report (On-Highway Dump Truck)

Year	2011
Make	Peterbilt
Model	367
Serial Number	1NPTLU0X4BD127976
Truck Odometer Reading	425,002 miles
Current Inspection / State Cert / DOT	90 day b.i.t. Inspection performed 6/20/22 @424,994
Previous Application (e.g., earth moving, mining, demolition, etc)	asphalt road work

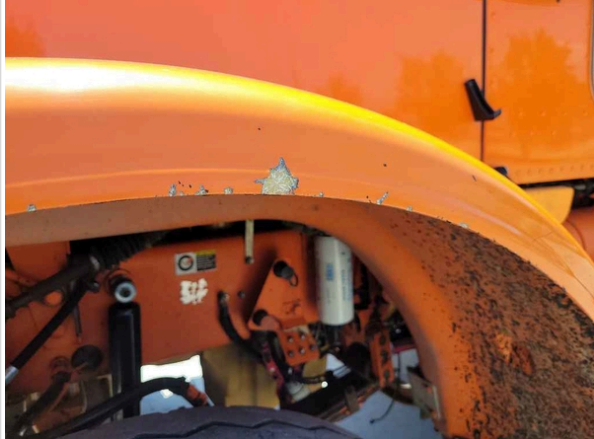
Front	3 - Normal Wear & Tear
Front Condition	No visible damage, Other (see comments)
Comments	minor fiberglass chips off fenders and clear coat peeling
Front Photos

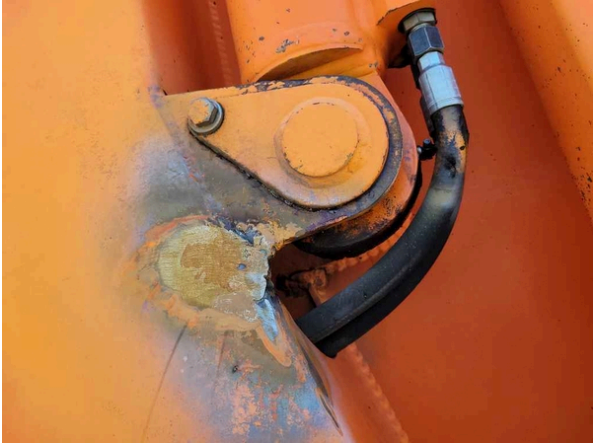
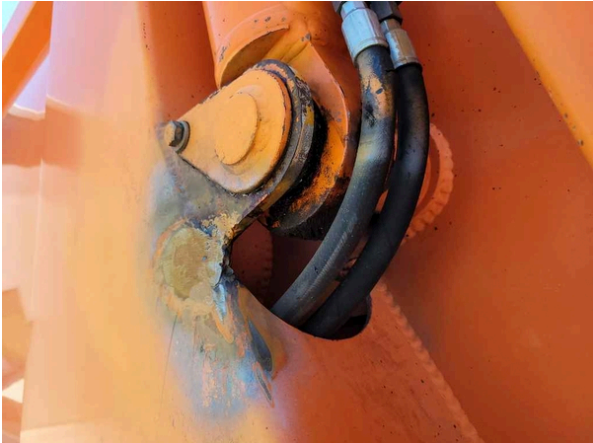
Rear	3 - Normal Wear & Tear	
Rear Condition	Other (see comments), No visible damage	
Comments	signs of weld repairs made to strong arm axle cylinder to dump frame mount	
Rear Photos

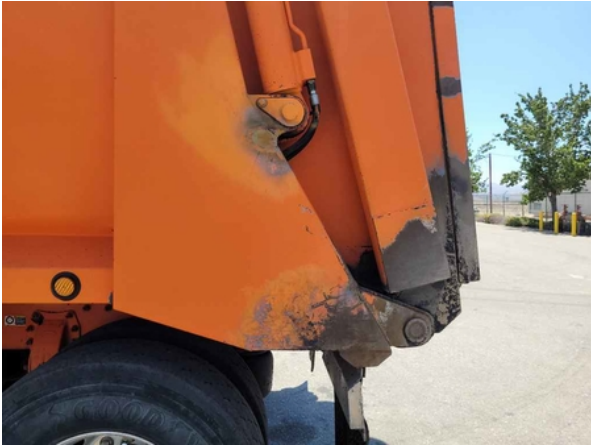
Left	3 - Normal Wear & Tear
Left Condition	Other (see comments), No visible damage
Comments	front left behind fender cover cracked (cosmetic) and rear left side discoloration from weld repairs
Left Photos

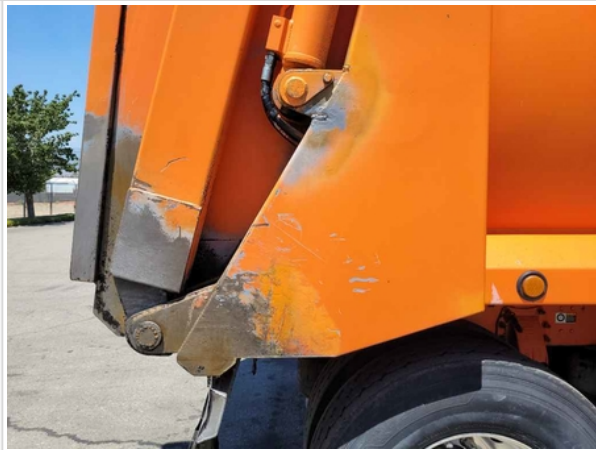
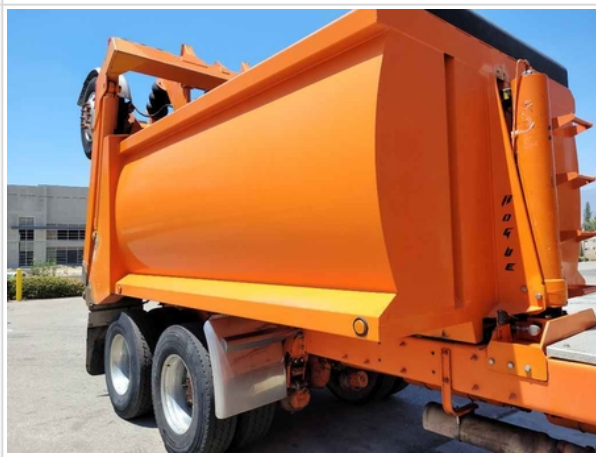
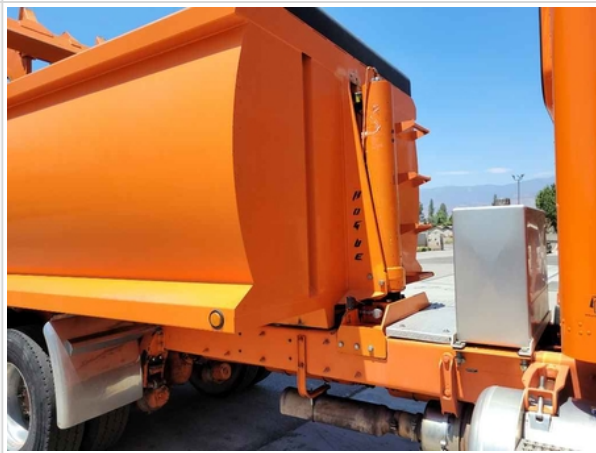
<p>Right Photos</p>

Right	3 - Normal Wear & Tear
Right Condition	No visible damage, Other (see comments)
Comments	discoloration from weld repairs

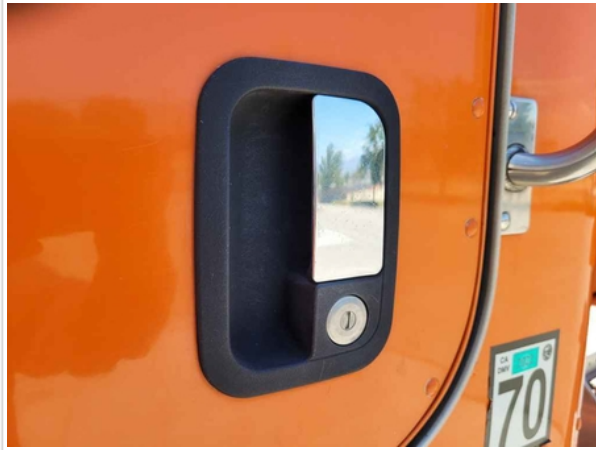
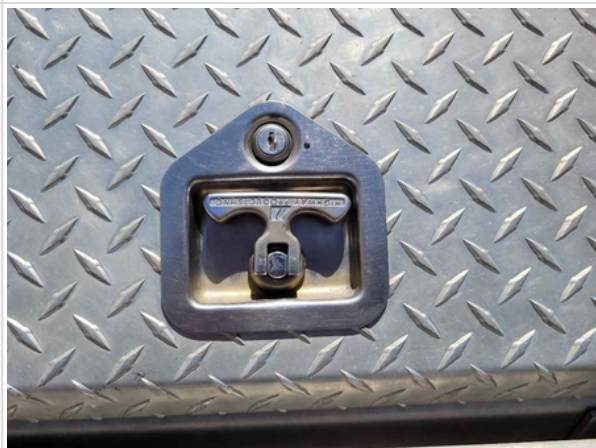
Body Panels (Any Rust Damage?)	0	
Doors / Canopy Latches	3 - Normal Wear & Tear	
Doors / Canopy Latches Condition	No visible damage	
Doors / Canopy Latches Photos

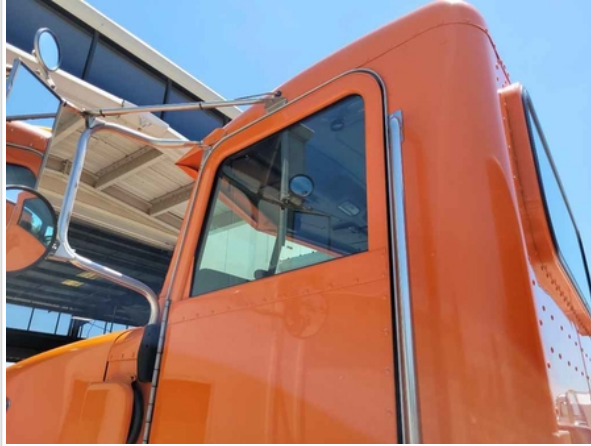
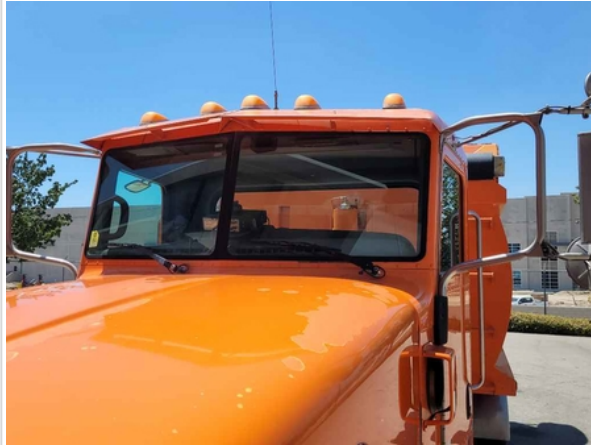
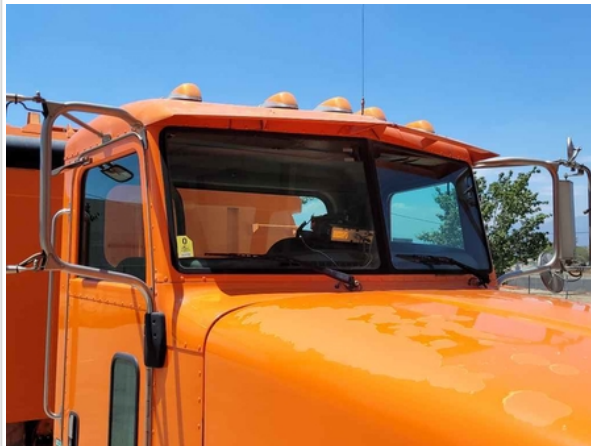
Glass Condition Photos

Glass Condition	4 - Like New, Recently Replaced	
Glass Condition Notes	Glass intact, no visible damage

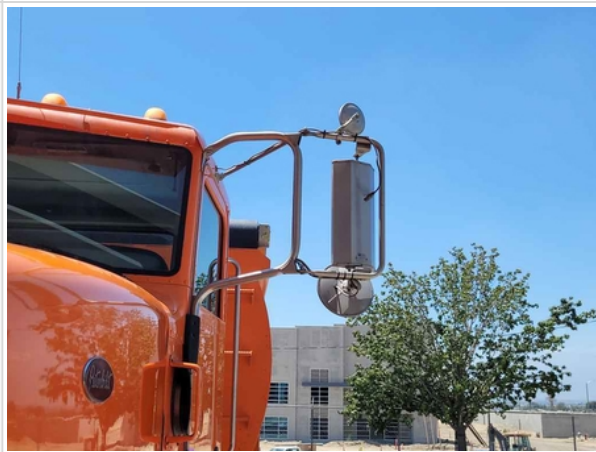
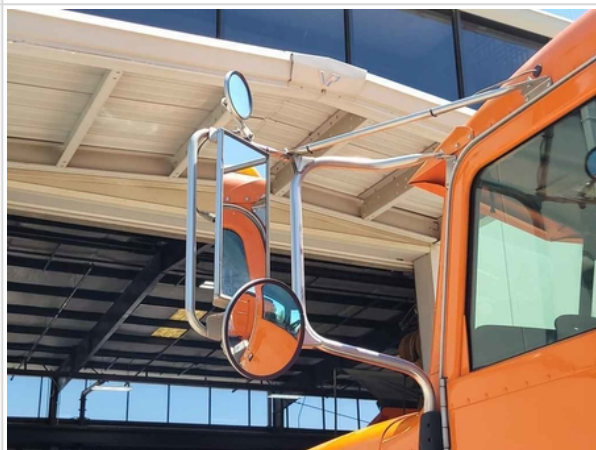
Mirrors	4 - Like New, Recently Replaced
Mirror Condition Notes	Mirrors present and intact, no visible damage
Mirrors Photos

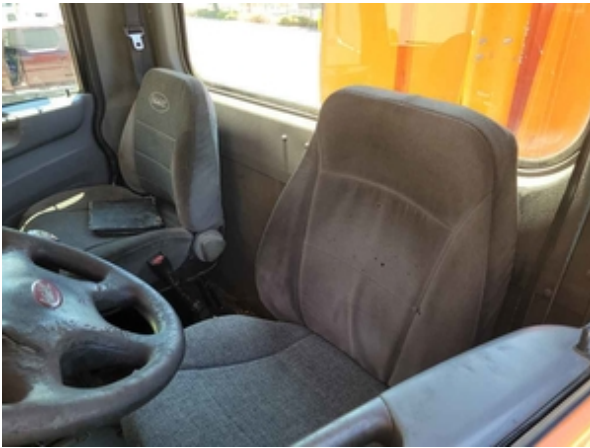
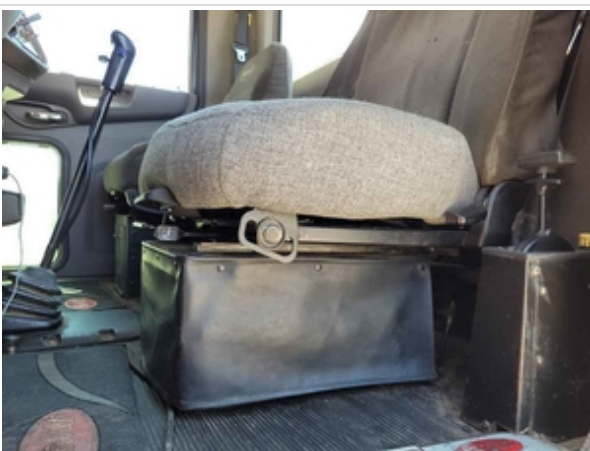
Operator Cabin	3 - Normal Wear & Tear	
Comments	normal wear, seats stained but interior pretty much intact	
Operator's Seat & Arm Rests	3 - Normal Wear & Tear	
Comments	cushion replaced, doesn't match original (cosmetic)	
Operator's Seat & Arm Rests Photos

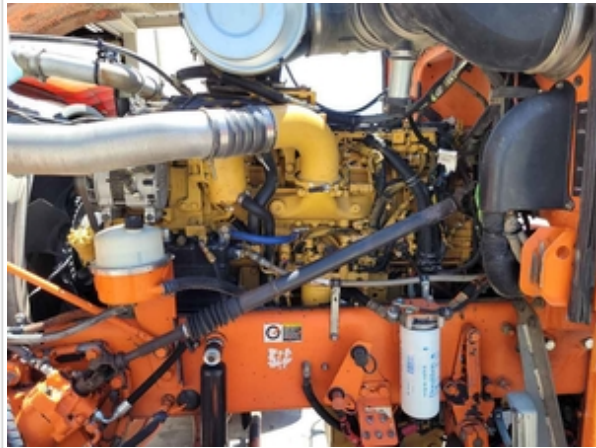
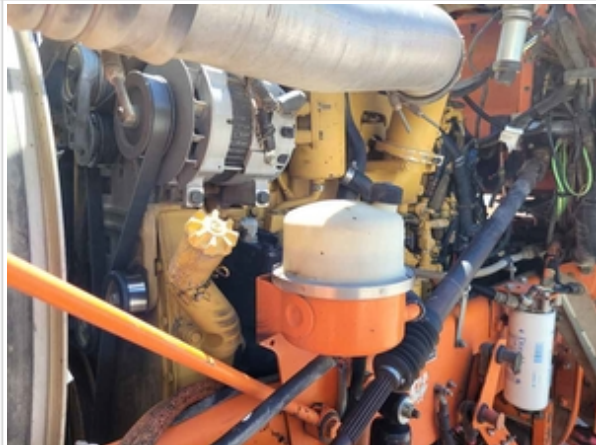
Engine	
Engine Type (Make, Model, Cylinders, Hp)	CAT C13, 6 CYL., 12.5L, 470hp
Engine Serial Number	LEE22134
Engine Fuel Type	Diesel
Engine Photos

Requires DEF (Diesel Exhaust Fluid)	No
Overall Engine Appearance	Clean & dry, Areas of dried seepage seen on engine hoses & components
Overall Engine Comments	Engine seems well maintained. May have small oil leak at oil pan and/or bell housing to pan leak.

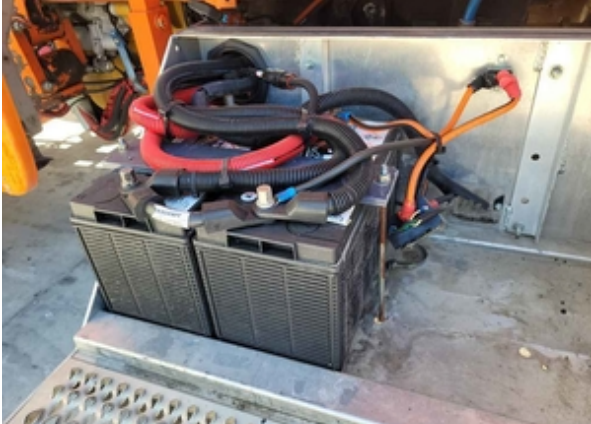
Blow-by (Visual Observation Check)	No	
Unusual Noises (Upon Start-up, Idle, Shutdown)	No	
Unusual Noise Notes	No unusual noises heard	
Engine Smoke (Upon Start-up, Idle, Shutdown)	No	
Engine Smoke Notes	No engine smoke issues observed	
Engine Exhaust Color	Clear	
Battery	4 - Like New, Recently Replaced	
Battery Condition	Like new, recently replaced	
Battery Condition Photos

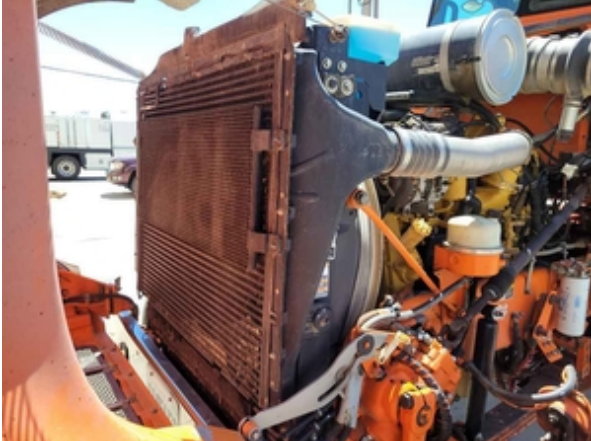
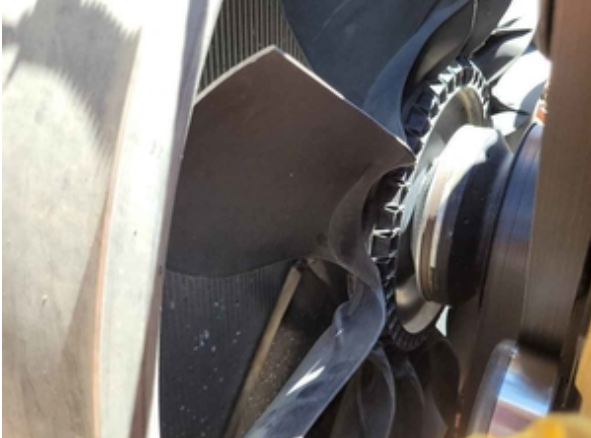
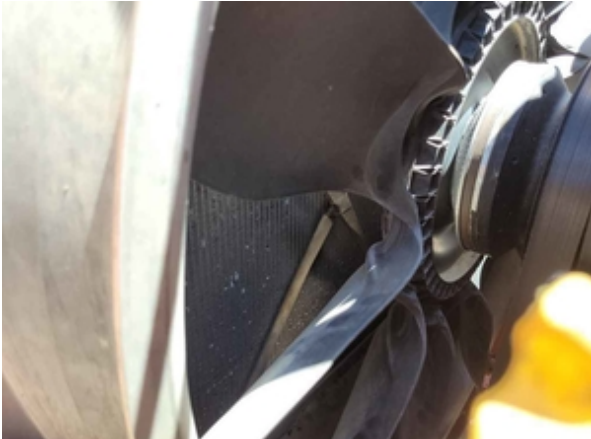
Radiator	3 - Normal Wear & Tear
Radiator Condition	Radiator fins & components appear to be in good working order, no signs of damage or leaks
Radiator Photos

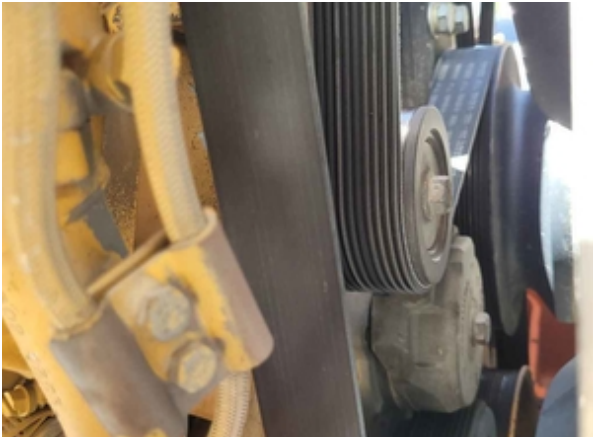
Belts	4 - Like New, Recently Replaced	
Belt Condition	Belts appear in good condition & alignment with proper tension	
Belt Photos

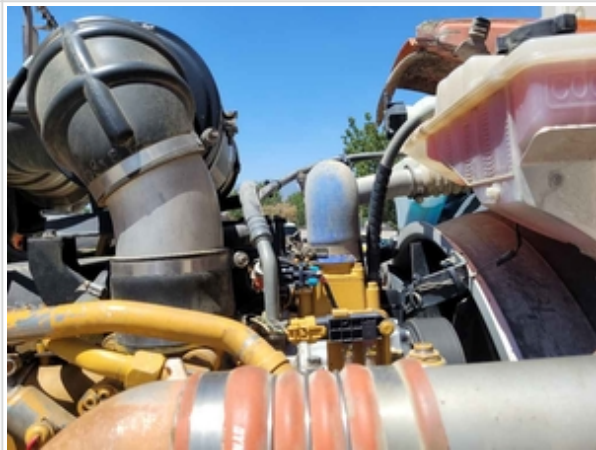
Hoses	3 - Normal Wear & Tear
Hose Condition	Firm, pliant hoses with no signs of wear or leaks
Hose Photos

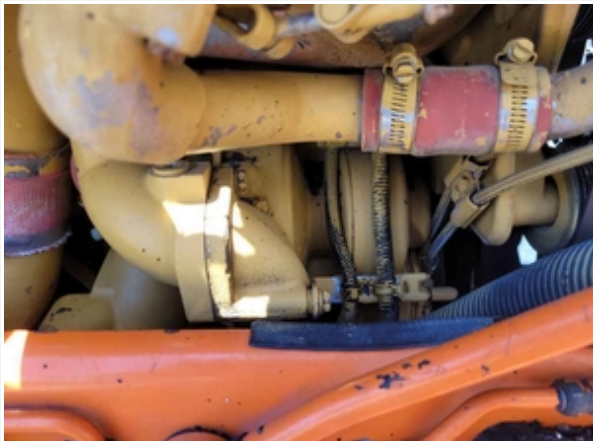
Water Pump	3 - Normal Wear & Tear
Water Pump Condition	No unusual pump noises heard
Water Pump Photos

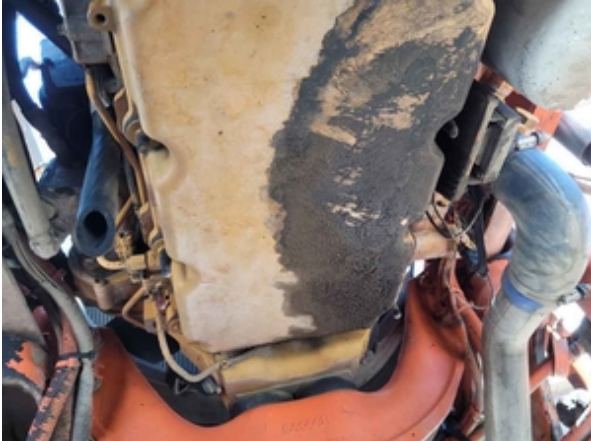
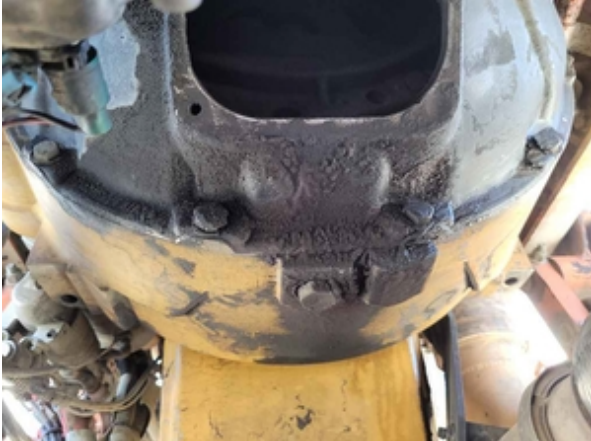
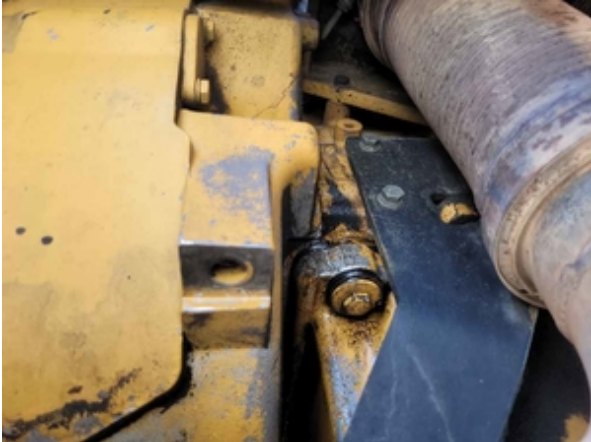
Cooling System Leaks	No
Coolant Color / Appearance	4 - Like New, Recently Replaced
Coolant Color/Appearance Notes	Normal Translucent appearance, no visual signs of contamination
Oil Leaks	Yes
Oil Leak Notes	Dried oil seepages seen

Comments	dried up oil seepage at right side of oil pan (possible leak)
Oil Leak Photos

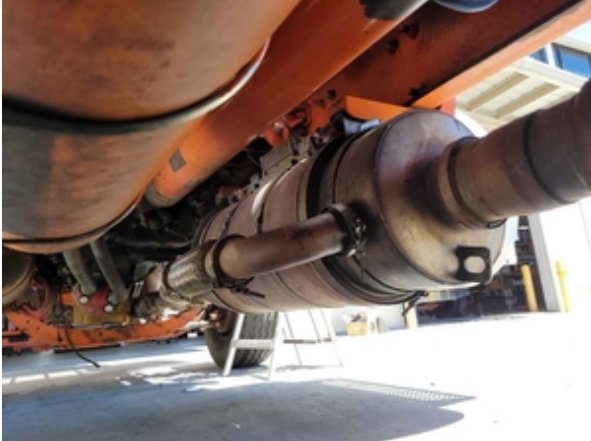
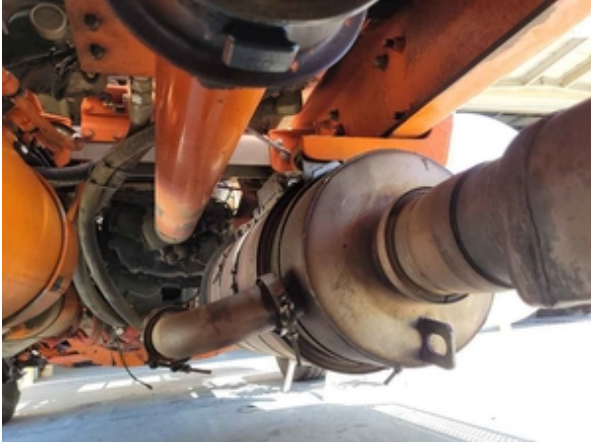
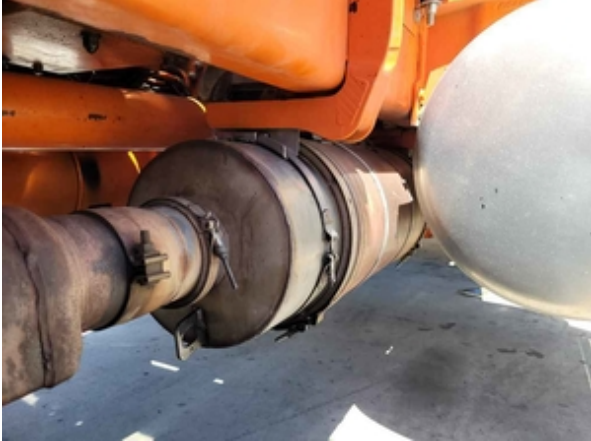
DPF Condition Notes	Filter housing is intact with no signs of damage or malfunction, DPF indicator is not illuminated
DPF Photos

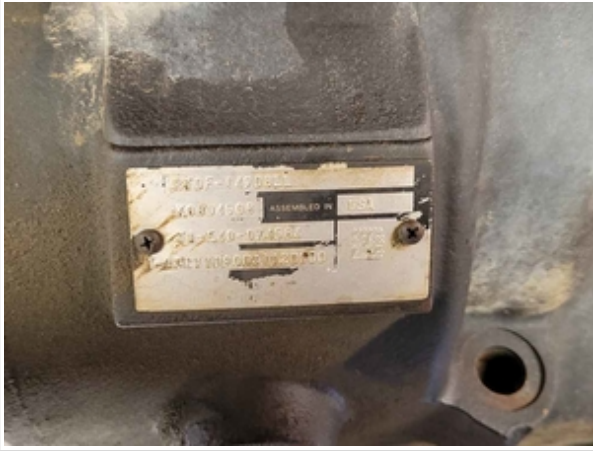
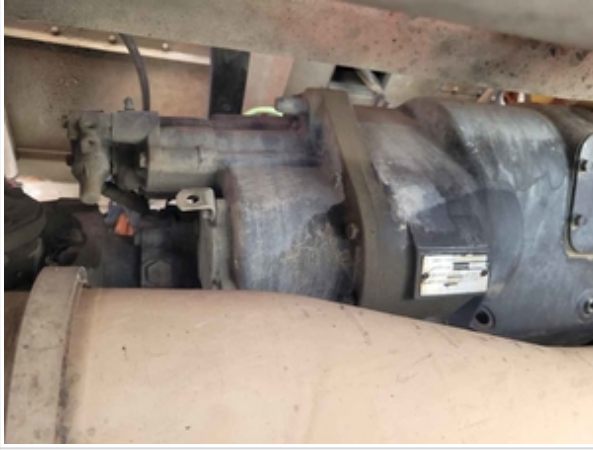
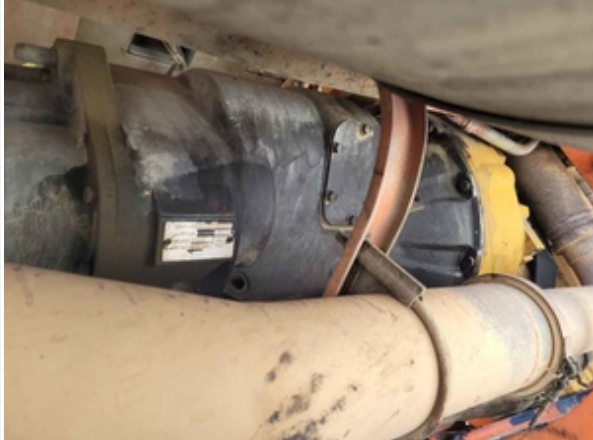
Transmission Info (Make/Model)	Eaton Fuller 10 speed
Drive Type	4X2
Overdrive	N/A
Transmission	3 - Normal Wear & Tear
Transmission Condition	No unusual noises or vibrations
Transmission Condition Photos

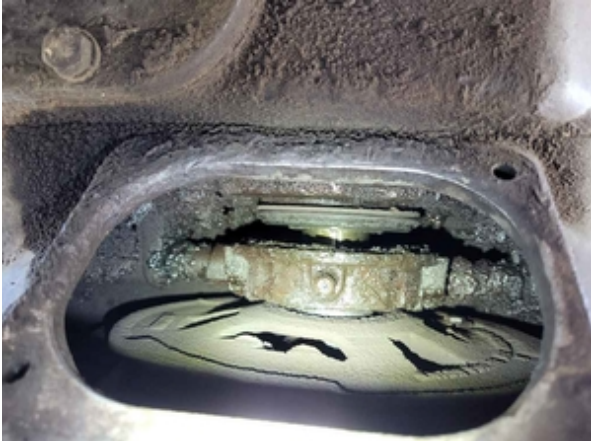
Clutch	3 - Normal Wear & Tear	
Clutch Condition	Other (see comments), Clutch is functioning as expected	
Comments	clutch pedal in need of adjustment	
Clutch Photos

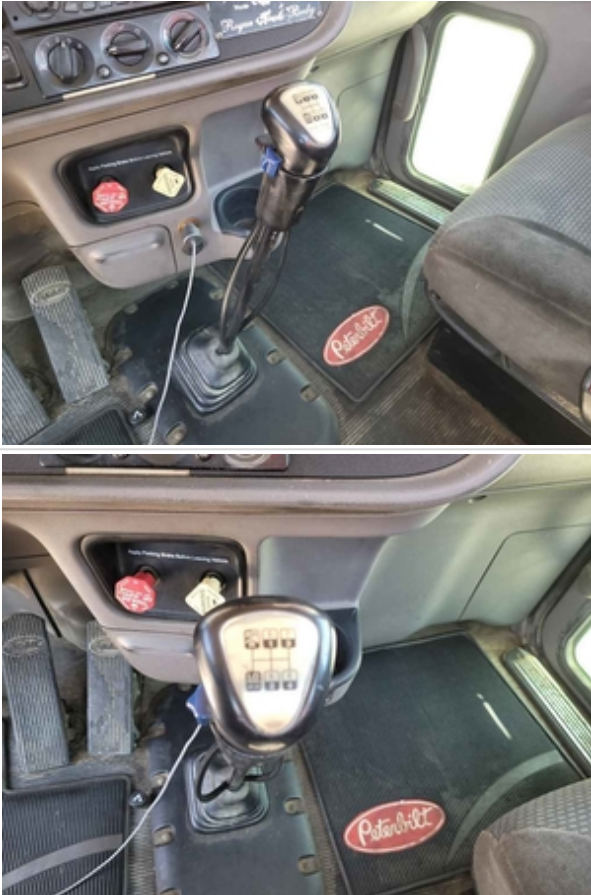
Shift Lever	3 - Normal Wear & Tear
Shift Lever Condition	Good forward and reverse function, Shifting delays observed
Shift Lever Photos

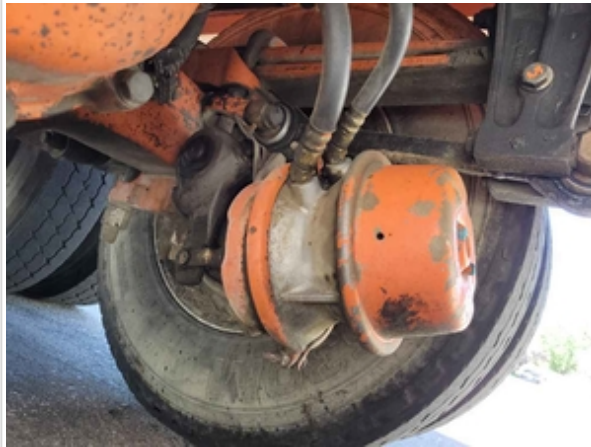
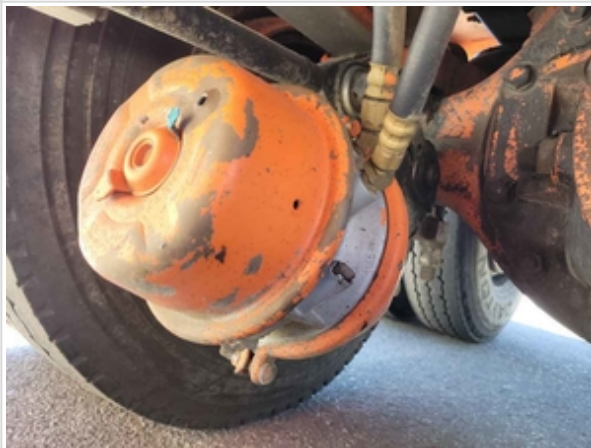
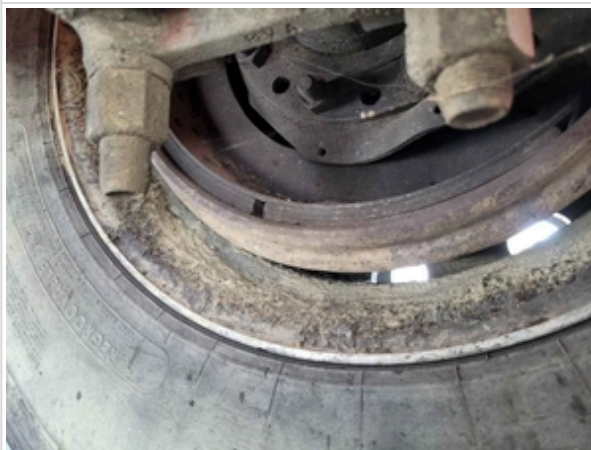
Front Differential	0
Brake System Type	Air Brakes
Air Brake System	3 - Normal Wear & Tear
Comments	air brake system working well
Foot Brake	3 - Normal Wear & Tear
Foot Brake Condition	Good brake function
Engine Brake Configuration	1 Position
Engine Brake	3 - Normal Wear & Tear
Parking Brake	4 - Like New, Recently Replaced
Parking Brake Condition	Good brake function

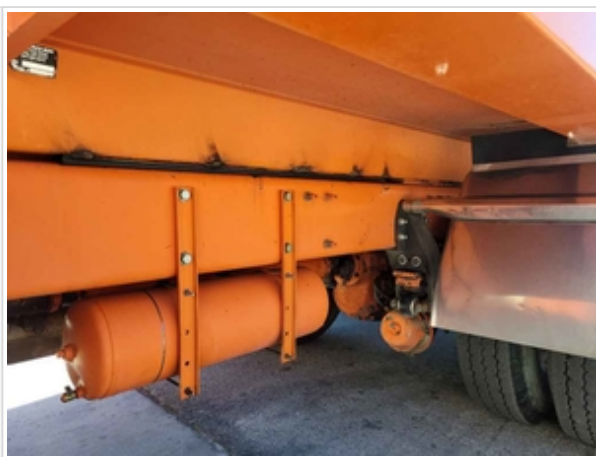
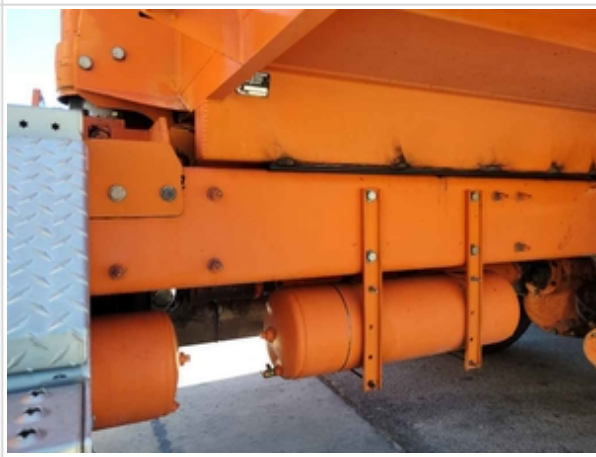
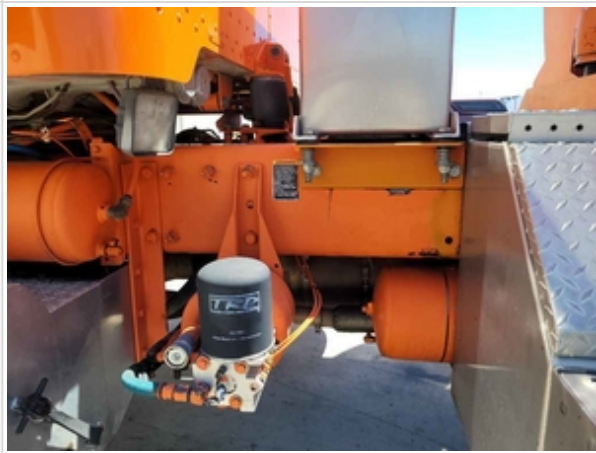
Frame	4 - Like New, Recently Replaced
Comments	Frame in great condition

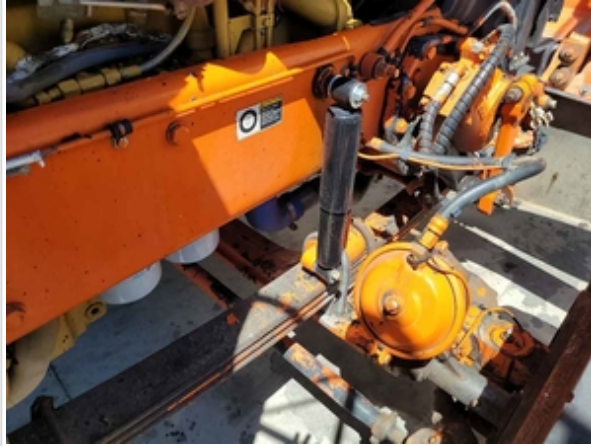
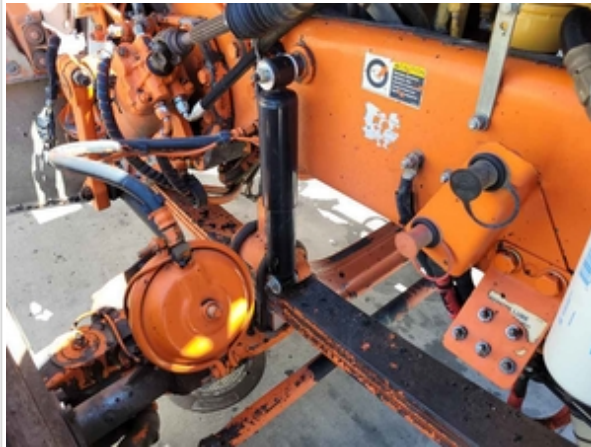
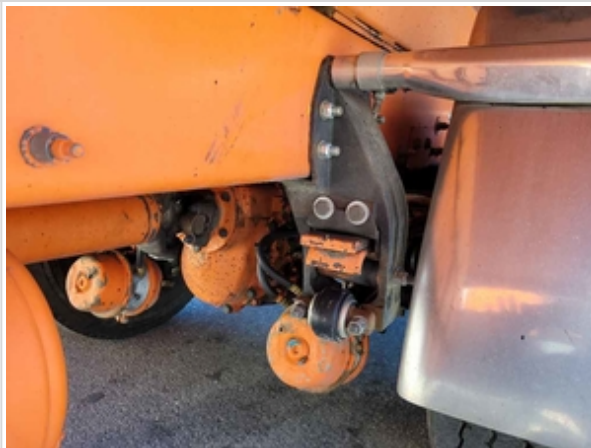
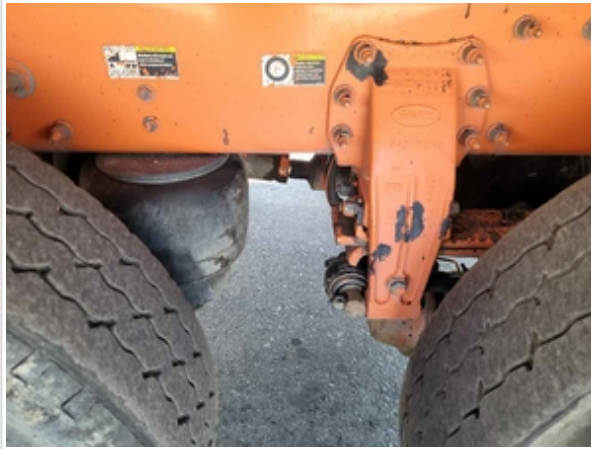
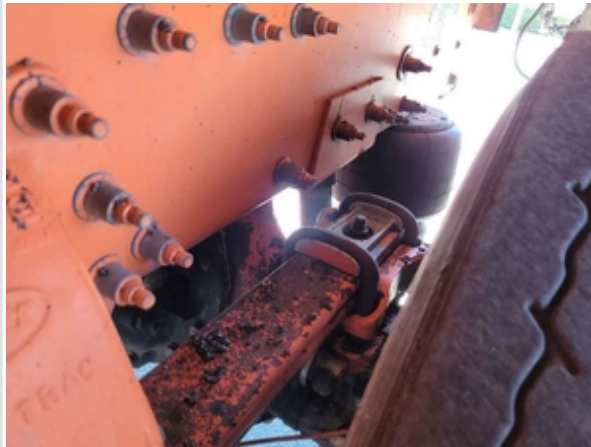
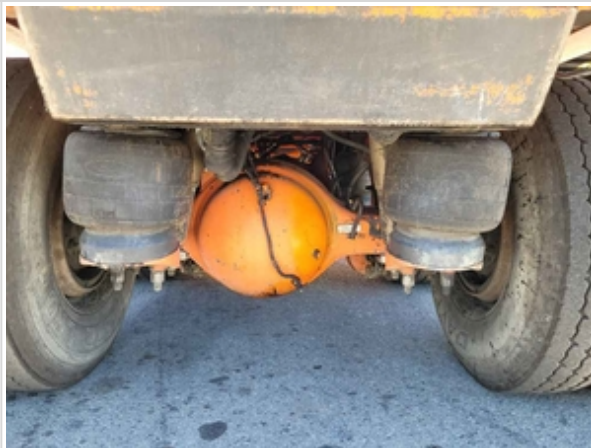
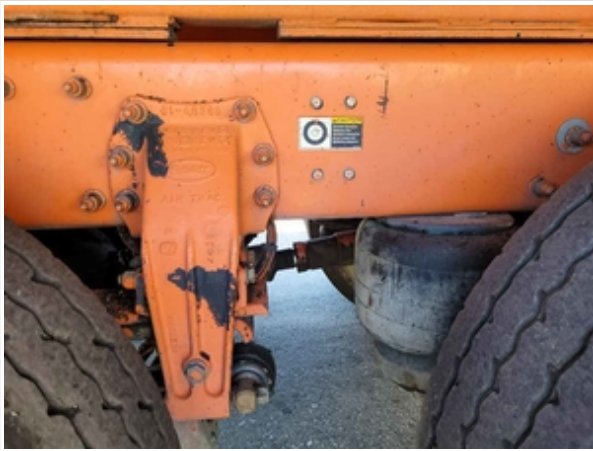
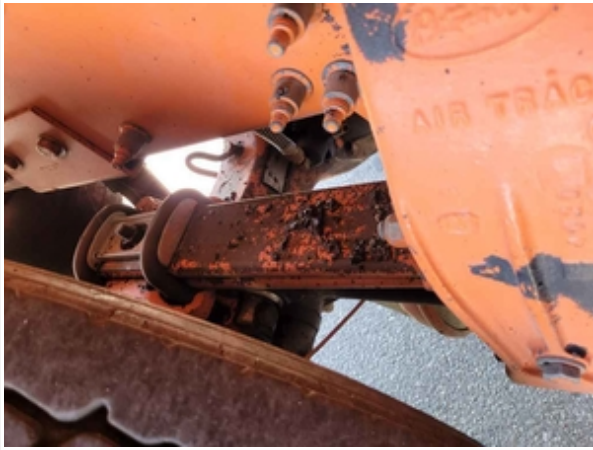
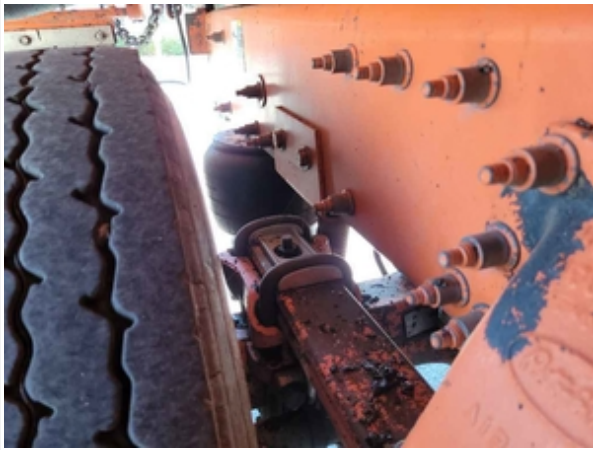
Suspension Photos

Suspension	3 - Normal Wear & Tear
Comments	suspension may need work done, front tires showing signs of uneven tread wear

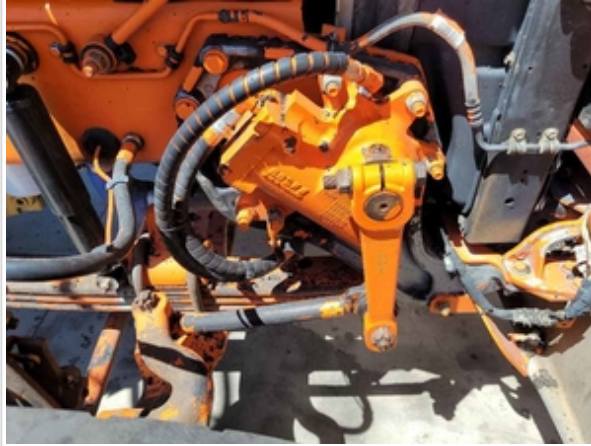
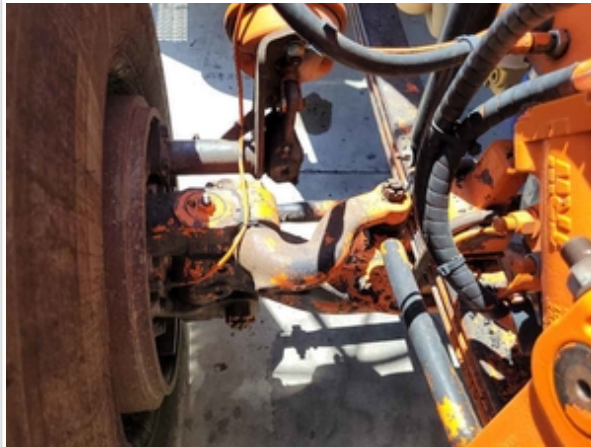
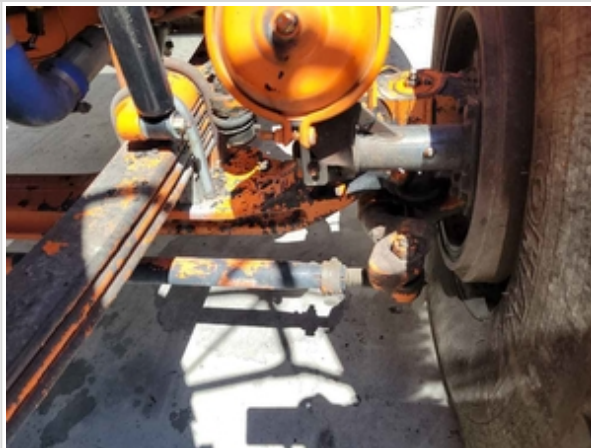
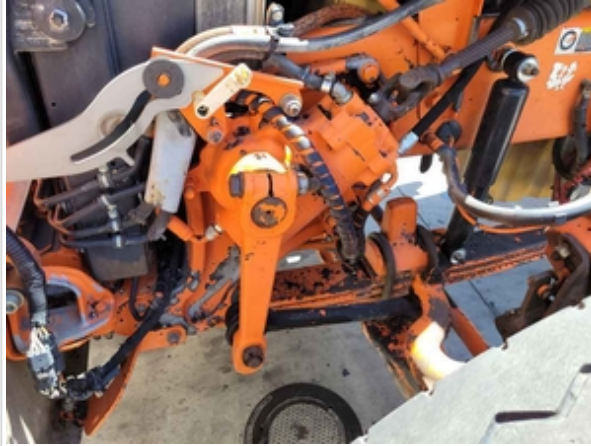
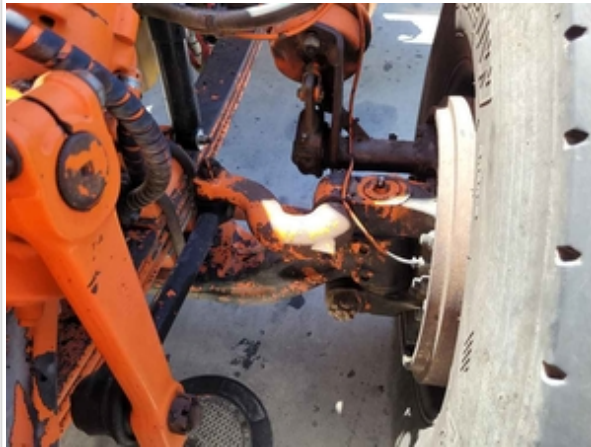
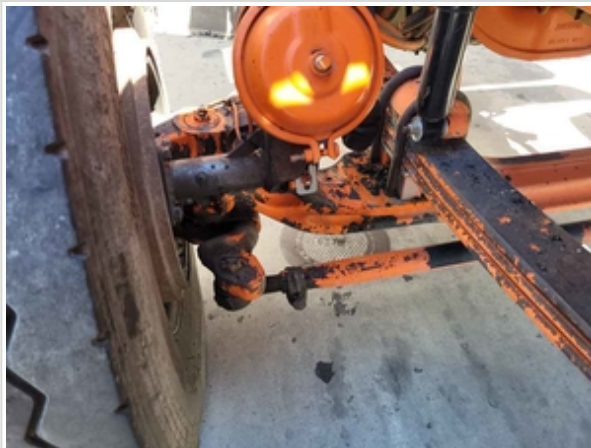
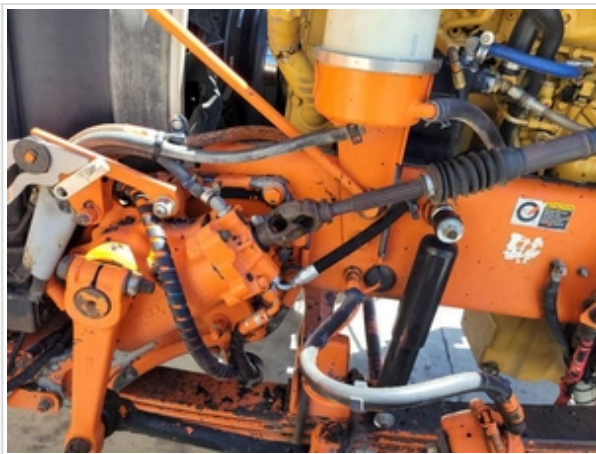
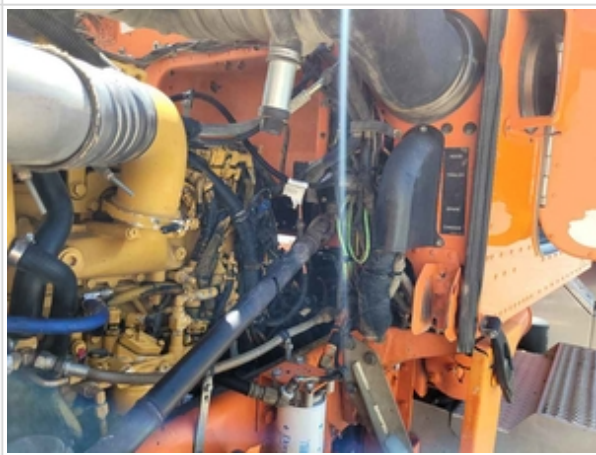
Steering Components Photos

Steering Components	3 - Normal Wear & Tear	
Comments	Front tires showing signs of uneven wear, may be related to worn steering components and/or alignment

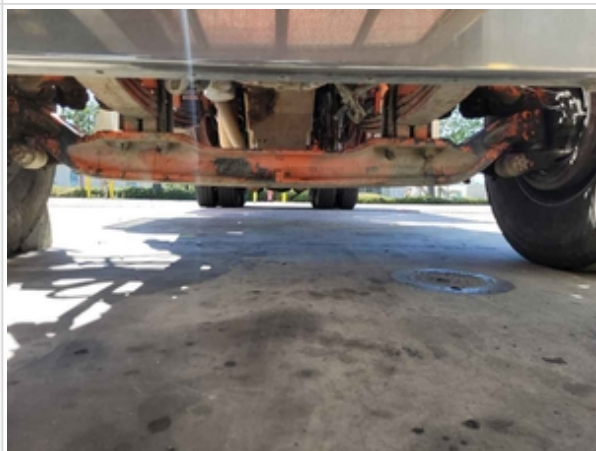
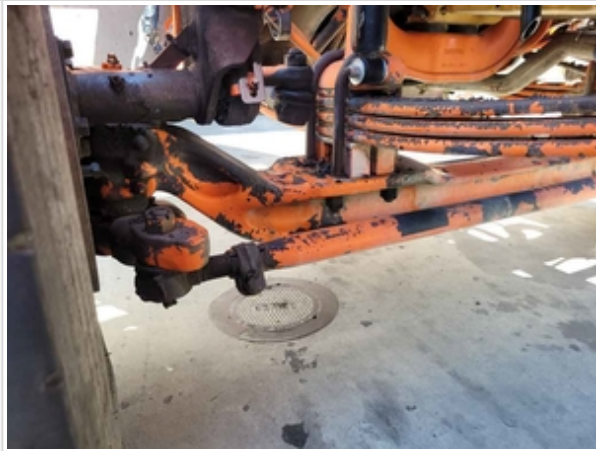
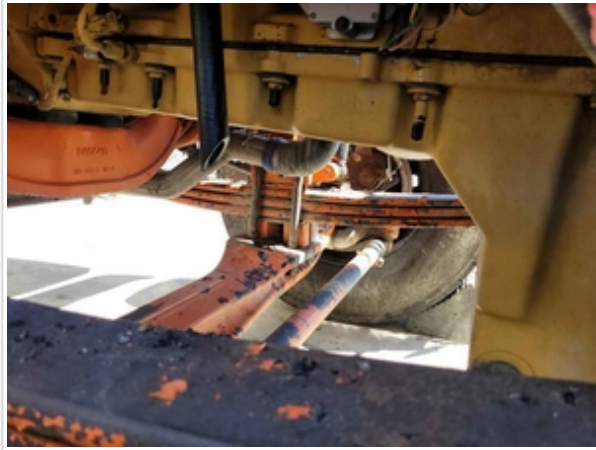
<p>Steer Axle Condition</p>	<p>3 - Normal Wear & Tear</p>	
<p>Steer Axle Condition Photos</p>

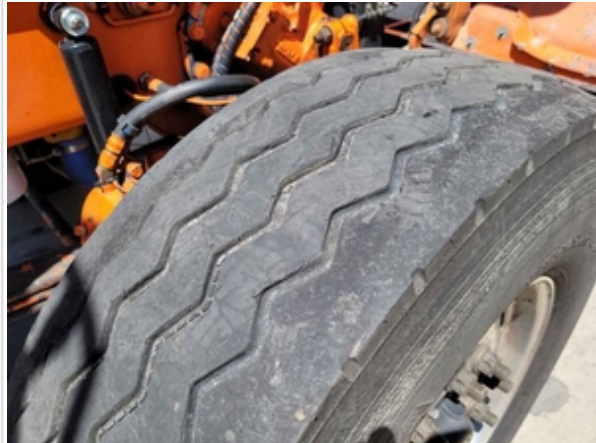
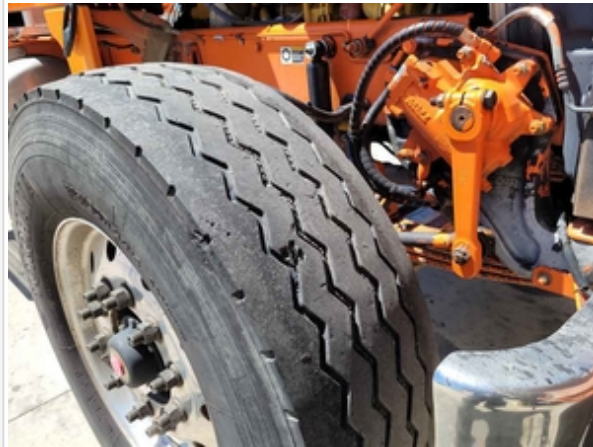
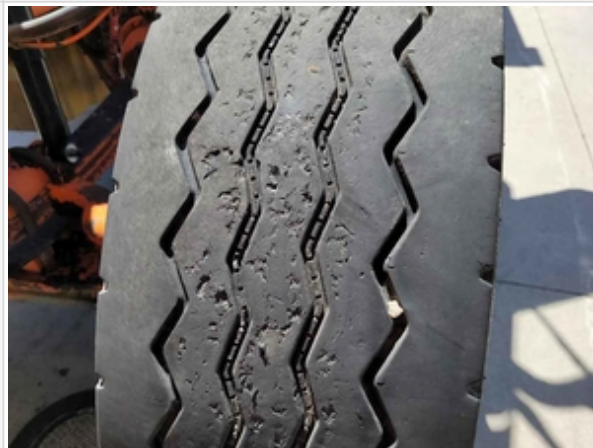
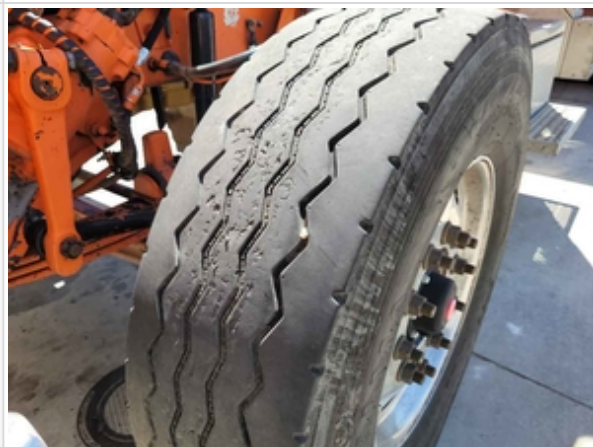
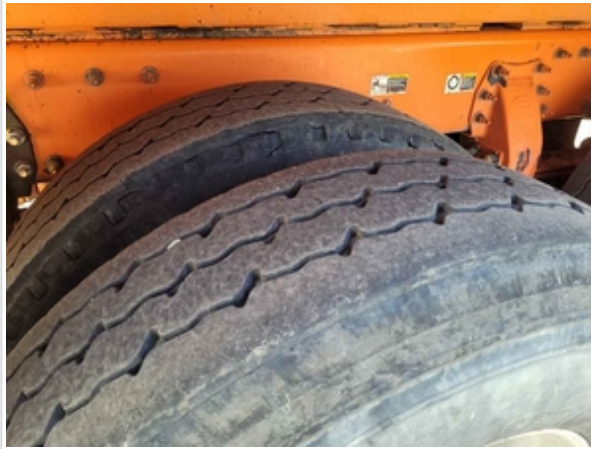
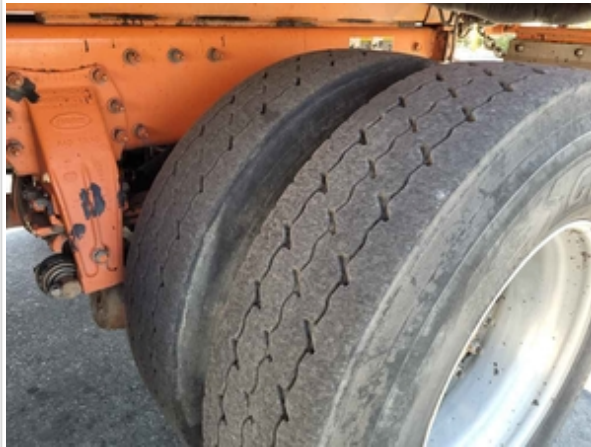
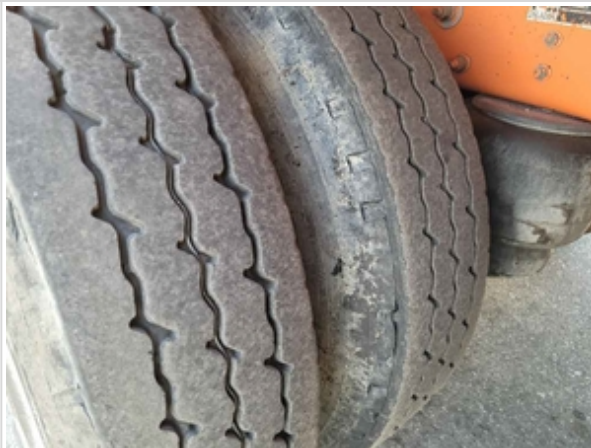
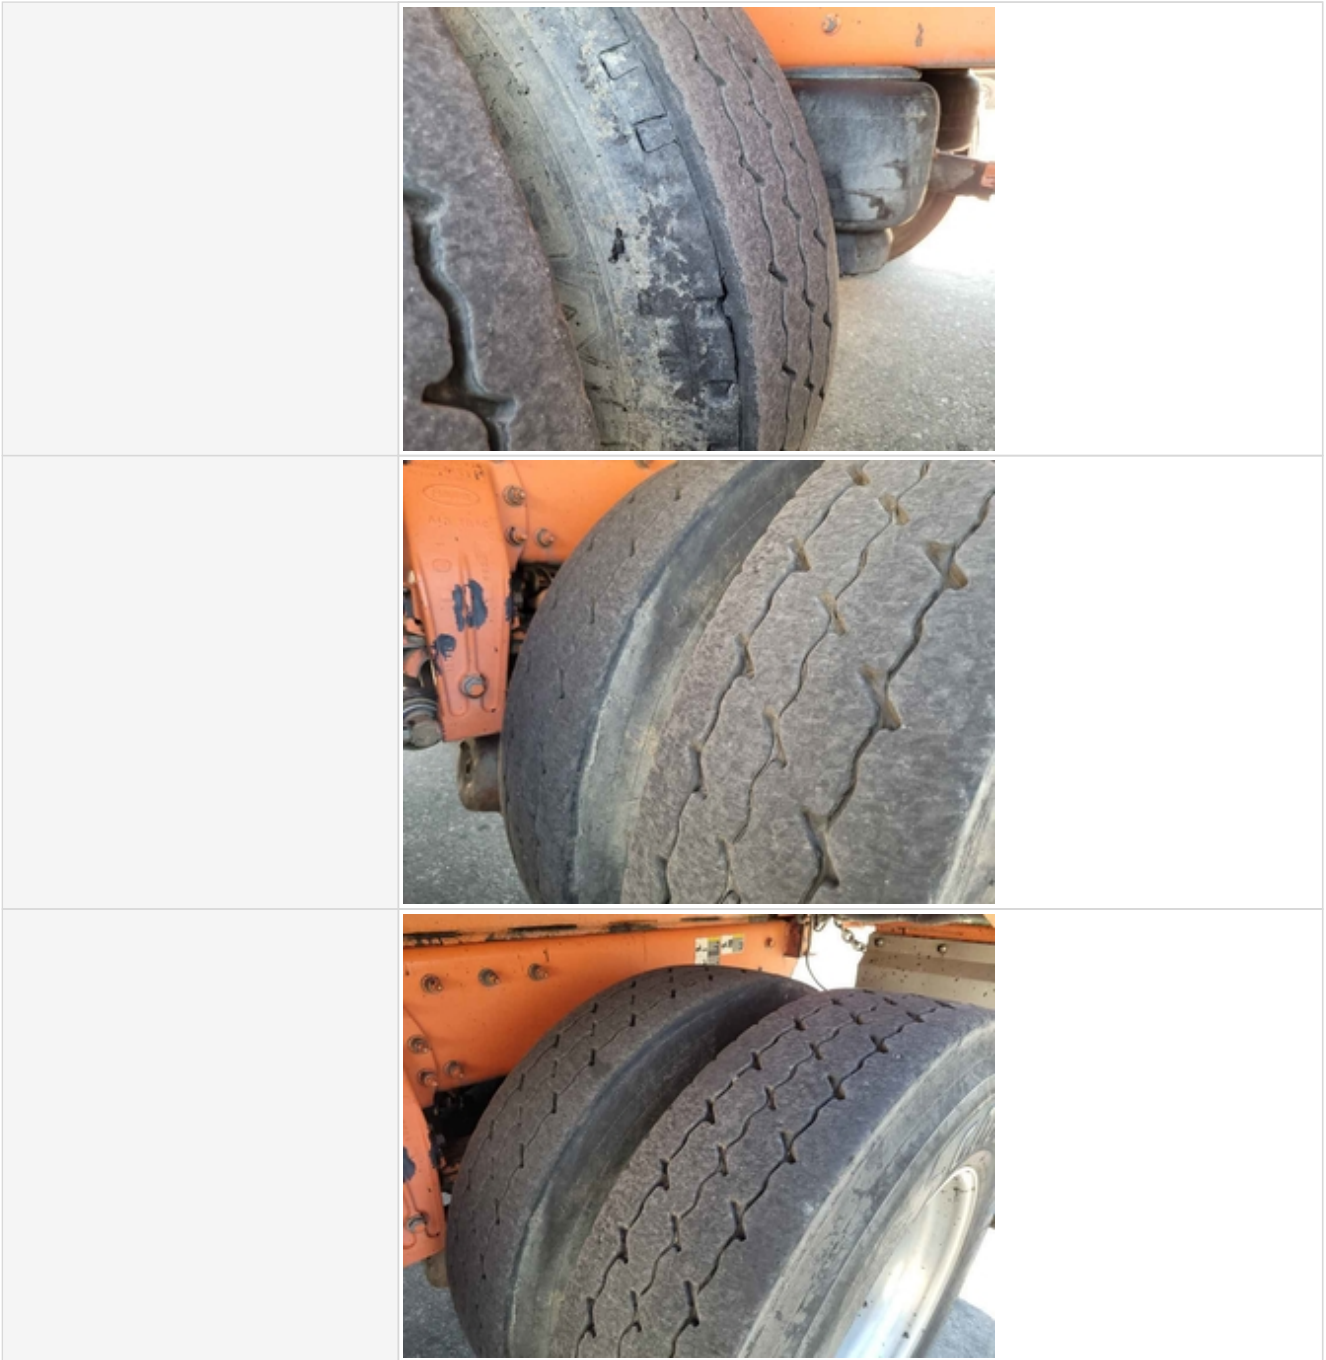
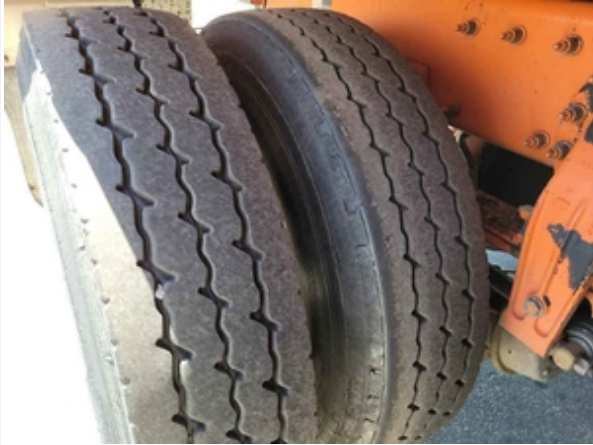
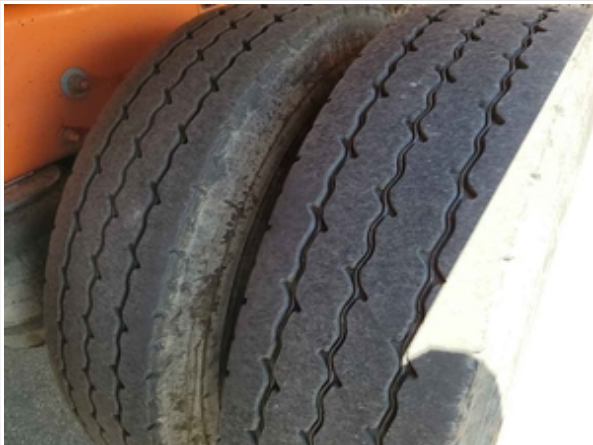
Wheels & Tires	2 - Above Average Wear	
Comments	front tires worn	
Wheels & Tires Photos

Tire Brand	Yokohama
Tire Size	315/80R/22.5 Front 11R/22.5 Rear
Front Left Tire - Ratio Remaining	10%
Front Right Tire - Ratio Remaining	10%
Rear Right Tire - Ratio Remaining	30%
Rear Left Tire - Ratio Remaining	30%
<h3>Additional Axle(s)</h3>

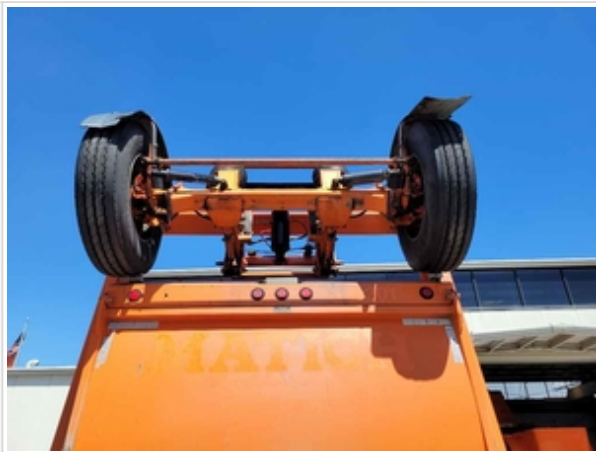
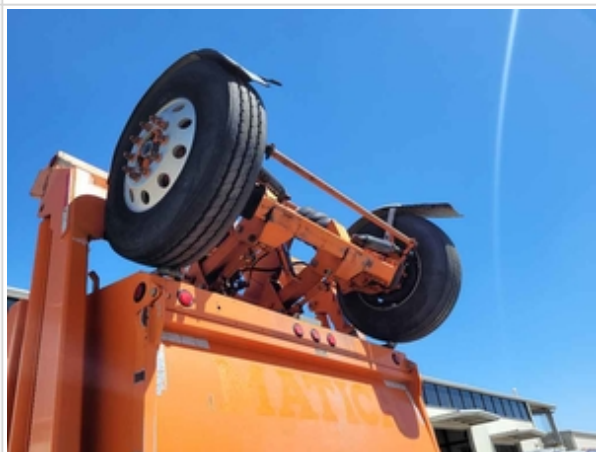
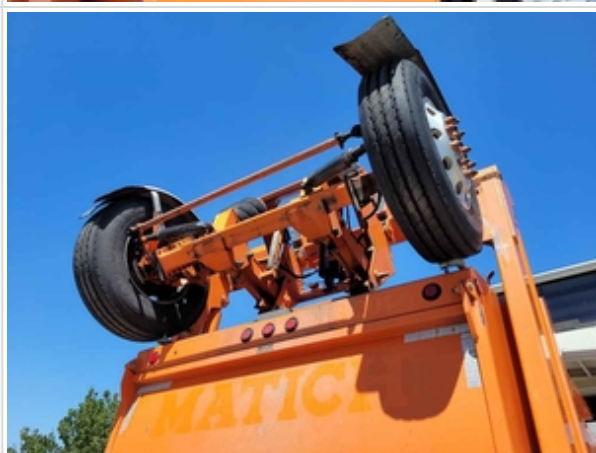
<p>Axle Condition Photos</p>

Instructions	Check the condition of additional axle(s), wheels & tires. Note any damage or wear. Take photos.
Axle Description & Position	Strong arm hydraulic drop down axle
Steerable?	No
Drop Axle?	Yes
Axle Condition	3 - Normal Wear & Tear
