Inspection Report (On-Highway Dump Truck)

Year	2011
Make	Peterbilt
Model	367
Serial Number	1NPTLU0X4BD127976
Truck Odometer Reading	425,002 miles
Current Inspection / State Cert / DOT	90 day b.i.t. Inspection performed 6/20/22 @424,994
Previous Application (e.g., earth moving, mining, demolition, etc)	asphalt road work

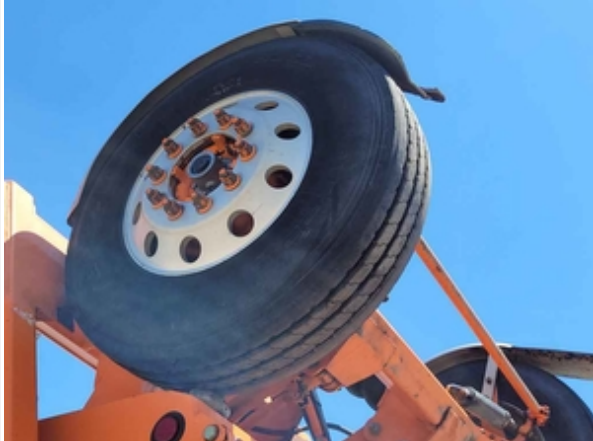
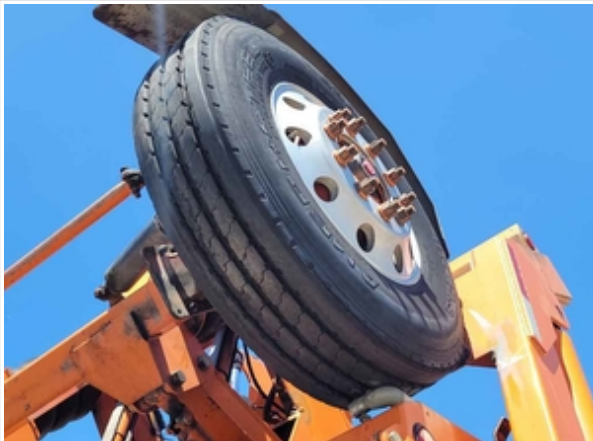
Wheels & Tires Photos

<p>Wheels & Tires</p>	<p>3 - Normal Wear & Tear</p>

Tire Brand	General tire
Tire Size	11R/22.5
Left Tire(s) Ratio Remaining	70%
Right Tire(s) Ratio Remaining	70%
Overall Chassis	3 - Normal Wear & Tear
Overall Chassis & Undercarriage Photos

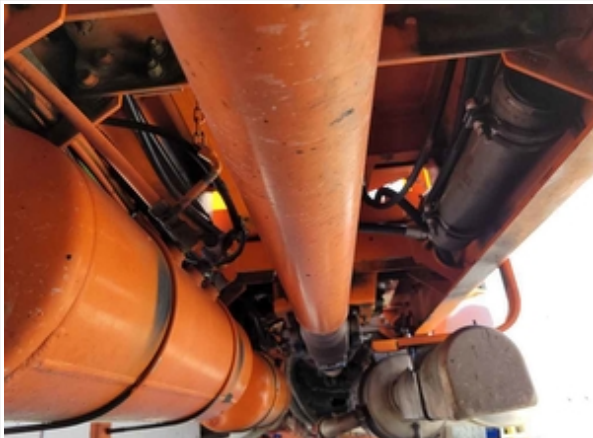
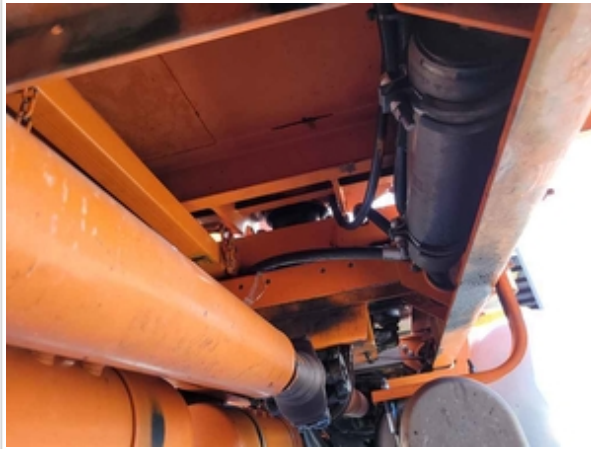
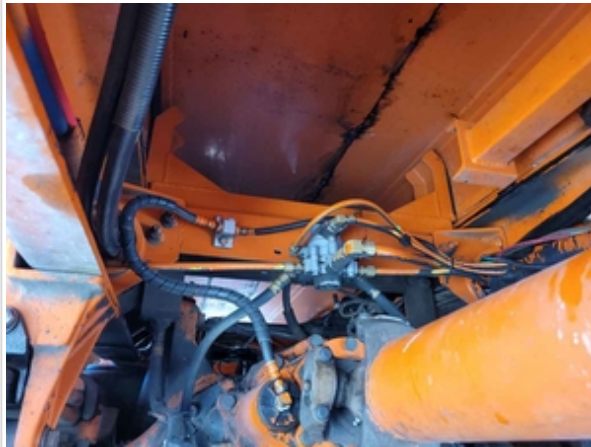
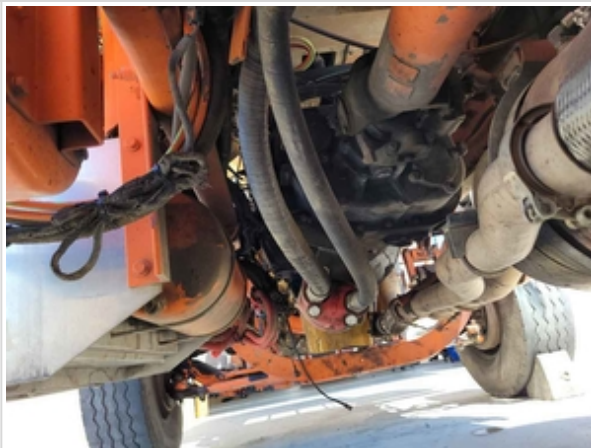
Overall Chassis Comments	Loose grease hose and loose ground cable underneath. Other than that chasis looks solid! Undercarriage looks clean

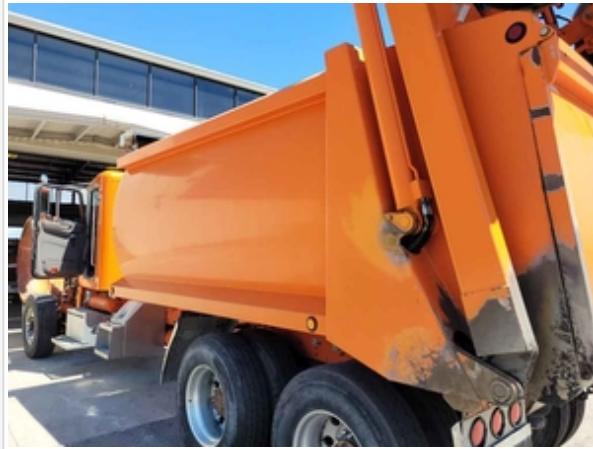
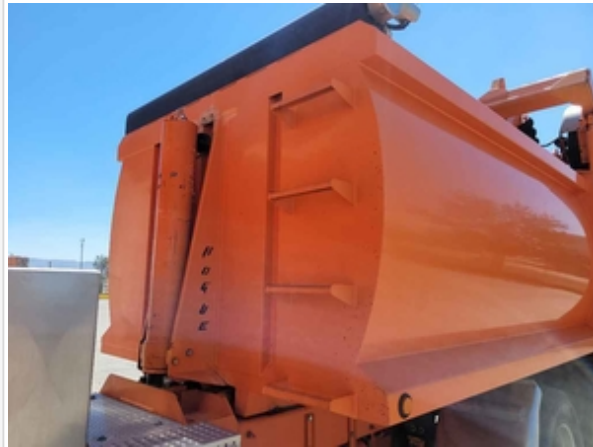
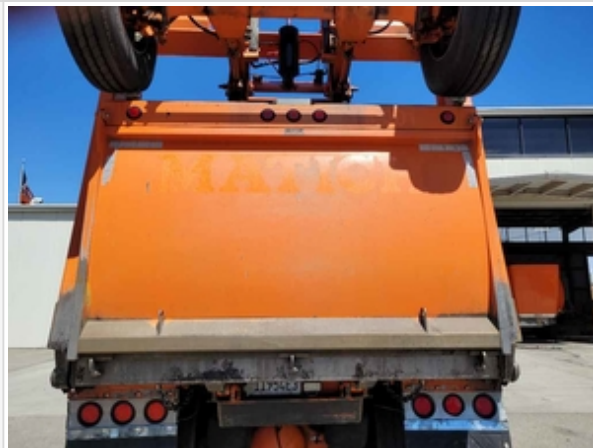
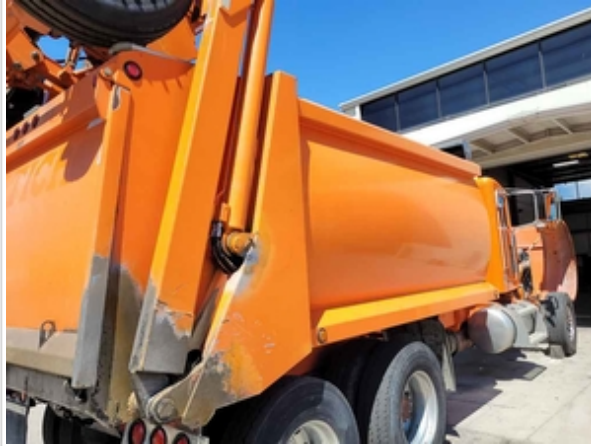
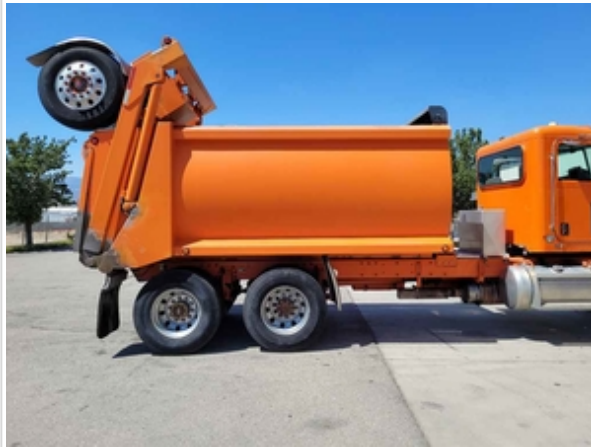
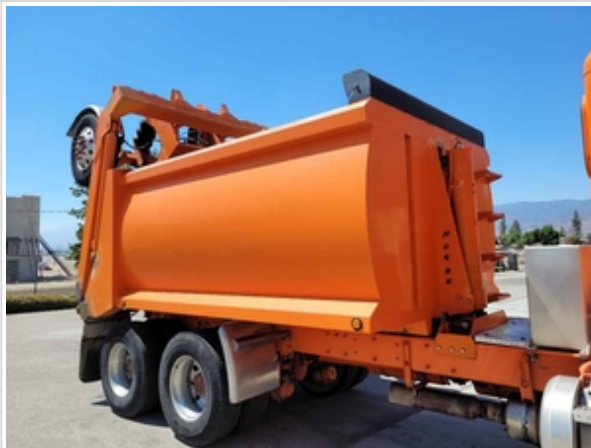
Dump Body, Tailgate, Support & Trap	Check the condition of the dump body, tailgate, support & tarp. Note any damage or wear. Take photos.	
Dump Body Make & Material	Rogue	
Dump Body Length (ft and inches)	14'	
Dump Body Height (ft and inches)	5'	
Bed Body	3	
Comments	dump body in good shape	
Bed Body Photos

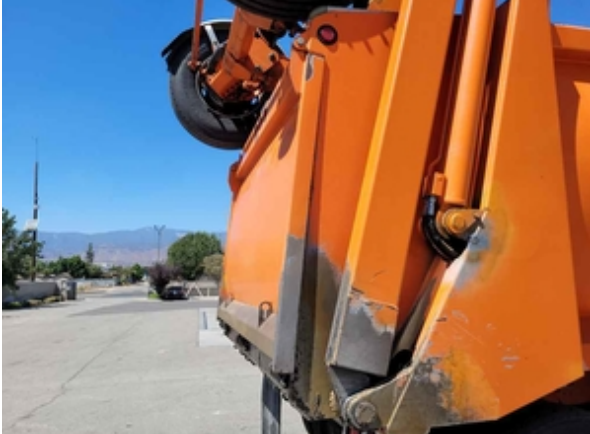
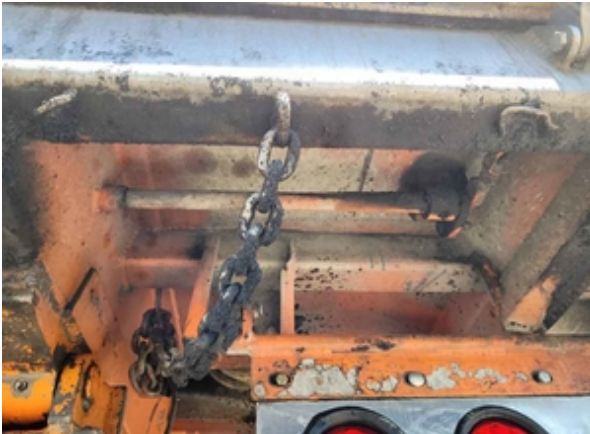
Tailgate	3	
Comments	tailgate in good shape	
Tailgate Photos

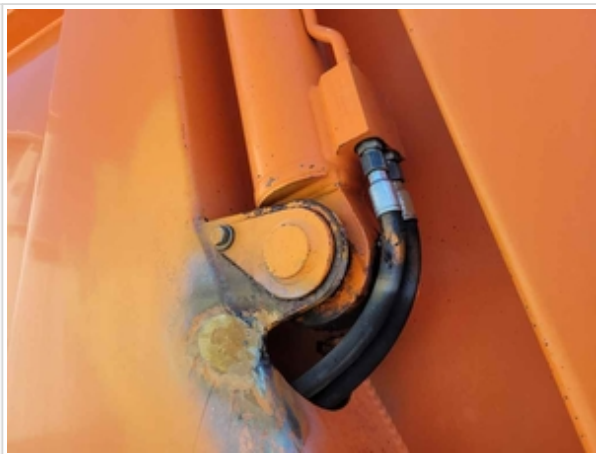
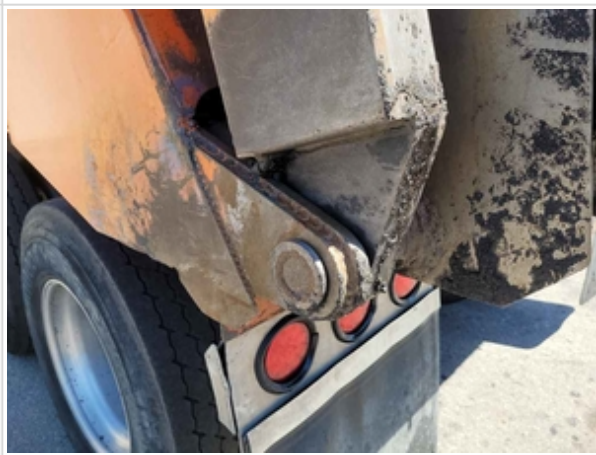
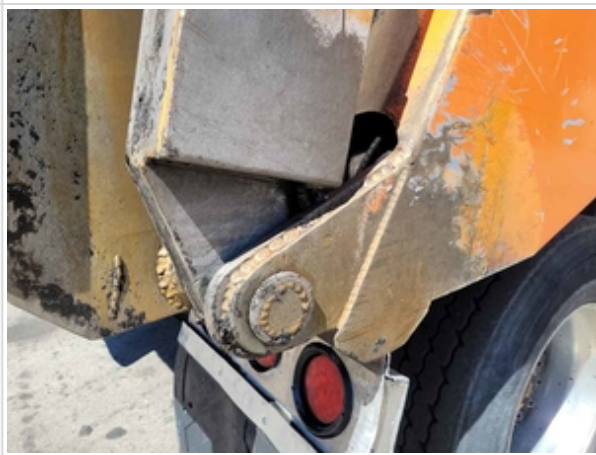
<p>Support Frame Photos</p>

Tailgate Latch	3	
Support Frame	3

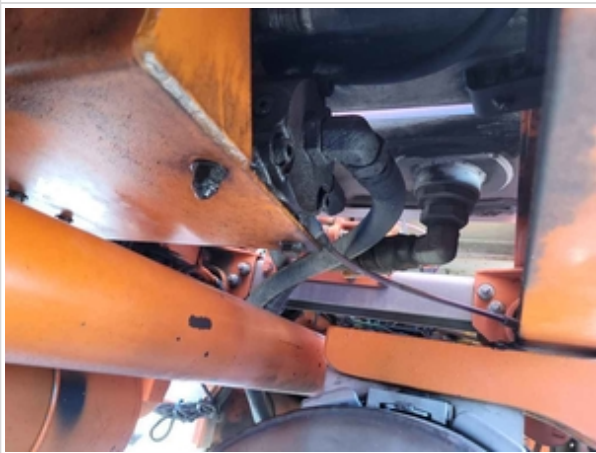
Hoses	3	
Comments	hoses from pto tank in good condition	
Hose Photos

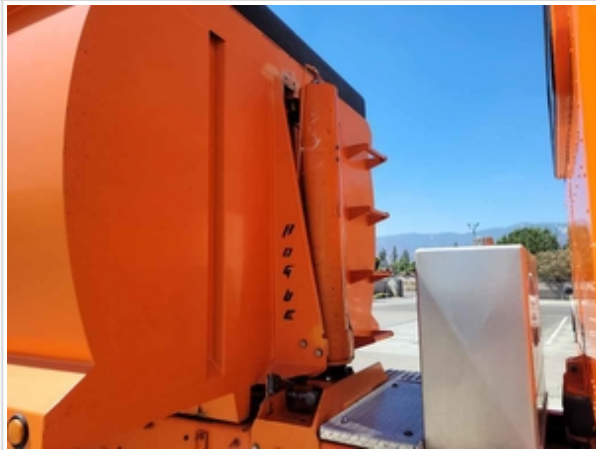
Hydraulic Cylinders	3	
Comments	hoses to strong arm axle worn (at rear)	
Hydraulic Cylinder Photos
