Inspection Report (On-Highway Flatbed Truck)

Year	2015
Make	Ford
Model	F-750
Serial Number	3FRXF7FE7FV662394
Truck Odometer Reading	219,869
Current Inspection / State Cert / DOT	Last Performed 09/2022
Previous Application (e.g., earth moving, mining, demolition, etc)	Compact Equipment Rental Hauler

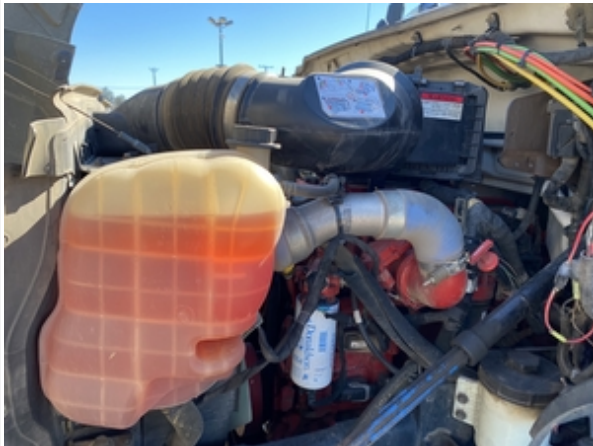
Engine Type (Make, Model, Cylinders, Hp)	Cummins - ISB6.7 289 - 6 CYL. - 280 Hp
Emissions Tier	Tier 4F
Engine Serial Number	73692358
Engine Fuel Type	Diesel
Engine Photos

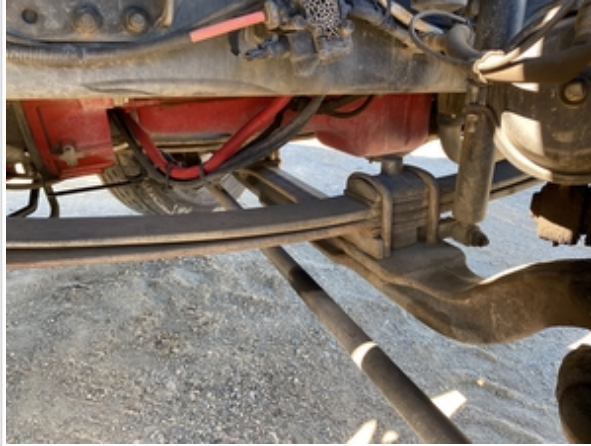
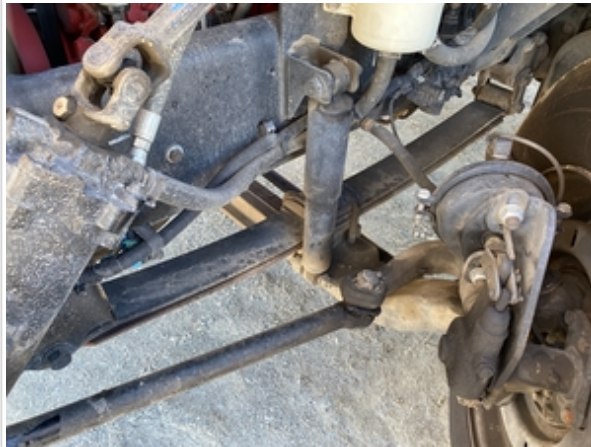
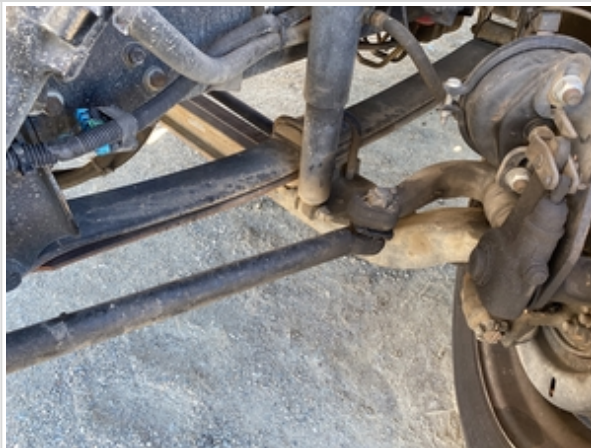
Chassis Inspection Points	Take photos of all undercarriage and chassis components including frame, suspension, axles, steering, and brake components. Note any damage or wear.
Chassis & Undercarriage Photos

Overall Chassis Condition	3 - Normal Wear & Tear	
Overall Chassis Comments	Overall chassis looks to be in solid shape. Front and rear axle, along with driveshafts look good. Steering components work well.

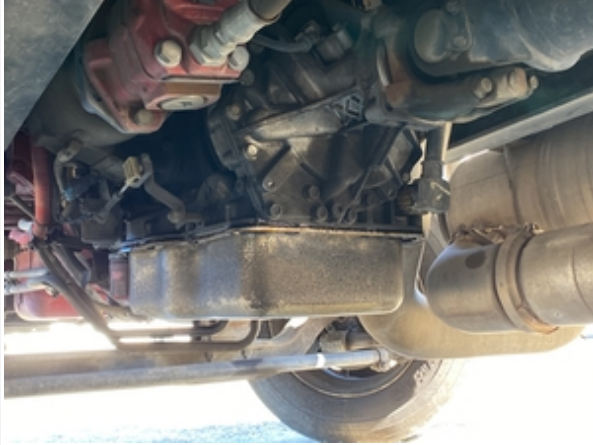
Transmission Info (Make/Model)	Allison 5 speed auto
Transmission	3 - Normal Wear & Tear
Transmission Condition	No unusual noises or vibrations, Other (see comments)
Comments	Possible leak around trans. Oil pan area
Transmission Condition Photos

Overall Drivetrain Condition	3 - Normal Wear & Tear	
Overall Drivetrain Comments	Overall drivetrain in solid shape. Minor leak at trans oil pan or around it observed.

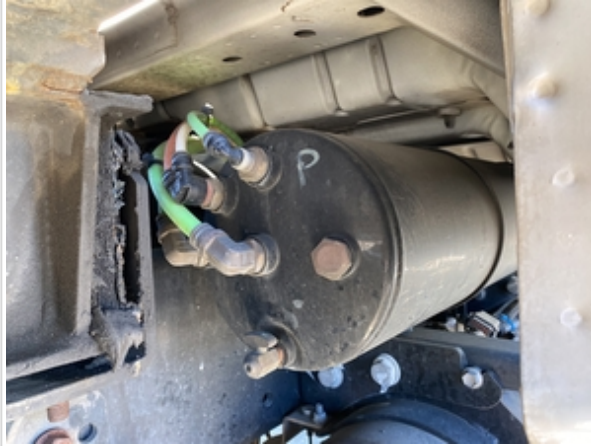
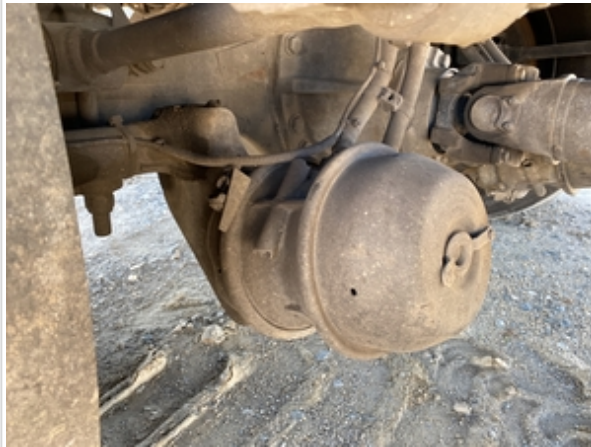
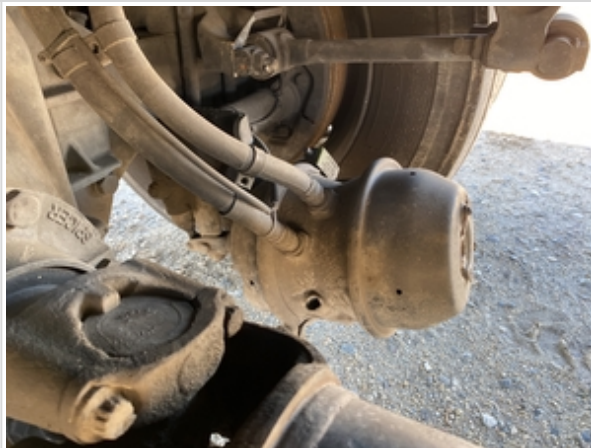
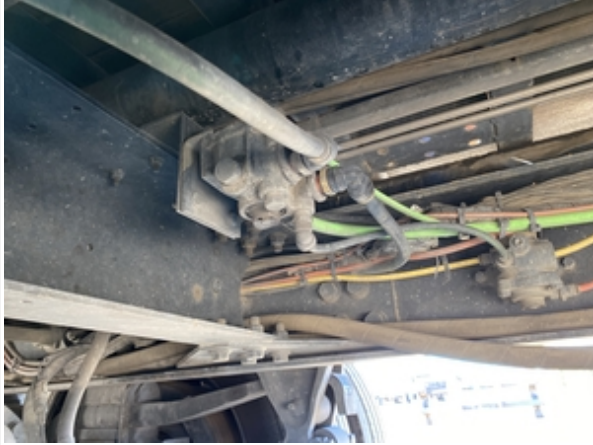
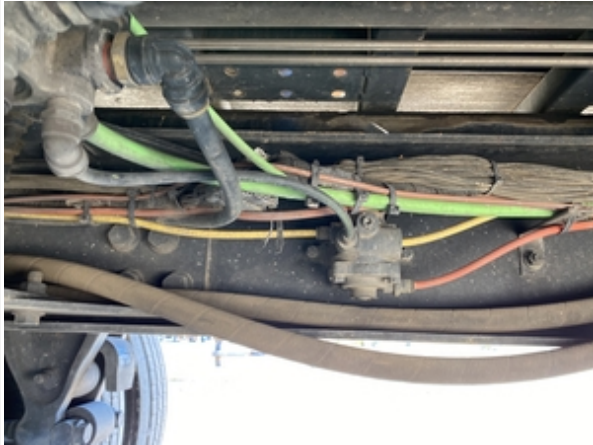
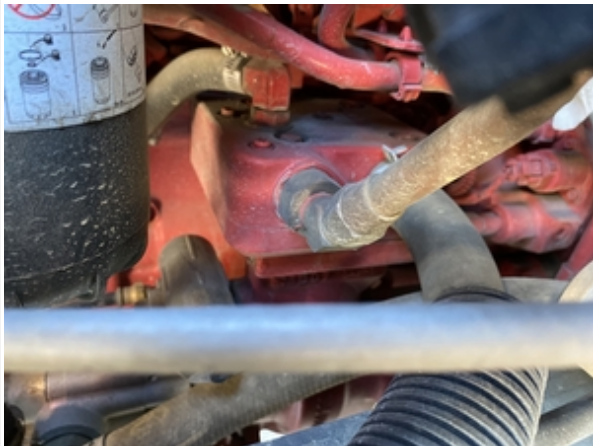
Air Brake System Photos

Differential	Check condition of the differential(s). Take photos and notes as relevant.
Rear Differential	3 - Normal Wear & Tear
Rear Differential Condition	Dry housing appearance, no unusual noises heard during operation
Front Differential	0
Brake Shoe Thickness	50%
Comments	Fronts at 50 to 60% shoe material left the rears true value unknown due to covers installed
Air Brake System Leaks	No
Air Brake Hose Condition	3 - Normal Wear & Tear
Comments	Very minor air leakage with truck sitting off, no obvious leaks heard

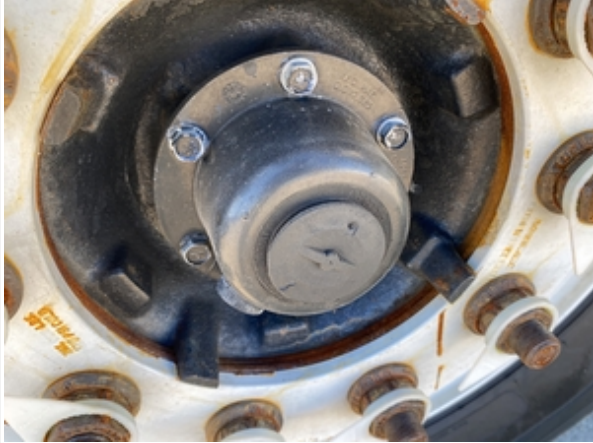
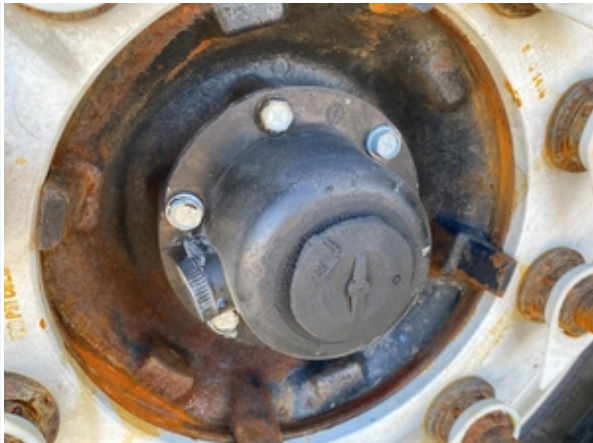
Wheels & Hub Condition	3
Wheels & Hub Photos

Wheel Seal Leaks	No
Tire Brand	Front - Goodyear. Rear - Sumitomo
Tire Size	Front & Rear - 275/70R/22.5.
Front Left Tire - Ratio Remaining	90%

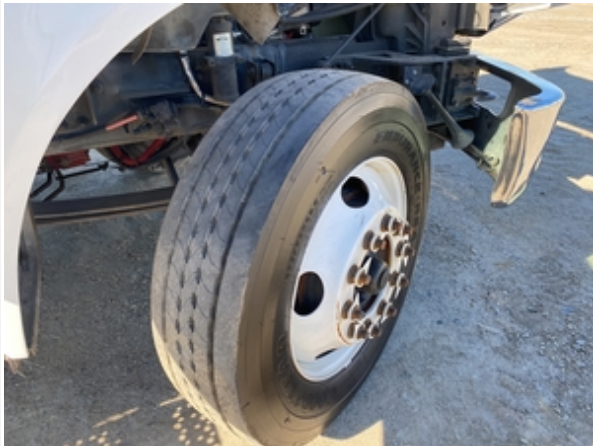
Front Right Tire - Ratio Remaining	90%
Front Right Tire Photos

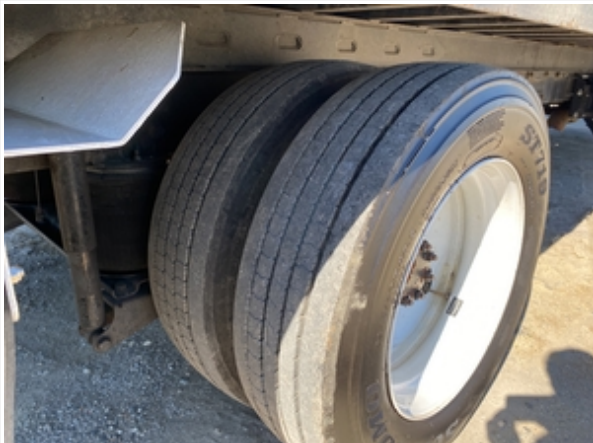
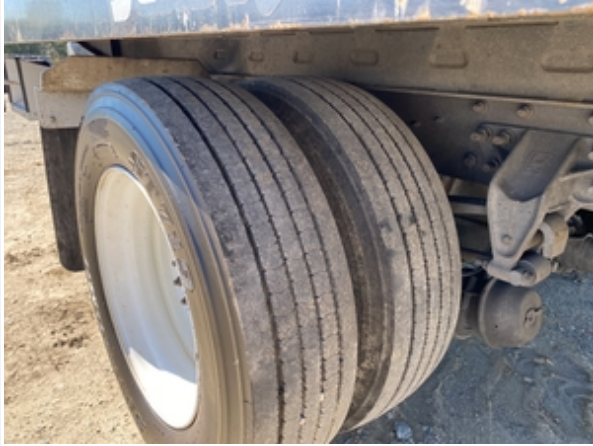
Rear Right Tire - Ratio Remaining	70%
Rear Right Tire Photos

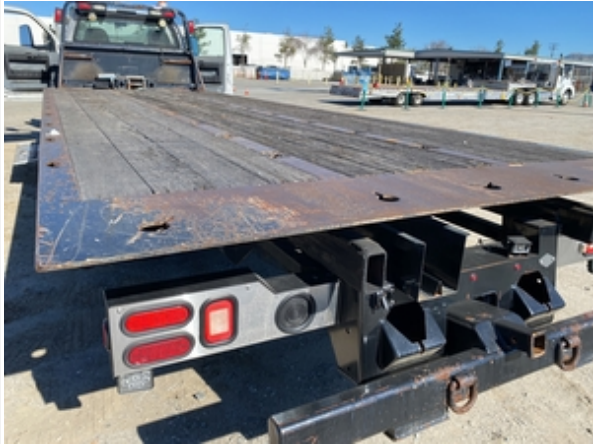
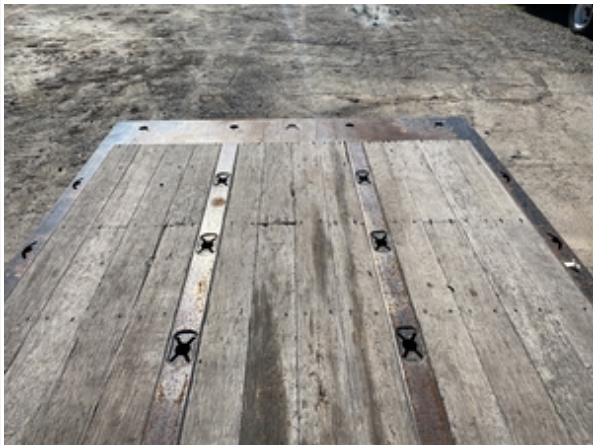
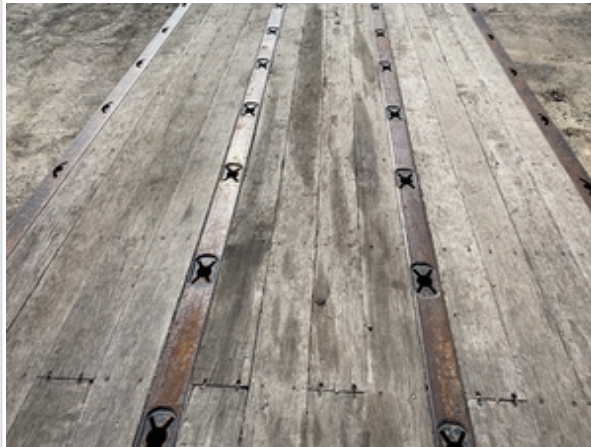
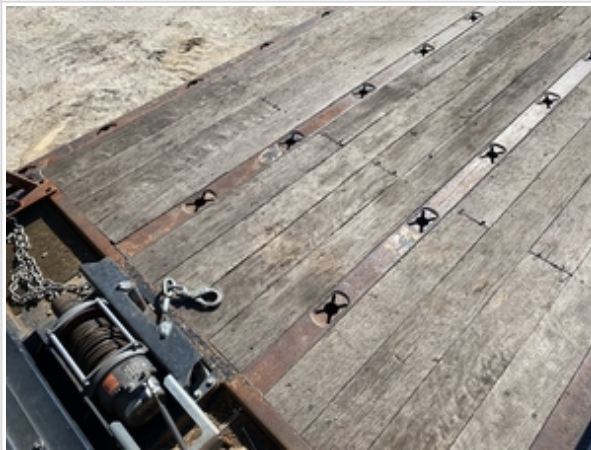
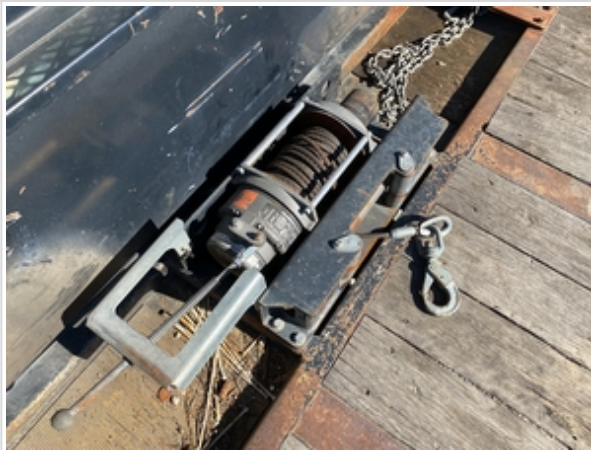
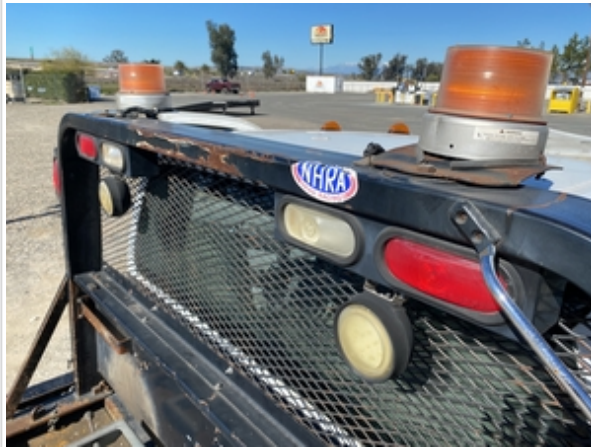
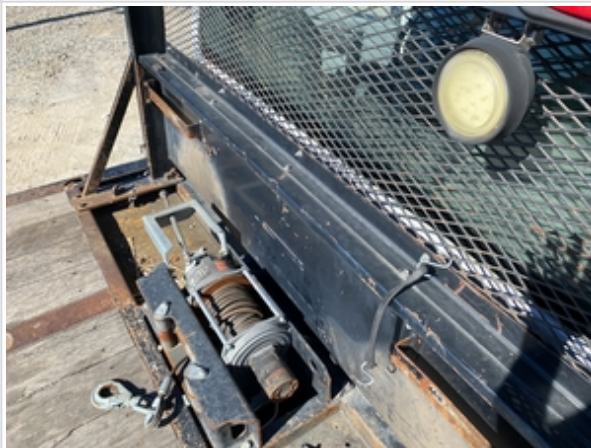
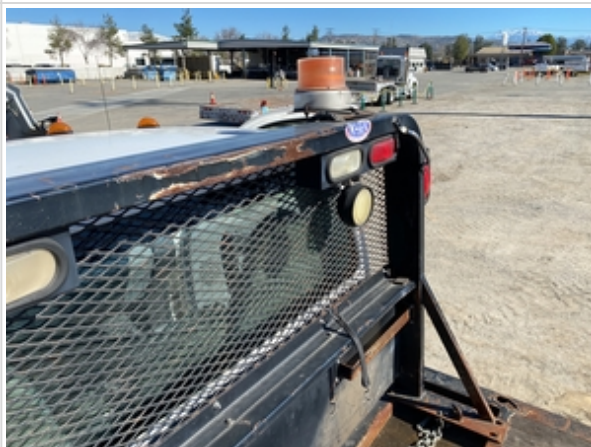
Bed Details (Deck Type, Additional Features)	Century 16,000 (Capacity)
Flatbed Length (ft and inches)	24'
Flatbed Width (ft and inches)	8'6"
Flatbed Body	3
Flatbed Body Photos
