## Inspection Report (Asphalt Trailer)

Year	2004
Make	Crafco
Model	Super Shot 250
Serial Number	N/A
Current Inspection / State Cert / DOT	N/A
Previous Application (e.g., earth moving, mining, demolition, etc)	Asphalt General Construction

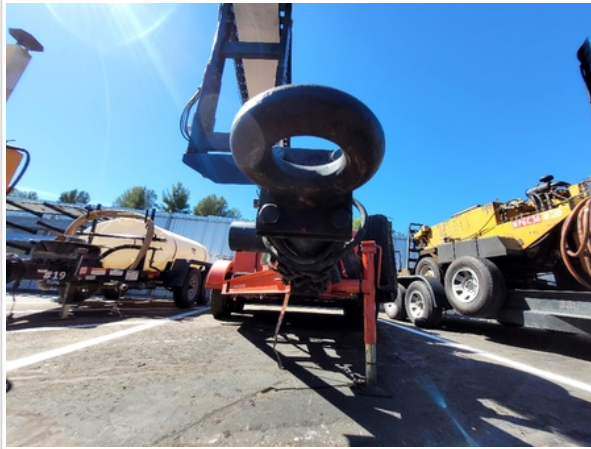
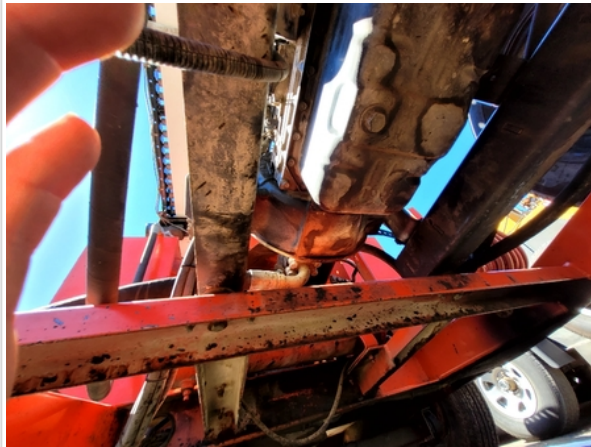
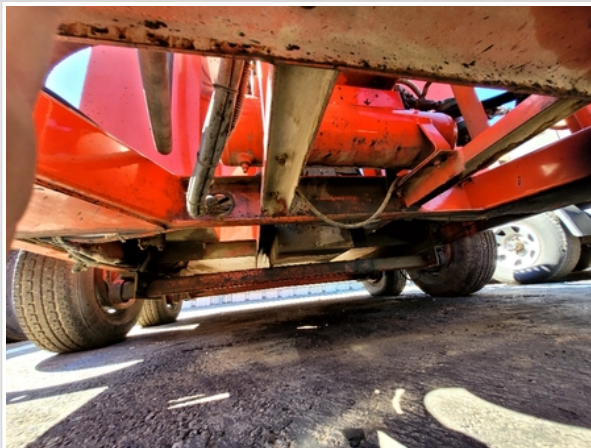
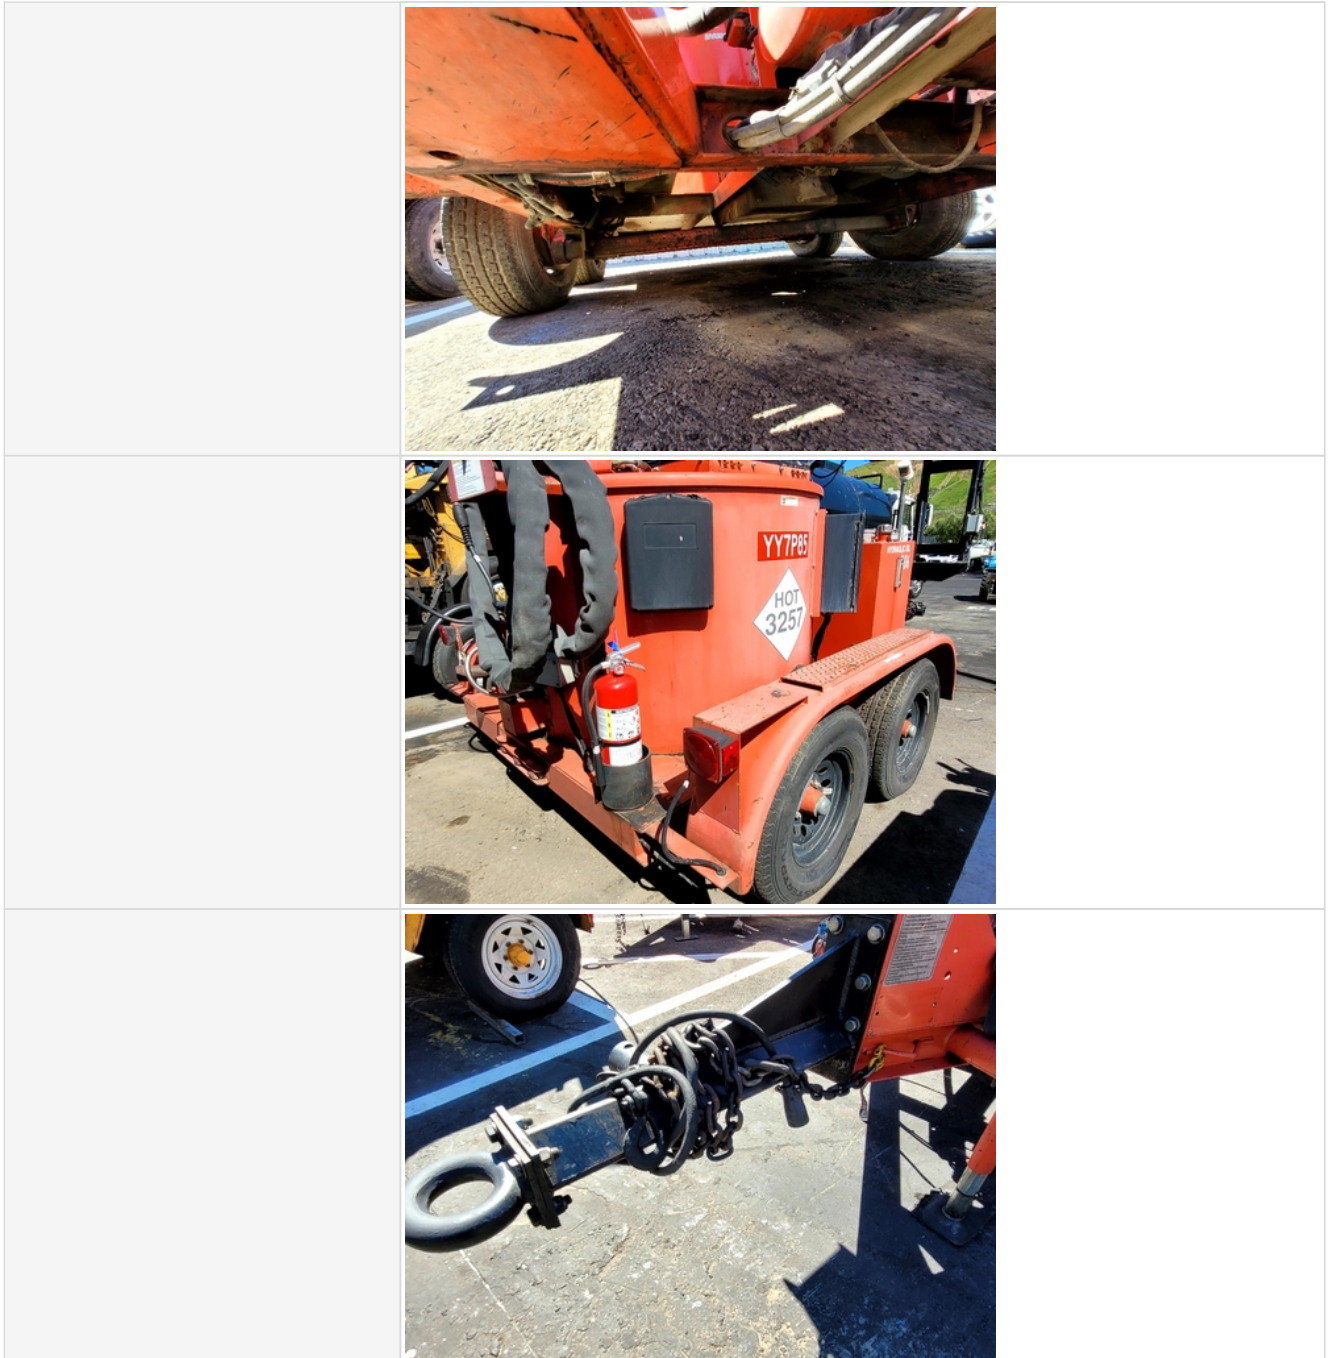
Overall Trailer & Undercarriage Photos	 
--	--

Frame Condition	3 - Normal Wear & Tear
Fenders	3 - Normal Wear & Tear
Mud Flaps	3 - Normal Wear & Tear
Trailer Lights/Wiring (Stop, Tail, Turn)	0
Reflectors	0

Overall Trailer Condition	3 - Normal Wear & Tear
Overall Trailer Comments	Most Tires need to be replaced. Trailer lights and brakes were not tested during inspection. Majority of trailer in good condition.
