Inspection Report (On-Highway Service Truck)

Year	2015
Make	Ford
Model	F750
Serial Number	3FRXF7FK9FV639995
Truck Odometer Reading	78,711
Current Inspection / State Cert / DOT	Last Inspected 8/2022
Previous Application (e.g., earth moving, mining, demolition, etc)	Underground Utility

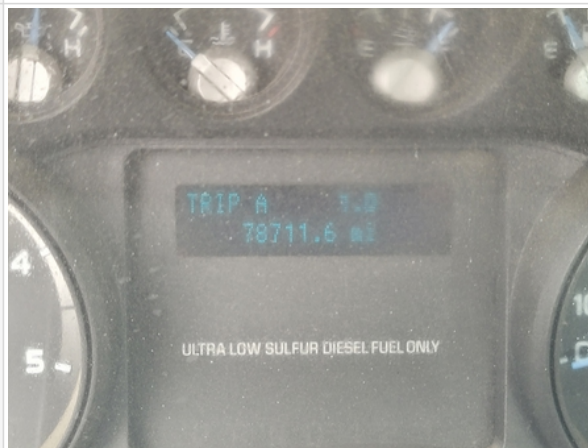
Odometer Photo

Odometer Activity	3 - Normal Wear & Tear	
Odometer Condition	Odometer is working and in good condition	
Controls/Switches/Gauges	3 - Normal Wear & Tear	
Controls/Switches/Gauges Condition	All switches/gauges are in good condition and functioning	
Brake System Type	Air Brakes	
Air Brakes Build Correct Pressure	Yes	
Clutch	0

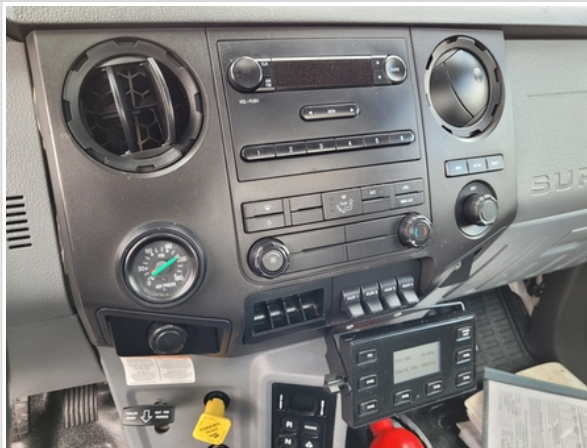
Cab Interior Photos

Horn	3 - Normal Wear & Tear
Horn Condition	Horn is functioning as expected, Other (see comments)
Comments	Additional air horn installed
Reverse Alarm / Backup Camera	3 - Normal Wear & Tear
Reverse Alarm / Backup Camera Condition	Reverse alarm working as expected
Heater & A/C	3 - Normal Wear & Tear
Heat & A/C Condition	Heater and A/C work as expected
Interior Lights	3 - Normal Wear & Tear
Interior Lights Condition	All interior lights are installed and functioning
Seats/Seat Belts	3 - Normal Wear & Tear
Seats/Seat Belt Condition	Seat(s) in good condition, no stains or tears in upholstery, Seat belt secures properly, Other (see comments)
Comments	Small hole in passenger seat
Cab Interior Overall Rating	3 - Normal Wear & Tear
Comments	Cab in well maintained and clean condition

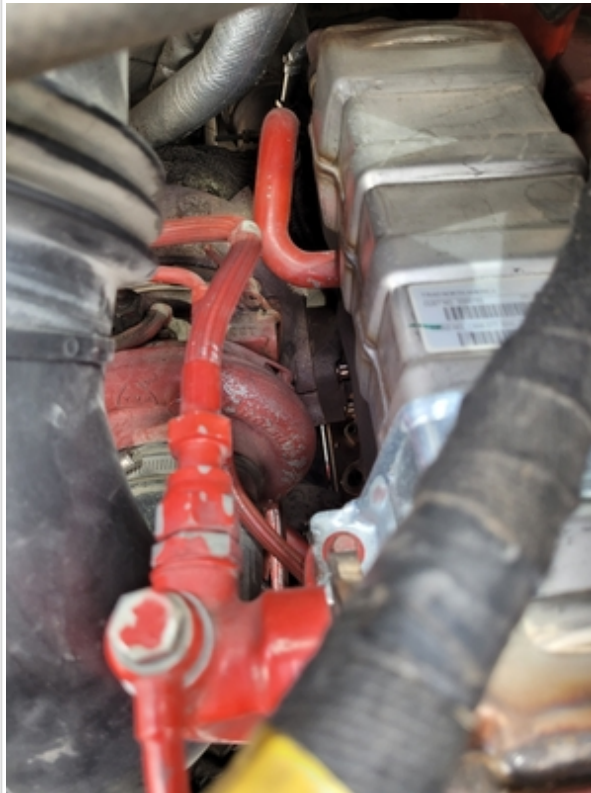
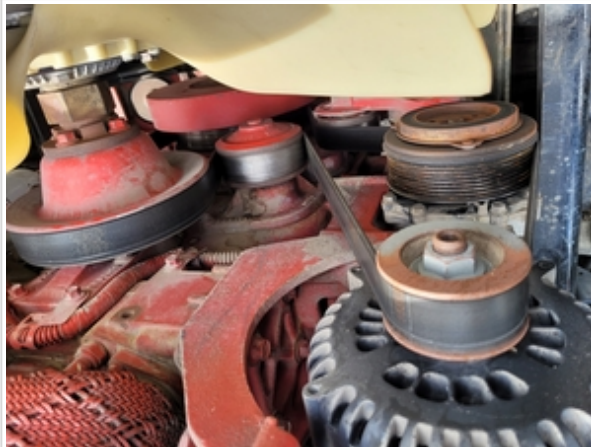
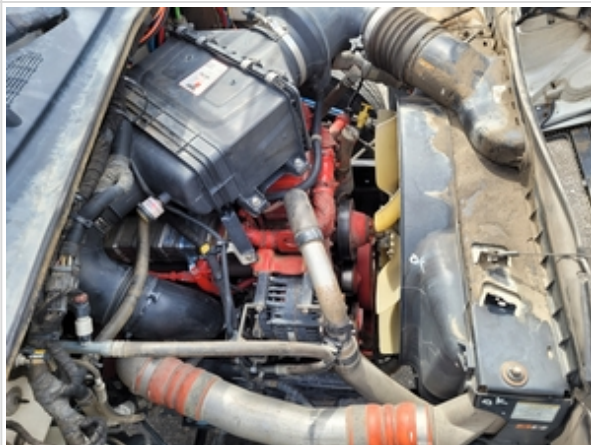
Engine Photos

Requires DEF (Diesel Exhaust Fluid)	Yes
DEF Tank	3 - Normal Wear & Tear
DEF Tank Condition	Area around DEF tank cap is clean, fluid is clear & appears free of contaminants
Overall Engine Appearance	Clean & dry
Overall Engine Comments	Overall engine sounds healthy and has well maintained appearance. No active leaks observed.

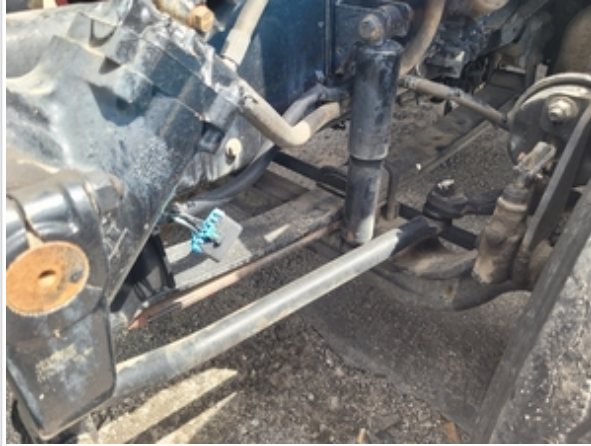
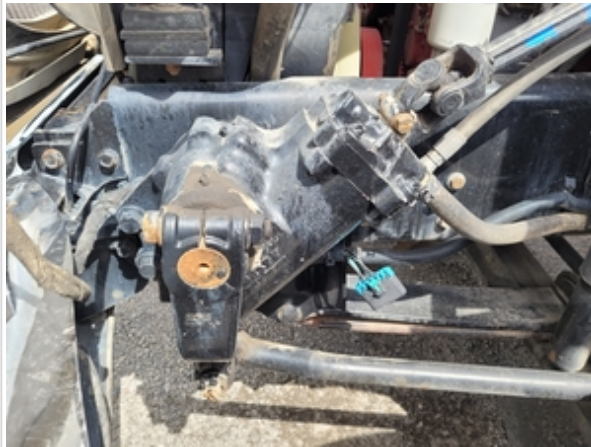
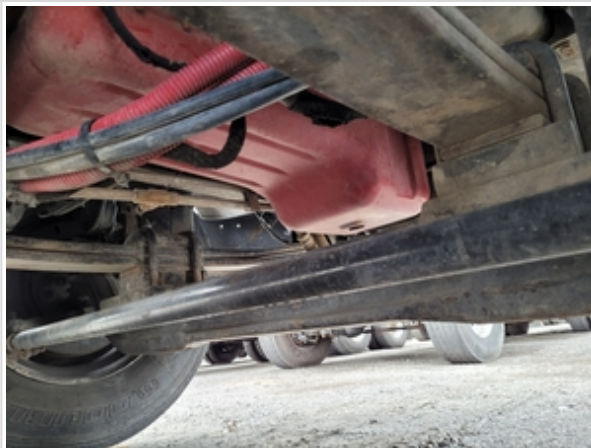
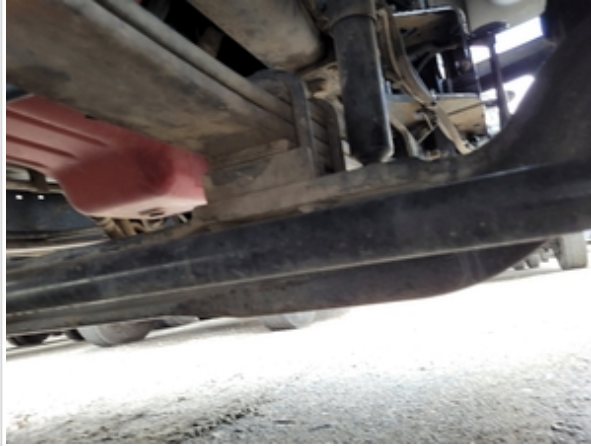
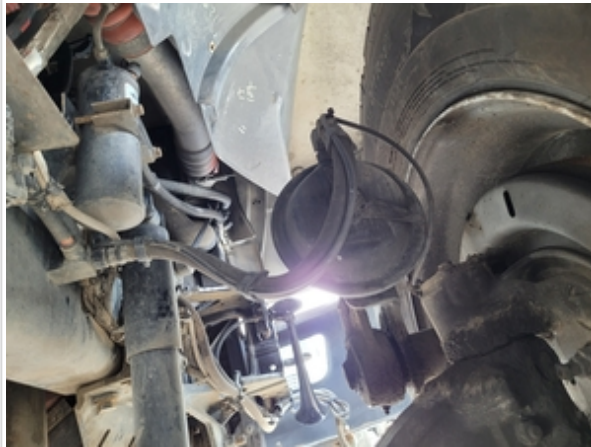
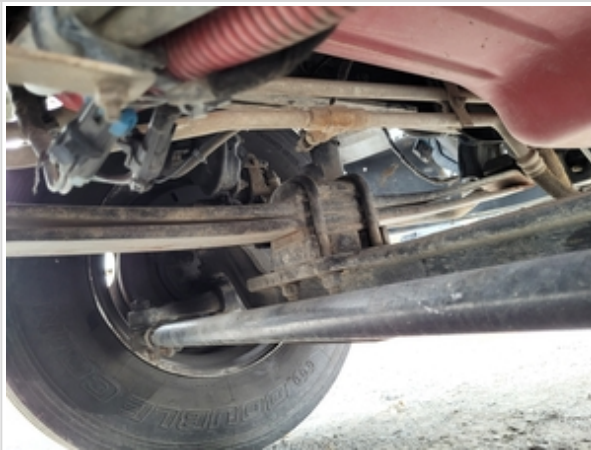
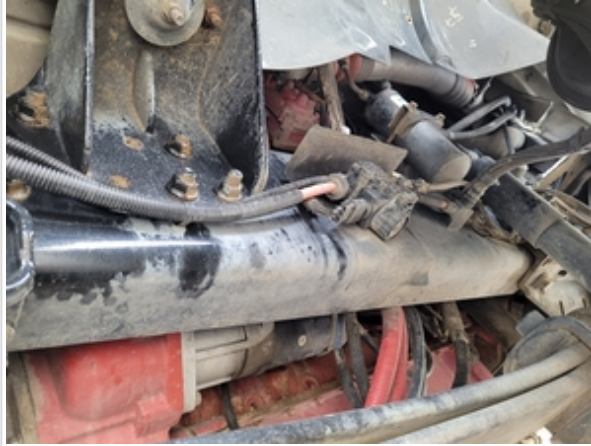
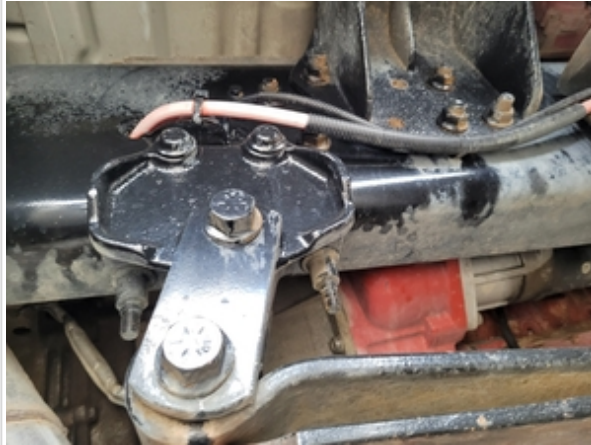
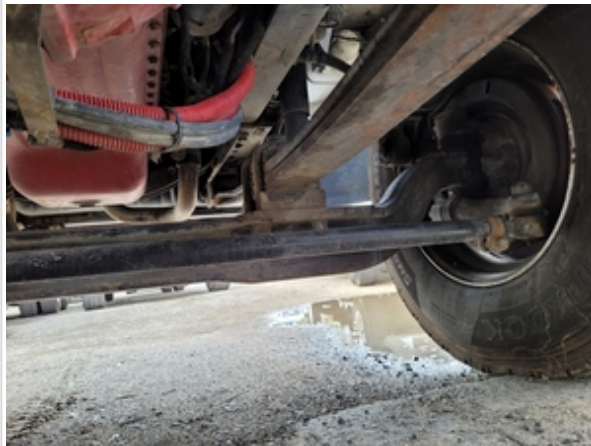
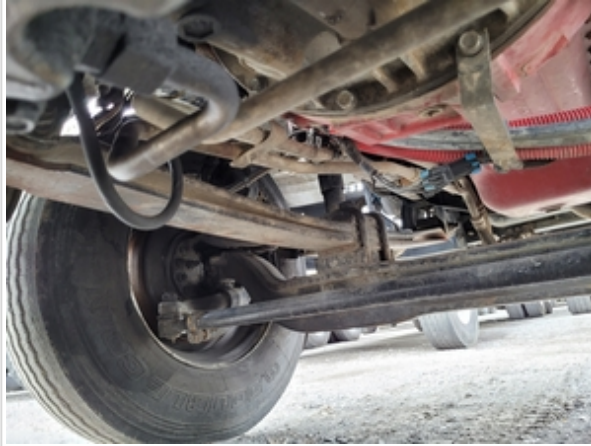
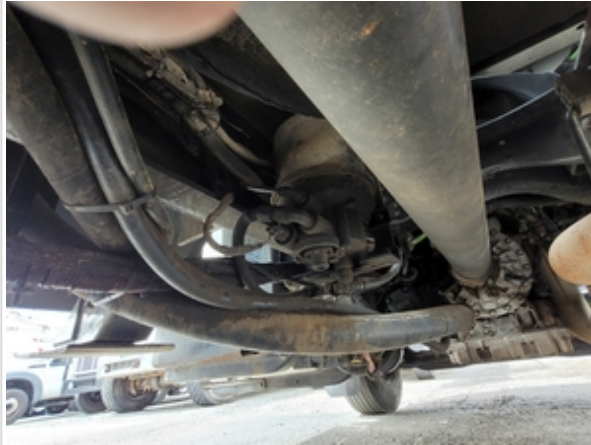
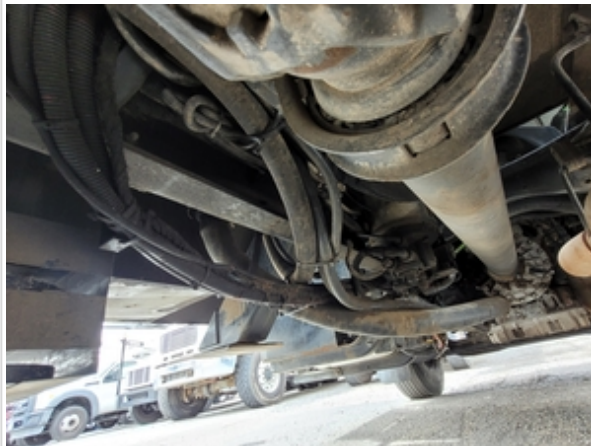
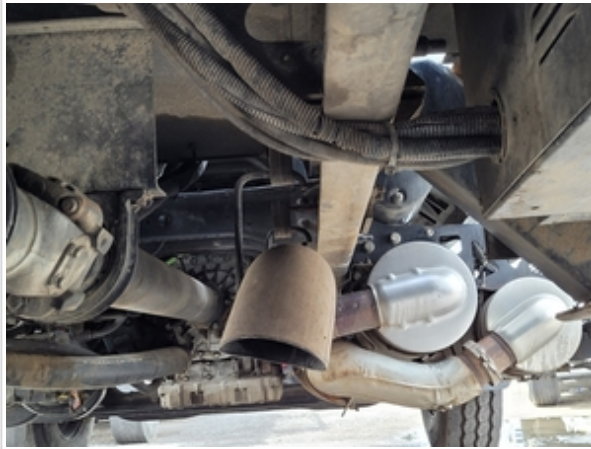
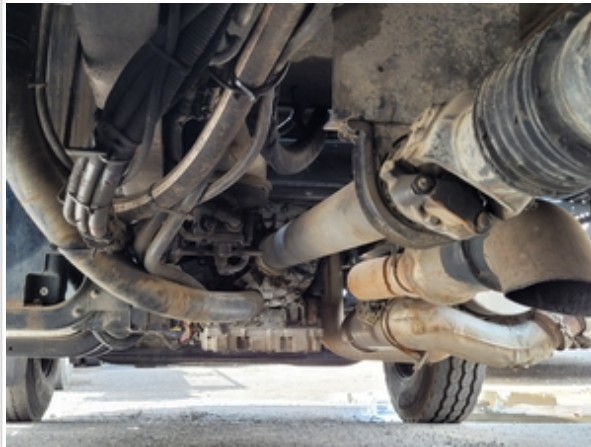
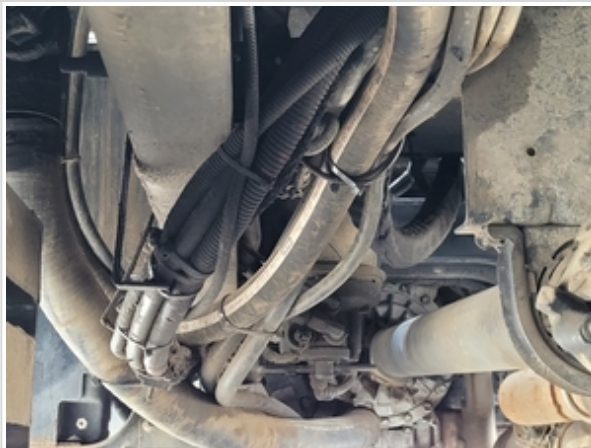
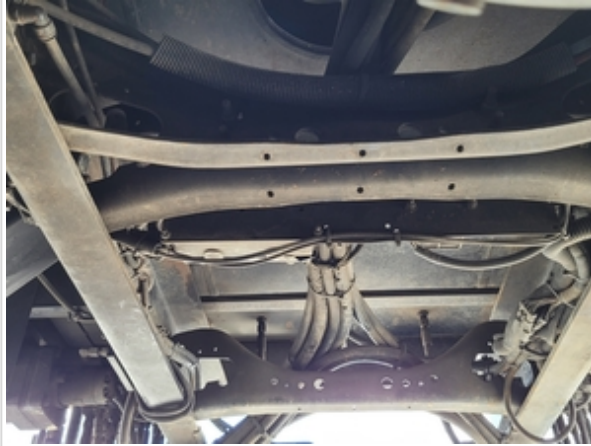
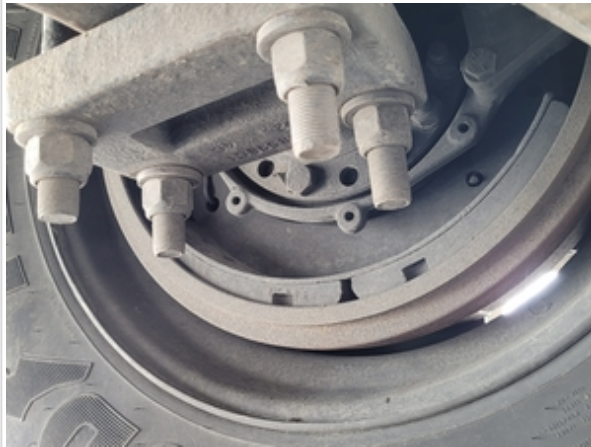
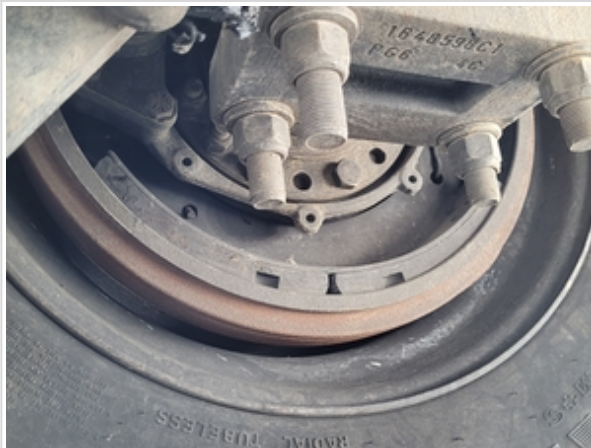
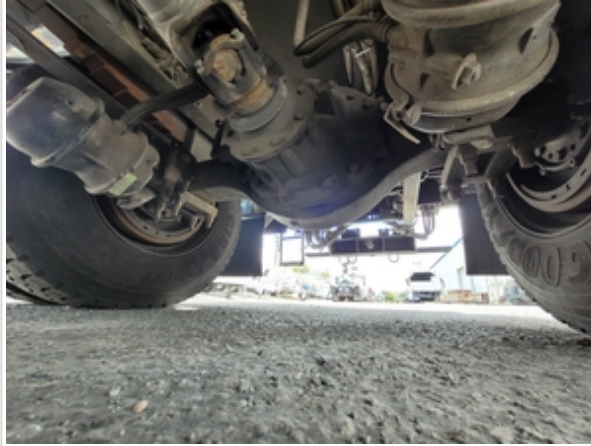
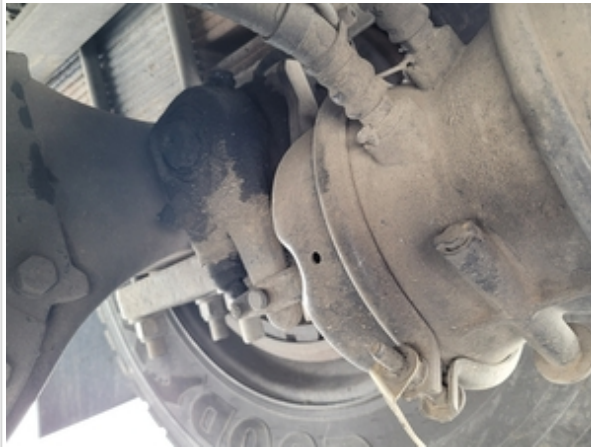
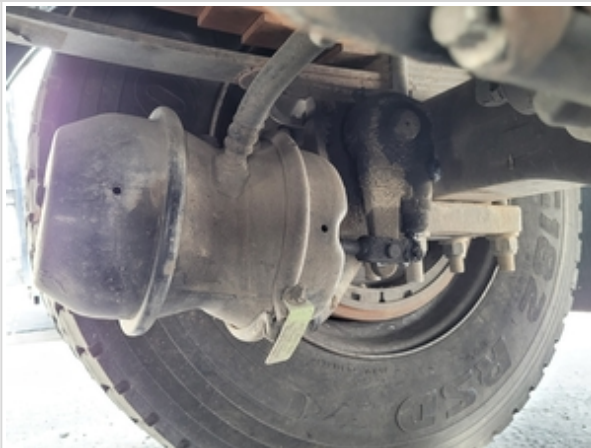
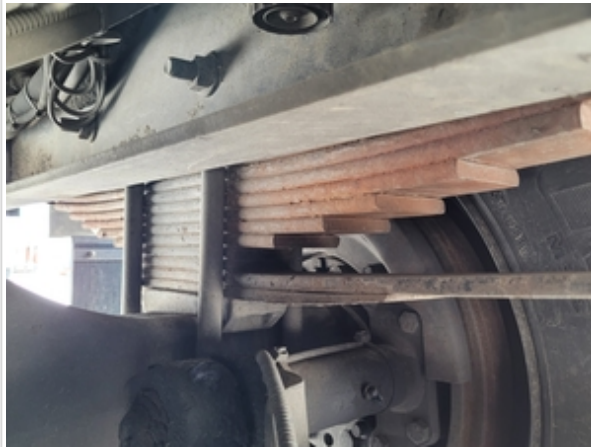
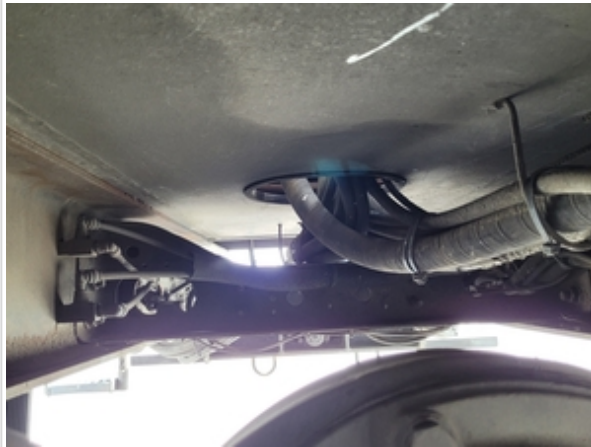
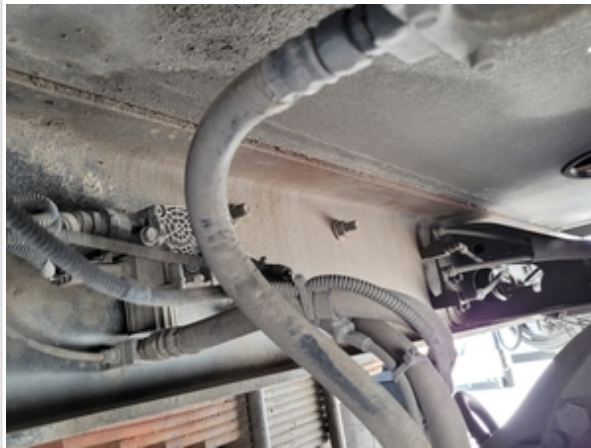
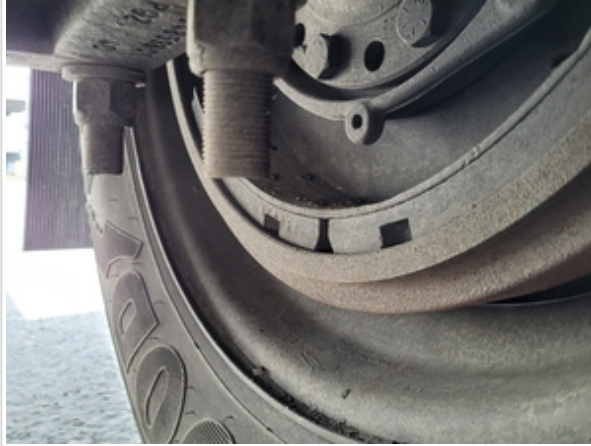
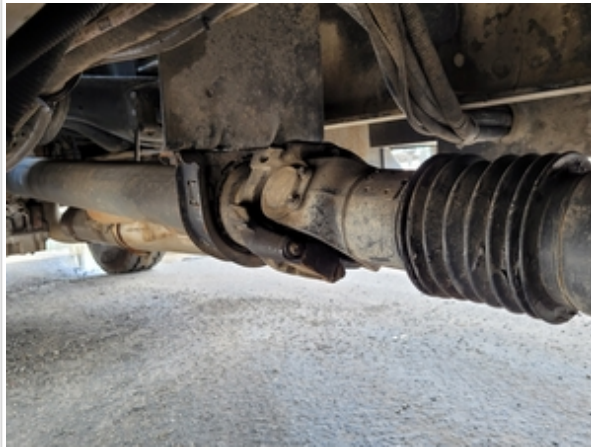
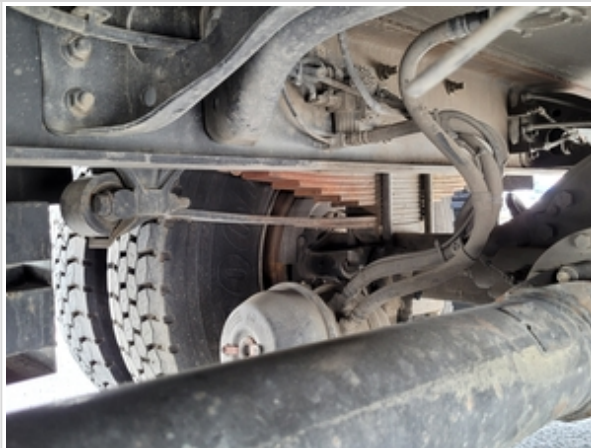
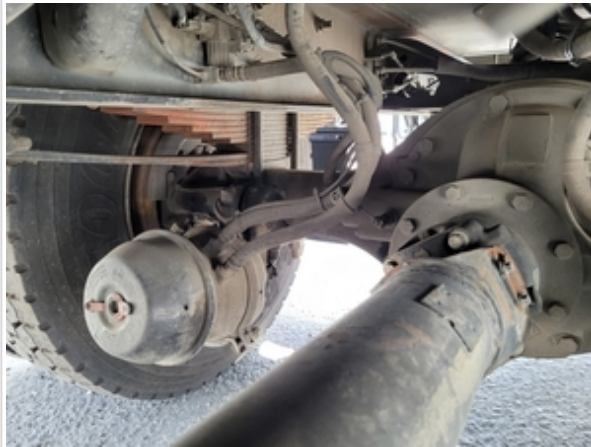
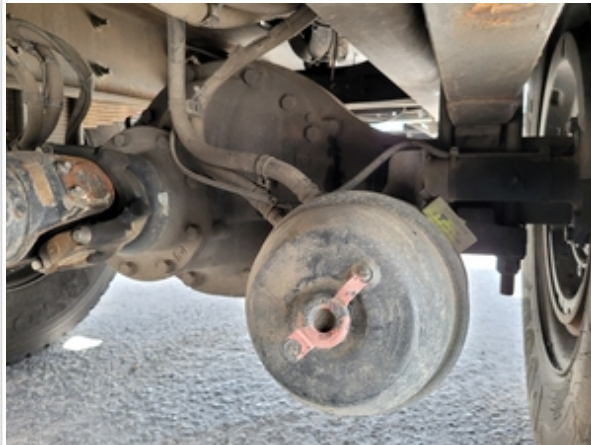
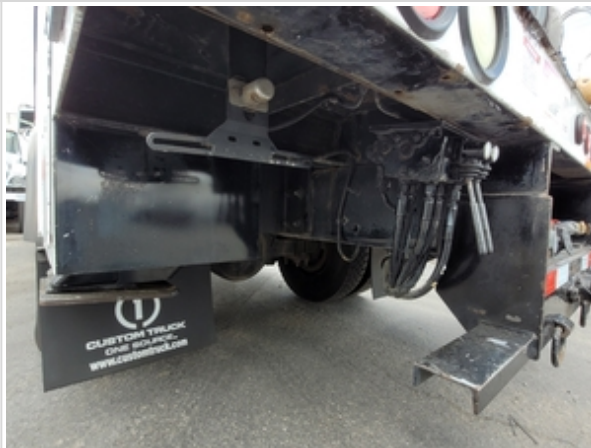
Chassis Inspection Points	Take photos of all undercarriage and chassis components including frame, suspension, axles, steering, and brake components. Note any damage or wear.	
Chassis & Undercarriage Photos

Frame	3 - Normal Wear & Tear
Suspension	3 - Normal Wear & Tear
Steer Axle Condition	3 - Normal Wear & Tear
Steering Components	3 - Normal Wear & Tear
Overall Chassis Condition	3 - Normal Wear & Tear
Overall Chassis Comments	Chassis in good shape. Font brake shoes not visible due to dust shields.

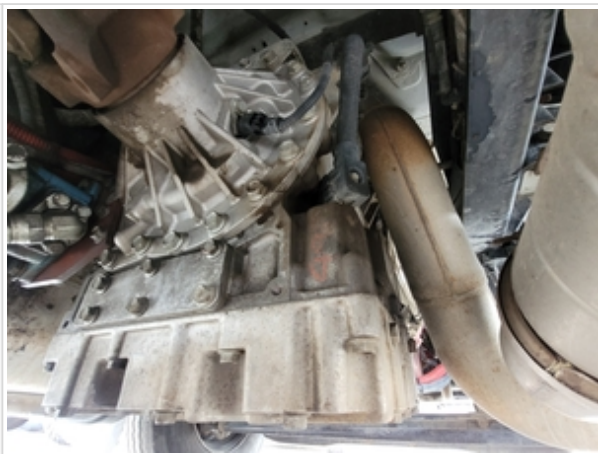
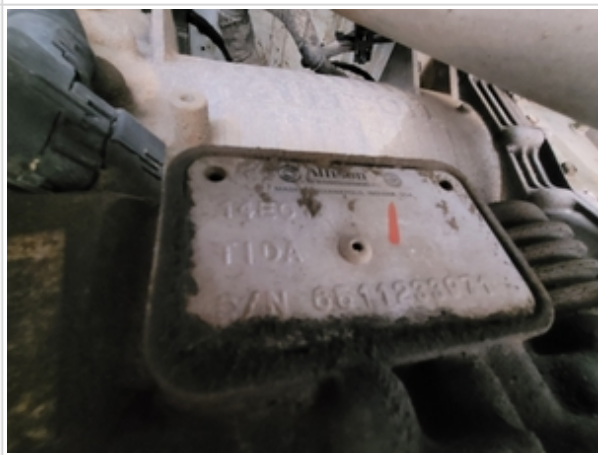
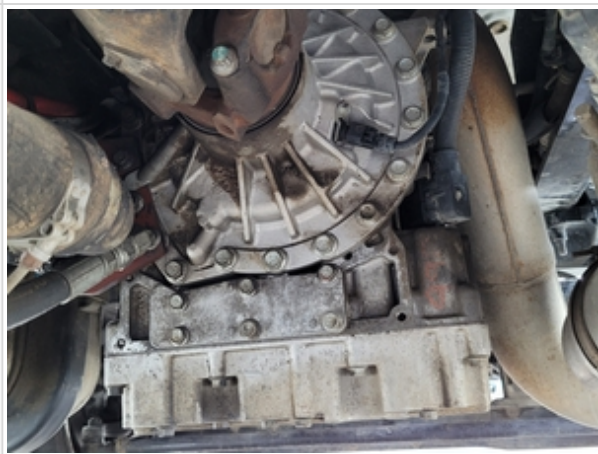
Transmission Info (Make/Model)	Allison 3000 - 5 Speed
Transmission	3 - Normal Wear & Tear
Transmission Condition	No unusual noises or vibrations
Transmission Condition Photos

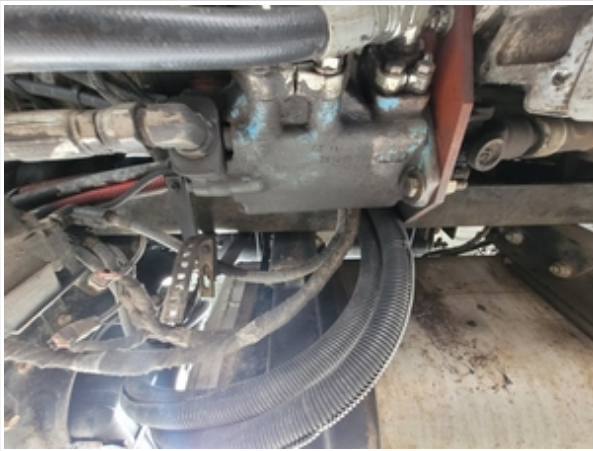
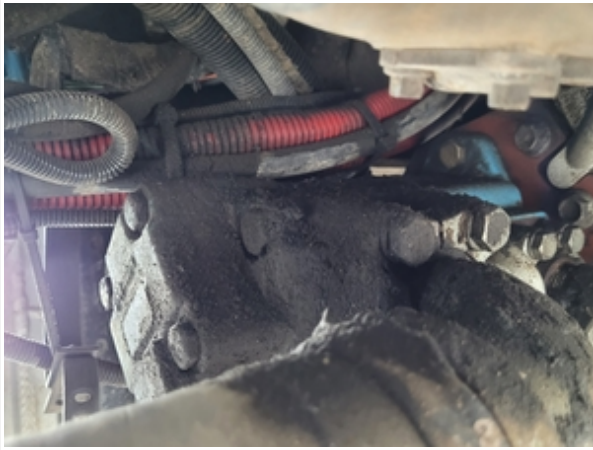
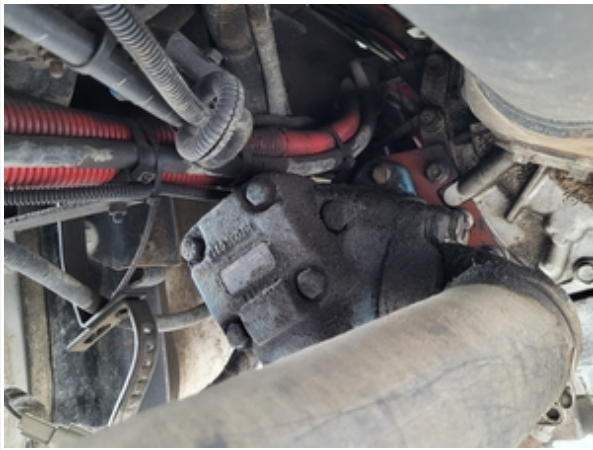
PTO Photos

PTO	3 - Normal Wear & Tear

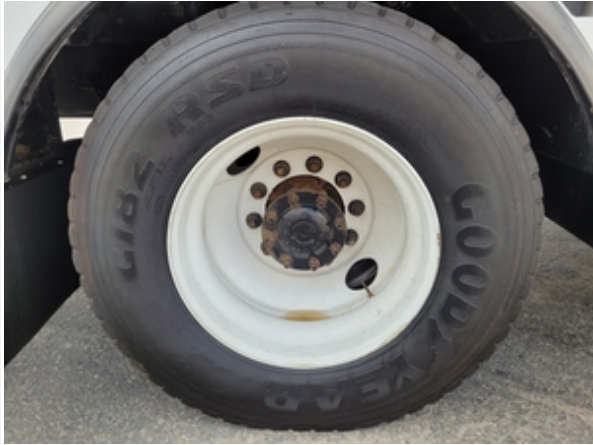
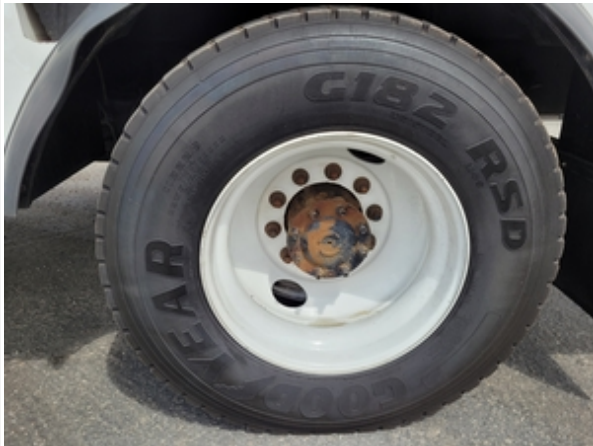
Wheels & Hub Condition	3
Wheels & Hub Photos

Wheel Seal Leaks	No
Tire Brand	Various Brands
Tire Size	11R 22.5
Front Left Tire - Ratio Remaining	30%

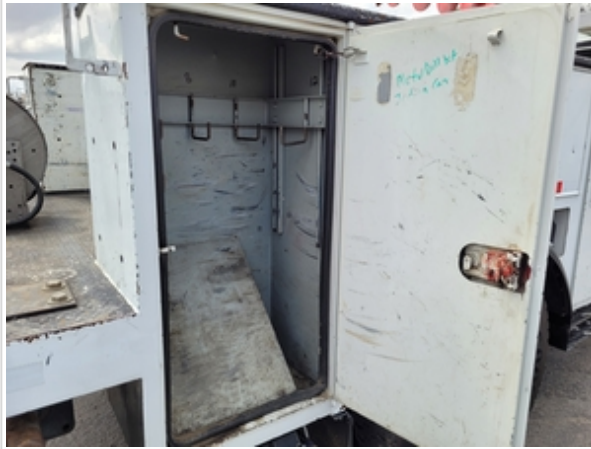
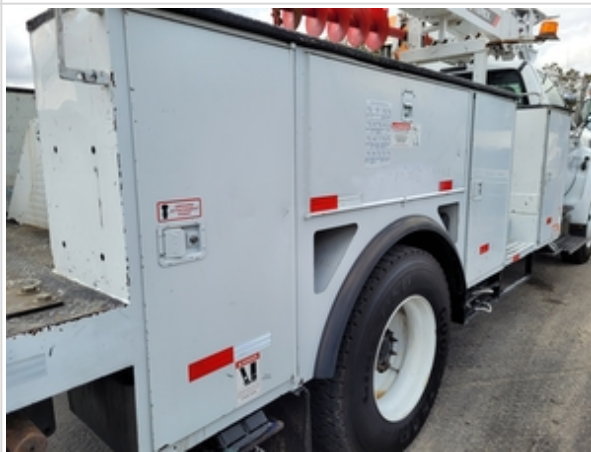
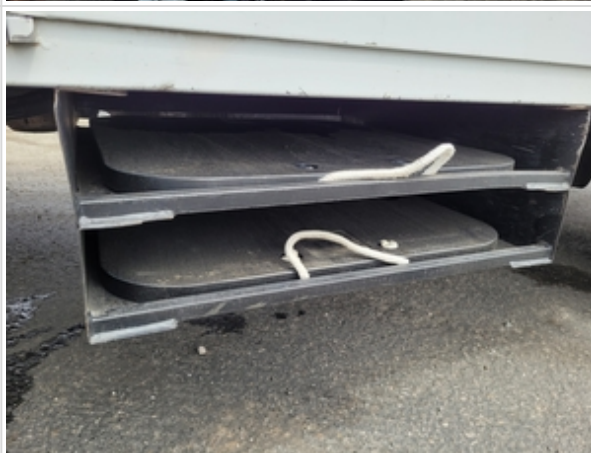
Bed Body Photos

Tool Truck Body	Check the condition of the tool truck bed body, tool boxes (interior and exterior), and lift gate (if equipped).
Bed Body	3

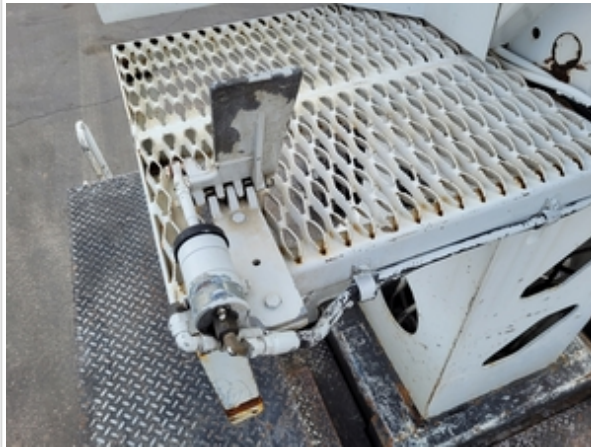
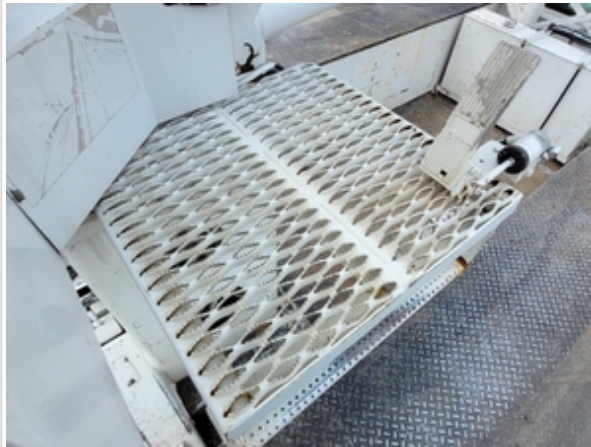
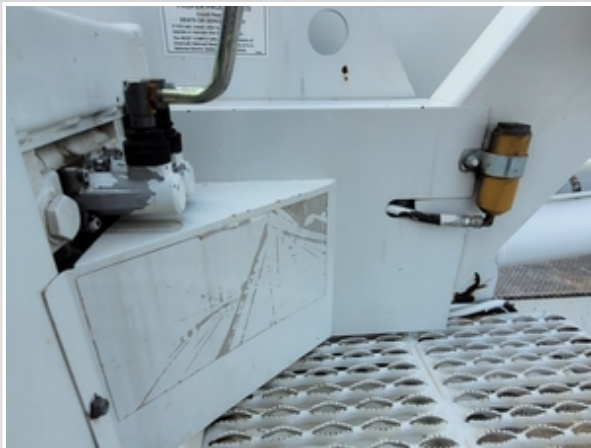
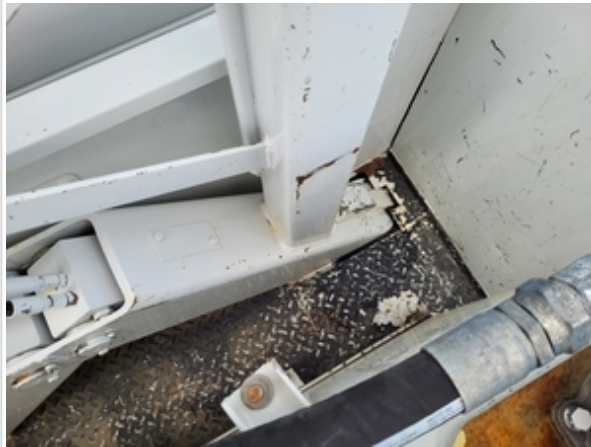
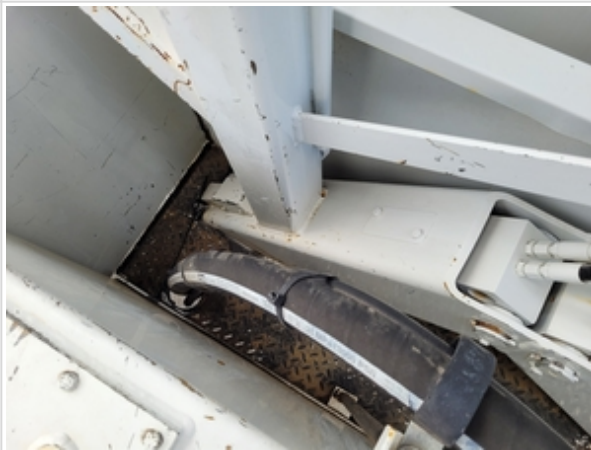
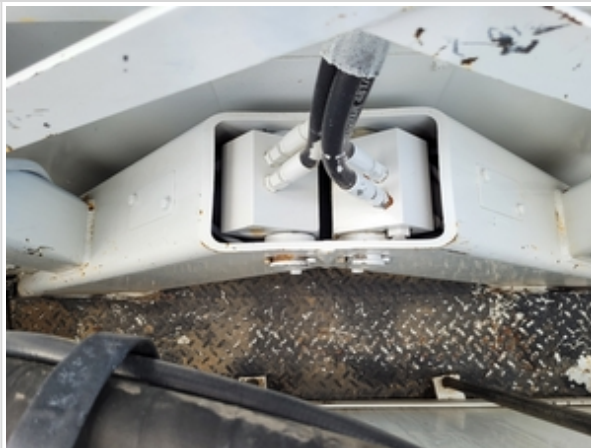
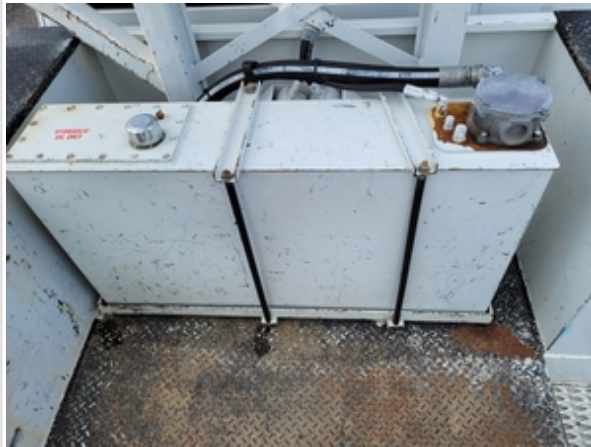
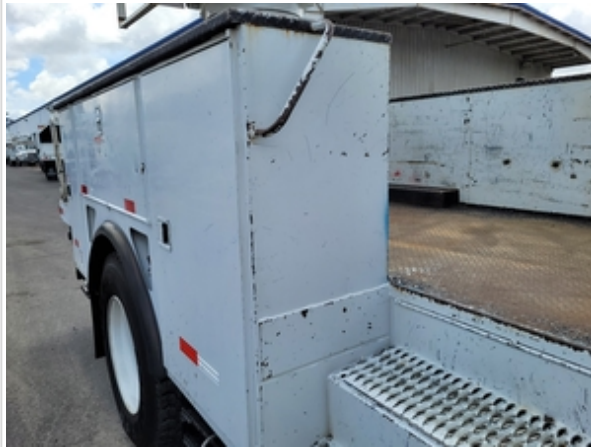
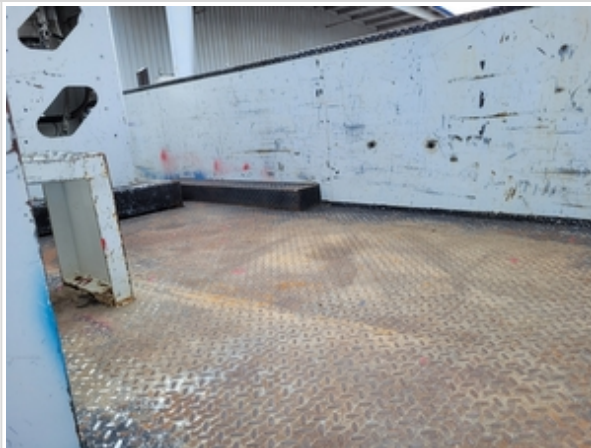
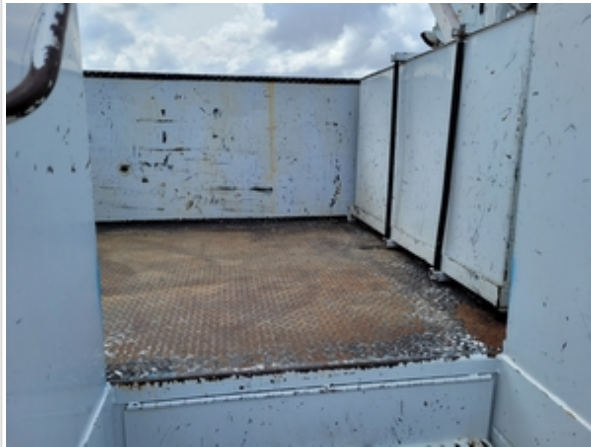
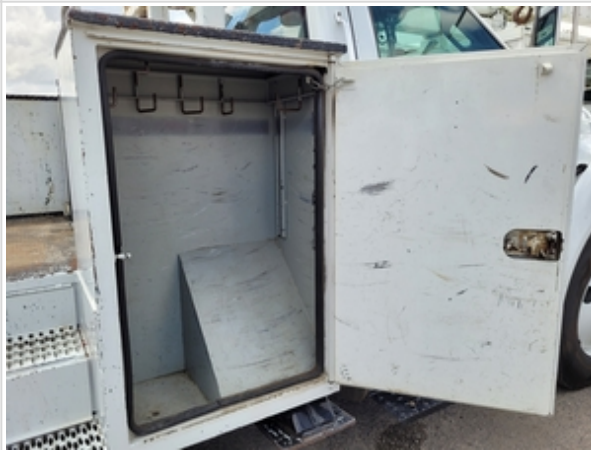
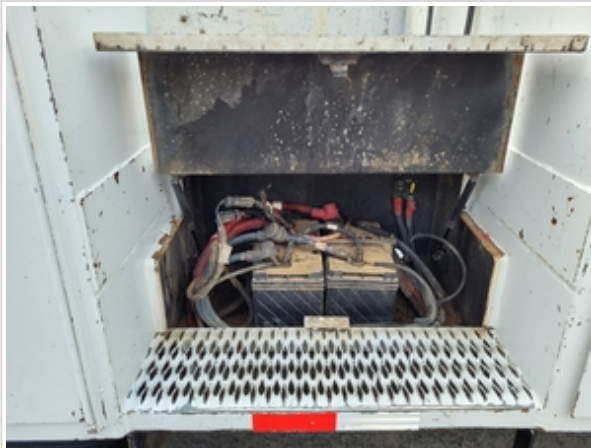
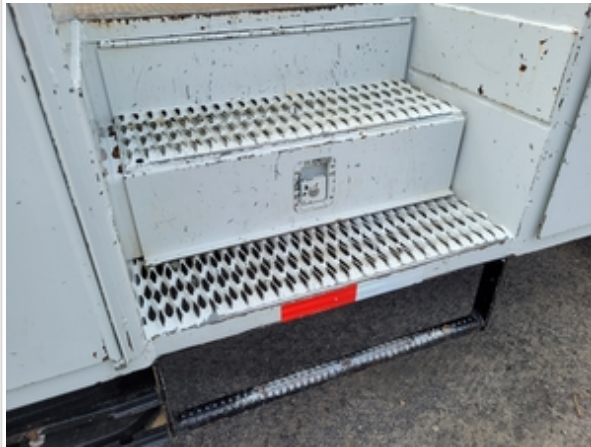
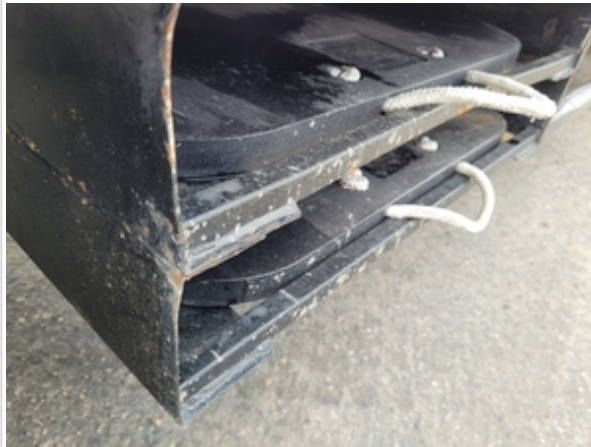
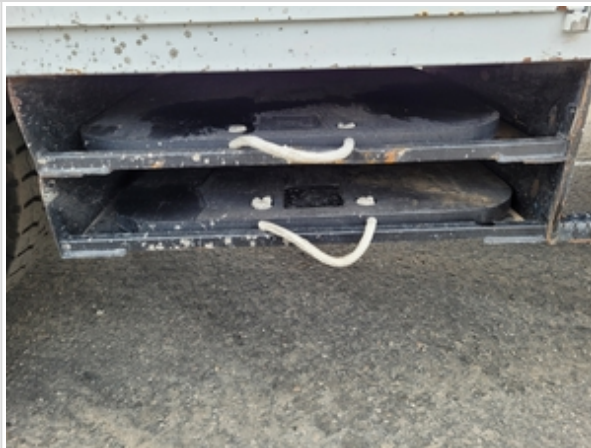
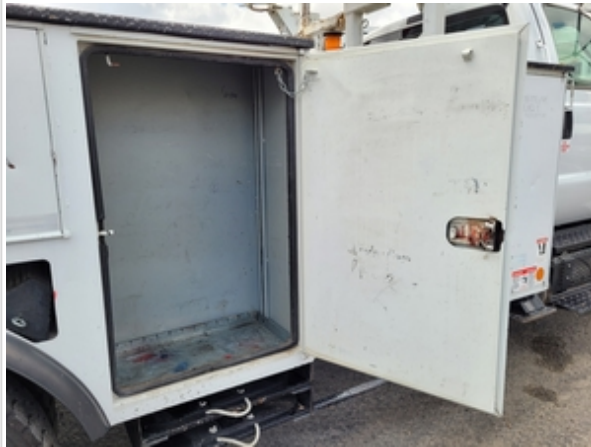
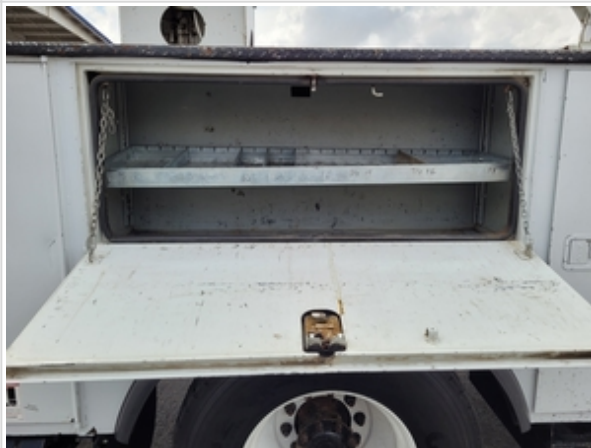
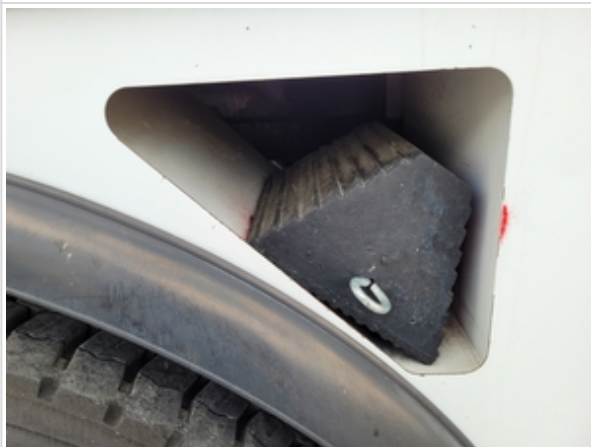
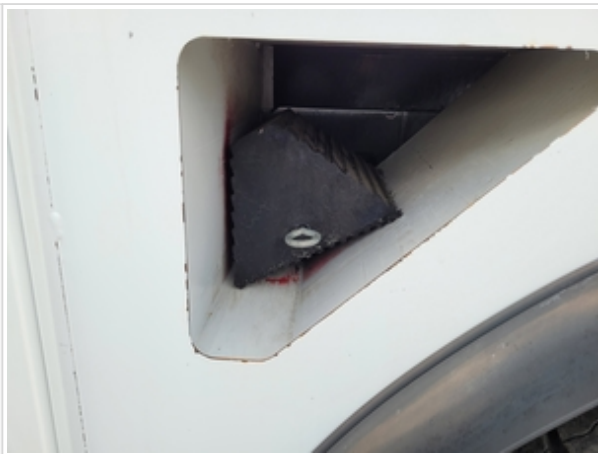
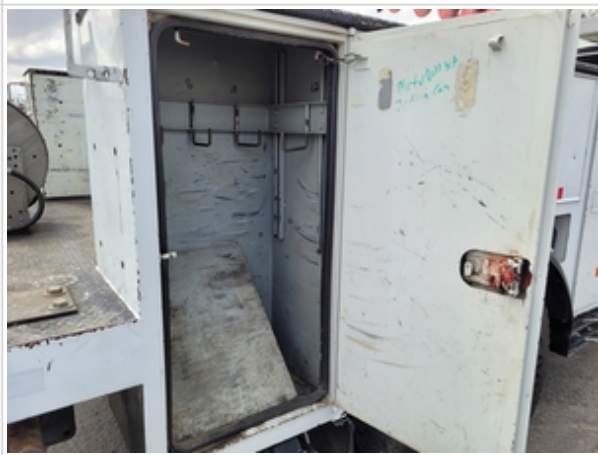
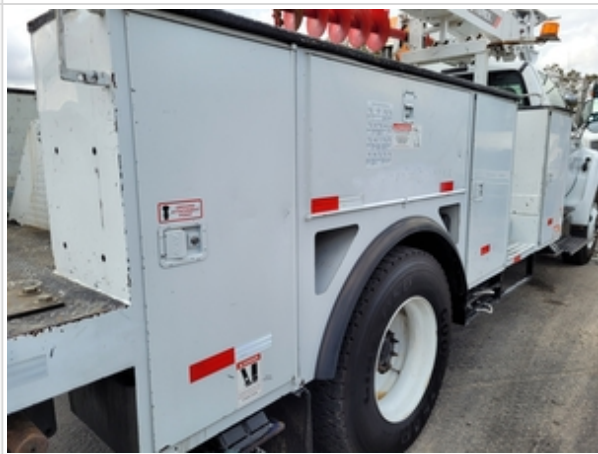
Toolboxes	3
