Inspection Report (On-Highway Service Truck)

Year	2015
Make	Ford
Model	F750
Serial Number	3FRXF7FK9FV639995
Truck Odometer Reading	78,711
Current Inspection / State Cert / DOT	Last Inspected 8/2022
Previous Application (e.g., earth moving, mining, demolition, etc)	Underground Utility

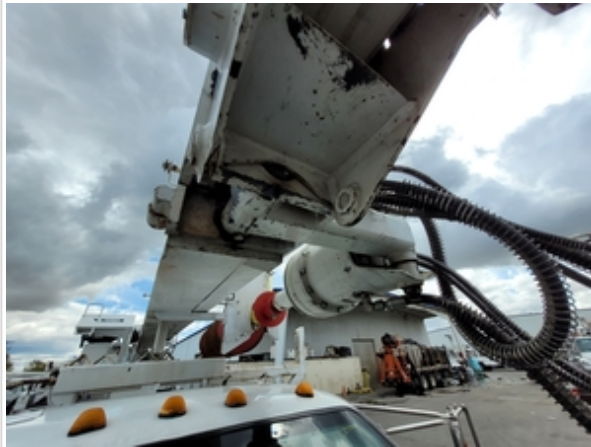
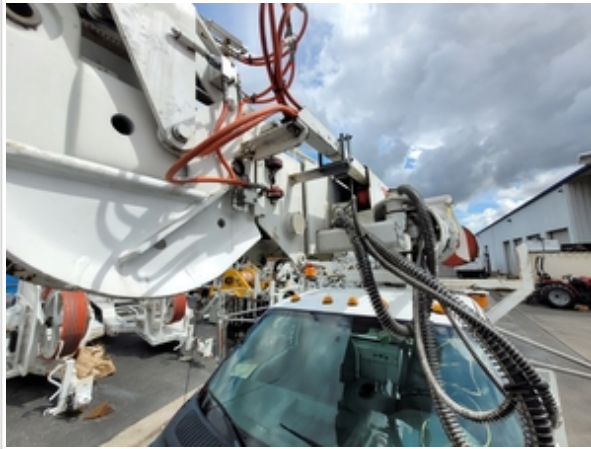
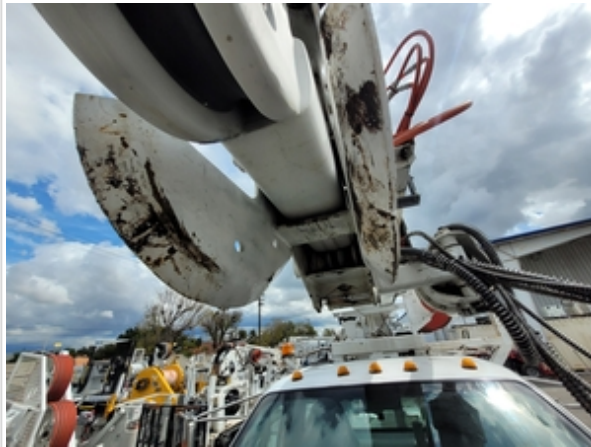
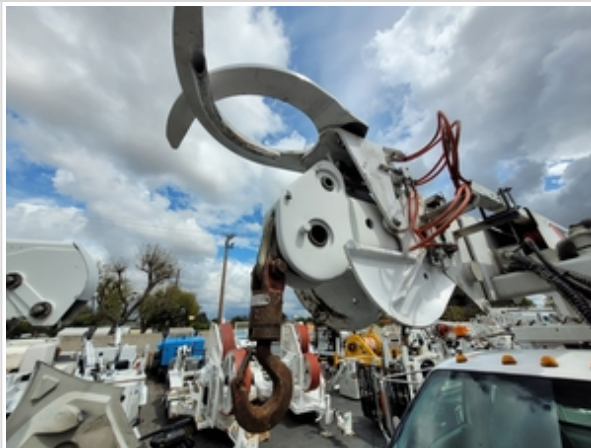
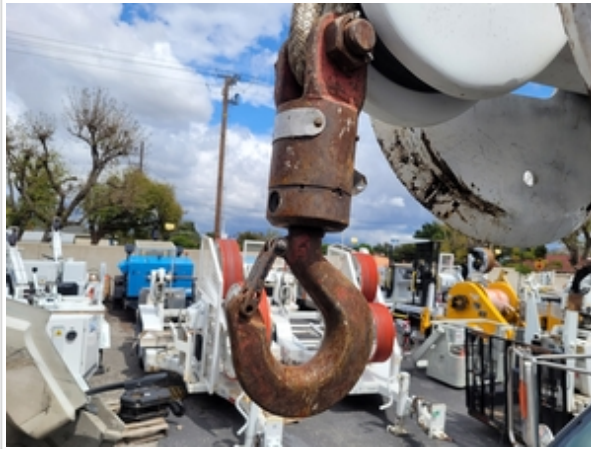
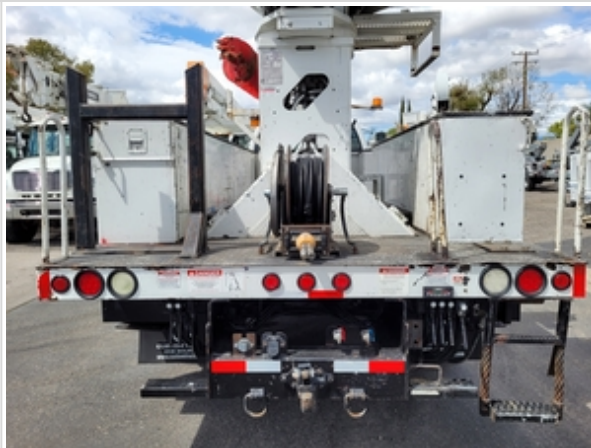
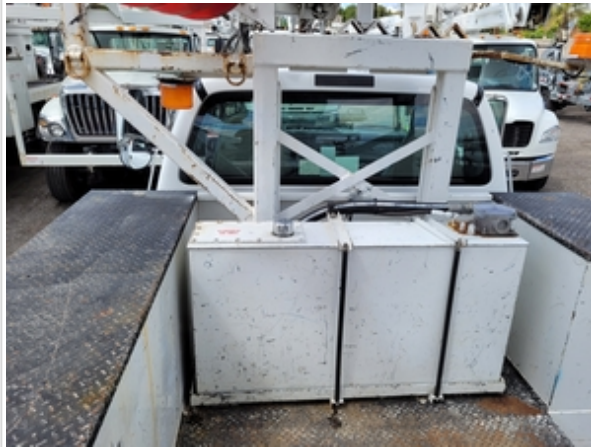
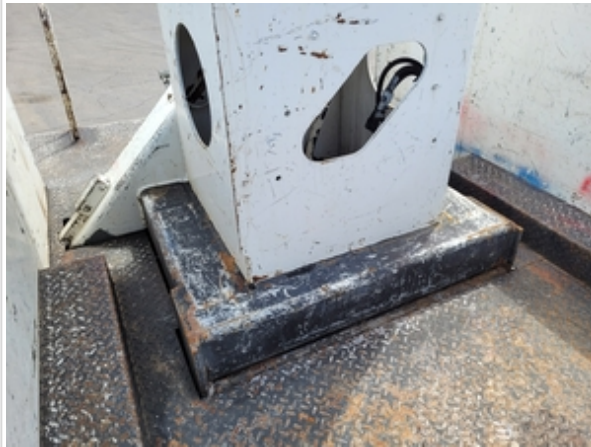
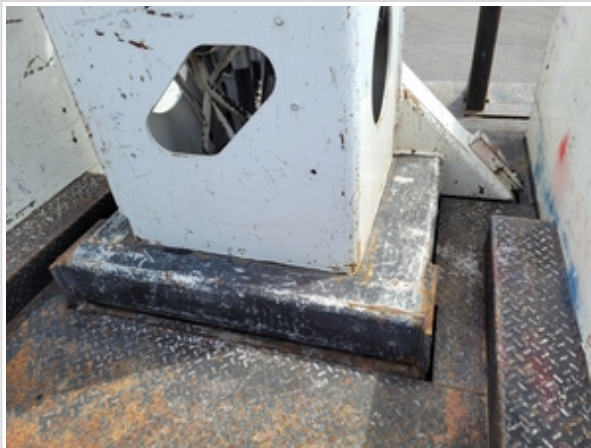
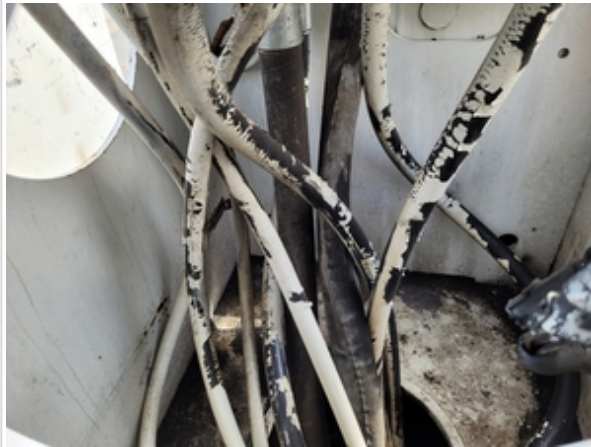
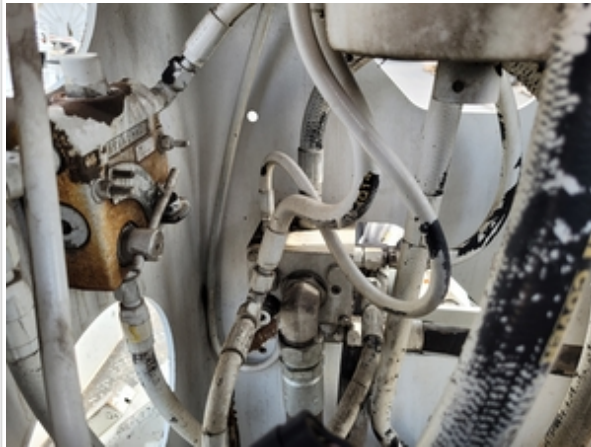
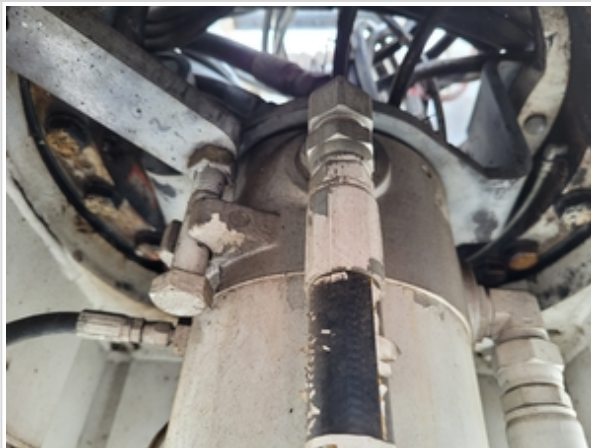
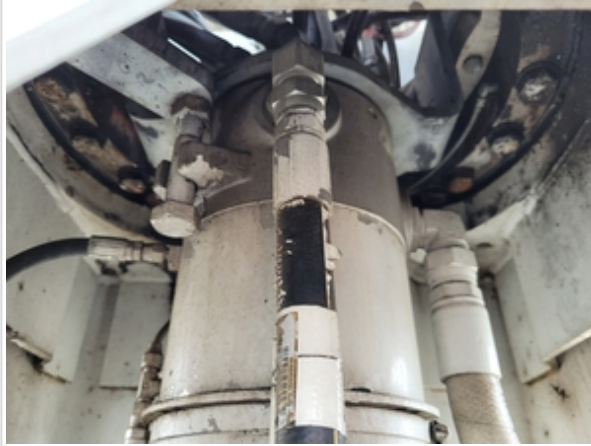
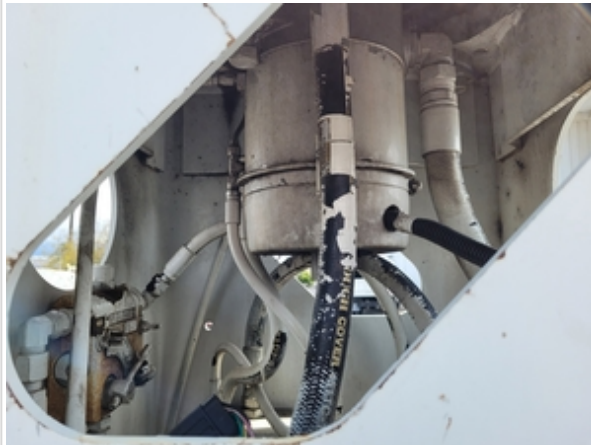
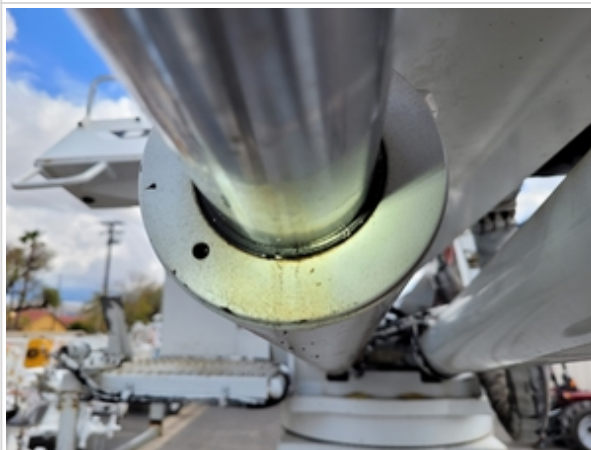
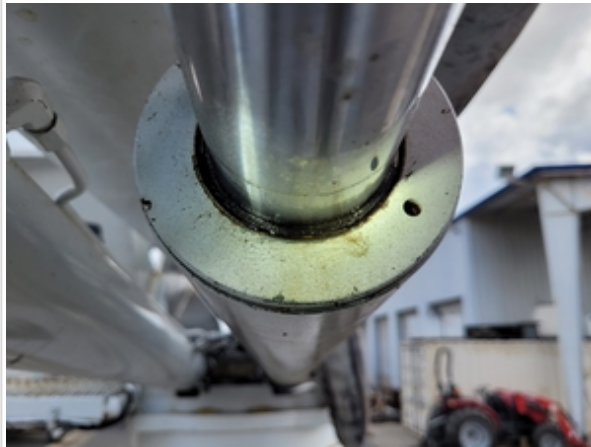
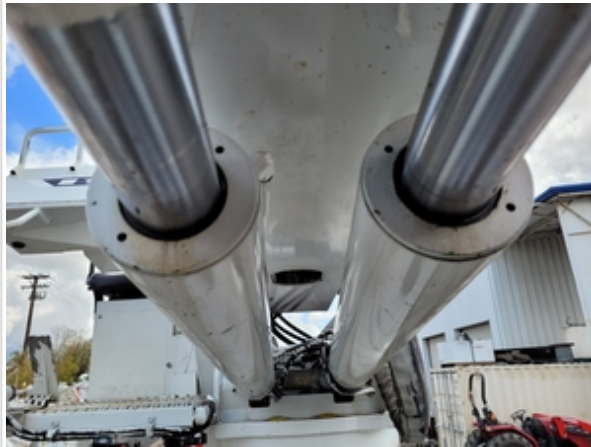
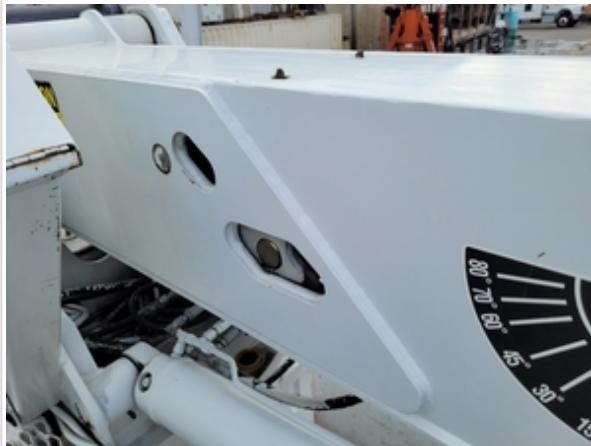
Crane Photos

Crane Condition	3 - Normal Wear & Tear
Crane Functionality	Operating as expected

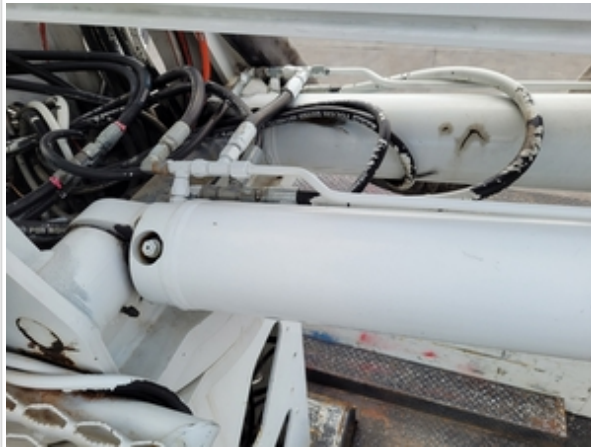
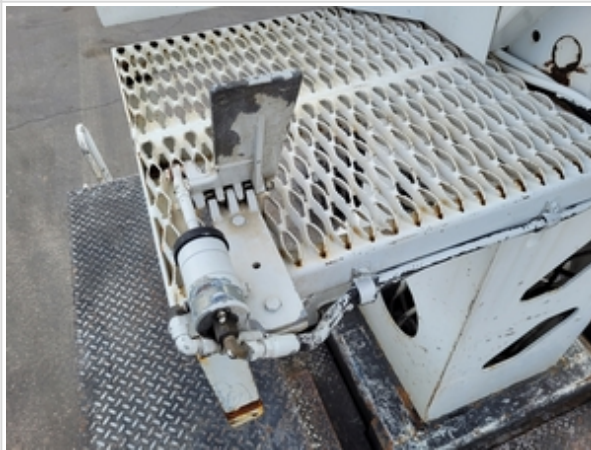
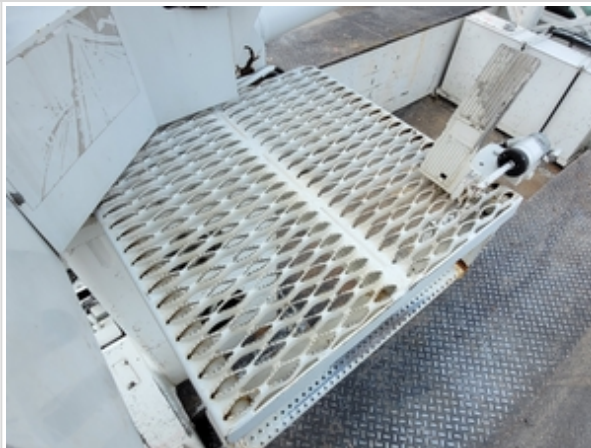
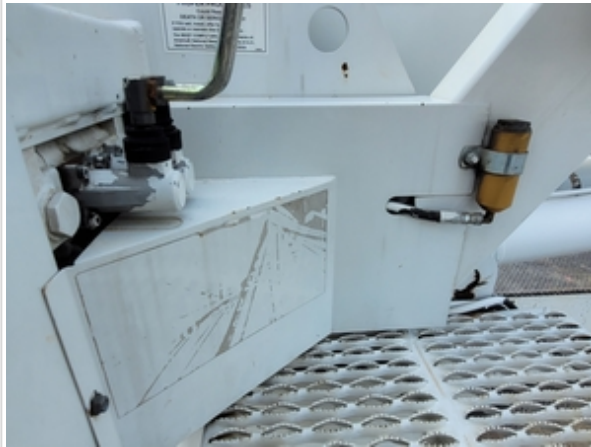
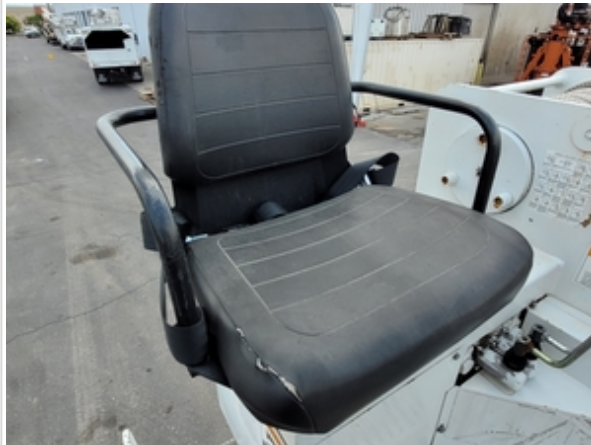
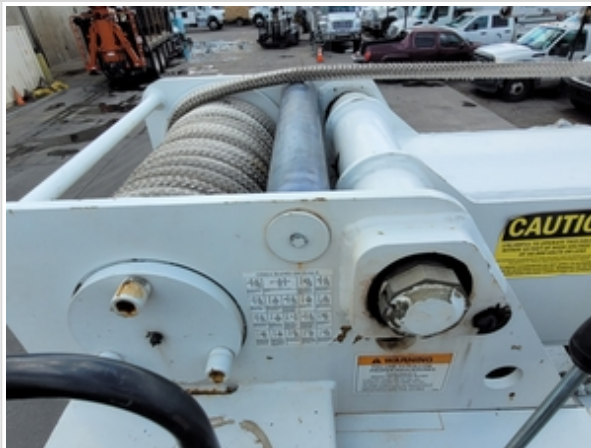
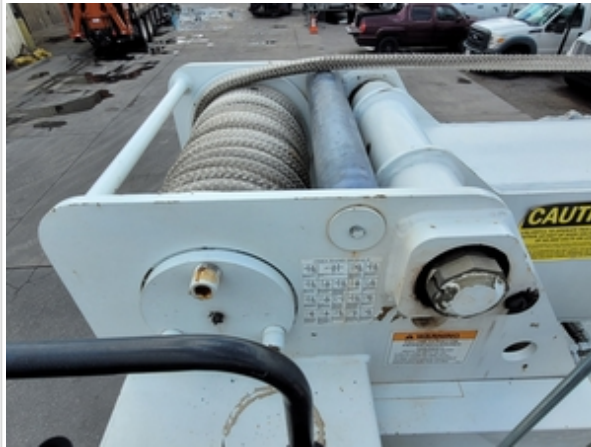
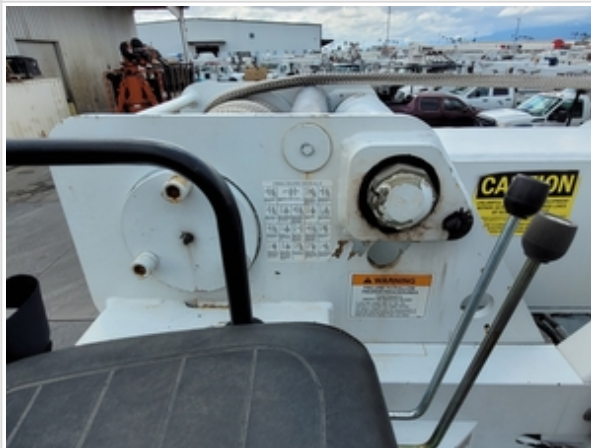
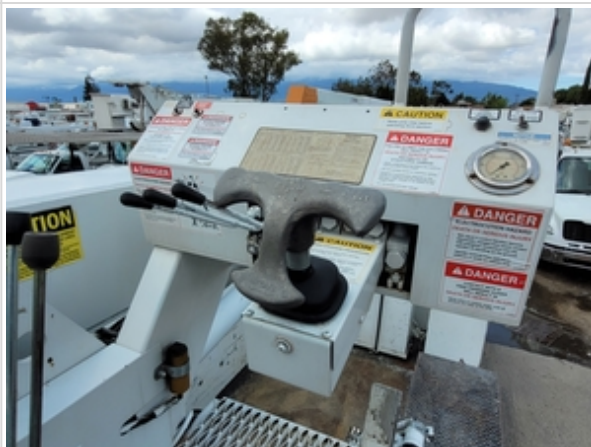
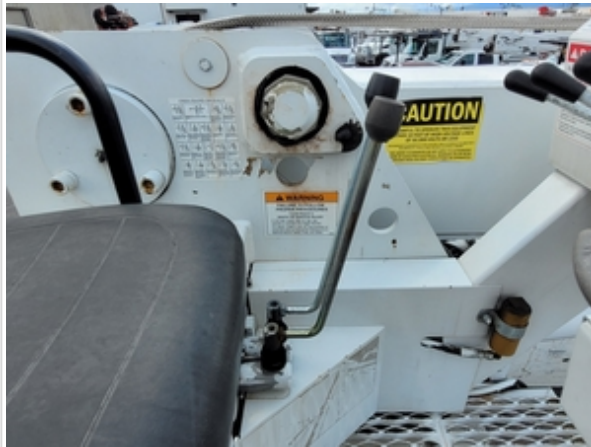
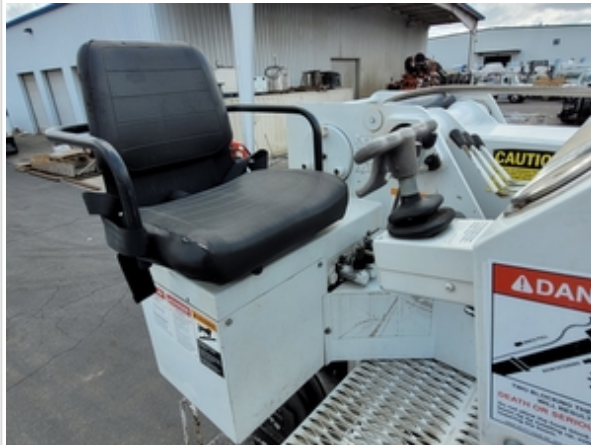
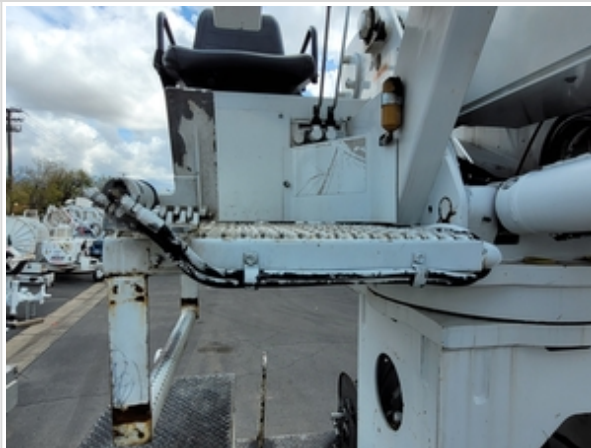
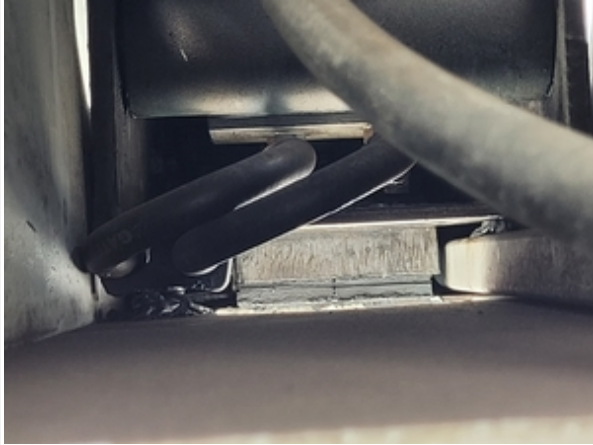
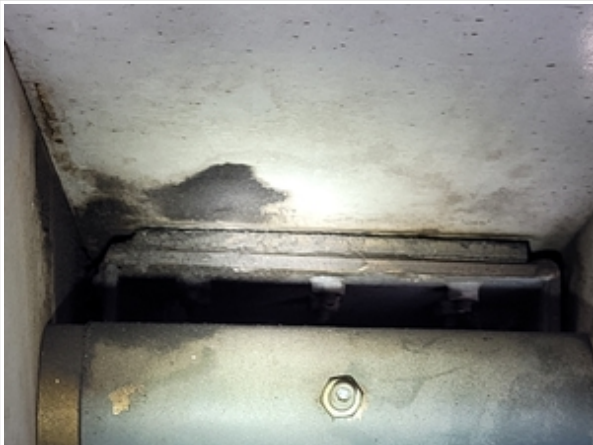
Stabilizer Jacks Condition	3 - Normal Wear & Tear	
Stabilizer Jacks Functionality	Operating as expected
