Enterprise Equipment Inspection

Category	Excavator
Travel System	Track Undercarriage
Comments	
Year	2017
Make	Takeuchi
Model	TB290
Fleet ID	10618512
Serial Number	185104456
Serial Number Plate

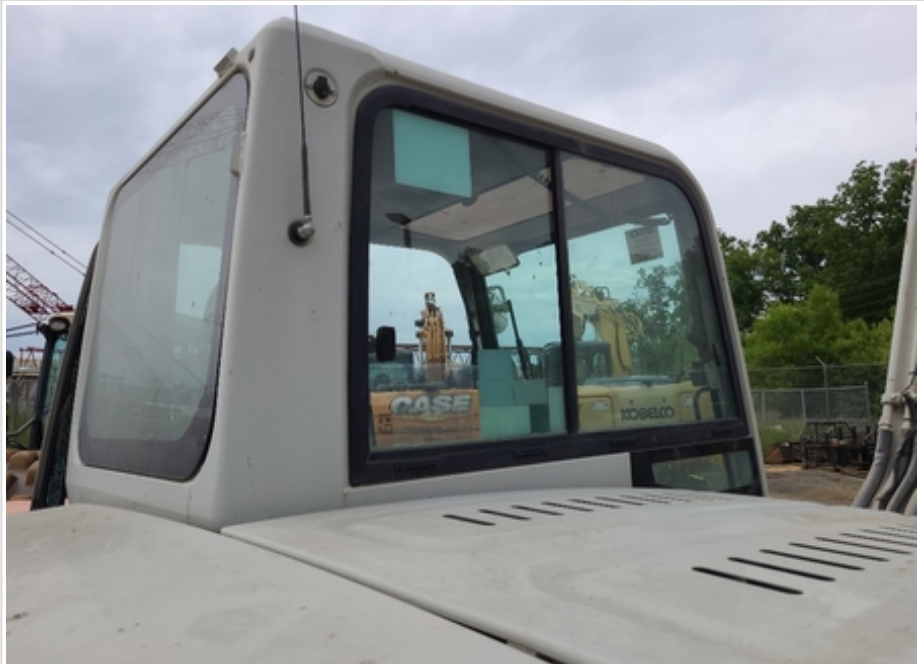
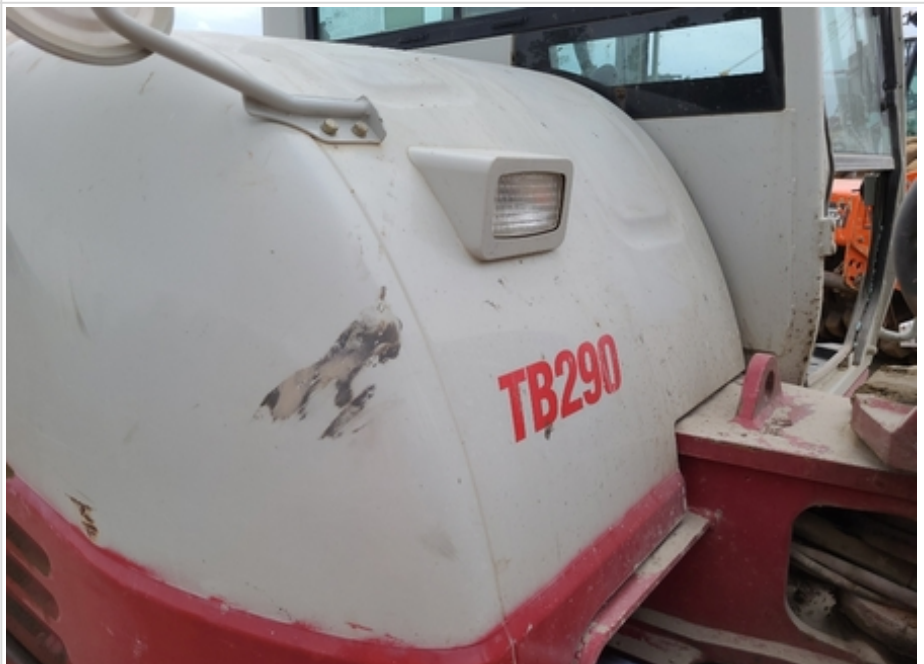
Exterior Rating	3 - Normal Wear & Tear
Exterior Comments	Door and 2 broken windows will be replaced, machine will be washed prior to sale.

What Needs Work	Camera cracked, fuel tank needs new cap, door and front bottom window needs replacement.	
Any Additional Info from the Seller?		
Date/Time	05-16-2023

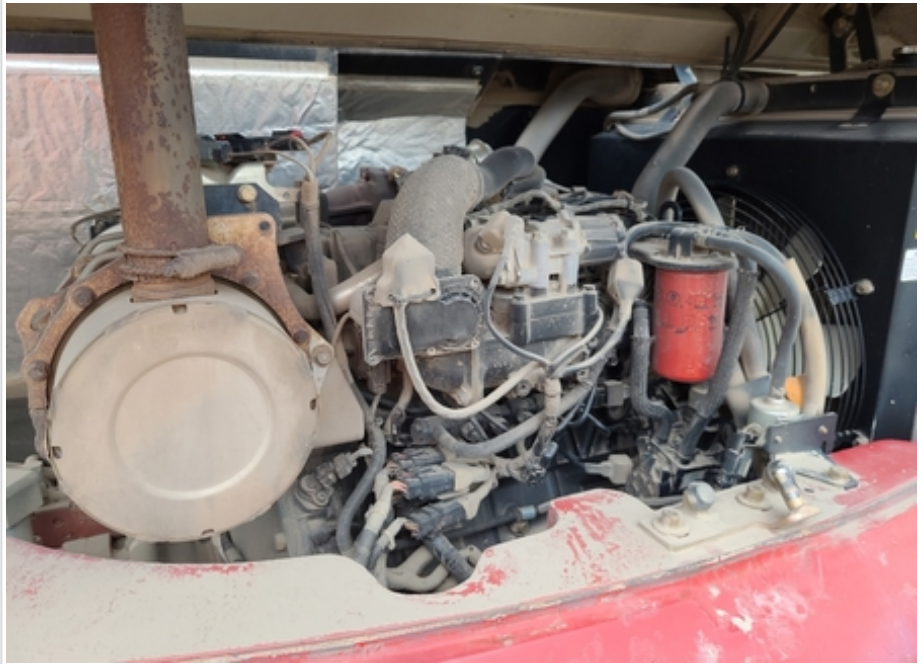
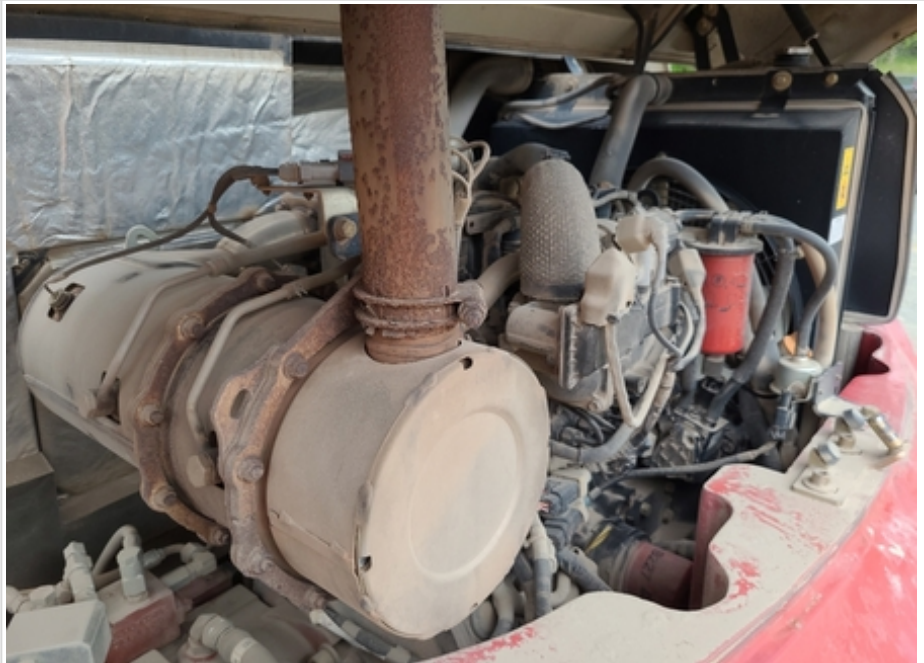
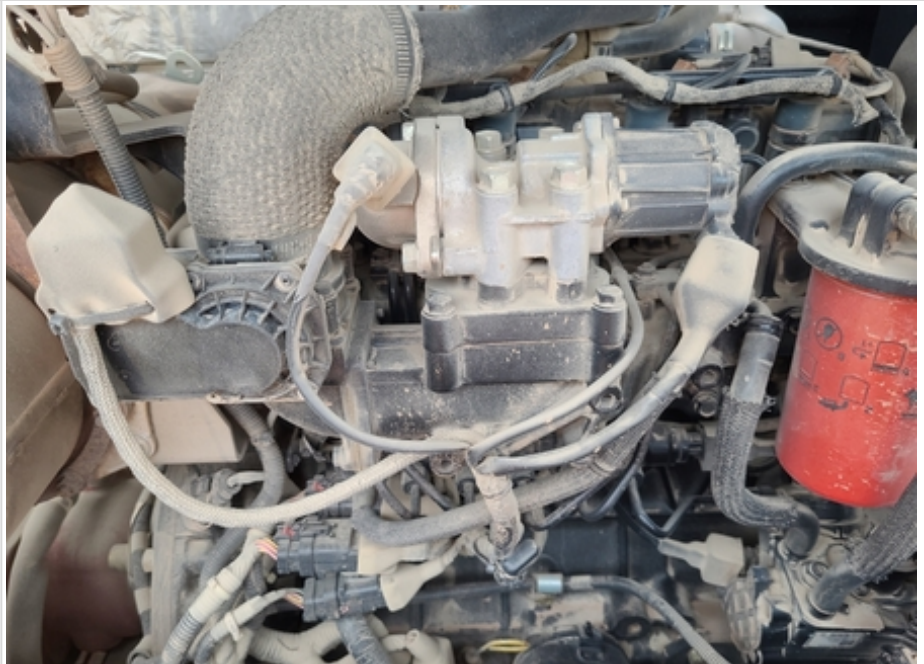
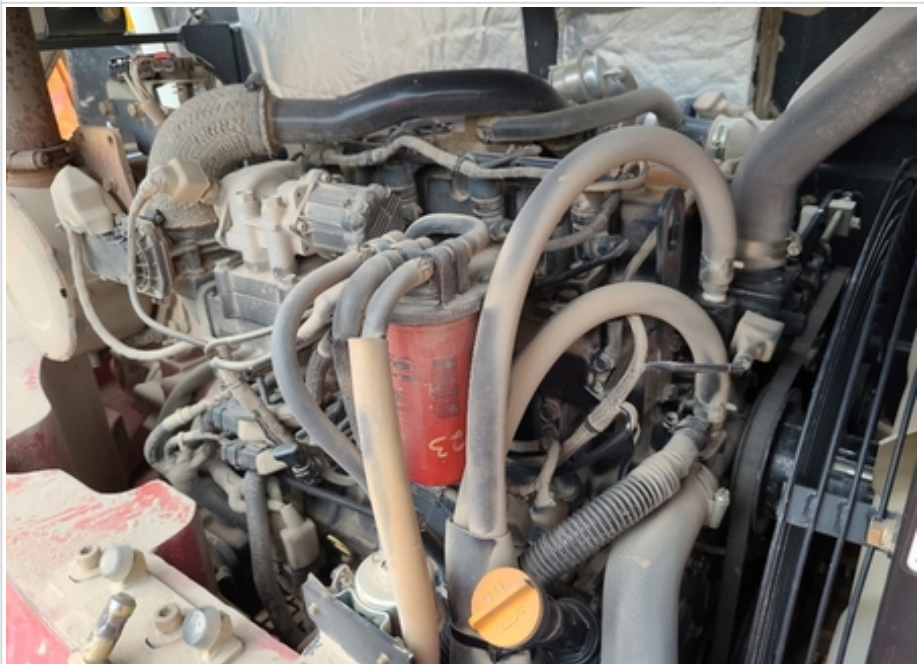
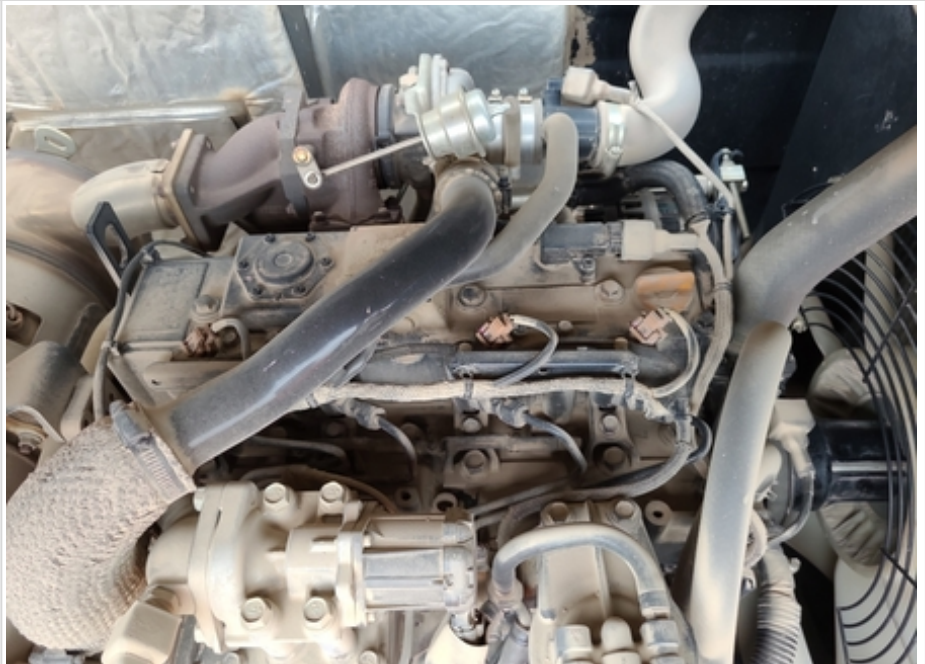
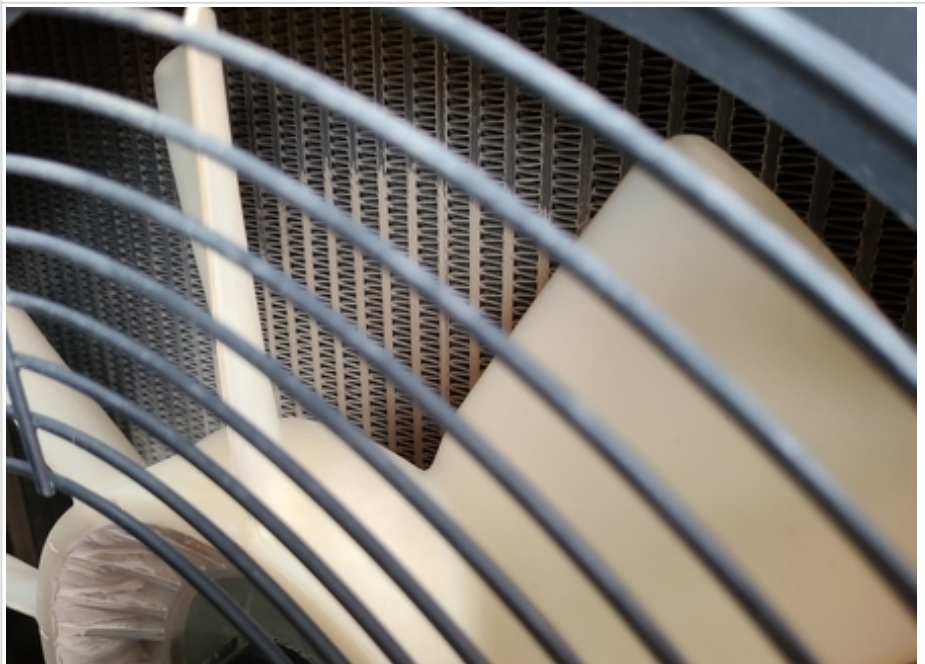
Engine Compartment

Engine Type (Make, Model, Cylinders, Hp)	Yanmar - 4Cyl. - 3.3L - 74HP
Emissions Tier	Tier 4F
Engine Rating	3 - Normal Wear & Tear
Engine Overall Comments	Engine fuel tank cap missing,

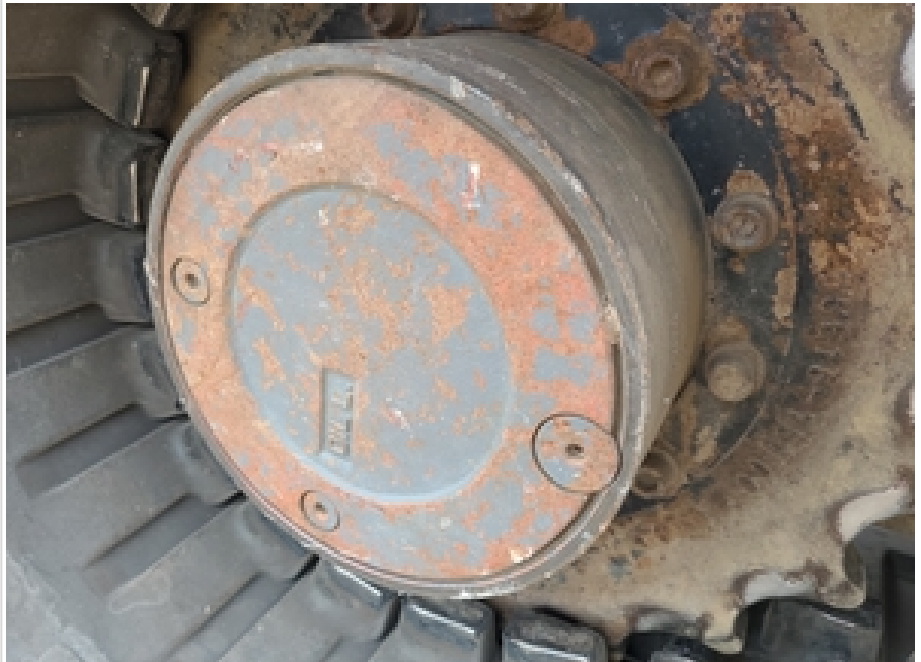
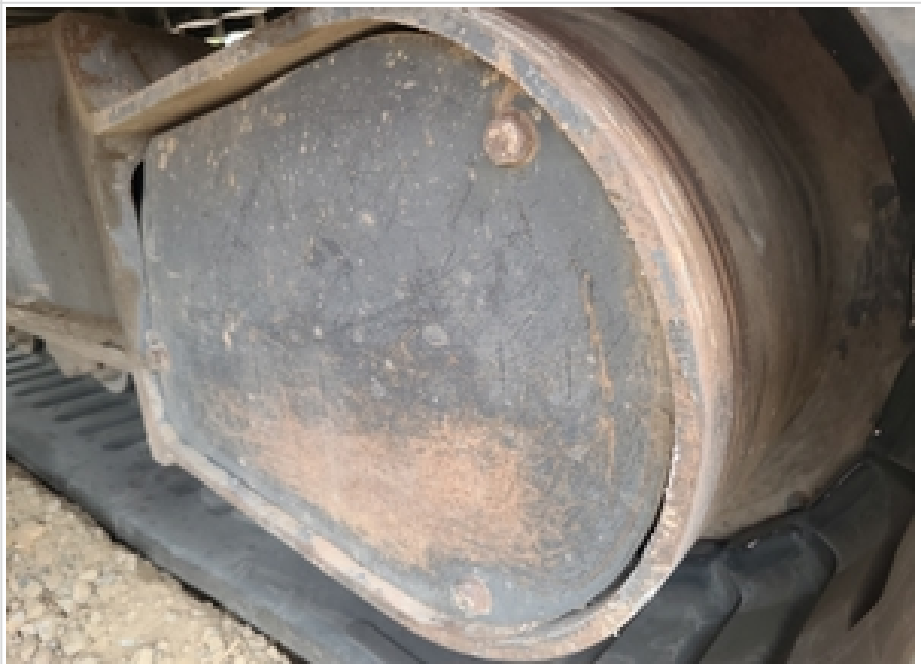
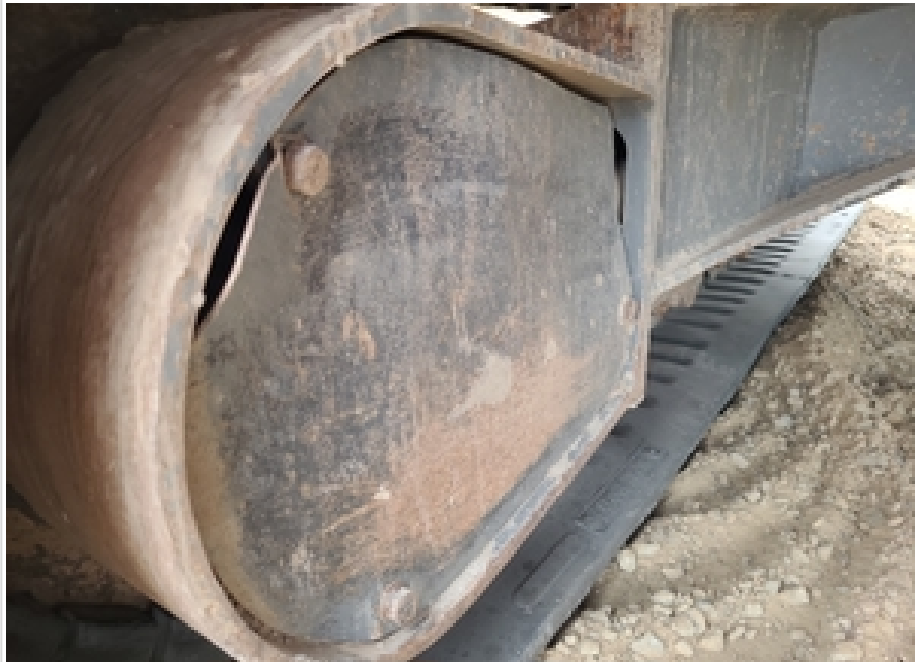
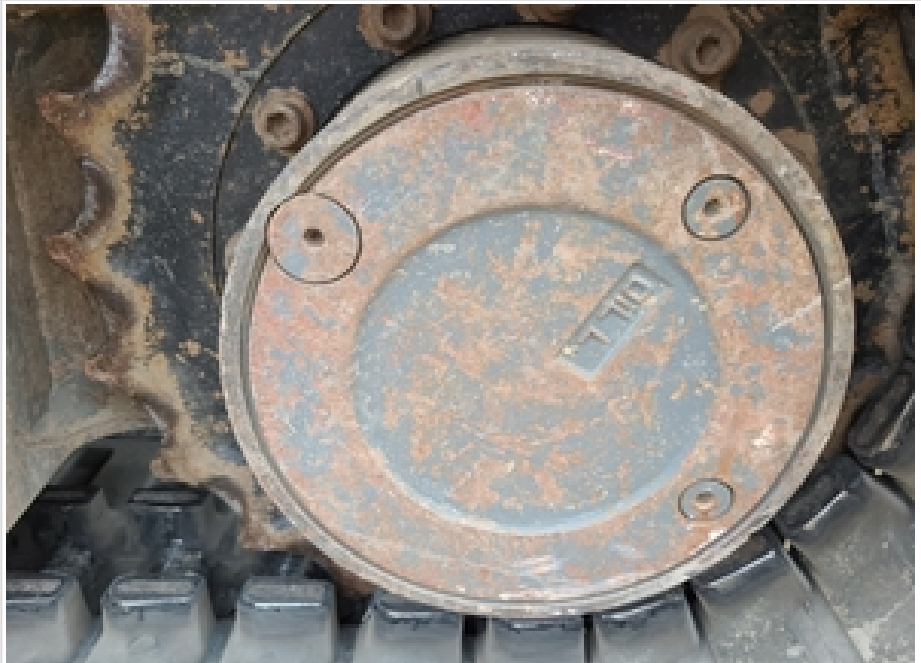
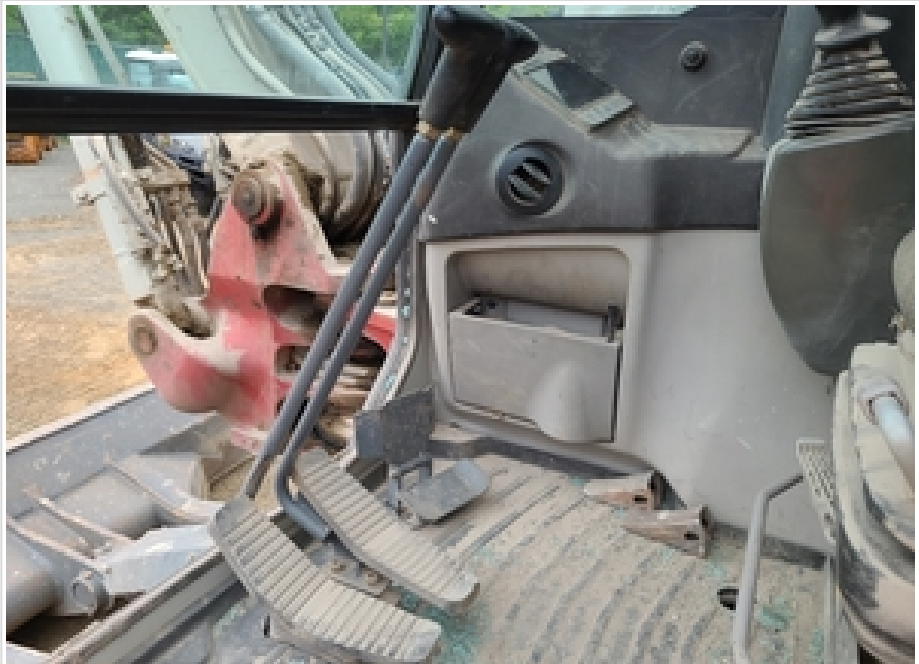
Drivetrain Photos

Hydrostatic Transmission?	Yes
2 Speed?	Yes
Hydrostatic Drive Configuration	Split Transmission
Comments	
Transmission Info (Make/Model/Speeds)	
Drivetrain Rating	3 - Normal Wear & Tear
Drivetrain Comments	Drivetrain in good shape with all travel functions working in all directions.

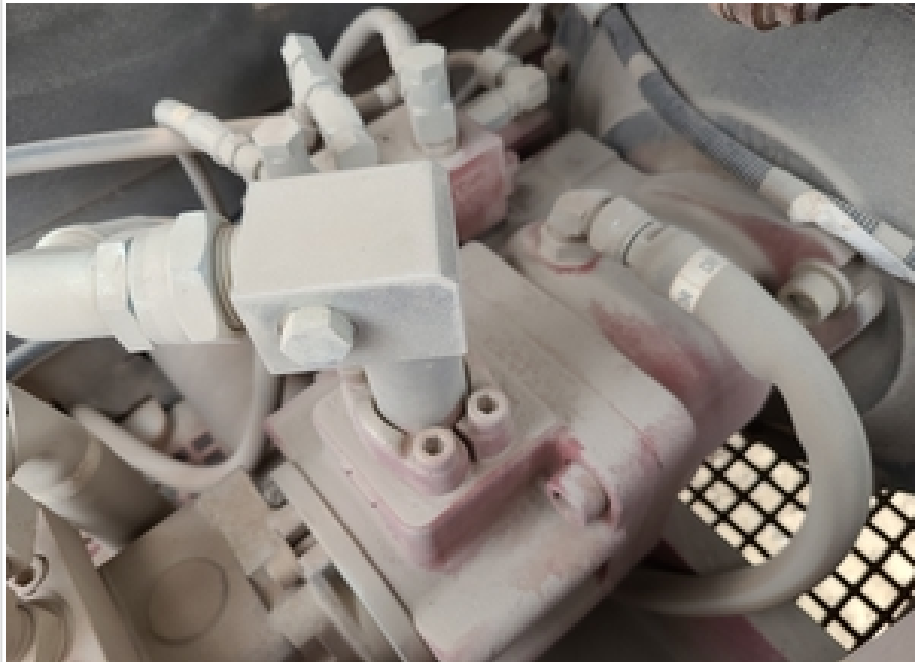
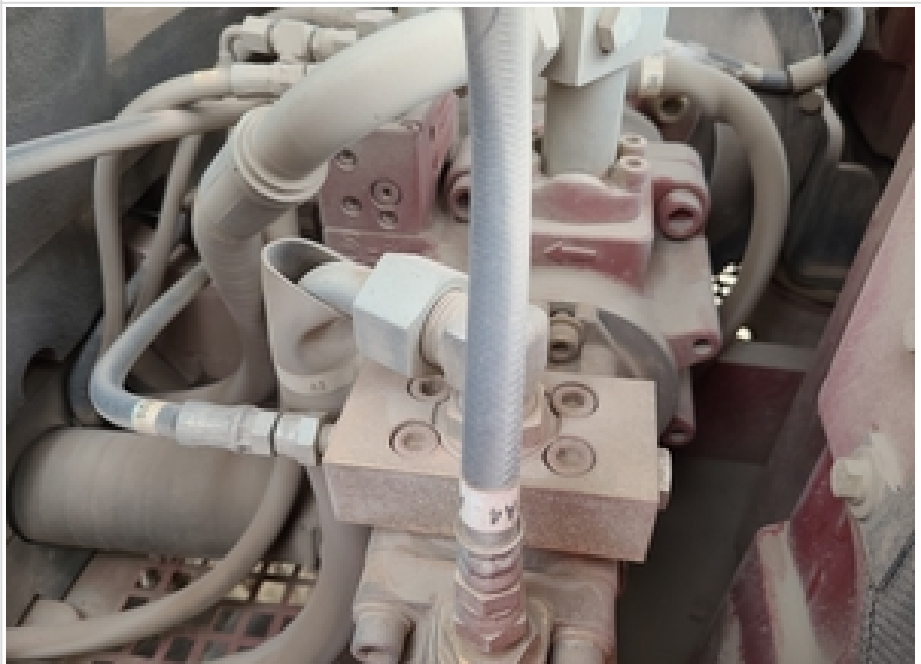
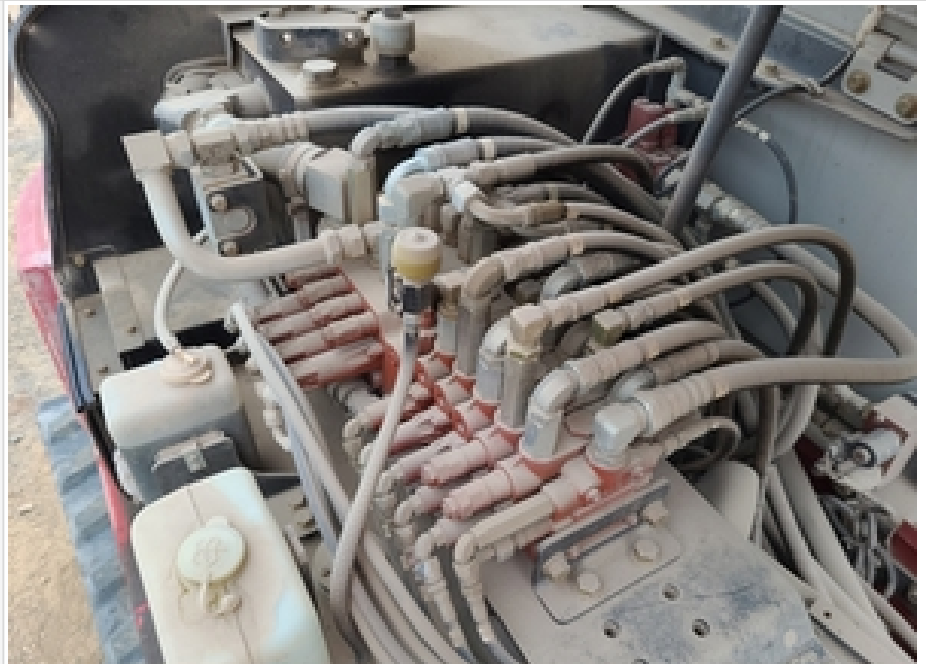
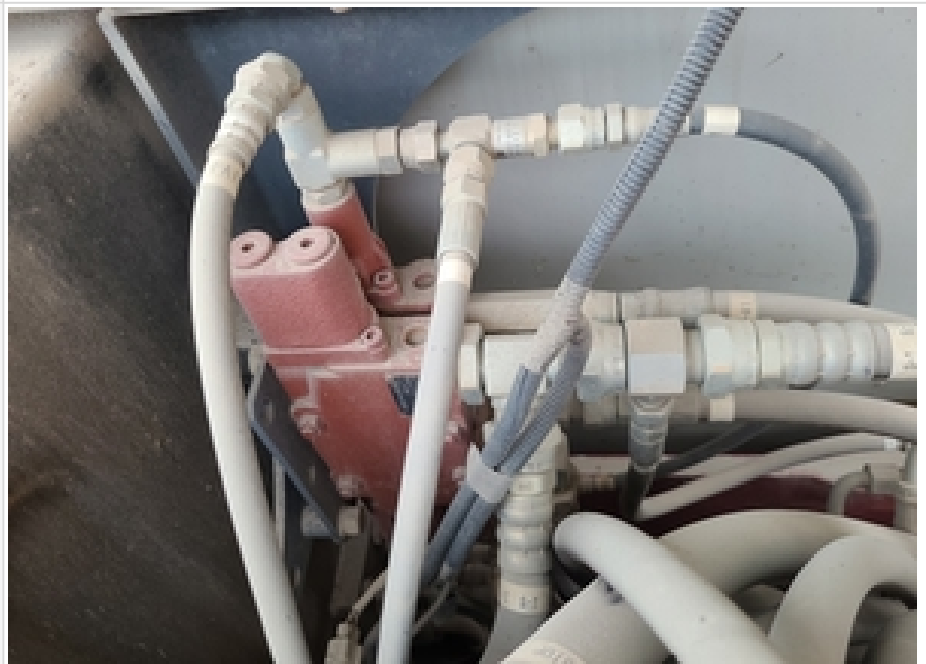
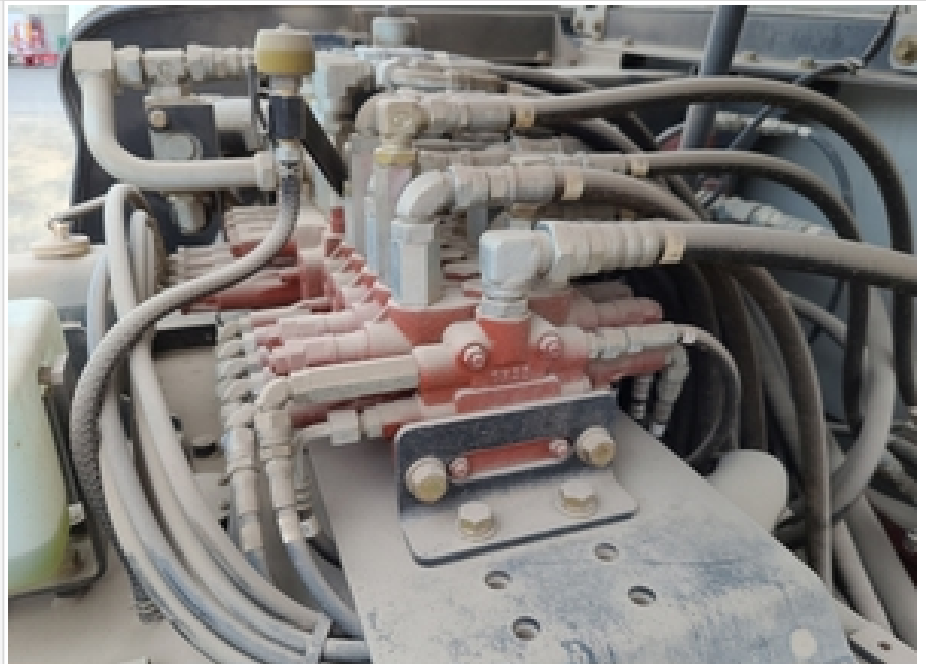
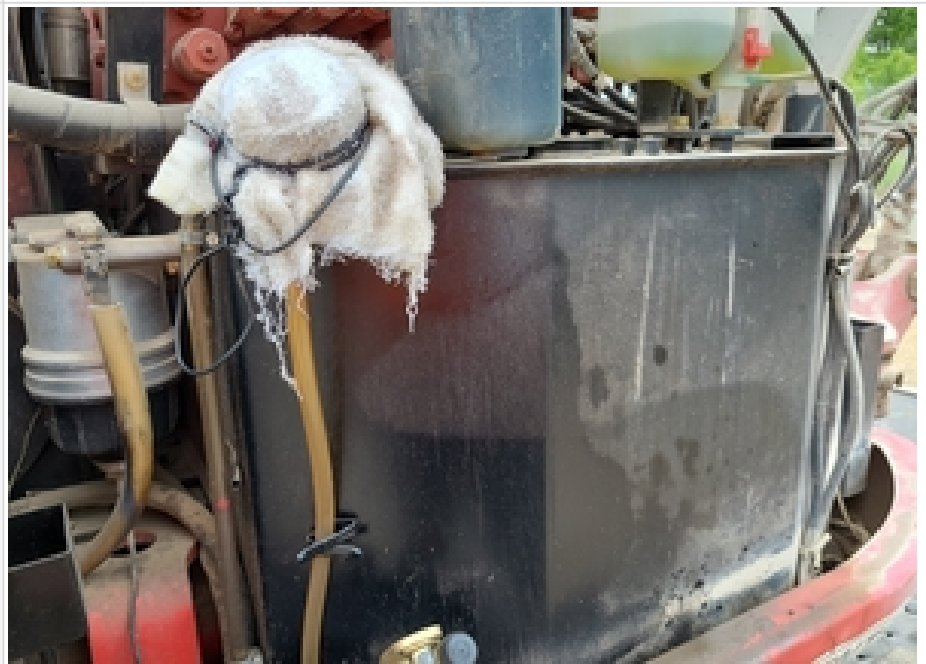
Hydraulic Pump/Fittings/Hoses

Hydraulic System Rating	3 - Normal Wear & Tear
Hydraulic System Comments	Hydraulic System in good working condition with no active leaks observed.

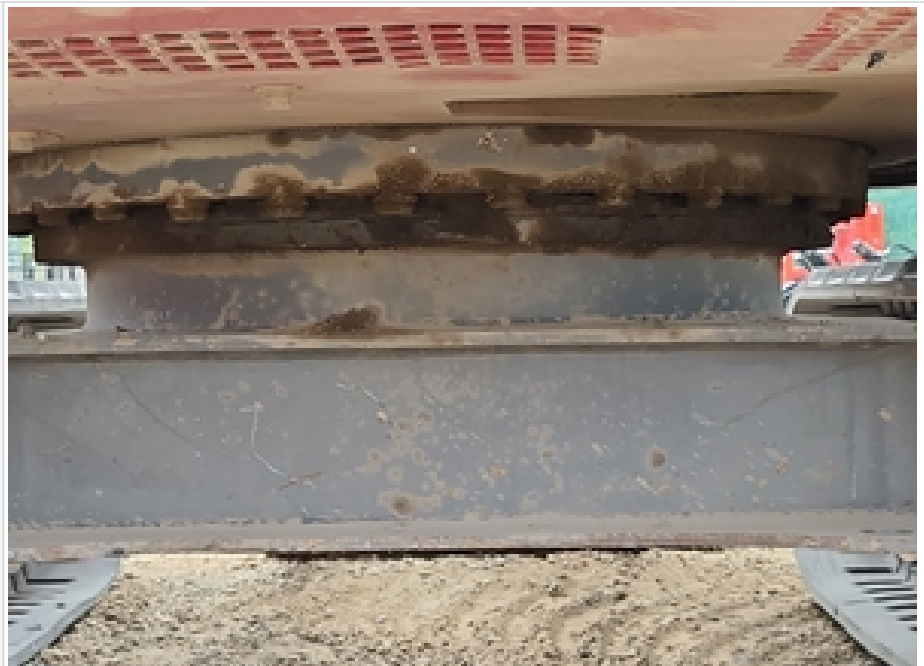
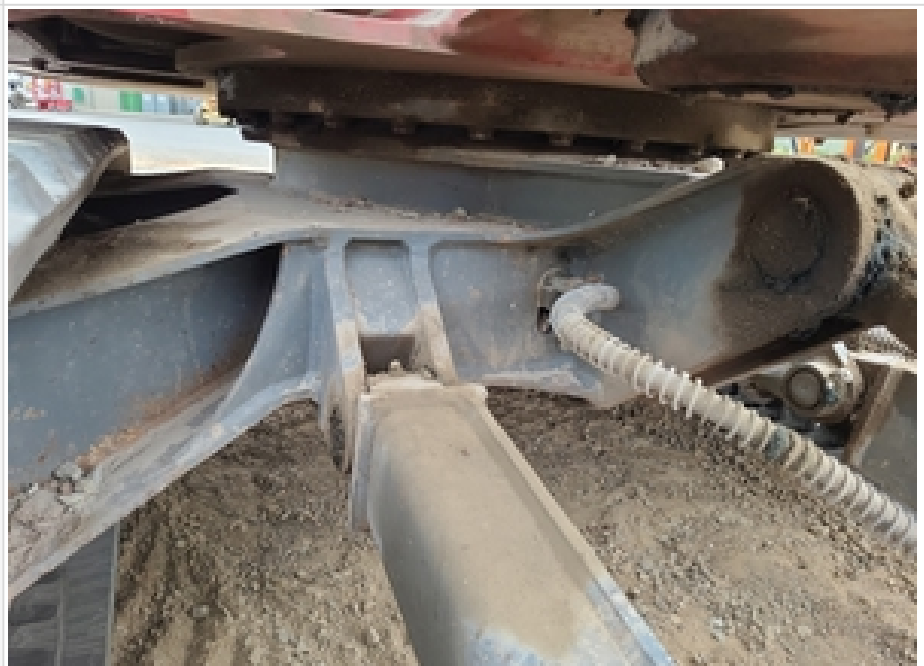
Chassis Photos	 
----------------	--

Chassis Rating	3 - Normal Wear & Tear
Comments	No Excessive play seen at implements

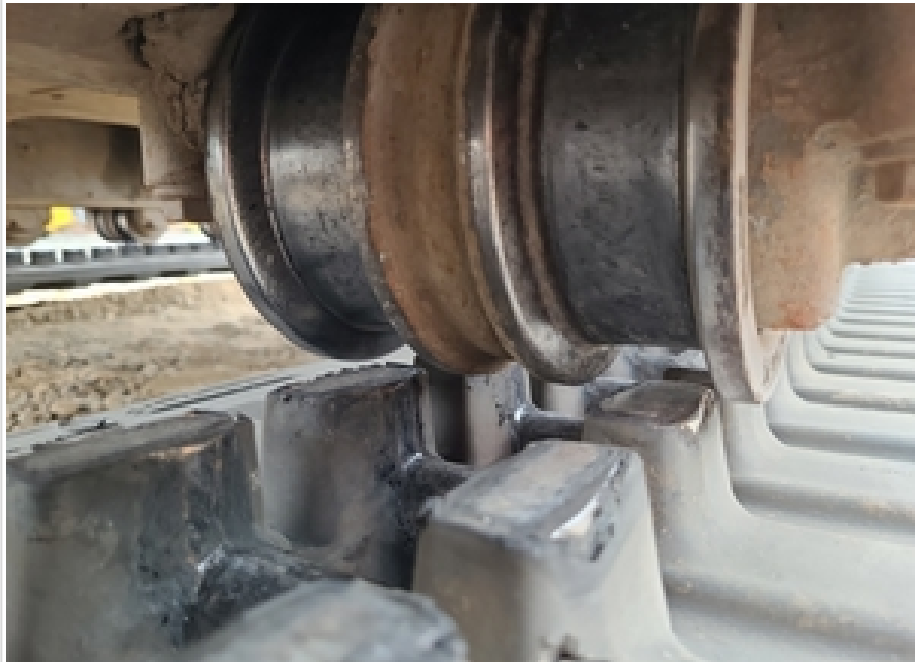
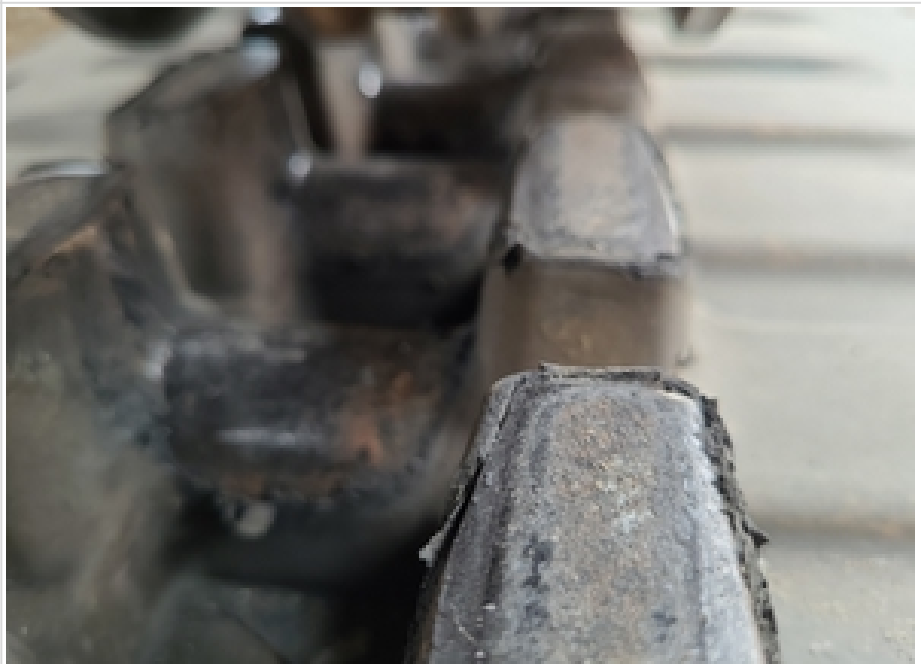
Undercarriage Rating	4 - Very Light or Minimal Wear
Undercarriage Comments	Tracks recently replaced and undercarriage in good condition

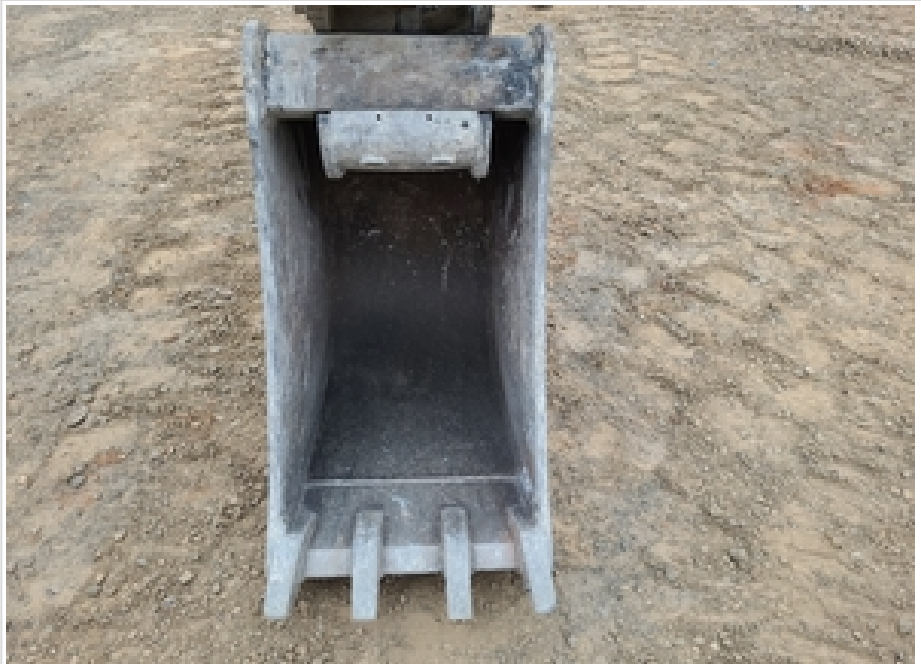
Bucket missing teeth

Attachment Rating	3 - Normal Wear & Tear
Attachment Comments	Bucket needs teeth and thumb operating okay
