Bartlett Regional Hospital

CONDITION SURVEY

FAMILY PRACTICE BUILDING

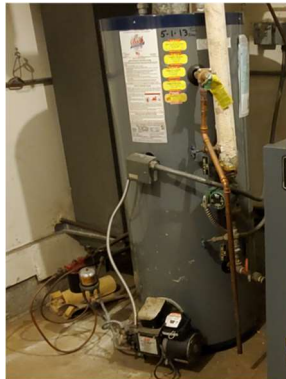
Plumbing System: The domestic water piping is copper and is largely insulated. The domestic waste piping is typically cast iron with some ABS likely added in later tenant improvements. A water service and meter are located in the unimproved crawlspace outside the boiler room. There is a reduced pressure backflow preventer (RPBP) segregating the entire domestic system from the city service. There does not appear to be an RPBP segregating the upper floor lab domestic water from the rest of the domestic system. The plumbing fixtures appear mostly original to the building with some replacements and tenant improvement modifications since the building was constructed. There are no hot water tempering or anti scald devices located at the lavatories or showers. Heated domestic hot water is provided by a single oil-fired hot water tank. The domestic water system is circulated by a single hot water recirculation pump located in the boiler room. Overall, the plumbing system is in good condition.

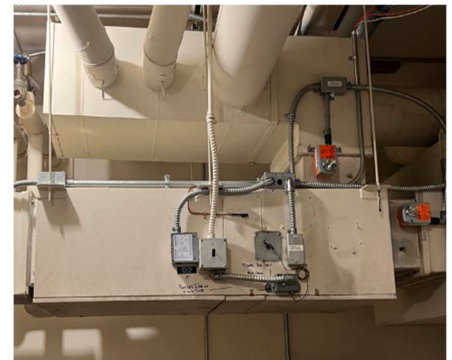
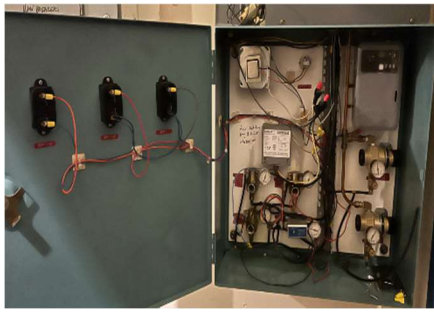
- **Ventilation Unit “P”:** Model- Pace SCF-79A-M1. Located in the lower floor Fan Room.
- **Ventilation Units “Q and T”:** Similar to Ventilation Unit “P”. Model- Pace SCF-79A-M1. Located in upper level spaces.
- **Ventilation Units “R and S”:** Similar to Ventilation Unit “P”. Model- Pace SCF-63A-M1. Located in upper level spaces.
- The ventilation units are typically in fair condition but are near the end of their service life. Repairs can be made to extend the service life of the ventilation units. Estimated service life of 0-10 years.

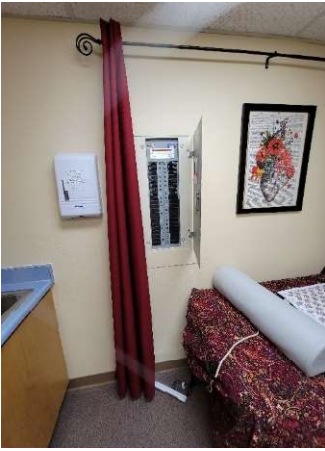
All the appliance panels are panelboard style with dead front covers over the circuit terminations on the circuit breakers. The panels are in good condition, but the circuit breakers have reached their service life and should be replaced.

The grounding system is not visible, and its condition not verified. With any modifications to the building, the system should be tested with a “drop of potential” type meter.

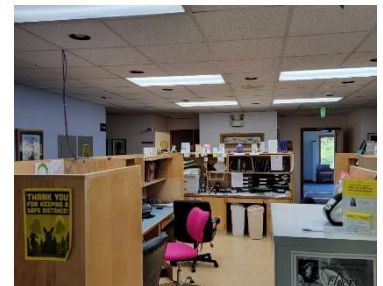
Lighting and Lighting Controls: Most of the interior illumination is accomplished using 2ft x 4ft troffers in the suspended ceiling. All utilize fluorescent lamps. There are some recessed cylinders in the public areas and the main nurse’s station, fitted for incandescent type lamps (some might be using LED lamps now). All the fixtures have exceeded their service life.

All the interior lighting is controlled with manually operated switches strategically located to control specific rooms. All the switches have exceeded their service life and should be replaced.

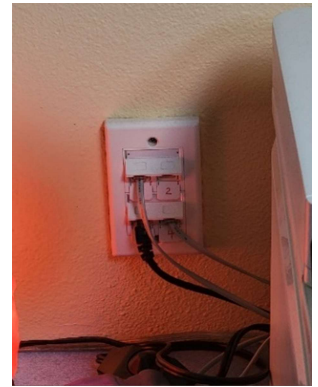
Data & Communications: The building was originally constructed with basic telephone service. With the advent of data networks and their general development over time since the original construction, data circuits have been routed throughout the building. The main distribution frame (MDF) is in the lower floor in the same room as the electrical service equipment. The circuits disperse from there to workstation and telephone terminals throughout the building. All the cables appear to be routed in an open manner, mostly concealed above suspended ceilings and within walls. Some circuits drop from the ceiling over the main nurse's station. The circuits and MDF are in fair condition.

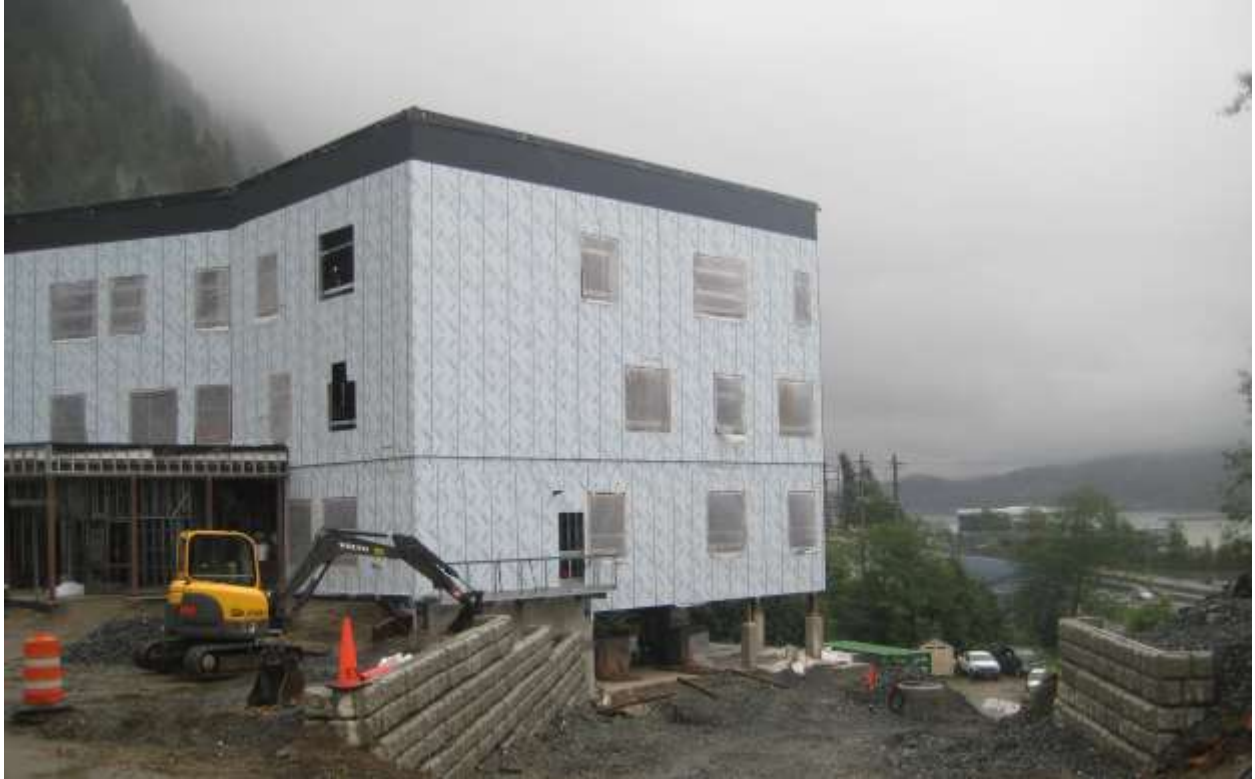
Photo 2375 – View of west façade, where DC workers, have completed the wind/vapor barrier installation.

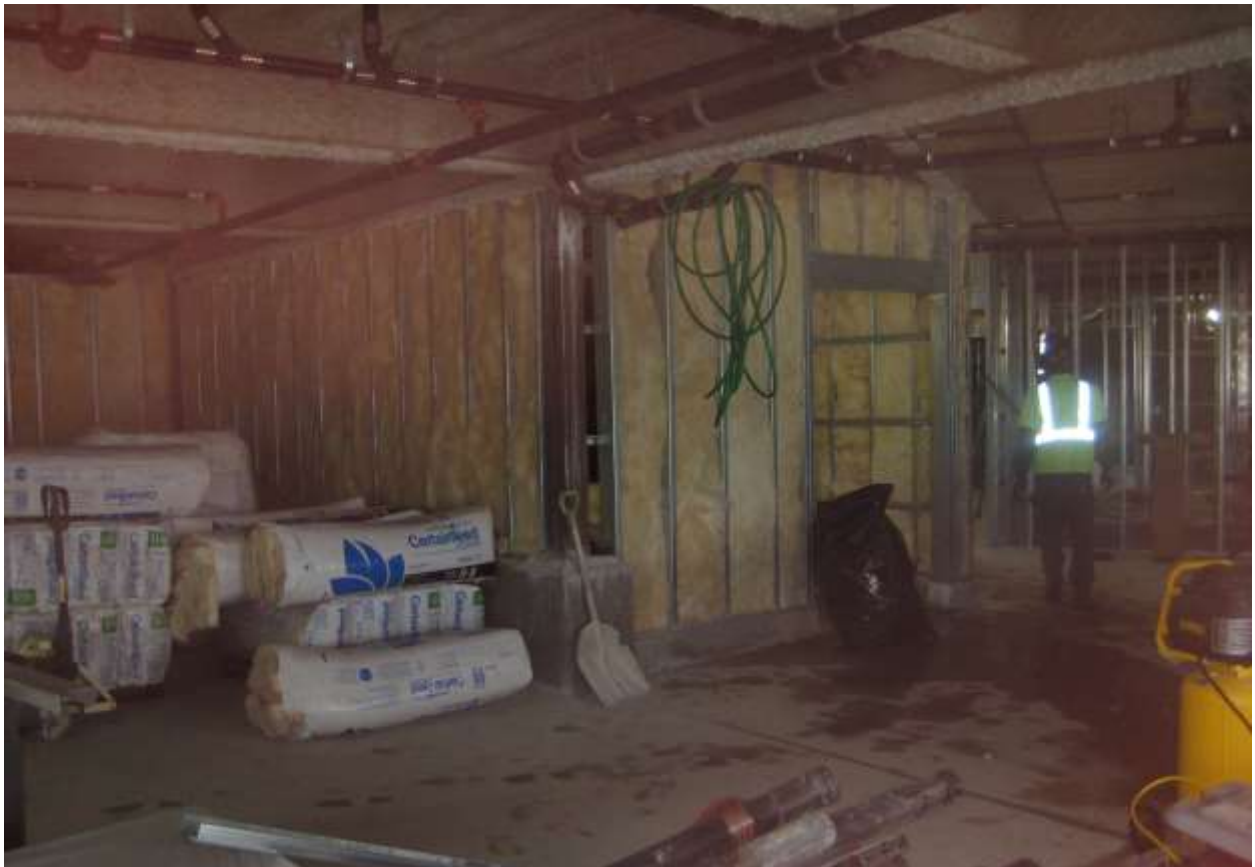
Photo 2376 – DC's two-man work crew, Gregg and Riley, installs batt insulation at interior, partition walls at the basement level.

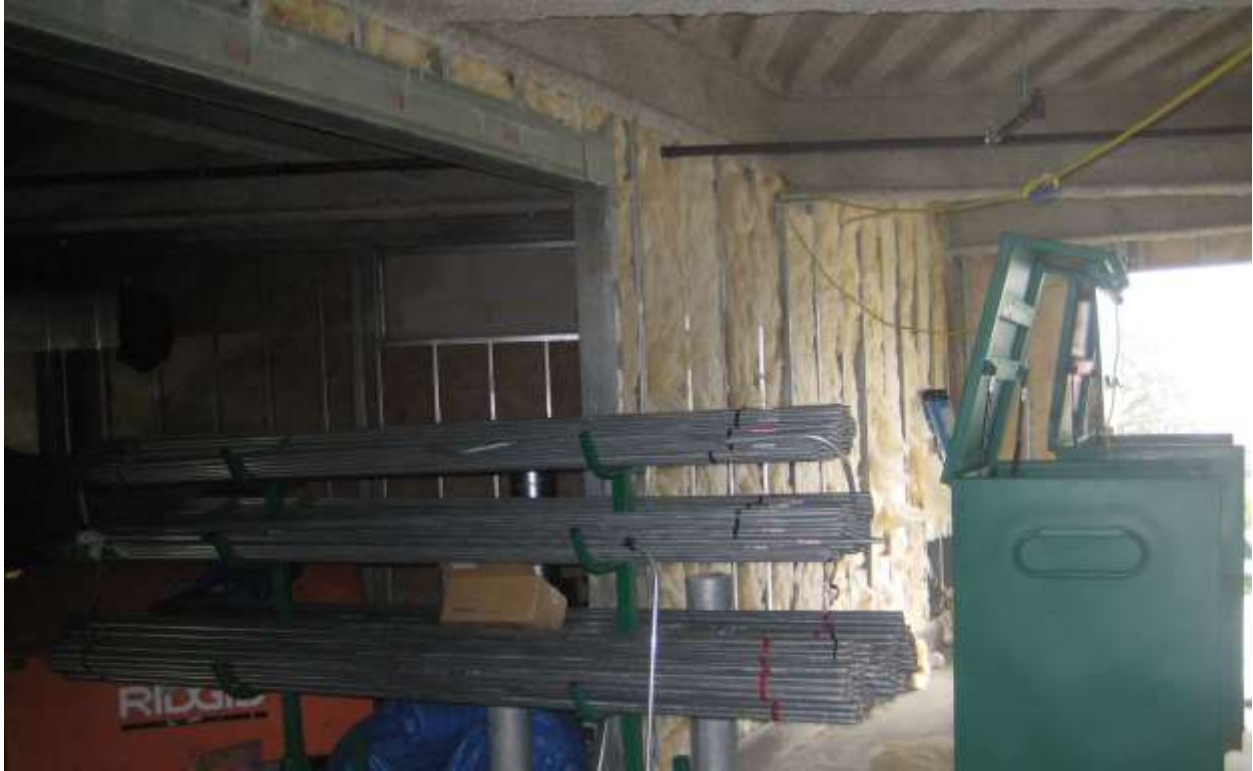
Photo 2377 – Basement level wall insulation continued.

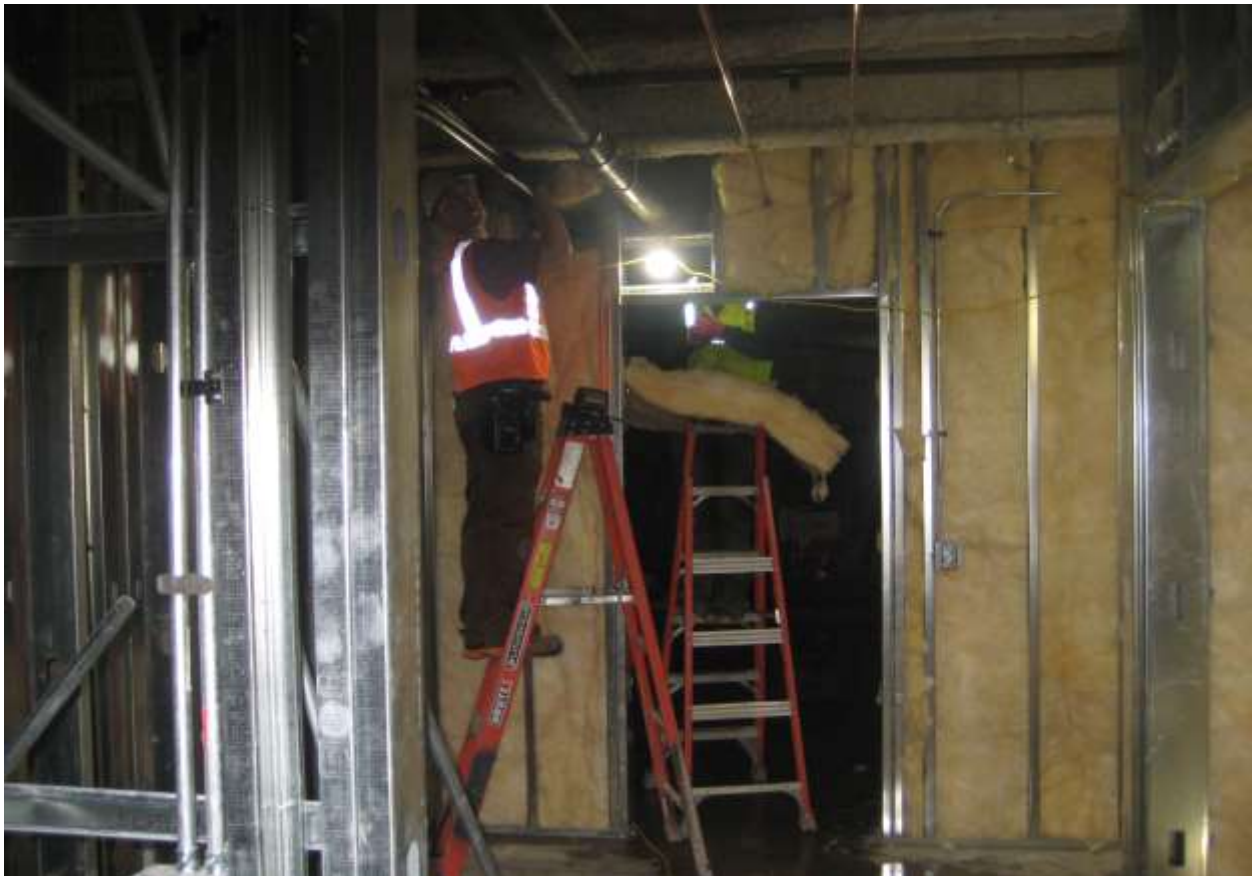
Photo 2378 – Continuation of wall insulation (by Gregg) at the basement level. Note presence of Long Control's worker, Adam, shown (in foreground) installing HVAC control (wiring) conduits.

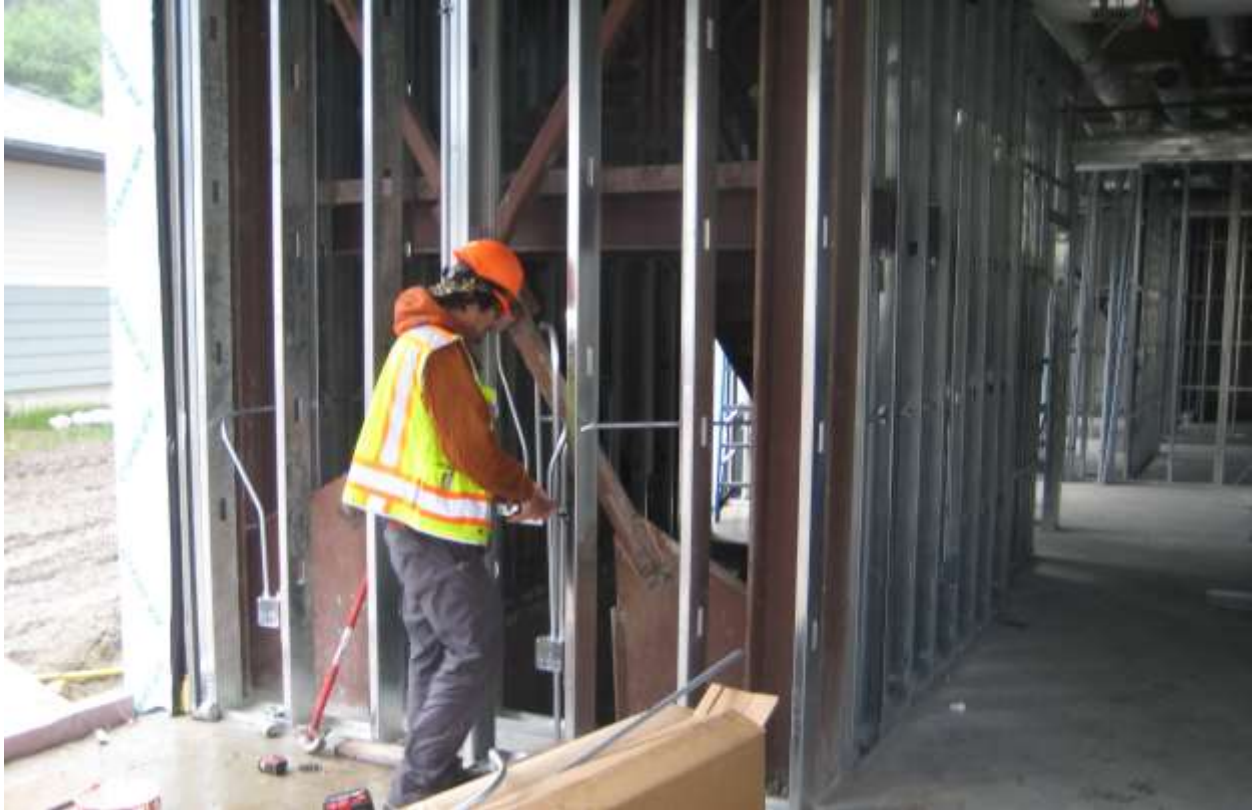
Photo 2379 – EE worker, Robert, installs electrical conduit into wall cavities at the first floor level.

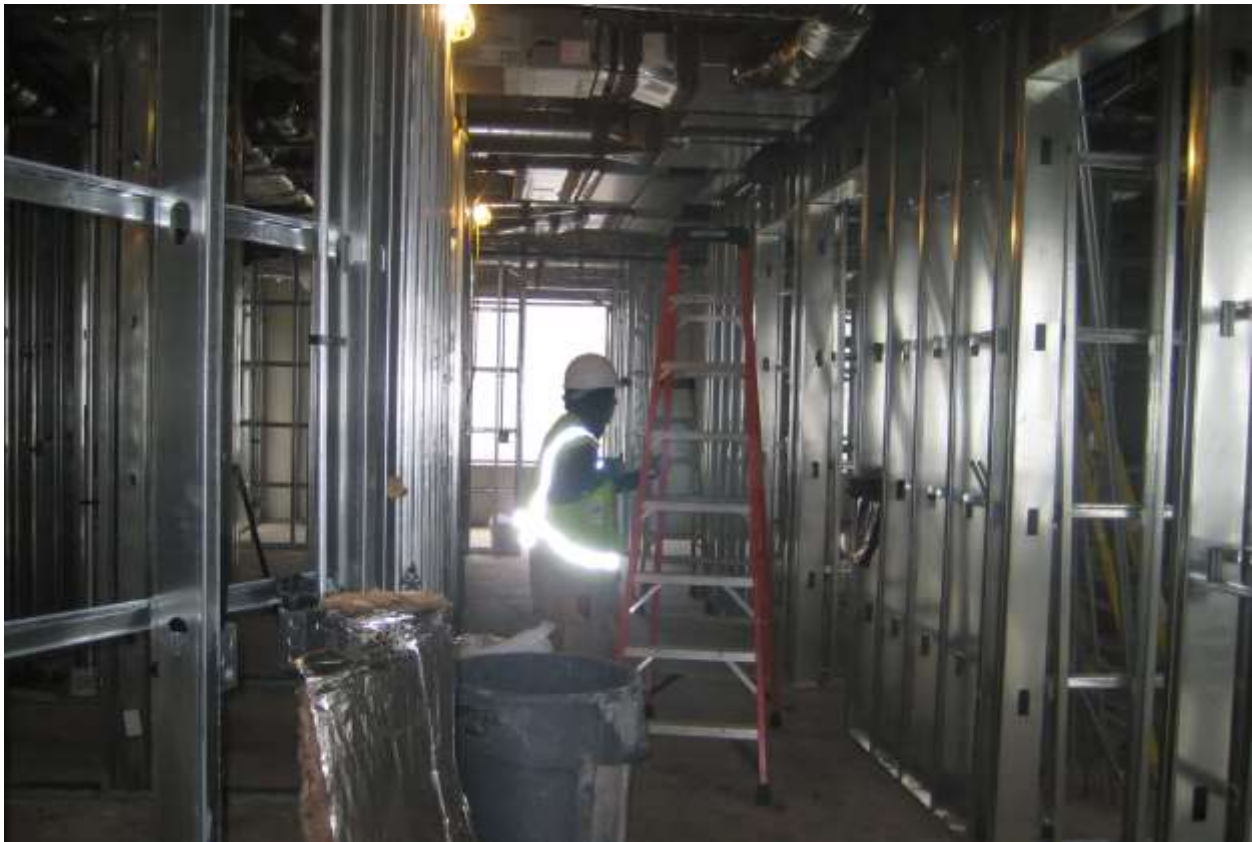
Photo 2380 – AIS worker, Tom, installs HVAC ductwork insulation at a round duct at the first floor.

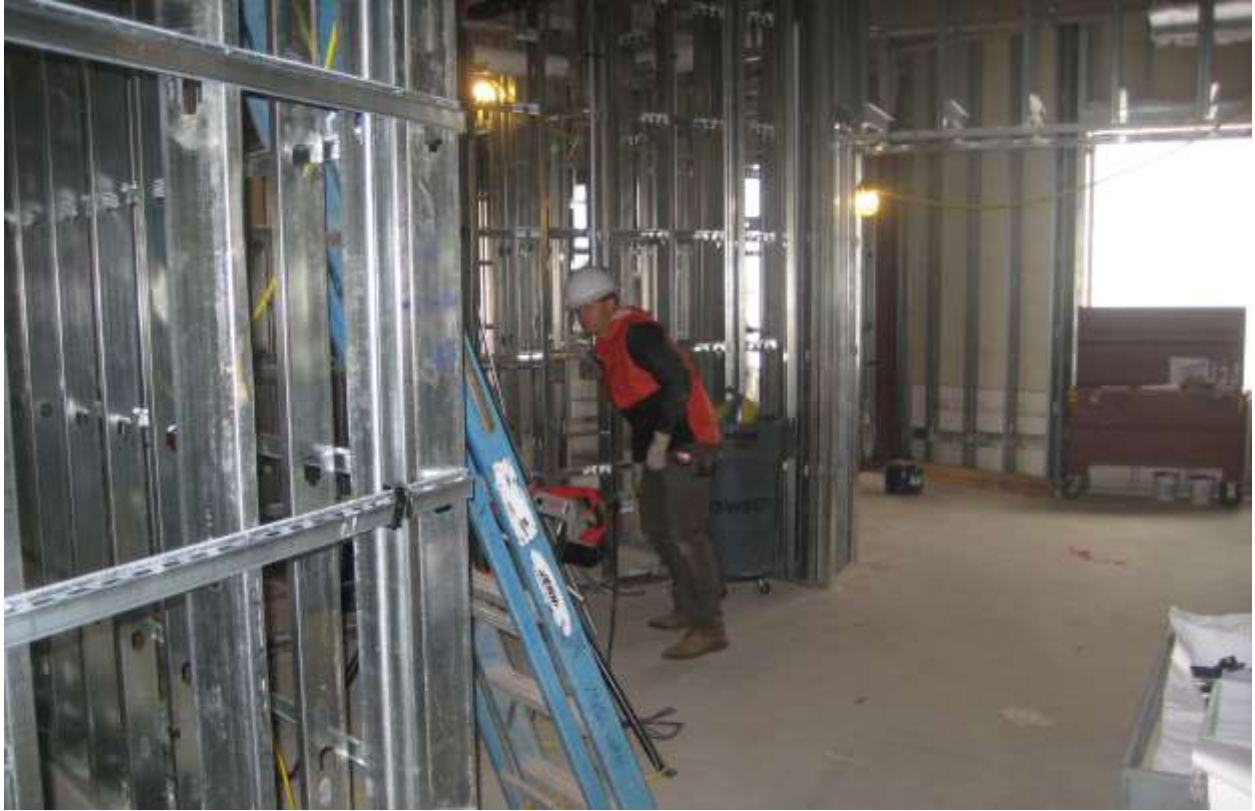
Photo 2381 – EE worker, Brian, installs electrical conduit into wall cavities at the second floor level.
