CONDITION SURVEY

FAMILY PRACTICE BUILDING

Family Practice Building 2022

EXECUTIVE SUMMARY

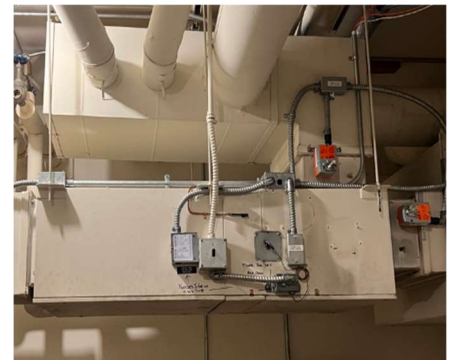
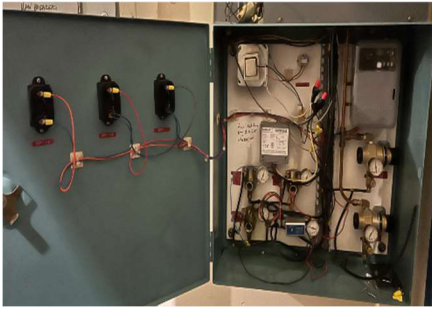
- **Ventilation Unit “P”:** Model- Pace SCF-79A-M1. Located in the lower floor Fan Room.
- **Ventilation Units “Q and T”:** Similar to Ventilation Unit “P”. Model- Pace SCF-79A-M1. Located in upper level spaces.
- **Ventilation Units “R and S”:** Similar to Ventilation Unit “P”. Model- Pace SCF-63A-M1. Located in upper level spaces.
- The ventilation units are typically in fair condition but are near the end of their service life. Repairs can be made to extend the service life of the ventilation units. Estimated service life of 0-10 years.
