# Home Inspection Report

3225 Hospital Drive, Juneau , AK 99801

**Inspection Date:**

Thursday, January 21, 2021

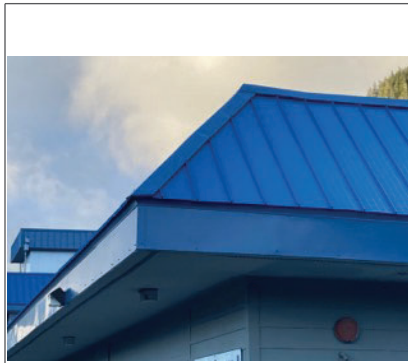
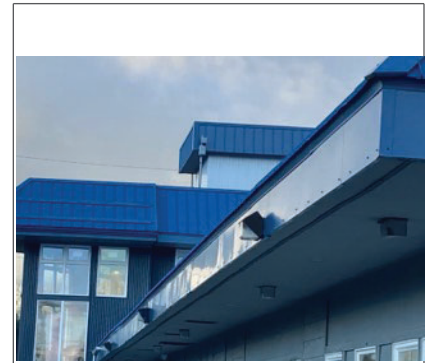
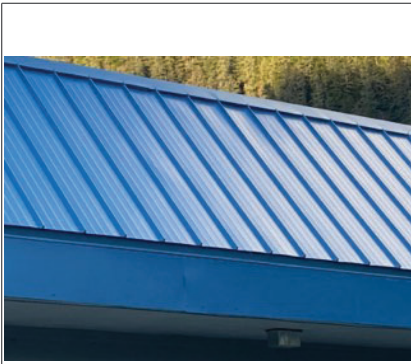
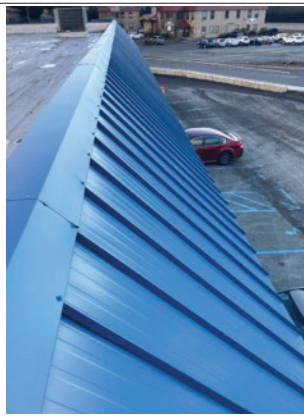
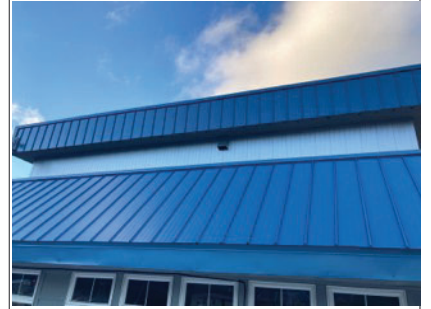
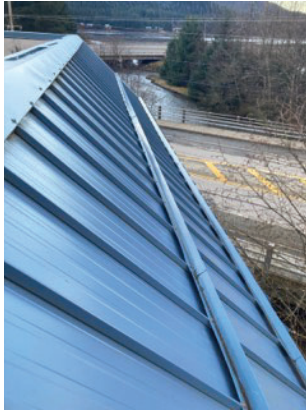
The mansard style metal roof at the extended eaves are built off the parapet walls to provide extended eaves. The roofing is a standing seam metal panel with hidden fasteners. The metal roofing appears to be in overall good condition. Proper flashing noted at eaves and wall caps. Snow stops installed and secure. No sign of active leaks or significant damage visible. Top wall cap flashings extends over the vertical areas of the flat ( low slope) touchdown roofing back side of parapet wall and appears to provide adequate protection.

The soffits show some signs of water staining however no elevated moisture readings noted when tested by digital meter. Stains appear to be from previous conditions. A small access hatch is located on front eave that allows for visual inspection of partial roof sheeting, fascias and soffits. Visible mansard roof sheeting and eave construction appears dry and sound, though access and visibility was limited to this portion. The fiber cement soffit cladding appear intact and sound.

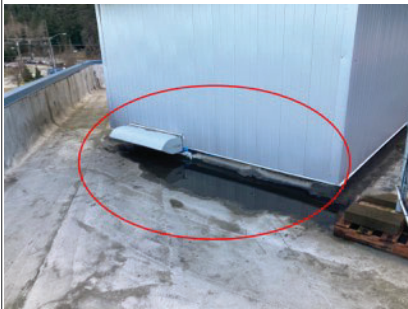
Water pools along side the penthouse wall, ventilation hood is cut low into the roof to wall coving. This area may be susceptible to water intrusion.

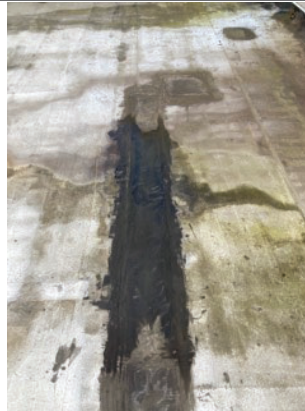
Several areas of patching and sealing present on roof. Recommend qualified roofing contractor evaluate and monitor/repair as needed to ensure proper protection and anticipate replacement of low slope roofing systems in the near future.

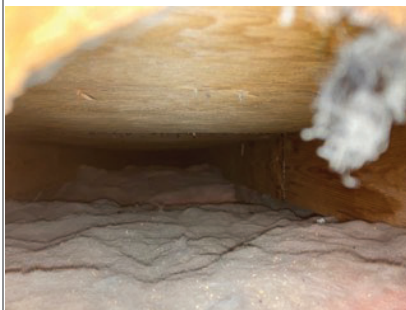
Limited visibility of the bottom side of roof sheeting is visible through bird block vents between truss top cords located in the mansard eave framing. No obvious signs of water damage 'intuition where visible.

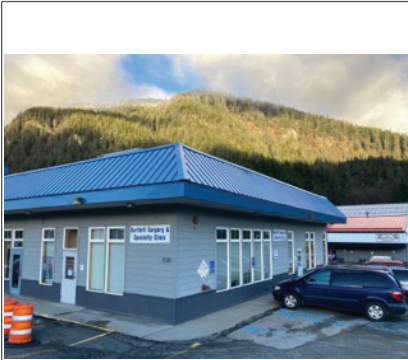
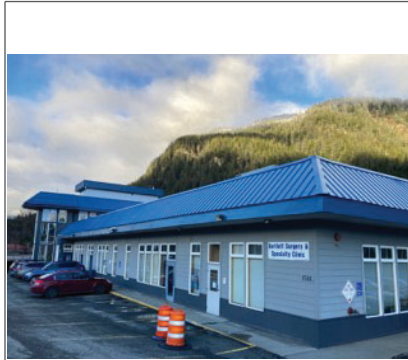
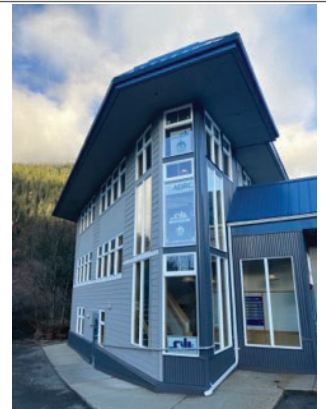
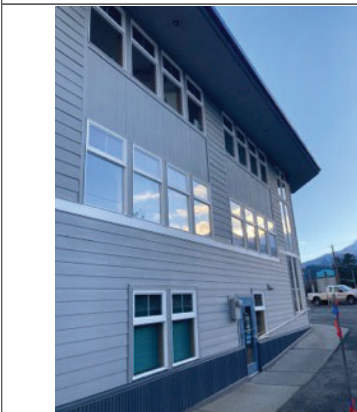
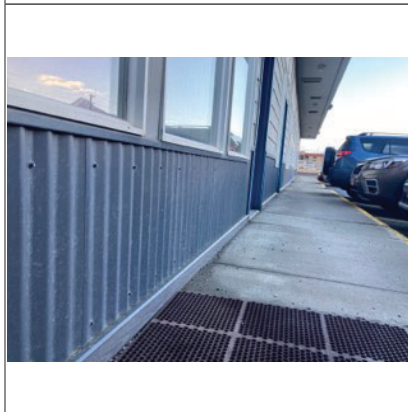
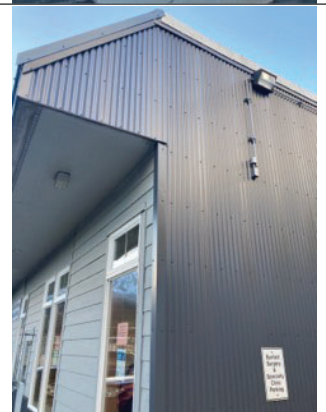
Cladding appears to be in overall good condition. No sign of significant damage or structural concerns visible. Some typical weathering and peeling paint / cracked caulking present. Minor maintenance type repairs and repainting should be anticipated to ensure prolonged integrity and weather protection.

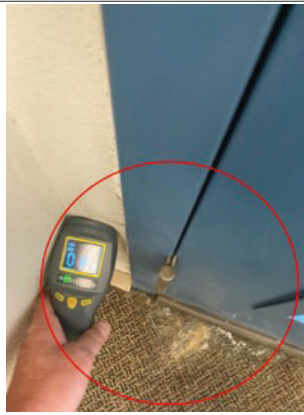
Interior wall cladding near exterior doors show elevated moisture readings due to water intrusion from improperly sloped walkways and excessively corroded and improperly sealed doors. Condition of fur out framing over foundation is unknown. Recommend Anticipating some minor wall repairs at time of door replacement.

Signs of water intrusion under doors. Flooring damage and moisture wicking up drywall.

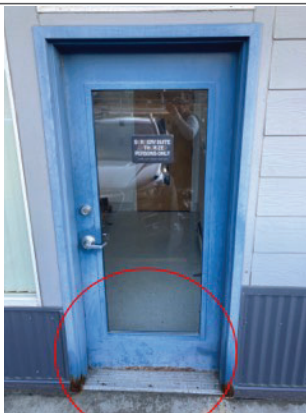
Many of the exterior doors are significantly weathered and are nearing the end of their serviceable life. Recommend Anticipating exterior door replacement throughout.

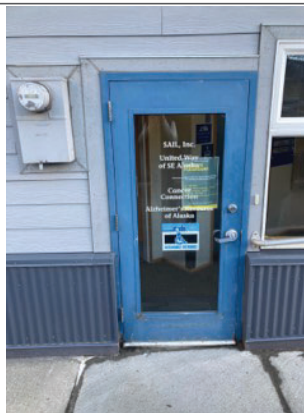
Damaged door and frames due to water pooling.

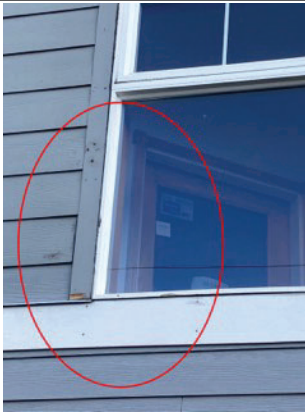
Areas of typical exterior weathering consistent with age. Recommend repair and repaint fiber cement sidings and trims as needed.

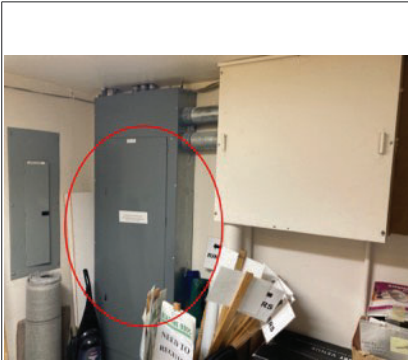
Main 800 amp electrical service panel with sub panel disconnects

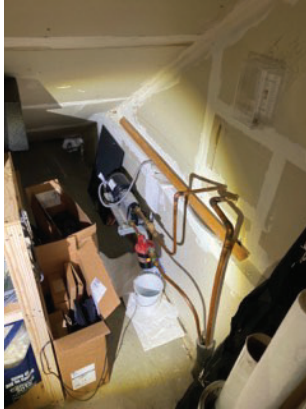
Fuel oil lift pump and shutoff is located storage closet under emergency escape stairs.

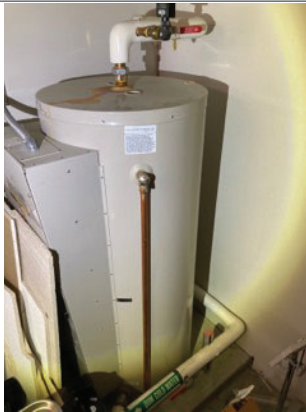
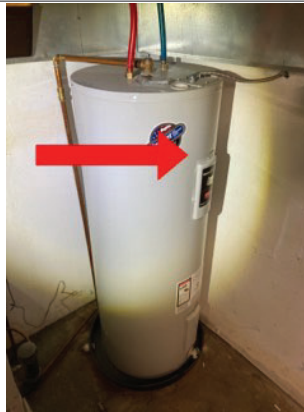
**Water heater unit** The domestic hot water appears to be provided by at least two electric water heaters. The hot water tested and system functional. Proper pressure relief valve and extension installed. No active leaks or excessive corrosion noted. Tanks appear to have several years of serviceable life expectancy.

All water heaters are required to be installed with seismic straps. Recommend installing seismic straps to all water heaters.

Recommend installing seismic straps on all water heaters as required.

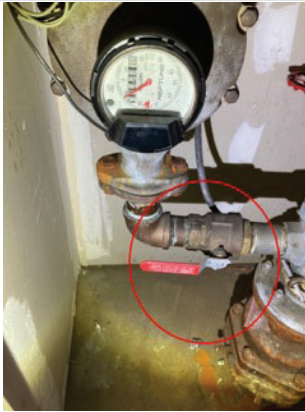
The main water shutoff valve is located in then sprinkler riser closet in the front , street side corner of building accessible through BRH space.
