**ANNUAL INSPECTION REPORT FOR COAL COMBUSTION RESIDUALS (CCR) UNITS  
SAN MIGUEL ELECTRIC COOPERATIVE POWER PLANT**

January 10, 2020

Wood Project No.: 6706160039

Appendix A    November 21, 2019 Inspection Summary

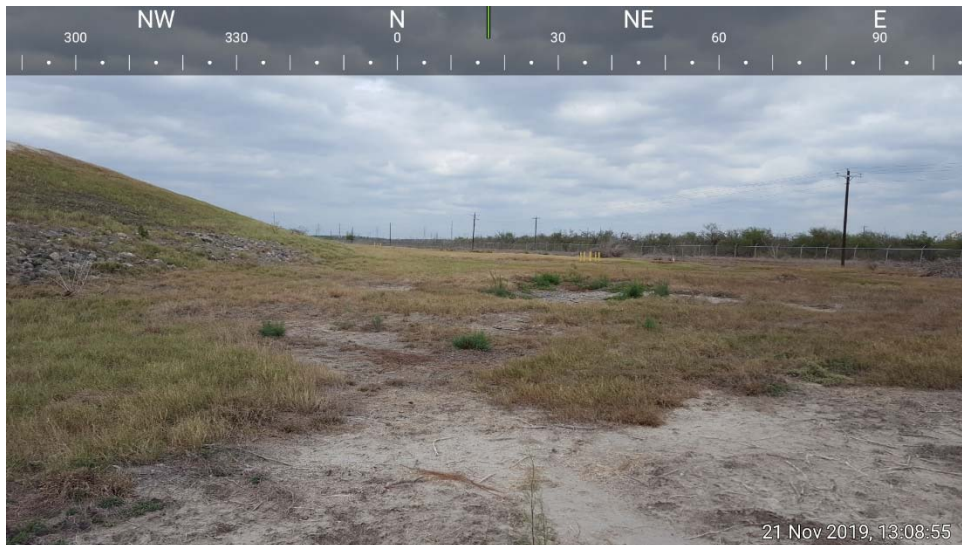
**PHOTO 12**

Looking to the north-northeast along the eastern side of the Equalization Pond. This area is drier than the southern side of the structure.

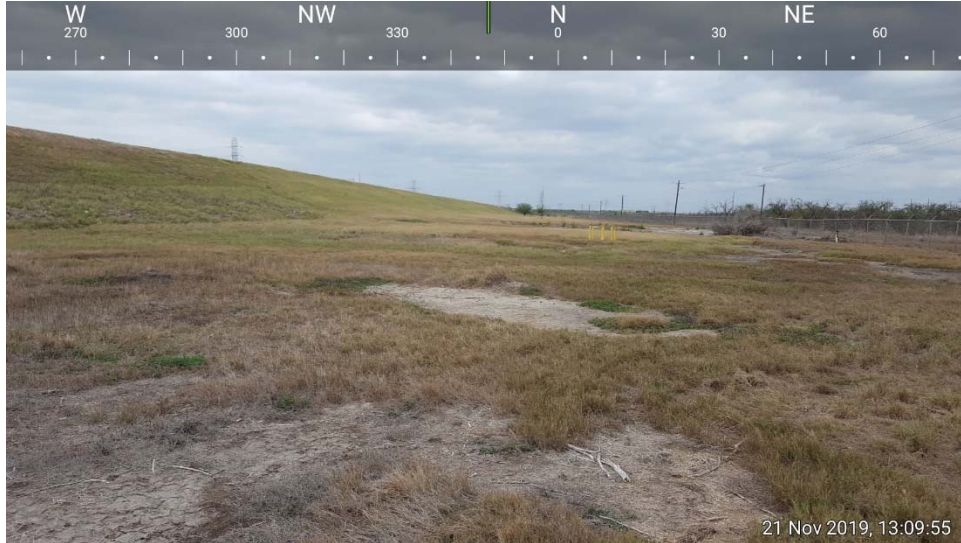
**PHOTO 13**

Looking to the north along the eastern side of the Equalization Pond. A perimeter groundwater monitoring well is visible in the distance.

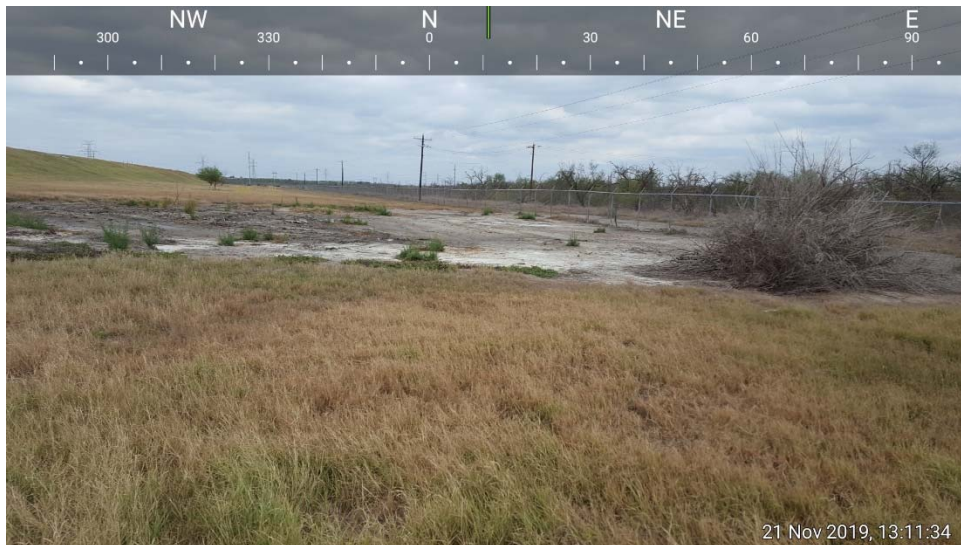
**PHOTO 14**

A barren area along the eastern side of the Equalization Pond that is along the stream channel. This is an area where woody vegetation was previously removed and the natural grasses have not fully recovered.

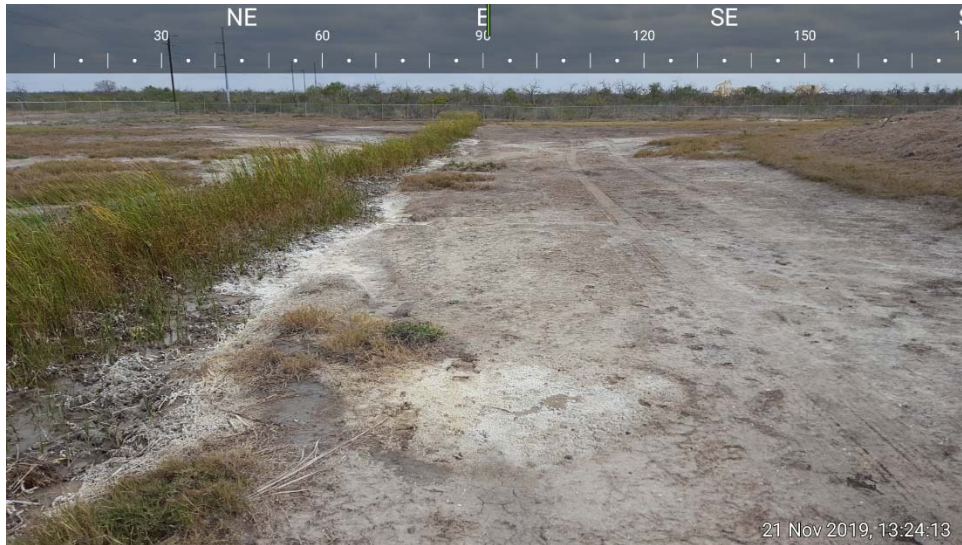
**PHOTO 18**

Looking to the east along the drainageway on the northern side of the Equalization Pond.

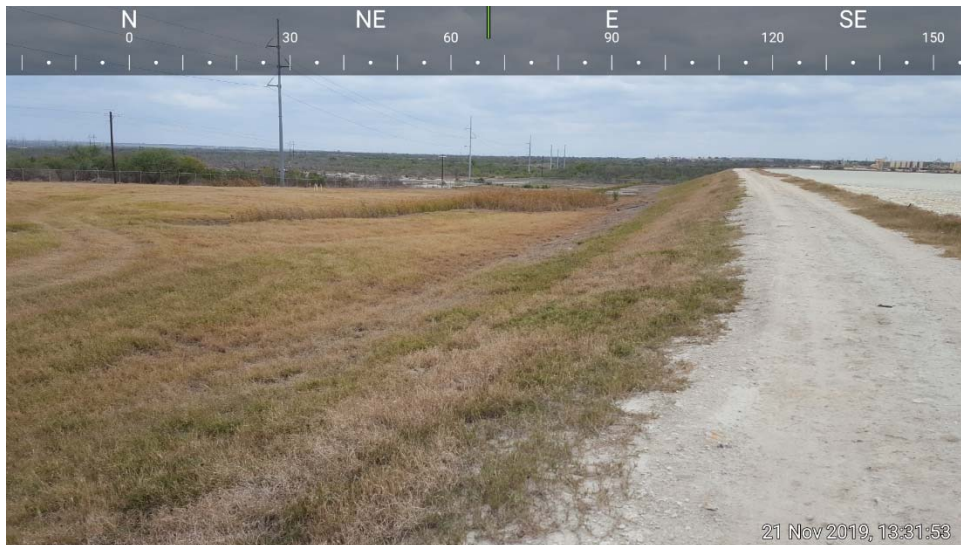
**PHOTO 20**

A wet area along the northern side of the Equalization Pond is marked by the presence of cattails. The surface in this area could be graded to improve drainage.

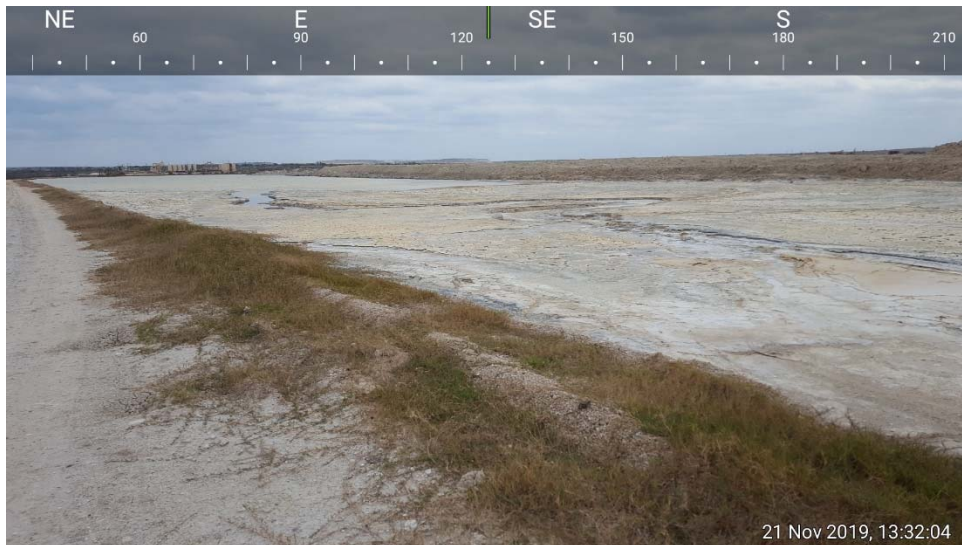
**PHOTO 22**

The accumulation of ash material within the northern extent of the Equalization Pond.

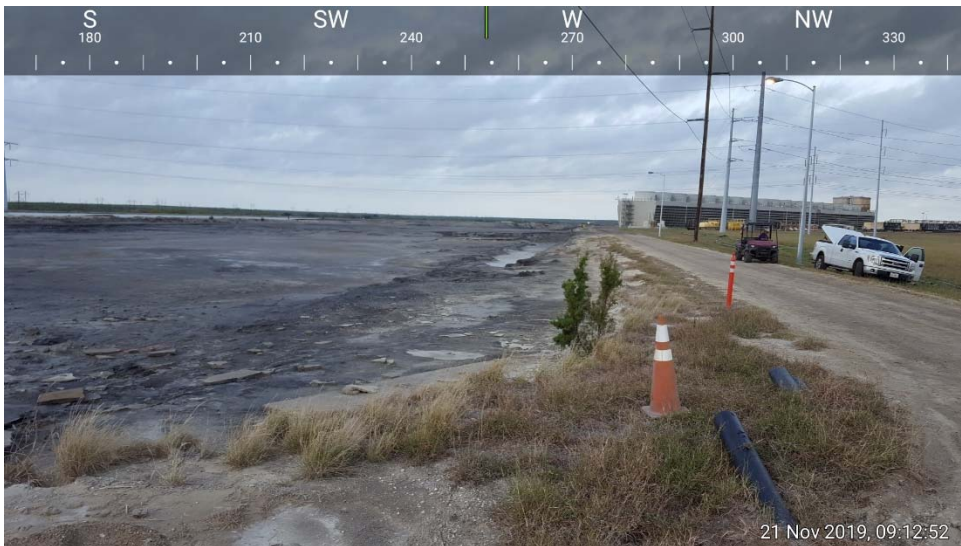
**PHOTO 2**

Looking to the west along the northern edge of Ash pond A. This area is dewatered and is awaiting ash material removal.

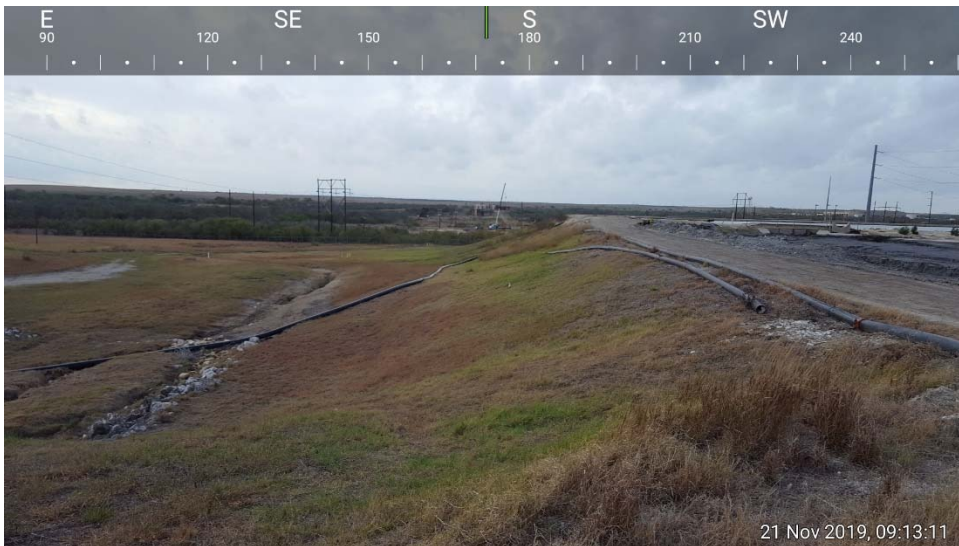
**PHOTO 5**

The weir that formerly connected Ash Pond A to Ash Pond B is now blocked to allow dewatering of Ash Pond A.

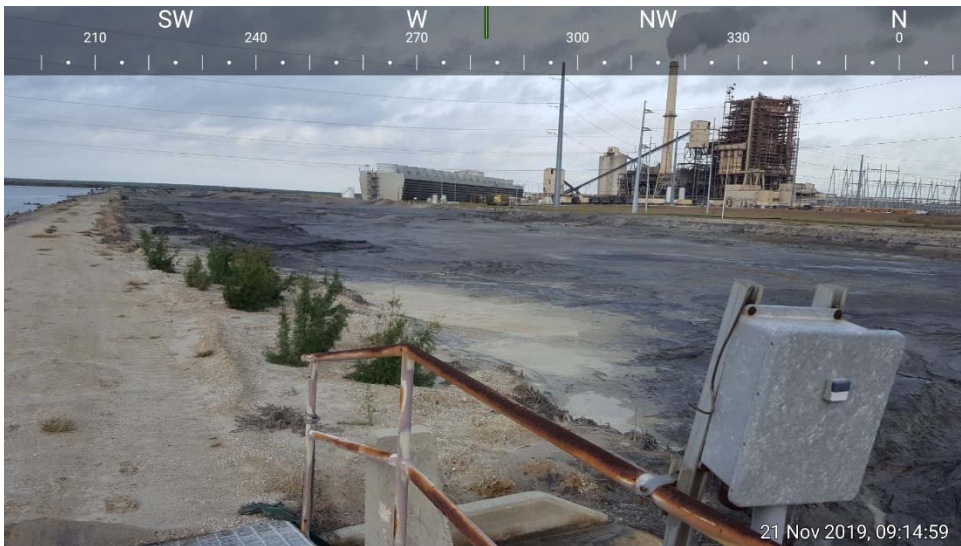
**PHOTO 6**

Looking to the west along the central dike that divides Ash Pond A from Ash Pond B. A minor amount of woody vegetation was beginning to grow at this end of the central dike.

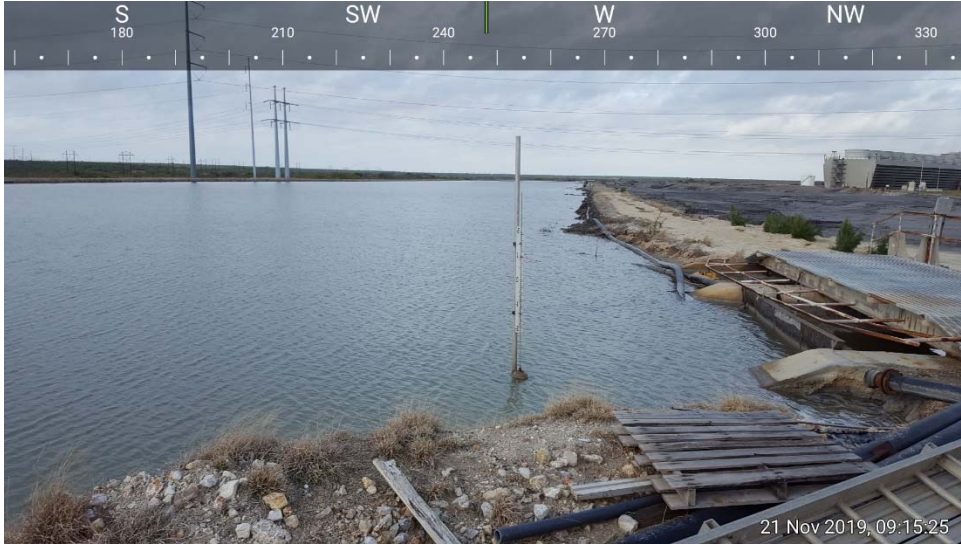
**PHOTO 7**

The relocated water level gauge in Ash Pond B. The water level gauge had not been surveyed at the time of the inspection.

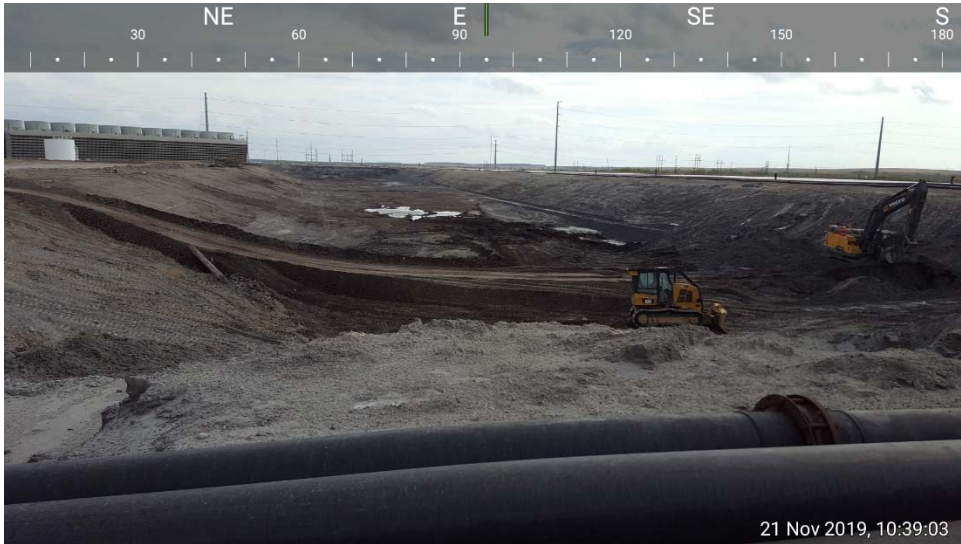
**PHOTO 11**

Looking to the east from the western crest of the embankment along Ash Pond A. An ash haul road is visible in the foreground of the photograph.

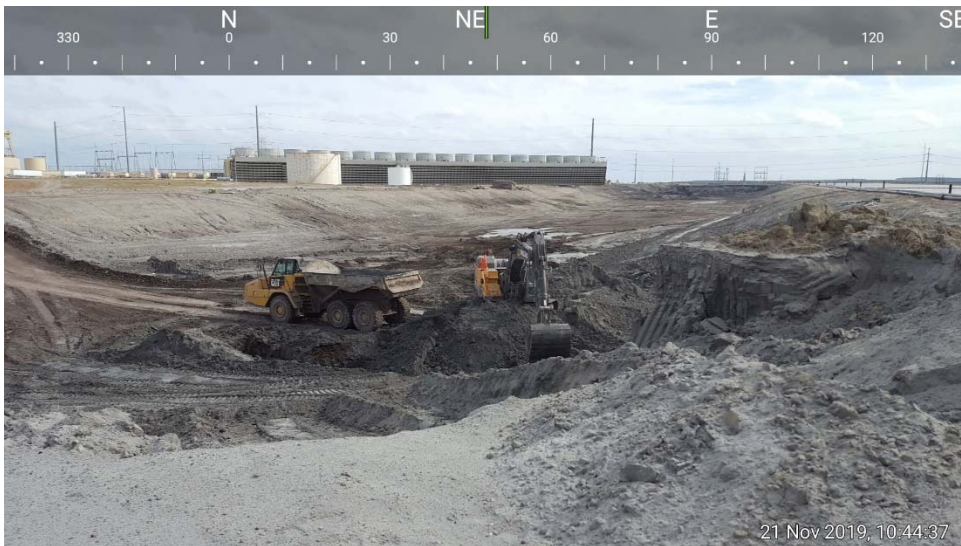
**PHOTO 12**

Loading dump trucks with the ash material from Ash Pond A. The ash is transported to the Ash Pile for blending and eventual transported to previously mined areas for disposal.

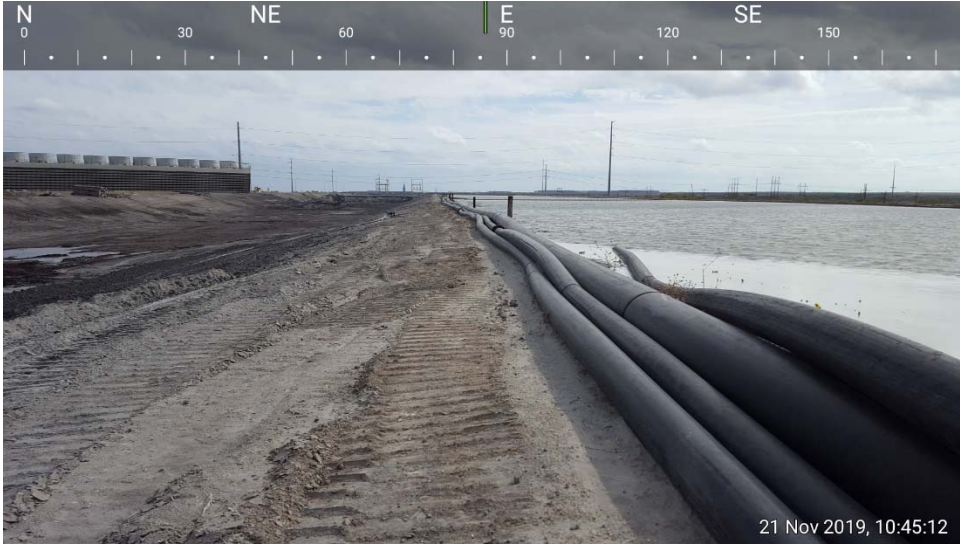
**PHOTO 14**

Water and ash material being pumped into Ash Pond B near the eastern portion of the impoundment.

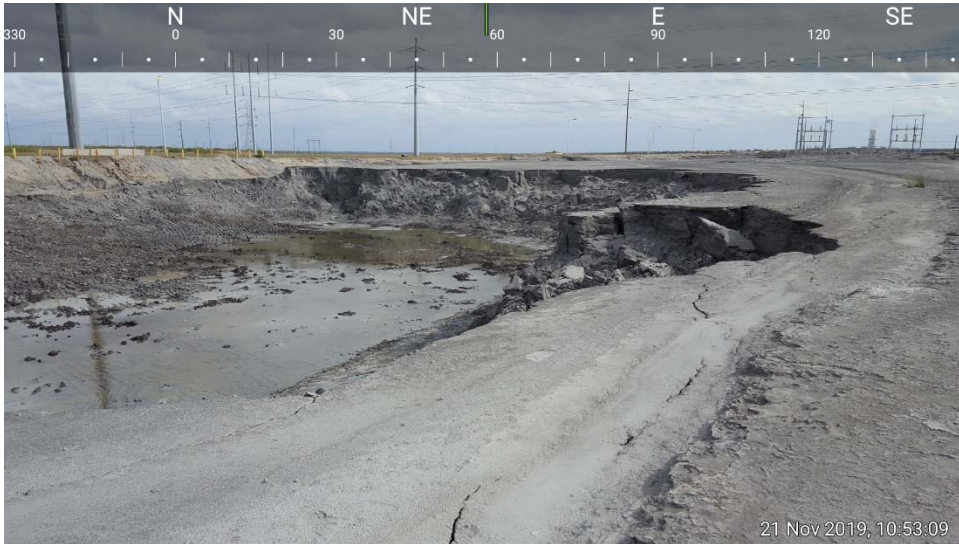
**PHOTO 15**

Looking to the northeast at the headwall of the excavated material within Ash Pond A. The excavated area extends to the east of the cooling towers and encompasses approximately two-thirds of Ash Pond A.

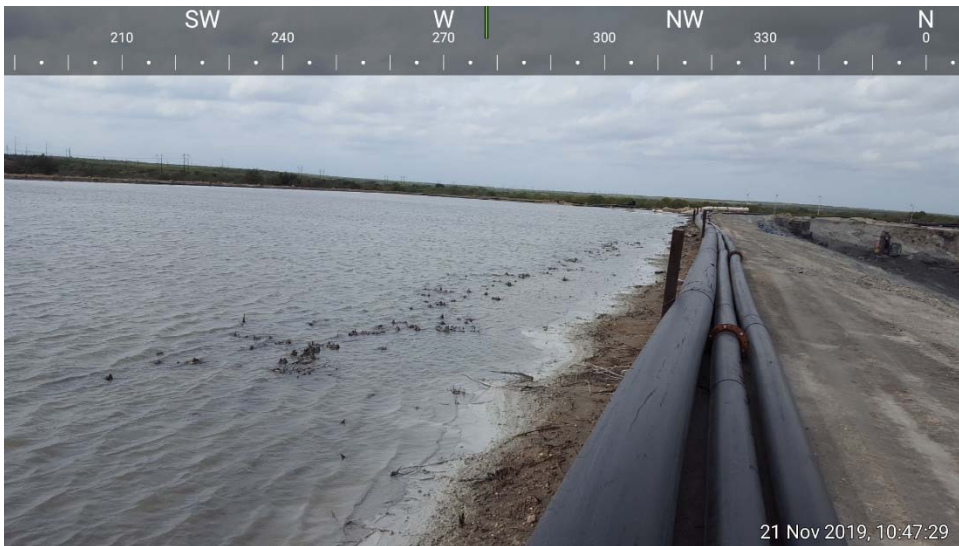
**PHOTO 16**

Looking to the west along the southern side of the central embankment that separates the excavated portion of Ash Pond A from the active Ash Pond B.

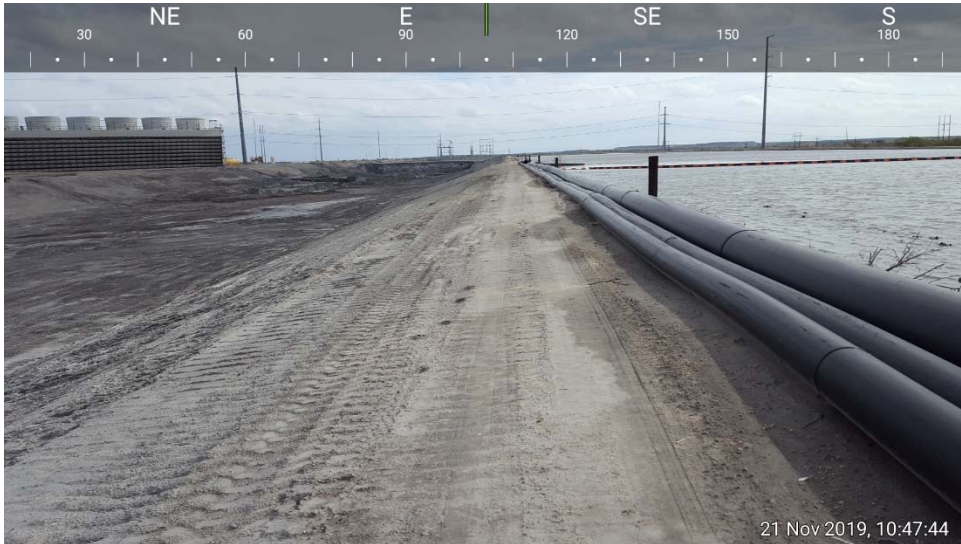
**PHOTO 17**

Another photograph of the excavated portion of Ash Pond A, the central dike, and the active Ash Pond B. The photograph is looking to the east.

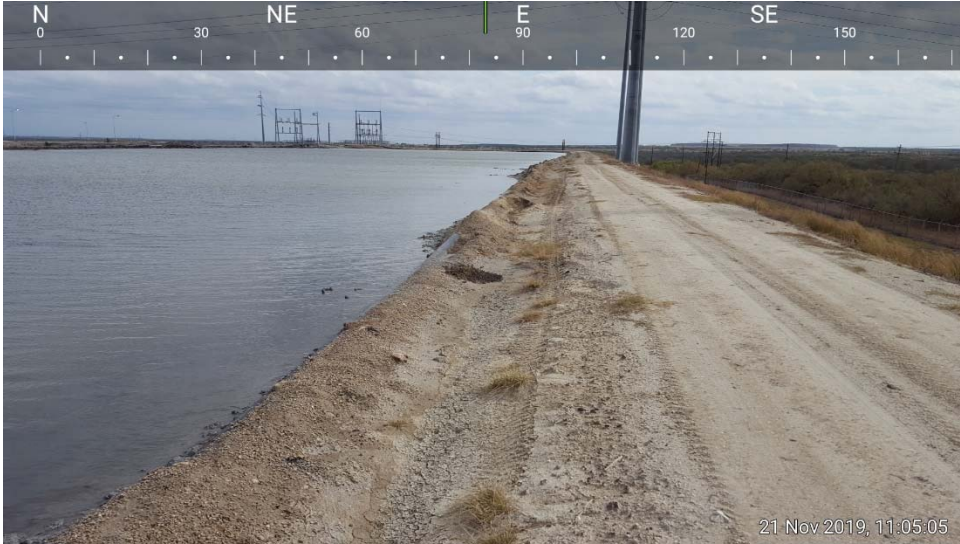
**PHOTO 20**

Looking to the north  
along the western end  
of Ash Pond B. The  
lignite silos and ash  
dewatering bins are  
visible in the  
background.

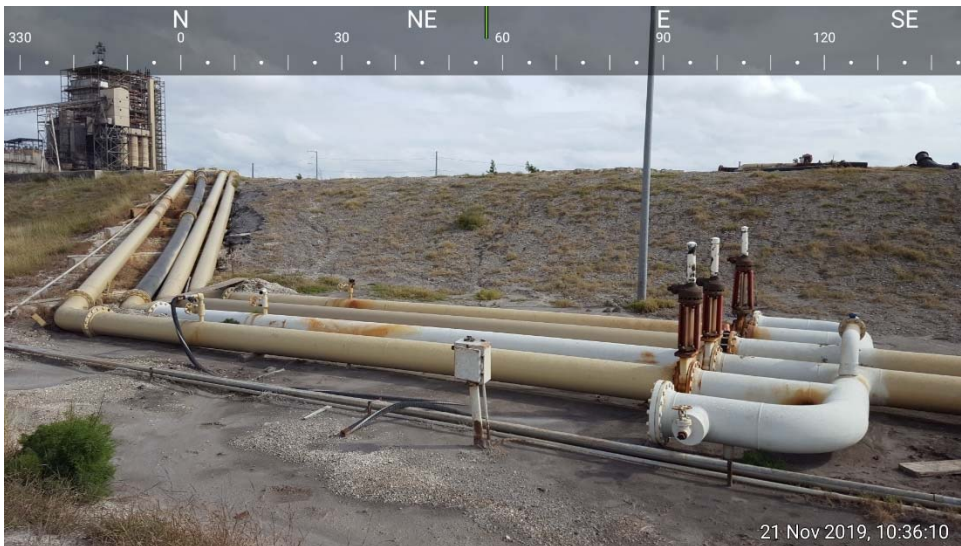
**PHOTO 22**

The northern portion of the western embankment that contains the toe drain that was installed in 2018. The area is sparsely vegetated and has been reseeded.

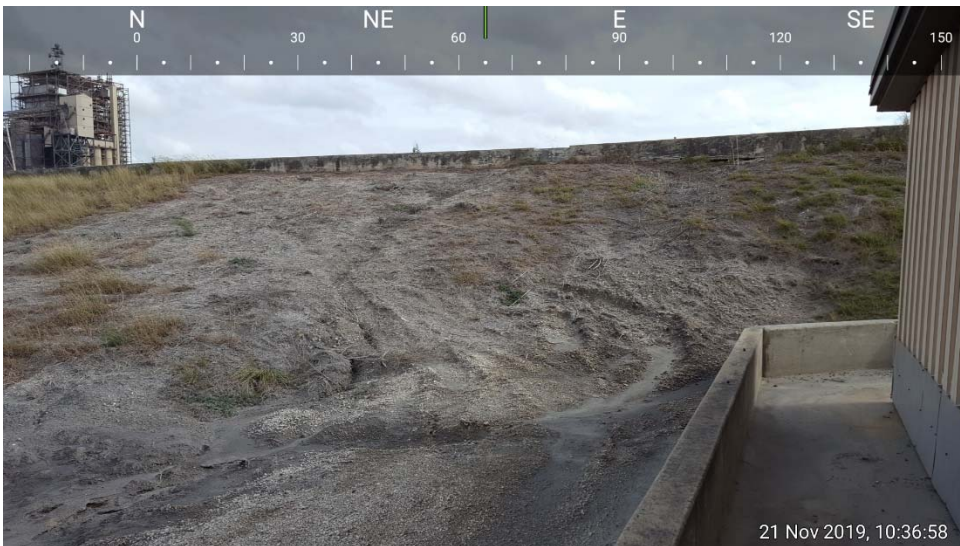
A barren slope near the electrical building located to the north of the toe drain. This area had washed-in soils removed in 2019.

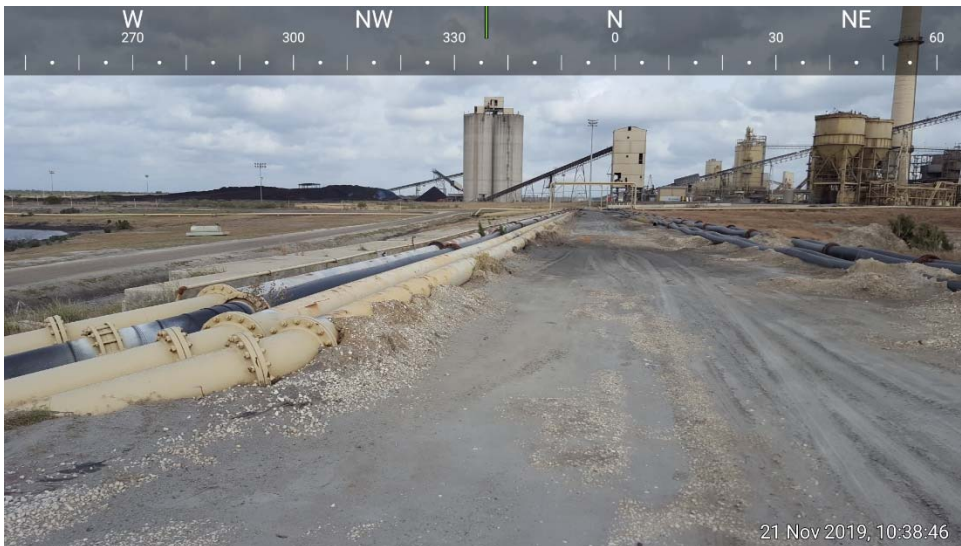
**PHOTO 26**

Looking to the north along the roadway between the piping located to the northwest of Ash Pond A.

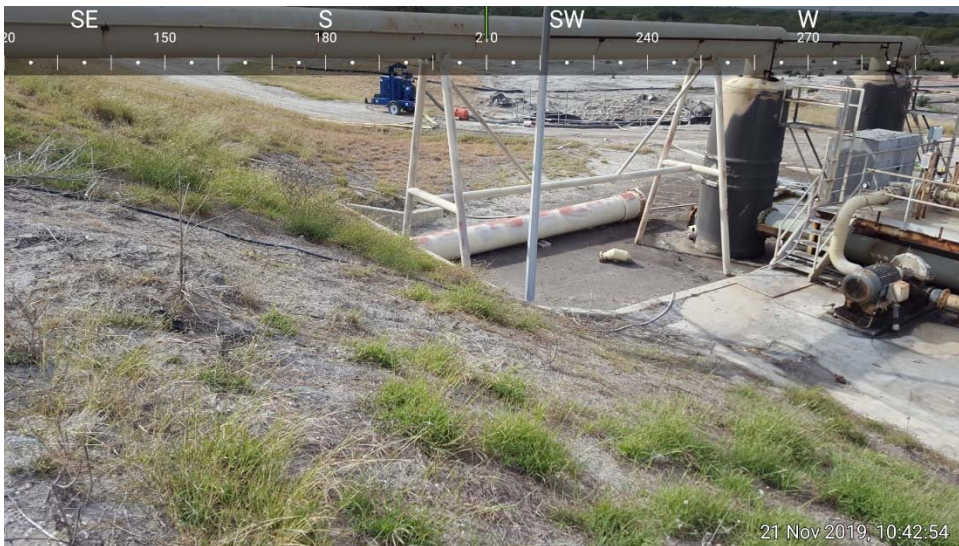
**PHOTO 30**

The southern end of the toe drain installation was sparsely vegetated.

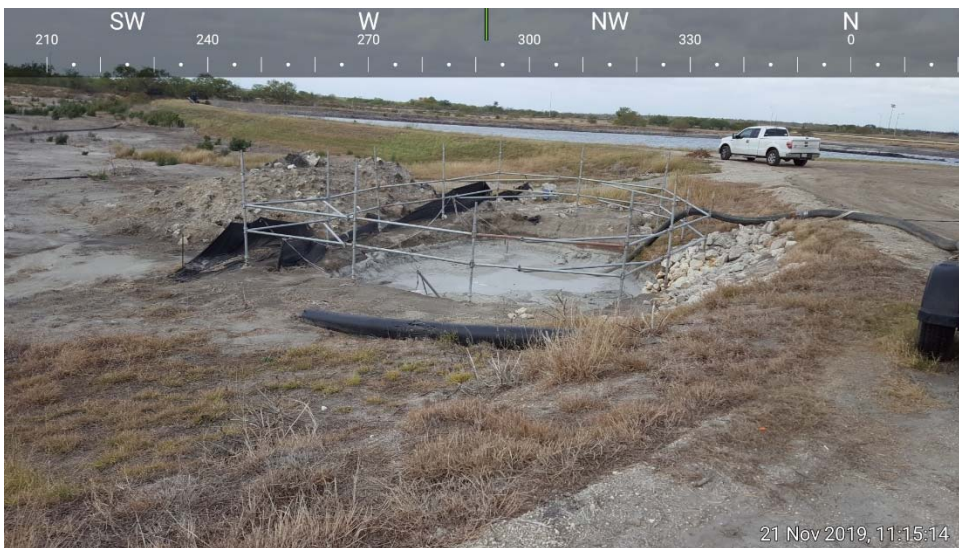
**PHOTO 32**

Containment down slope from the pumps at the western end of the Ash Ponds. The runoff water is collected and pumped to the Ash Ponds.

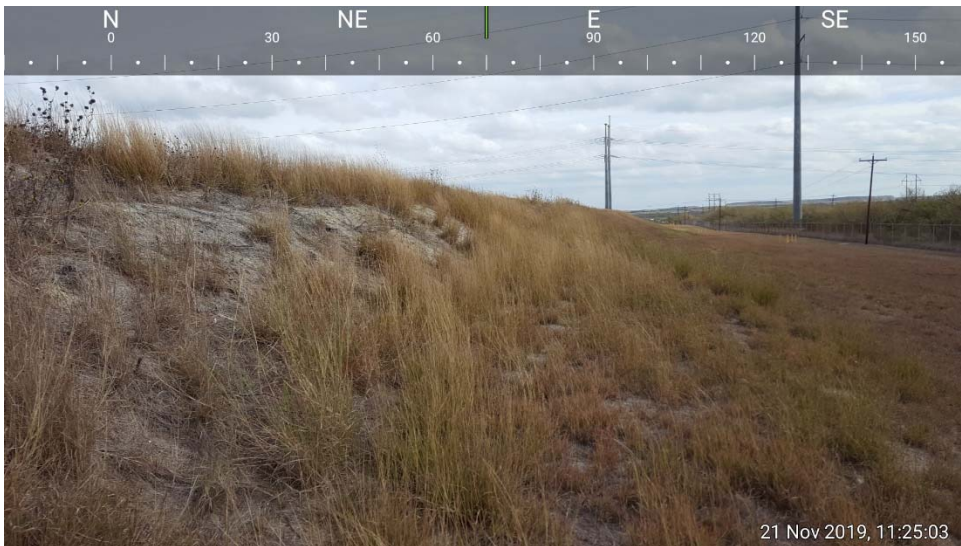
**PHOTO 34**

Grass cover along the southern slope of the Ash Pond B embankment.

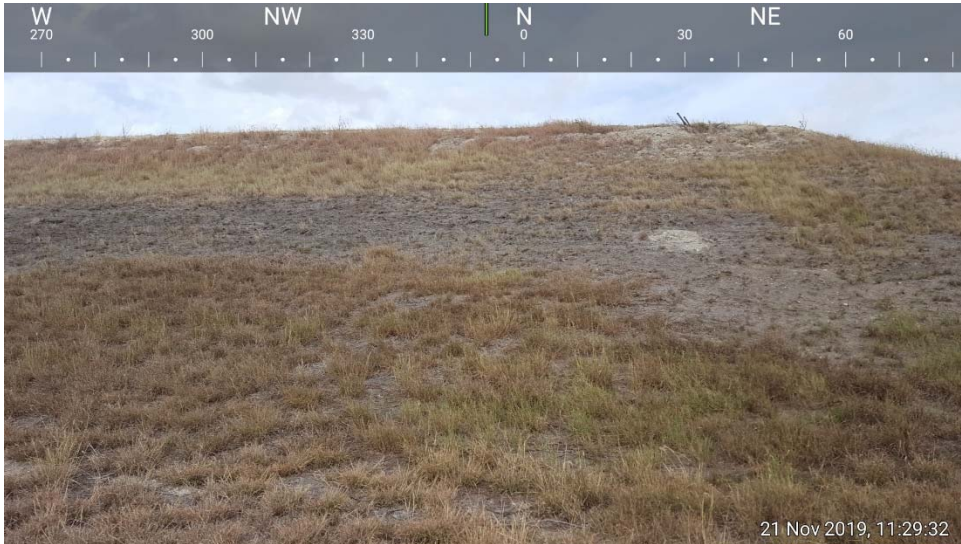
PHOTO 36

The southern portion of the slope realignment along the eastern side of the Ash Ponds. The area is sparsely vegetated but has been reseeded.

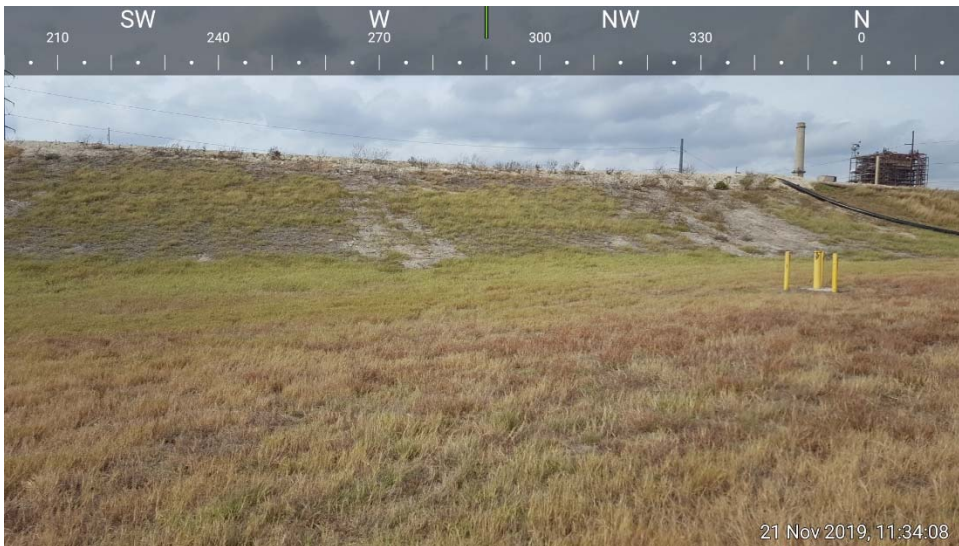
**PHOTO 38**

Another view of the northern portion of the slope realignment area. Two areas are less vegetated than the adjacent areas.

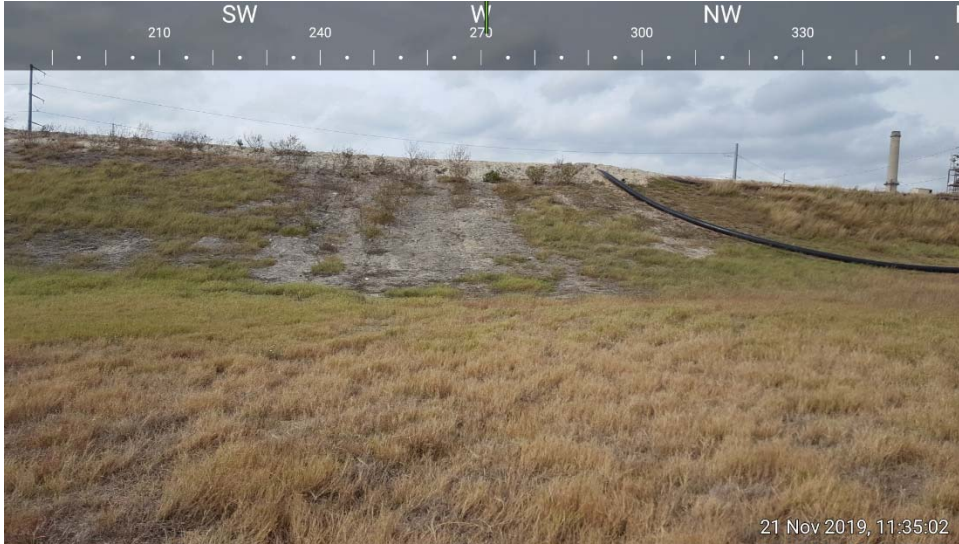
**PHOTO 40**

The area downslope from the catchment for drainage from the dewatering bins.

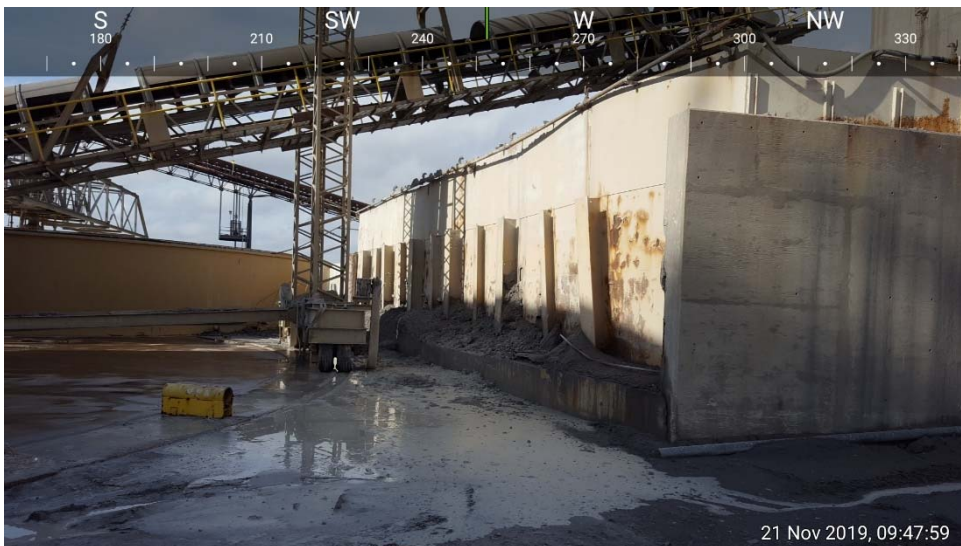
**PHOTO 2**

Looking to the west along the southeastern wall of the Ash Pile containment that was repaired in 2018. The area was wetter than usual due to the increased water content of the ash that is mixed with the ash removed from Ash Pond A.

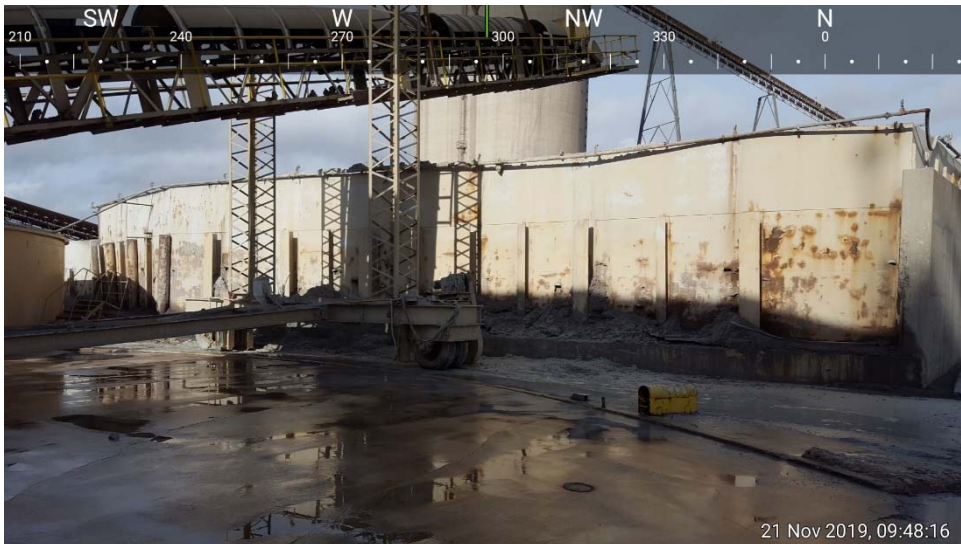
PHOTO 4

Ash was accumulating along the southeastern wall of the Ash Pile containment structure.

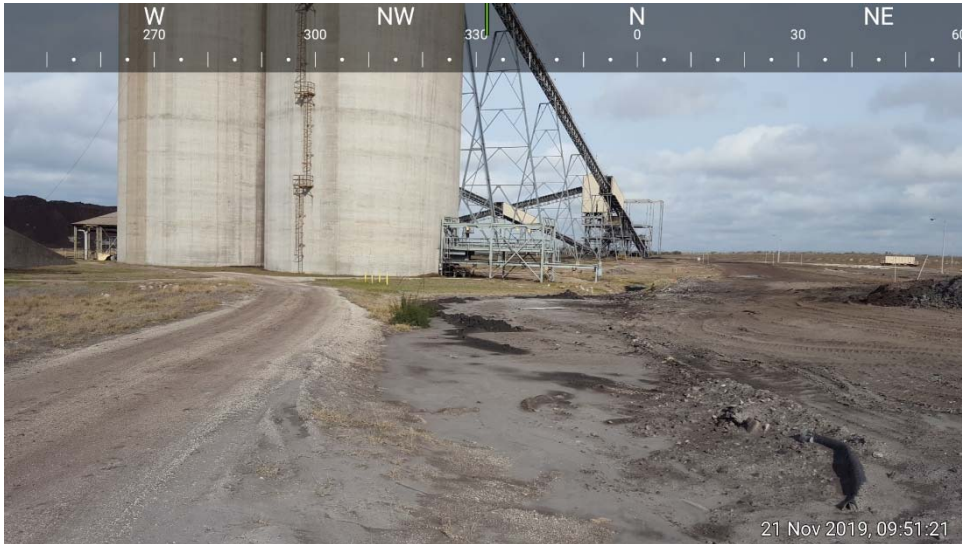
PHOTO 7

Erosion gullies observed along the drainage channel.	This is a routine maintenance matter. SMECI excavated the ditch as part of their routine maintenance in August 2018. The area was cleaned using the front-end loader and most of the erosion rills were removed prior to the 2018 inspection. The area was observed to be in similar condition during the 2019 Annual Inspection. See Photo Nos. 7, 8, 9 and 10
Sludge pile is exposed resulting in minor erosion.	This is a routine maintenance matter. Ash material is routinely removed from the Ash Pile for disposal. See Photo Nos. 1, 5, 14, 15, and 16
Storm water runoff not draining properly. Storm water runoff ditches are present on west and north sides of the Ash Pile. Run on drainage behind the concrete wall has no contact with the sludge waste.	This is a routine operations maintenance matter. SMECI excavated the ditches/drainageway on the western side of the Ash Pile as part of their routine maintenance in August 2018. There appeared to be little change to the drainageway during the 2019 Annual Inspection. The drainageway to the north of the Ash Pile should be cleaned but is functioning to remove stormwater from the Ash Pile area. See Photo Nos. 7, 8, 9, 10, 11, 12, and 13

Drainage from the area to the southwest of the Ash Pile is directed to the north to a stormwater drain.

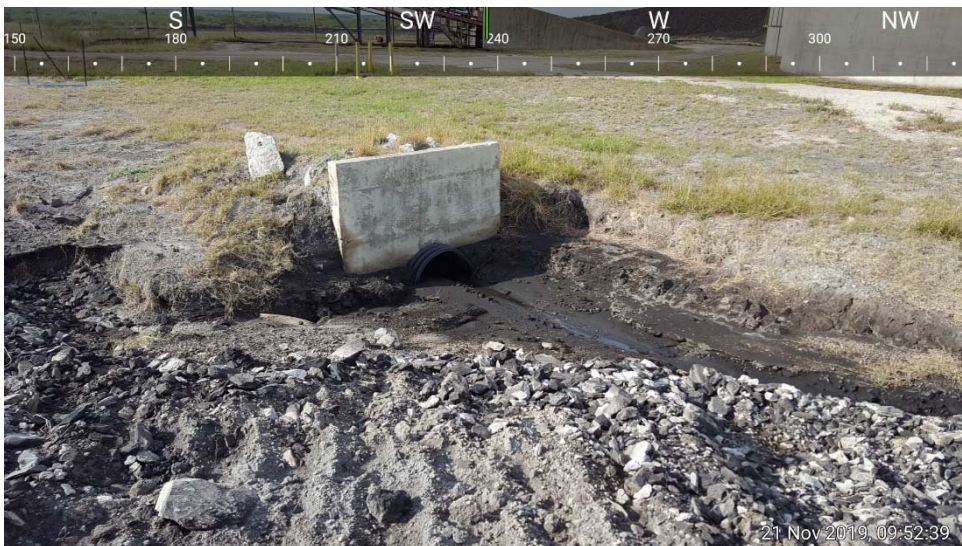
PHOTO 8

Rutting along haul roads.	This is a routine operations maintenance matter. Rutting was not observed at the time of the 2019 Annual Inspection. See Photo Nos. 9, 16, 17, and 18
Stormwater structures need repair.	This is a routine operations maintenance matter. General repairs were made to stormwater structures in August 2018 and are routinely maintained and repaired on an as-needed basis. Stormwater structures were observed to be operating as designed during the 2019 Annual Inspection. See Photo No. 8, 11, 12, and 13

The stormwater drain located along the western edge of the Ash Pile area.

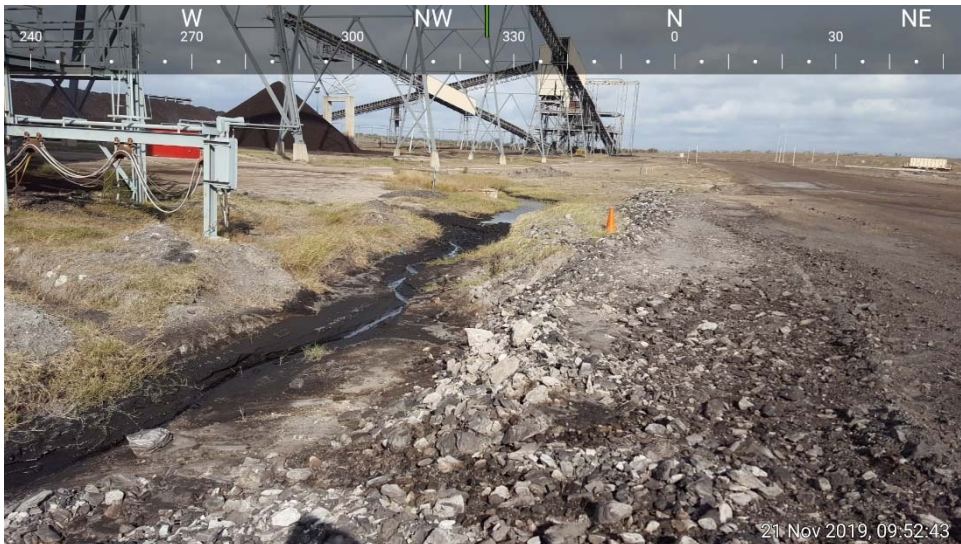
**PHOTO 9**

Drainage along the western edge of the Ash Pile area that flows to the south to the stormwater drain shown in the previous photograph.

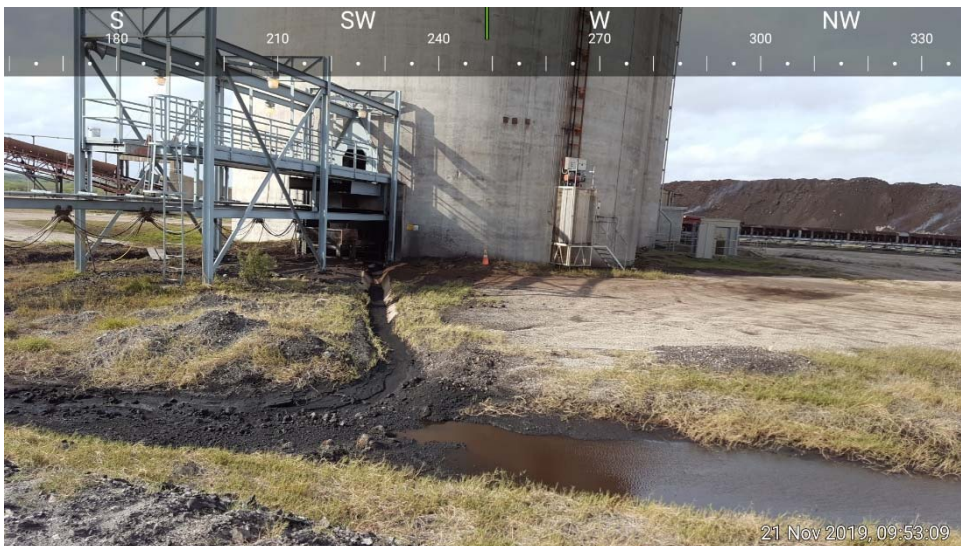
**PHOTO 10**

The drainage from the lignite silo area as it flows to the drainageway along the western edge of the Ash Pile area.

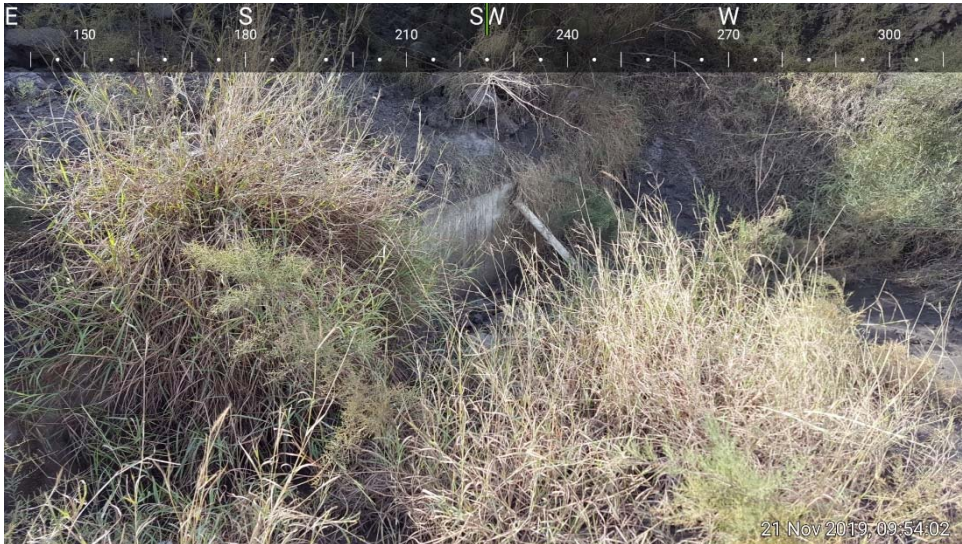
**PHOTO 11**

The stormwater drains at the southern end of the drainageway located between the incoming and outgoing haul roads. This drainageway should be cleared of excess sediment material but is functional. The inflow of sediment should be minimized to avoid accumulation in the drainageway.

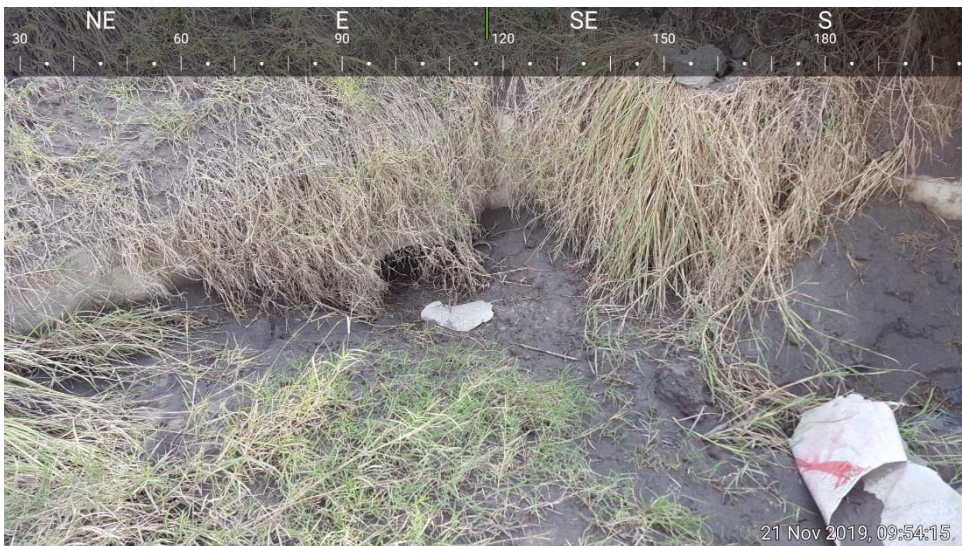
**PHOTO 12**

Stormwater culverts located on the eastern side of the drainageway shown in the previous photograph.

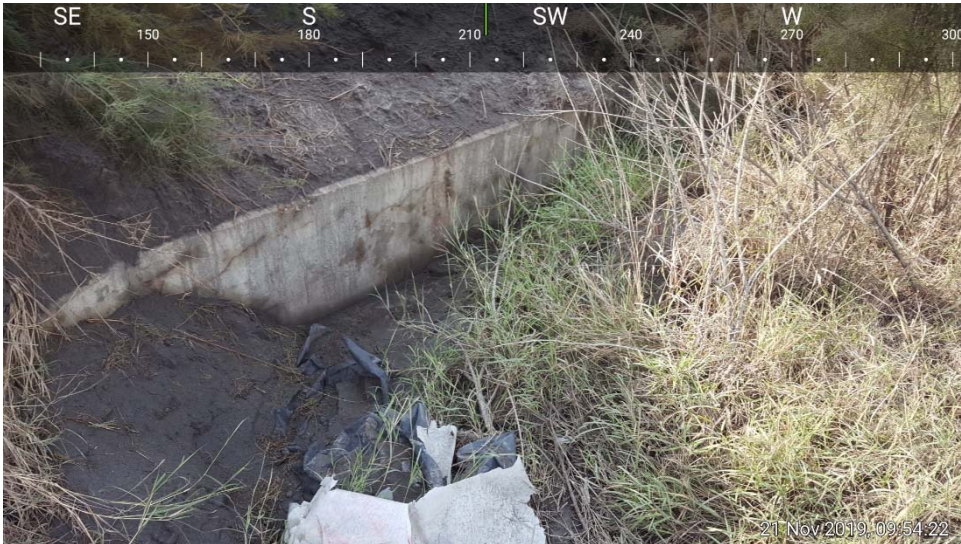
PHOTO 13

Another view of the headwall located at the southern end of the drainageway between the haul roads to the north of the Ash Pile.

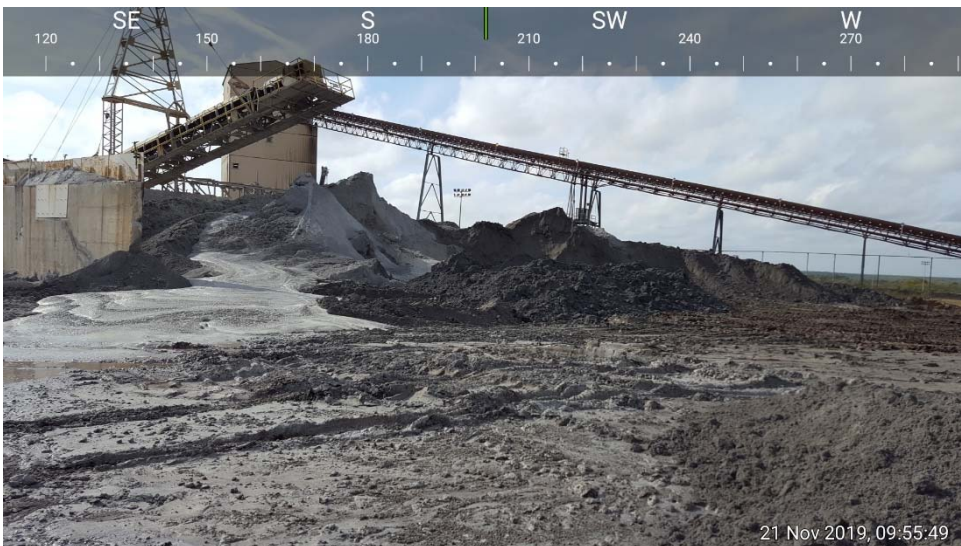
PHOTO 14

Looking to the south-southwest at the Ash Pile. The darker material is from the Ash Pond A ash removal project. The lighter material is currently being generated at the plant. The two materials are blended and then transported for disposal in previously mined areas.

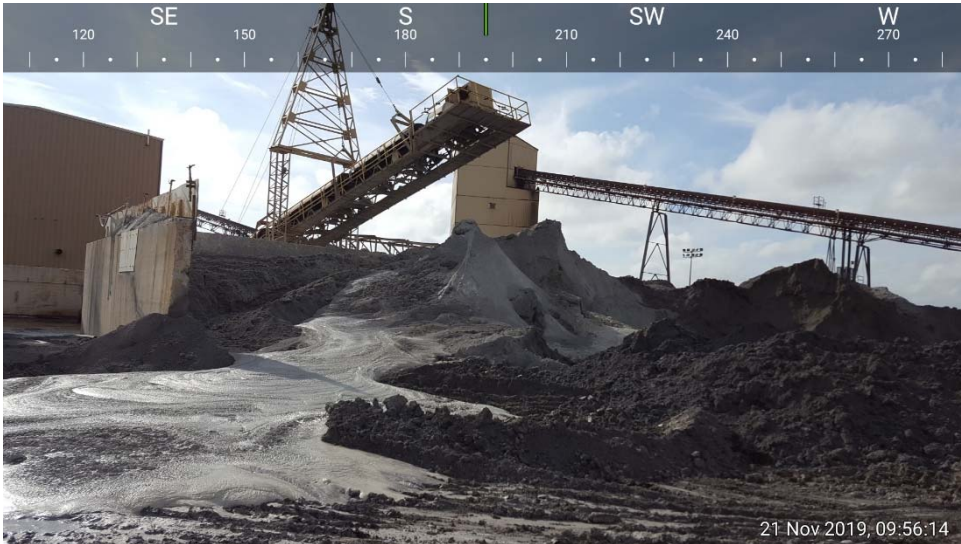
PHOTO 15

A closer view of the two ash materials to be blended for disposal.

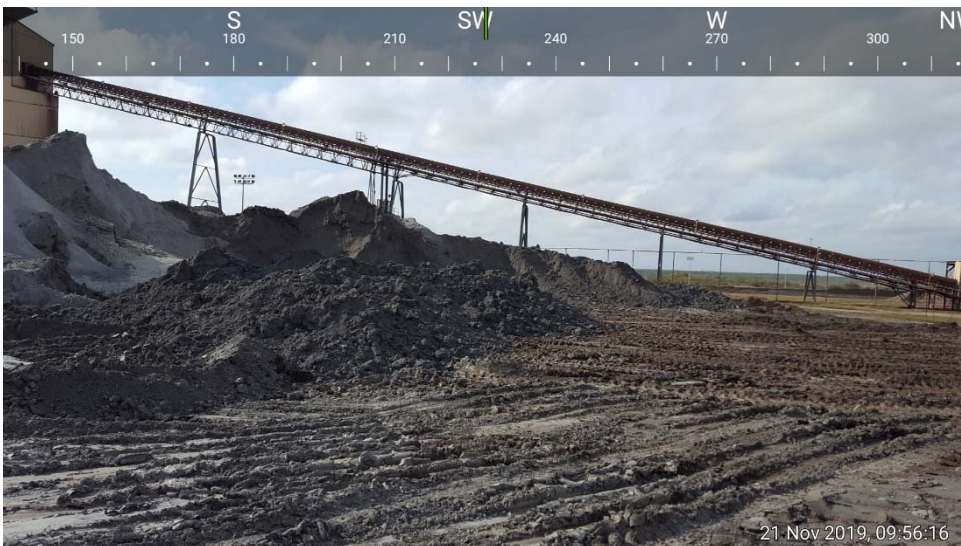
PHOTO 16

The loading area located to the north of the Ash Pile containment structure.

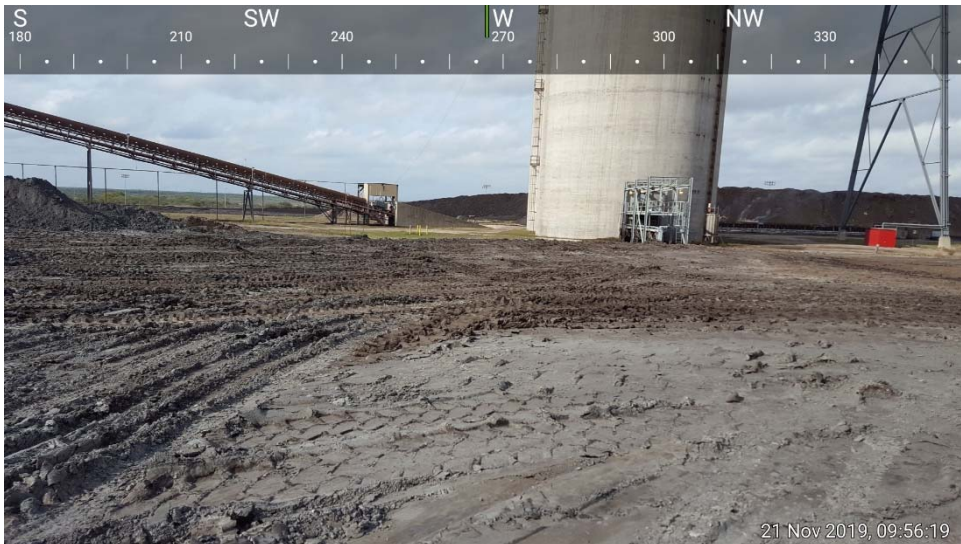
**PHOTO 17**

The recently cleaned loading area with the lignite silos in the background.
