**ANNUAL INSPECTION REPORT FOR COAL COMBUSTION RESIDUALS (CCR) UNITS  
SAN MIGUEL ELECTRIC COOPERATIVE POWER PLANT**

January 10, 2020

Wood Project No.: 6706160039

Appendix A    November 21, 2019 Inspection Summary

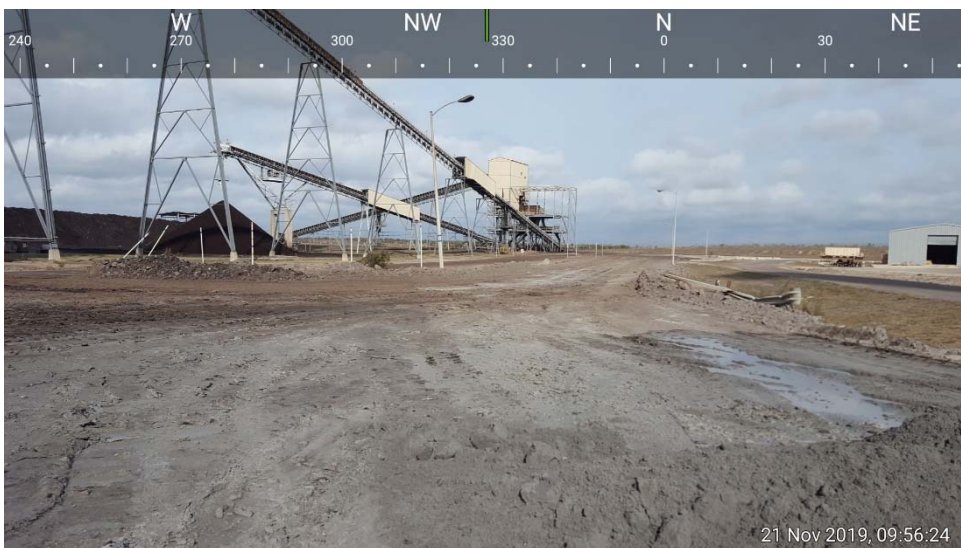
**PHOTO 18**

Rutting along haul roads.	This is a routine operations maintenance matter. Rutting was not observed at the time of the 2019 Annual Inspection. See Photo Nos. 9, 16, 17, and 18
Stormwater structures need repair.	This is a routine operations maintenance matter. General repairs were made to stormwater structures in August 2018 and are routinely maintained and repaired on an as-needed basis. Stormwater structures were observed to be operating as designed during the 2019 Annual Inspection. See Photo No. 8, 11, 12, and 13

Looking to the north-northwest along the entrance haul road to the Ash Pile containment area. The exit haul road is on the left of the photograph on the eastern side of the conveyor structure.
