Vendor's building survey report
**The Plaza, Elms Road,
Wokingham RG40 2AA**

Prepared for: Aviva Life & Pensions UK Limited
Prepared by: Shaun Miller BSc (Hons) MRICS
Mark Hannan
Issue date: 11 June 2024
Report stage: Final
Reference: 124359-100/MAS/SPM

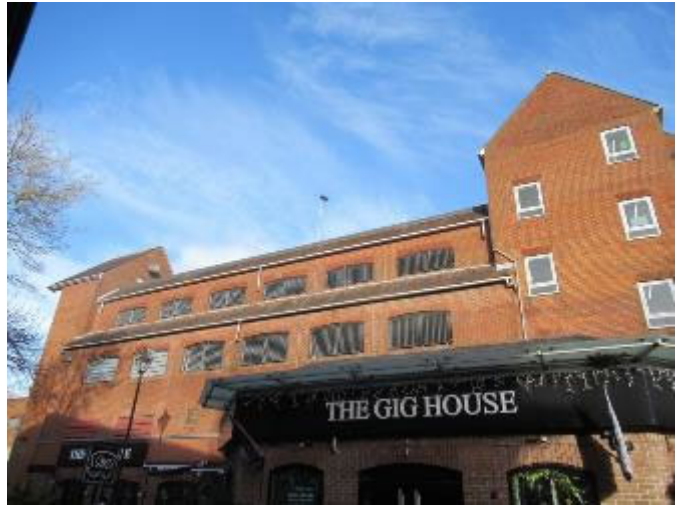
<p>5.</p>	<p>A view of cracking to Gauged brickwork to the southern elevation.</p>

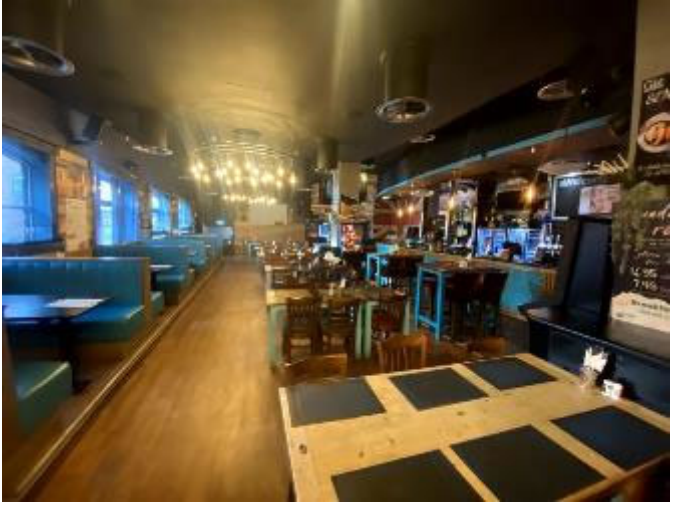
A photograph of a bar or pub interior. The space is filled with wooden tables and chairs, blue upholstered seating, and a bar counter in the background. The lighting is warm and ambient.
27.	Water/damp ingress to isolated ceiling areas of unit 2.

- A number of areas of ceiling stains were noted, which appear to be as a result of leaks from roof areas or rainwater goods (including internal rainwater goods from the car park). Isolated repairs will be necessary alongside the repairs noted to rainwater goods above.

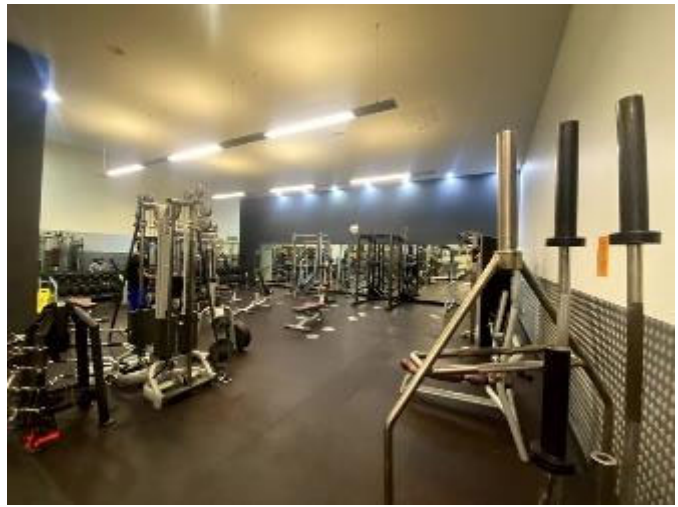
33.	Isolated areas of water ingress to back of house areas to Nuffield health.

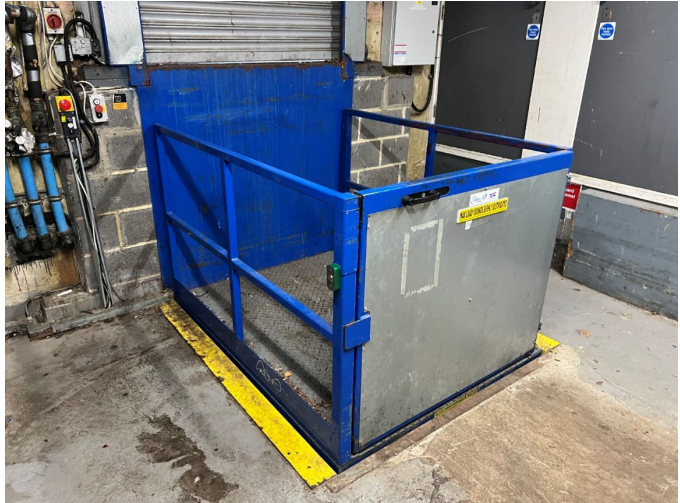
A white stair lift is installed on a staircase. The lift is a platform-style lift with a handrail and a control panel. It is positioned on a grey tiled floor next to a set of stairs with yellow safety markings. The background shows a plain wall and a metal handrail.
38.	The service yard scissor hoist.
