# Inspection Result Certificate

Brand/ Model (Year)	Nissan / XTrail (2005)
Mileage	121,308 km
Engine Type / Size	QR20 (DE) / 2000 cc
Transmission / Type of WD	AT / 4WD
Fuel	Petrol

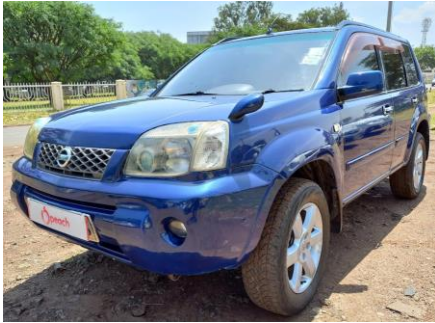
Scratches on driver's side rear door  
 Repainted

No serious issue found.

Evidence of oil leaks

Brake discs worn  
 Brake pipe damaged  
 Some instability during braking

Worn ball joints  
 Excessive play from steering rack  
 Evidence of leaks from steering pump

Tires significantly worn  
 Left headlight lens broken  
 Power mirrors, power windows, and radio not working properly

- Replacement of ball joints, steering rack ends, left headlight
- Brake disc skimming
- Purchase of new tires, do wheel alignment and balancing
- Regular service recommended after purchase as a new owner
