4T65E SHIFT KIT®

Long shifts, hard shifts, chatter with heavy acceleration from stop, no lockup or 4th. Codes P1811--PO741

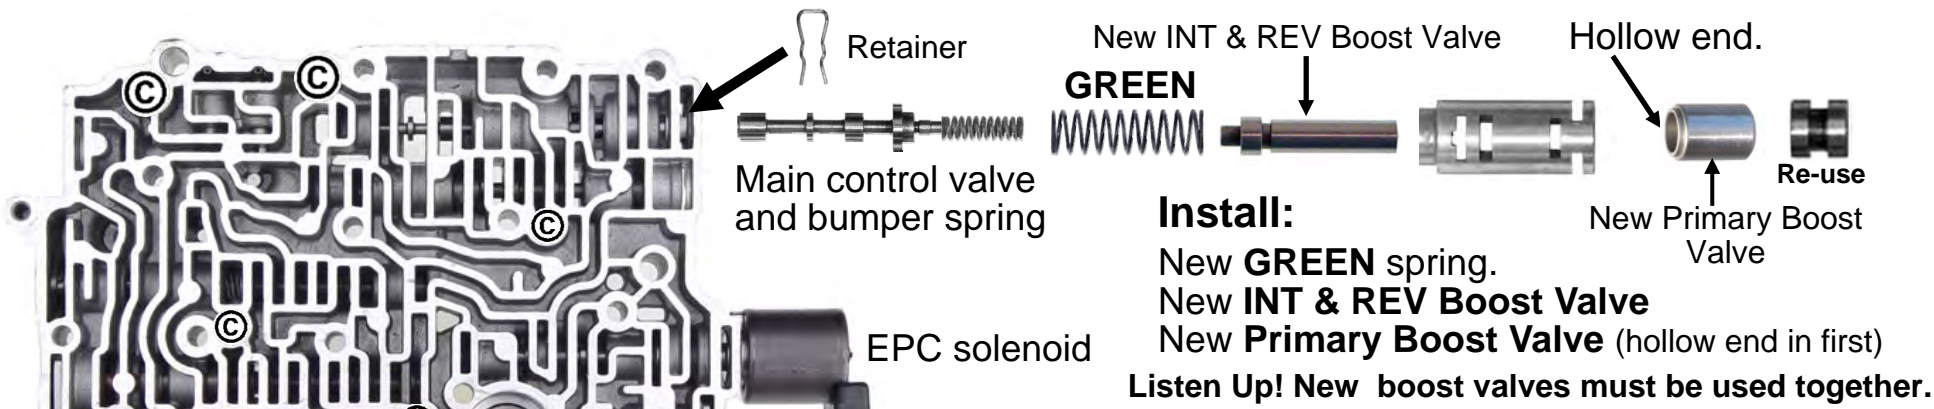
Six VB check-balls:
 Four © .250
 Two © .375

EPC solenoid: Replace it!

This solenoid fails with no metal contamination, even on a perfectly clean low mileage transmission.

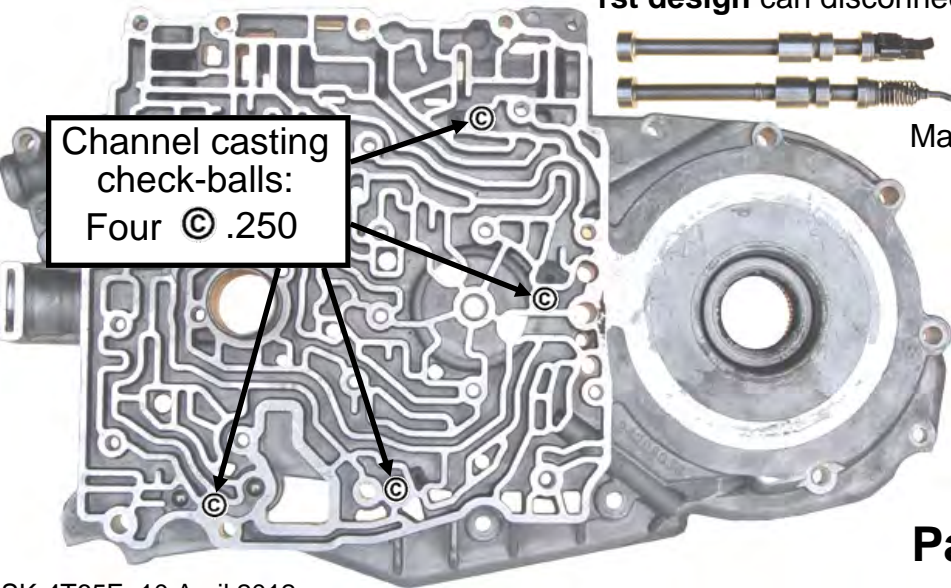
Consider upgrading manual valve.
1st design can disconnect from link.

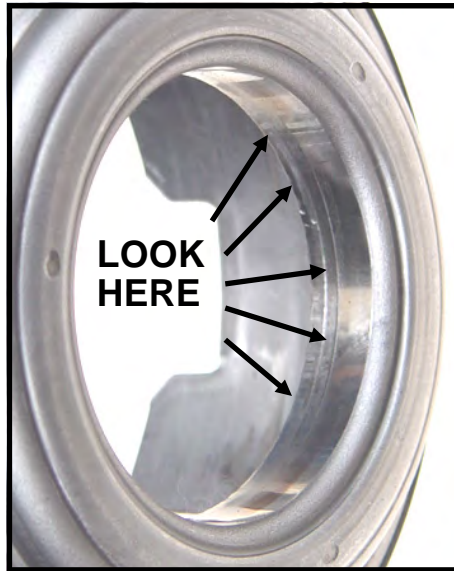
Input clutch piston

Won't move, neutrals at stop may be worse hot or cold:

Input piston worn. **Replace it.**
The three input drum solid teflon rings shrink, **always** replace them.
