SK° 604 Non-VLP 604/41TE & 606/42LE 1989-2006 Also fits 42RLE 2003-2006

Corrects / Prevents / Reduces

Delay or No Forward or Reverse, Rough Coast Down 4-3, Stabilizes Clutch Pressure & CVI's.

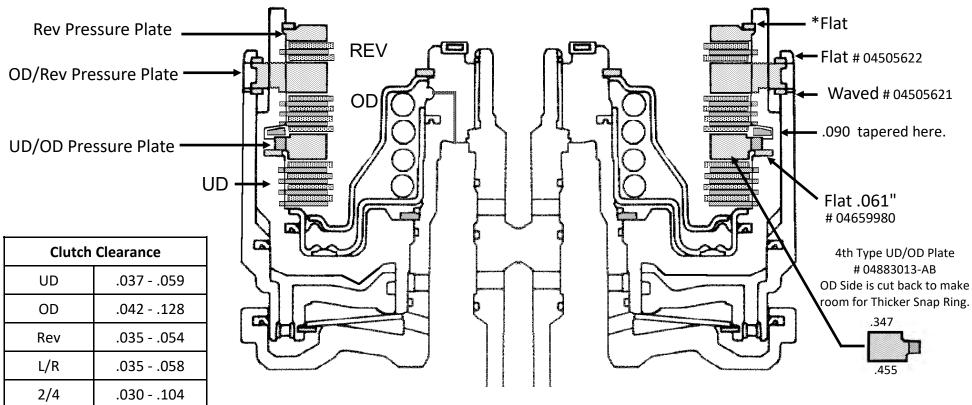
604/42RLE 4th Type** Stack-up

UD clutch: Has four .073 thick frictions. High Energy/Brown Paper **OD clutch:** Has four .073 thick frictions should be High Energy.

Reverse clutch: Has two .073 frictions High Energy/Brown Paper

UD stack- Start with .068 steel plate, alternate .073 clutch plates, the stack will end with a friction. Install .061" flat snap-ring, 4th design UD/OD Pressure plate then tapered .090 snap-ring.

OD stack- Start with .073 friction plate, alternate with .068 steel plate. The stack will end with a friction plate. Install waved snap-ring, OD/Rev Pressure Plate then install flat snap-ring.

*Rev stack- Start with .073 friction, .068 steel, .073 friction, Pressure Plate and flat selective snap-ring. Selective Rev Snap Rings: 1.53-1.58mm- # 04377195, 1.77-1.83mm- # 04412871, 2.02-2.07mm- # 04412872, 2.27-2.32mm- # 04412873.

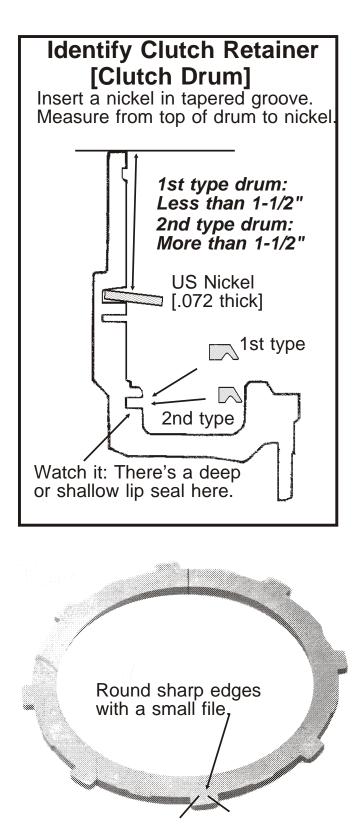
1st & 2nd type UD/OD pressure plates are flat & <u>sharp</u> across top and tooth. File teeth edges. Just barely file edge of teeth so sharp edge won't cut snap ring.

Don't use .061 taper snap ring any-where.
