SK® CD4E-Jr Shift Kit® Series 7D Corrects/Prevents/Reduces

Converter Slip and Code 628

Ford CD4E Mazda LA4A-EL

READ THIS: CD4E Repair Data

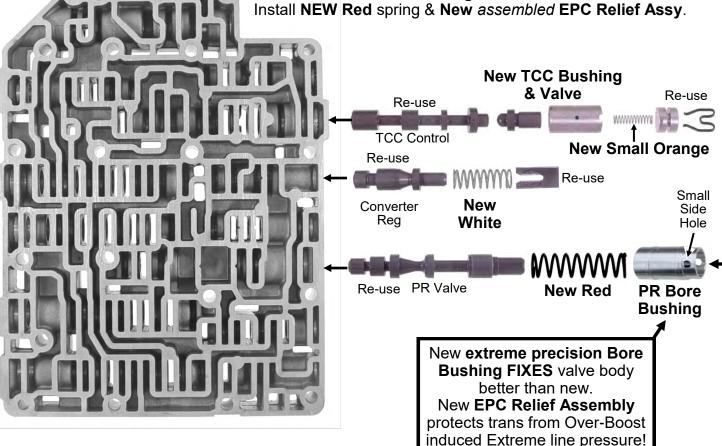
Main Valve Body

The bore at "A" erodes over size. Converter and EPC then mix which causes high line pressure and converter slip with blinking OD light-Code 628. No worries! You're *fixing the problem* with this kit!

Clean PR bore. Lube & install PR Valve fully into the bore. Install **NEW PR Bore Bushing** with small side hole outboard. Install **NEW Red** spring & **New** assembled **EPC Relief Assv**.
