GF4A-EL Shift Kit®

Probe: All 1993. 1994-97 with 2.5L [Ford designation: 4EAT-GF] Mazda: 1994-97 MX-6/626 with 2.5L-1995-97 Millenia with 2.5L

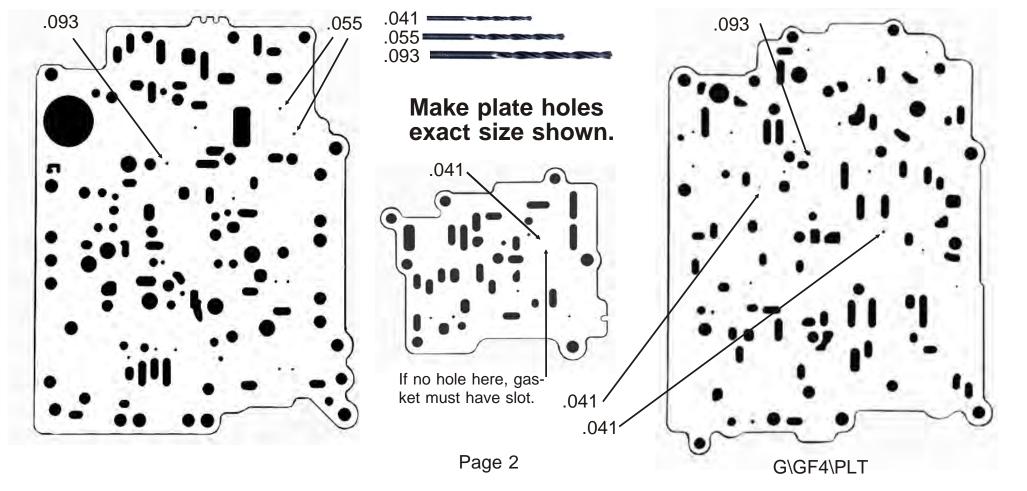
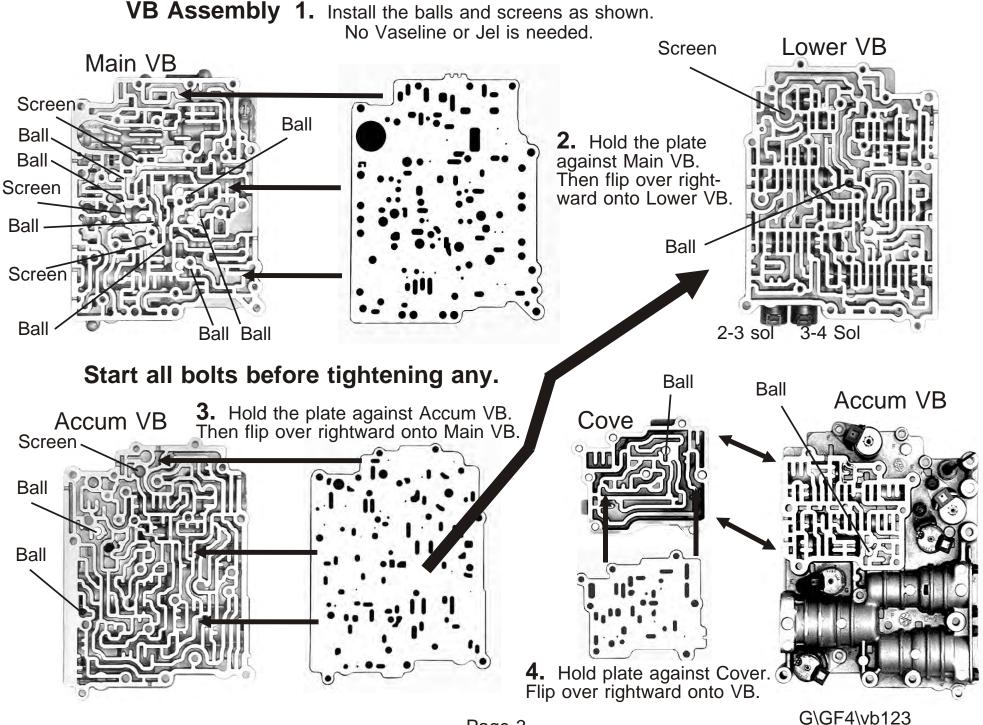
Flat sand this cover

Do not flat sand the valve bodies.

The PWM and EPC solenoids are the same. Available from Ford, F32Z-7G136AA \$47. If 3/4 clutch was burned out replace the EPC Solenoid.

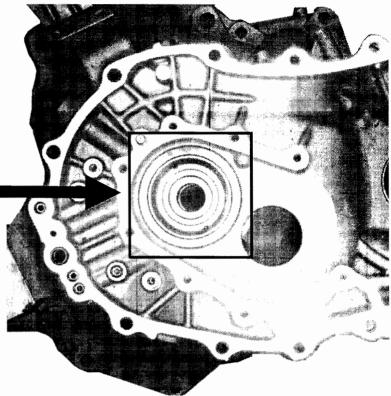
Complaints: 3-4 clutch burn-up; Runaway instead of 2-3 shift; Long and soft 2-3 upshift. Two things effect these rings. Fix the rings: Grind a 45° chamfer about 1/3 of the way across the OD. Skip the portion close to the scarf cut. Run your finger nail around the edges to scrape off any fringe or grinding burrs. Then pull the ring out flat once to open it up. Install it in groove with Vaseline. Some replacement rings are too narrow or wide. All Teflon rings in this trans should be .077 to .080 wide.
