Submitted by
AECOM
9400 Amberglen Boulevard
Austin, Texas 78729
October 17, 2018

CCR Certification: Unstable Area

Ash Pond, Equalization Pond and
Ash Pile

San Miguel Plant

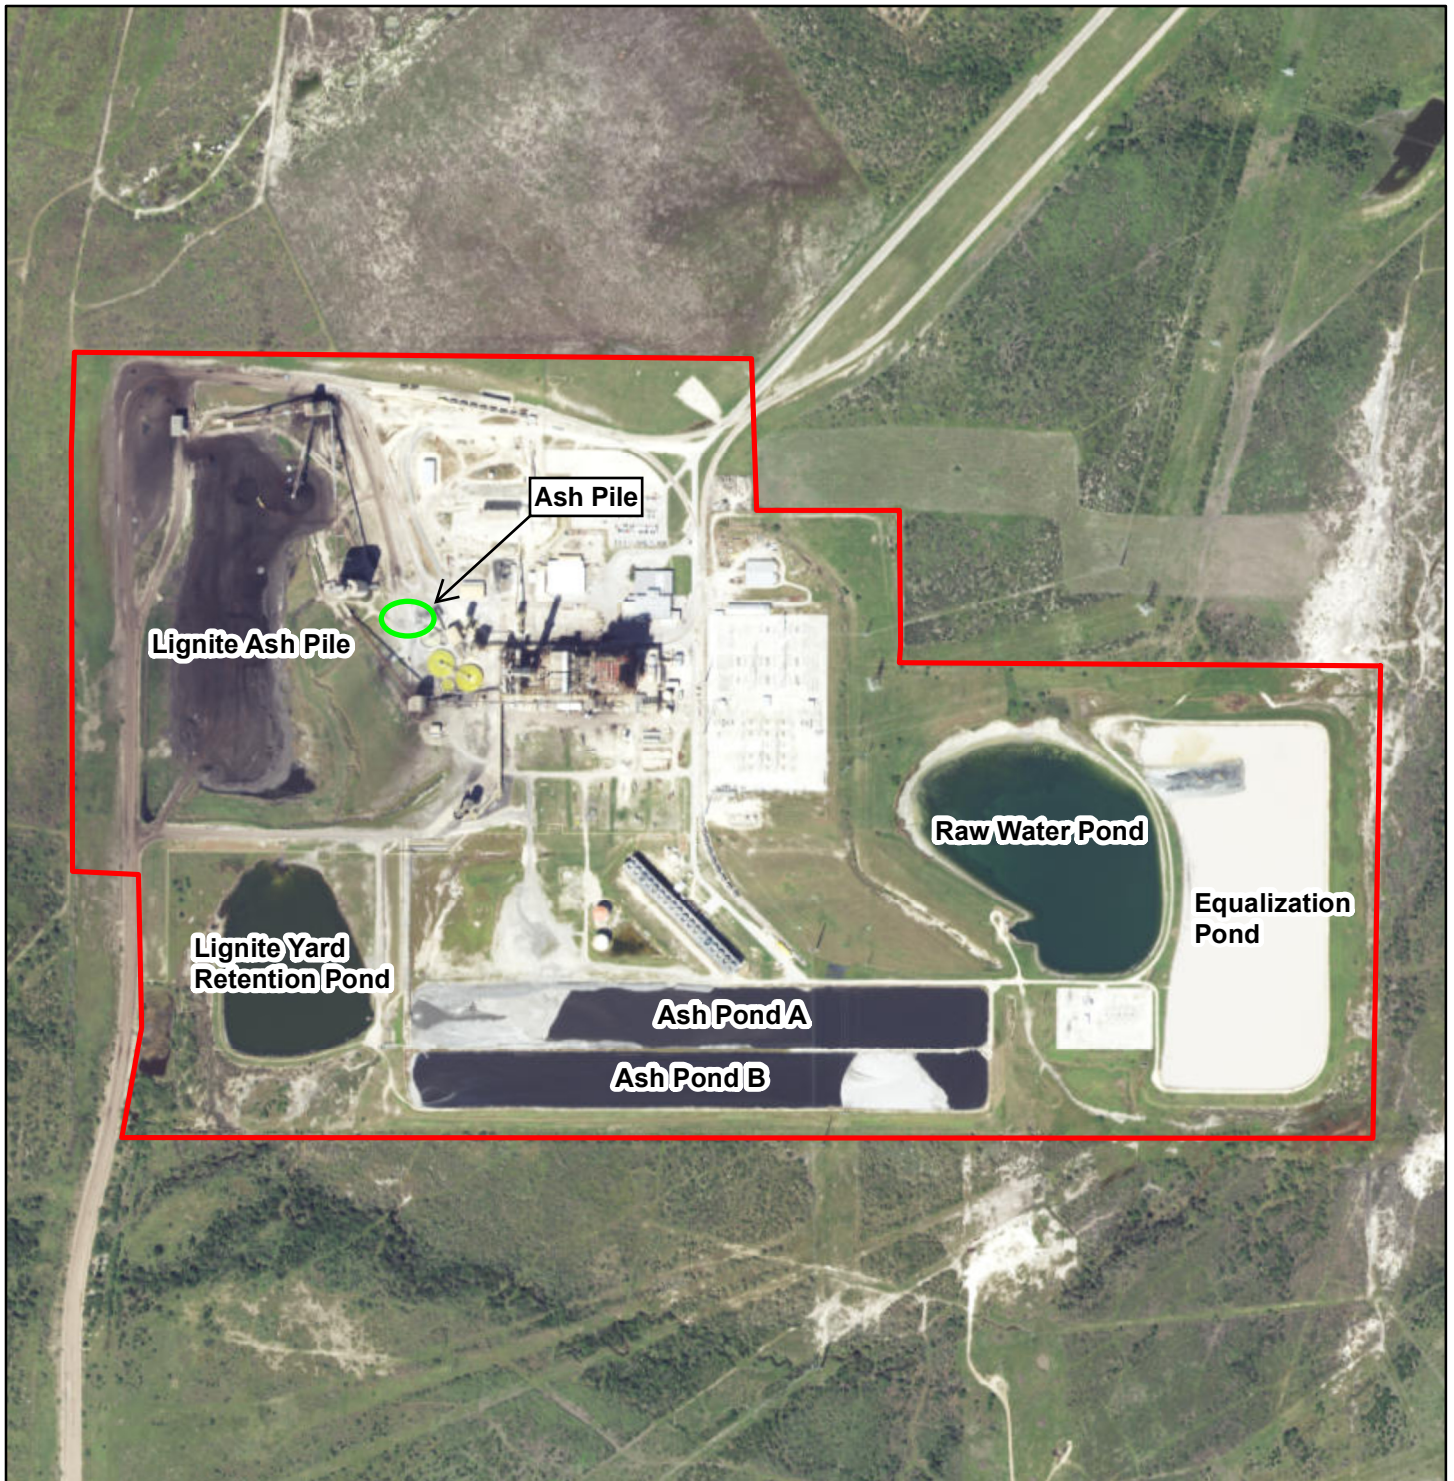
FIGURE 2

Aerial Source: NAIP 2016 (10/10/2016)

2016 AERIAL PHOTOGRAPH MAP

The San Miguel Plant is located in south central Atascosa County in Christine, Texas. The plant is surrounded by open grassy areas, a majority of which is used as pastureland for livestock. The Plant has three CCR units which include two surface impoundments (the Ash Pond and Equalization Pond) and one landfill (the Ash Pile). A site Location Map showing the area surrounding the San Miguel Plant is included as **Figure 1 of Appendix A. Figure 2 in Appendix A** presents the San Miguel Plant Site Map.
