Submitted by
AECOM
9400 Amberglen Boulevard
Austin, Texas 78729

CCR Certification: Fault Area

Ash Pond, Equalization Pond and
Ash Pile

San Miguel Plant

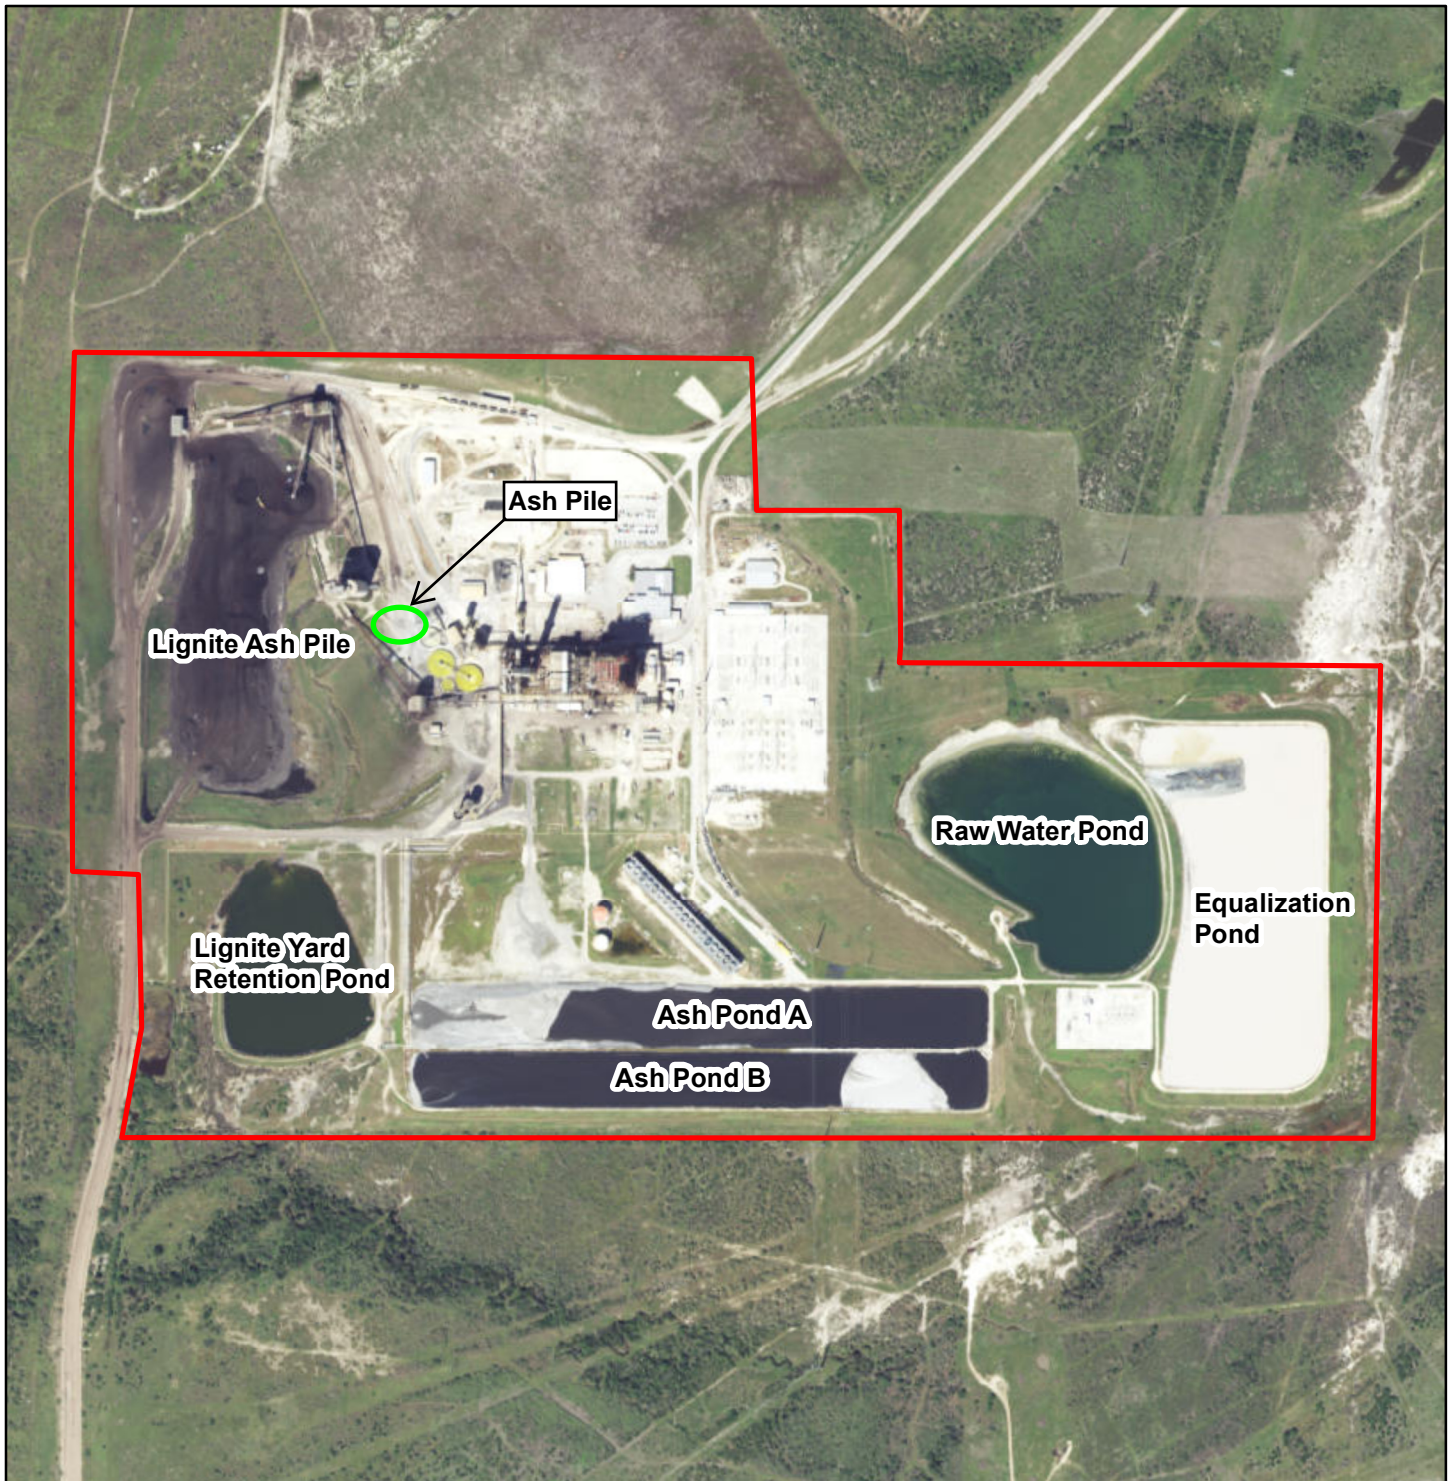
FIGURE 2

Aerial Source: NAIP 2016 (10/10/2016)

2016 AERIAL PHOTOGRAPH MAP

The San Miguel Plant is located in south central Atascosa County in Christine, Texas. The plant is surrounded by open grassy areas, a majority of which is used as pastureland for livestock. The Plant has three CCR units which include two surface impoundments (the Ash Pond and Equalization Pond) and one landfill (the Ash Pile). A site Location Map showing the area surrounding the San Miguel Plant is included as **Figure 1 of Appendix A. Figure 2 in Appendix A** presents the San Miguel Plant Site Map.
