**LINER SYSTEM CERTIFICATION REPORT  
For  
ASH WATER TRANSPORT POND 1-B**

**SAN MIGUEL ELECTRIC COOPERATIVE, INC.  
SAN MIGUEL PLANT  
CHRISTINE, ATASCOSA COUNTY, TEXAS**

**ZEPHYR ENVIRONMENTAL CORPORATION  
TEXAS REGISTERED ENGINEERING FIRM F-102  
TEXAS GEOSCIENCE FIRM NO. 50037  
2600 VIA FORTUNA, SUITE 450  
AUSTIN, TEXAS 78746**

**NOVEMBER 28, 2017**

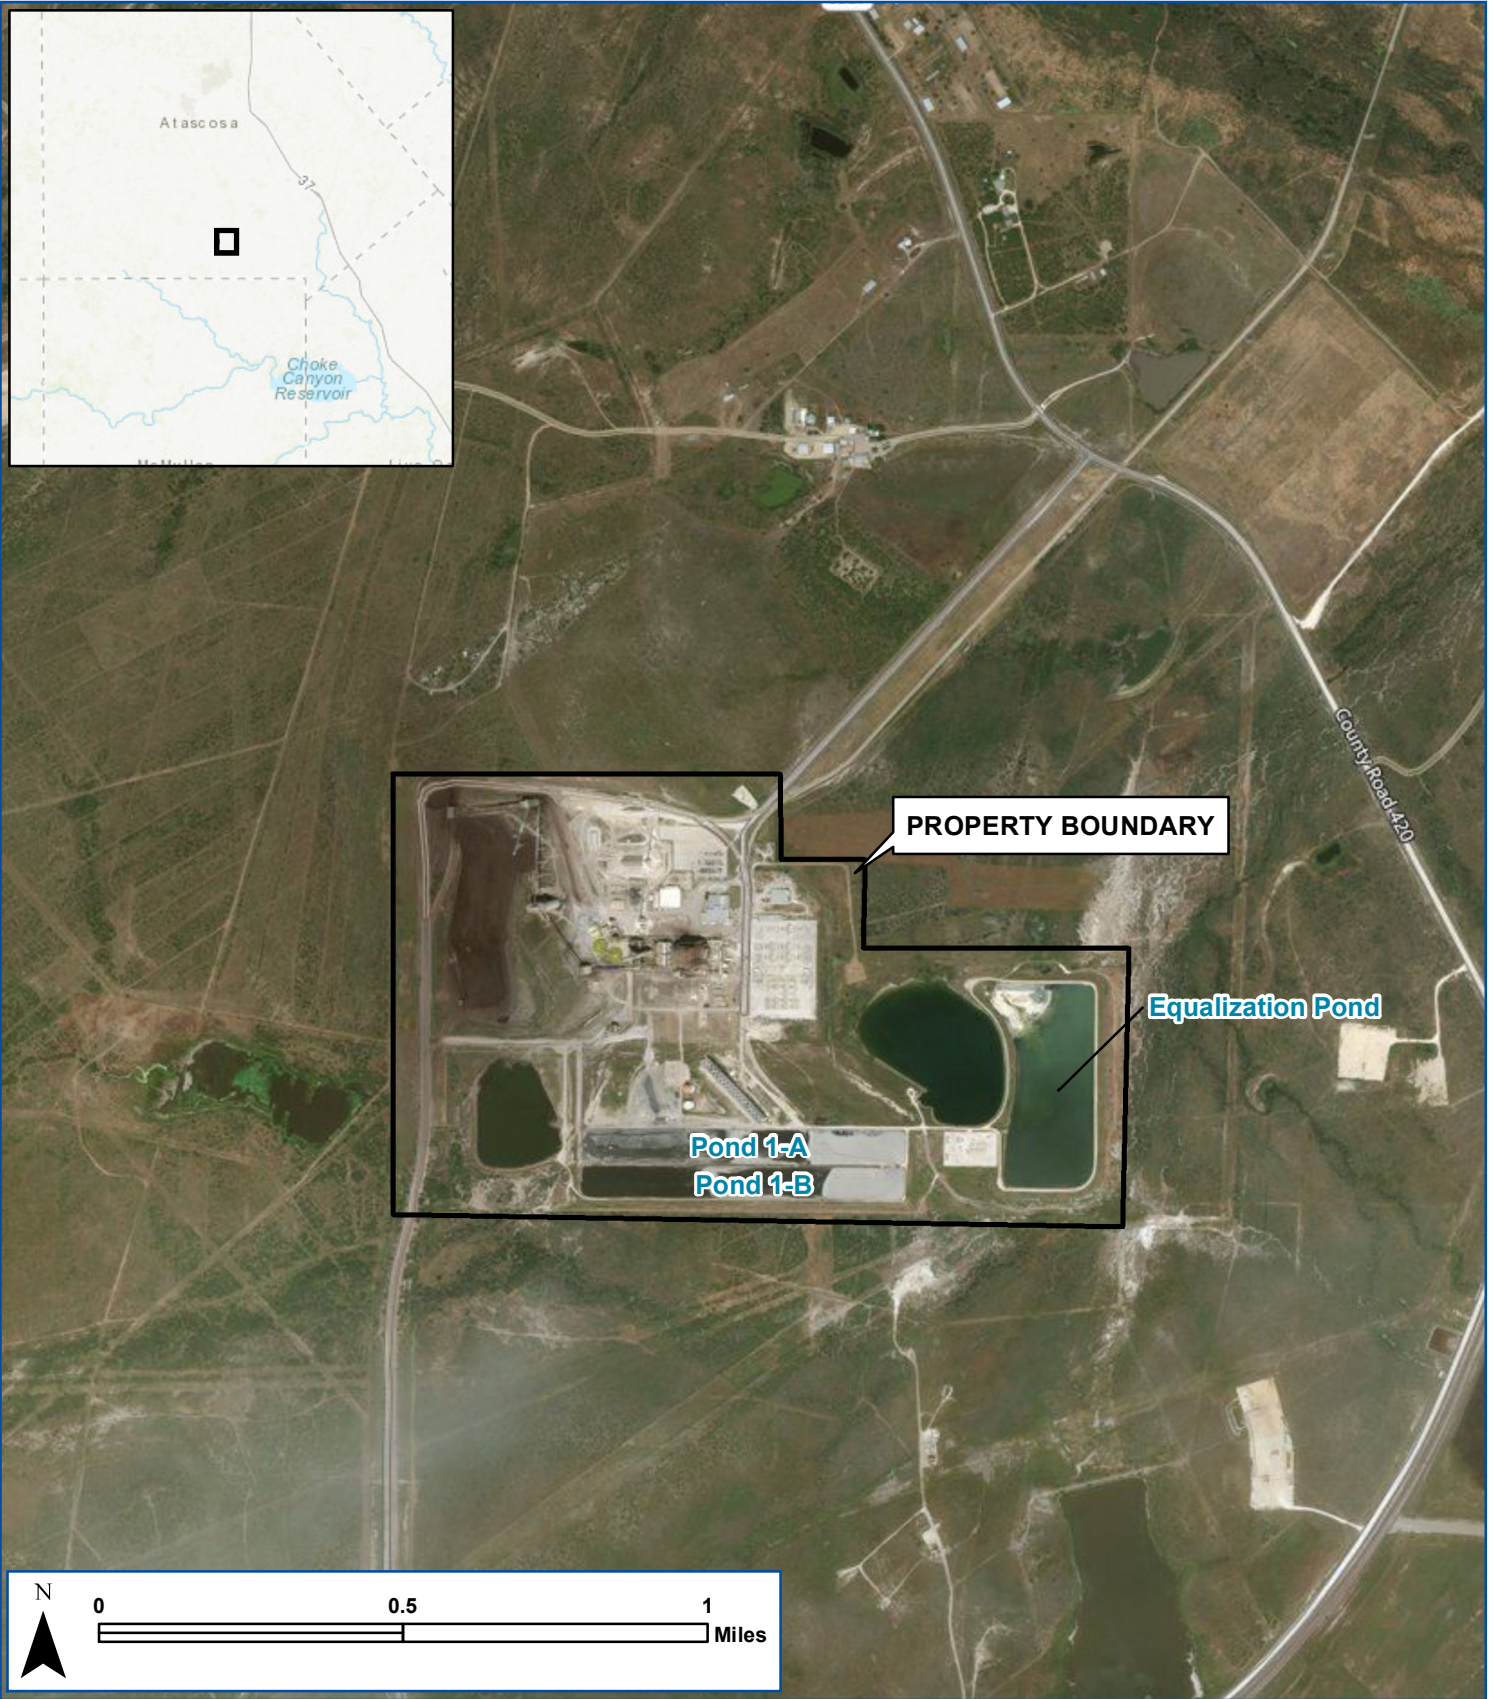
**FIGURE 1**  
**AREA MAP**

<b>FIGURE 1 - AREA MAP</b> <b>San Miguel Electric Cooperative, Inc.</b> <b>Atascosa County, Texas</b>			
		<small>H:\San Miguel Electric\017789 Pond Liner Evaluation\Drawings\1_AreaMap.mxd</small>			
<small>Drafted By: J. Knowles</small>		<small>Reviewed By: D. Sorrells</small>		<small>Project No.: 017789</small>	
				<small>Date: 11/28/2017</small>

**Figure 1** provides an area map depicting the location of these units within the facility.

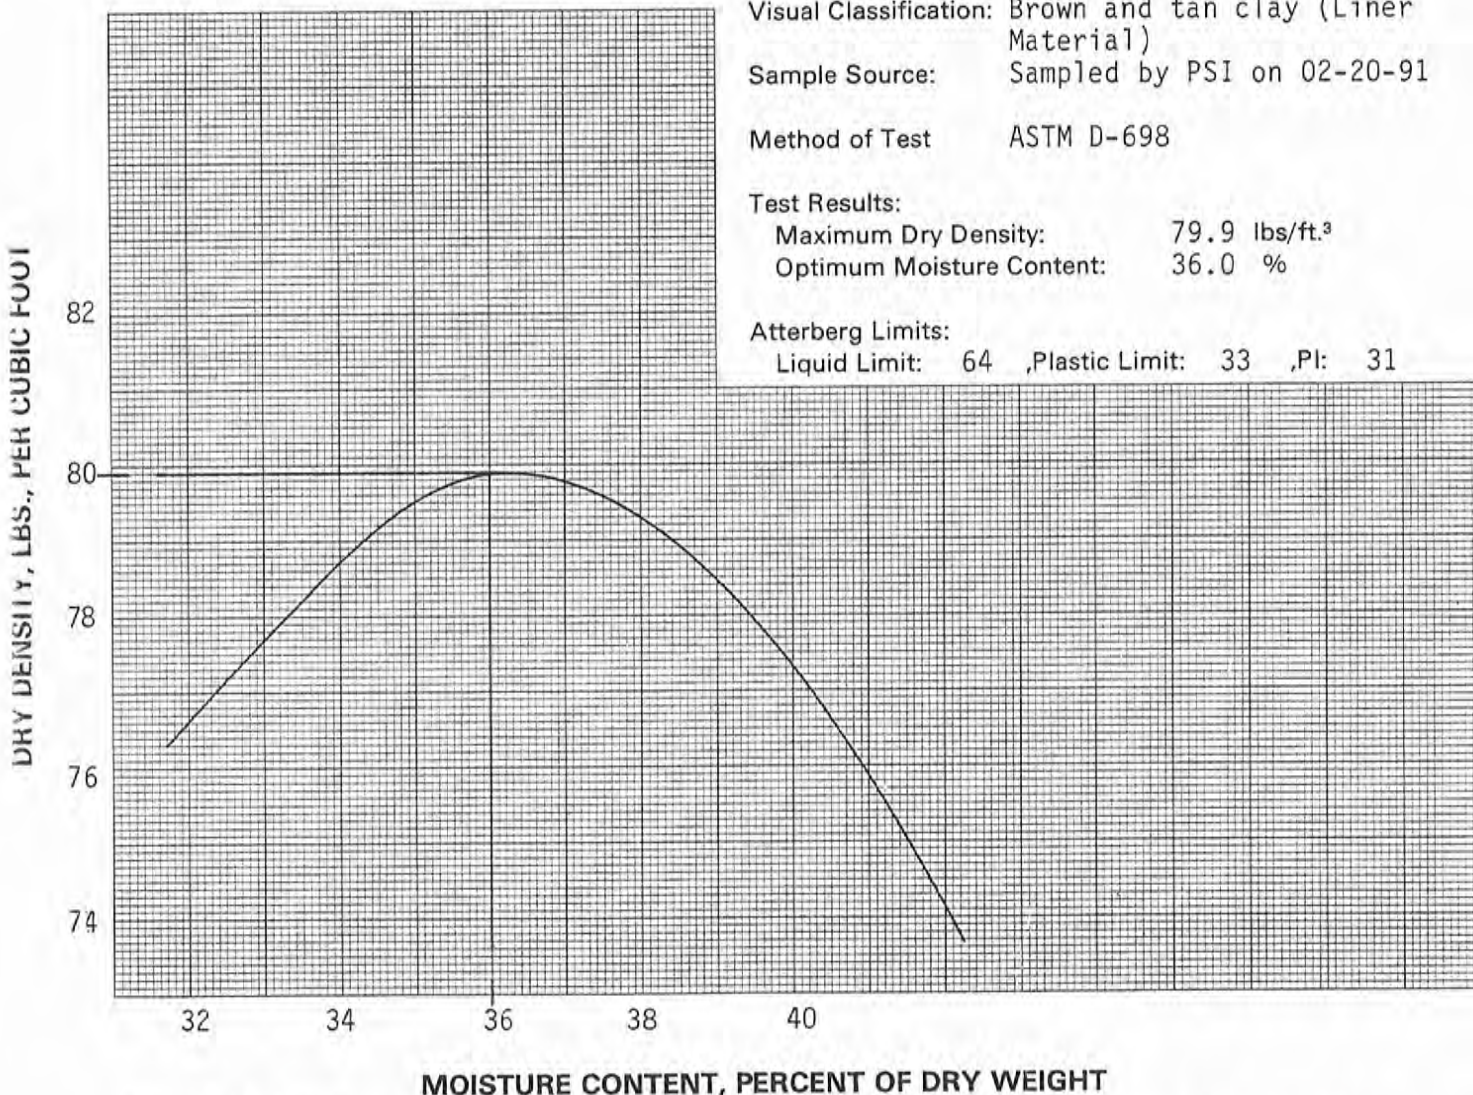
## REPORT OF MOISTURE DENSITY RELATIONSHIP OF SOIL

Maximum Dry Density: 79.9 lbs/ft.<sup>3</sup>  
Optimum Moisture Content: 36.0 %

Liquid Limit: 64 , Plastic Limit: 33 , PI: 31
