CCR Surface Impoundment Structural Stability Assessment

San Miguel Electric Cooperative, Inc.

Atascosa County, Texas

October 17, 2016

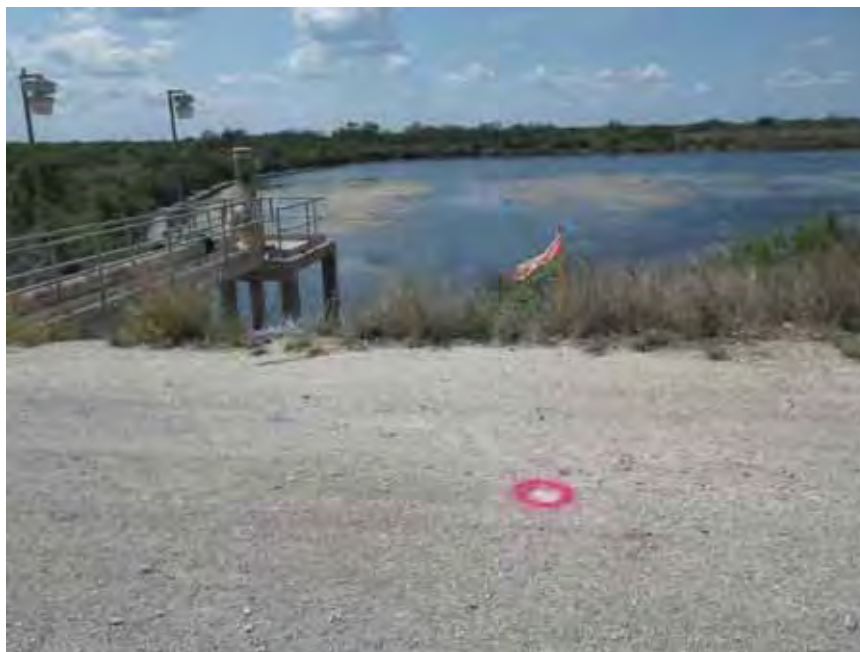
Photo 1 – View looking west at Boring B-2 and the Yard Drainage Retention Pond.

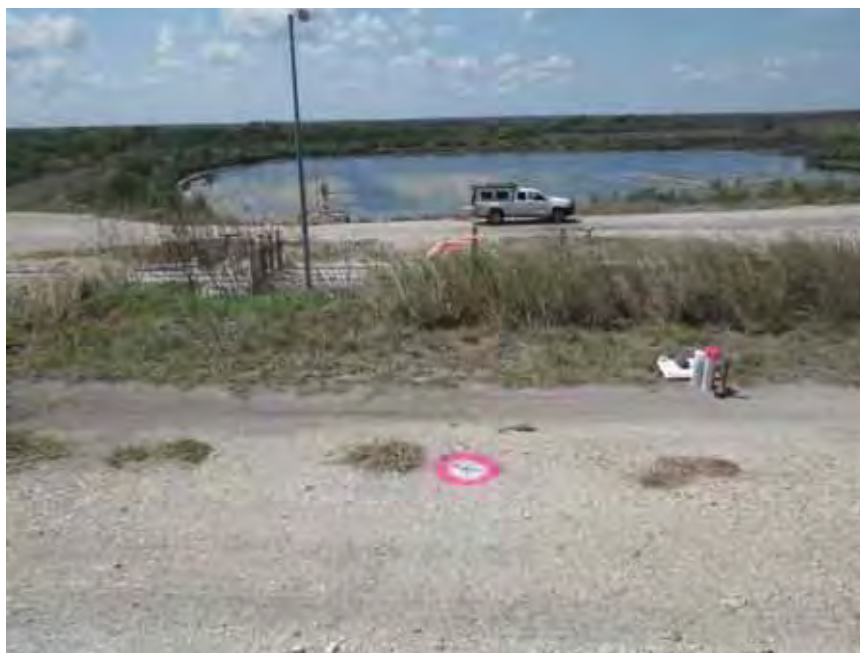
Photo 2 – View looking west from Ash Disposal Pond at Boring B-1, with Boring B-2 in the distance.

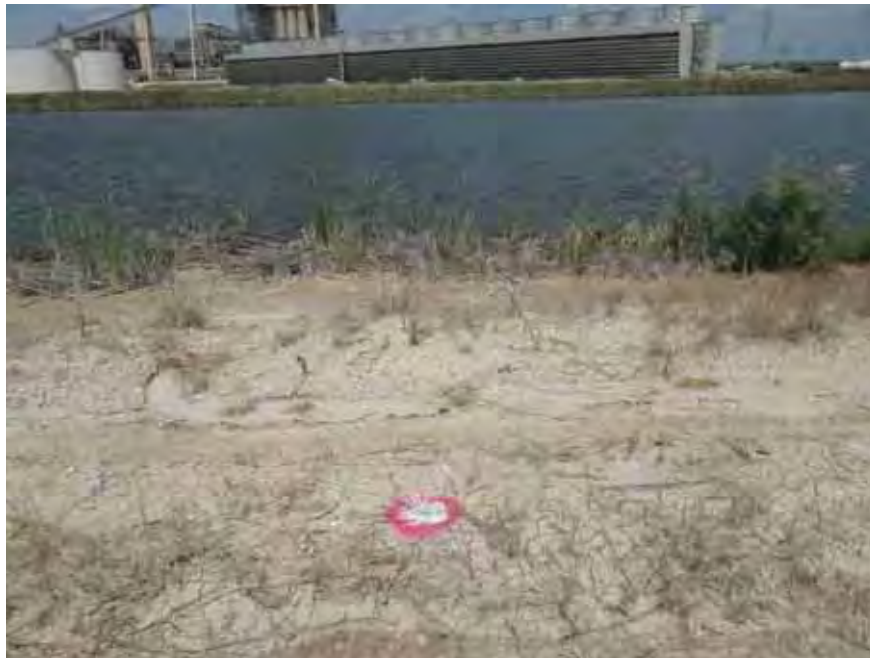
Photo 3 – View looking north at Ash Disposal Pond from Boring B-5.

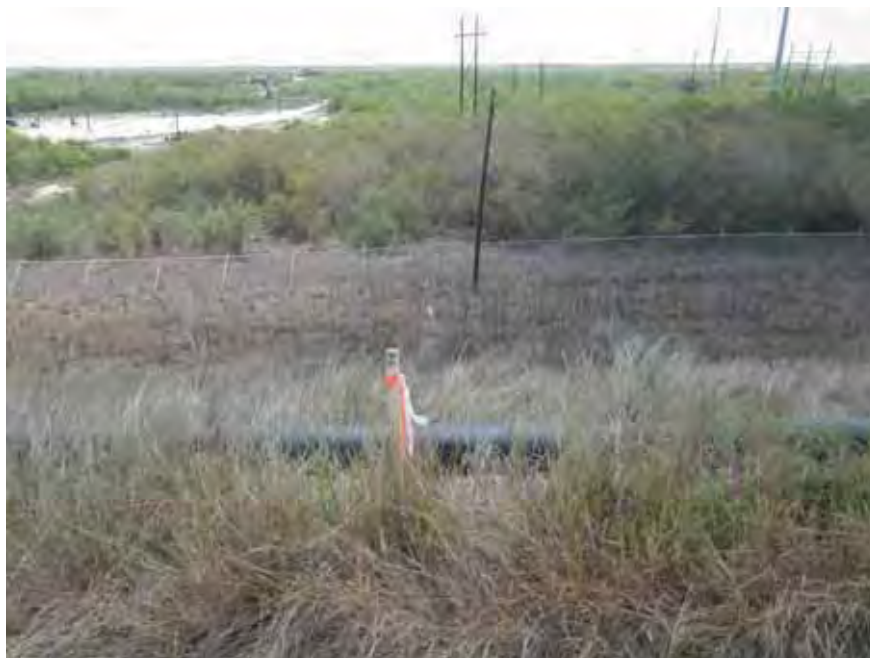
Photo 4 – View looking south from Boring B-6 towards Boring B-7 near the fence.

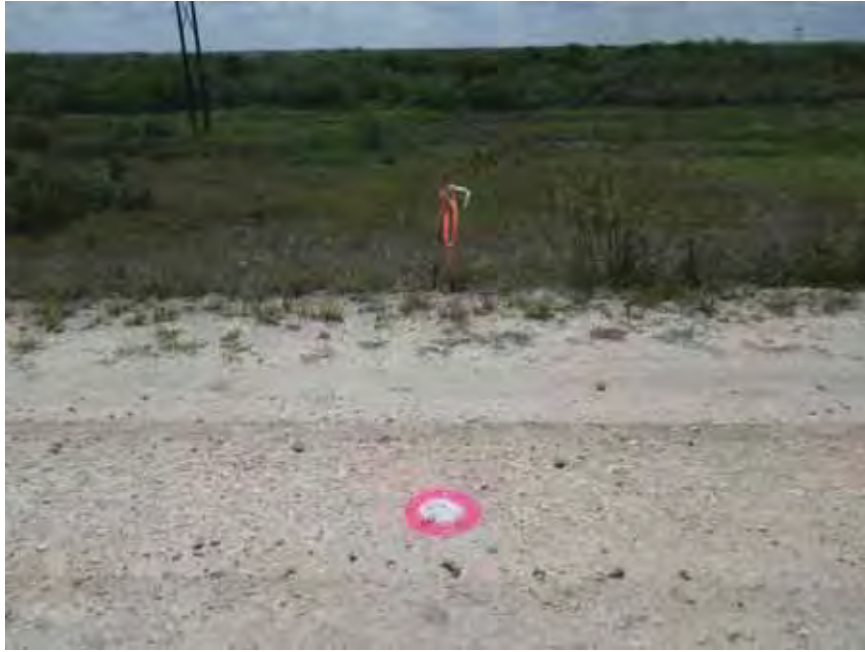
Photo 5 – View looking south from Sludge Disposal Basin at Boring B-8, with Boring B-9 in the distance.

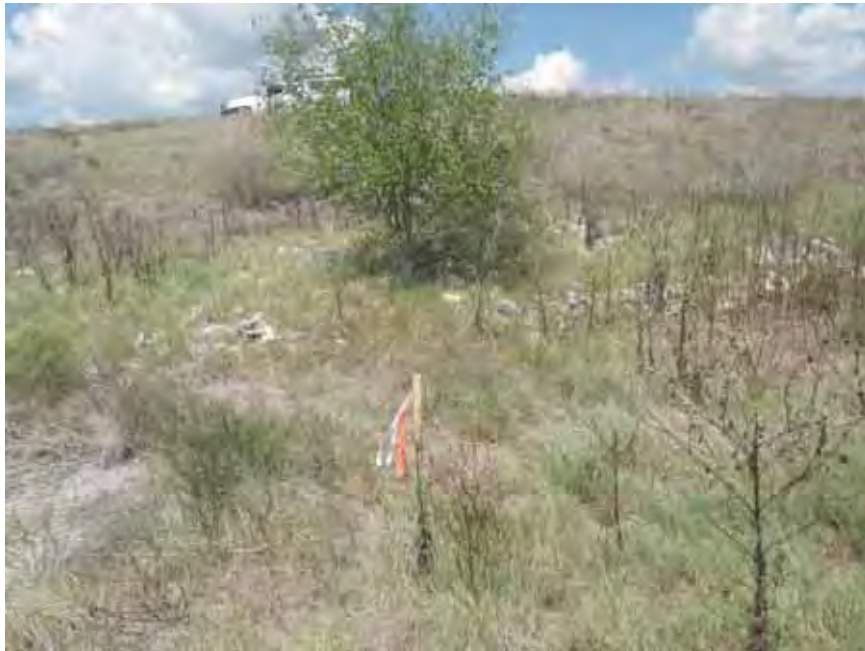
Photo 6 – View looking to the northwest at Boring B-11, with Boring B-10 at top near the truck.

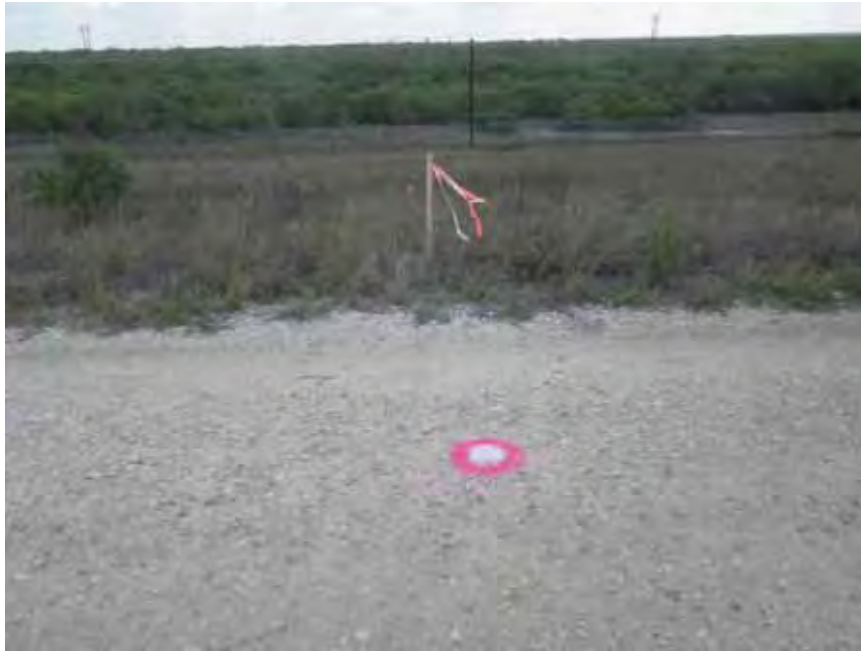
Photo 7 – View looking east from Sludge Disposal Basin at Boring B-13, with Boring B-14 in the distance.

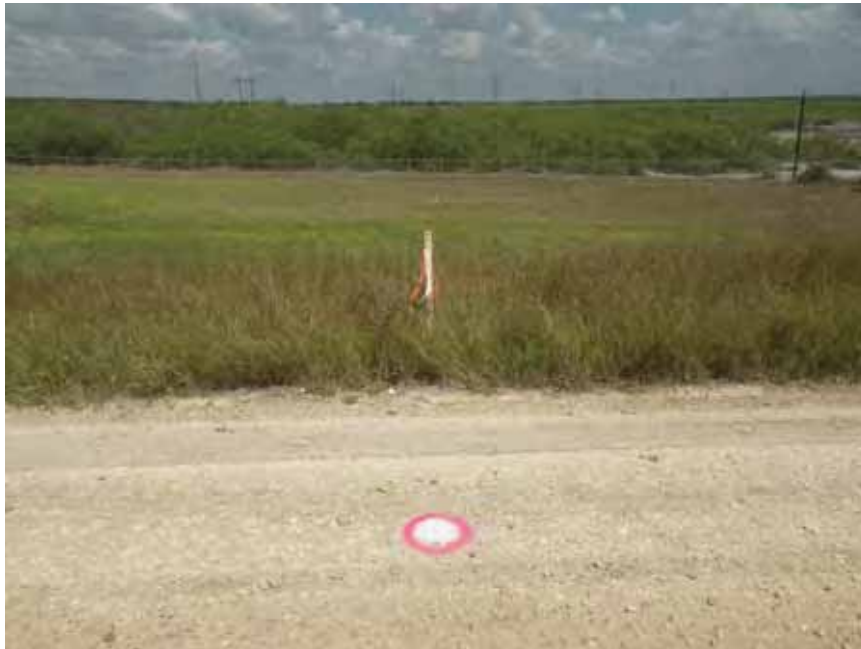
Photo 8 – View looking north from Sludge Disposal Basin at Boring B-16, with Boring B-17 in the distance.

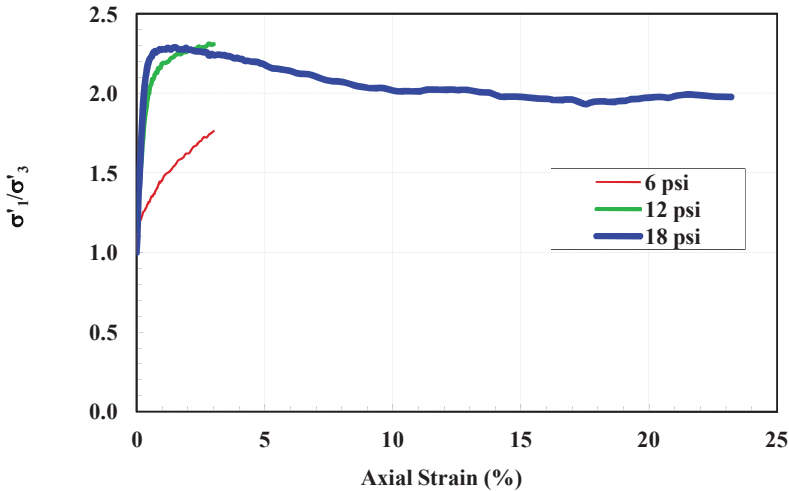
Principal Stress Ratio vs. Axial Strain

Initial Specimen Conditions			
Stage	#1	#2	#3
Eff. Consolidation Stress (psi)	6	12	18
Depth/Elev (ft):	14 - 16	14 - 16	14 - 16
Avg. Diameter (in)	D _o 2.84		
Avg. Height (in)	H _o 5.75		
Avg. Water Content (%)	w _o 35.4		
Bulk Density (pcf)	WD _o 109.3		
Dry Density (pcf)	DD _o 80.8		
Saturation (%)	S _o 87.8		
Void Ratio	e _o 1.09		
Specific Gravity (assumed)	G _s 2.70		
B-Coefficient	B 0.98
