CCR Surface Impoundment History of Construction Documentation

San Miguel Electric Cooperative, Inc.

Atascosa County, Texas

October 14, 2016

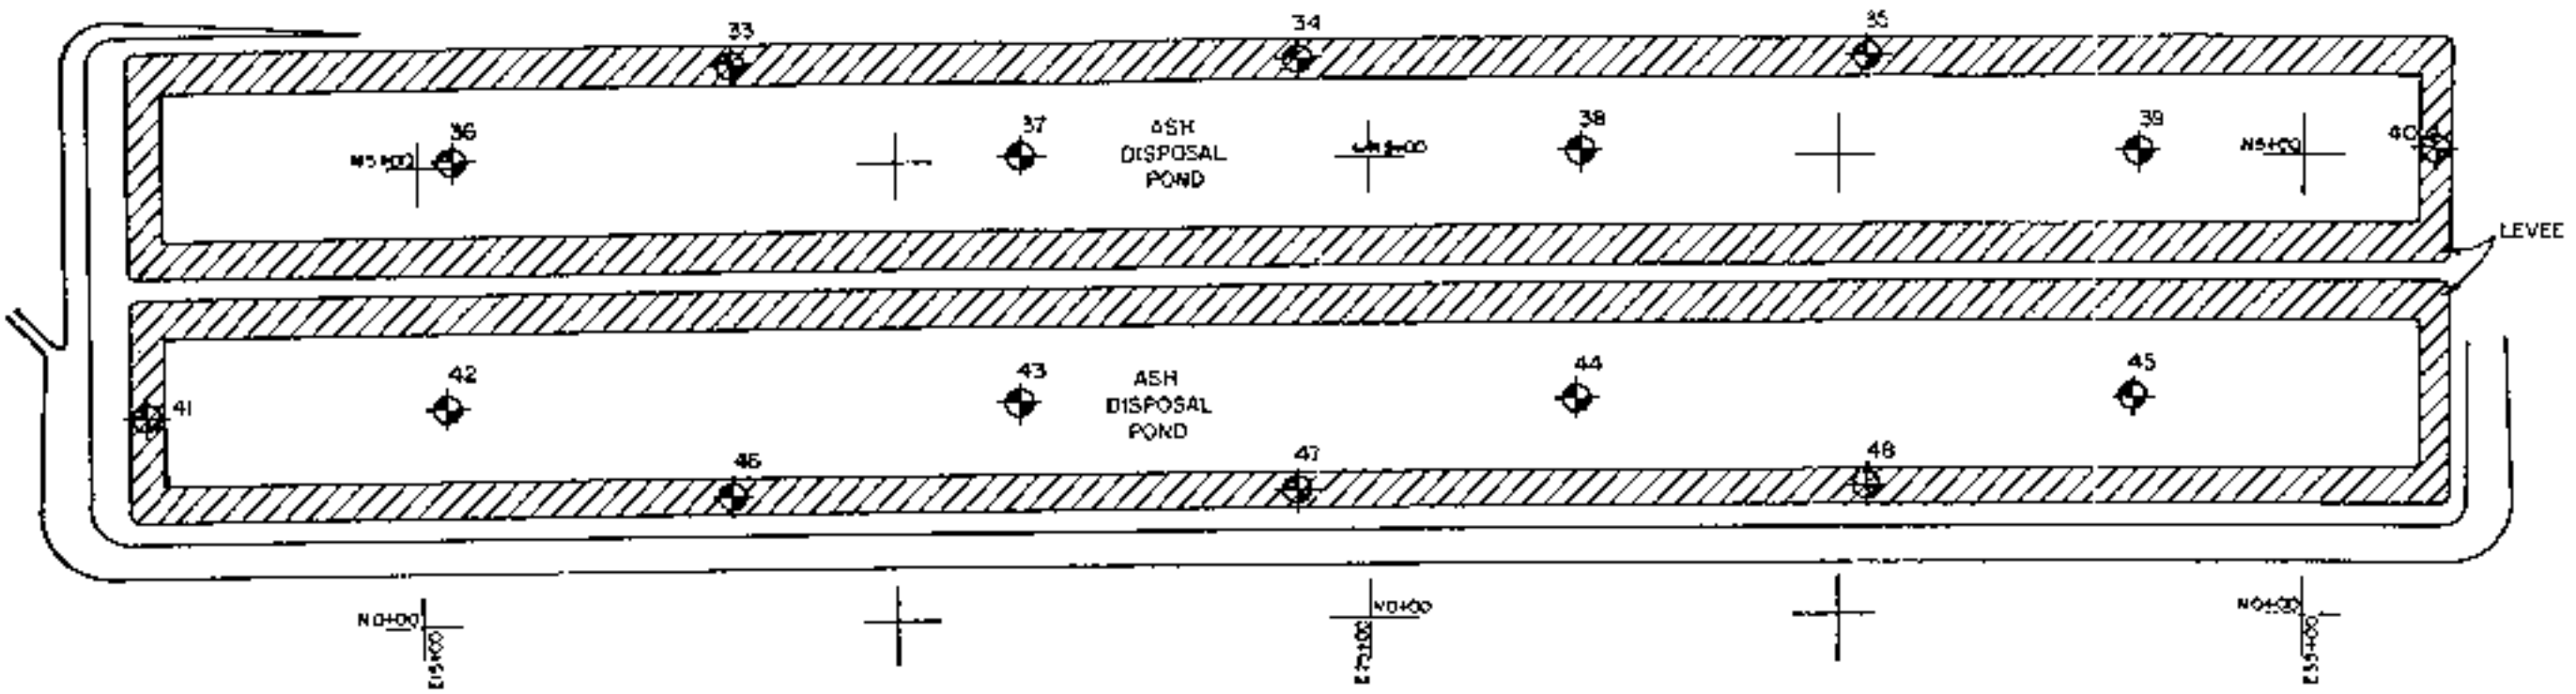
PLAN OF TEST LOCATIONS

N
Scale 1" = 200'

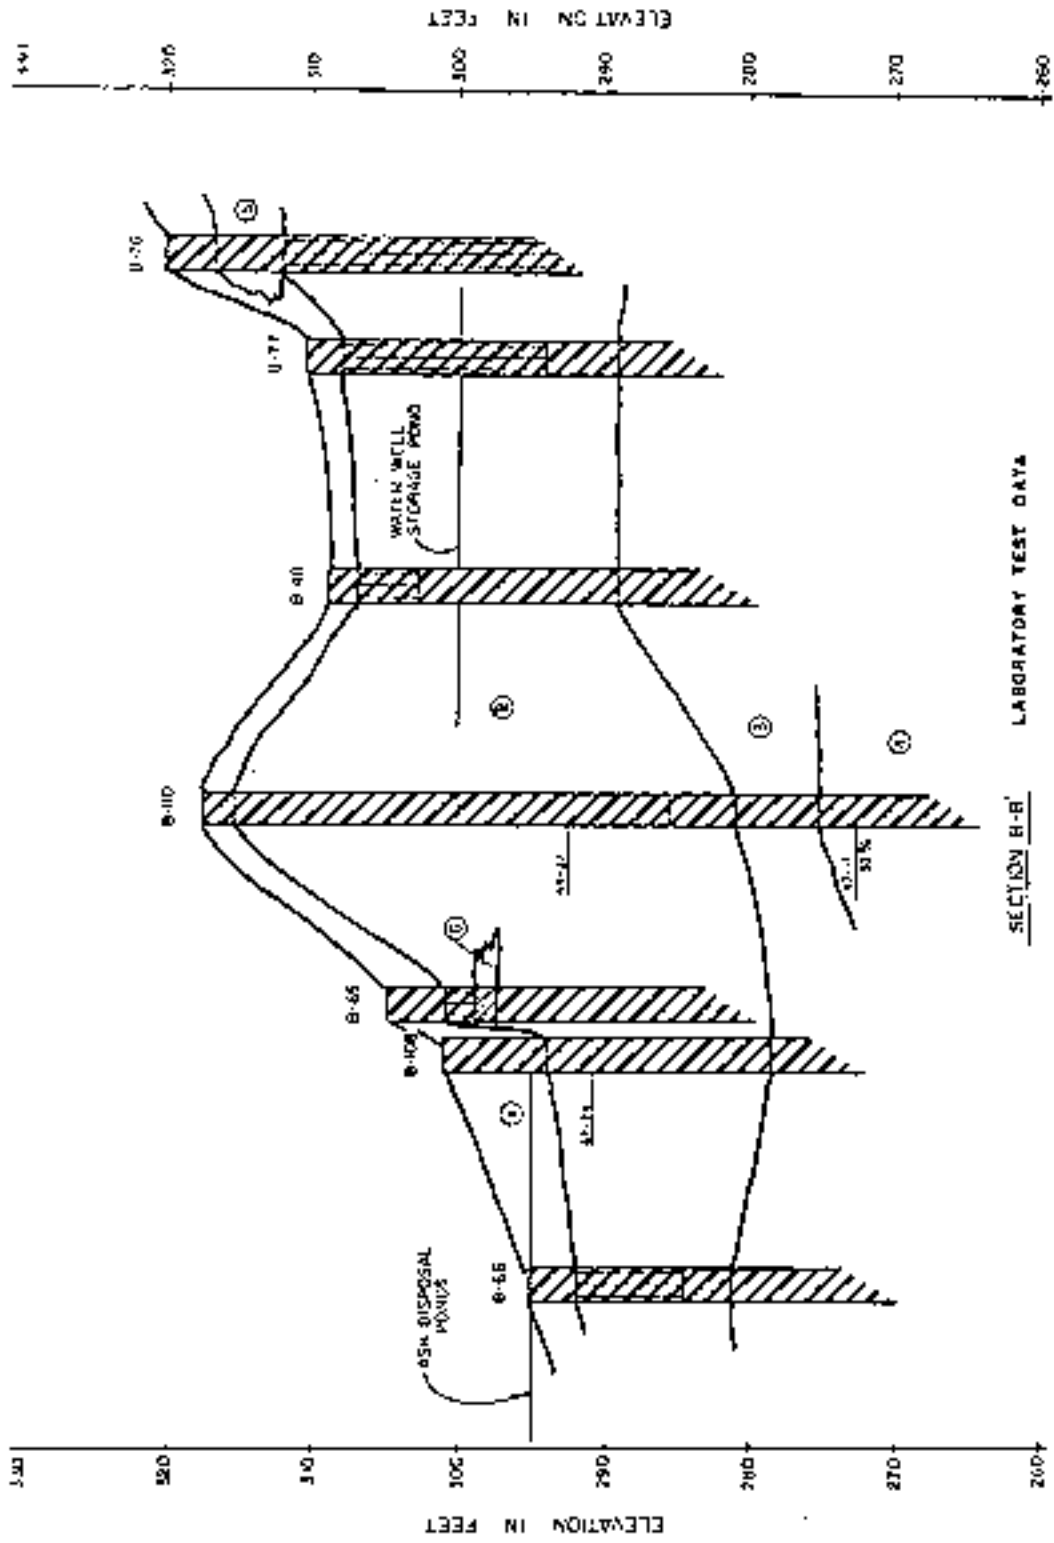
SECTION B-B LABORATORY TEST DATA

NOTE: For Shrinkage Descriptions see Section A-A

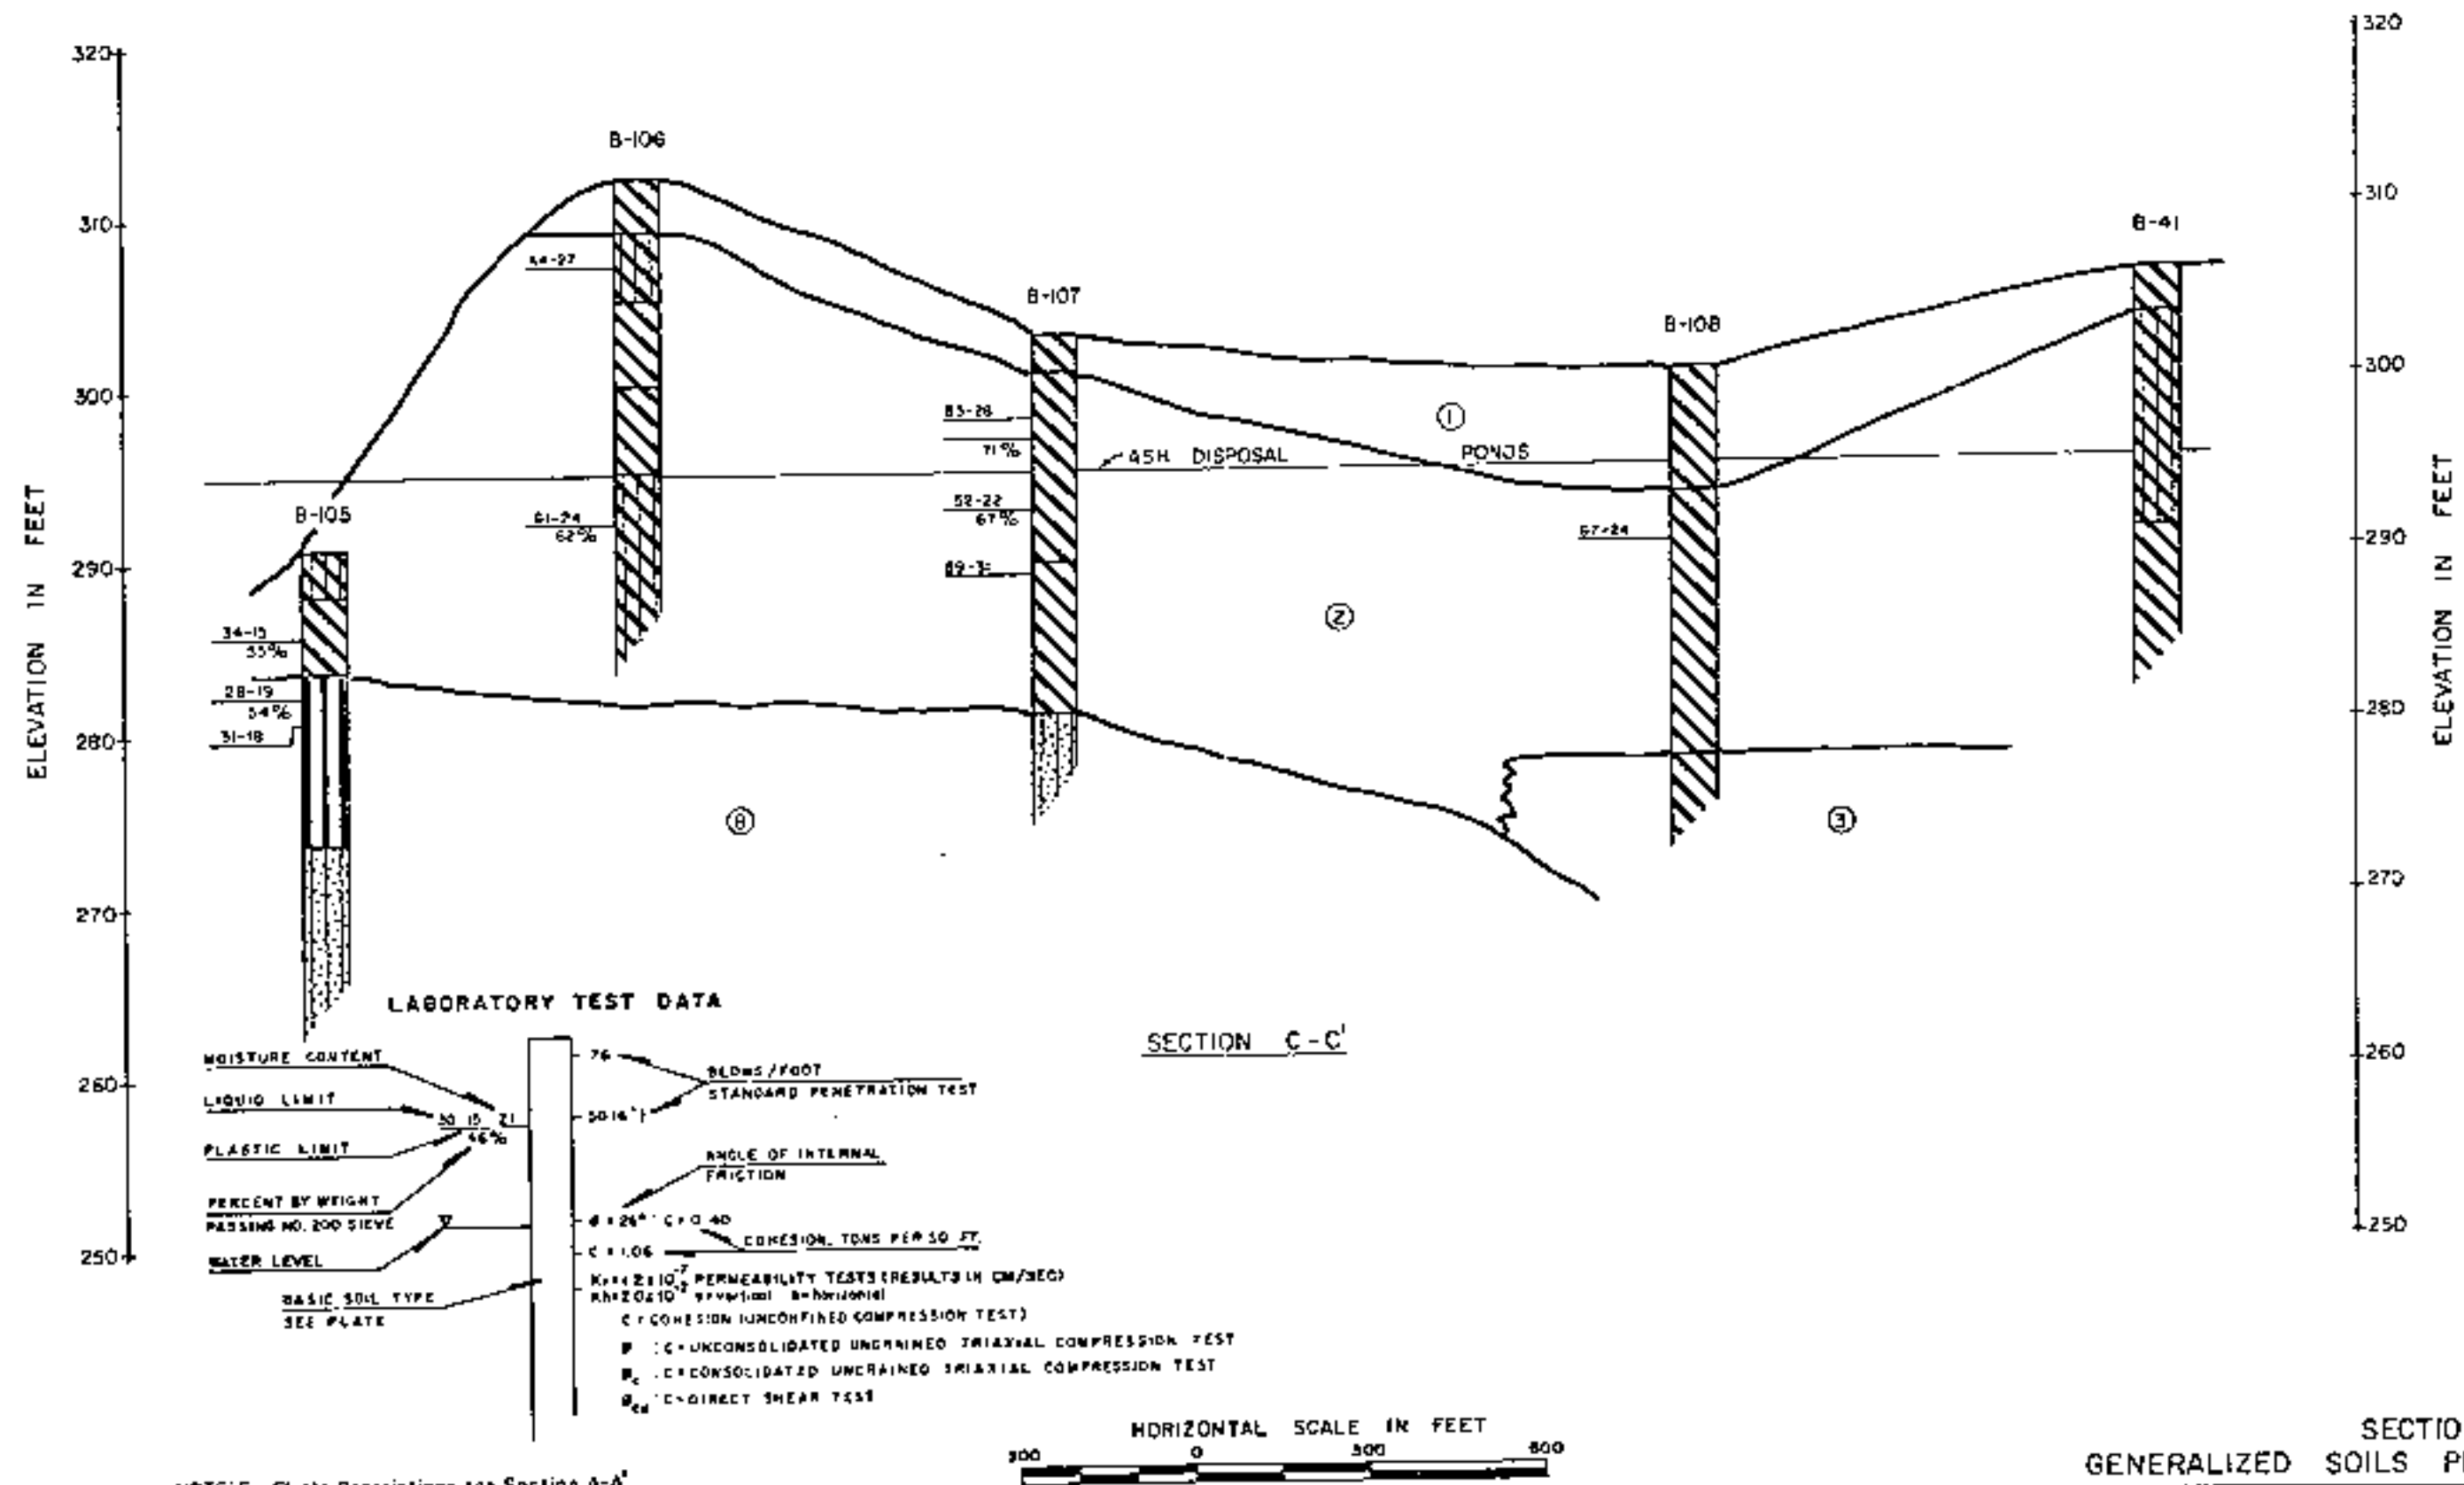
SECTION B-B'
GENERALIZED SOILS PROFILE

MOISTURE CONTENT	76	76	BLDG./FOOT
LIQUID LIMIT	50	50	STANDARD PENETRATION TEST
PLASTIC LIMIT	21	21	ANGLE OF INTERNAL FRICTION
PERCENT BY WEIGHT PASSING NO. 200 SIEVE	46%		$\phi = 26^\circ; c = 0.40$
WATER LEVEL			$c = 1.08$ COHESION, TONS PER SQ. FT.
BASIC SOIL TYPE			$K_v = 2 \times 10^{-7}$ PERMEABILITY TESTS (RESULTS IN CM/SEC)
SEE PLATE			$K_h = 0.5 \times 10^{-7}$ PERMEABILITY TESTS (RESULTS IN CM/SEC)
			$\sigma_c = 1.08$ UNCONSOLIDATED UNDRAINED TRIAXIAL COMPRESSION TEST
			$\sigma_c = 1.08$ CONSOLIDATED UNDRAINED TRIAXIAL COMPRESSION TEST
			$\sigma_{cs} = 1.08$ DIRECT SHEAR TEST

Preconstruction subsurface conditions in the vicinity of the ash disposal ponds are represented by the logs of borings B-35, B-39, B-41, B-42, B-60, B-65, B-66, B-105, B-106, B-107, and B-108. Locations of the borings are shown on Plate I, with the logs of the referenced borings being presented on Plates 3 through 15. Logs of these borings are also illustrated in graphical form on Sections A-A', B-B', C-C', and D-D' of the Generalized Soils Profiles, Plates 16 through 19.

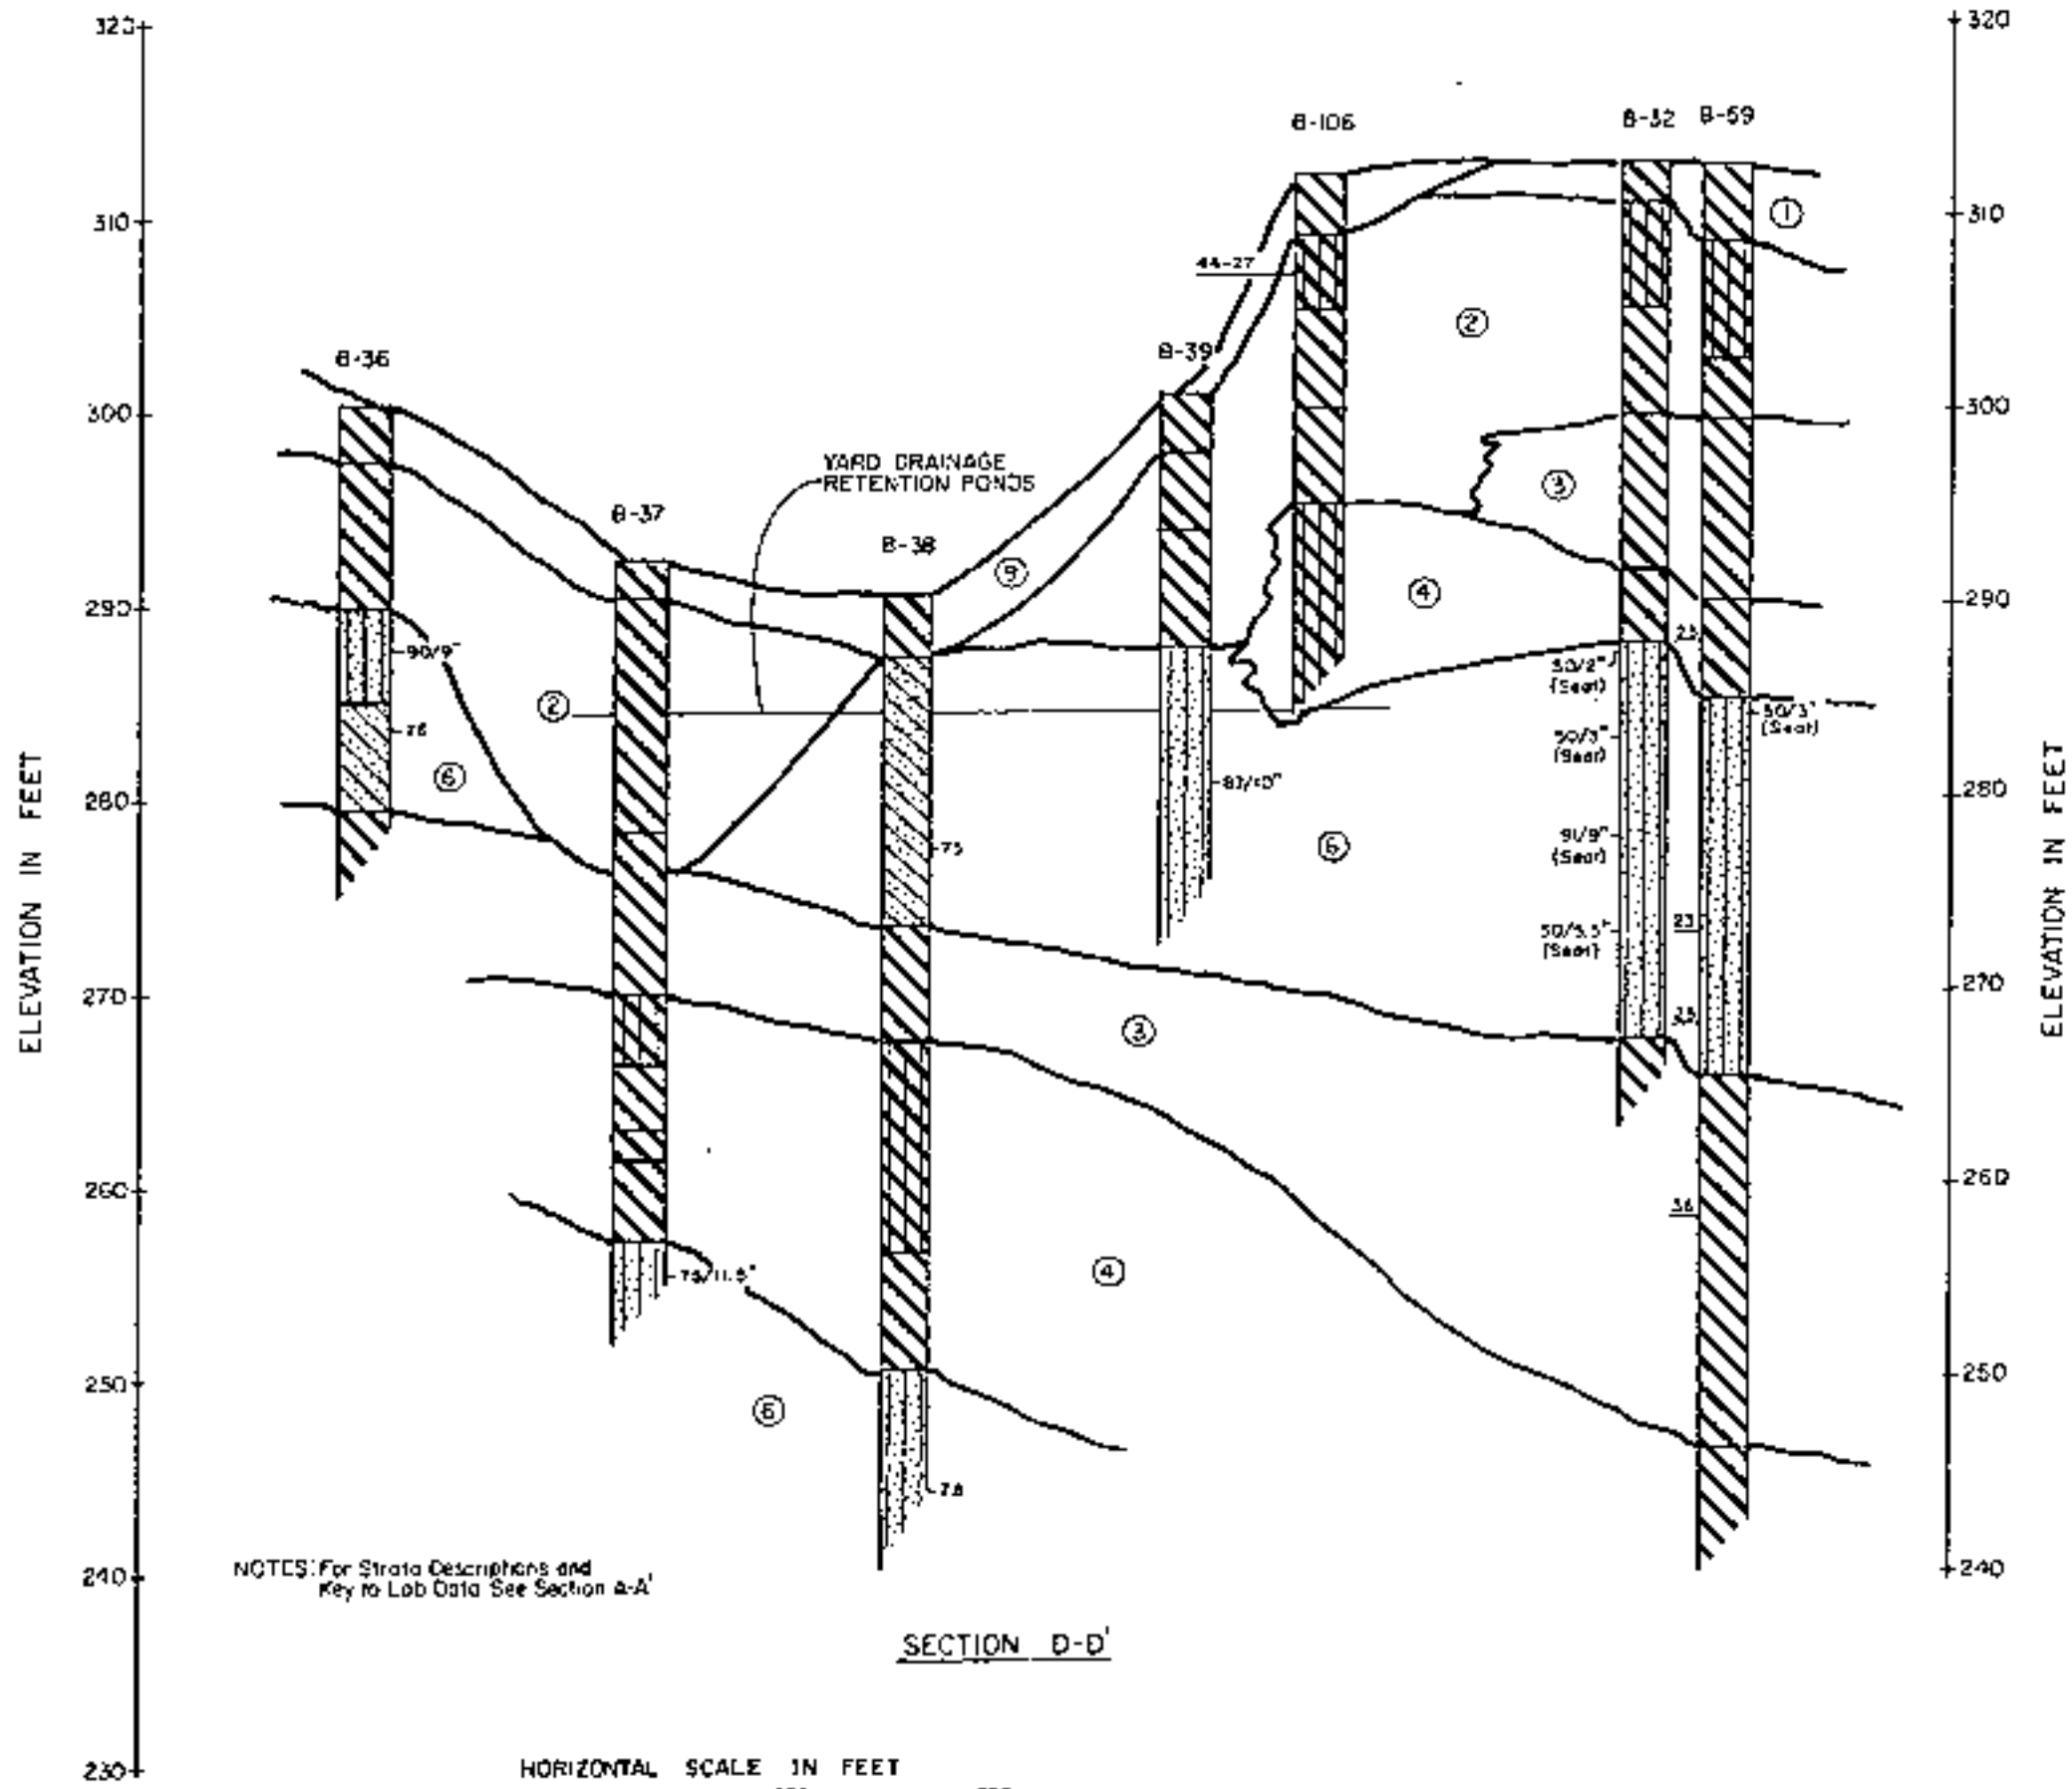
SECTION D-D'

NOTES: For Strata Descriptions and Key to Lab Data See Section A-A'

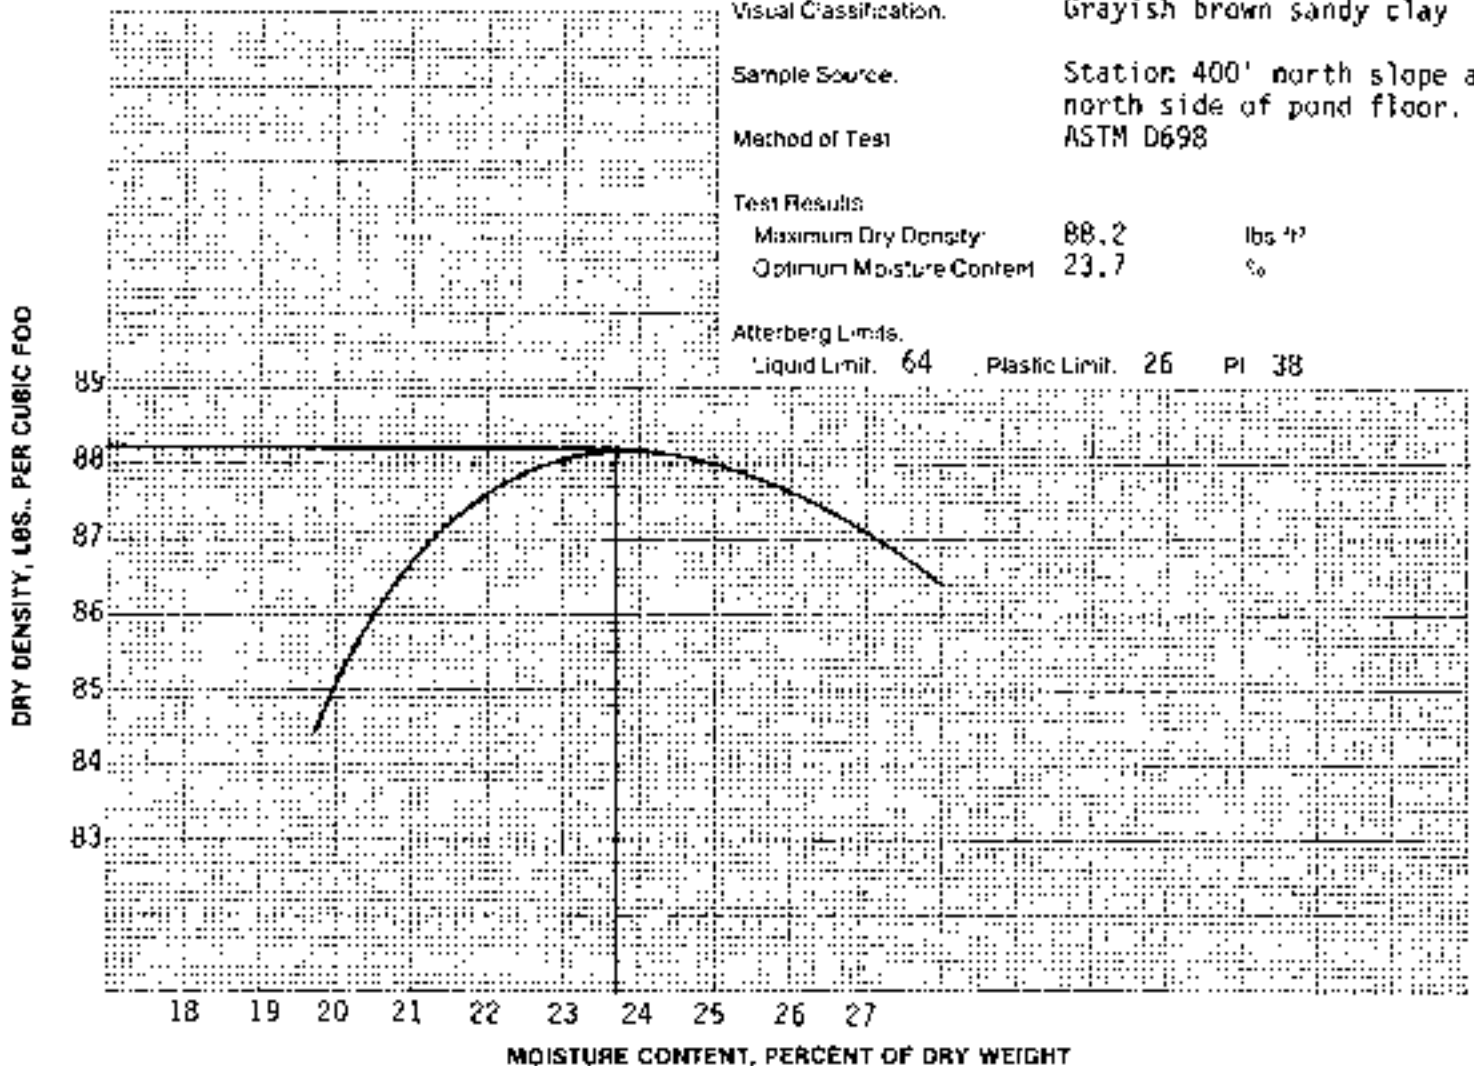
Visual Classification. Grayish brown sandy clay
Sample Source. Station: 400' north slope and north side of pond floor.
Method of Test ASTM D698
Test Results
Maximum Dry Density 88.2 lbs/ft³
Optimum Moisture Content 23.7 %
Atterberg Limits.
Liquid Limit 64 Plastic Limit 26 PI 38

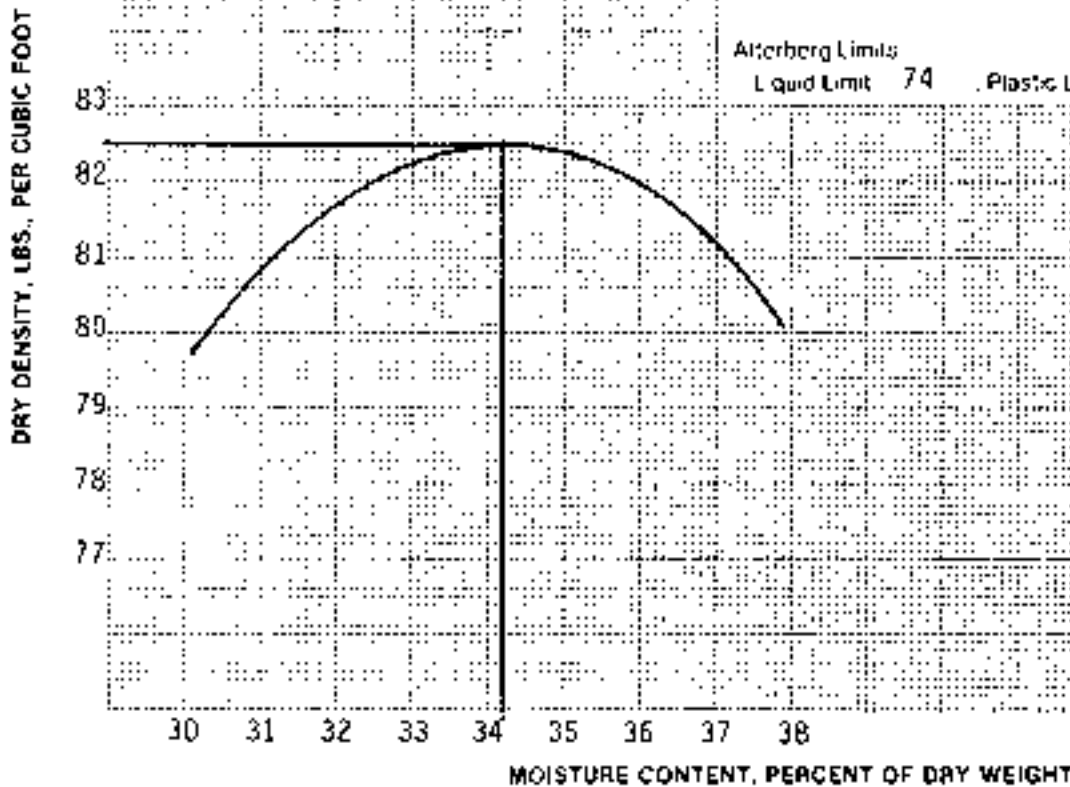
Visual Classification Reddish tan clay with some sand
 Sample Source Bottom of the South Slope at Stations 1900'-2100'
 Method of Test ASTM D-698
 Test Results
 Maximum Dry Density 82.5 lbs./ft.³
 Optimum Moisture Content 34.2 %
 Atterberg Limits
 Liquid Limit 74 Plastic Limit 37 PI 37

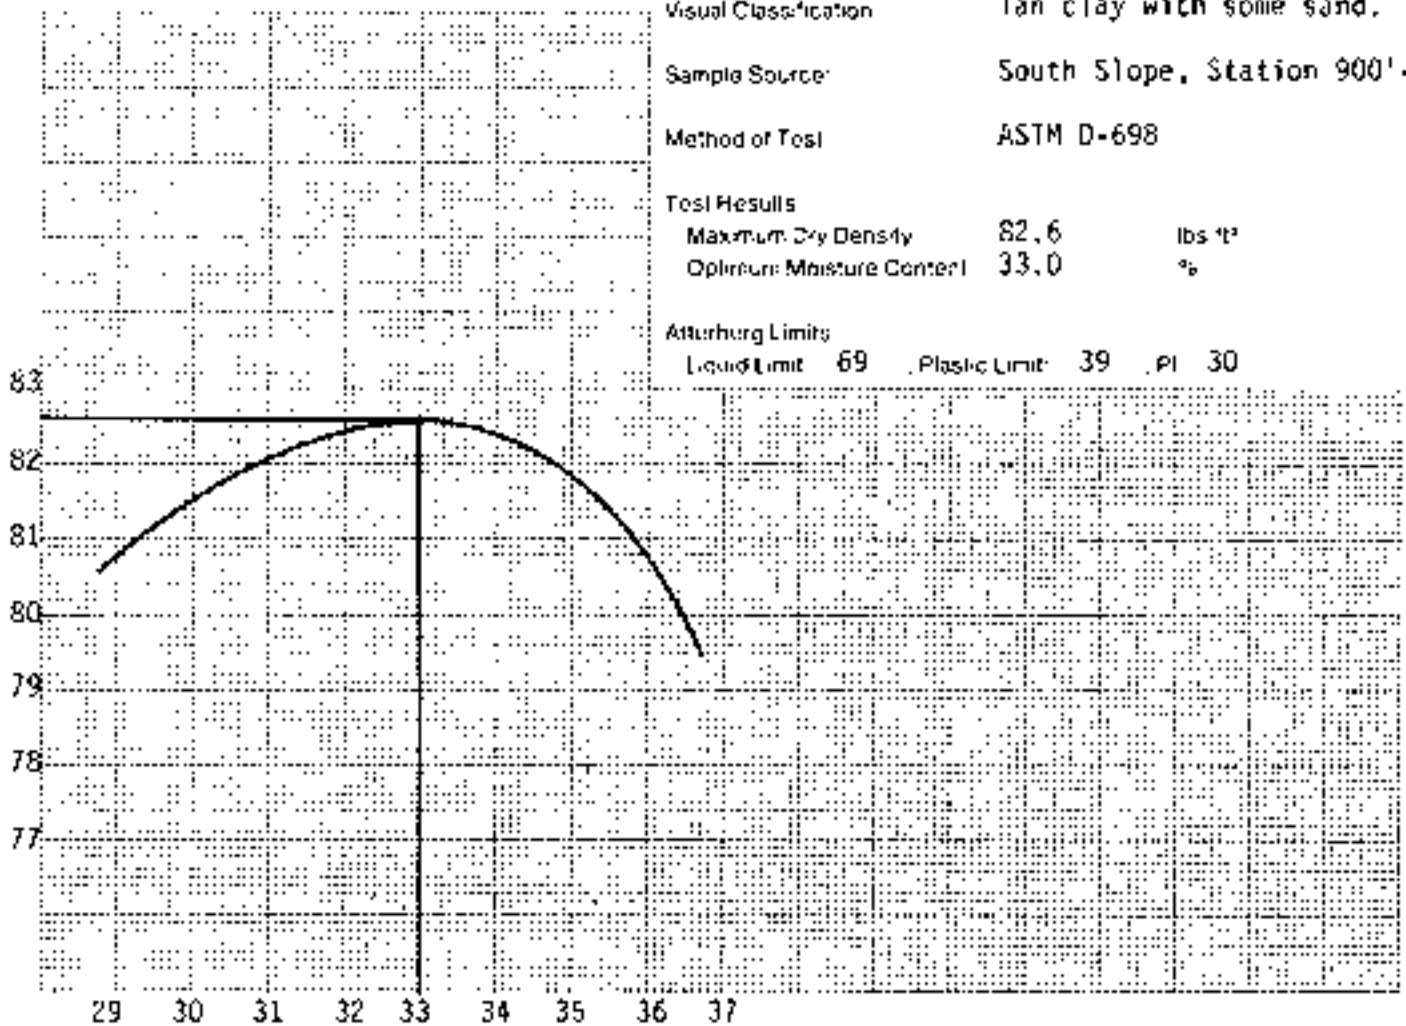
Visual Classification Tan clay with some sand.
Sample Source South Slope, Station 900'-1300'
Method of Test ASTM D-698
Test Results
Maximum Dry Density 82.6 lbs/ft³
Optimum Moisture Content 33.0 %
Atterberg Limits
Liquid Limit 69 Plastic Limit 39 PI 30

DRY DENSITY, LBS., PER CUBIC FOOT

MOISTURE CONTENT, PERCENT OF DRY WEIGHT

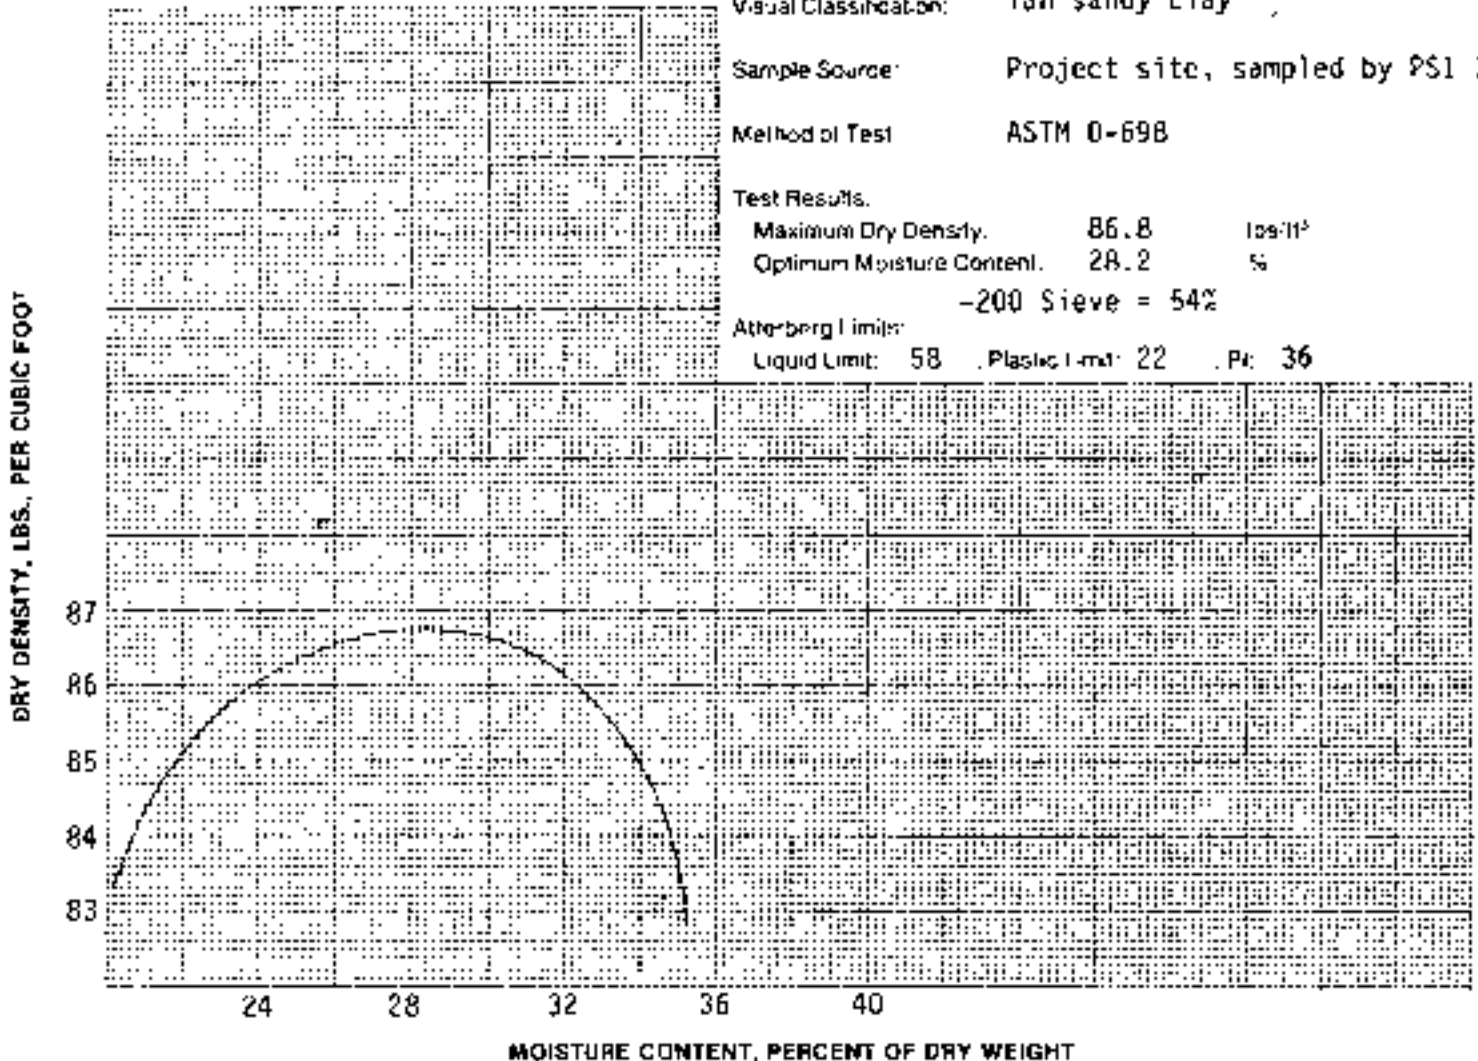
Visual Classification: **Tan sandy clay**
 Sample Source: **Project site, sampled by PSI 7-25-**
 Method of Test: **ASTM D-698**
 Test Results:
 Maximum Dry Density: **86.8** lbs./ft.³
 Optimum Moisture Content: **28.2** %
 -200 Sieve = **54%**
 Atterberg Limits:
 Liquid Limit: **58** Plastic Limit: **22** PI: **36**

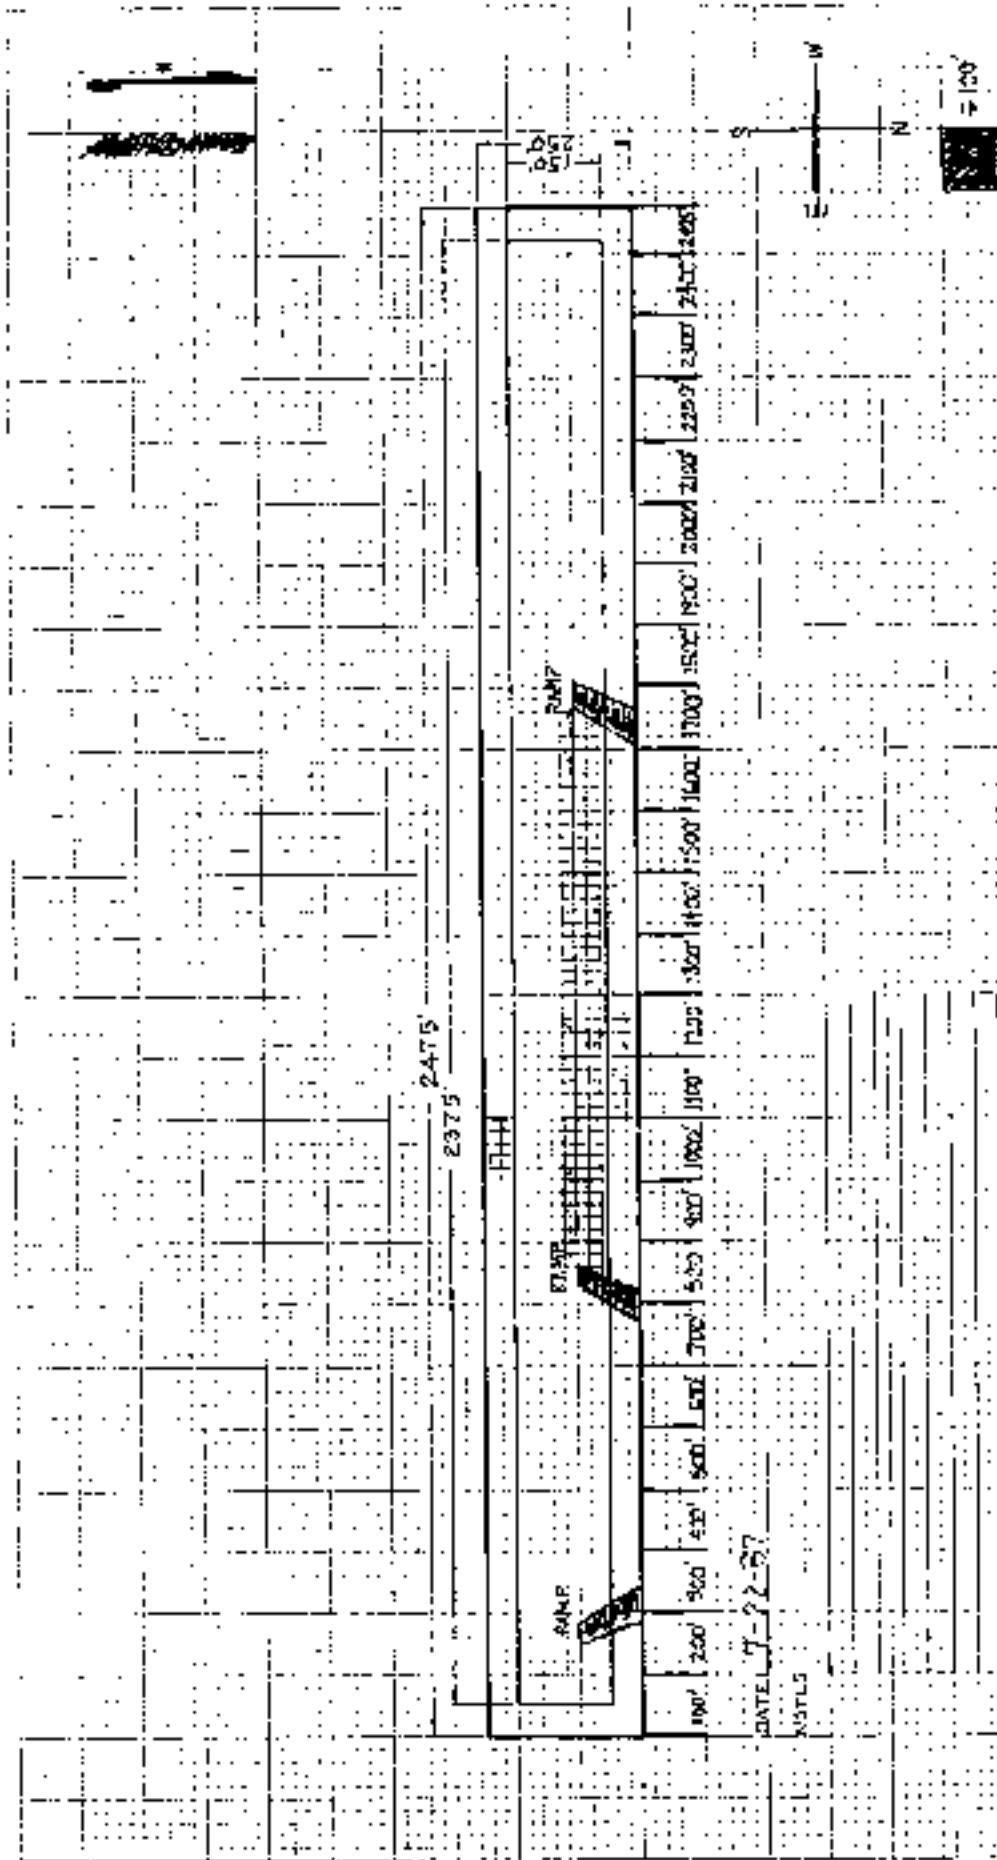
HIGHLIGHTED AREA IS
AREA BEING RECONSTRUCTED

IA. ASH POND LINER RECONSTRUCTION	
SCALE: 1" = 50'	5/10/2002
DATE: 4-22-07	5/10/2002

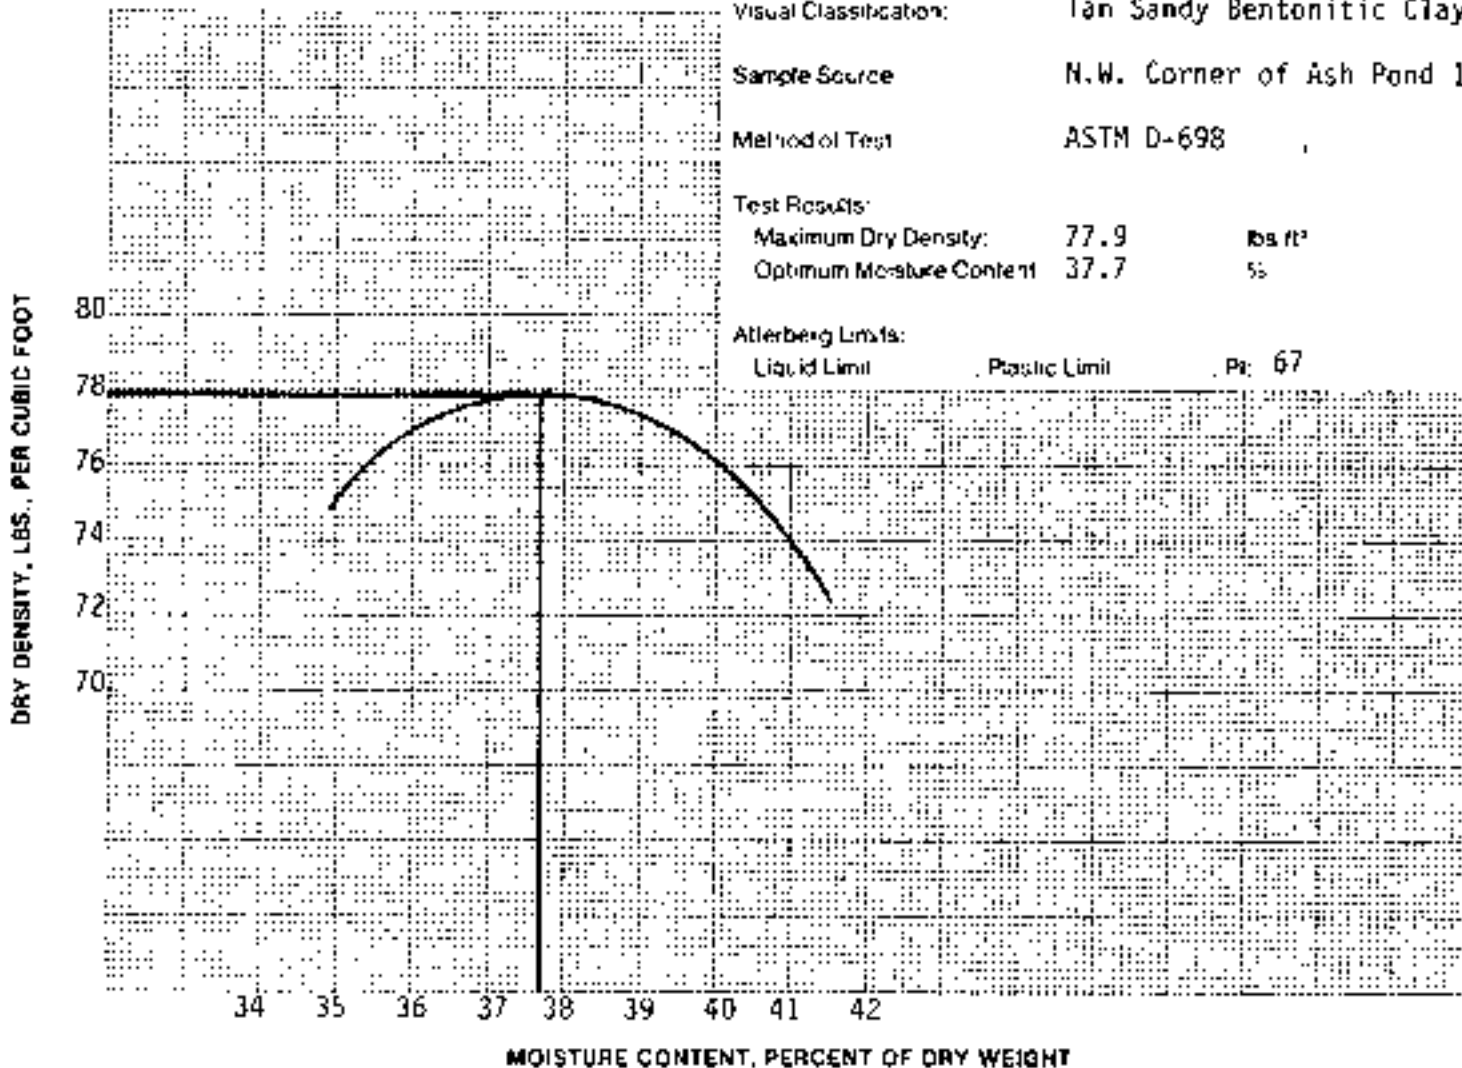
Visual Classification: Tan Sandy Bentonitic Clay
 Sample Source: N.W. Corner of Ash Pond 1A
 Method of Test: ASTM D-698
 Test Results:
 Maximum Dry Density: 77.9 lbs/ft³
 Optimum Moisture Content: 37.7 %
 Atterberg Limits:
 Liquid Limit: Plastic Limit: Ps: 67

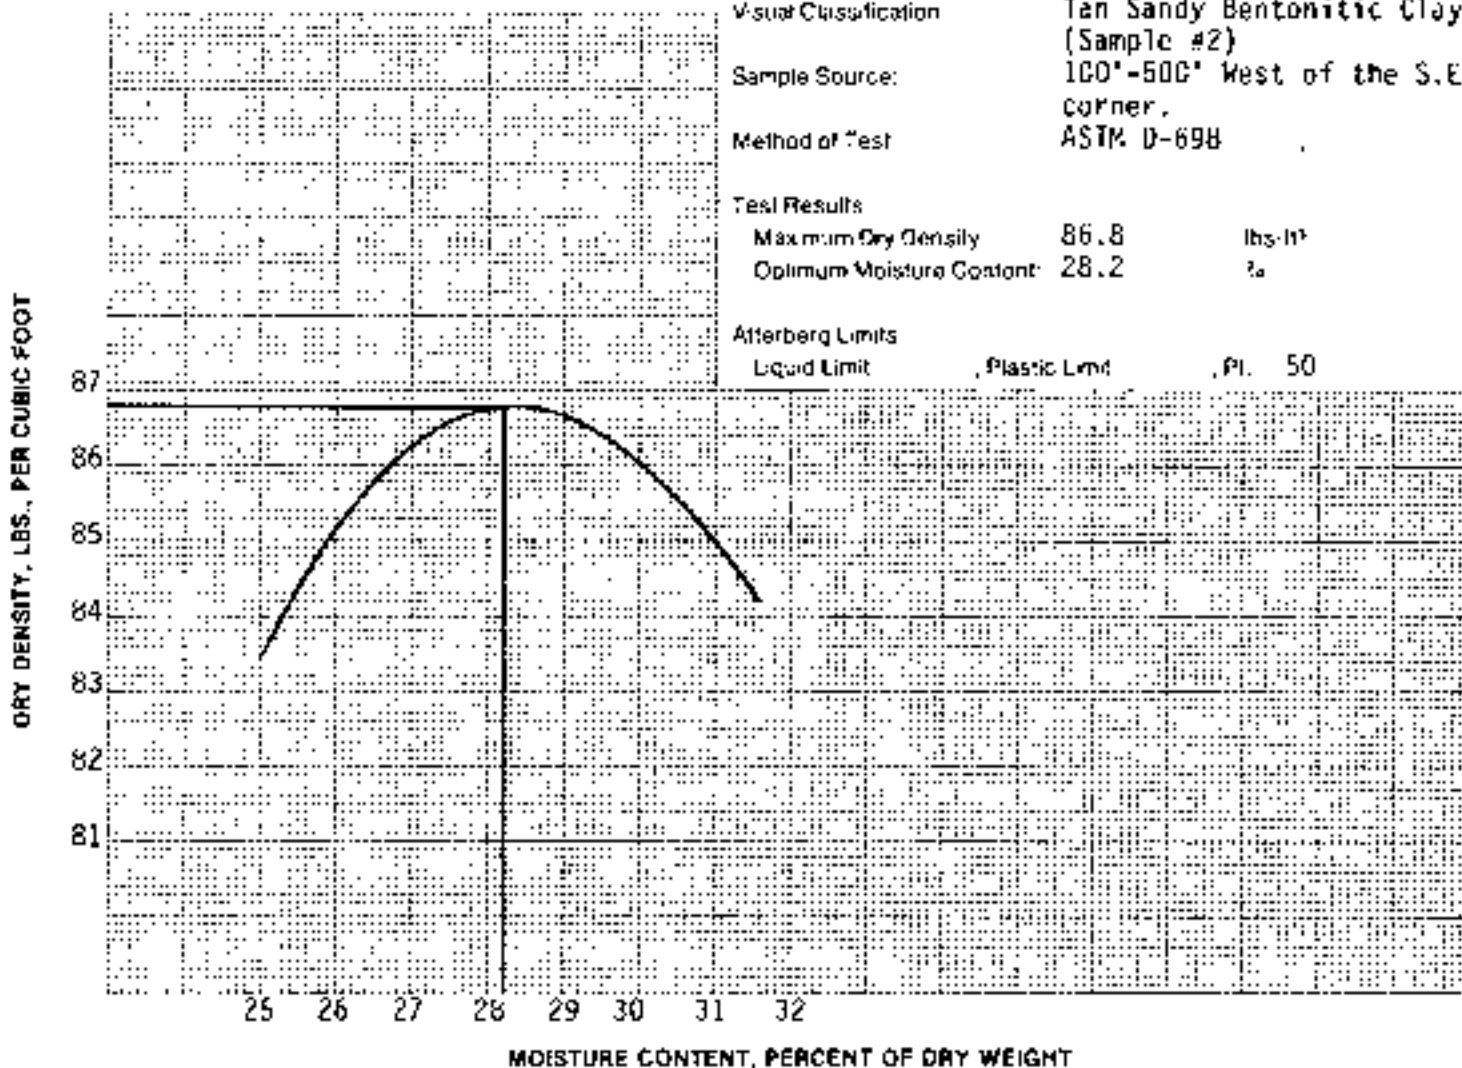
Visual Classification Tan Sandy Bentonitic Clay (Sample #2)
 Sample Source: 100'-500' West of the S.E. Corner.
 Method of Test ASTM D-698
 Test Results
 Maximum Dry Density 86.8 lbs./ft.³
 Optimum Moisture Content 28.2 %
 Atterberg Limits
 Liquid Limit Plastic Limit PI 50

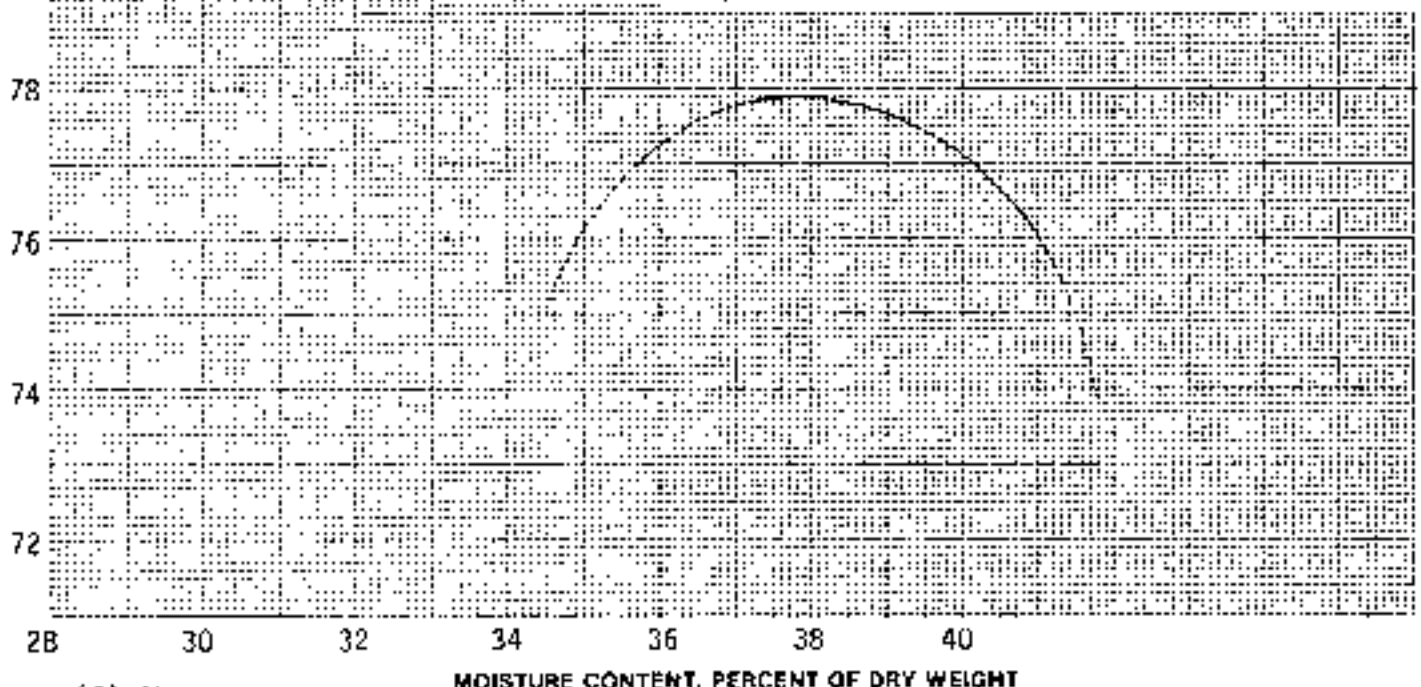
Visual Classification **Tan Sandy Clay**
 Sample Source **Jobsite, sampled by PSI 7-17-87**
 Method of Test **ASTM D-698**
 Test Results:
 Maximum Dry Density: **77.9** lbs-ft³
 Optimum Moisture Content **37.7** %
 Atterberg Limits:
 Liquid Limit **103** Plastic Limit **36** PI: **67**

DRY DENSITY, LBS., PER CUBIC FOOT

optimum moisture content - 37.7 + 3-4% = 40.7 - 41.7%
