CCR Surface Impoundment History of Construction Documentation

San Miguel Electric Cooperative, Inc.

Atascosa County, Texas

October 14, 2016

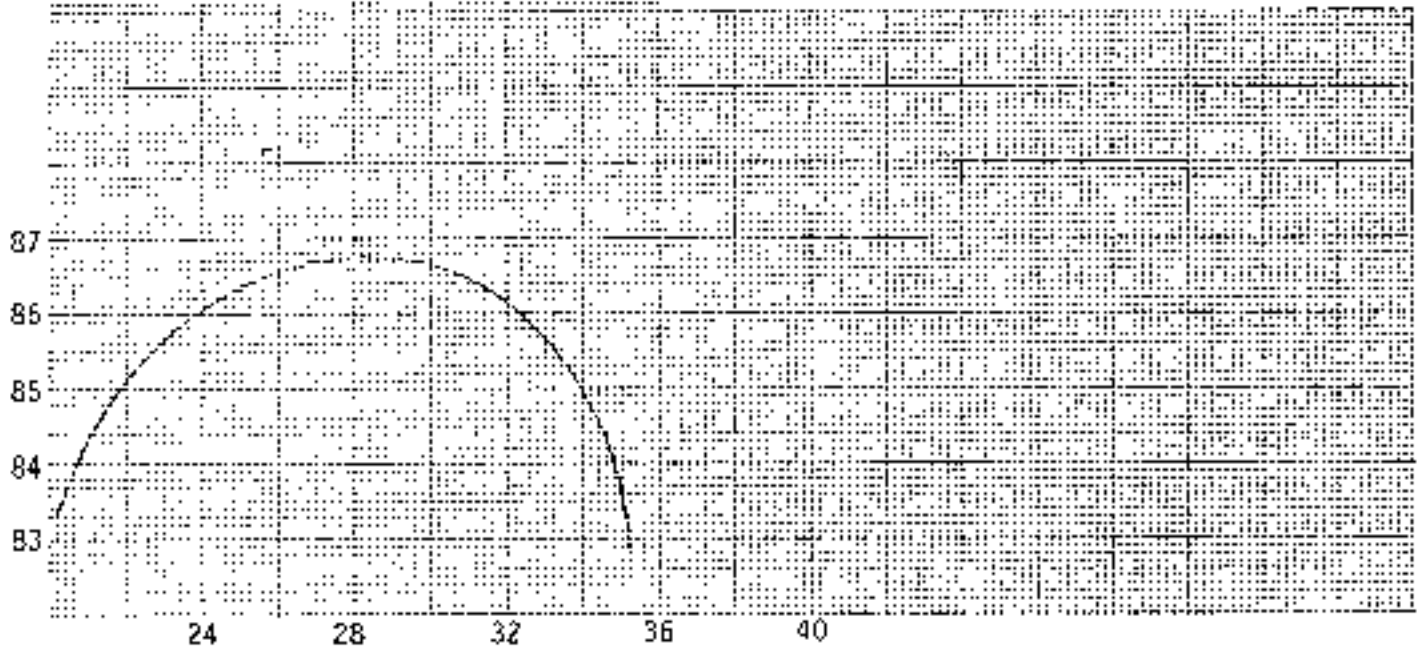
Visual Classification **Tan sandy clay**
Sample Source **Project site, sampled by PSI 7-25-**
Method of Test **ASTM D-698**
Test Results:
Maximum Dry Density: **86.8** lbs./ft.³
Optimum Moisture Content: **28.2** %
-200 Sieve = 54%
Atterberg Limits
Liquid Limit: **58** , Plastic Limit: **22** , P.I.: **36**

DRY DENSITY, LBS., PER CUBIC FOOT

MOISTURE CONTENT, PERCENT OF DRY WEIGHT

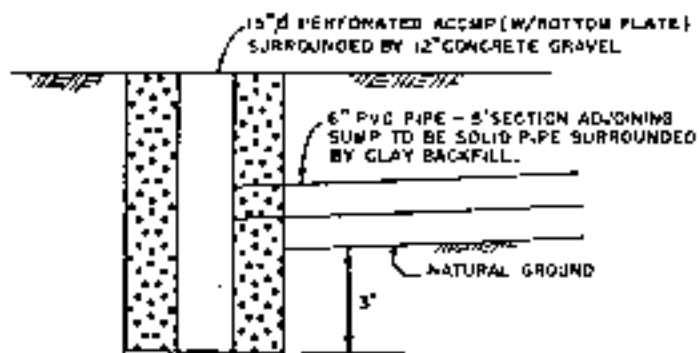
SUMP DETAIL
Not to Scale

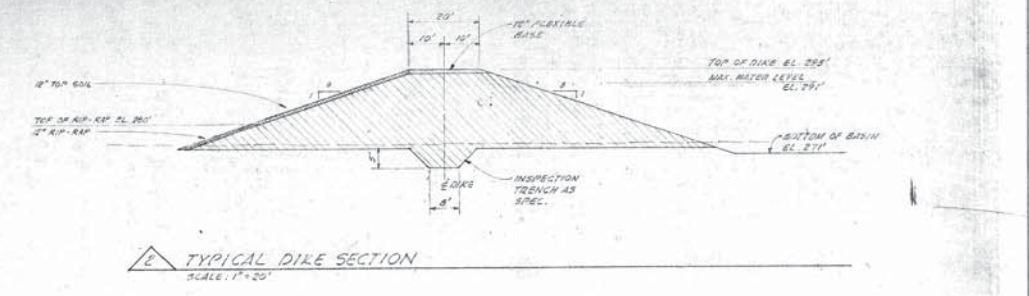
2 TYPICAL DIKE SECTION
SCALE: 1" = 20'

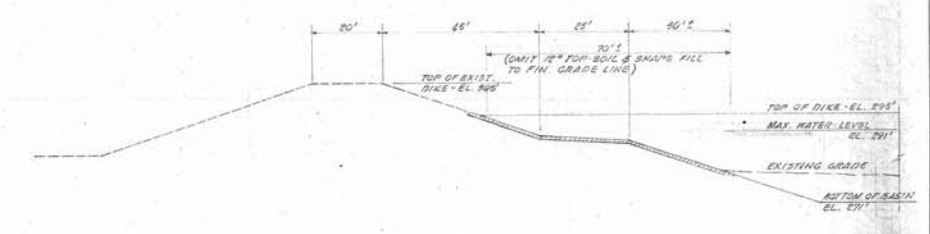
3 TYPICAL DIKE SECTION (EXIST. @ WATER WELL STG. POND)
SCALE: 1" = 20'

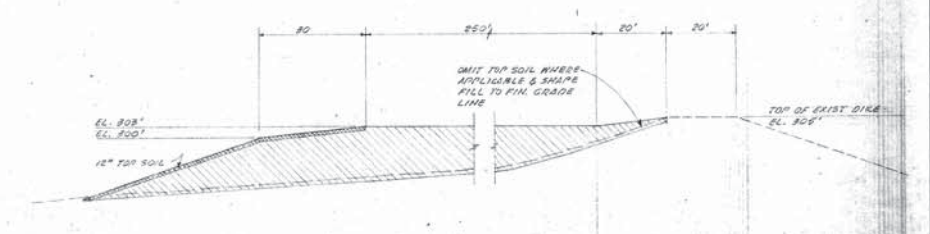
4 TYPICAL SECTION - SUBSTATION SITE
SCALE: 1" = 20'

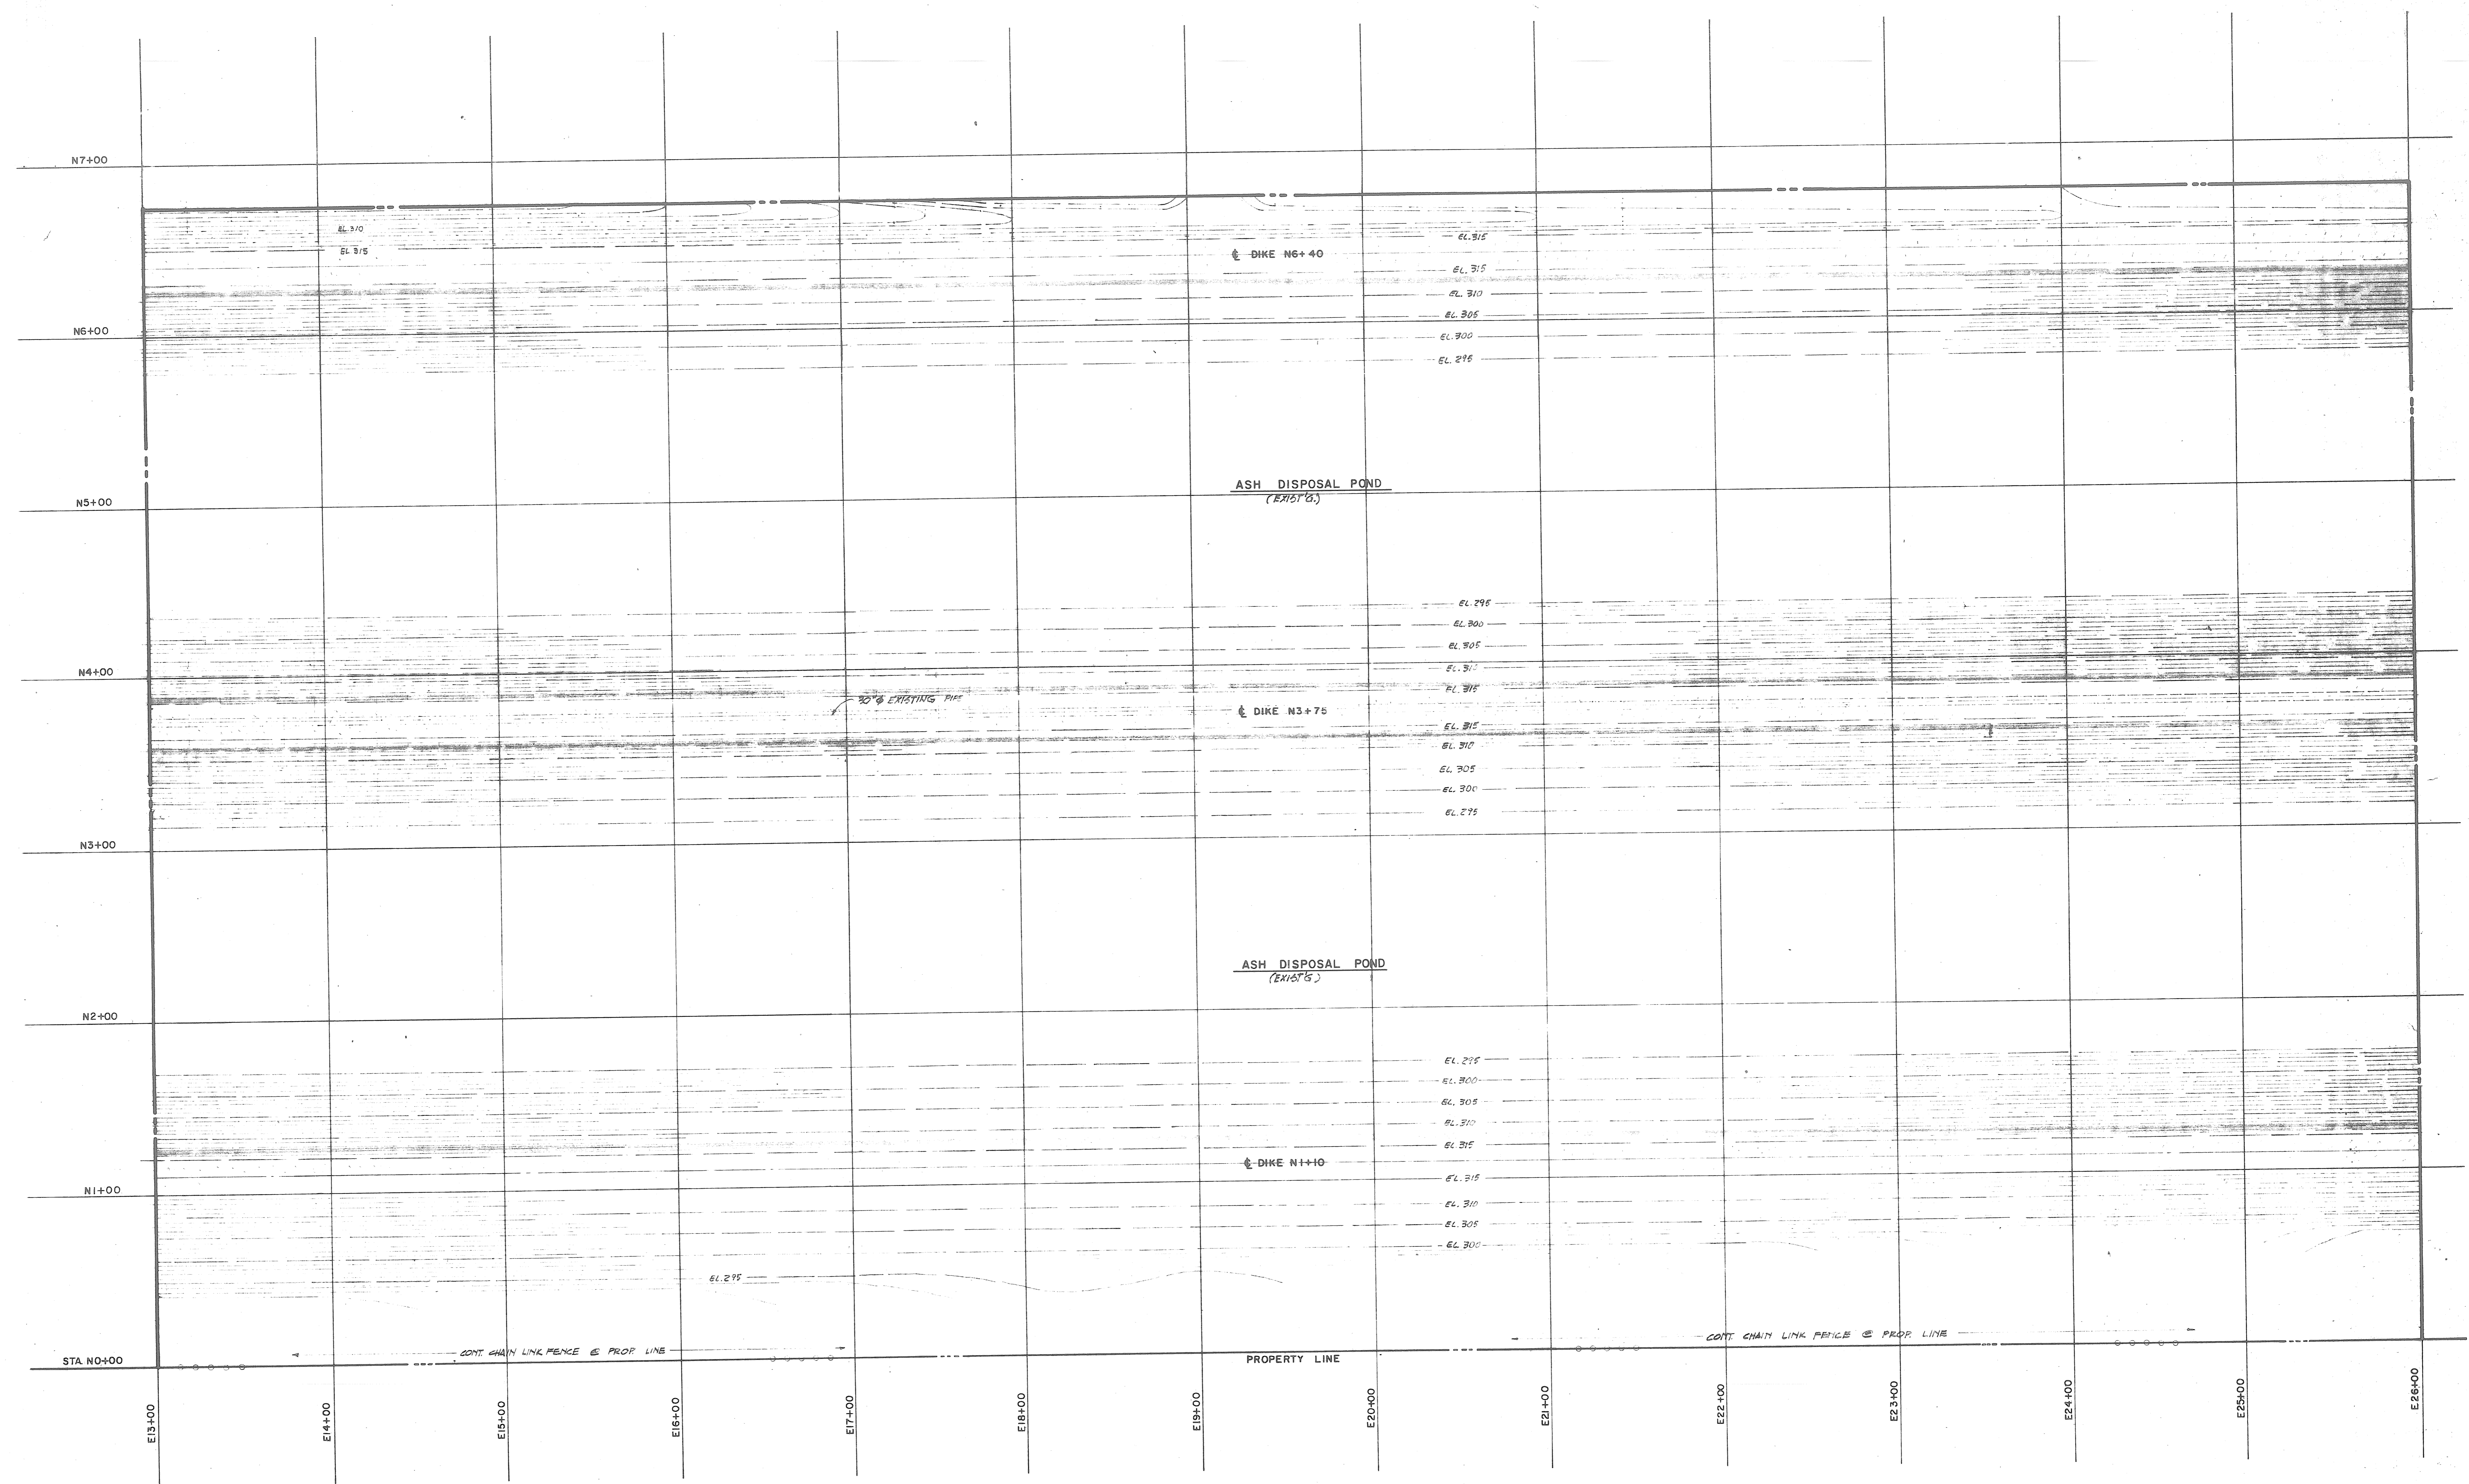
Site Plan Section No. 8, San Miguel Plant Unit No. 1, Drawing No. 1-C-37, Rev. 0, Tippet & Gee, Inc., April 1, 1977, revised August 18, 1977.

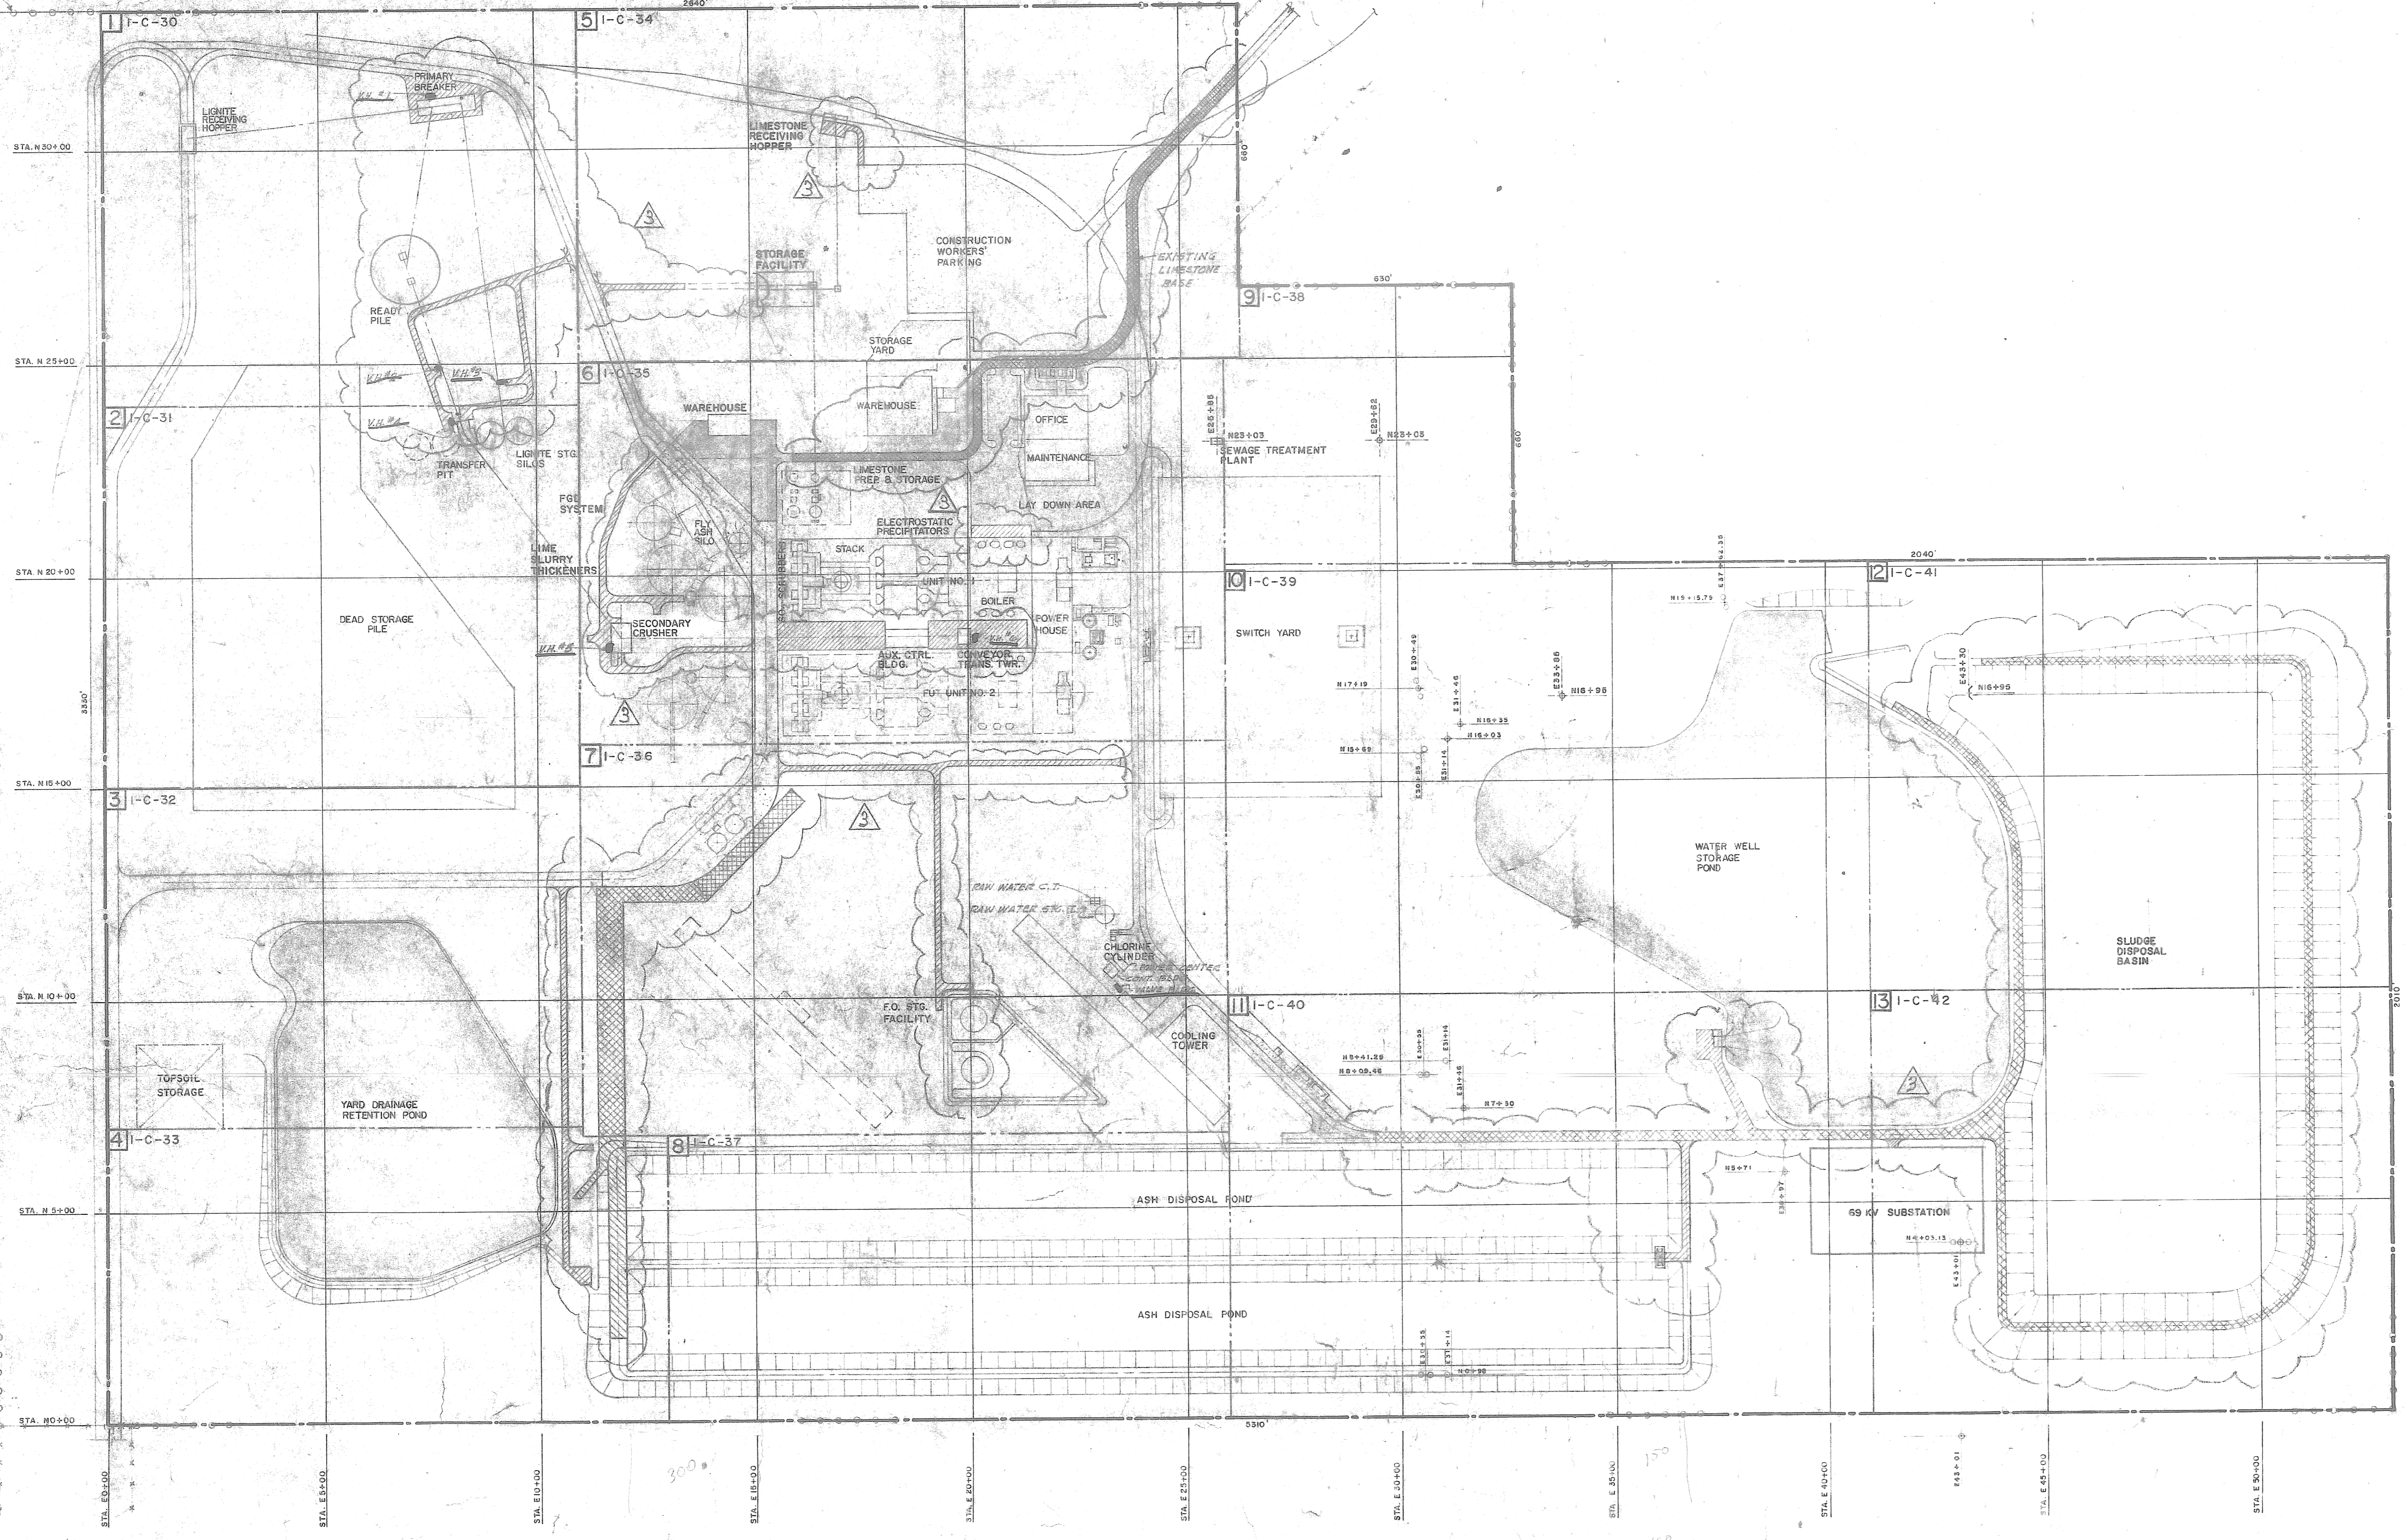
EXISTING CHAIN LINK FENCE

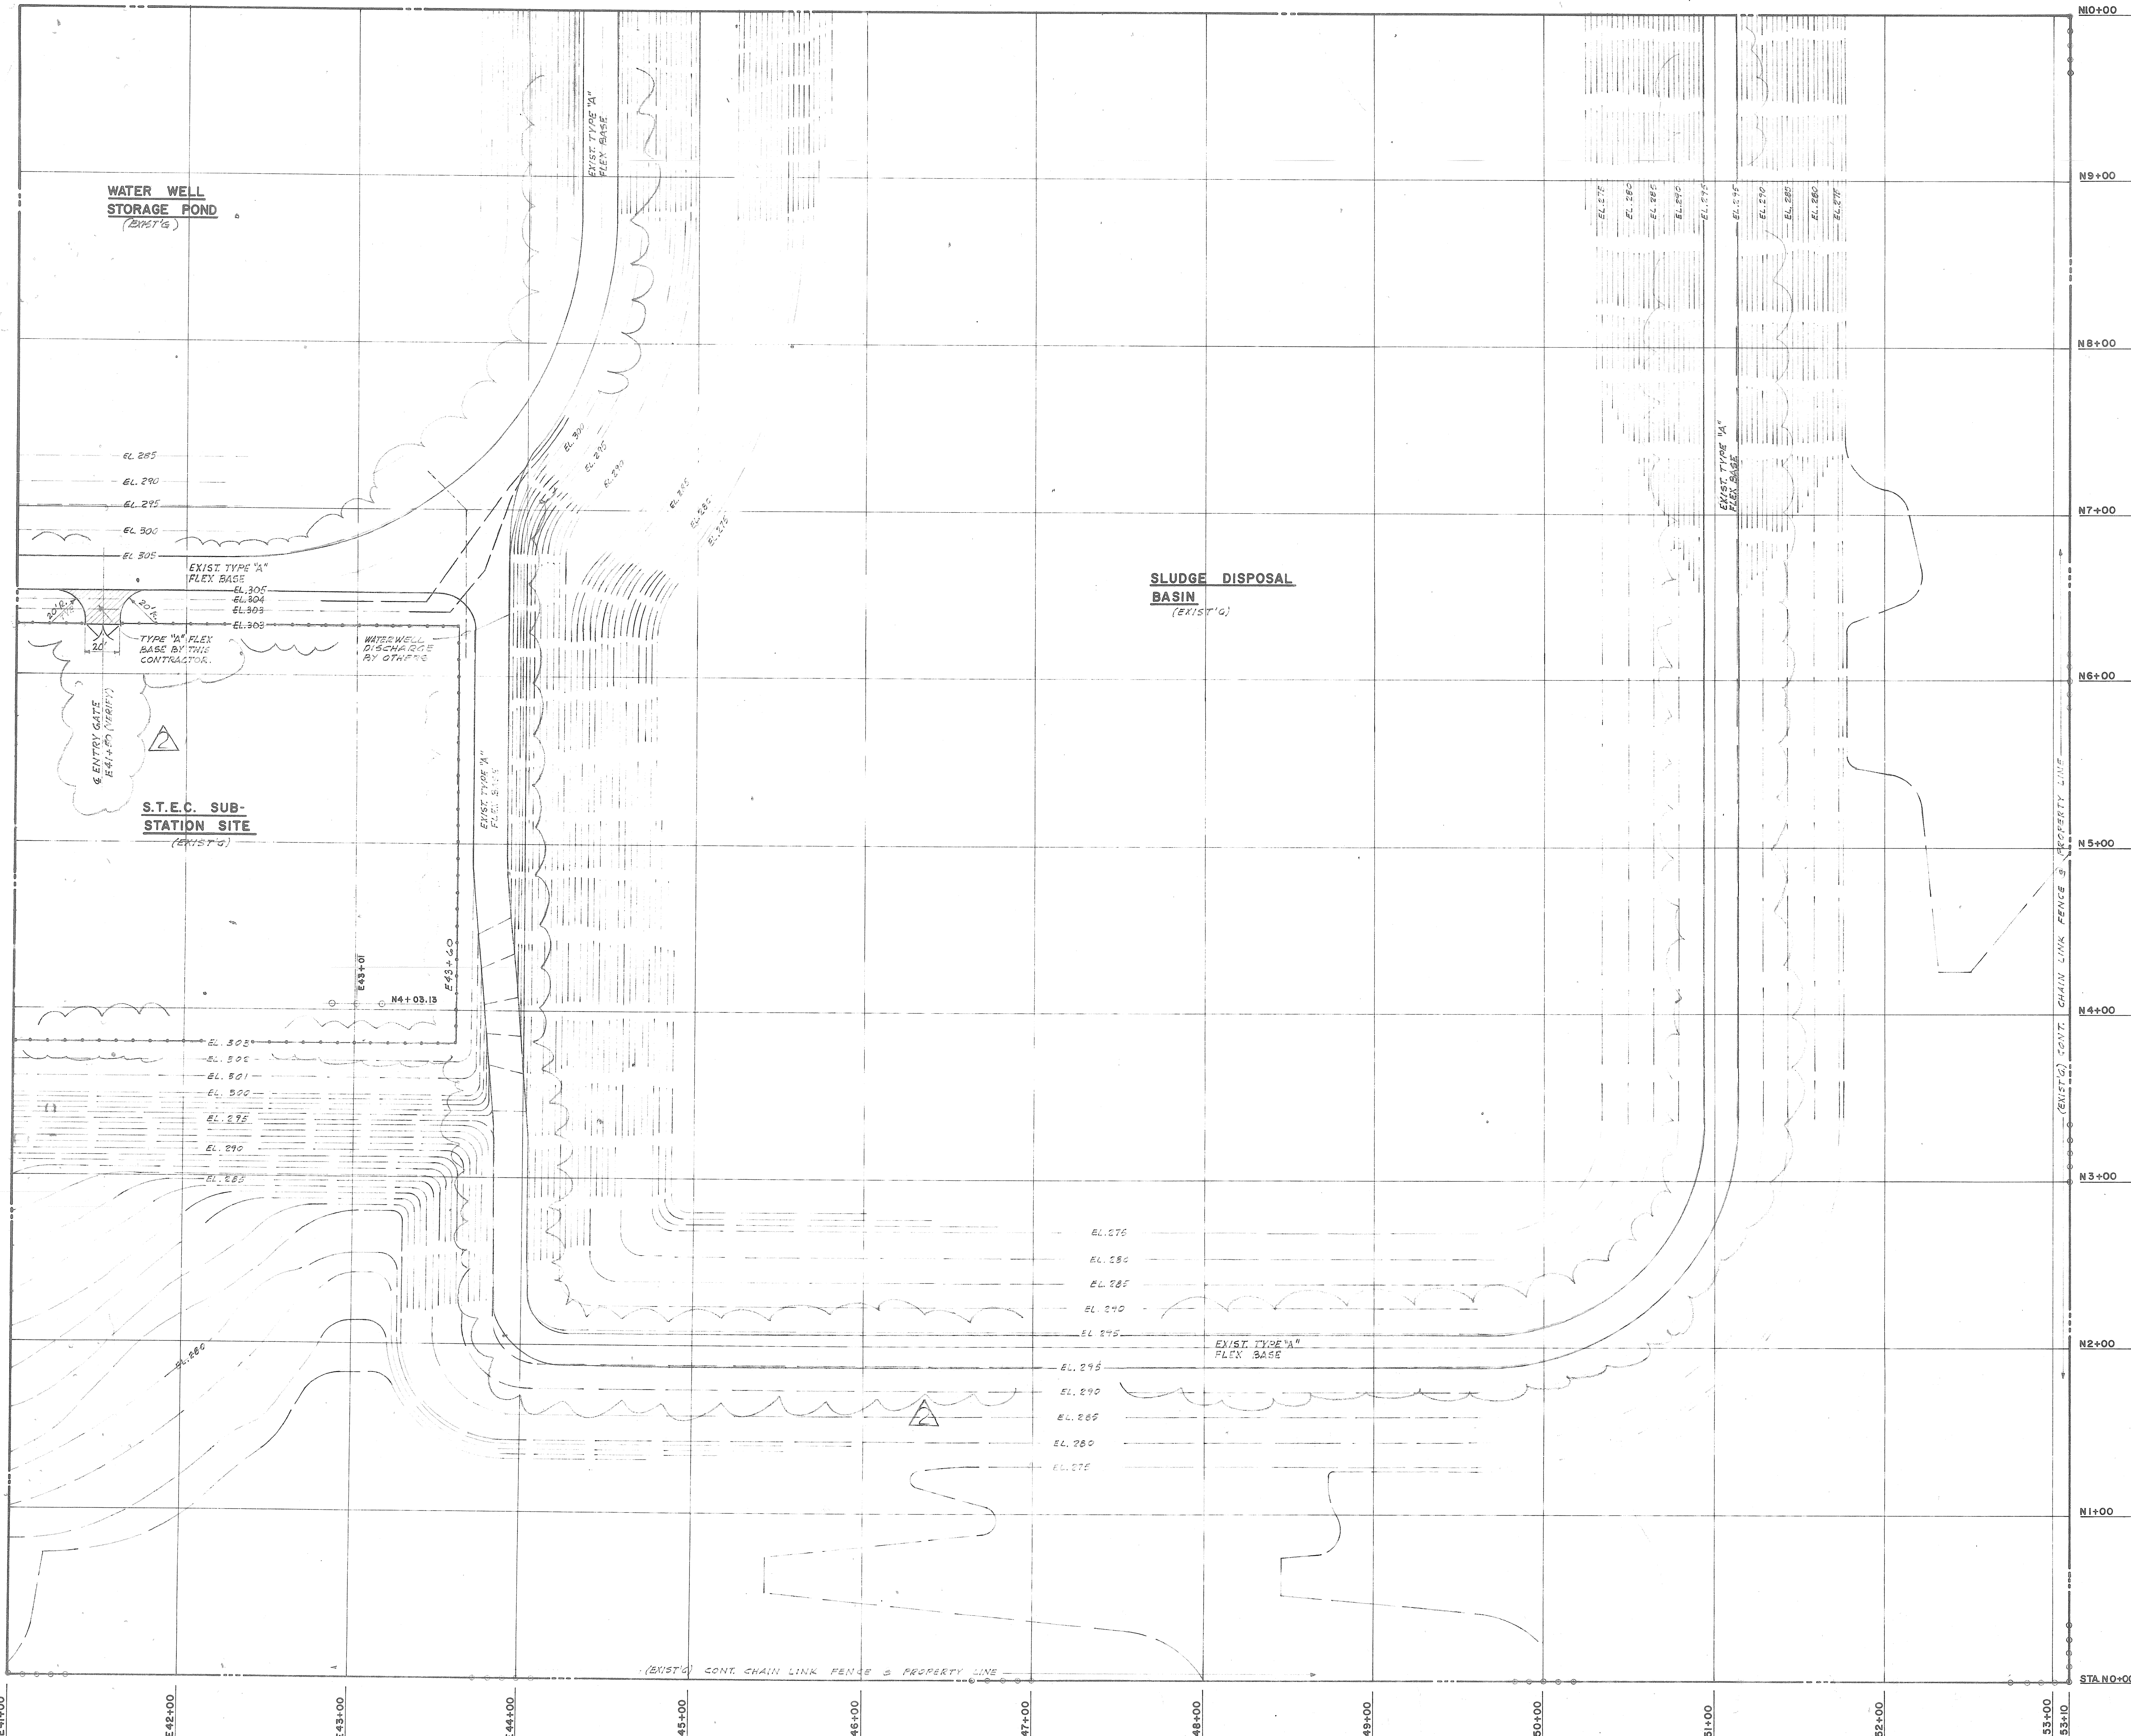
Site Plan Section No. 13, San Miguel Plant Unit No. 1, Drawing No. 1-C-42, Rev. 2, Tippet & Gee, Inc., April 1, 1977, revised April 14, 1980.

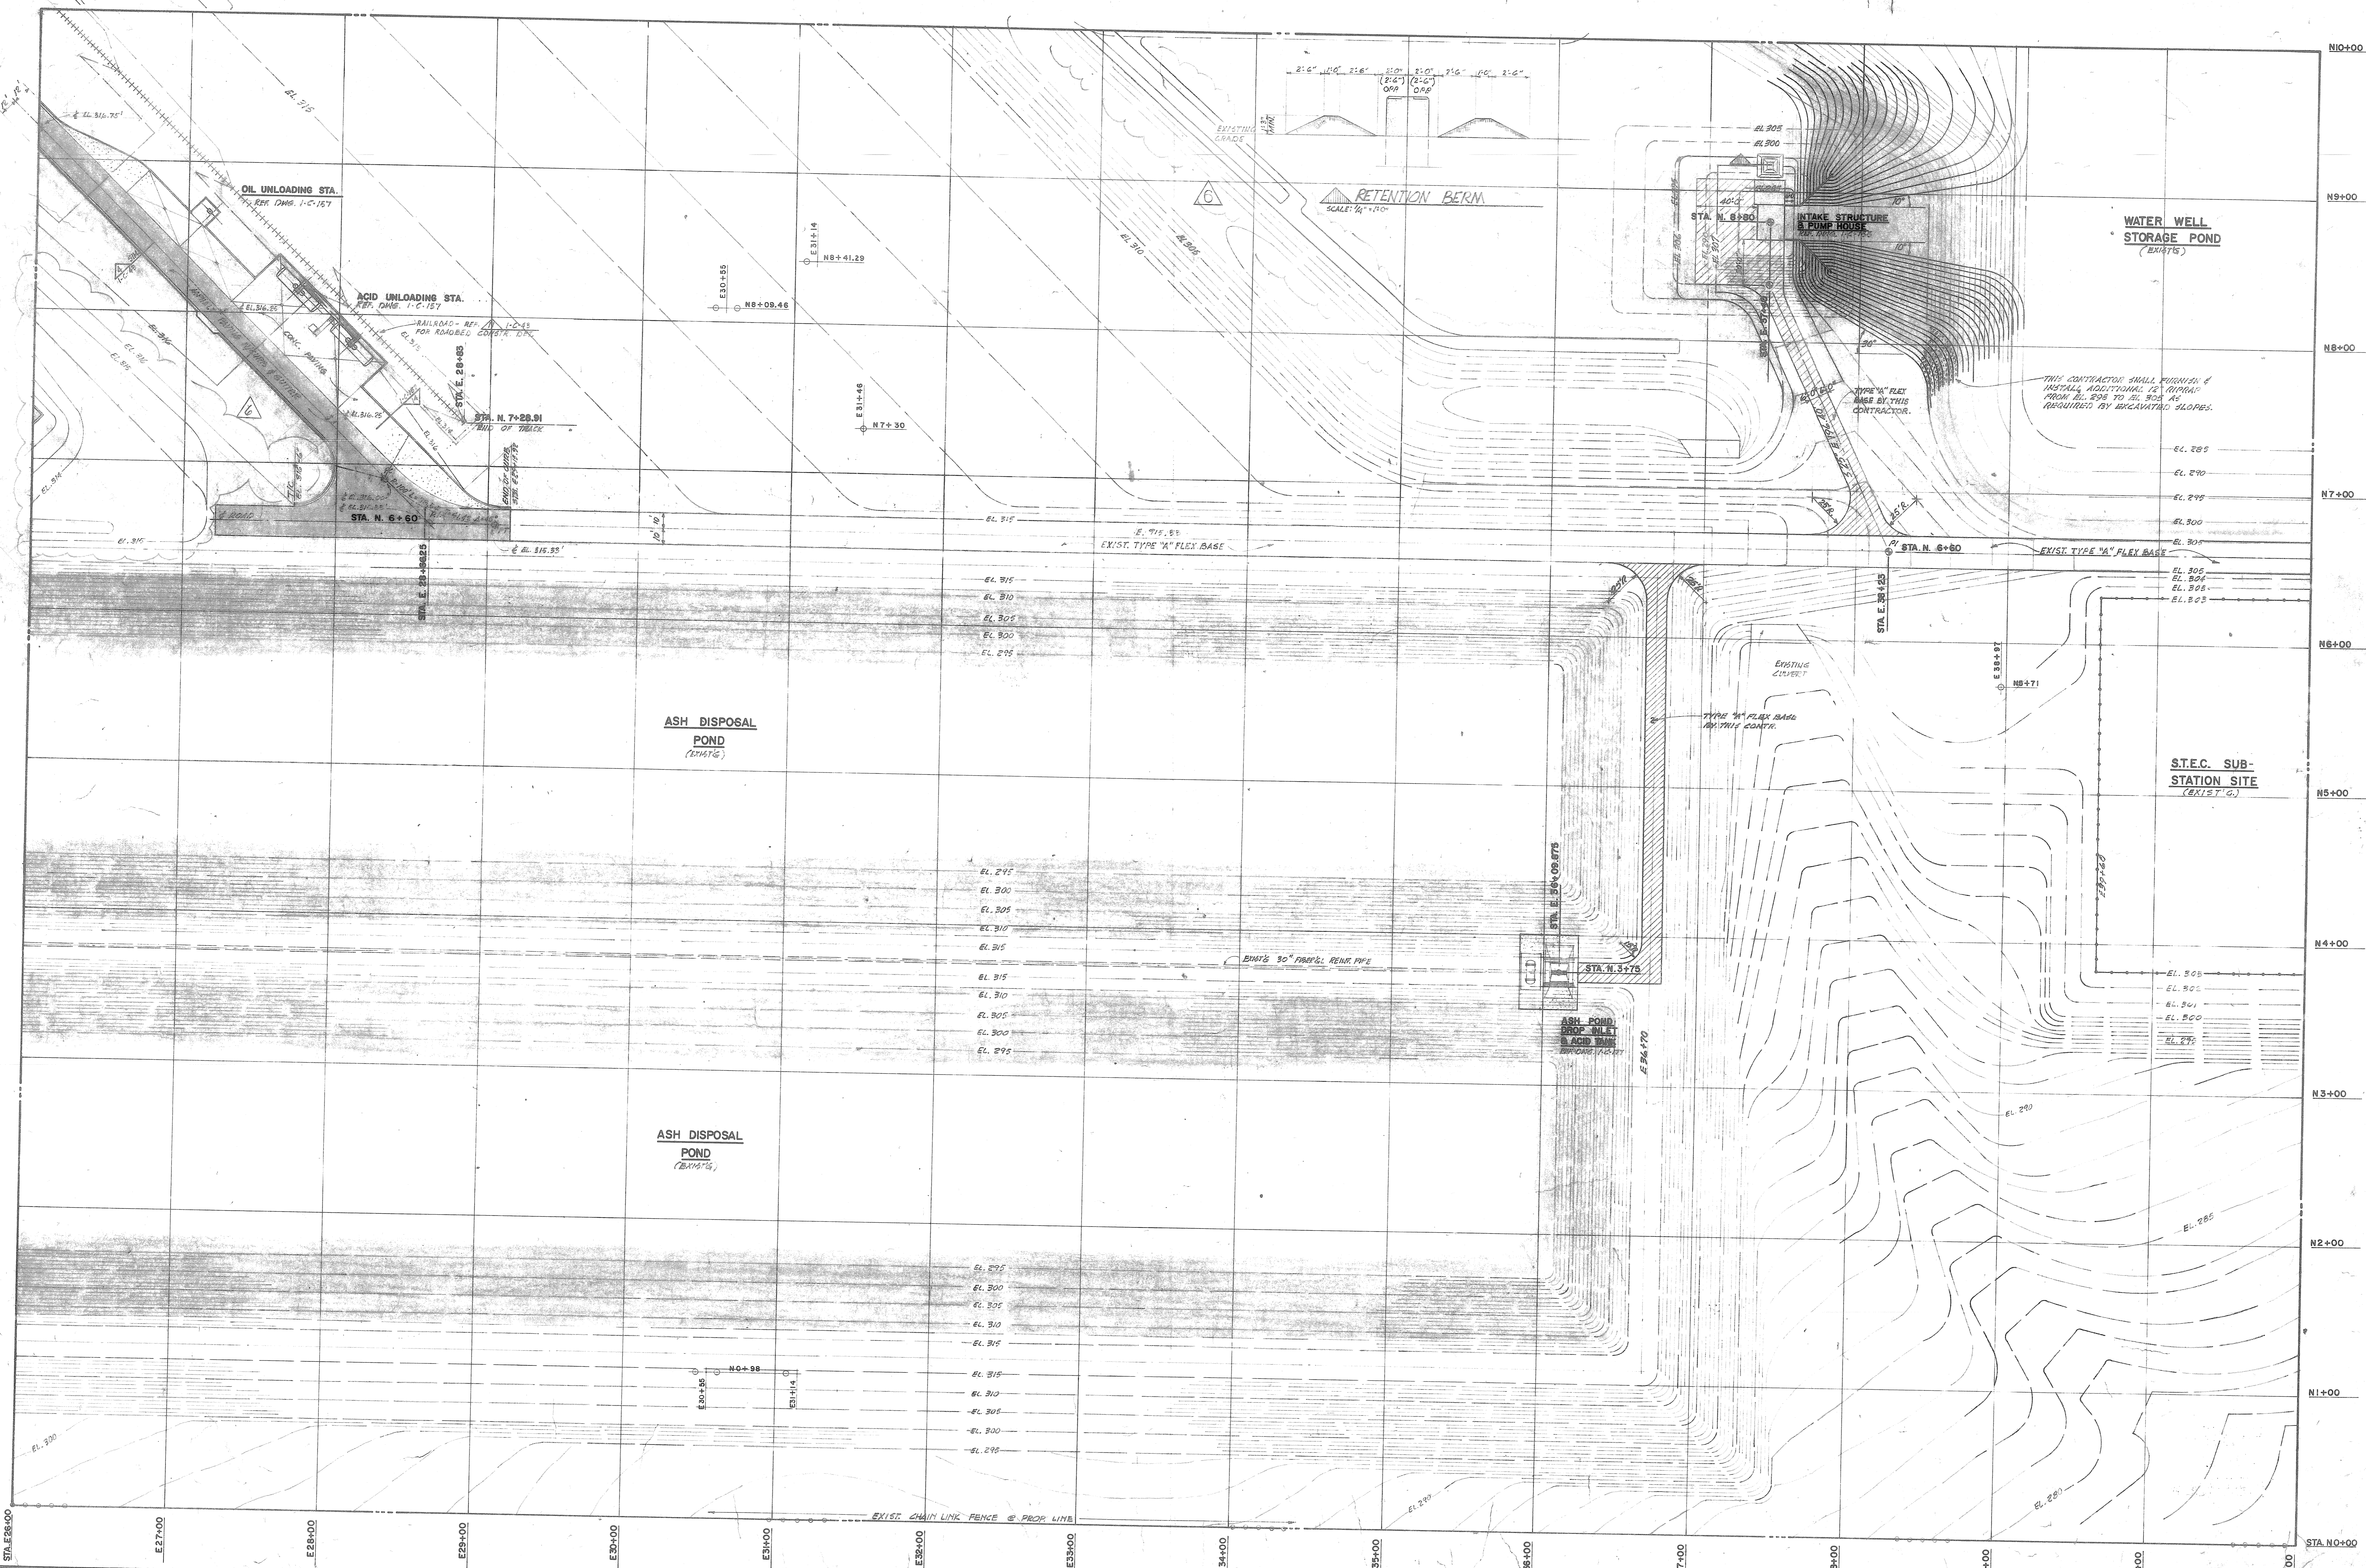
Site Plan Section No. 11, San Miguel Plant Unit No. 1, Drawing No. 1-C-40, Rev. 6, Tippet & Gee, Inc., April 1, 1977, revised June 13, 1980.

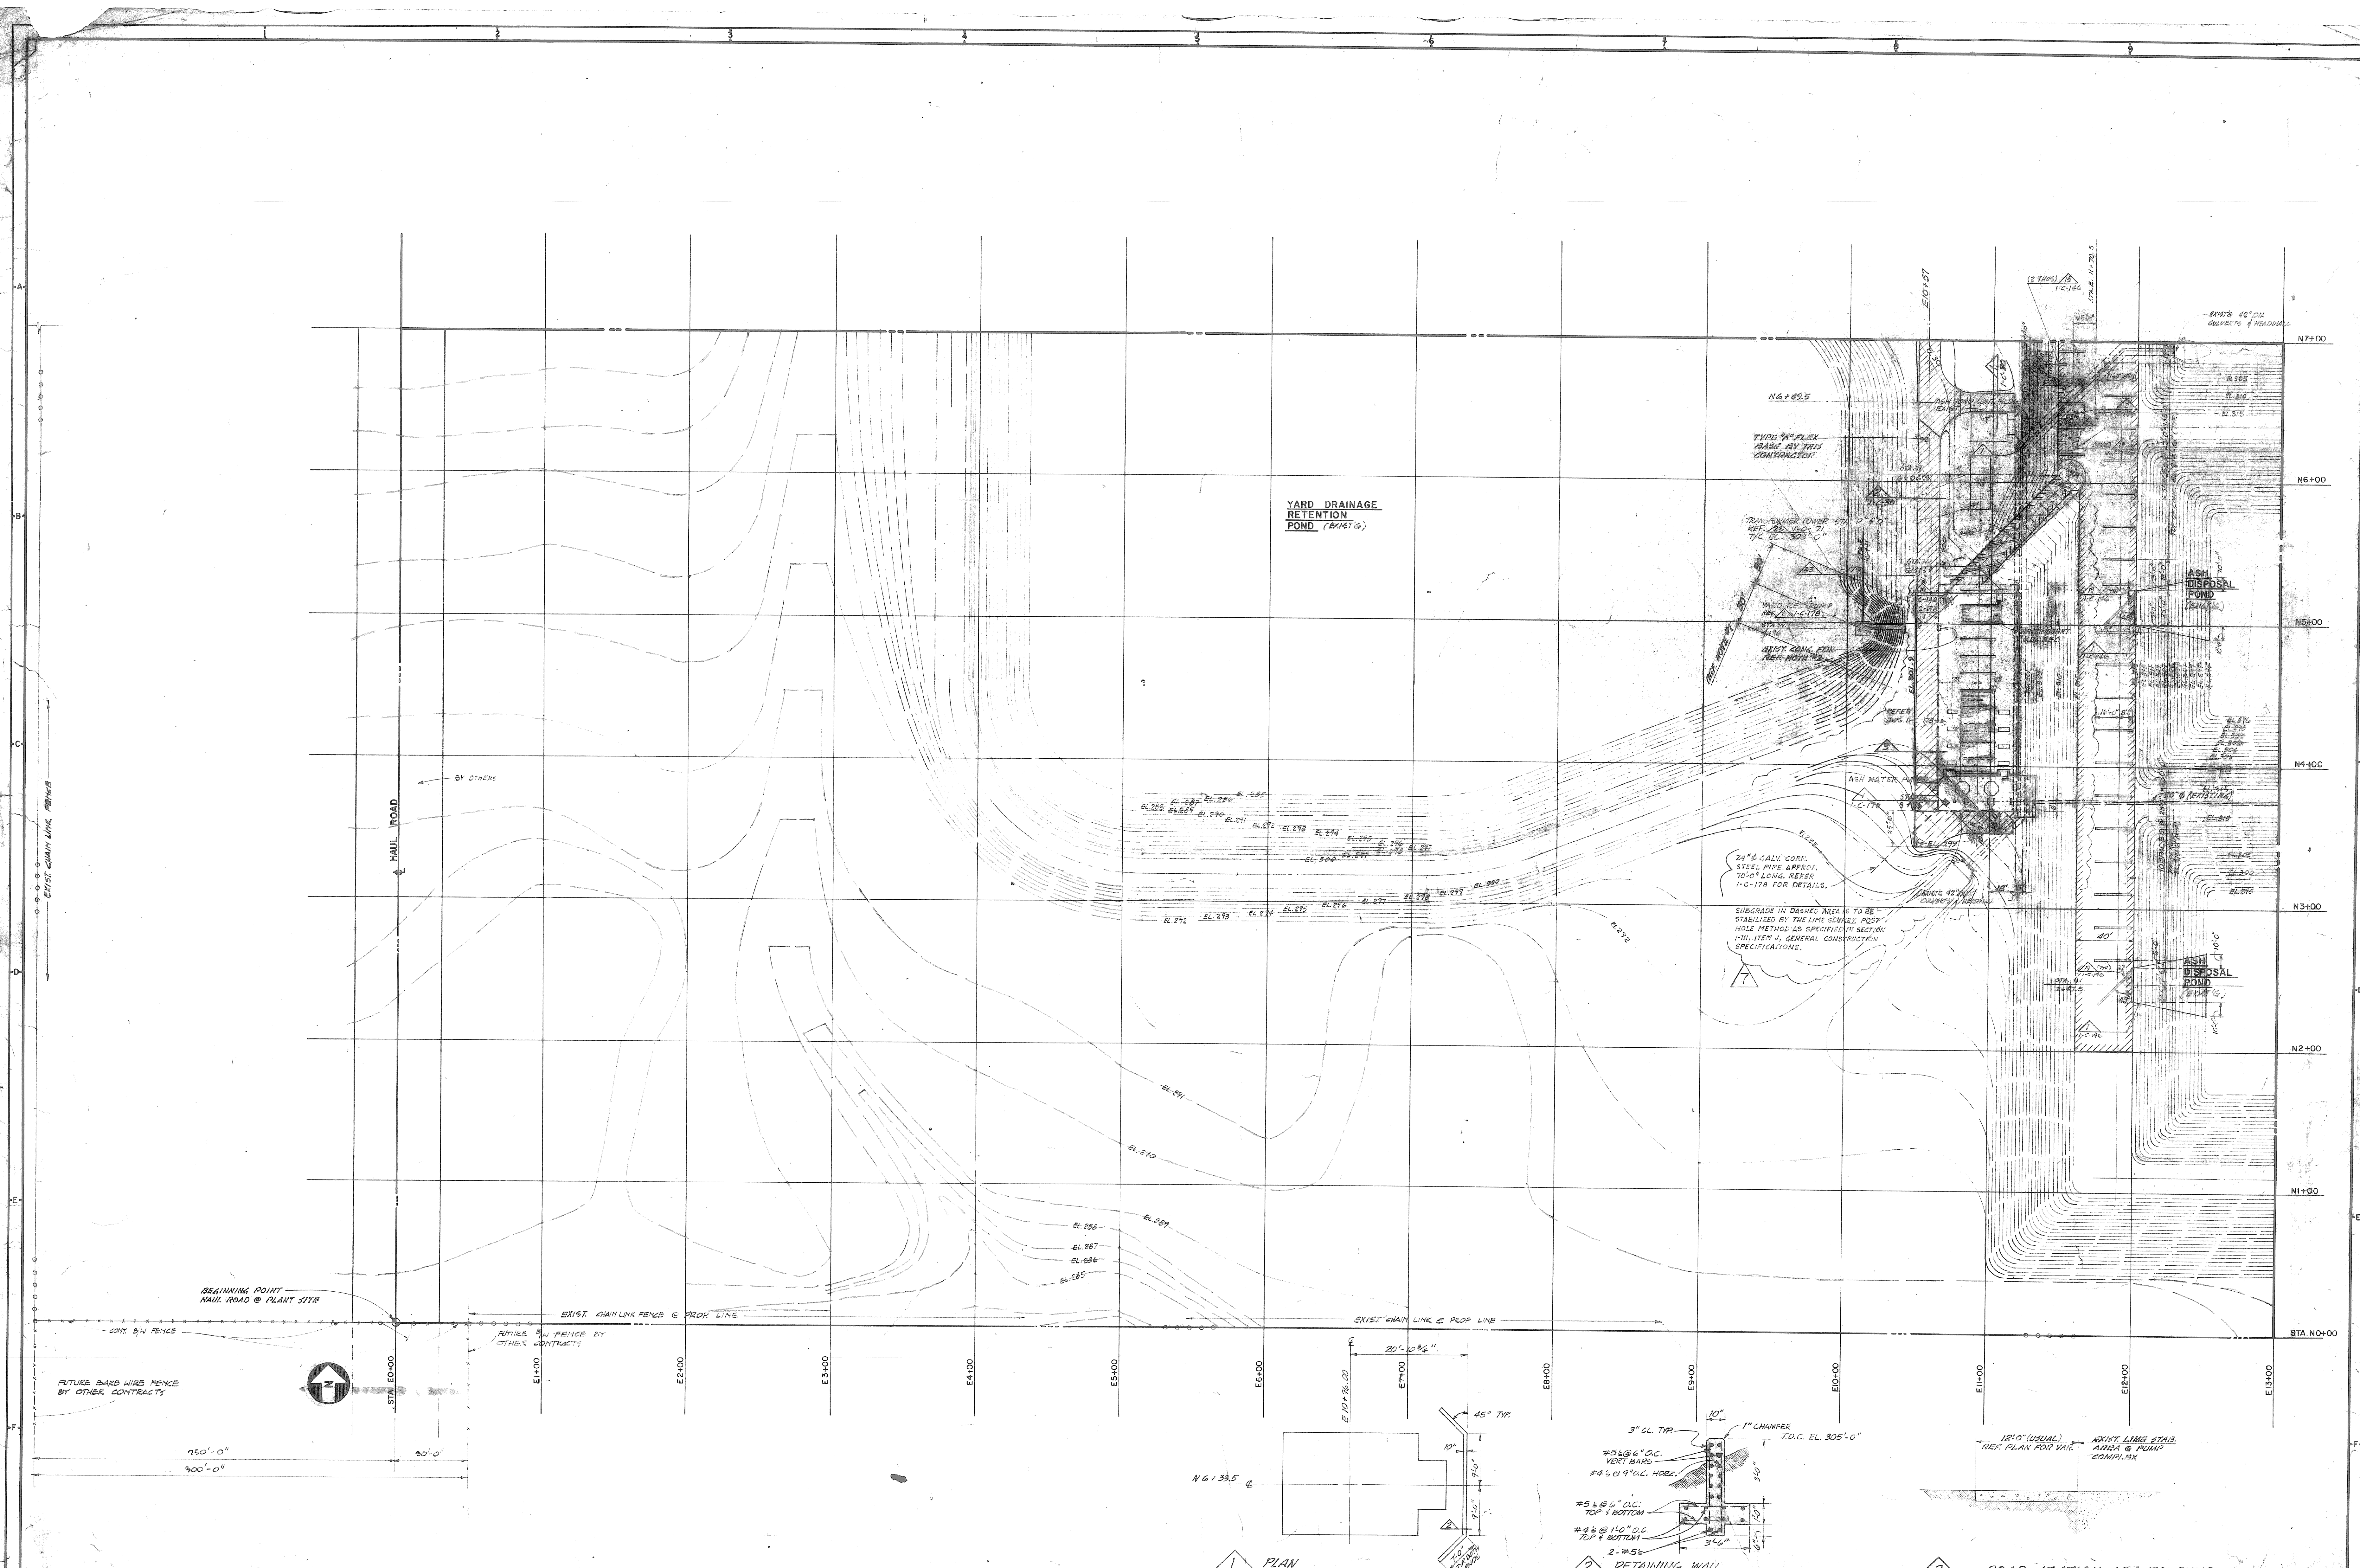
Site Plan Section No. 4, San Miguel Plant Unit No. 1, Drawing No. 1-C-33, Rev. 7, Tippet & Gee, Inc., April 1, 1977, revised May 13, 1981.

1. THIS CONTRACTOR TO FURNISH & INSTALL 12" DIPSAP ALONG SLOPE AROUND CONC. PUMP SUPPORT STRUCT. AS SHOWN. RIPRAP SHALL EXTEND FULL HT. OF SLOPE ELEV. 300' TO ELEV. 300'.
2. EXISTING CONC. FOUNDATION TO BE REMOVED TO TOP OF PIERS, ELEV. 299'0"
